Maine Department of Transportation

Pavement Condition Report

DEWITT FIELD OLD TOWN MUNICIPAL AIRPORT (KOLD)

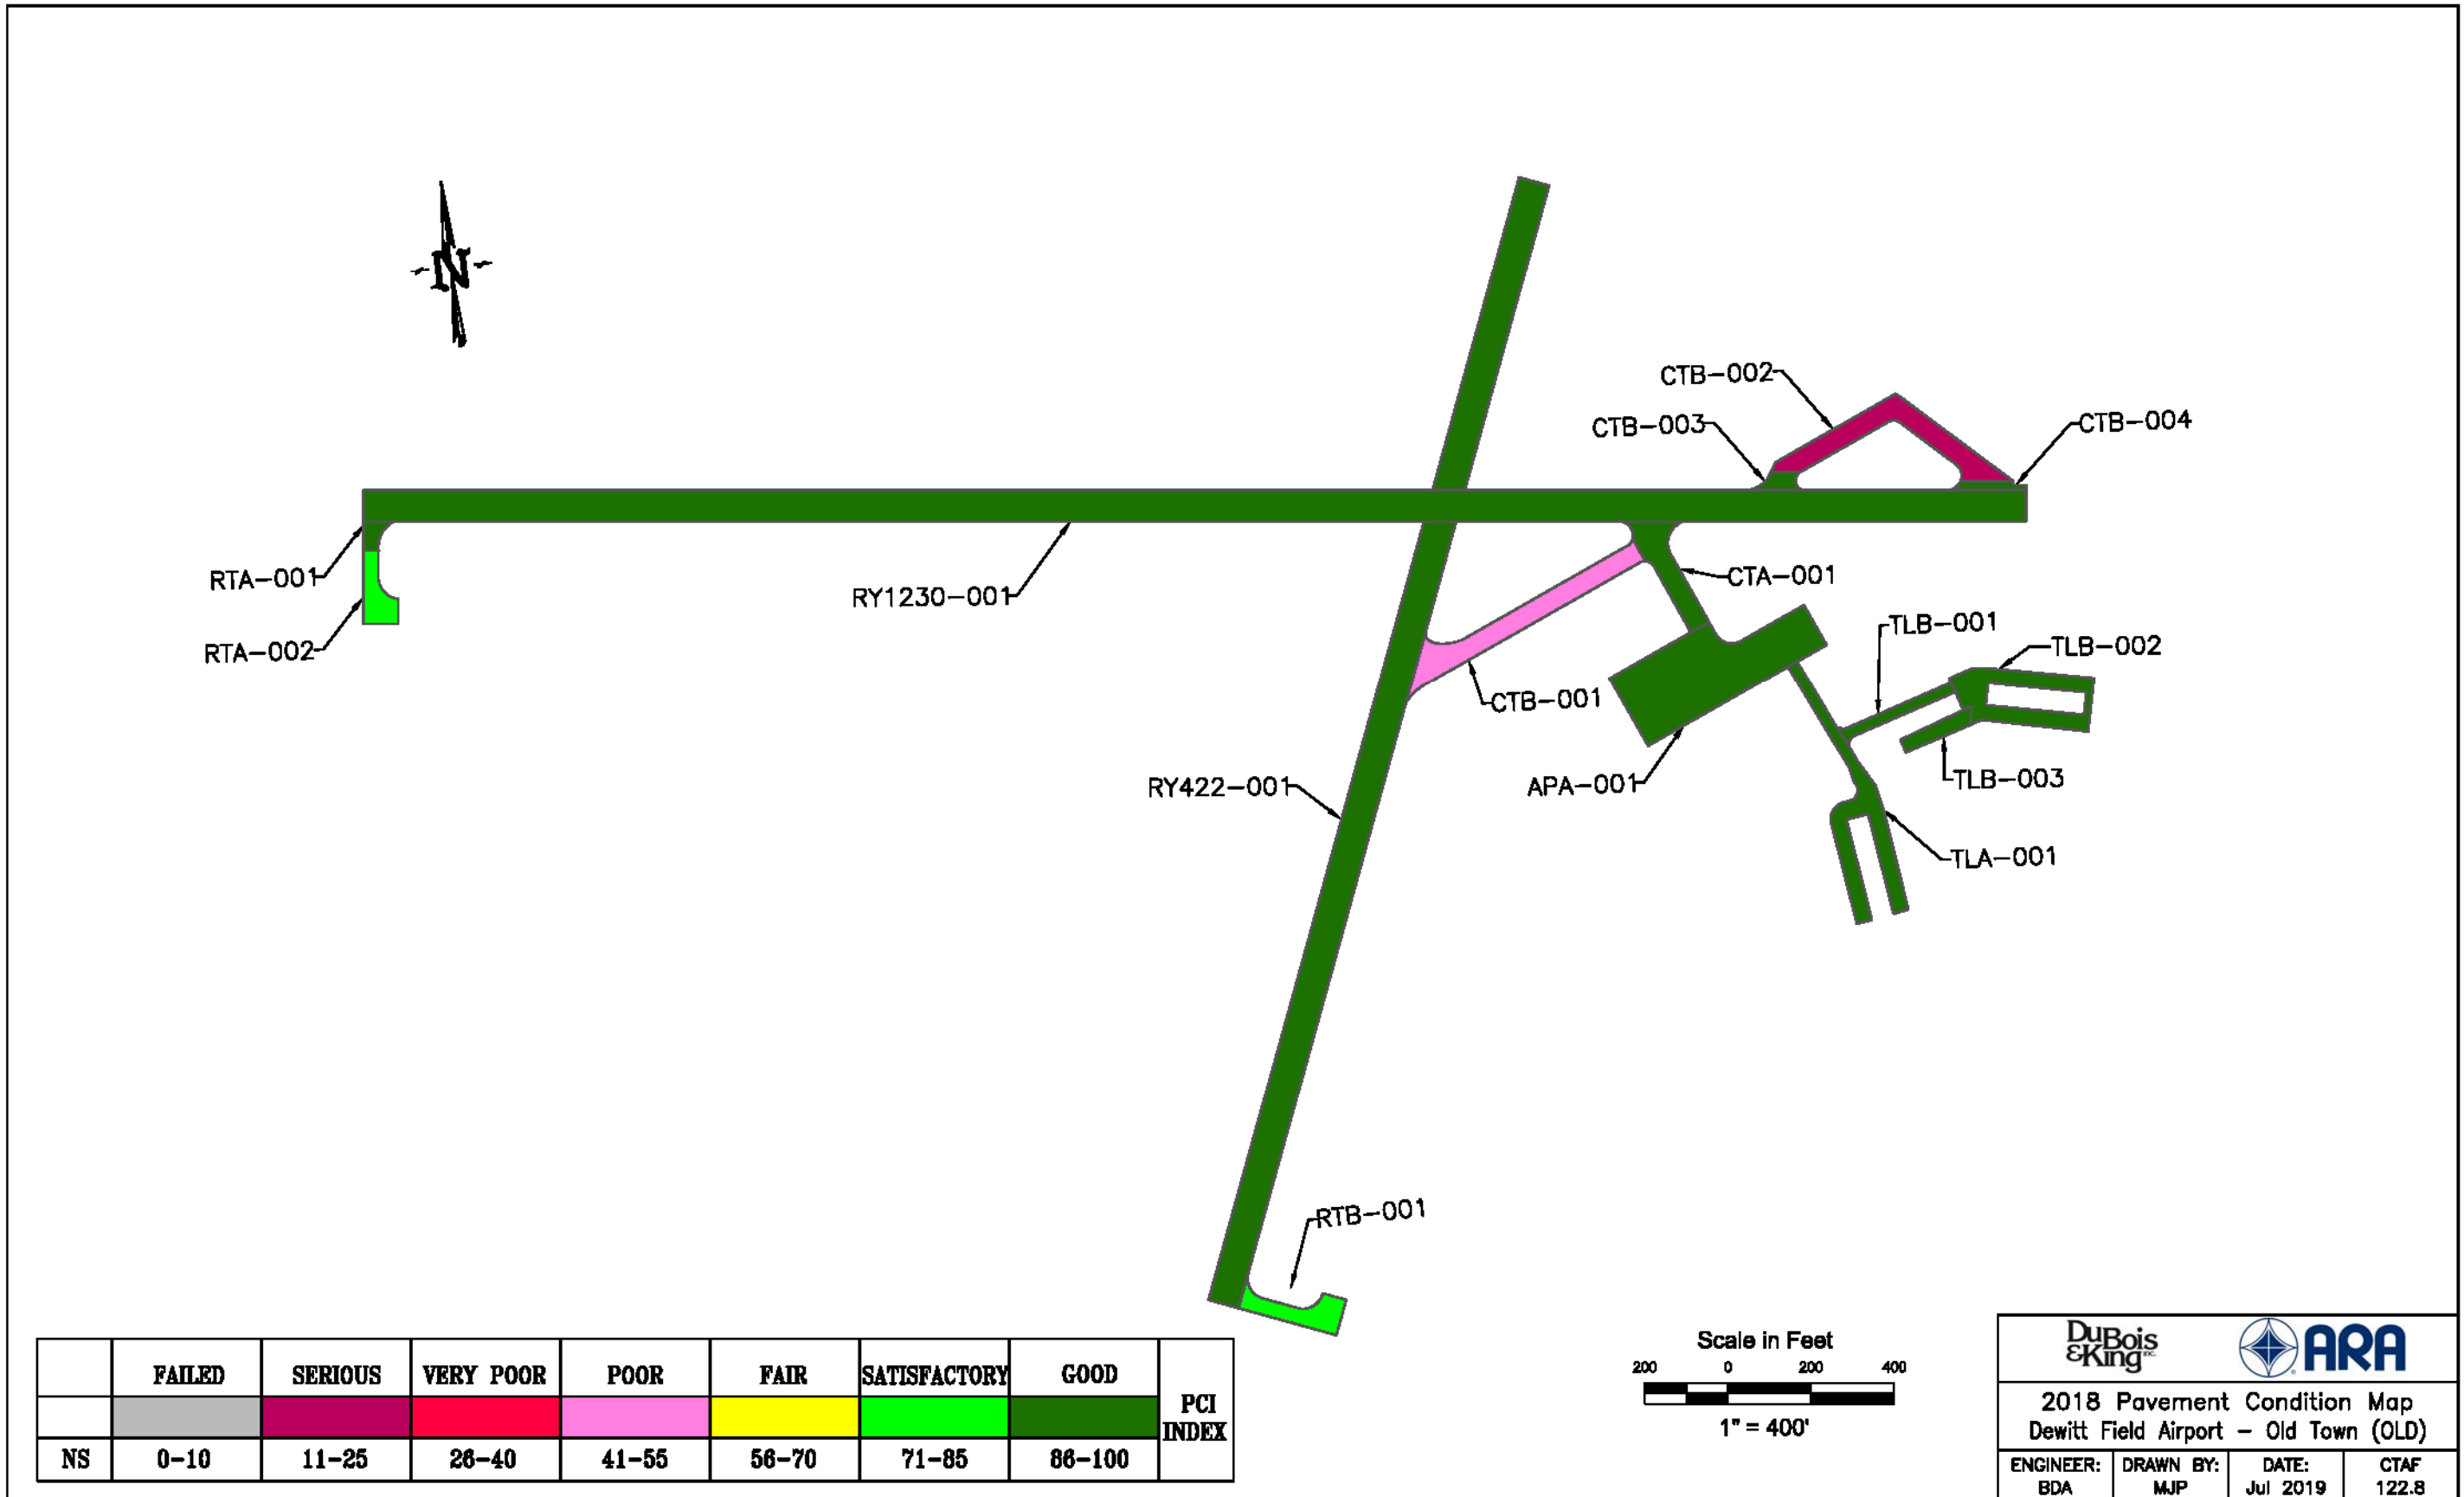
Figure 7. 2018 PCI Map at Dewitt Field Airport – Old Town (OLD)

The average inspected Pavement Condition Index (PCI) for all the airfield pavements at OLD was 93. Runways had an average inspected PCI of 99, which is above the MSL of 70. Taxiways had an average inspected PCI of 55, taxilanes had average inspected PCI of 94, and aprons had an average inspected PCI of 97. A comparison of the average PCI values at OLD to the statewide average PCI values, by branch use, is shown in the figure below.

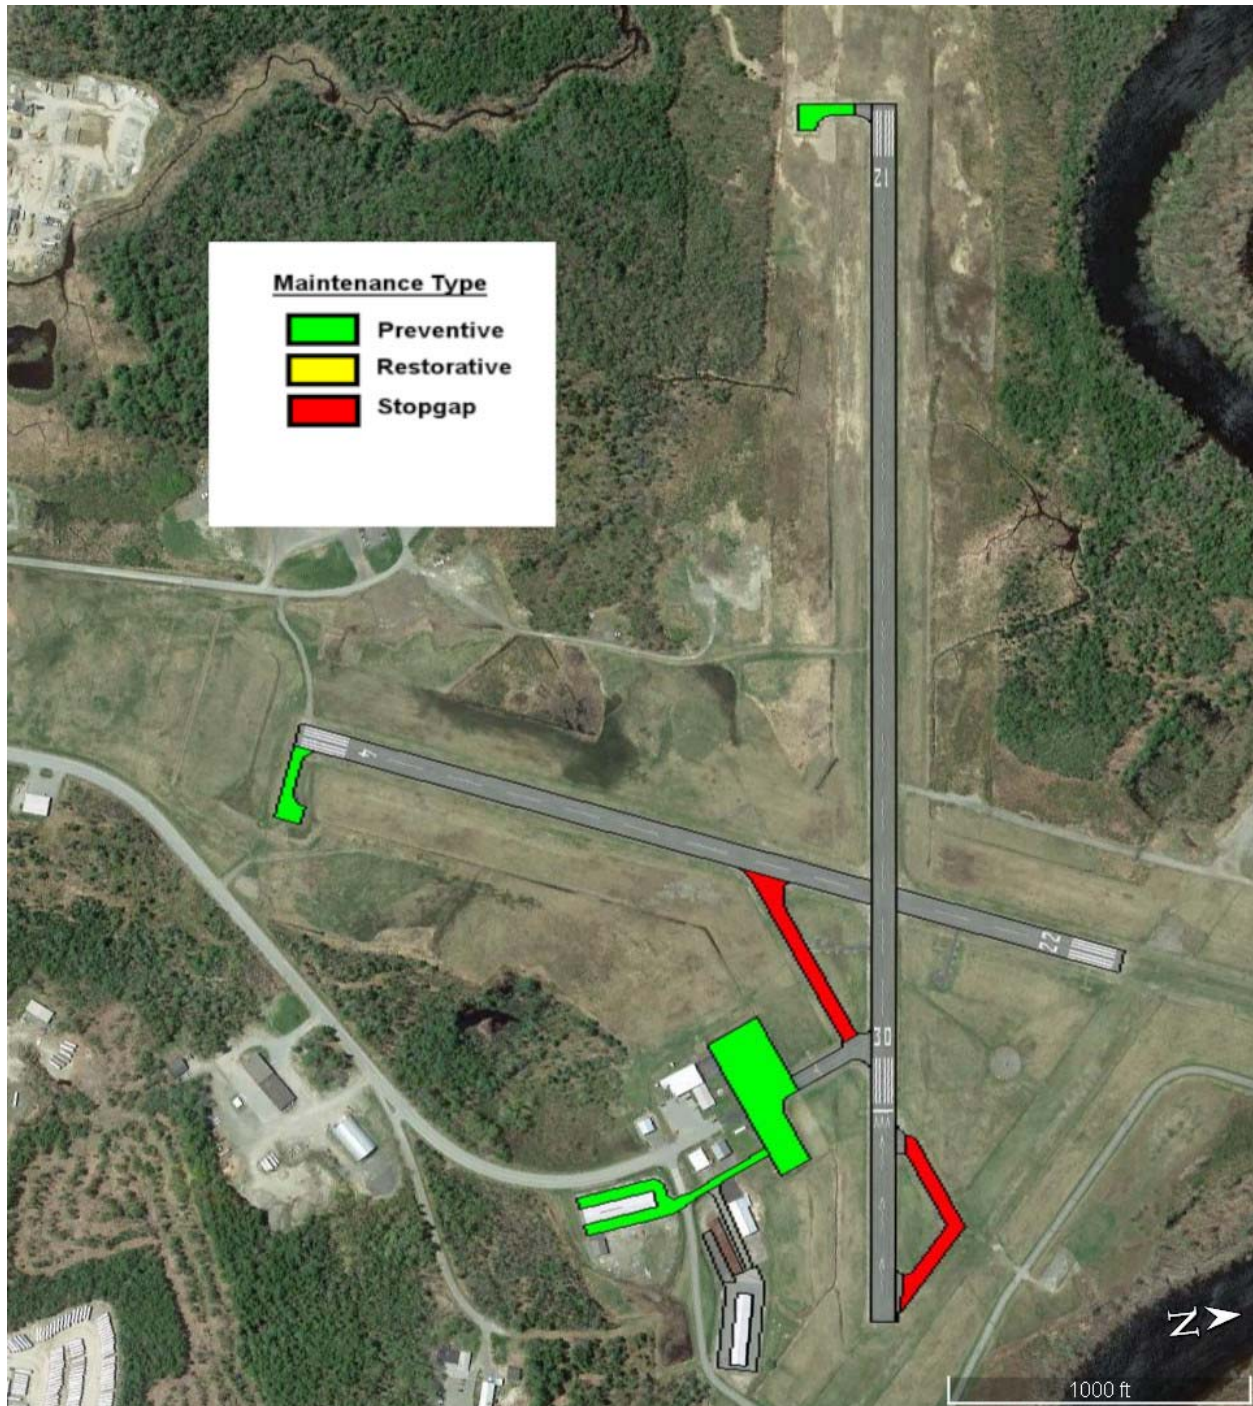
Figure 8. Maintenance type

Table 7 presents the summary of maintenance work quantities and estimated costs to apply the near term maintenance plan at OLD. The repair quantities are based on extrapolated distress quantities from PAVER using the 2018 PCI inspection and the maintenance policy matrix as defined in appendix E.

Branch	Section	Work Type	Quantity	Unit	Cost
APA	001	Crack Sealing - AC	13	Ft	\$18
CTB	001	Crack Sealing - AC	771	Ft	\$1,064
CTB	001	Patching - AC Deep	3,418	SqFt	\$63,512
CTB	001	Patching - AC Shallow	80	SqFt	\$1,339
CTB	002	Crack Sealing - AC	2,362	Ft	\$3,260
CTB	002	Patching - AC Deep	9,879	SqFt	\$183,558
RTA	002	Crack Sealing - AC	152	Ft	\$209
RTB	001	Crack Sealing - AC	19	Ft	\$26
TLA	001	Crack Sealing - AC	46	Ft	\$63

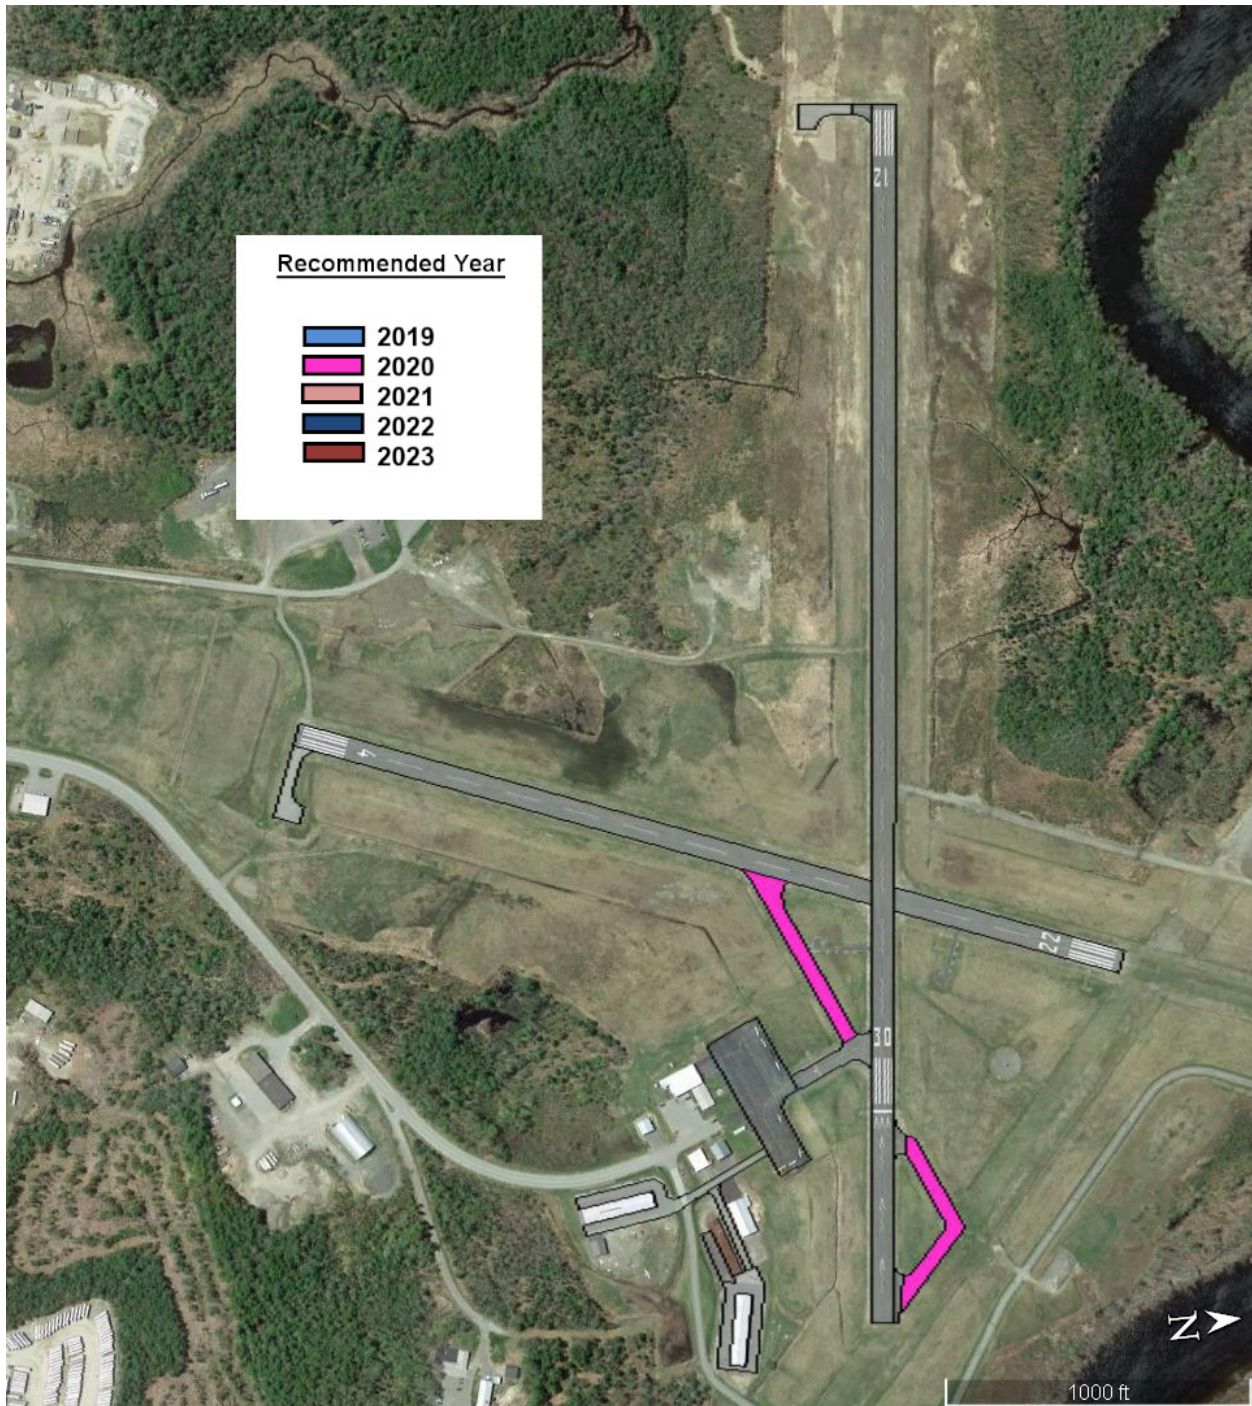
Figure 9. Major M&R

The pavement sections identified for major rehabilitation in Table 10 and shown in Figure 9 are at or are predicted to reach a condition level where major M&R should be considered. While the predicted rehabilitation timeline identifies specific sections and the general timing for the repair, more in-depth project-level studies will be needed to determine exactly how to fix each pavement (i.e. asphalt overlay, reconstruction, or some other repair alternative). Additionally, the airport may find it desirable to adjust the timing of projects to meet fiscal and operational constraints. For example, if the runway and several connector taxiways were forecast to reach the MSL in various years ranging from 2019-2023, it may be preferable to group these pavement sections into a single project.

Branch ID	Section ID	Year	Predicted PCI Before Rehab	Estimated Cost
CTB	001	2020	38	\$696,648
CTB	002	2020	21	\$649,729
5-year Airport Total				\$1,346,377

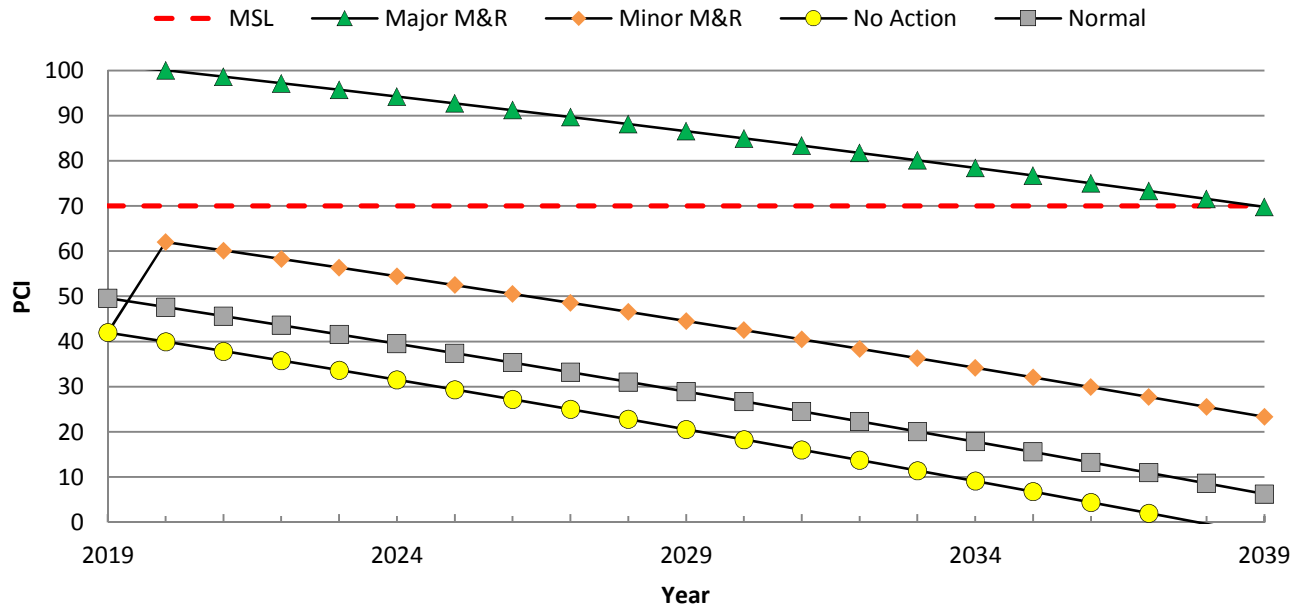
Section:	OLD::CTB::001
Description:	Connecting Taxiway B
PaveType:	AC
Area:	34,150
Built:	1/15/1989
Age:	30yr

M&R	Action	Year / Quantity	Cost (\$)	Ending PCI
Major	Major M&R	2020	696,648	100
Minor	All Minor	2020	65,915	62
1	Patching - AC Deep	3418 SqFt	63,512	-
2	Patching - AC Shallow	80 SqFt	1,339	-
3	Crack Sealing - AC	771 Ft	1,064	-
4	-	-	-	-
5	-	-	-	-
6	-	-	-	-
7	-	-	-	-

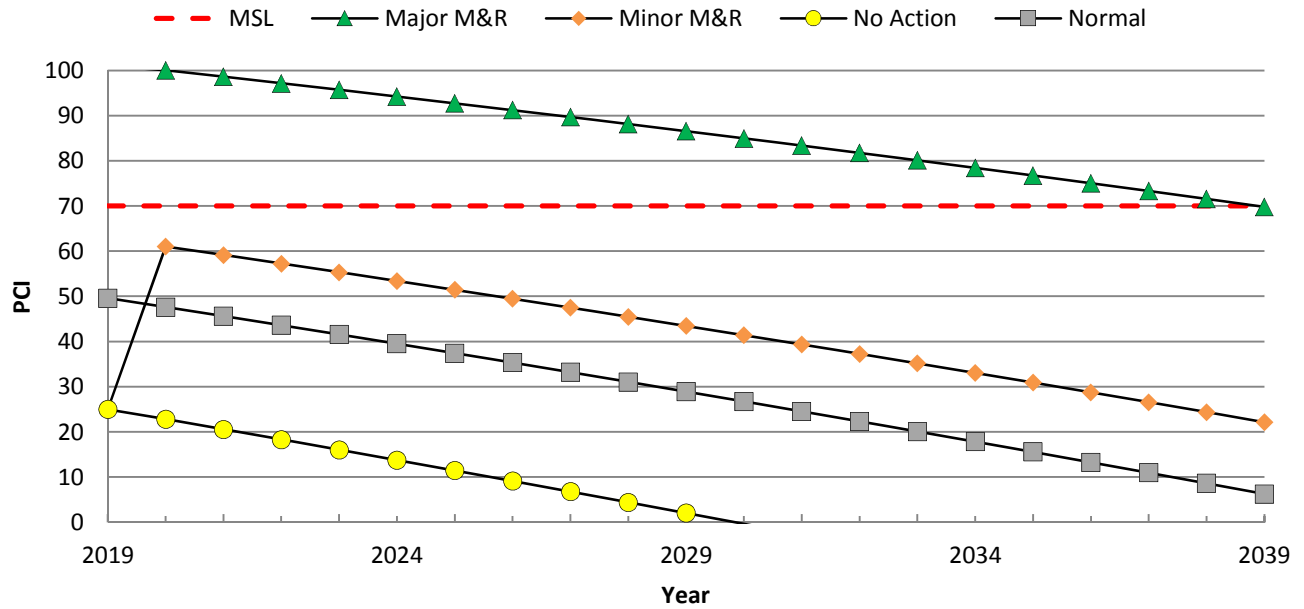
Section:	OLD::CTB::002
Description:	Connecting Taxiway B
PaveType:	AC
Area:	31,850
Built:	1/15/1989
Age:	30yr

M&R	Action	Year / Quantity	Cost (\$)	Ending PCI
Major	Major M&R	2020	649,729	100
Minor	All Minor	2020	186,817	61
1	Patching - AC Deep	9879 SqFt	183,558	-
2	Crack Sealing - AC	2362 Ft	3,260	-
3	-	-	-	-
4	-	-	-	-
5	-	-	-	-
6	-	-	-	-
7	-	-	-	-
