Geologic Site of the Month
November, 2007

Brunswick, Maine Patriots' Day 2007 Landslide

Text by
Michael E. Foley

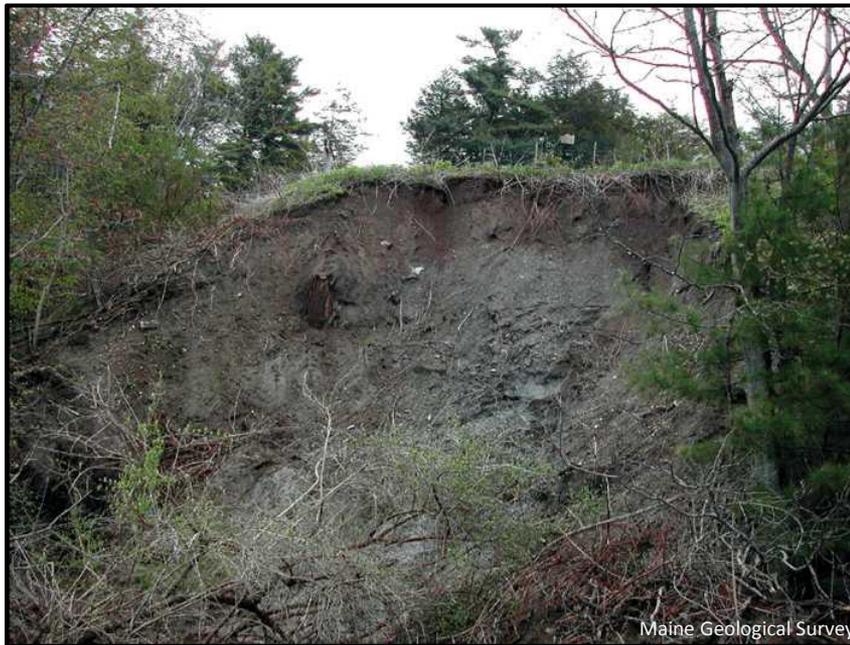
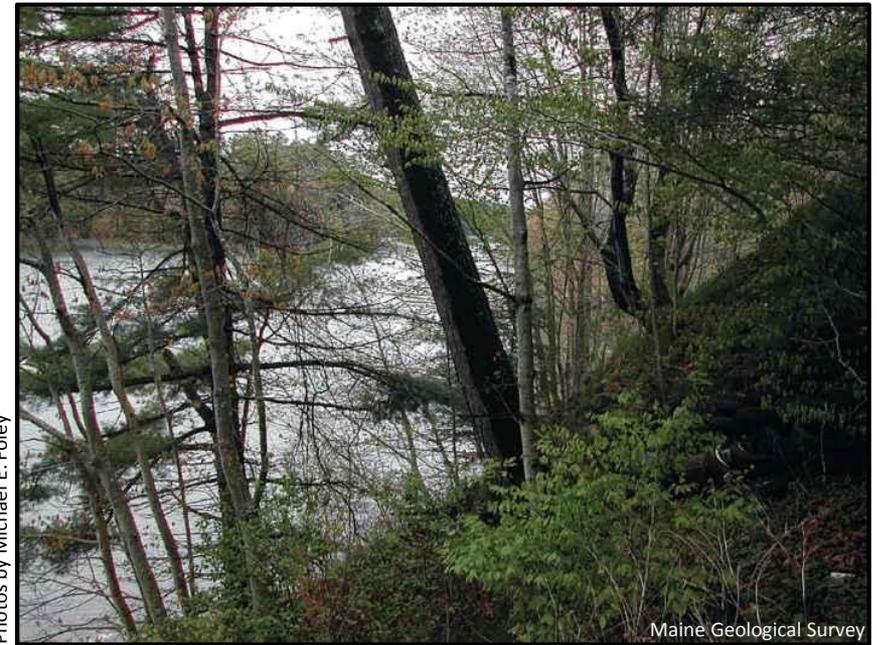
Figure 1. (Left) View of the rotational landslide looking northeast from Buttermilk Cove toward Route 24 (Gurnet Road). (Right) Bluff slope and leaning trees. Buttermilk Cove is in the background.

The slide occurred along a steep bluff (Bryant and others, 2002) adjacent to Route 24 (Gurnet Road) (Figure 3). The bluff top was about 30 feet above sea level (Figure 1, Right).

1. **Unstable soils** - leaning trees exhibiting prior slope creep and movement. The presence of large leaning trees demonstrates that earth movement has been continual over time.

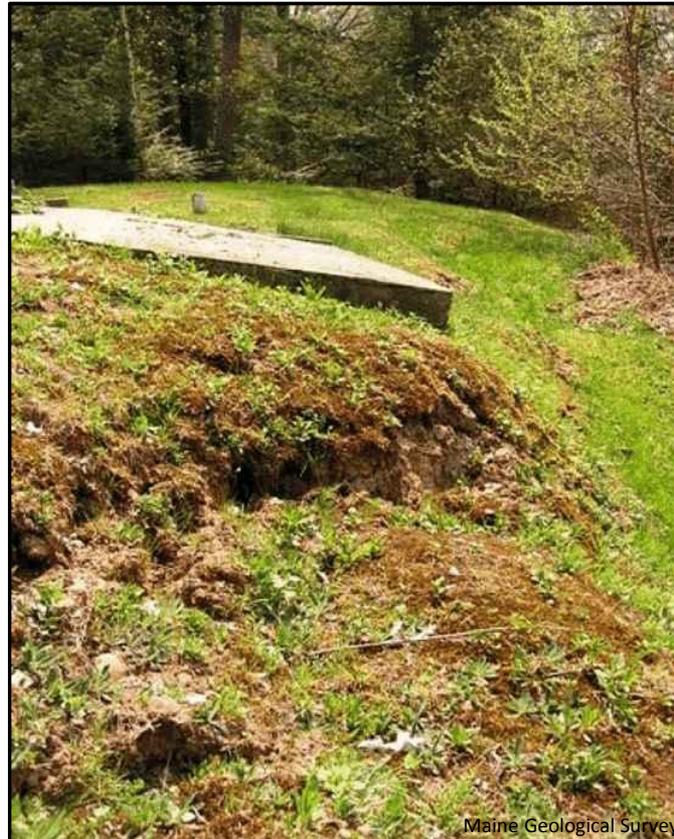
Figure 2. Backyard slumping and scarps show down-dropped sections of earth. The top of the bluff and shoreline are to the right and the house to the left.

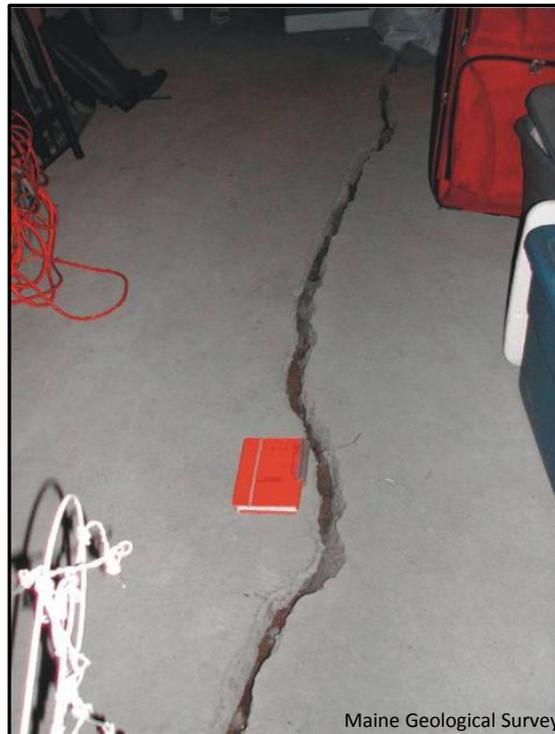
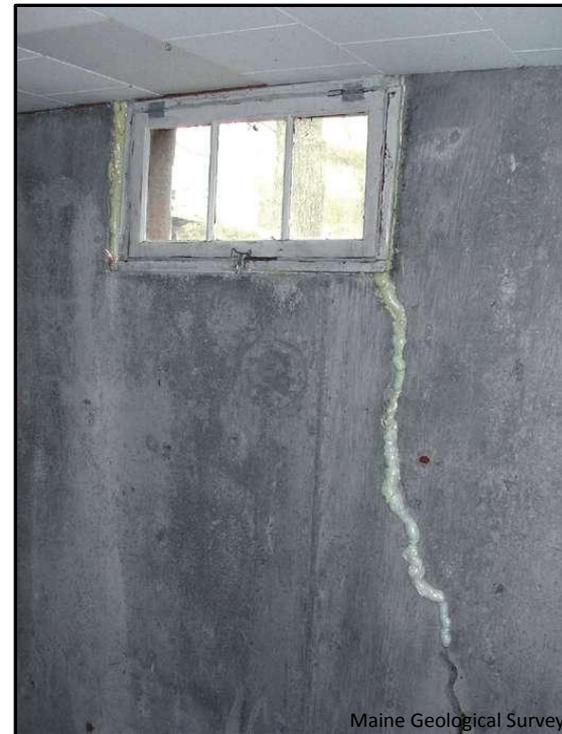
This site location has evidence of prior slope failure and subsidence. The basement and foundation walls show previous cracking due to ground subsidence (Figures 5). The most prominent crack runs along the entire length of the basement floor and resulted in a slight separation in the cement. The floor section on the west side of the basement towards the water shows subsidence and also drastic sloping down toward the shoreline.

Figure 5. (Left) Basement floor of the residence with a large crack parallel to the bluff face. (Right) Relic basement wall cracks from previous subsidence. The bluff is to the right.

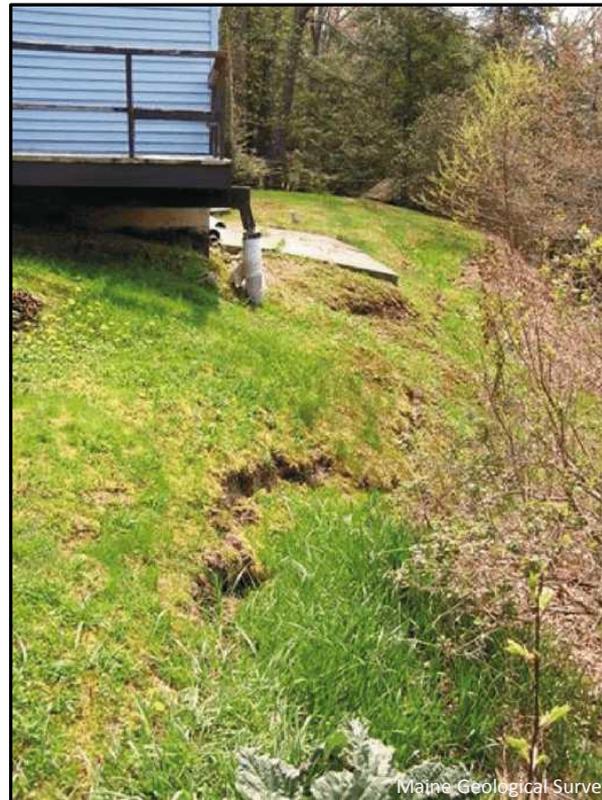
The back yard, which is located west of the house towards the water, exhibits extensive subsidence and sloping from prior slope failure events (Figure 6). There is evidence of 2 to 3 old landslide scarps in this same area between the building and the bluff face.

Figure 6. Back yard showing subsidence, tension cracks and small landslide scarps. The shoreline is to the right and the major landslide site is behind the photographer.

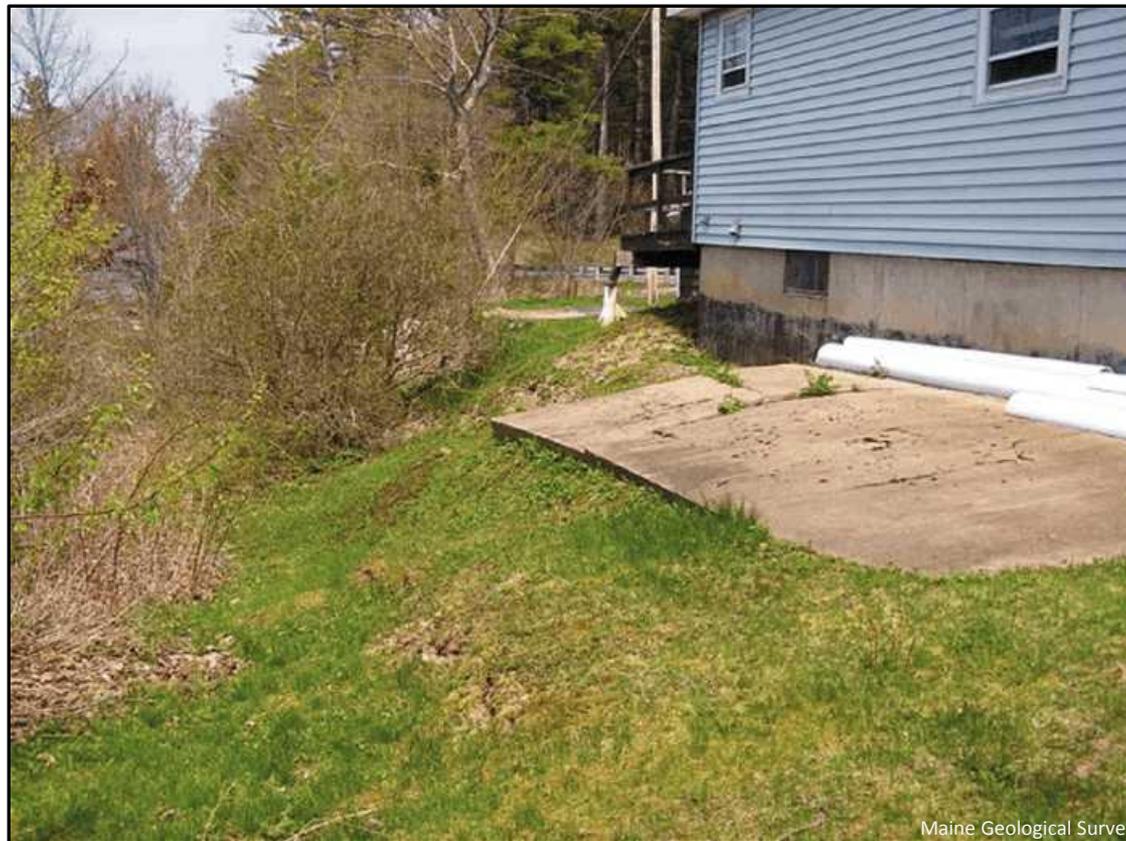
A cement patio, built in the early 1970's level to the ground, now exhibits a 20-degree slant towards the water (Figure 7). The patio slab is now completely broken up and cracked by previous ground movements.

Figure 7. Patio slab showing slumping, multiple cracks and uneven vertical offset. Buttermilk Cove is to the left.

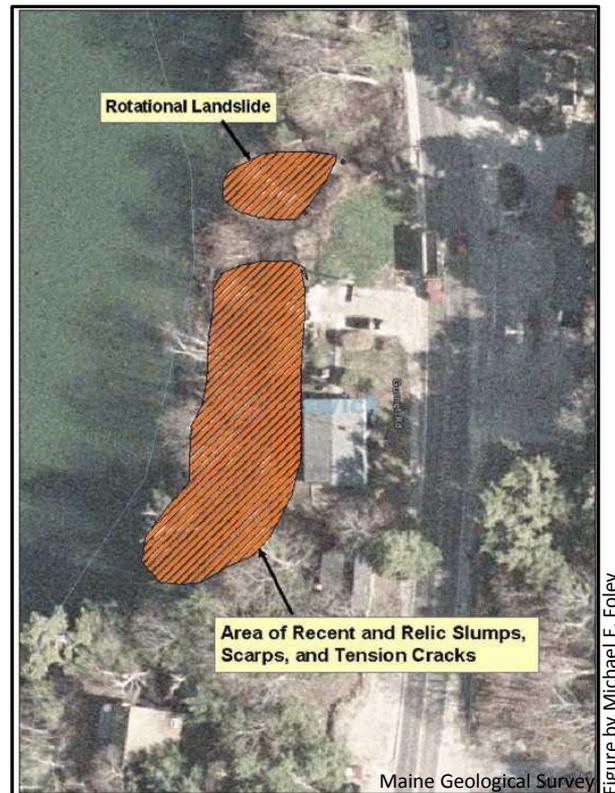
During a site visit by Maine Geological Survey geologists, two distinct areas of slope failures were observed (Figure 8). One, a large rotational landslide, occurred 90 feet north of the house in an area where runoff from both a cross-road culvert and the leach field drainage were focused. This rotational slide produced a distinct 30-foot long concave scarp with a tree-covered toe at the base.

Figure 8. Aerial photograph showing areas of rotational slides and slumping.

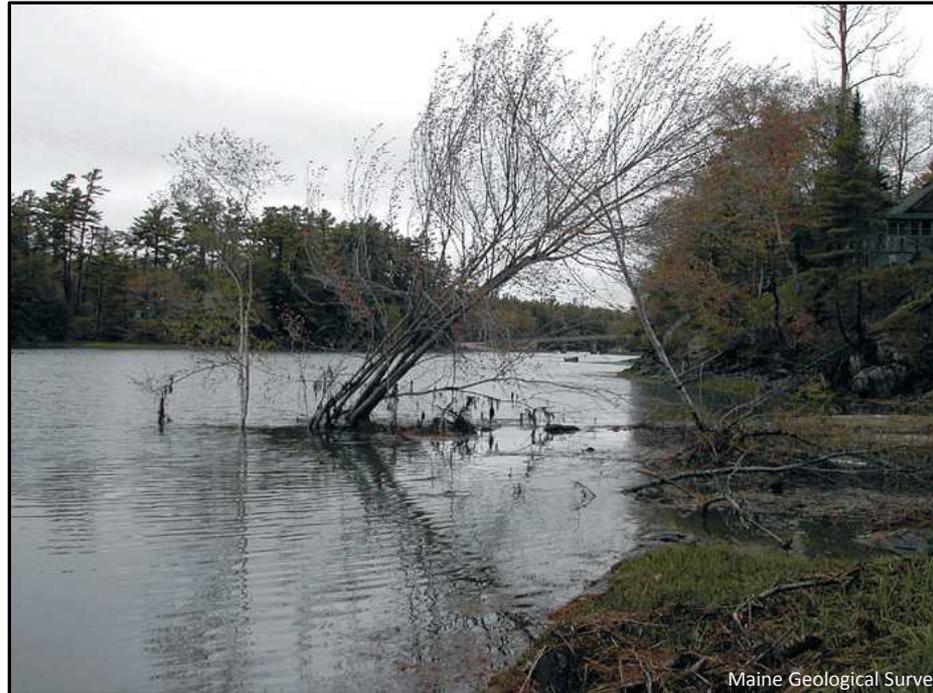
The landslide toe extended into the intertidal zone of Buttermilk Cove (Figure 9). The second area of slope movement extended from the southern edge of the main scarp, southward for approximately 90 feet. This is in the same area as the previous subsidence and slope failure on the west side of the house described above. This slope movement and subsidence consisted of fresh tension cracks and minor parallel scarps in the lawn. This movement caused the ground behind the house to slope more steeply toward the top of the bluff and water.

Figure 9. The toe of the rotational landslide moved out into the intertidal zone in Buttermilk Cove.

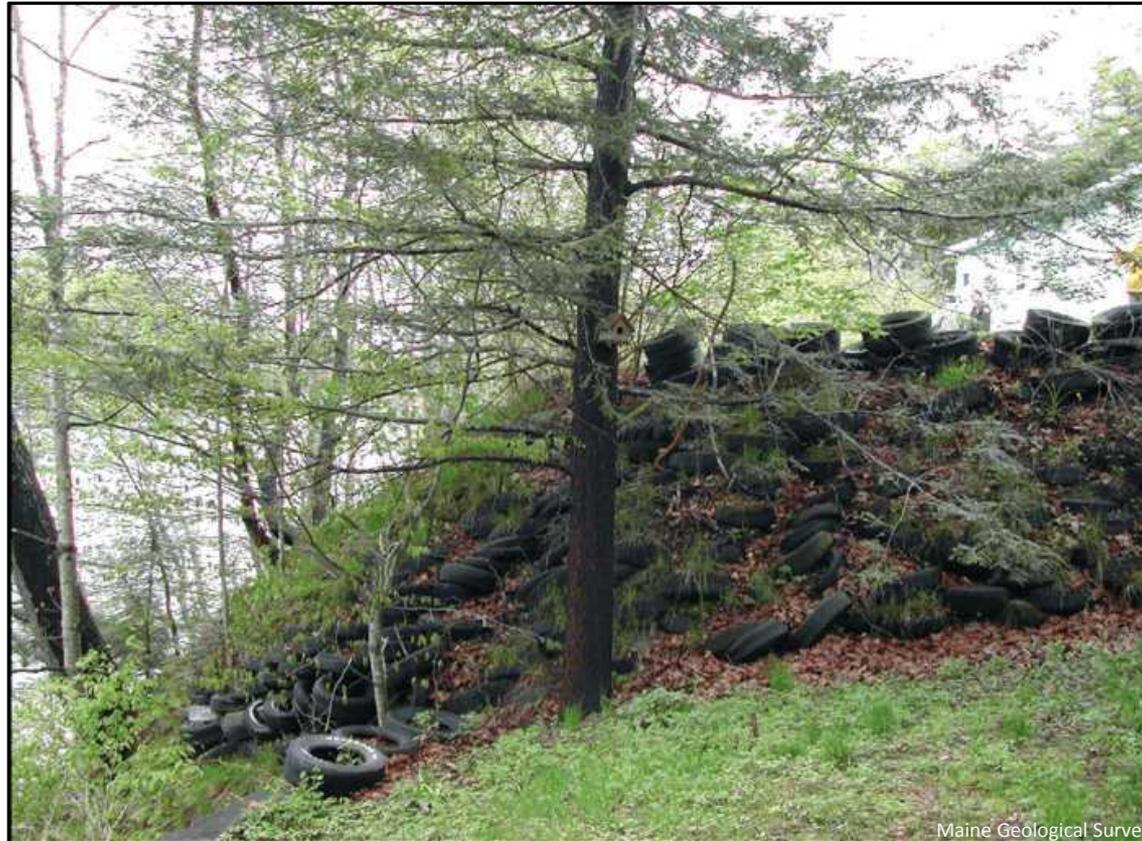
The site has been built up and out towards the water with artificial fill (Figure 10). The north end of the site appears to be filled with a medium to coarse-grained sand which the owner thought came from a local construction site. This area is also the location of a leach field for the home's septic system. The remainder of the site is filled with a mixture of material, the majority of which consists of old tires.

These tires are loosely placed and prevalent on and within the oversteepened slope (bluff face) and appear to have been placed haphazardly and not in an engineered form. Other slope materials include metal, cement, bricks, shrubs, and trees.

Figure 10. Tire fill used to level the back yard of the property. Buttermilk Cove is in the background.

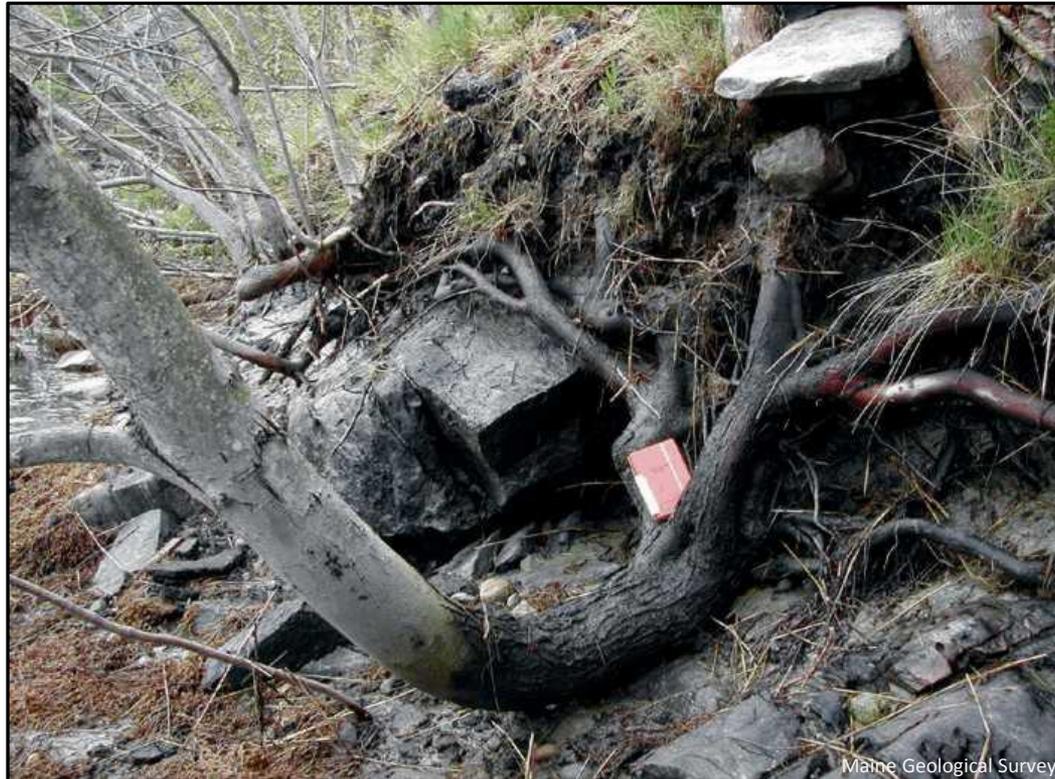
Observation of the bluff toe suggests very little or no till present and Presumpscot Formation clay overlies bedrock at this site. Bedrock underlying the sediment is metamorphic rock of the Sebascodegan and Cape Elizabeth Formations (ancient rocks of Ordovician to Early Silurian age). These rocks crop out along the edge of Buttermilk Cove near the elevation of mean high tide (Figure 11). Outcrops are also located directly across Route 24 to the east of the slide area.

Figure 11. Bedrock outcrop along the high tide line at the base of the coastal bluff in Buttermilk Cove. Note the bent tree trunk caused by previous landslide movements or gradual creep due to toe erosion.
