**Re: Remediation Status of Mason Station Power House Site, Wiscasset, Maine**

## Mason Station - TRIP REPORT

**DATE: 09/16/2022**

Mason Station, Wiscasset

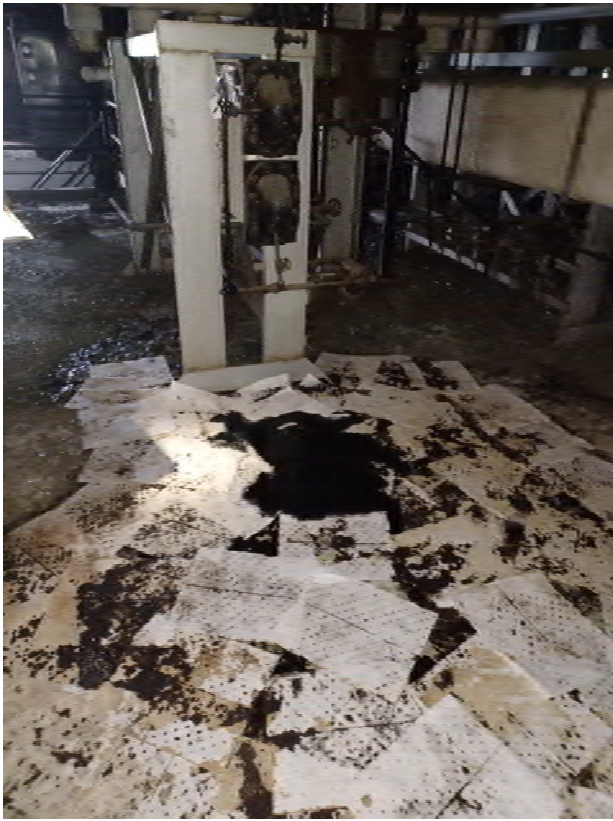
1: The #6 oil identified on the 2<sup>nd</sup> floor, Units 1 & 2 continues to discharge from the severed pipe associated with the heater bank. The absorbent pad wrapped around the severed pipe is not containing the release and the absorbent pads on the ground are saturated. **No cleanup has been implemented and this spill continues to actively discharge.** (Reference Photo 1)

Photo 1: #6 oil release 2<sup>nd</sup> floor Units 1 & 2

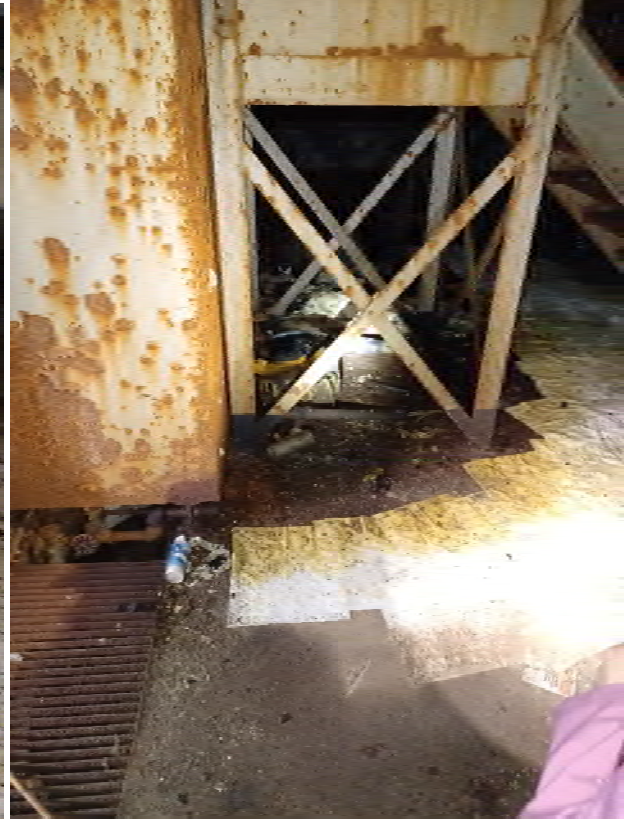
2: The 1st floor in Unit 1 & 2 medium heavy DTE Oil release adsorbent pads have some staining. The gearbox is not leaking anymore which suggests it has discharged all its contents. Rain appears to be entering the gearbox and flushing residual oil onto the floor. The absorbent pads and area have been driven on with forklift which is tracking oil. Absorbent pads have been replaced several times and remain next to gearbox in trash bags. **No cleanup has been implemented.** (Reference Photos 2 & 3)

Photo 2: #2 Gearbox oil release, 1<sup>st</sup> floor Units 1 & 2

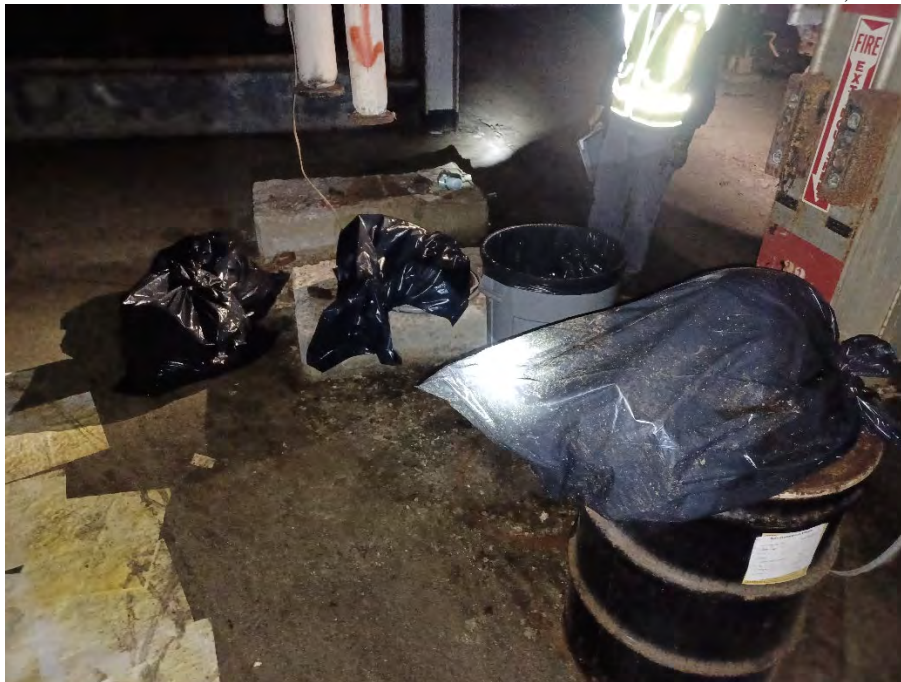
Photo 3: Gearbox oil release, 1<sup>st</sup> floor Units 1 & 2 used pads placed in trash bags.

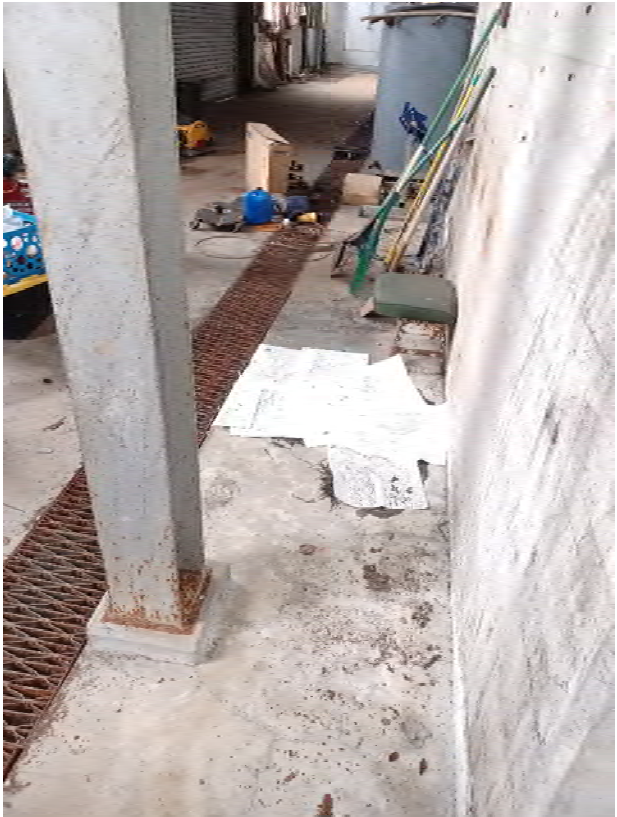
3: The roofing tar spill site on the first floor, Units 3 & 4 in the northeast corner of the building remains stable. The five-gallon buckets of roofing tar were removed but the floor and floor trench have not been cleaned. (Reference Photo 4)

Photo 4: Roofing tar release, 1<sup>st</sup> floor, Units 3 & 4

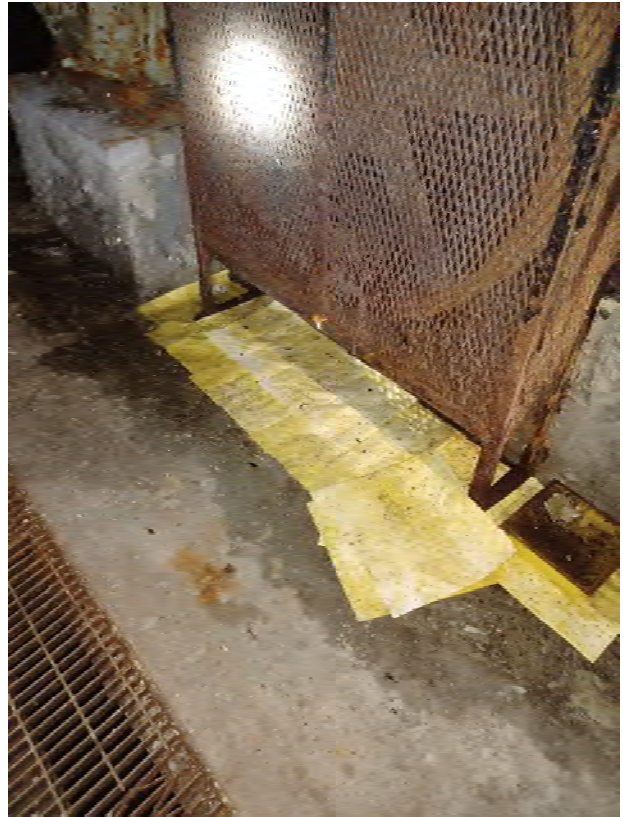
4: A series of compressors located on the 1st floor, Units 3 & 4 is leaking a yellow oily substance onto the ground surface. Absorbent pads are saturated and require replacing. Oil has migrated from the compressor into the nearby floor trench which also contains water. This oil requires characterization. **No cleanup has been implemented and this spill continues to actively discharge into floor trench.** (Reference photos 5 & 6)

Photo 5 : Unknown yellow oil discharging from series of pumps. 1<sup>st</sup> floor, Units 3 & 4.

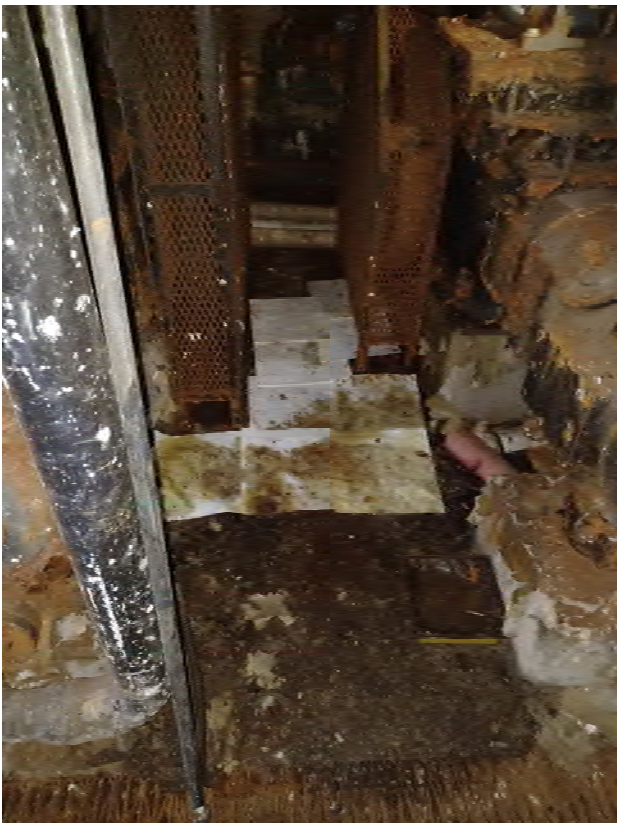
Photo 6 : Unknown yellow oil discharging from series of pumps. 1<sup>st</sup> floor, Units 3 & 4

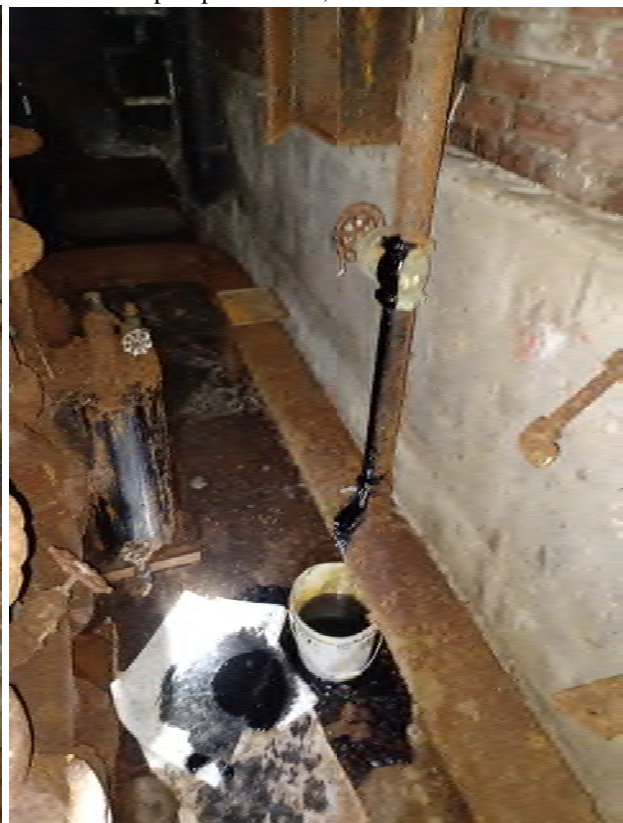
5: Adjacent to the leaking compressors is a series of pumps and piping on the first floor, Units 3 & 4. The piping was identified to be leaking #6 oil in several locations. Oil has reached the floor trench and can be seen on the surface of standing water. **No cleanup has been implemented and this spill continues to actively discharge into a floor trench.** (Reference photo 7 & 8)

Photo 7: #6 oil release from severed pipe. 1<sup>st</sup> floor, Units 3 & 4.

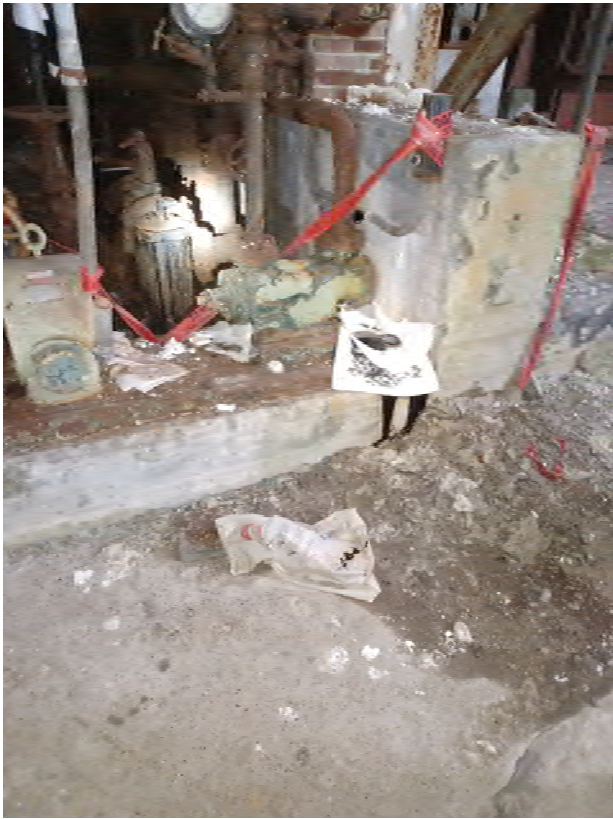
Photo 8: #6 oil release from severed pipe. 1<sup>st</sup> floor, Units 3 & 4

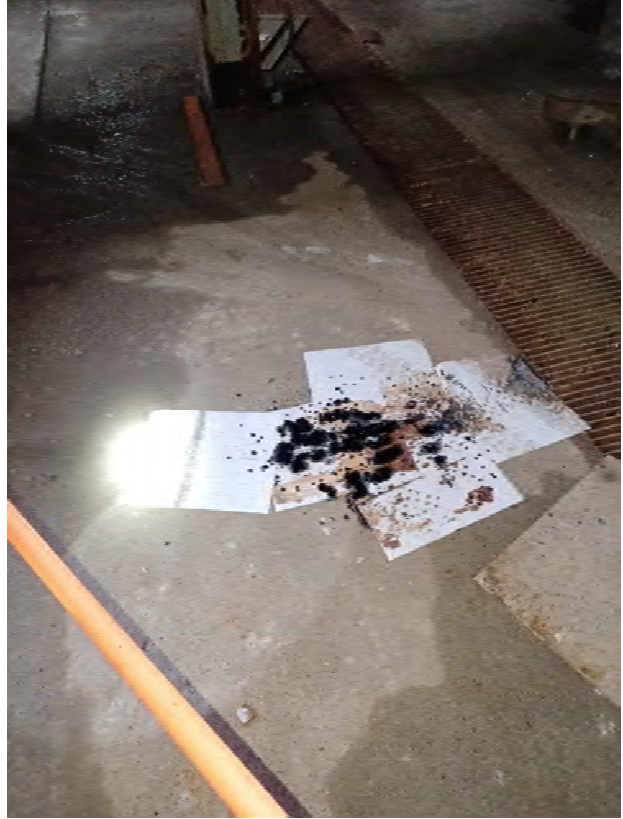
6: Two Equipment lockers on the 2nd floor, Units 1 & 2 are releasing #6 oil from severed pipes. These equipment lockers contain mercury devices that are documented in Ransoms 2019 mercury assessment report. In both instances, the leaking pipes are discharging #6 oil onto overhanging pipes, mezzanines, and the buildings structural I-beams and pooling on the ground on the 1st floor. A fifty-gallon drum has been placed below one of the lockers, but it is not containing the release. Two new release points have developed since the time of MEDEPs last inspection. **No cleanup has been implemented and these spills continue to actively discharge.** (Reference photos 9 - 13)

Photo 9: #6 oil release from equipment locker. First floor, Units 1 & 2.

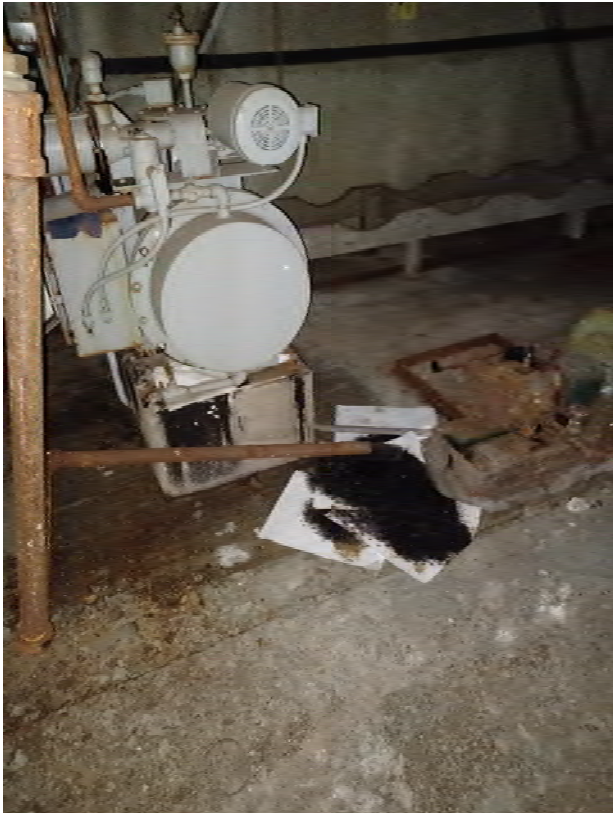
Photo 10: #6 oil release from equipment locker. First floor, Units 1 & 2.

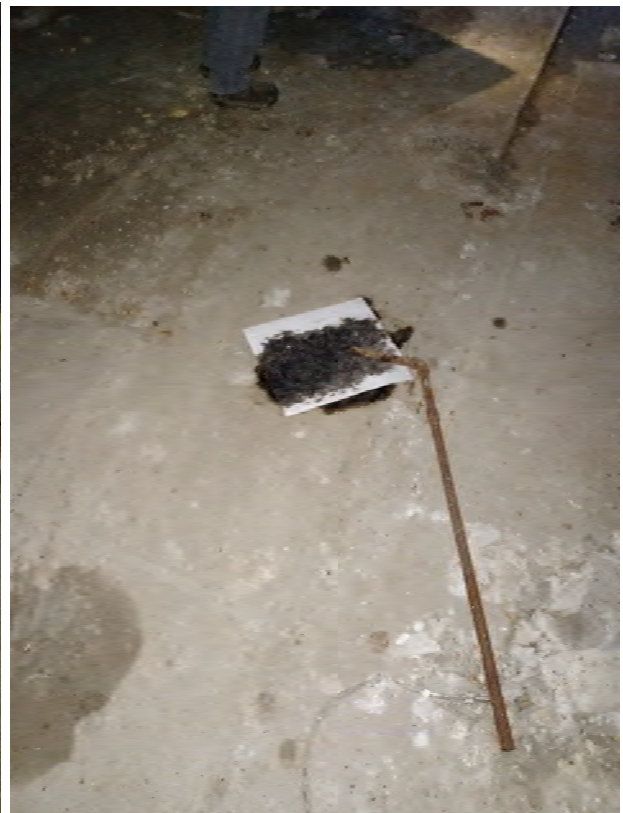
Photo 11: #6 oil release from equipment locker. First floor, Units 1 & 2

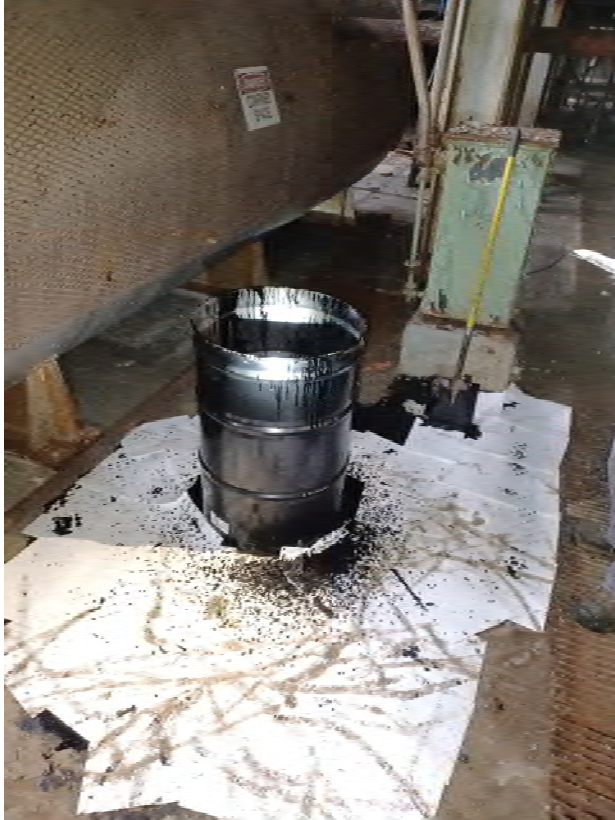
Photo 12: #6 oil release from equipment locker. First floor, Units 1 & 2

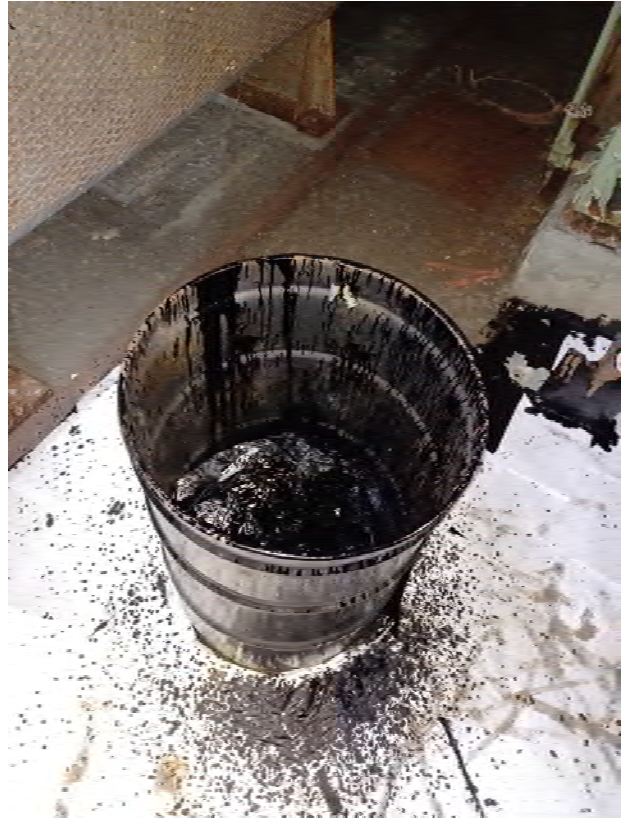
Photo 13: #6 oil release from equipment locker. First floor, Units 1 & 2

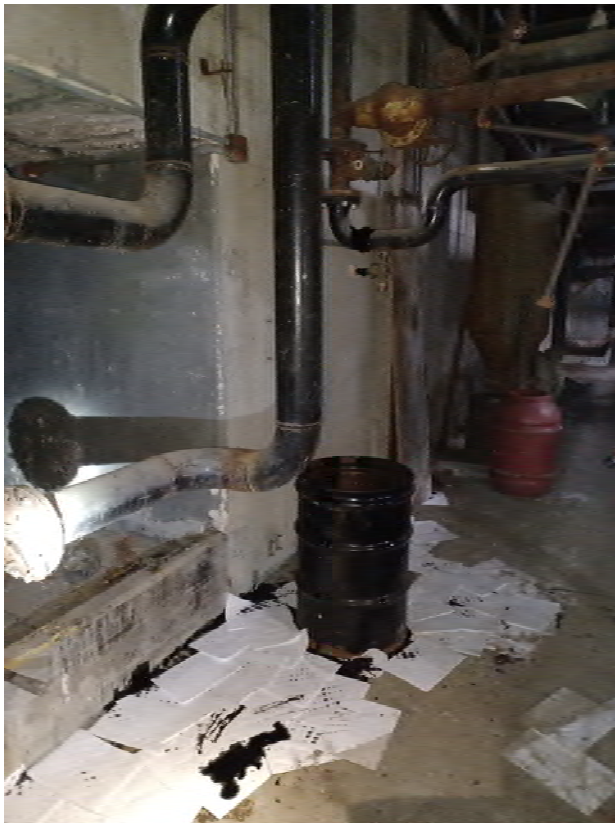
7: The #6 oil release identified on the first floor of Unit 5 in the southwest corner of the building continues to actively discharge. A fifty-gallon drum has been placed below the leaking pipe, but it is not containing the release. Product has reached the floor trench but there is no standing water. **No cleanup has been implemented and this spill continues to actively discharge.** (Reference photo 14 - 15)

Photo 14: #6 oil release from leaking overhead pipe first floor, Unit 5

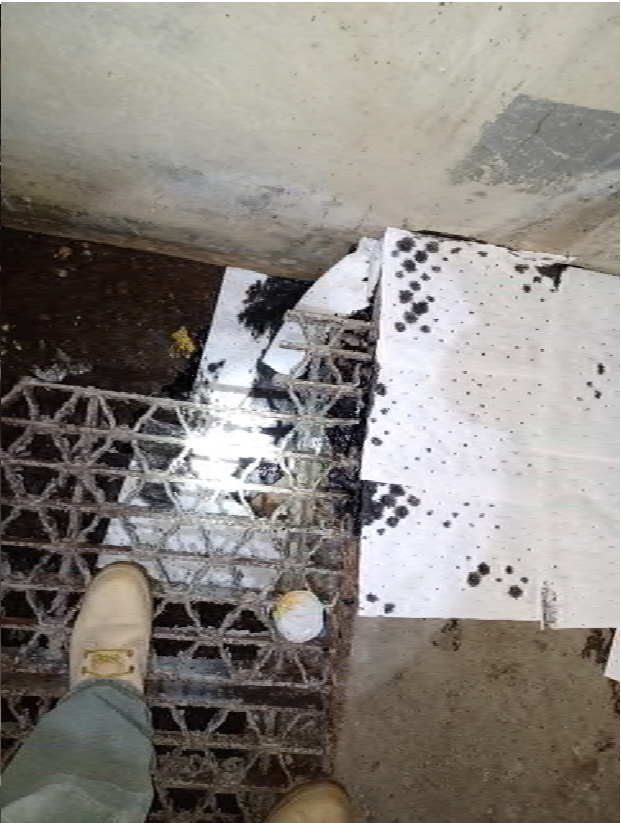
Photo 15: #6 oil from release overhead pipe in floor trench. first floor, Unit 5.

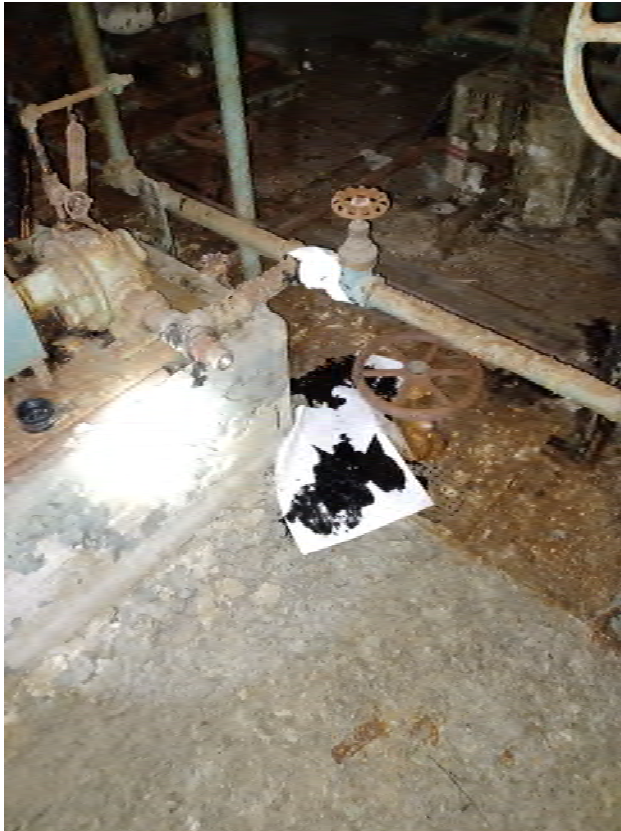
8: A series of pumps and piping located on the first floor, Units 1 & 2 was identified to have multiple discharges. #6 oil is leaking from multiple severed pipes and has discharged to the ground surface and nearby floor trench. A yellow oily substance has also released from an unknown source. This oily substance has also reached the nearby floor trench and a small vault in the floor was identified to be full of oil water and #6 oil. The yellow oil requires characterization. **No cleanup has been implemented and spills continues to actively discharge.** (Reference photos 16 - 19)

Photo 16: #6 oil release from leaking pipe. First floor, Unit 1 and 2.

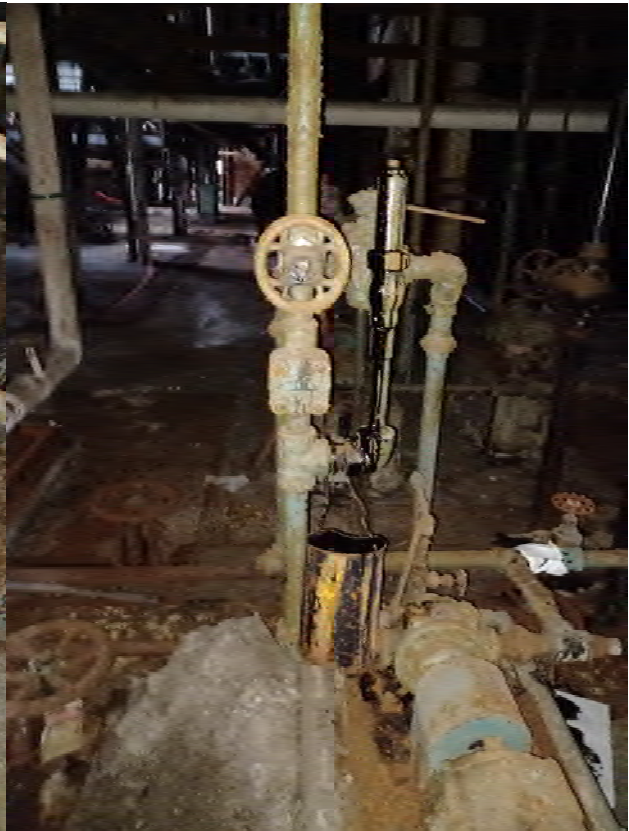
Photo 17: #6 oil release from leaking pipe. First floor, Unit 1 and 2.

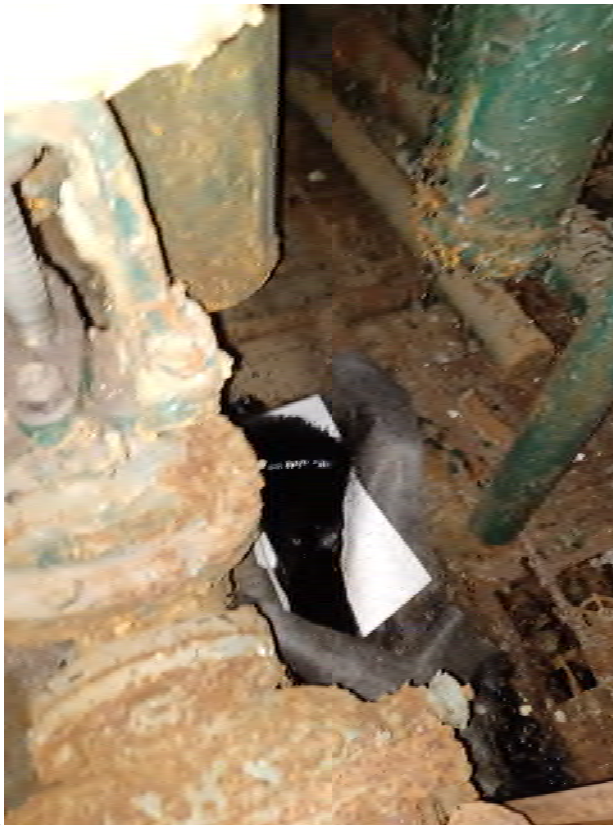
Photo 18: Oil release from leaking pipe. First floor, Unit 1 and 2.

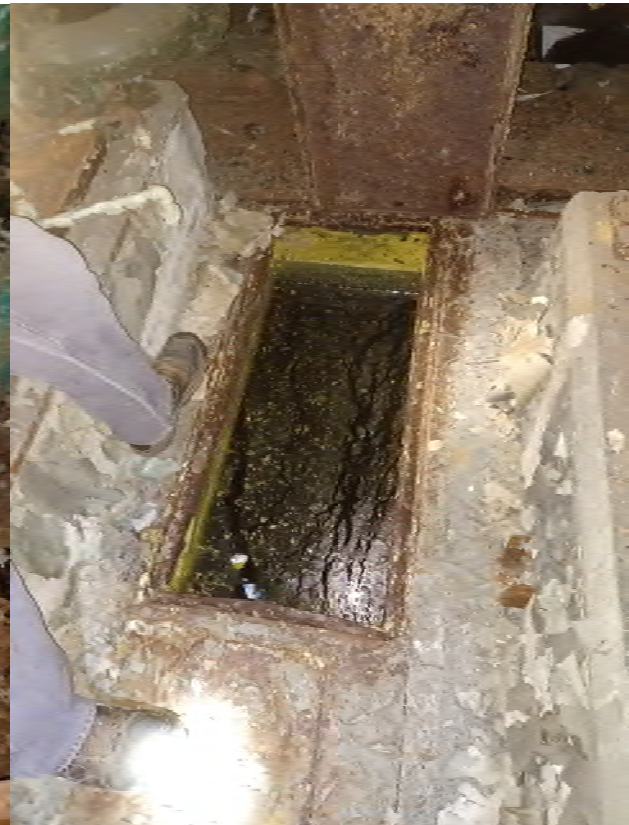
Photo 19: Unknown yellow oil release in floor vault and trenches. First floor, Units 1 & 2.

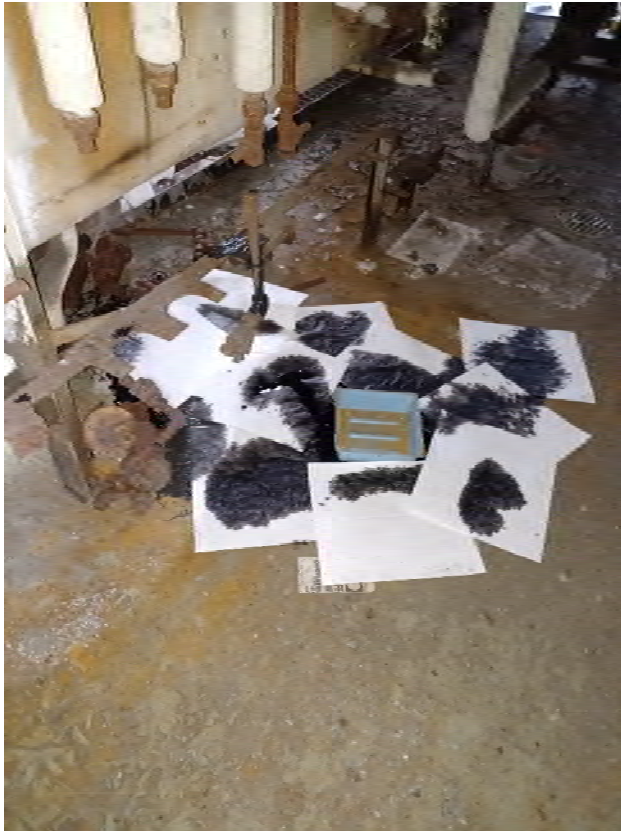
9: A oil heater bank on the second floor of Units 3 & 4 was identified to be leaking #6 oil in two locations. Ransom has plugged one of the severed pipes with an absorbent pad which has slowed the release. **No cleanup has been implemented and spills continues to actively discharge.** (Reference photos 20 - 22)

Photo 20: Release of #6 oil from heater bank on 2<sup>nd</sup> floor, Units 3 & 4.

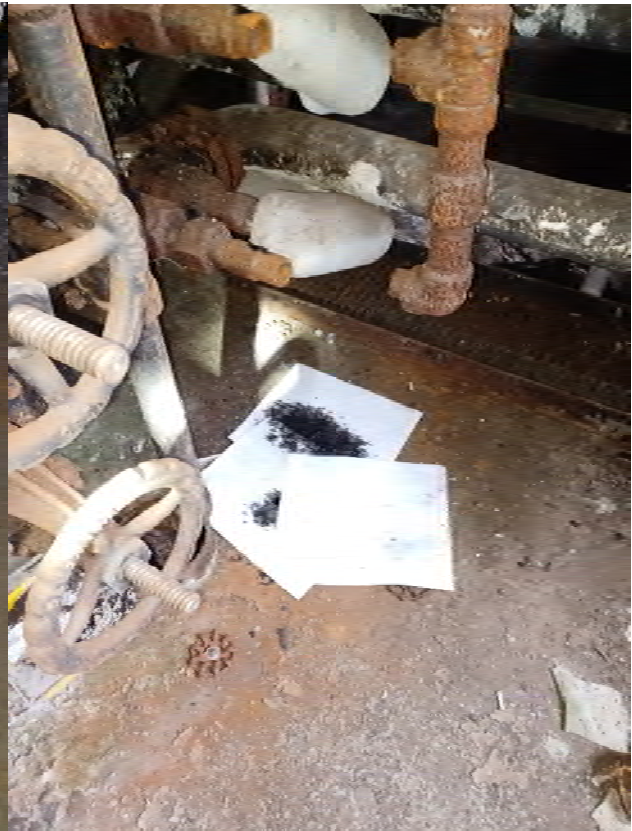
Photo 21: Release of #6 oil from heater bank on 2<sup>nd</sup> floor, Units 3 & 4.

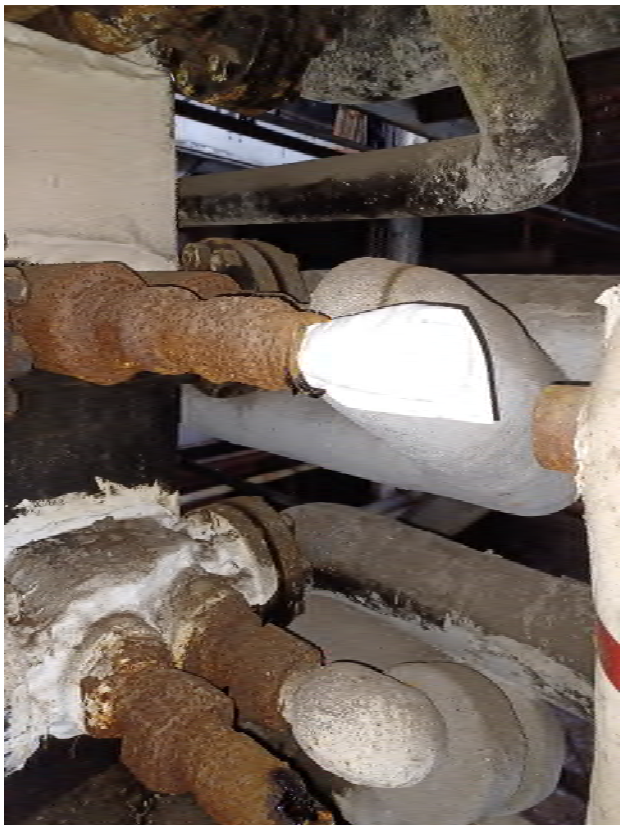
Photo 22: absorbent pad plugging the leak from a heater bank on 2<sup>nd</sup> floor, Units 3 & 4.

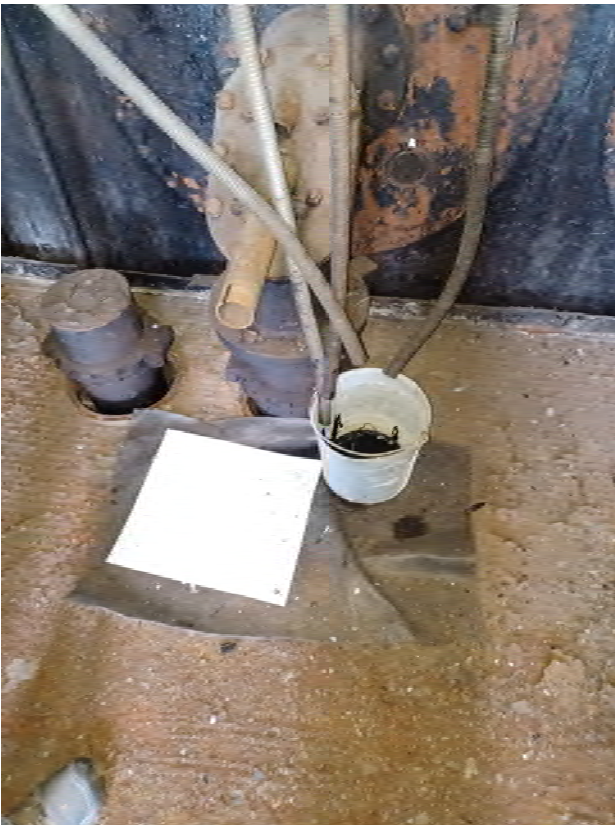
10: A series of boilers on the 3<sup>rd</sup> floor of units 1 & 2 have severed pipes that are leaking de-minimus amounts of #6 oil. Absorbent pads and small buckets have been placed to prevent migration. **No cleanup has been implemented and spills continues to actively discharge.** (Reference photos 23 - 24)

Photo 23: Severed pipes from boiler on third floor, Units 1 & 2.

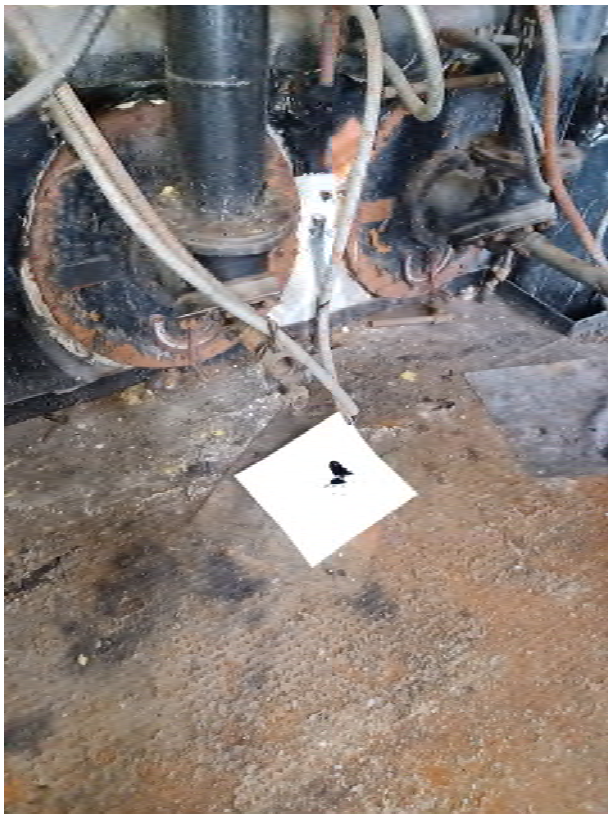
Photo 24: Severed pipes from boiler on third floor, Units 1 & 2.

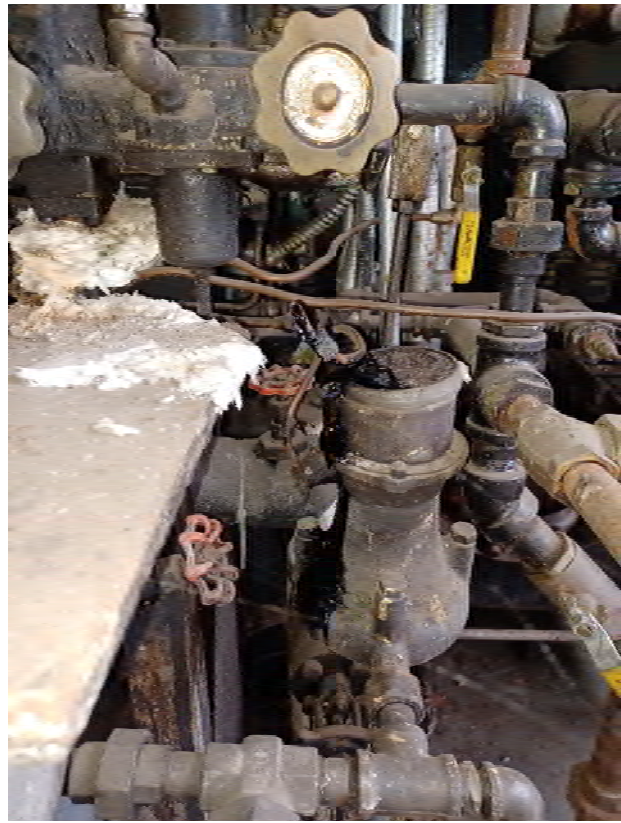
11: A boiler on the first floor of Units 1 & 2 adjacent to the main entrance is leaking #6 oil to the ground surface. Absorbent pads have been placed on the ground to prevent migration. **No cleanup has been implemented and spill continues to actively discharge.** (Reference photos 25 - 26)

Photo 25: Leaking pipe on boiler. First floor, Units 1 & 2

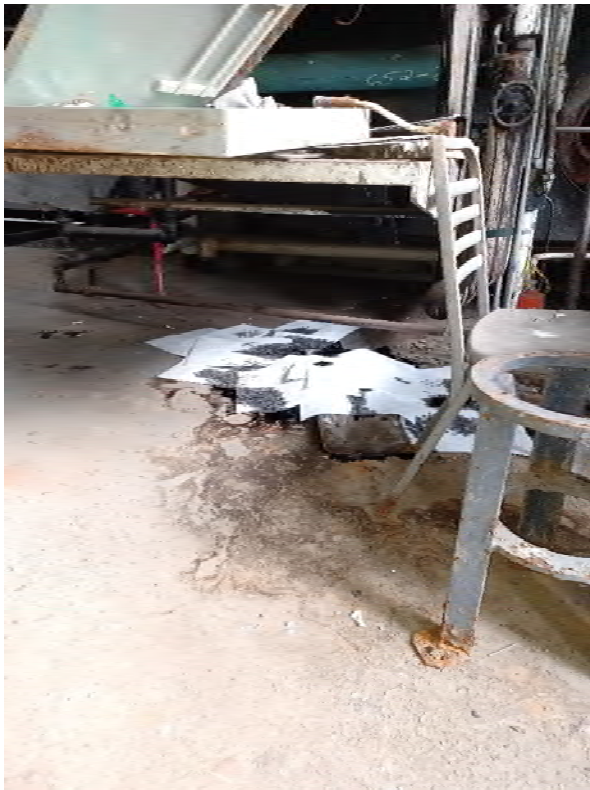
Photo 26: #6 oil release from boiler. First floor, Units 1 & 2

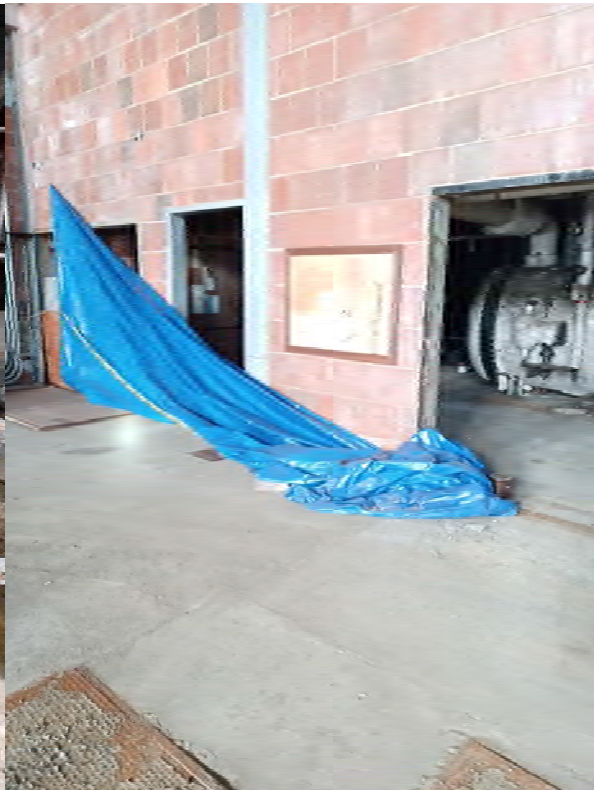
The tarp that was hung as a petition to prevent access to deteriorated asbestos has fallen. A more permanent barrier should be constructed if asbestos abatement is not planned (Reference photo 27).

Photo 27: Tarp intended to segregate portion of building and prevent exposure to asbestos has fallen
