February 19, 2020

Project 171.06108

RE: Mercury Assessment  
Mason Station  
Wiscasset, Maine

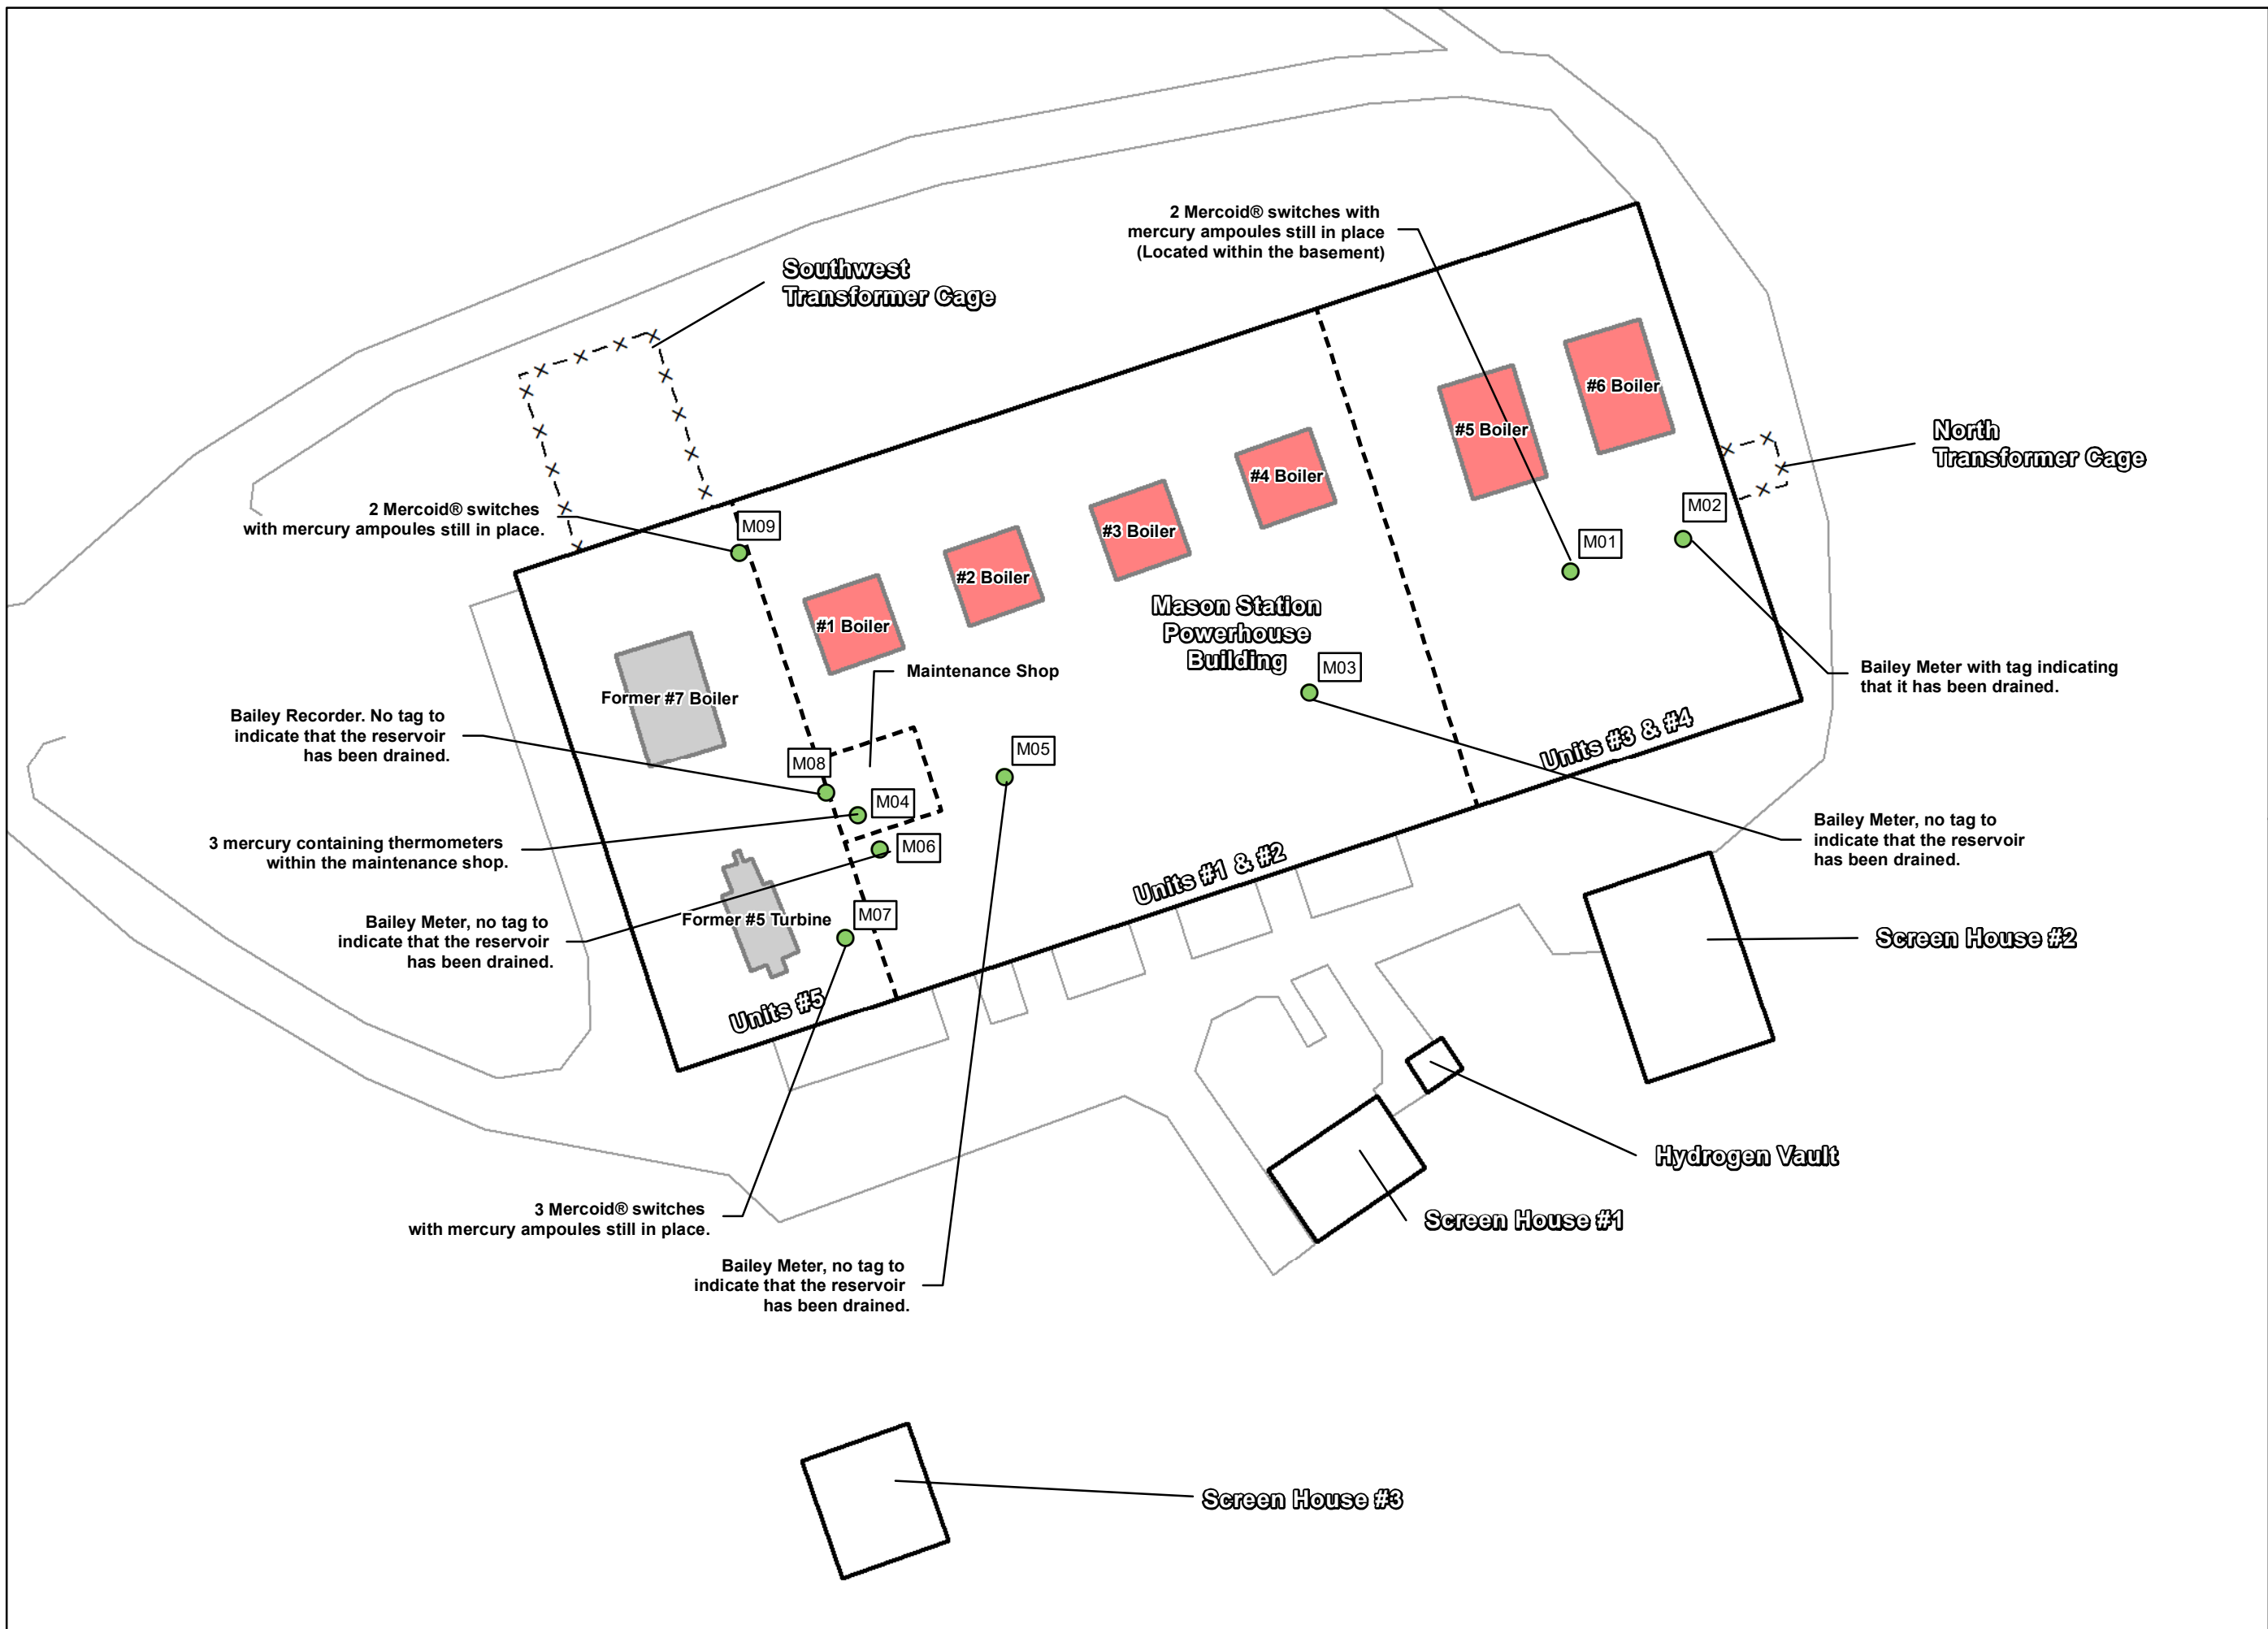
**Figure 1**  
Ground Floor

On the ground level within the Powerhouse Building, Ransom observed mercury-containing thermometers, Mercoïd<sup>®</sup> switches containing mercury ampoules and former equipment with mercury-containing reservoirs. Some of the mercury-containing reservoirs did not have tags indicating whether they had been drained. The type, quantity and location of the mercury-containing equipment observed on the ground floor is described in the table below and depicted on Figure 1.

Location	Location ID	Description	Quantity
Units #3 and #4, ground floor, east of #6 boiler.	M02	Bailey meter with reservoir. Tag indicating that the reservoir was drained, but residual mercury is likely present within the unit.	1
Units #1 and #2, ground floor, east of #3 and #4 boiler.	M03	Bailey meter with reservoir. A tag indicating the reservoir had been drained was not present.	1
Units #1 and #2, Ground floor maintenance shop, east of #2 boiler.	M04	Within the maintenance shop there are three thermometers. Two are attached to the walls while one is present on a work bench.	3
Units #1 and #2, ground floor, east of #2 boiler.	M05	Bailey meter with reservoir. A tag indicating the reservoir had been drained was not present.	1

Location	Location ID	Description	Quantity
Units #1 and #2, ground floor east of #1 boiler, north of former #5 turbine.	M06	Bailey meter with reservoir. A tag indicating the reservoir had been drained was not present.	1
Unit #5, ground floor, north of the former #5 turbine.	M07	Location of three Mercoïd® switches with the mercury-containing ampoules still in place.	3
Unit #5, ground floor, centrally located along the wall dividing Unit #5 and Units #1 and #2.	M08	Bailey recorder with reservoir. A tag indicating the reservoir had been drained was not present.	1
Located in the northwest corner of Unit #5 of the ground floor.	M09	Location of three Mercoïd® switches, two of which had the mercury-containing ampoules still in place.	2

2. The equipment still containing mercury along with the reservoirs that formerly contained mercury should be removed from the Powerhouse building and disposed of under Universal Waste guidelines.

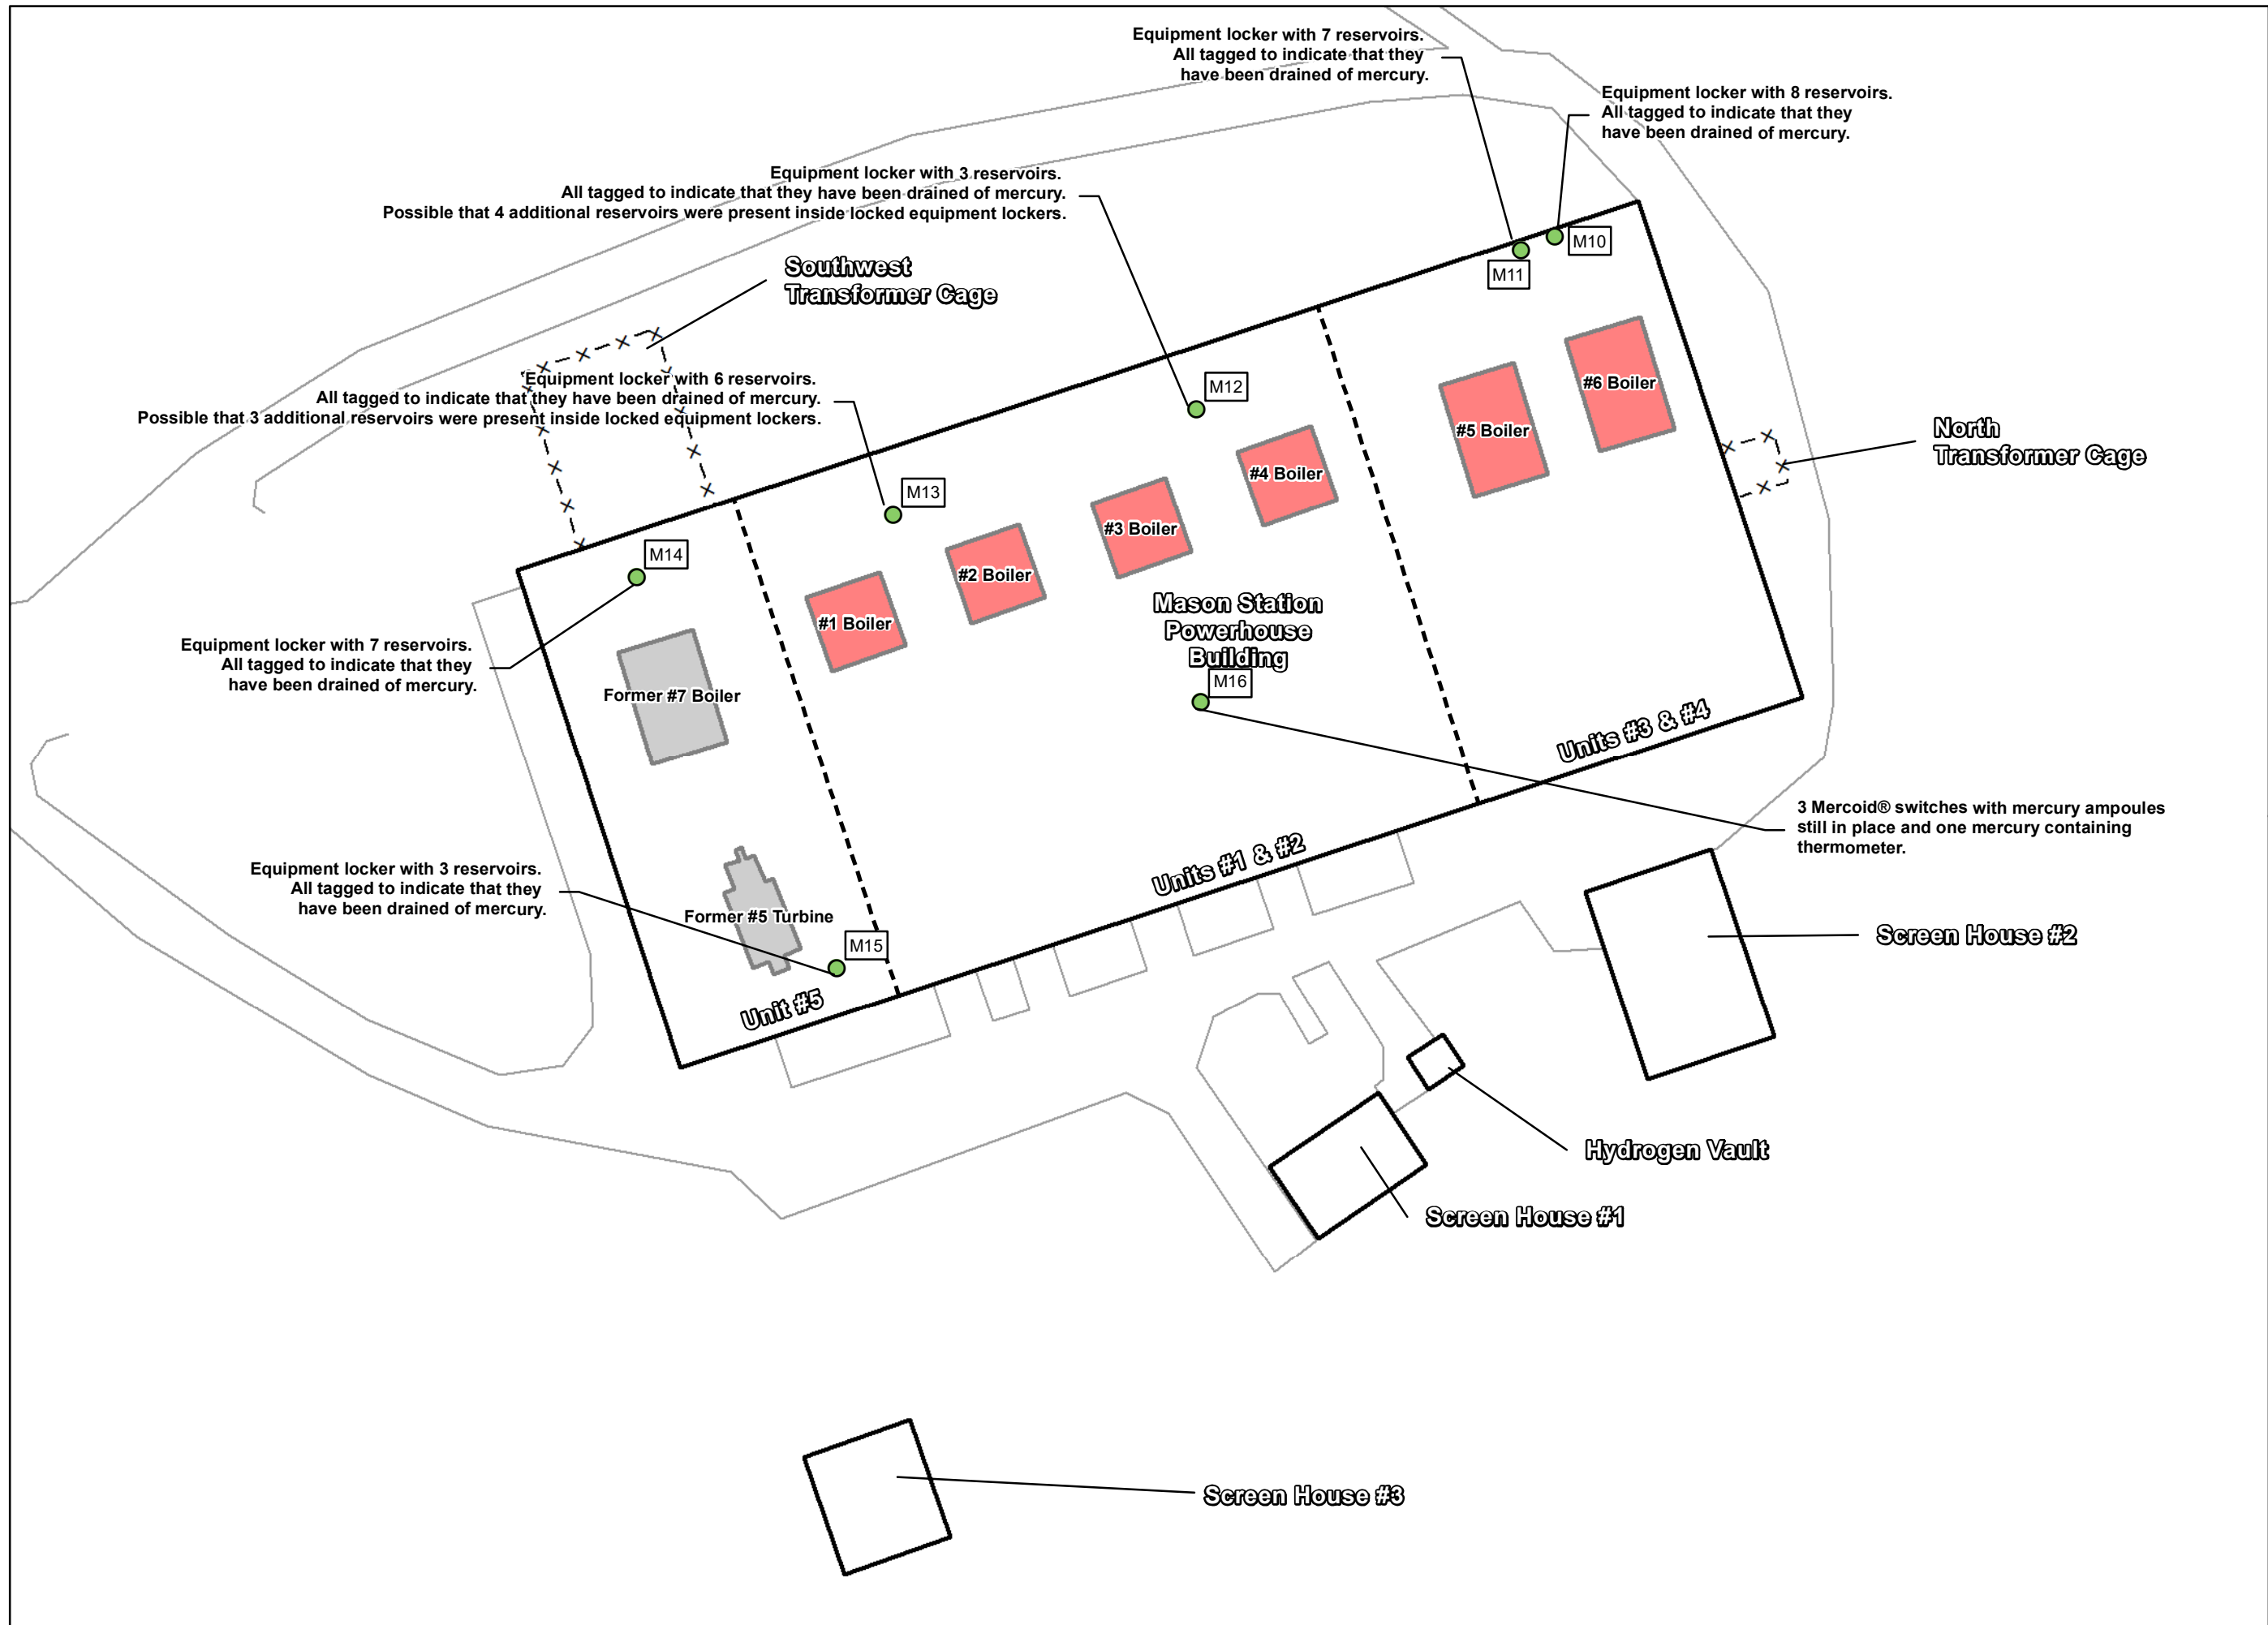
**Figure 2**  
Second Level

On the second level within the Powerhouse building, Ransom observed mercury-containing switches located atop a wooden crate in the central area of the second level along with equipment lockers that housed reservoirs designed to contain liquid mercury. The type, quantity and location of the mercury-containing equipment observed on the second level are described in the table below and depicted on Figure 2.

Location	Location ID	Description	Quantity
Northwest corner of Units #3 and #4, second level.	M10	Equipment locker containing eight mercury reservoirs. All of which had tags indicating mercury had been drained, but likely to contain residual amounts of mercury.	8
Immediately south of the equipment locker described above.	M11	Equipment locker containing seven mercury reservoirs. All of which had tags indicating mercury had been drained, but likely to contain residual amounts of mercury.	7
Western wall of Units #1 and #2, between the #3 and #4 boilers.	M12	Equipment lockers containing mercury reservoirs. Three were observed with tags indicating mercury had been drained, but likely to contain residual amounts of mercury. Some of the lockers could not be opened, but based on the layout of the equipment; it is possible that an additional four reservoirs are present.	3 - 7
Western wall of Units #1 and #2, between the #1 and #2 boilers.	M13	Equipment lockers containing mercury reservoirs. The six observed had tags indicating mercury had been drained, but likely to contain residual amounts of mercury. Some of the lockers could not be opened, but based on the layout of the equipment; it is possible that an additional three are present.	6 - 9

Location	Location ID	Description	Quantity
Western wall of Unit #5, located to the west of the former #7 boiler.	M14	Equipment locker containing seven mercury reservoirs. All of which had tags indicating mercury had been drained, but likely to contain residual amounts of mercury.	7
Eastern wall of Unit #5, located east of former #5 turbine.	M15	Equipment locker containing three mercury reservoirs. All of which had tags indicating mercury had been drained, but likely to contain residual amounts of mercury.	3
Centrally located in Units #1 and #2 of the second level atop wooden crates.	M16	Three Mercoïd® switches and one mercury thermometer all still contain mercury.	4

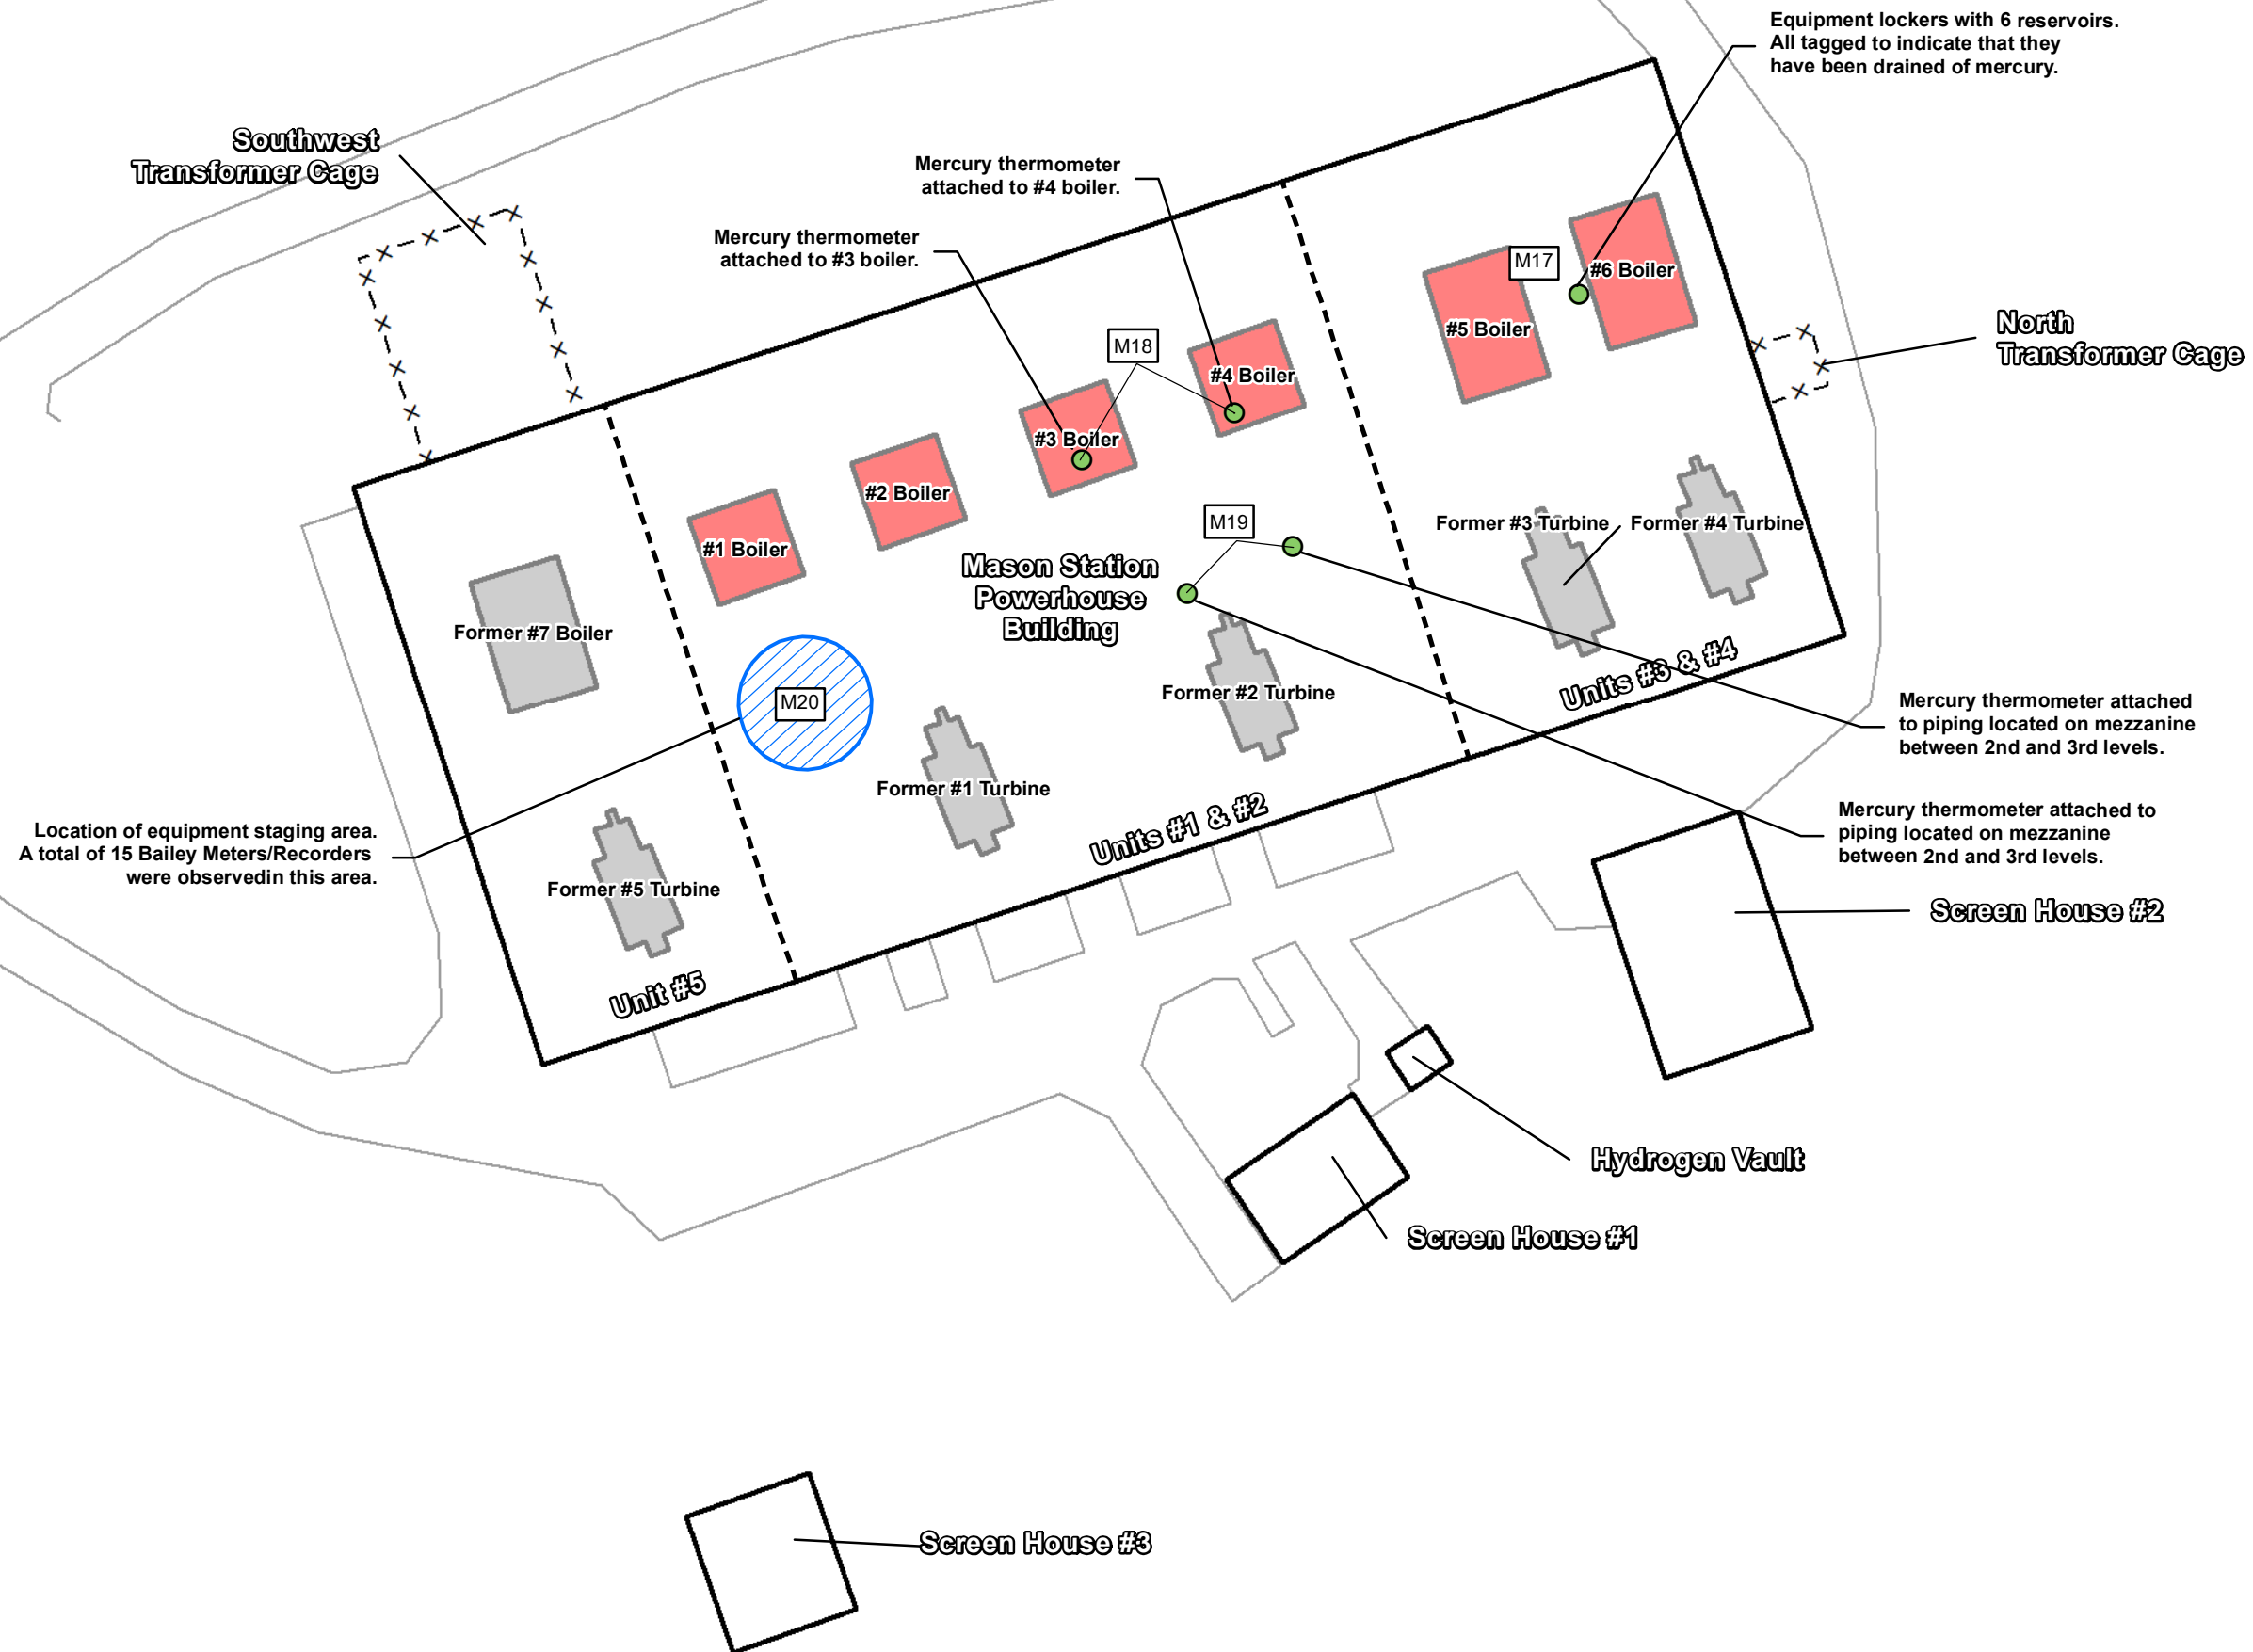
**Figure 3**  
Third Level

On the third level within the Powerhouse building, Ransom observed mercury-containing thermometers attached to piping along with mercury-containing reservoirs that had tags indicating that they had been drained. Additionally, Ransom observed what appeared to be a staging area for discarded meters, gauges and other equipment located to the east of the #1 boiler. In this area, Ransom observed 15 removed Bailey meters which, based on observations made throughout the Powerhouse building, are known to be associated with mercury-containing reservoirs/equipment. The type, quantity and location of the mercury-containing equipment observed on the third level are described in the table below and depicted on Figure 3.

Location	Location ID	Description	Quantity
Units #3 and #4, third level, located between the #5 and #6 boilers.	M17	Six mercury containing reservoirs between two equipment lockers (3 in each). One of the reservoirs had been removed from the locker and was located on the floor. All six had tags indicating mercury had been drained, but likely contain residual amounts of mercury.	6
Units #1 and #2, attached to piping on the eastern side of the #3 and #4 boilers.	M18	Two thermometers likely containing mercury.	2
Units #1 and #2, located on the mezzanine just below the third level, to the east of the #3 and #4 boilers.	M19	Two thermometers attached to piping which likely contain mercury.	2

Location	Location ID	Description	Quantity
Units #1 and #2, located to the east of the #1 boiler	M20	Broken and discarded equipment staging area. Ransom observed 15 Bailey meters that are associated with mercury. Ransom observed 33 other pieces of equipment (gauges, meters etc.) that have the possibility to currently or have historically contained mercury. Visual observations did not identify mercury currently present in connection with these pieces of equipment.	15

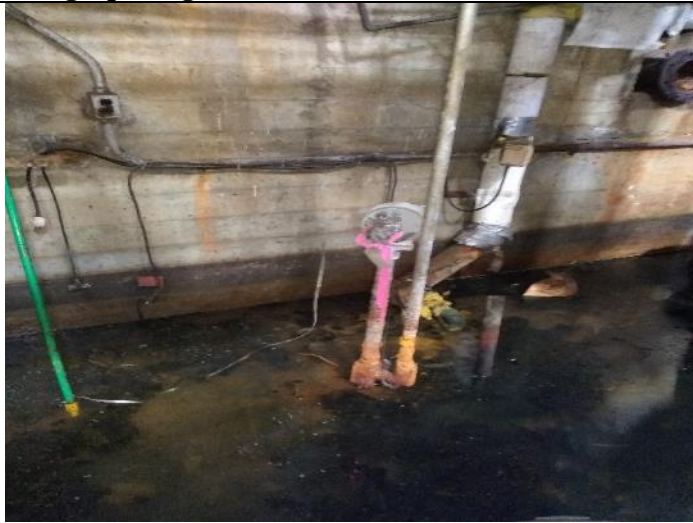
Within the northern portion of the Powerhouse building in the vicinity of the #5 and #6 boiler (**Location ID M01**), a Mercoïd<sup>®</sup> switch containing two mercury ampoules was present. Mercury-containing components were not observed to be present in other inspected portions of the Site building's basement, however; a portion of the basement in Unit #5 was flooded and could not be accessed.

**Location M01: View of two mercury ampoules located on a float switch in the basement towards the north portion of the powerhouse.**

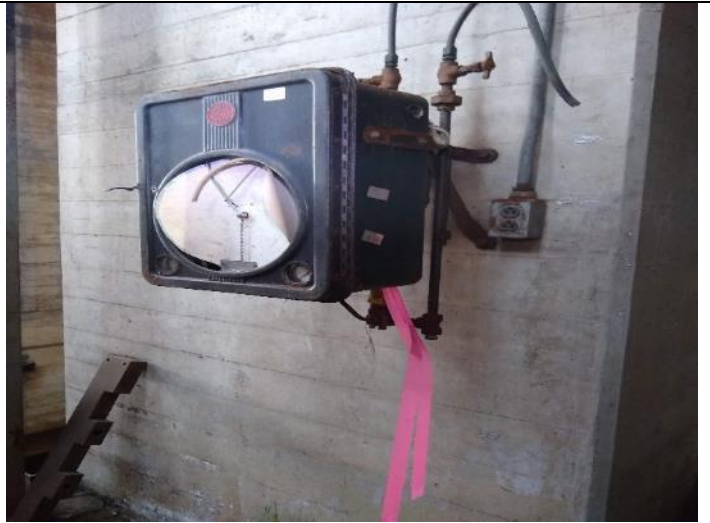
**Location M02: View of Bailey meter located to the north portion on the ground level.**

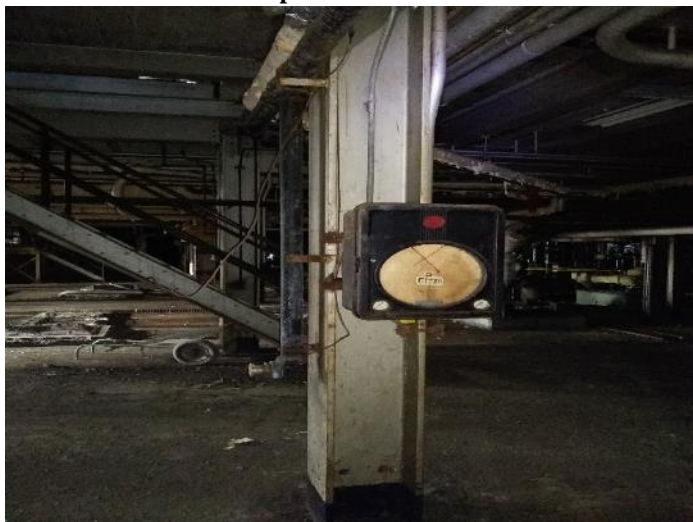
**Location M03: View of reservoir on Bailey meter with no tag indicating if it has been drained. Located in central portion of ground floor.**

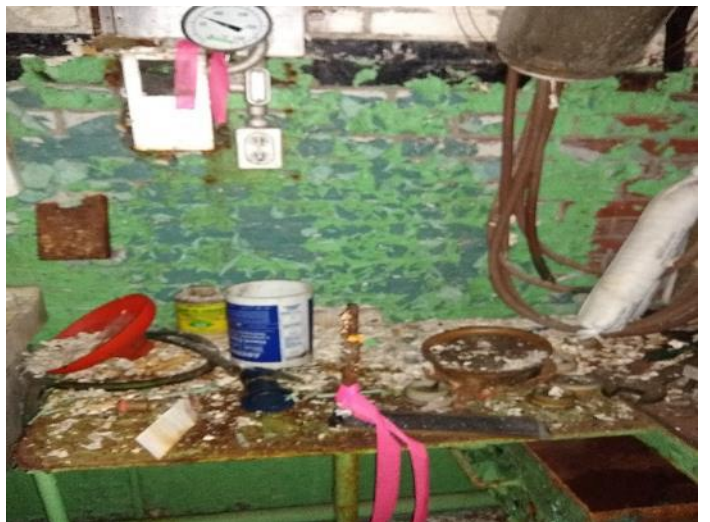
**Location M04: View of two (out of three) mercury containing thermometers located within the maintenance shop on the ground level.**

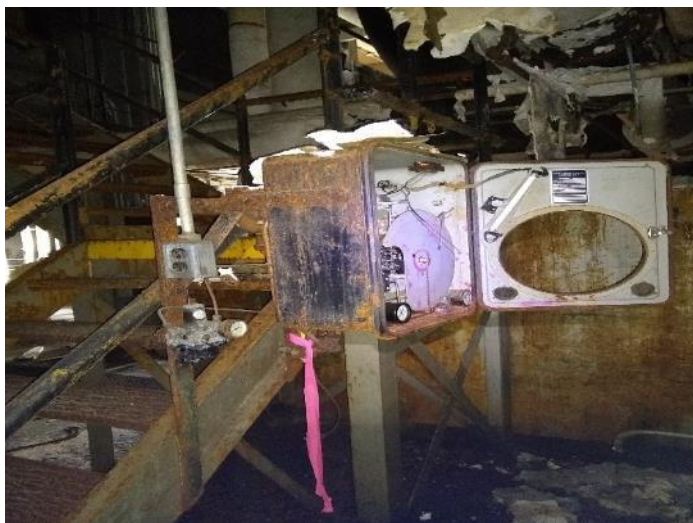
**Location M05: Bailey Meter, no tag indicating if it has been drained.**

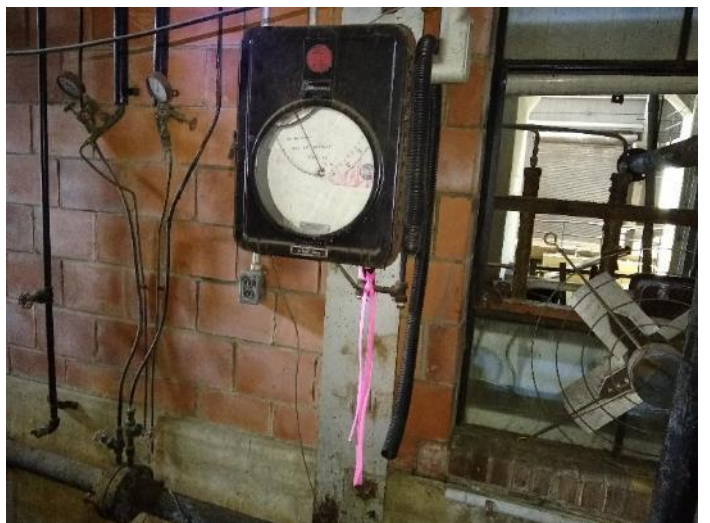
**Location M06: Bailey Meter, no tag indicating if it has been drained.**

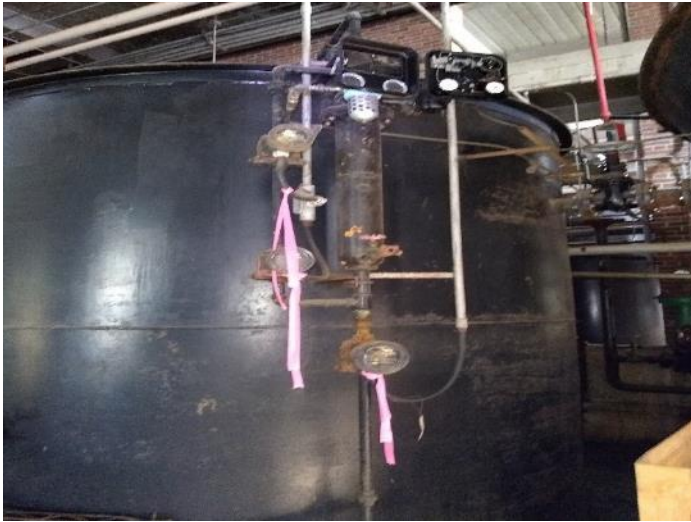
**Location M07: View of three Mercoïd® switches located in the southern portion near the former #5 turbine.**

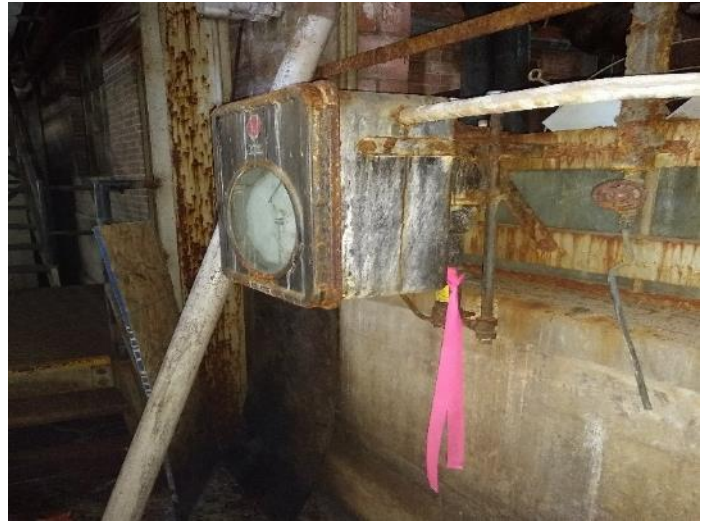
**Location M08: Bailey Meter, no tag indicating if it has been drained.**

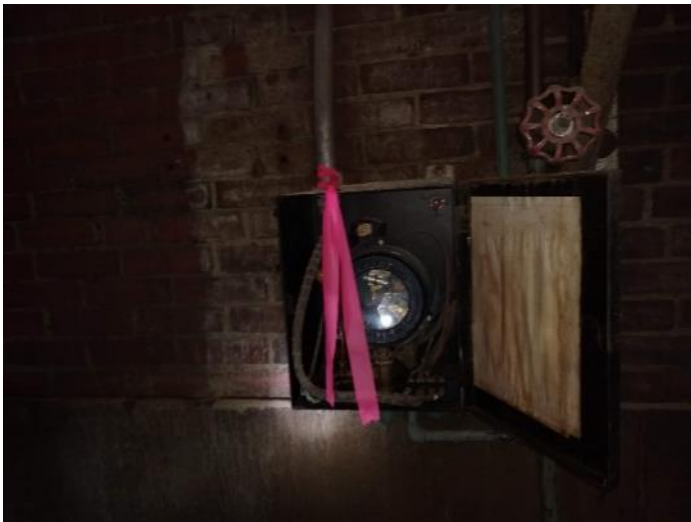
**Location M09: Two Mercoïd® switches with the ampoules still in place.**

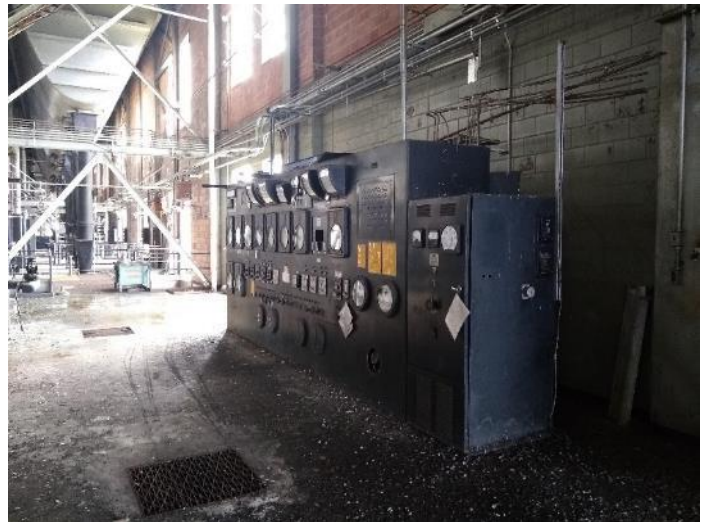
**Location M10 & M11: View of equipment locker located in the northwest portion of the building.**

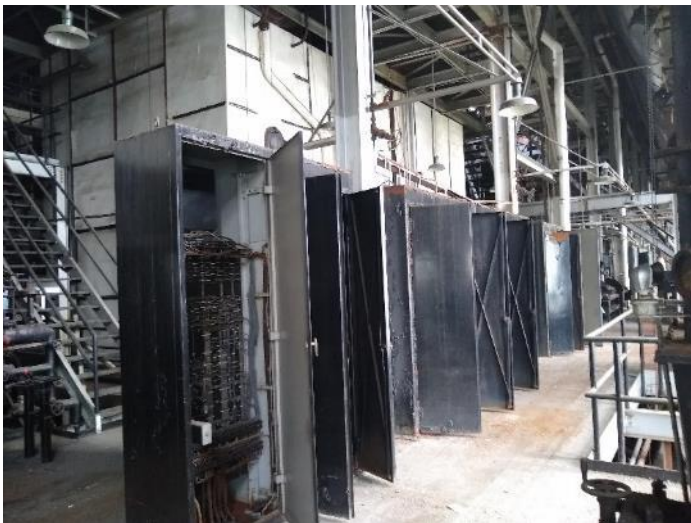
**Location M12: View of equipment lockers located to the west of the #3 and #4 boilers.**

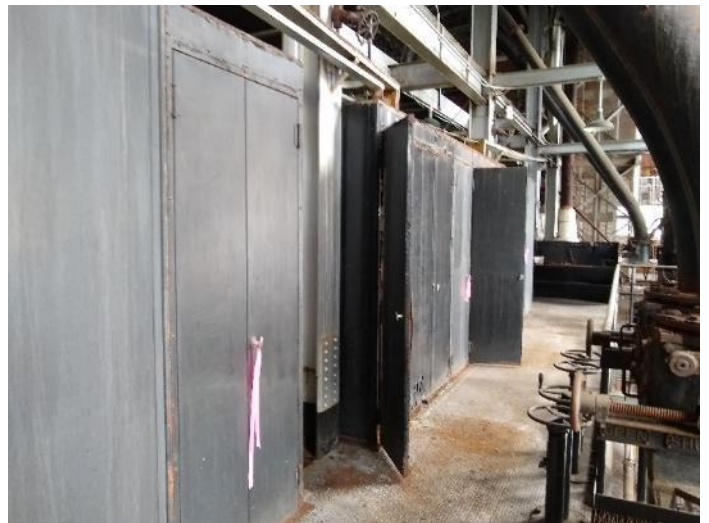
**Location M13: View of equipment lockers located to the west of the #1 and #2 boilers.**

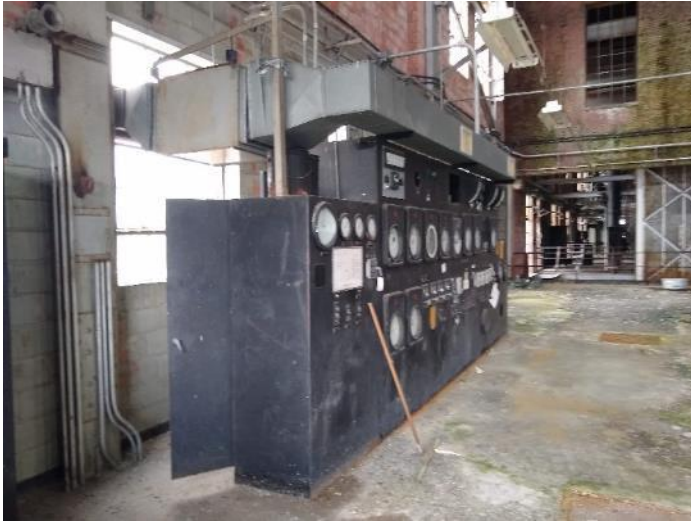
**Location M14: View of equipment lockers located to the west of former #7 Boiler.**

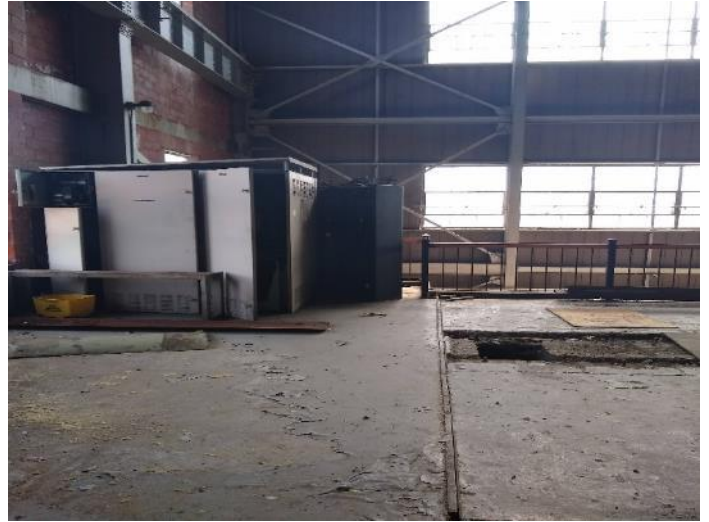
**Location M15: View of equipment lockers located to the west of former #7 Boiler.**

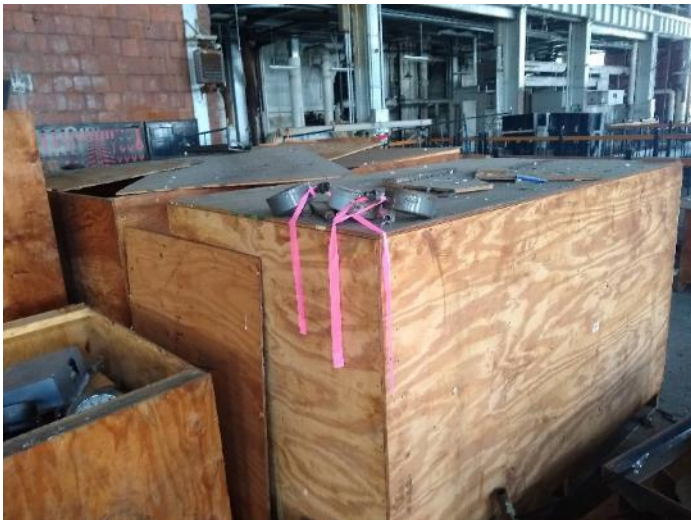
**Location M16: View of three Mercoïd® switches and one thermometer all still containing mercury. Centrally located second level.**

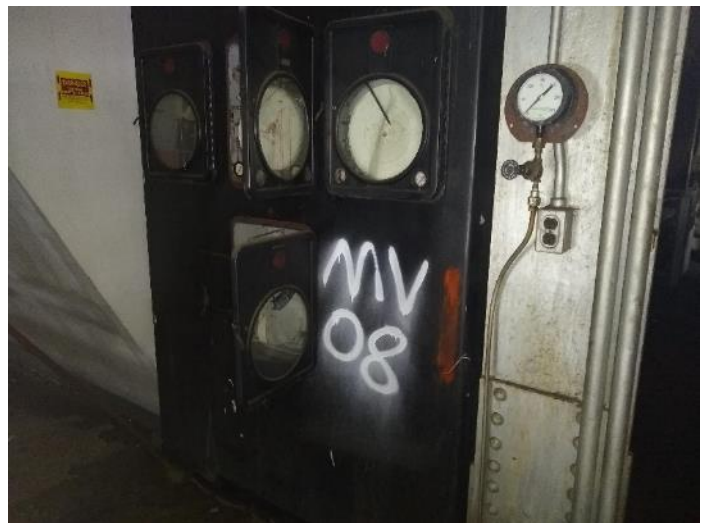
**Location M17: View of equipment locker situated between the #5 and #6 boilers on the third level.**

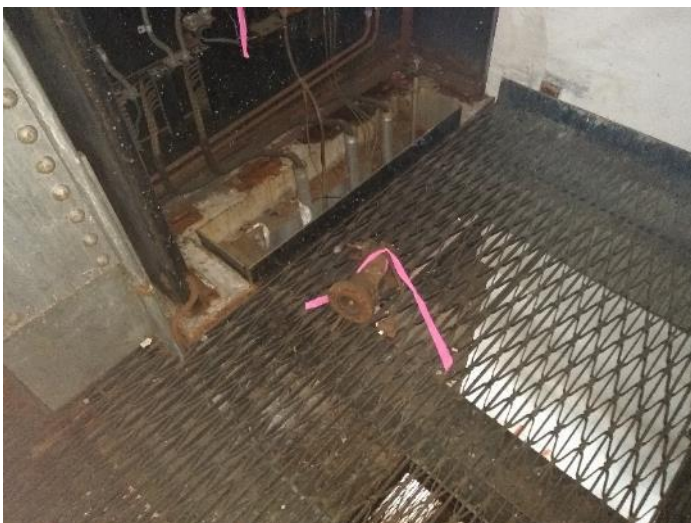
**Location M17: View of reservoir formerly containing mercury situated on the floor.**

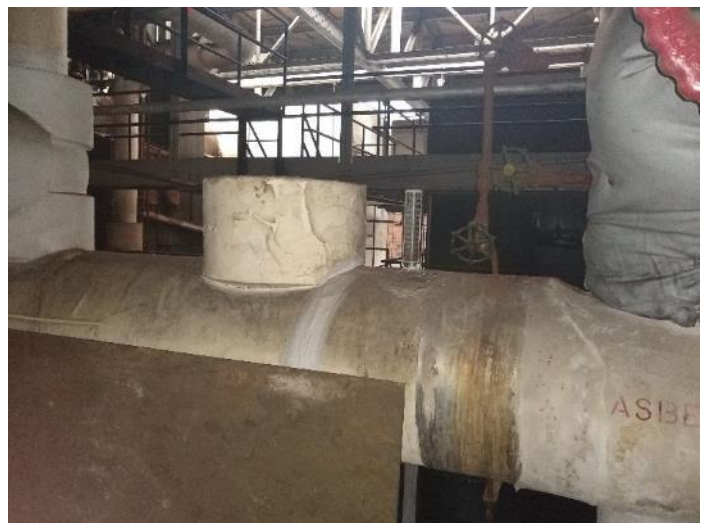
**Location M18: Mercury thermometer attached to #3 boiler.**

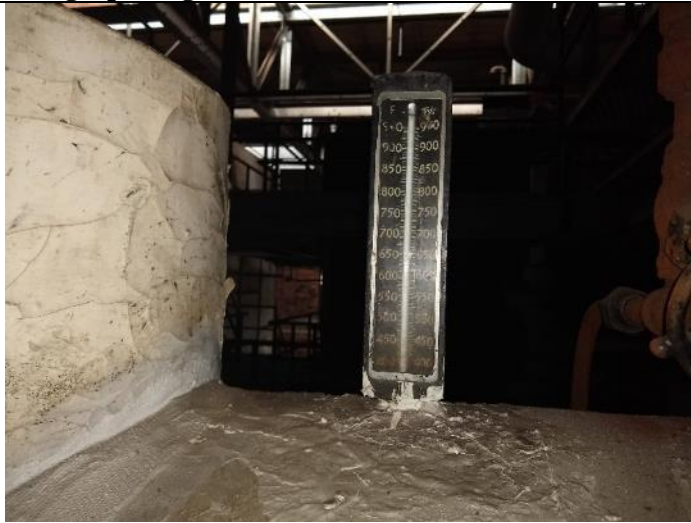
**Location M18: Mercury thermometer attached to #4 boiler.**

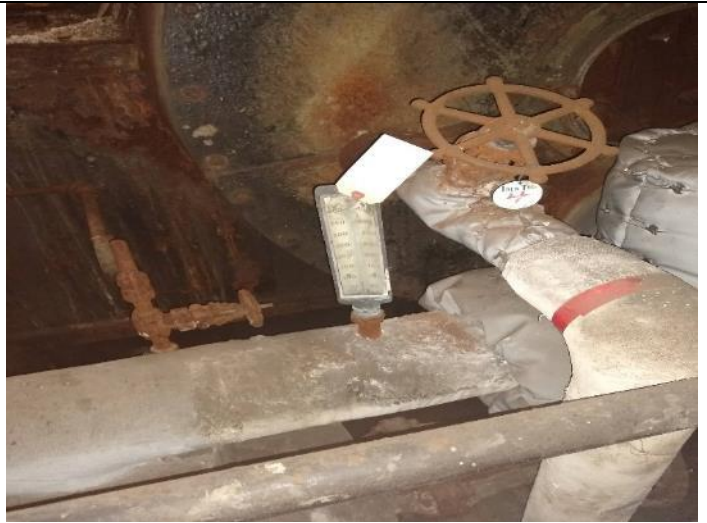
**Location M19: Mercury thermometer attached to piping on mezzanine between 2<sup>nd</sup> and 3<sup>rd</sup> floors.**

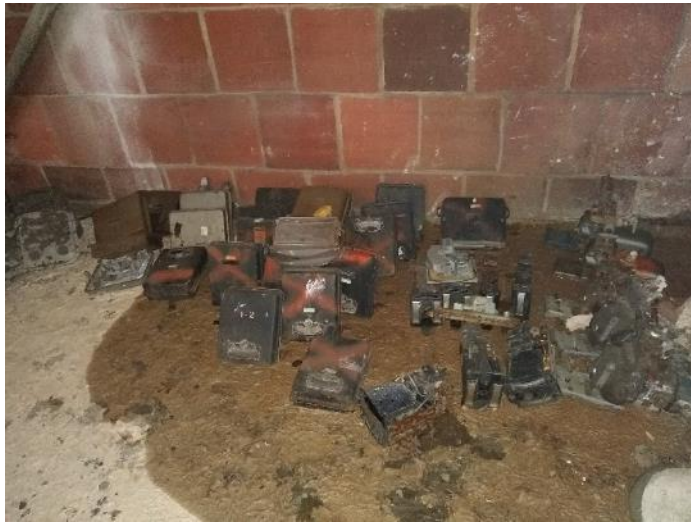
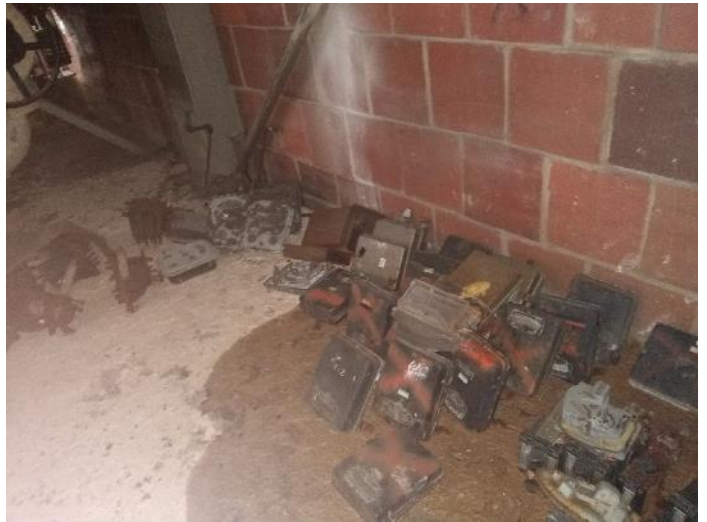
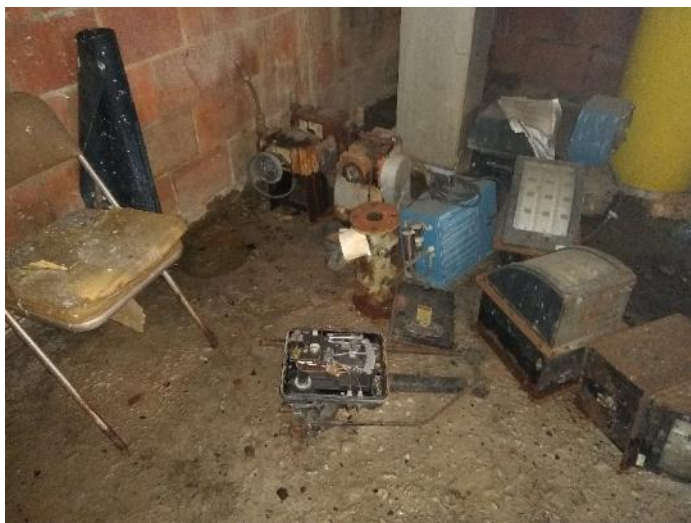
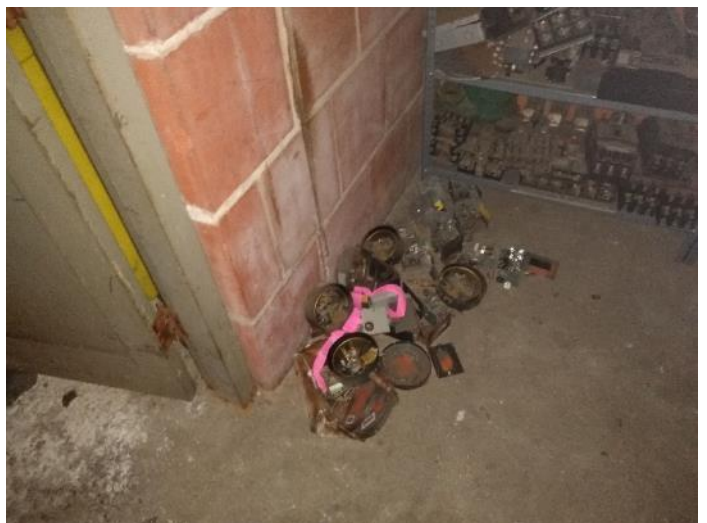
**Location M20: Various Bailey Meters and other equipment that formerly or currently contain mercury.**
