October 19, 2021

Project 171.06108.011

RE: Asbestos Conditions Assessment
Mason Station
Wiscasset, Maine

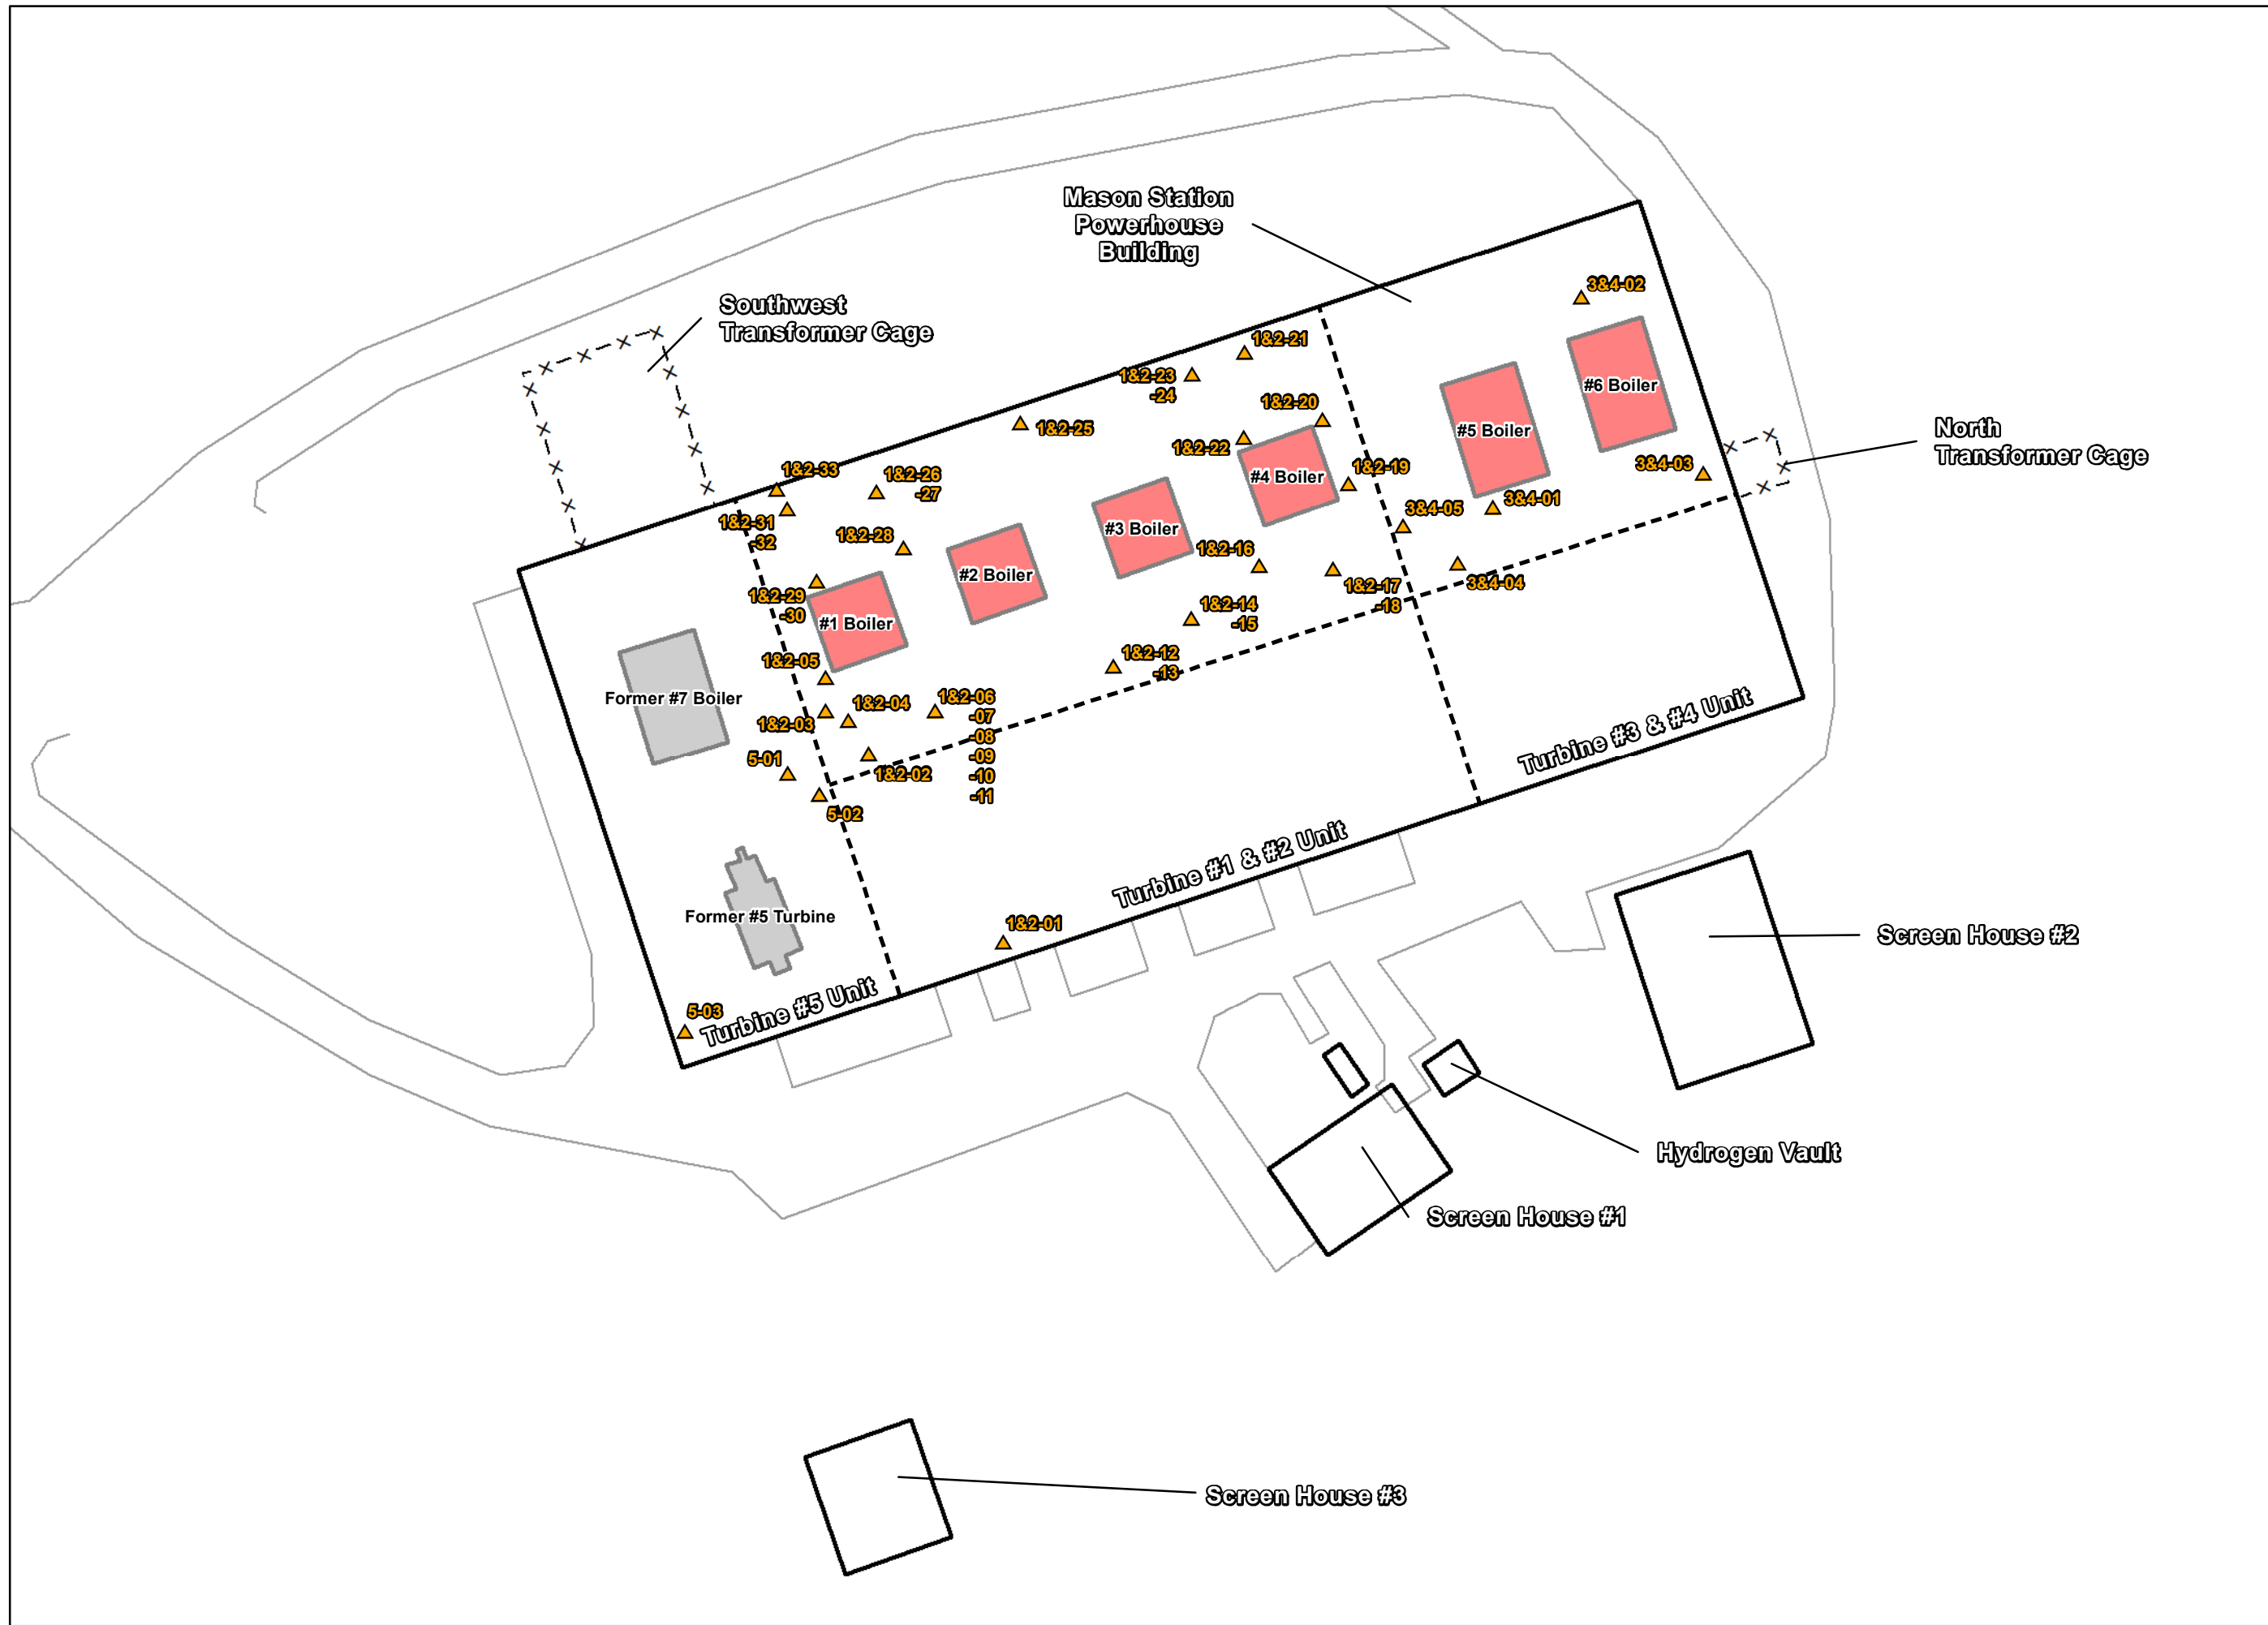
Figure 1
Ground Floor

actionable condition, is located in the Units #1 & #2, and Units #3 & #4 building areas, on the western side of the Powerhouse building (refer to Figures 1 through 5).

Ransom recommends that the Powerhouse building be evaluated for renovations designed to permanently enclose the majority of the asbestos materials within the building which at a minimum, should include construction of an enclosure wall to prevent contact with the actionable materials, repair or replacement of the roof, and securing the building against trespassers. A plan should be developed in consultation with the MEDEP that outlines the proposed enclosure design specifications, inspection, and long-term maintenance requirements. Any asbestos materials identified in short-term actionable condition which are located outside the proposed enclosure area should be removed by a licensed asbestos contractor as part of the short-term asbestos abatement plan.

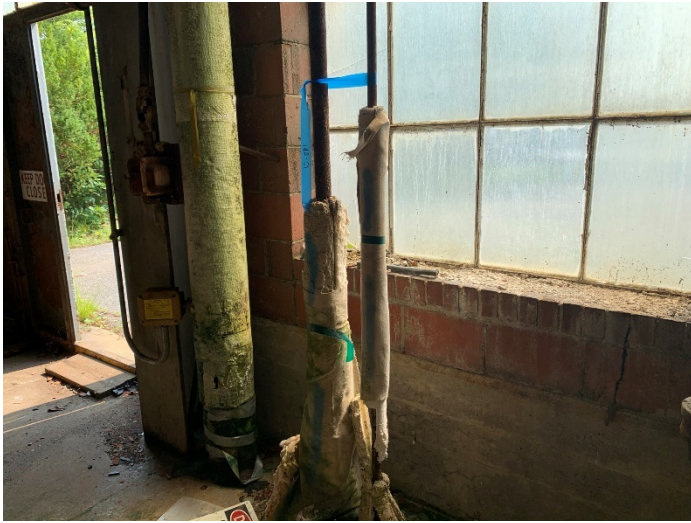
Photo 1&2-01: Non-ACM by analysis

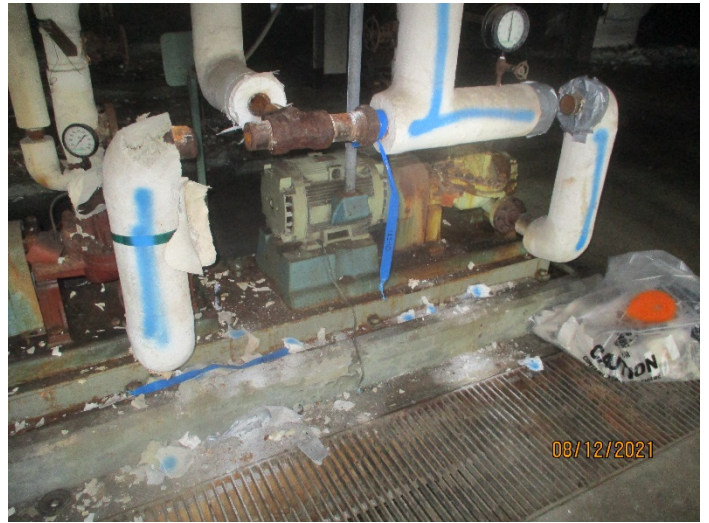
Photo 1&2-10/11: Non-ACM by Analysis

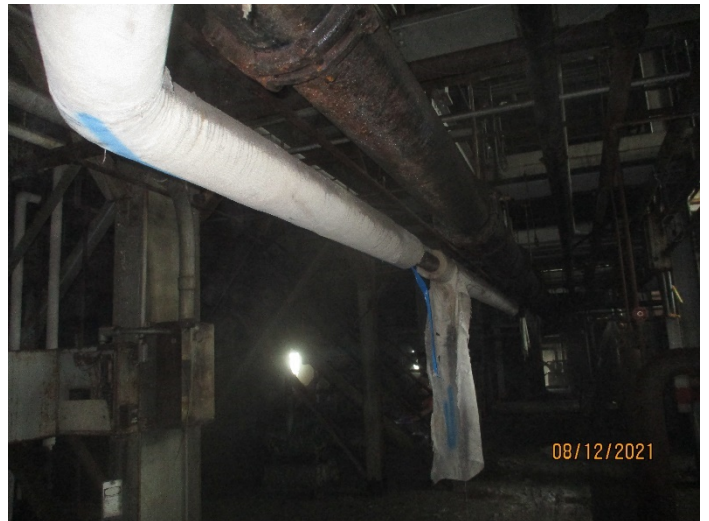
Photo 1&2-26: Non-ACM by Analysis

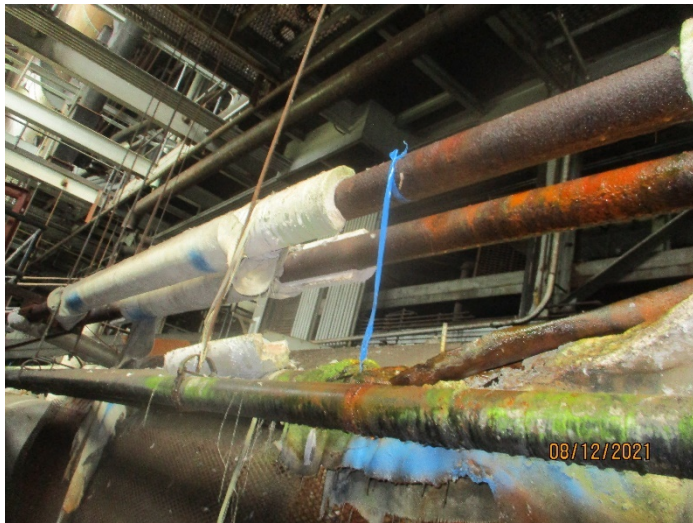
Photo 1&2-31: Non-ACM by Analysis

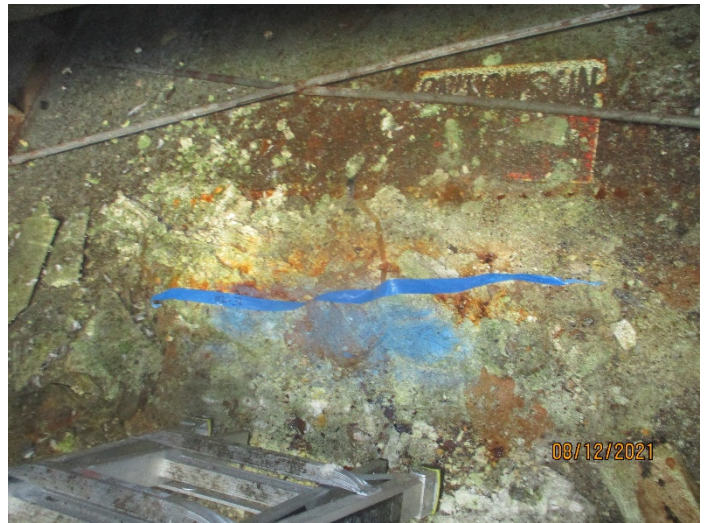
Photo 1&2-32: Non-ACM by Analysis

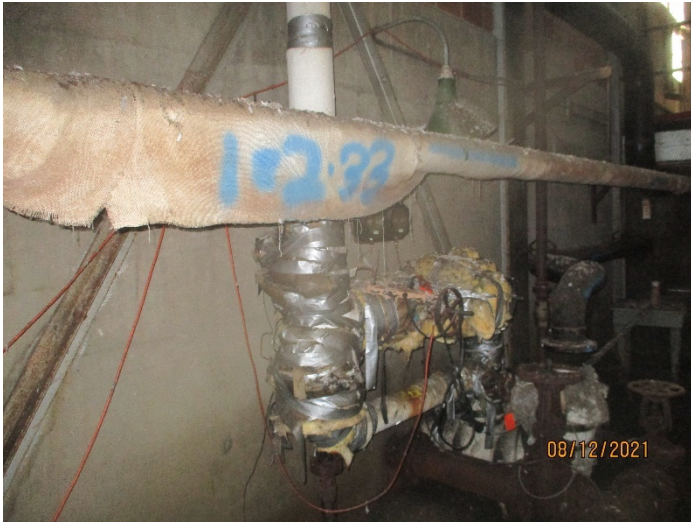
Photo 1&2-33: Non-ACM by Analysis

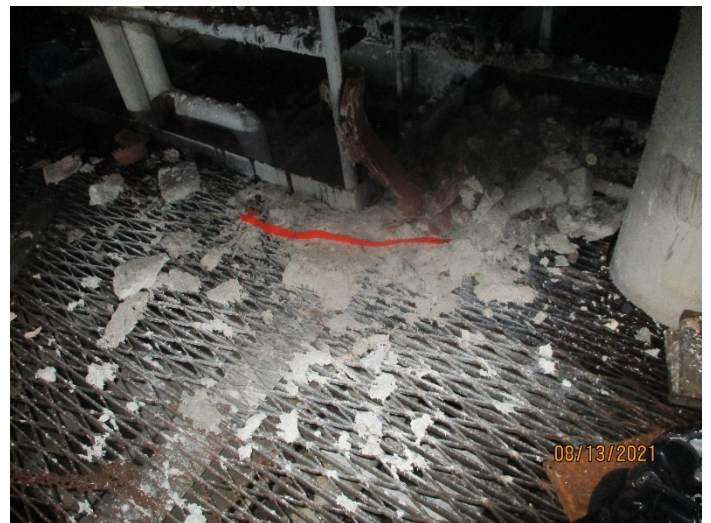
Photo 3&4-09: Positive ACM by Analysis
