# POTENTIAL HAZARDOUS BUILDING MATERIALS INVENTORY

**Miller's Department Store  
230 Penobscot Avenue  
Millinocket, Maine 04462**

**June 2016**

TRC Project No: 233392

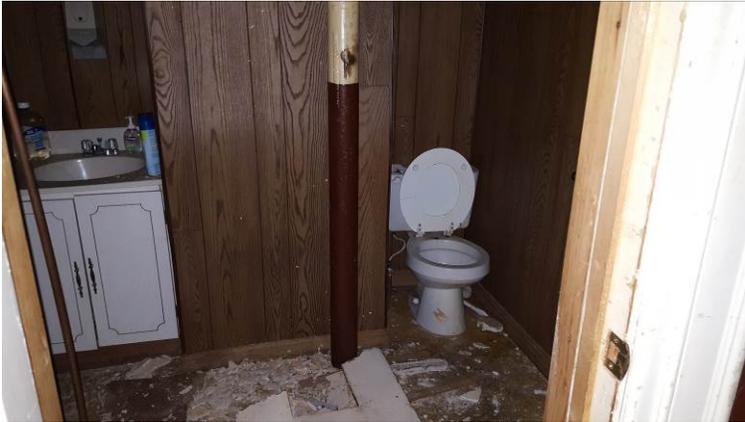
1. Image showing bead board (and glue), sink lining, basecoat (and mastic), beige/peach paint, and burgundy paint on 2<sup>nd</sup> floor.

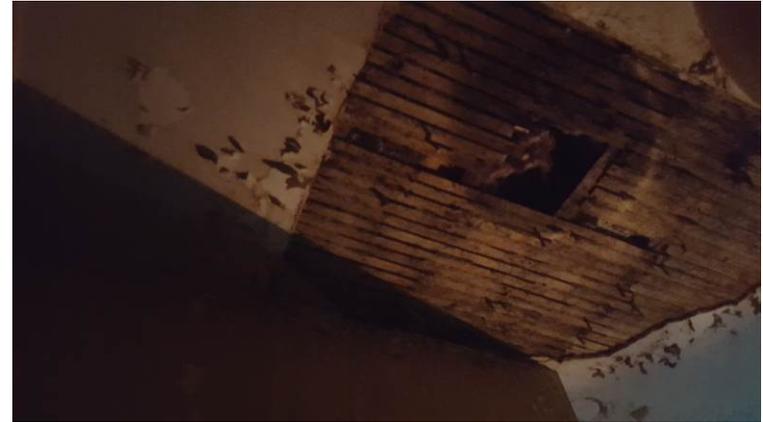
2. Image showing plaster, vermiculite, and white paint of second floor ceiling.

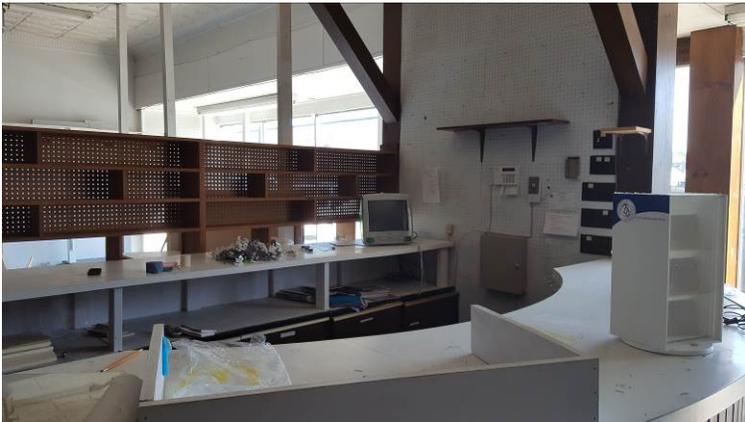
3. Image showing countertop and computers on 1<sup>st</sup> floor.

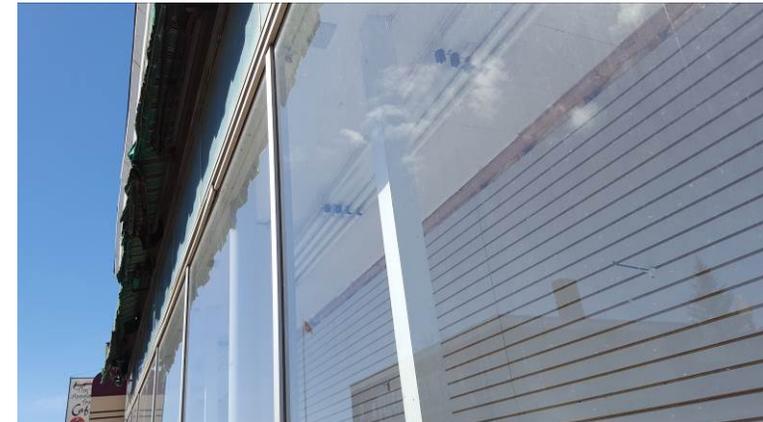
4. Image showing 1' X 1' ceiling tile, fluorescent lamps - 4 foot tube, ballasts, window caulk, and window glaze in the front display area.

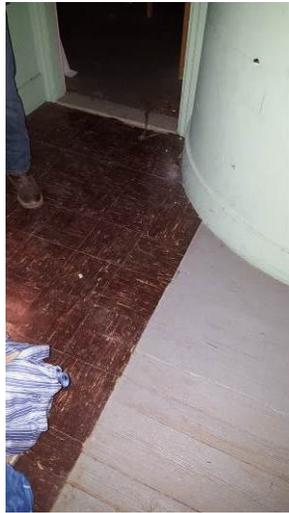
5. Image showing 9" X 9" floor tile (and mastic), mint paint, and gray paint on 2<sup>nd</sup> floor.

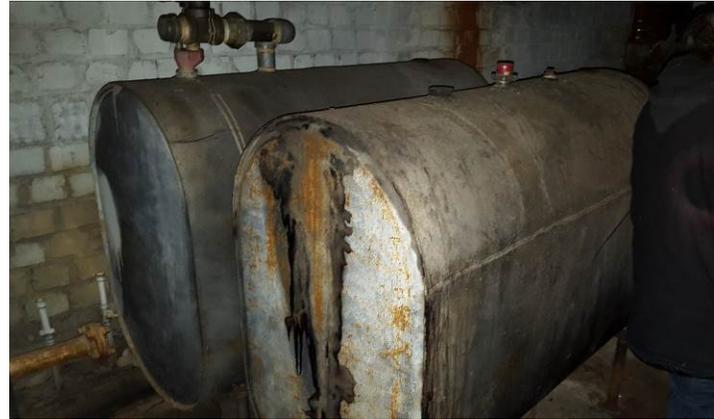
6. Image of cinder blocks (and mortar), ASTs, and gasket(s), in basement.

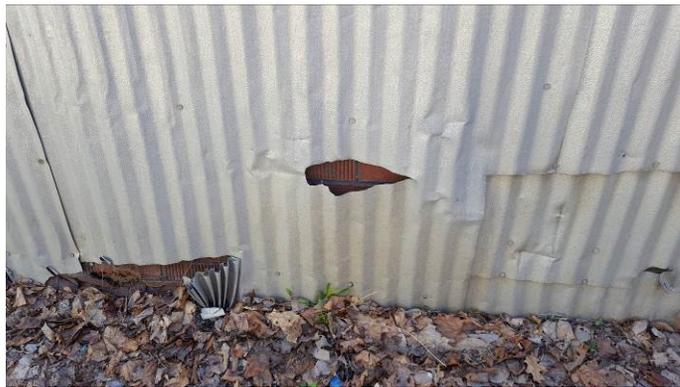
7. Image showing the faux brick siding (behind metal sheeting) on the exterior of the building.

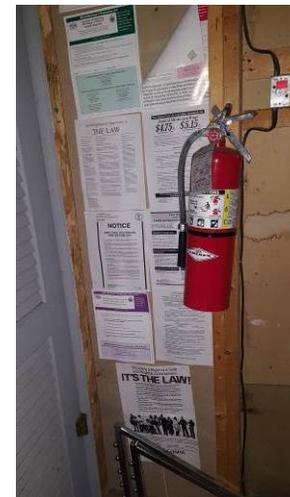
8. Image showing a fire extinguisher on the 1<sup>st</sup> floor.
