Hazardous Building Materials Inventory

**0 and 3 Thompson's Point
Portland, Maine**

DRAFT May 19, 2016

In Reference to:
Credere Project No. 15001312

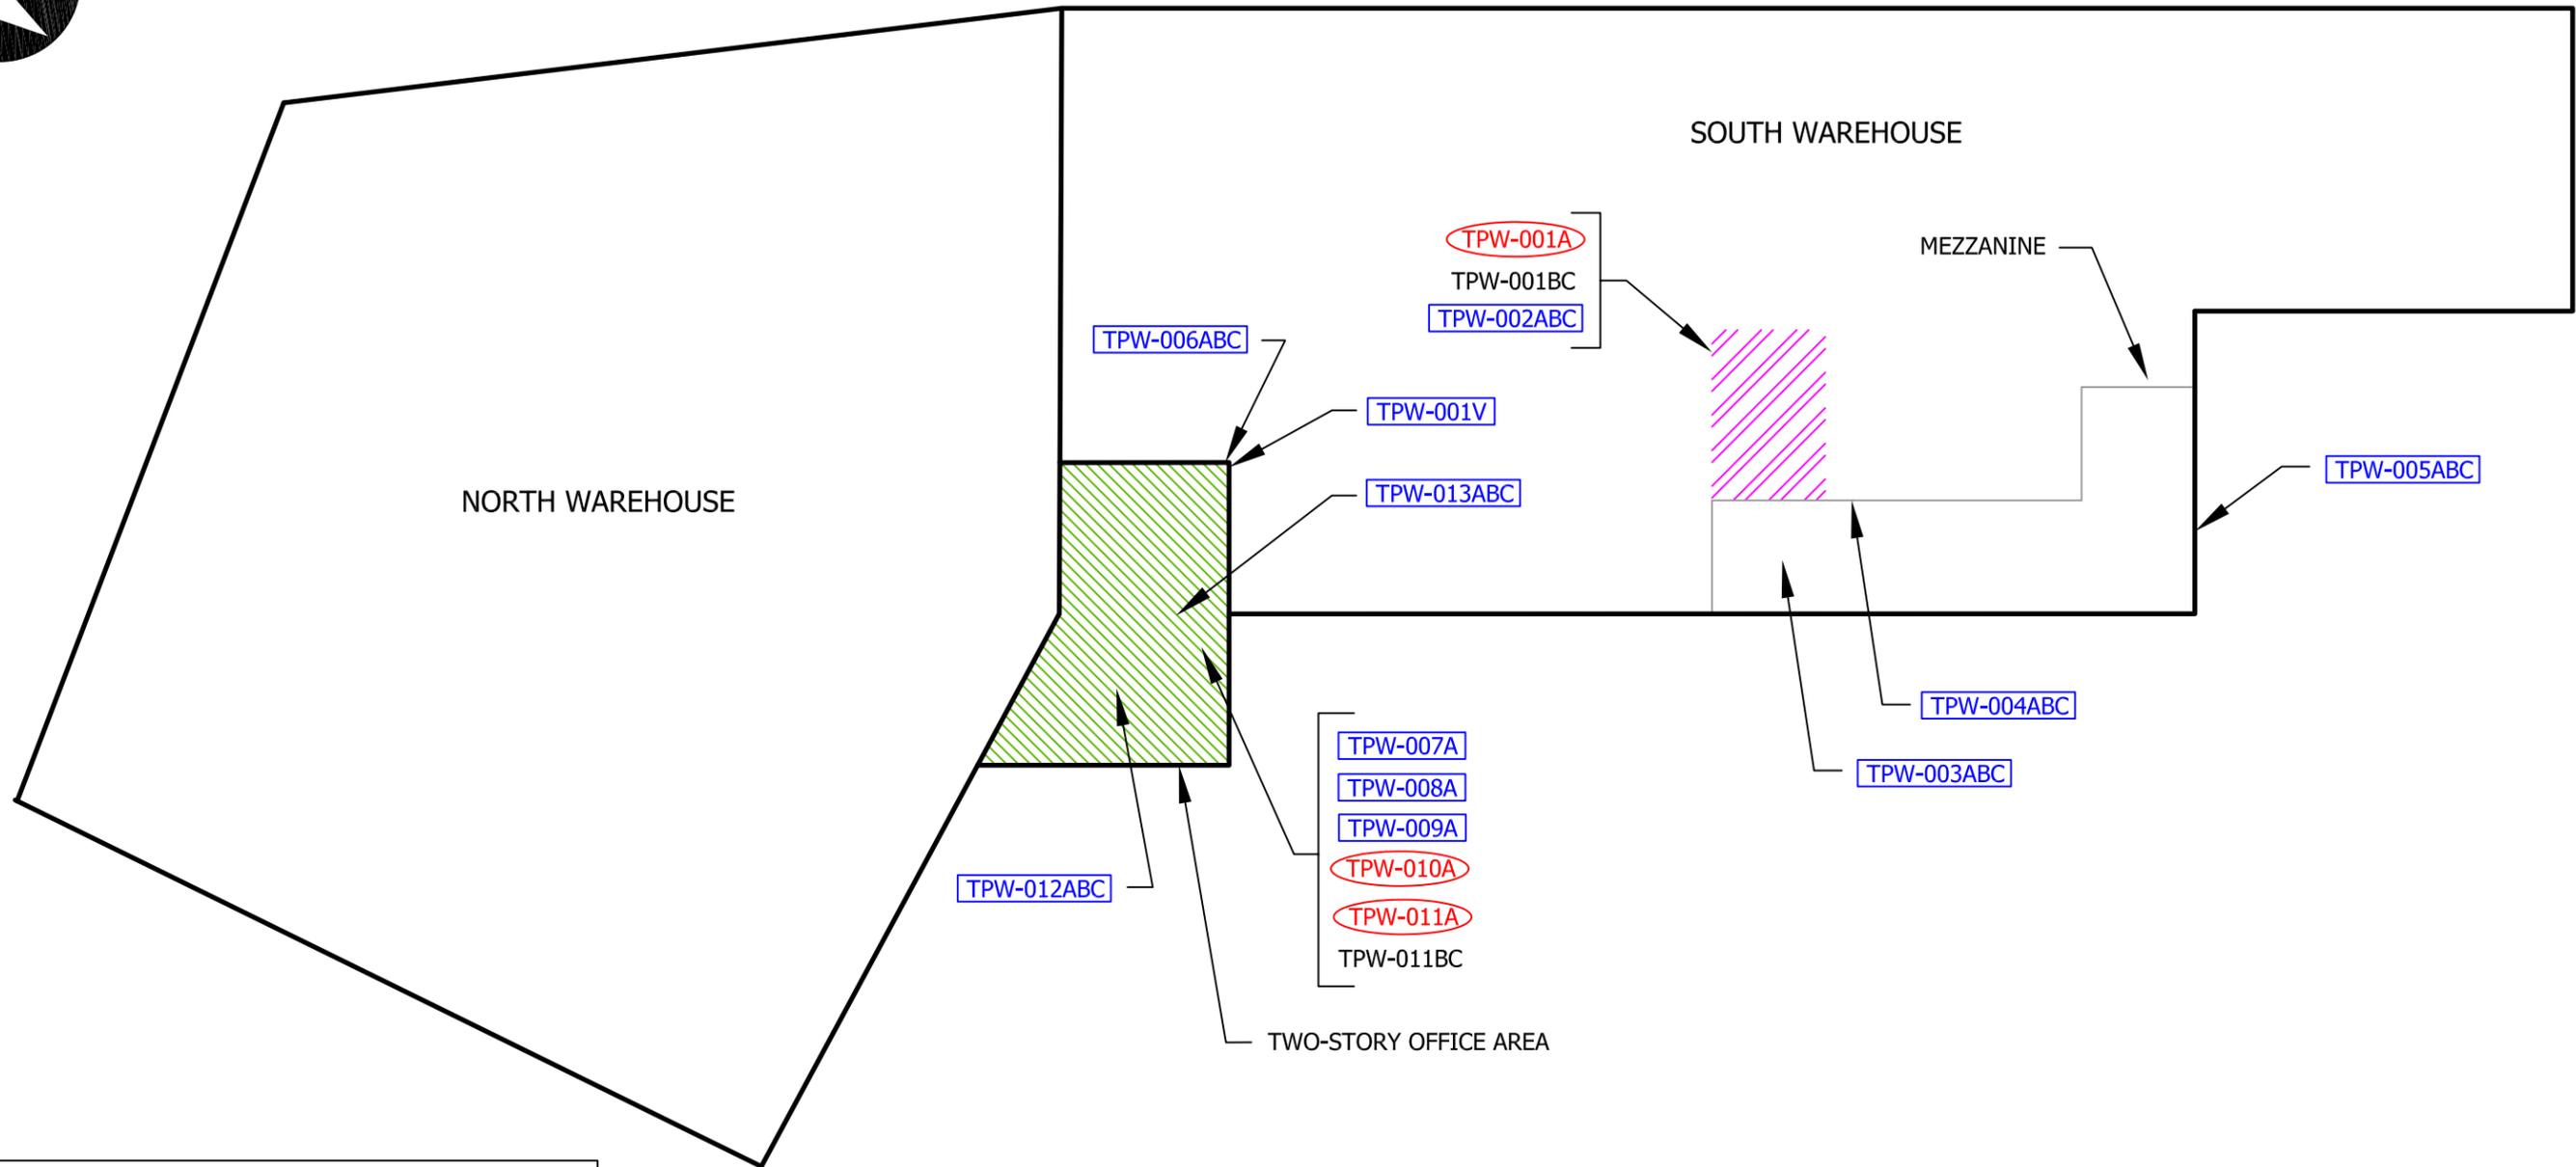
FIGURE 1

- 9-inch by 9-inch green floor tile in the south warehouse;
- 12-inch by 12-inch brown floor tile in the office building; and
- Subflooring material in the office building.

Current regulations require ACM to be removed prior to disturbance by renovation, demolition or other building maintenance activities. The ACM floor tile identified within the south warehouse and the ACM floor tile and associated subflooring on the first floor of the office building must be abated (i.e., be removed) prior to demolition or renovation of the building. ACM abatement must be performed using a Maine licensed Asbestos Abatement Contractor, using approved methods in accordance with applicable regulations established by the MEDEP, the USEPA, and the Occupational Safety and Health Administration (OSHA). Should the membrane roof present over the north warehouse and office be impacted by future renovations or demolition, the roof should be evaluated for the presence of suspect ACM at that time.

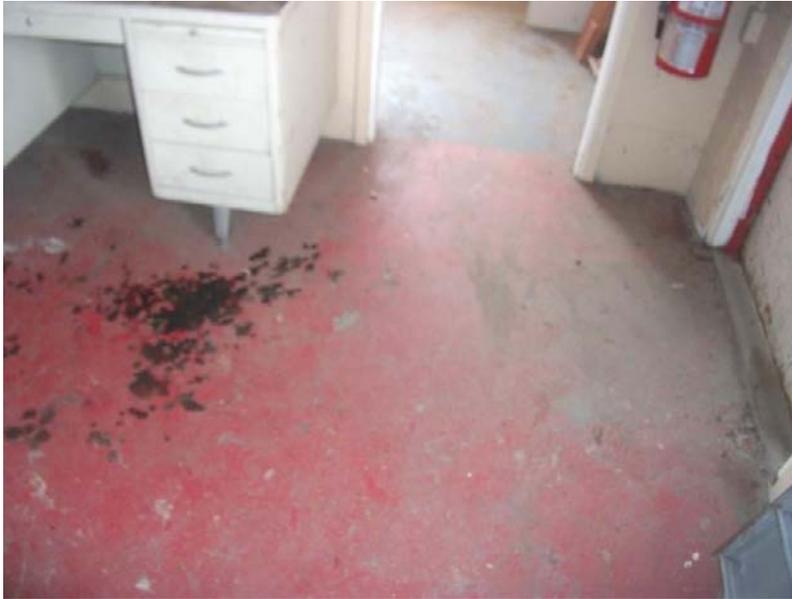
1. Potential lead and PCB paint on floors in Building #3.

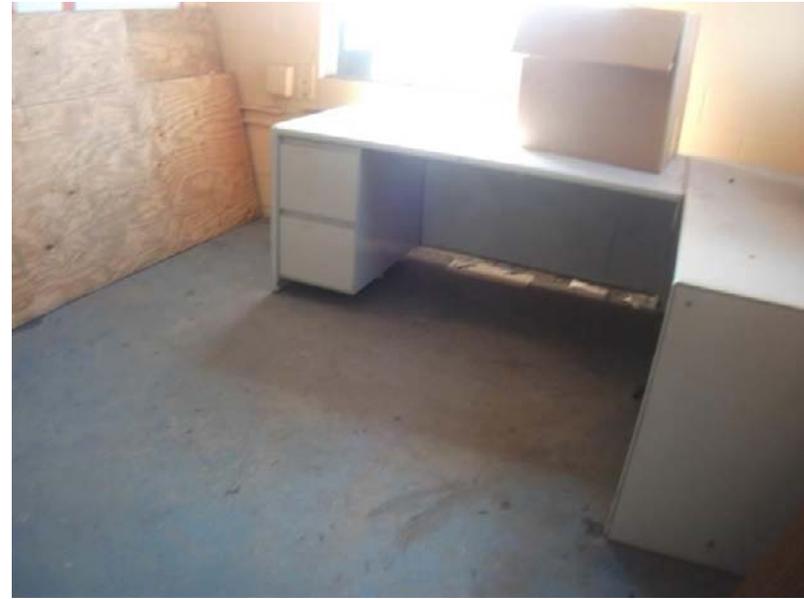
2. Potential lead and PCB paint on floors in Building #3.

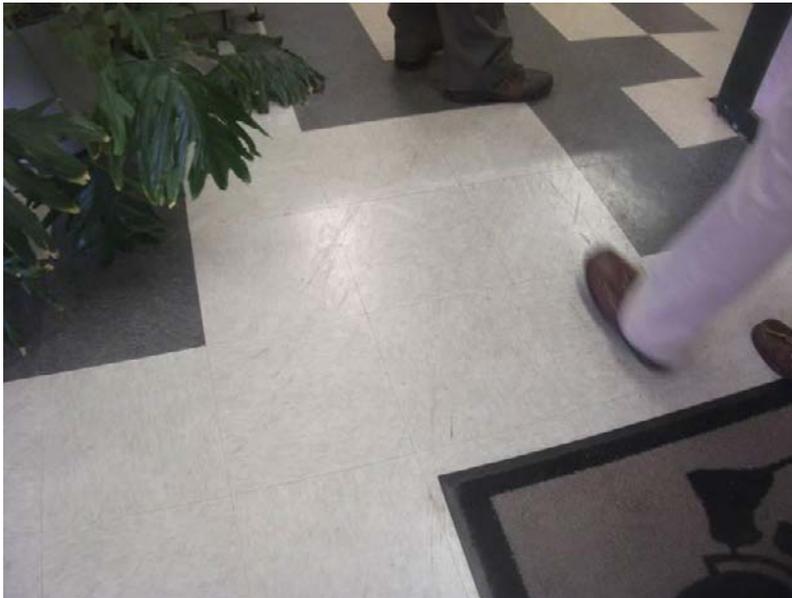
3. Potential ACM floor tile in Building #1, room 1.

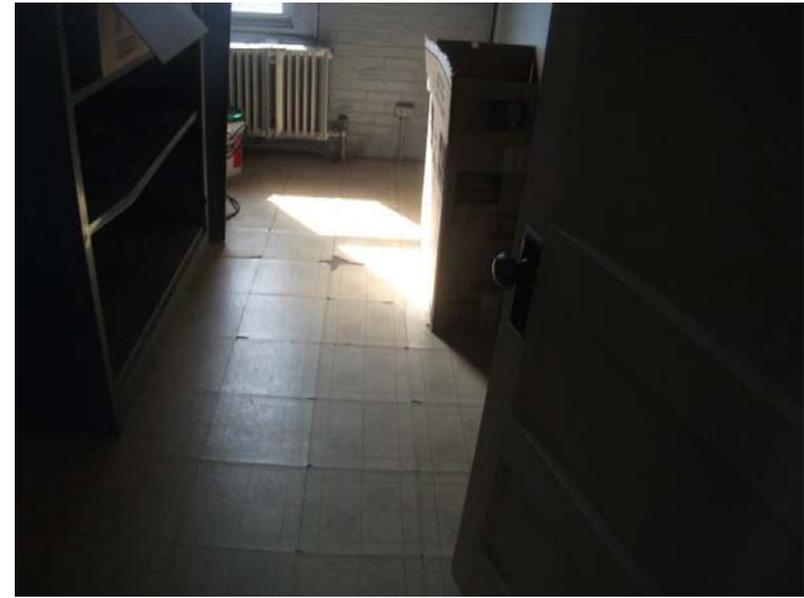
4. Potential ACM floor tile in Building #1, room 9.

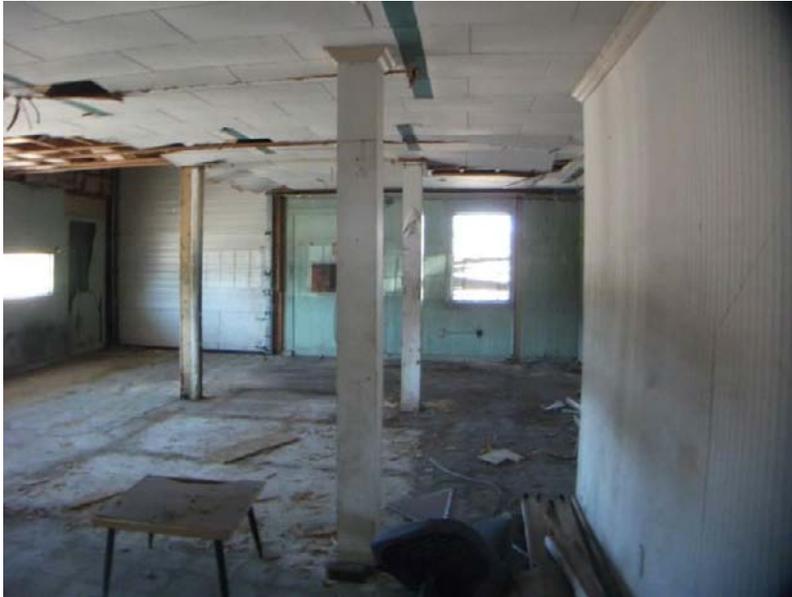
5. Potential lead and PCB paint on walls and floors, potential ACM floor tile, and waste fluorescent lighting in Building #2, room 1.

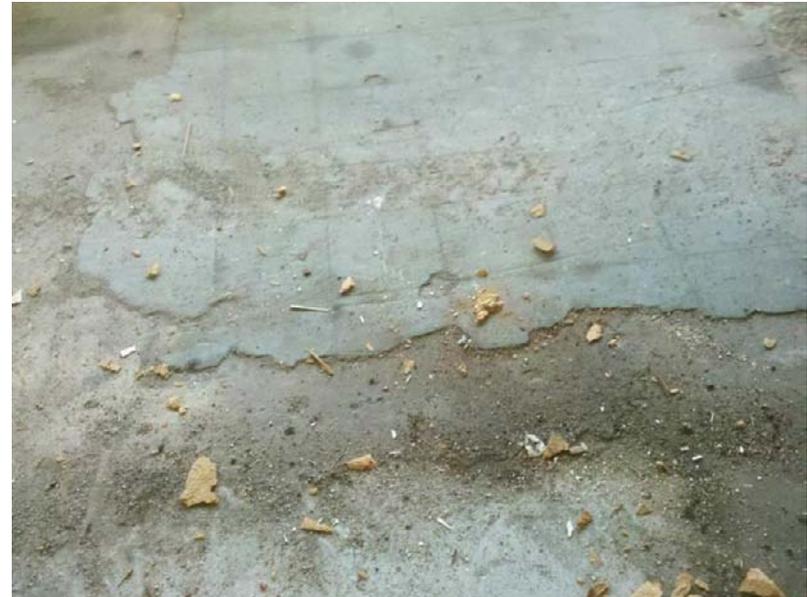
6. Potential ACM floor tile in Building #2, room 1.

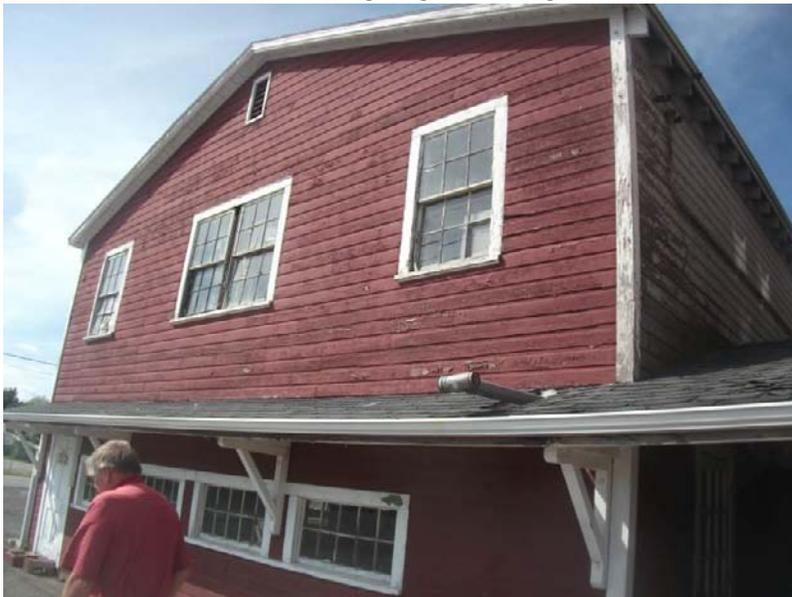
7. Potential lead and PCB paint on walls and trim, potential ACM window glazing, on exterior of Building #2.

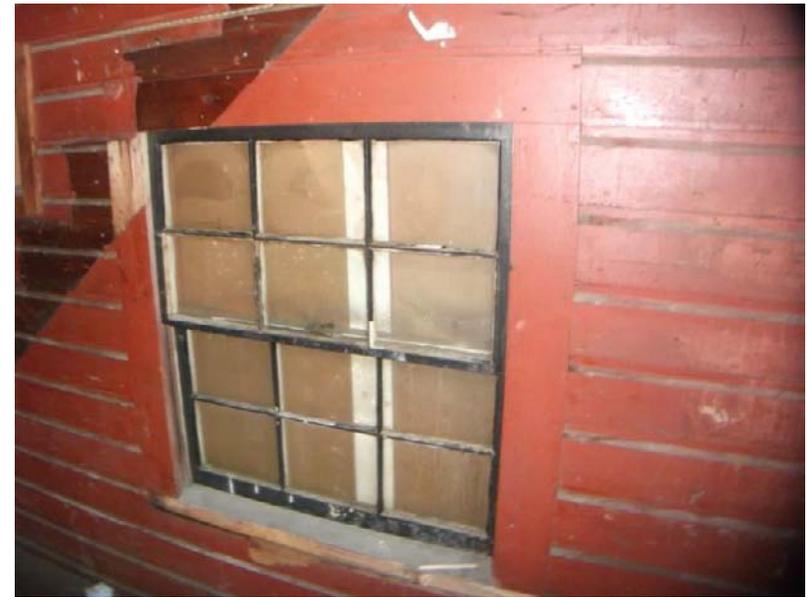
8. Potential lead and PCB paint on walls and potential ACM window glazing in Building #2, room 2.

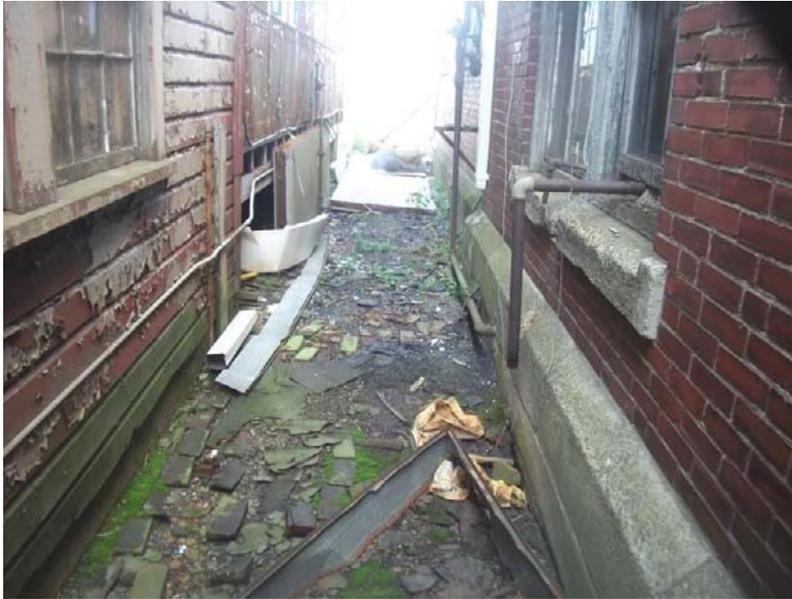
9. Waste potential ACM roof shingles in between Buildings #1 and #2

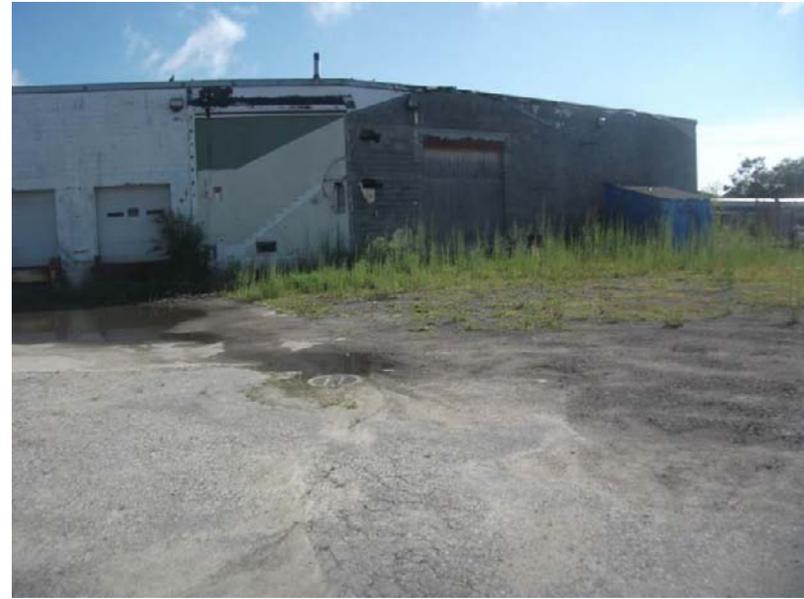
10. Potential lead and PCB paint on walls on exterior of Building #5.

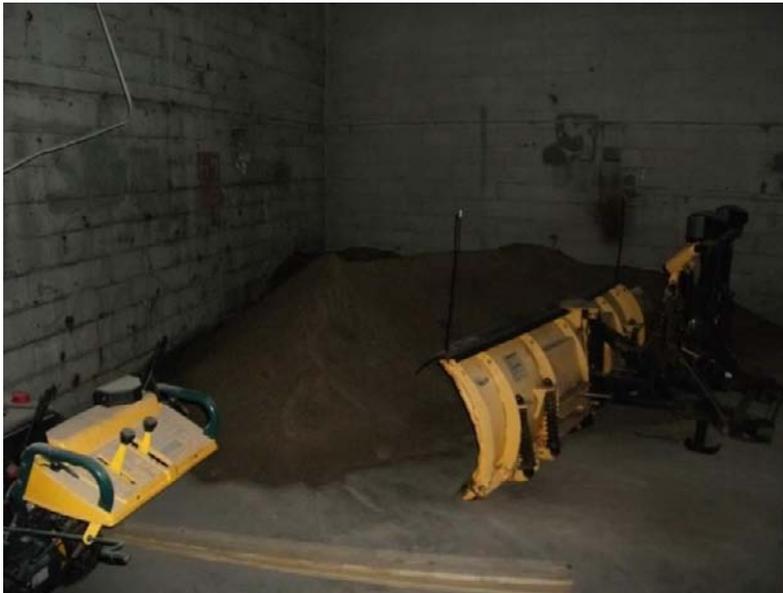
11. Potential lead and PCB paint on walls on interior of Building #5.
