# Appledore Marine Engineering Inc.

Re: Underwater Inspection of Deer Isle-Sedgwick Bridge  
Deer Isle, Maine  
**Letter Report**  
Appledore Project No. 5059

## **SUMMARY**

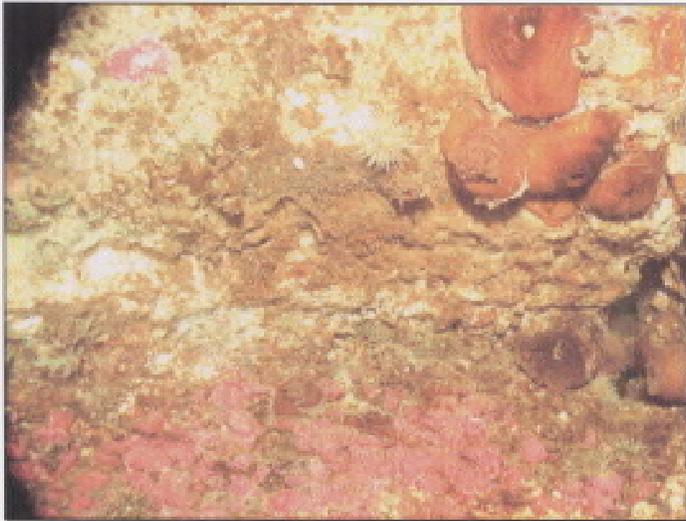
Photo 4:

The concrete pylon bases contain areas of moderate deterioration where the metal sheeting has corroded and the concrete is exposed. At these areas, the concrete is soft with exposed aggregate and could be pulverized with a hammer (Photos 4 and 5). At some locations, holes in the metal sheeting resulted in voids in the concrete up to 12 inches deep, or cracks up to 1/2-inch wide as shown in Photos 4 and 5. Several voids were observed in the pylon bases of both piers.

Void in the eastern face of the pylon base at the northeast corner of Pier 5. Void is 2' wide by 1' high by 12" deep. Note the void extends through the soft concrete and continues to the northern face.

- A. Concrete cores be extracted from the pylons and pylon bases in order to obtain specimens for determining the compressive strength of the concrete. One core should be extracted from the footing in order to determine the general concrete strength at this location. Figure 4 illustrates a concrete coring plan.
- B. It is recommended that the voids in the pylon bases be repaired. The cost associated with this repair is shown in Table 1.

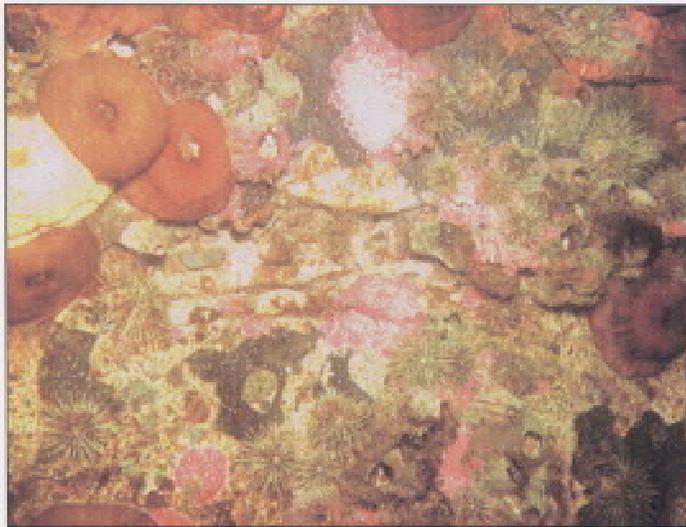
Photo 5:

Horizontal crack in the soft concrete on the southern side of the pylon base at Pier 4.

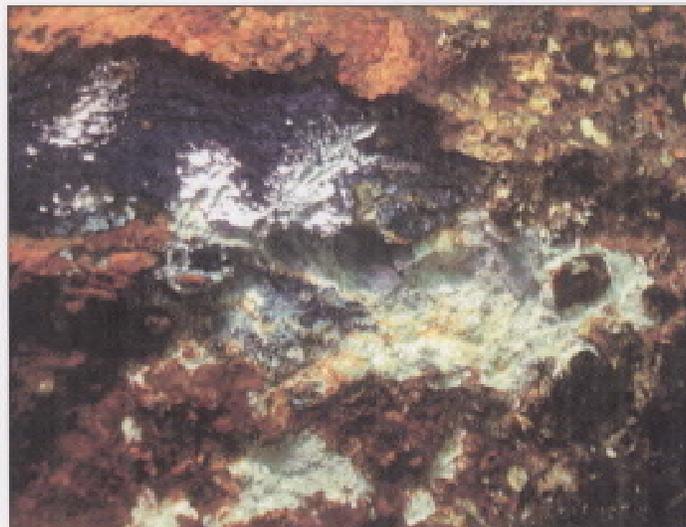
Photo 6:

The concrete pylons contain areas of minor deterioration where the metal sheeting is deteriorated and the concrete is exposed. At these areas, the concrete is semi-hard but could not be easily broken up with a hammer. At each of the four pylons there is a band of exposed concrete around the circumference of the pylons between El. -2.0 and -5.0 (Photos 6 and 7). This deterioration occurs between the mean low water line and the base of the pylons.

Typical underwater condition of the exposed concrete at the pylons between EL. -2.0 and EL. -5.0. Note white areas where semi-hard concrete was sounded with a chipping hammer.

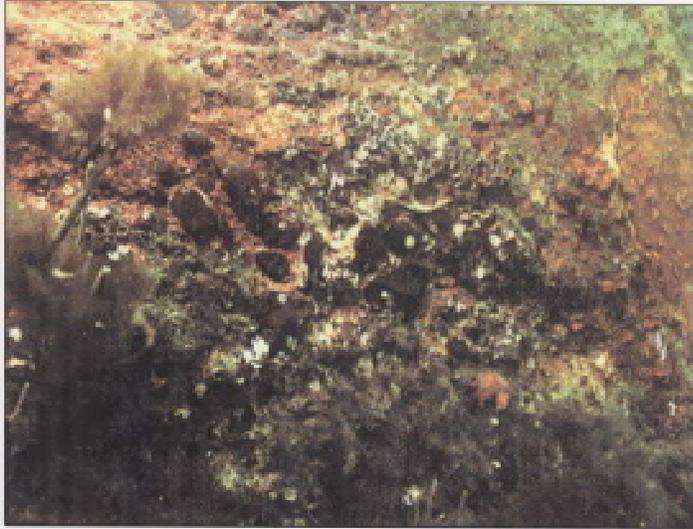
Photo 7:

Typical underwater condition of the exposed concrete at the pylons between EL. -2.0 and EL. -5.0 (MLLW). Note exposed concrete aggregate.

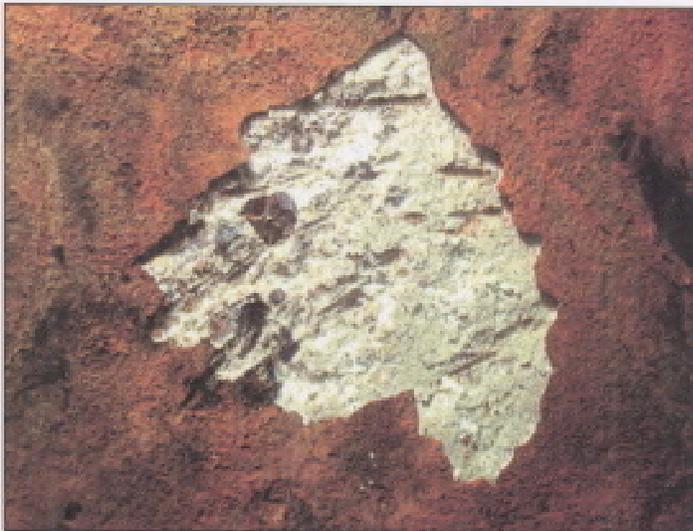
Photo 8:

Above the mean low water line and throughout the tidal zone, the metal sheeting is thin and could be punctured with a hammer (Photo 8). The concrete is semi-hard in this area but could not be easily broken up with a hammer.

Typical underwater condition of the metal sheeting covering the pylons. Note the thinness of the sheeting material. The concrete is semi-hard at these exposed areas within the tidal zone. Note hammer markings in the concrete.

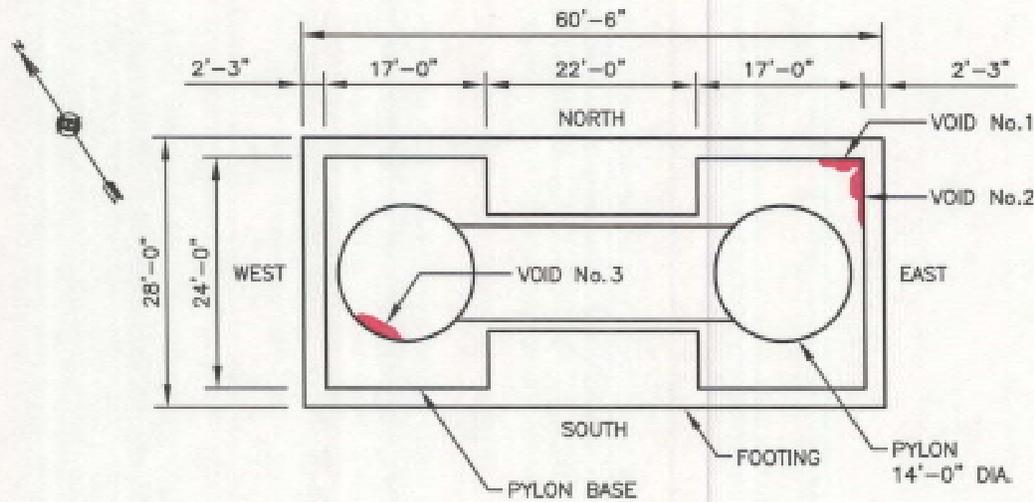
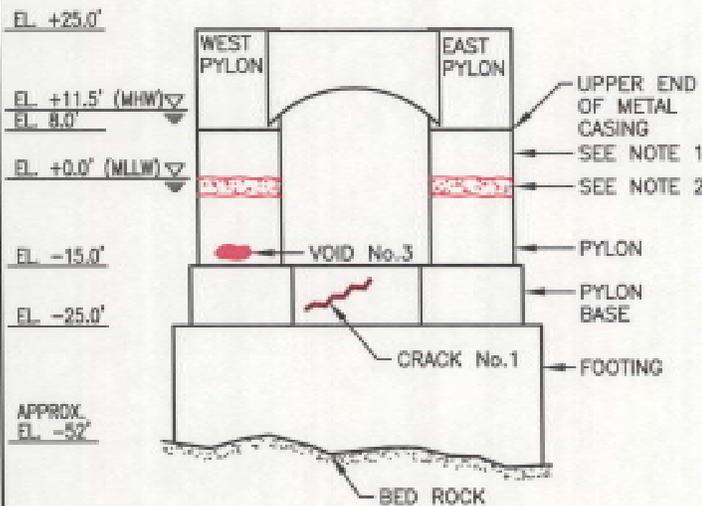
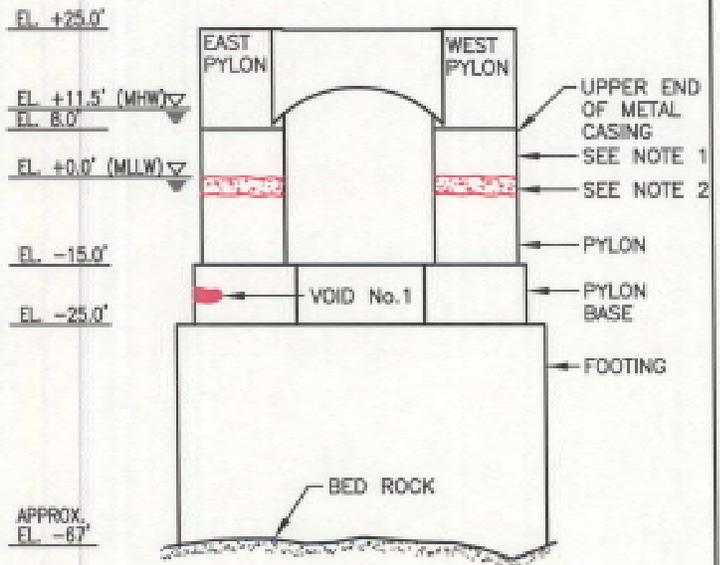
TranSystems Lichtenstein 11 Huron Drive Natick, MA 01760-1314	DEER ISLE - SEDGWICK BRIDGE	DEER ISLE, ME	FIG. NO.
	PIER 4 OBSERVATIONS			2

OBSERVED DETERIORATION	
VOID No.1	4'W x 2'H x 1'D
VOID No.2	4'W x 2'H x 1'D
VOID No.3	2'W x 1'H x 3'D
CRACK No.1	6'L x 1/2"H

- NOTES:  
1. CORROSION OF METAL CASING IN TIDAL ZONE  
2. SEMI-HARD AREA OF EXPOSED CONCRETE

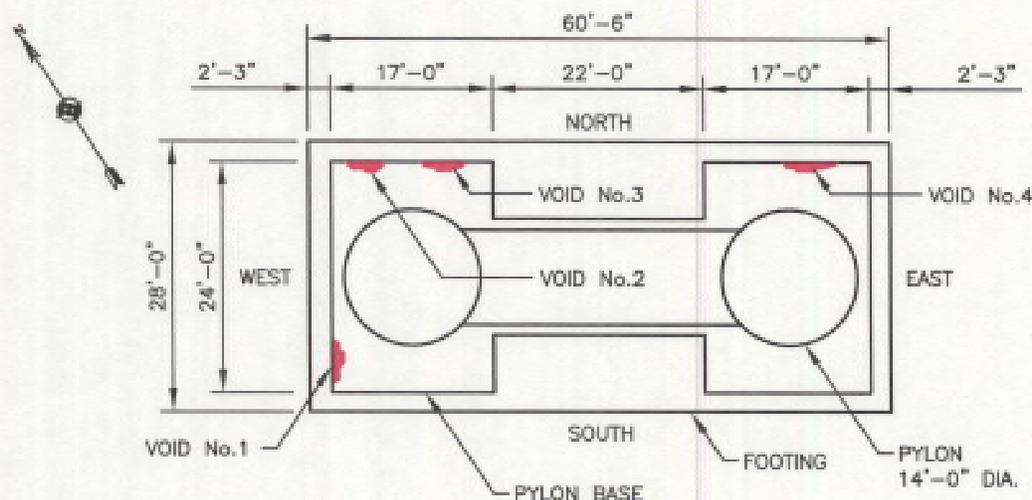
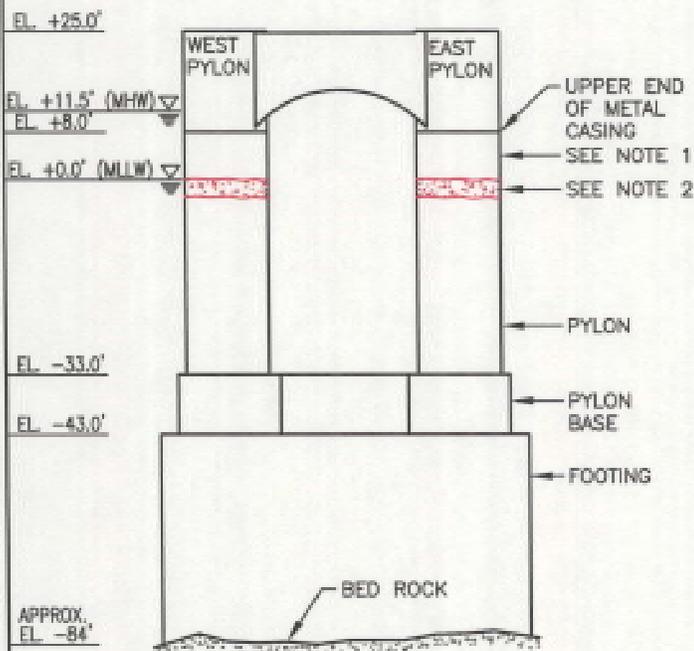
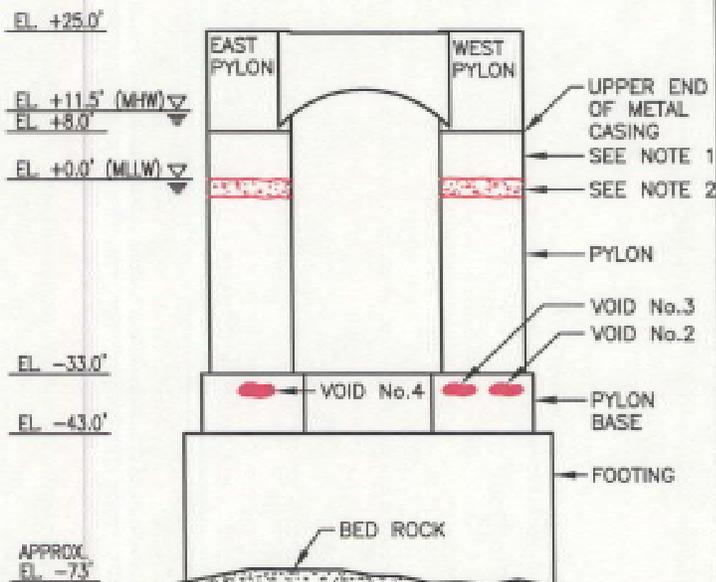
PIER 5 OBSERVATIONS

OBSERVED DETERIORATION	
VOID No.1	2'W x 2'H x 8"D
VOID No.2	4'W x 2'H x 4"D
VOID No.3	2'W x 1'H x 4"D
VOID No.4	3'W x 3'H x 4"D

- NOTES:  
1. CORROSION OF METAL CASING IN TIDAL ZONE  
2. SEMI-HARD AREA OF EXPOSED CONCRETE
