COST FEASIBILITY STUDY

Portland Commuter Rail Study

Portland, Maine
to
Brunswick & Auburn, Maine

December 14, 2005

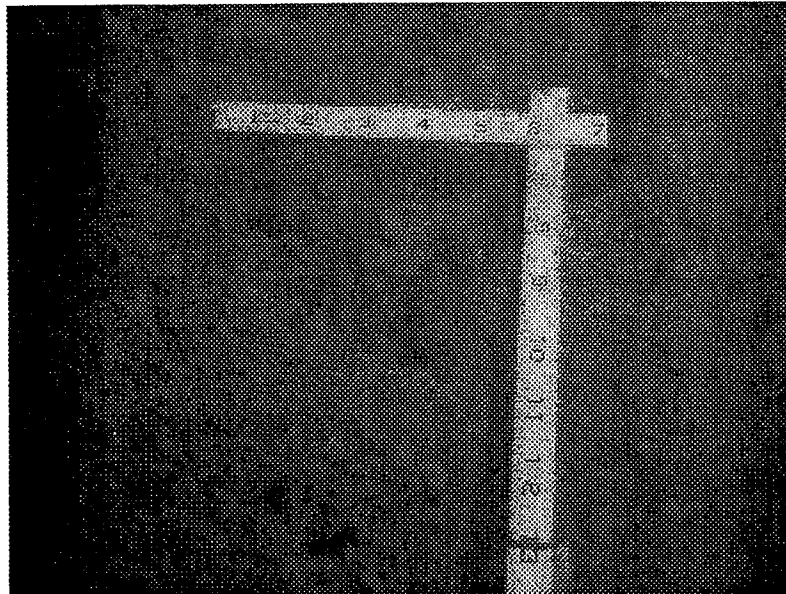
The north and south rest piers also require repairs. Inspection of the south rest pier showed large deteriorated areas of sheet piling and deep voids extending into the concrete fill. Inspection of the north rest pier showed sections of the sheet piling that has tilted and pulled away from the concrete fill. A timber whaler has been added at the southeast face in an attempt to halt the movement. Underwater inspection also revealed large deteriorated areas of sheet piling and deep voids extending into the concrete fill below the waterline similar to the south rest pier. Recommended repairs to the rest piers consists of replacing deteriorated sections of sheet piling and pressure grouting behind the piling to fill the voids. Additionally, at the south rest pier, the six steel H pilings exposed in front of the sheeting supporting the ends of

Photo #1, South Pier, 7" wide hole in sheet pile at station 72, at the mudline

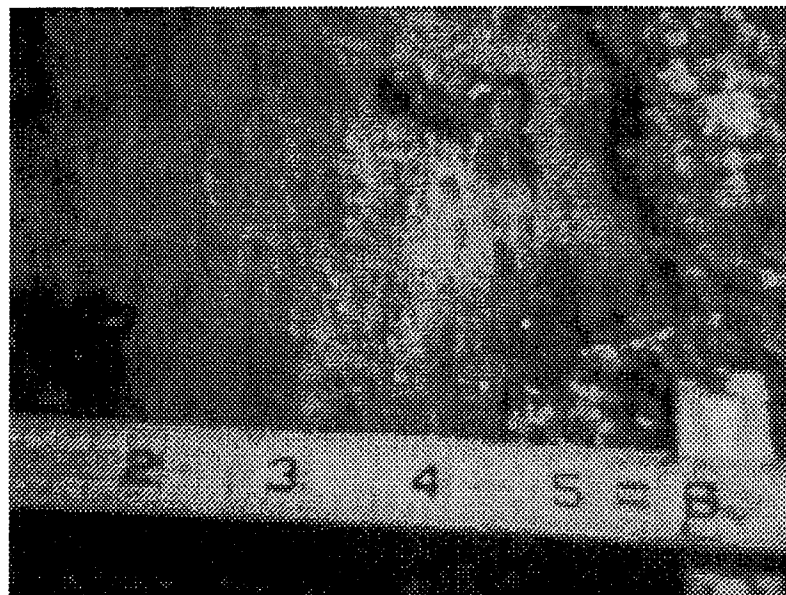
Photo # 2 South Pier, Station 10, elevation mean low water, surface cleaned for steel thickness reading

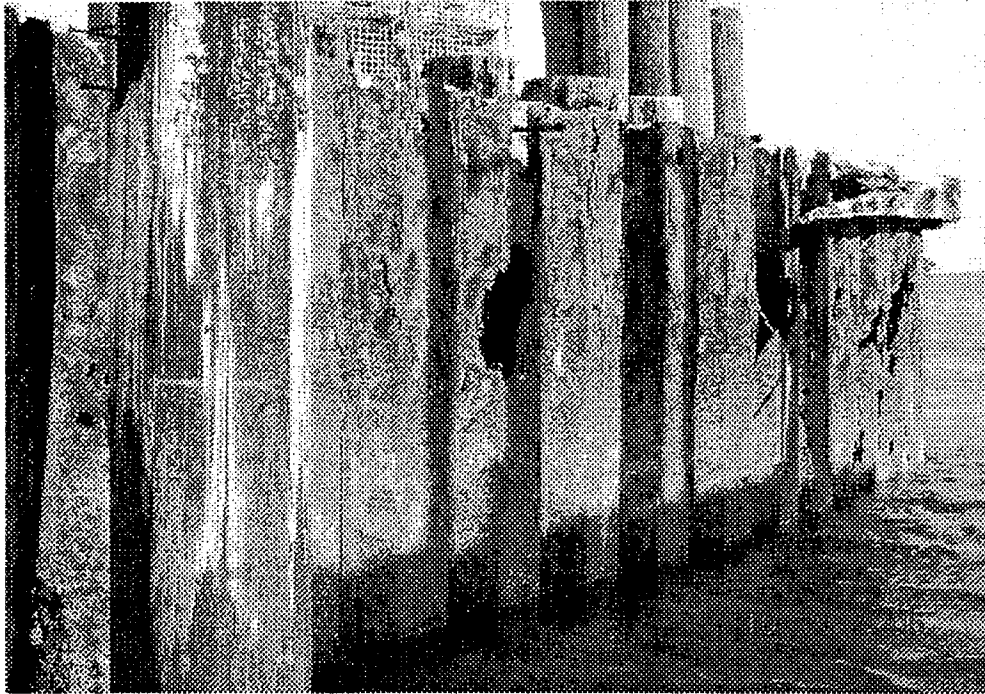
Photo # 3, South pier, Station 18 – 50, general conditions above the water line

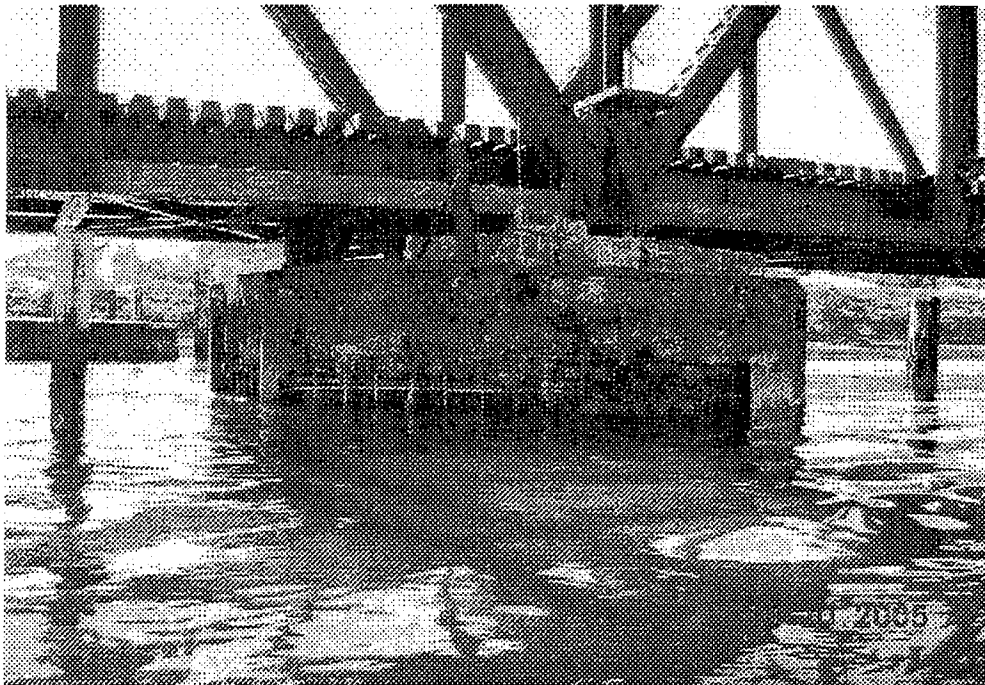
The post 1950 rehabilitation of the center pier has severely deteriorated to the point where large voids in the reinforced concrete fill and steel plate have exposed the original granite blocks. Given this, it is recommended that the remains of the existing reinforced concrete fill and steel sheets be entirely removed and replaced. The replacement could consist of installing steel sheet piling extended well below the mud line and attaching it to an upper and lower steel ring frame which itself is attached to standoffs embedded into the original granite pier. The sheet piling would serve as formwork for a tremied concrete fill encapsulating the pier.

Photo # 4 Center pier, general condition above mean low water

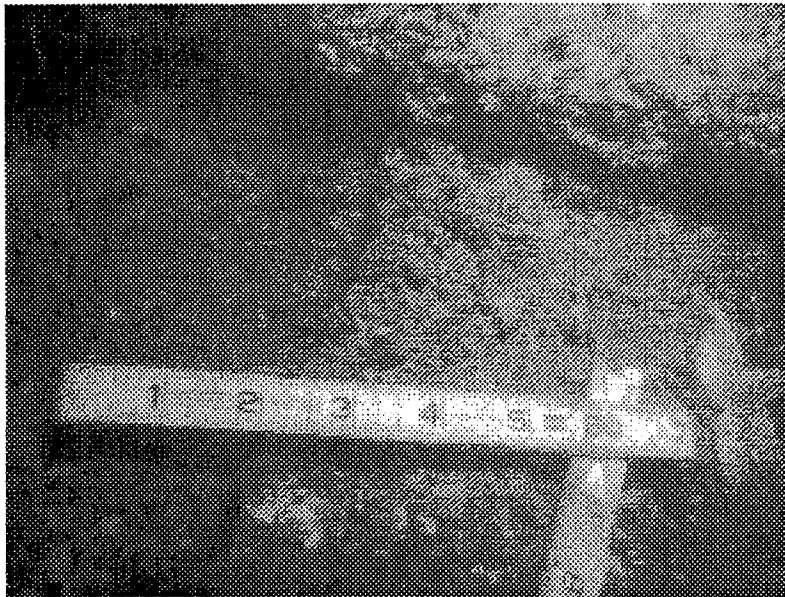
Photo # 5 Center Pier, station 19, crack in granite block

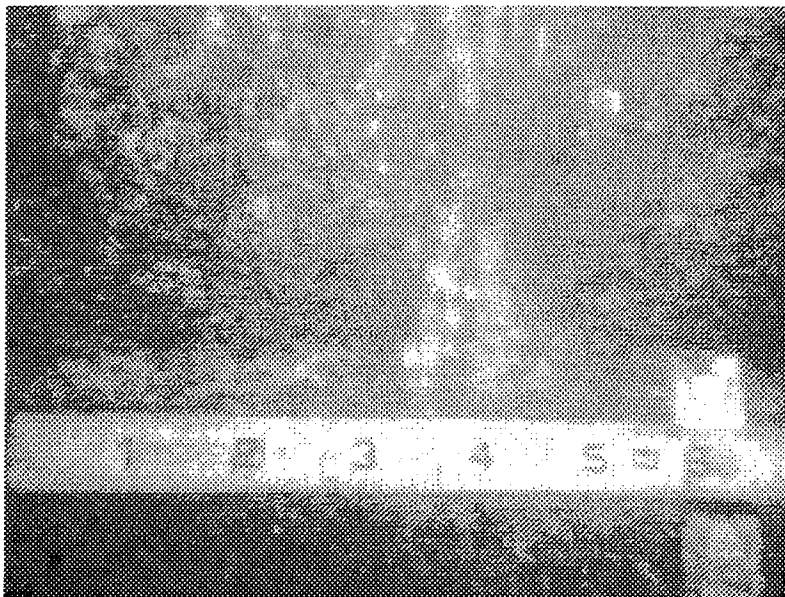
Photo # 6 Center Pier, typical granite block joint open 2 1/2"

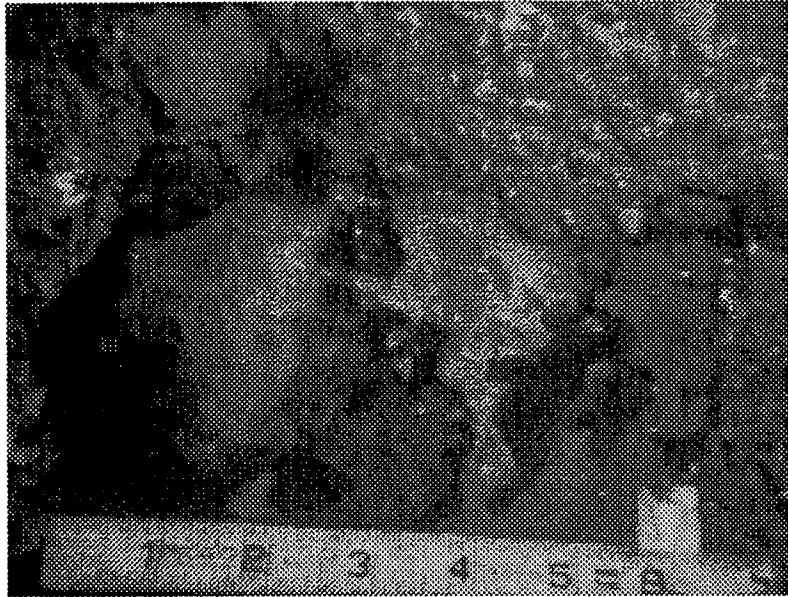
Photo # 7 North Pier, Station 18, elevation mean low water,
Surface cleaned for steel thickness reading

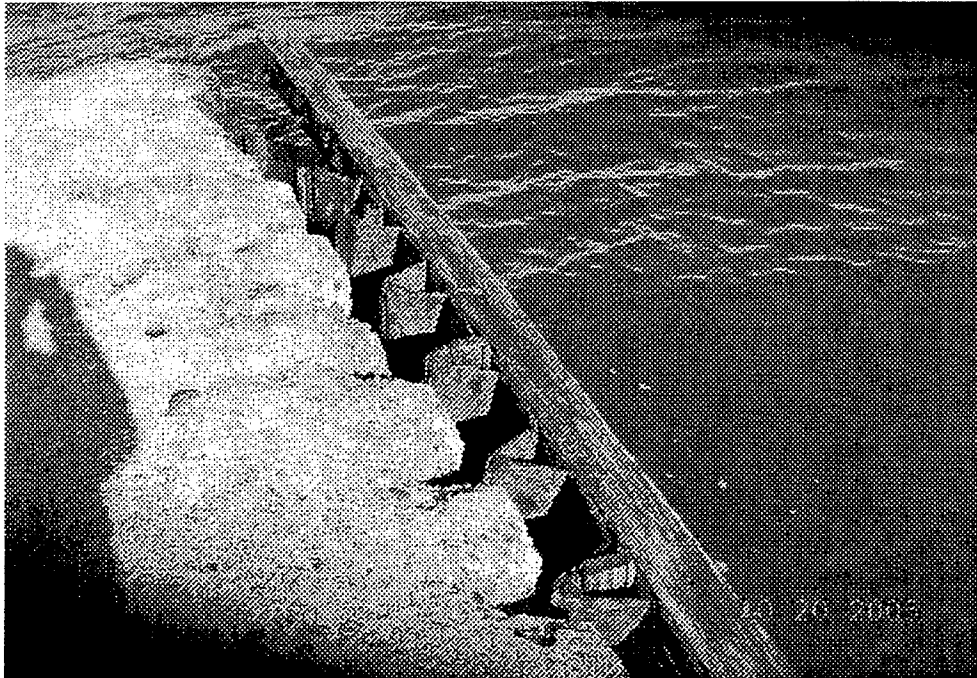
Photo # 8, North Pier, Sheet pile on South east face is separated

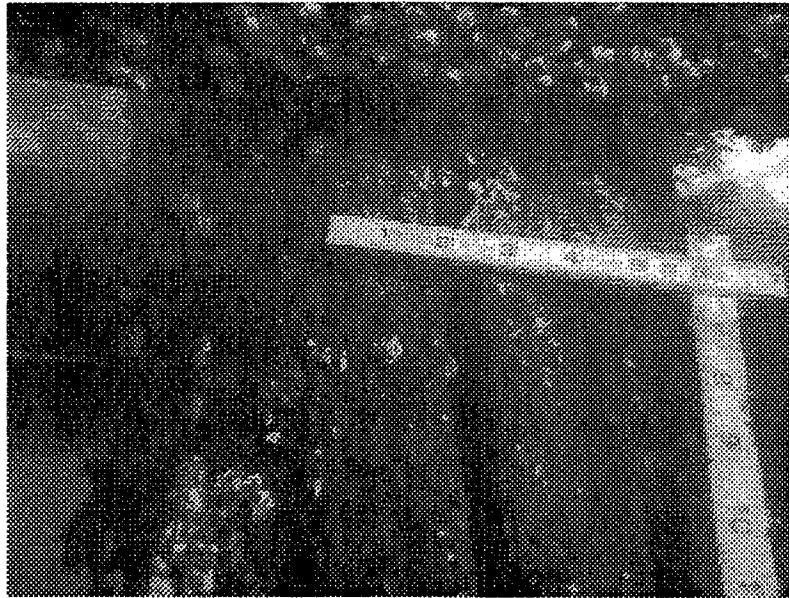
Photo # 9, Bent 3 pile 3, split just below horizontal bracing

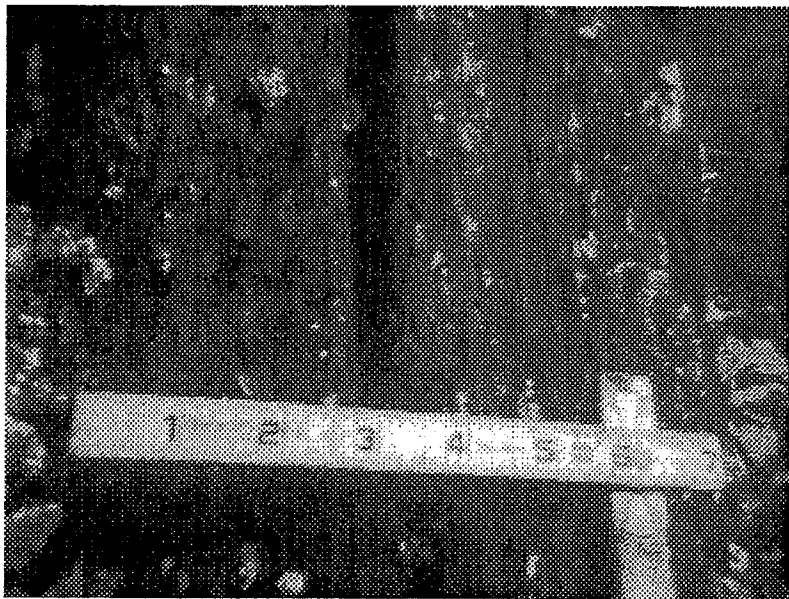
Photo 10, Bent 2, pile # 2, split at mean low water
