Final Report
Docket No. 2005-705
CMP Distribution Plant Evaluation

M*aine Public Utilities Commission*
P
U
C

February 26, 2007

Williams Consulting, Inc.

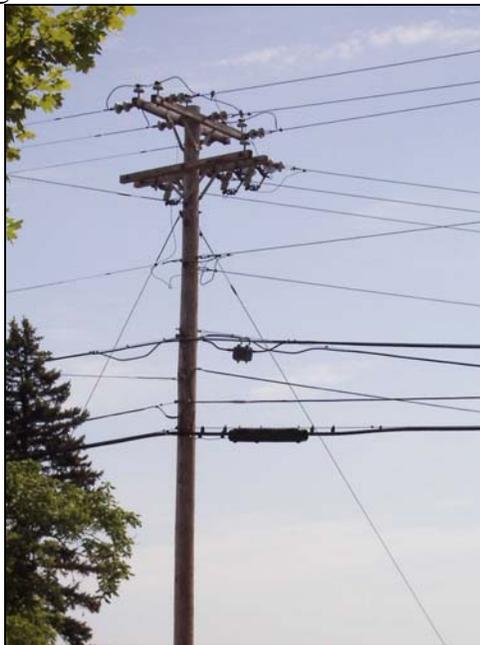
Typical 3-phase pole

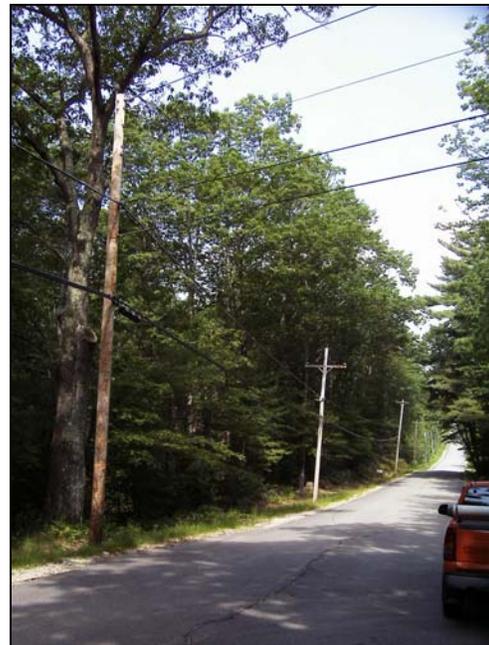
Typical 1-phase circuit

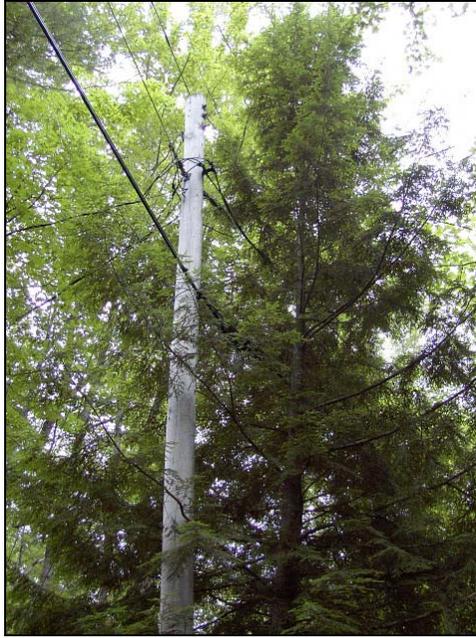
Heavy vegetation in contact with 1-phase circuit

- Modify the current reactive vegetation management program and provide sufficient budget funding to implement a proactive tree trim cycle of 4 to 5 years. In order to accomplish this, CMP should develop a formal estimate of annual costs to maintain a 4-5 year trim cycle as well as the additional up-front expenditures required to reach a 4-5 year cycle within a reasonable time frame. Environmental Consultants, Inc. offered similar recommendations in a 1988 report entitled “Distribution Line Clearance Program”, and Barakat & Chamberlin, Inc. in a 1990 report entitled “Assessment of Environmental and Other Impacts of Central Maine Power’s Line Clearance Program”. To maintain a 5-year trim cycle, CMP should increase its vegetation management budget to accommodate trimming 102,000 segments annually (CMP currently trims about 60,000 segments annually). CMP estimates that this will require an annual trim budget in the range of \$15 million (at current pricing), excluding storm budget. This is an increase of \$6 million over current spending. This spending level is based on today’s pricing as set forth in the current Lucas Tree contract and does not reflect any adjustments for contract price increases. Further, CMP should undertake to remediate clearances immediately where vegetation is in direct contact with conductor and within one year where it is within 3 feet of the conductor. As a more general observation, it is likely that what is important to customers is the performance of the system rather than any particular level of expenditures. This suggests that, should the Commission conclude that some metric for performance is warranted here, an outcome based measure (such as a SAIFI or CAIDI) rather than an expenditure target, should be preferred.

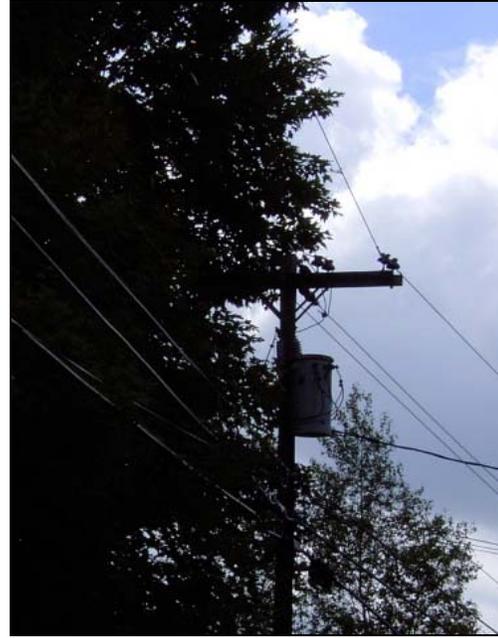
Heavy vegetation in contact with 3-phase circuit
