**SUBJECT: DRAFT** Analysis of a Failed Lift Tower Turnbuckle Assembly (Our project number SUG-11100)

**BACKGROUND:** We received a failed turnbuckle assembly from Sugarloaf and were asked to analyze it to determine whether it failed in tension or compression.

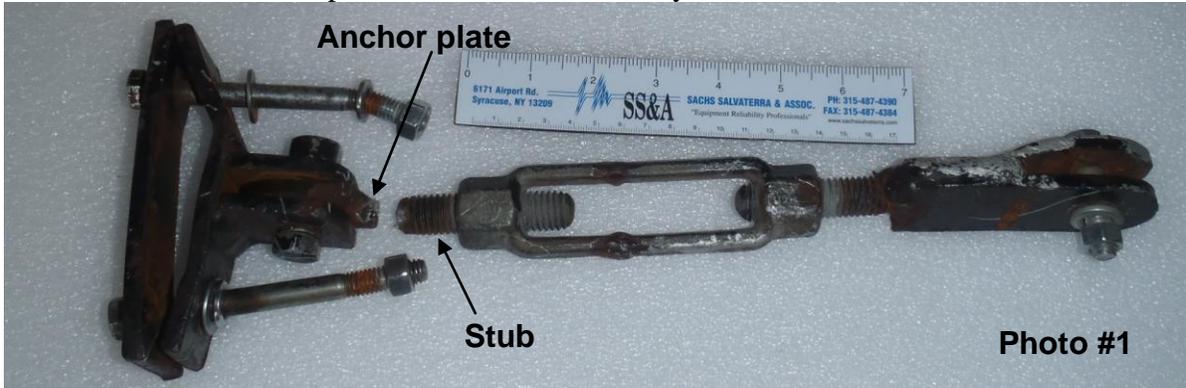
**FINDINGS:** Below is a photo of the failed assembly as we received it.

As shown in *Photo #1*, the failure occurred when the weld anchoring the stub to the anchor plate parted. *Photo #2*, to the right, shows the pieces of the turnbuckle anchor bracket as it was disassembled.

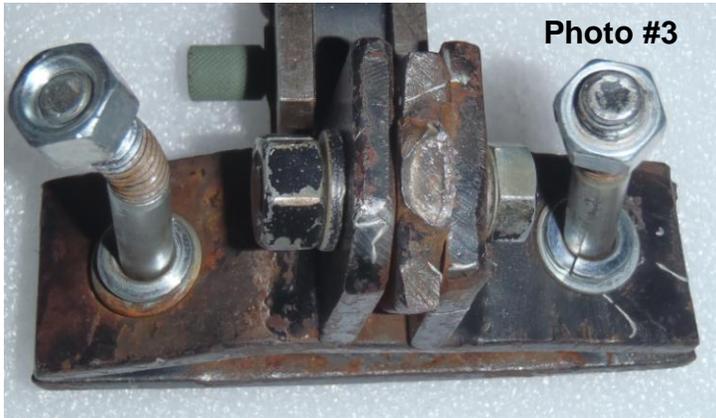
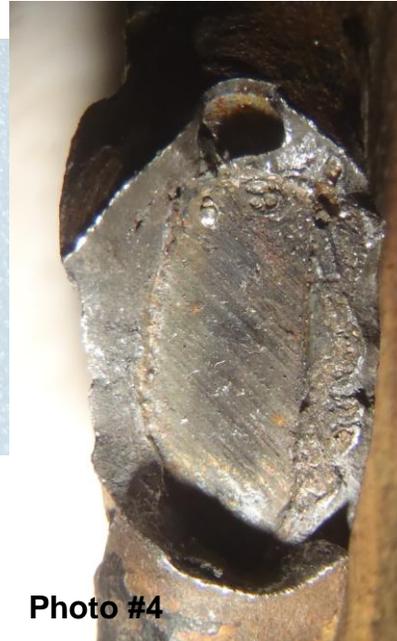
*Photos #3* and *#4* are better views of the actual failure. *#3* is of the anchor bracket assembly, with the failed weld at the center, while *#4* is a close-up of the weld at the end of the anchor plate.

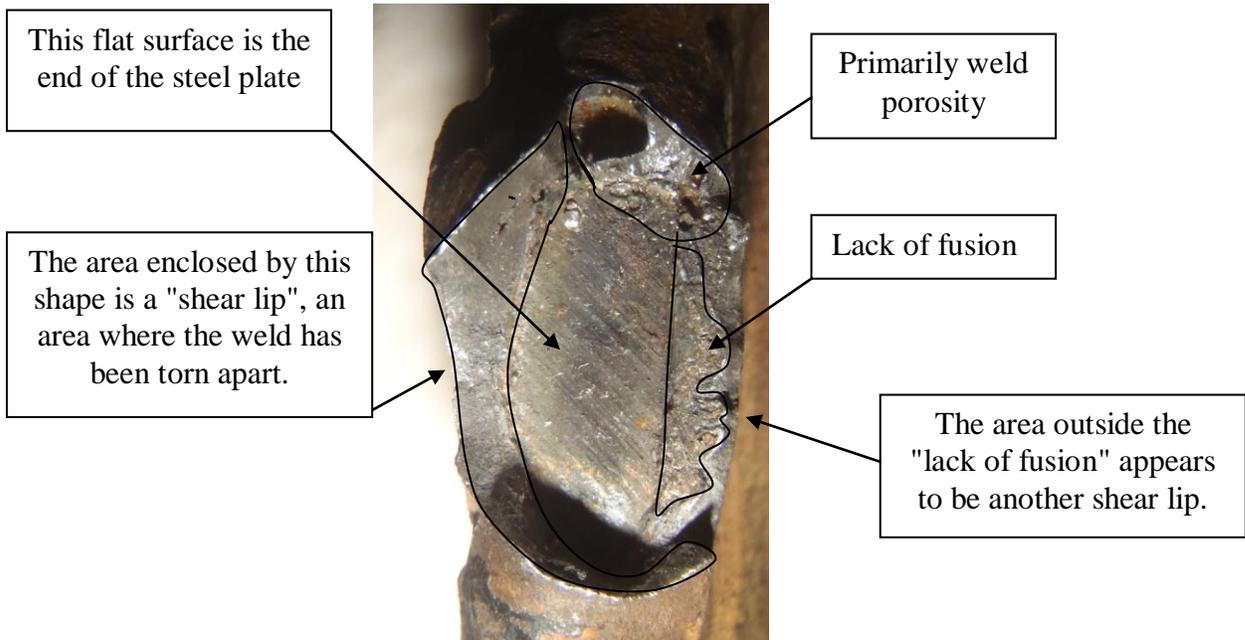
We looked at the fracture on the end of the anchor plate shown in *Photo #4* and expanding on it shows the failure details below.

From the existence of the shear lips, it is apparent that the weld failed when it was heavily loaded in tension.

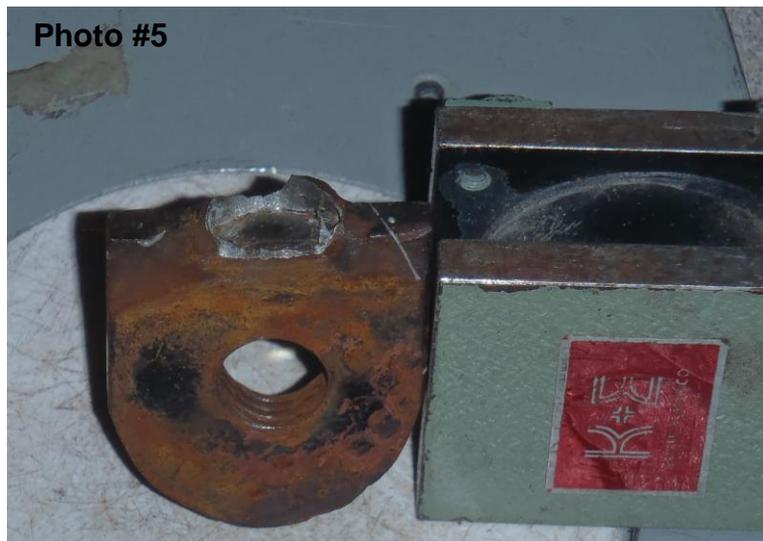
Further confirmation that the pieces were loaded in tension can be seen in the deformation of the bolt hole in the anchor plate and **Photo #5** shows it supported by a magnet. Inspection of the bolt hole shows the heaviest impression of the bolt threads in the bottom of the hole and at 90<sup>0</sup> to that. These thread impressions are also heavier to one side, suggesting a misalignment of the load, and they are almost nonexistent in the top of the hole.

In a similar manner, the holes in the two pieces welded to the bracket also show thread impressions that indicate a tension loading. However, confirming the misalignment, the indentations on the piece on the bolt head side are much heavier than those on the other (nut) side.
