Photo Log for Accident Investigation for Deropement of Spillway East

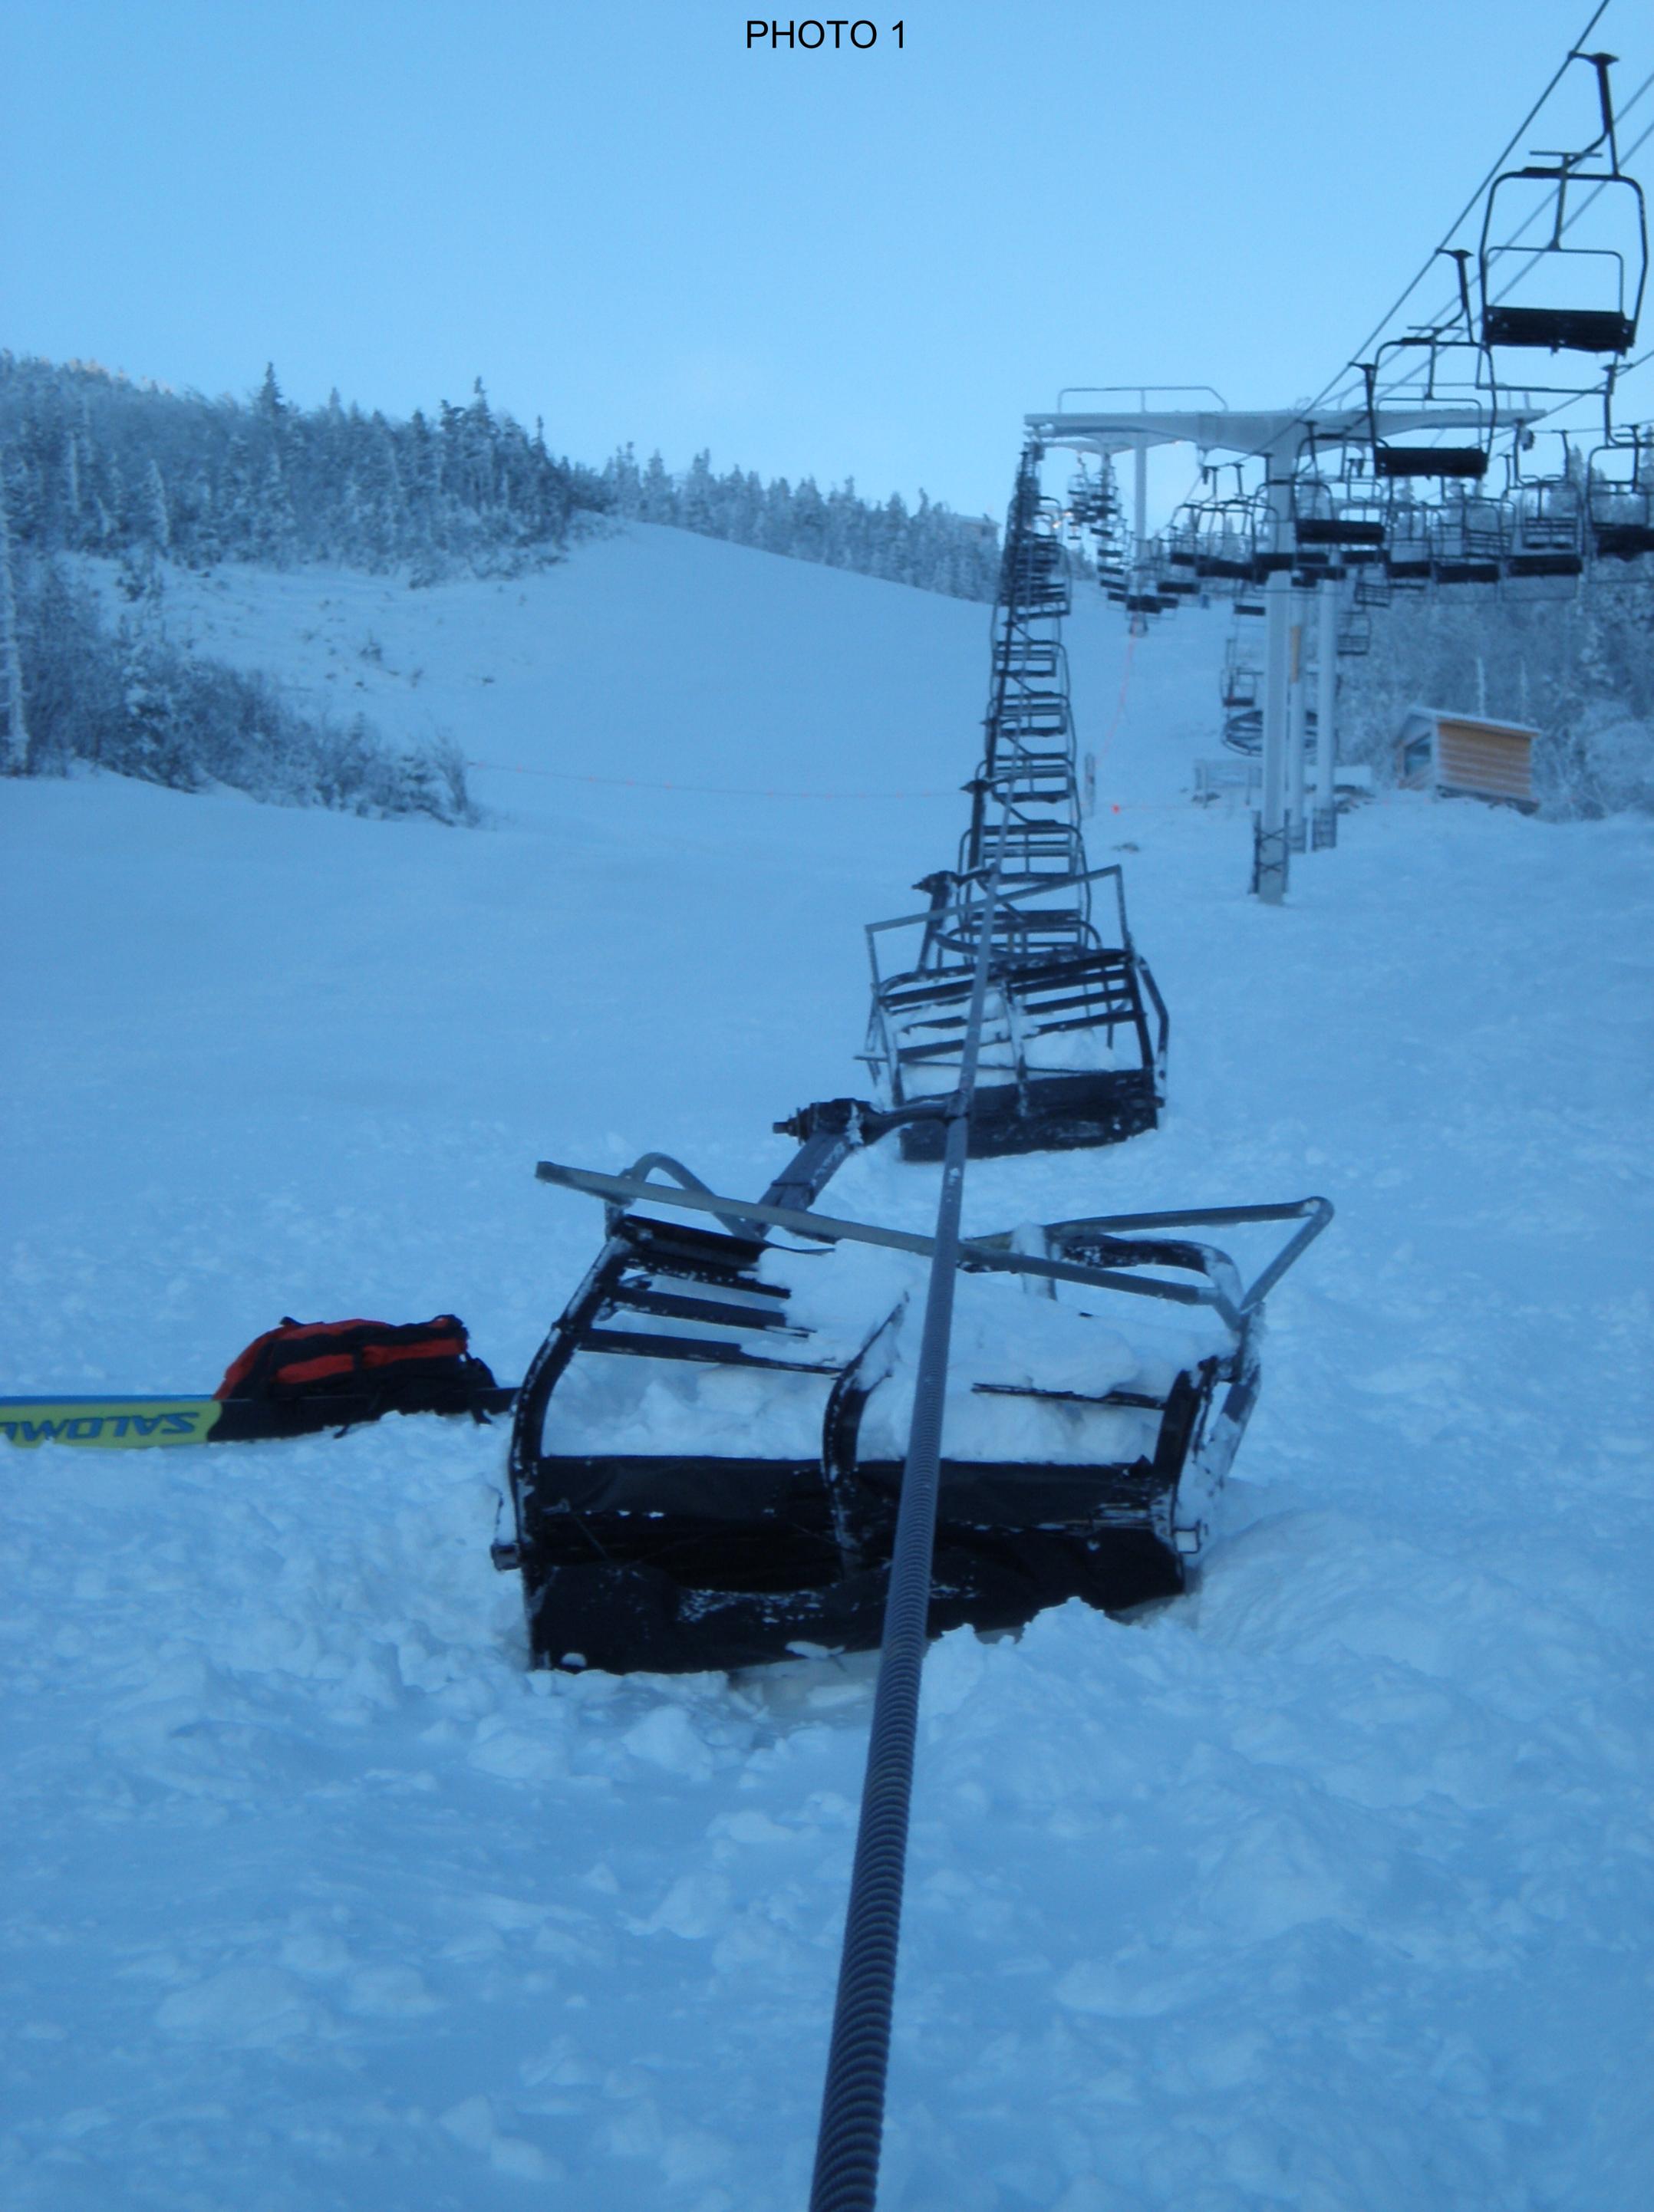
PHOTO 1

Photo 1 -Spillway East lift line on ground

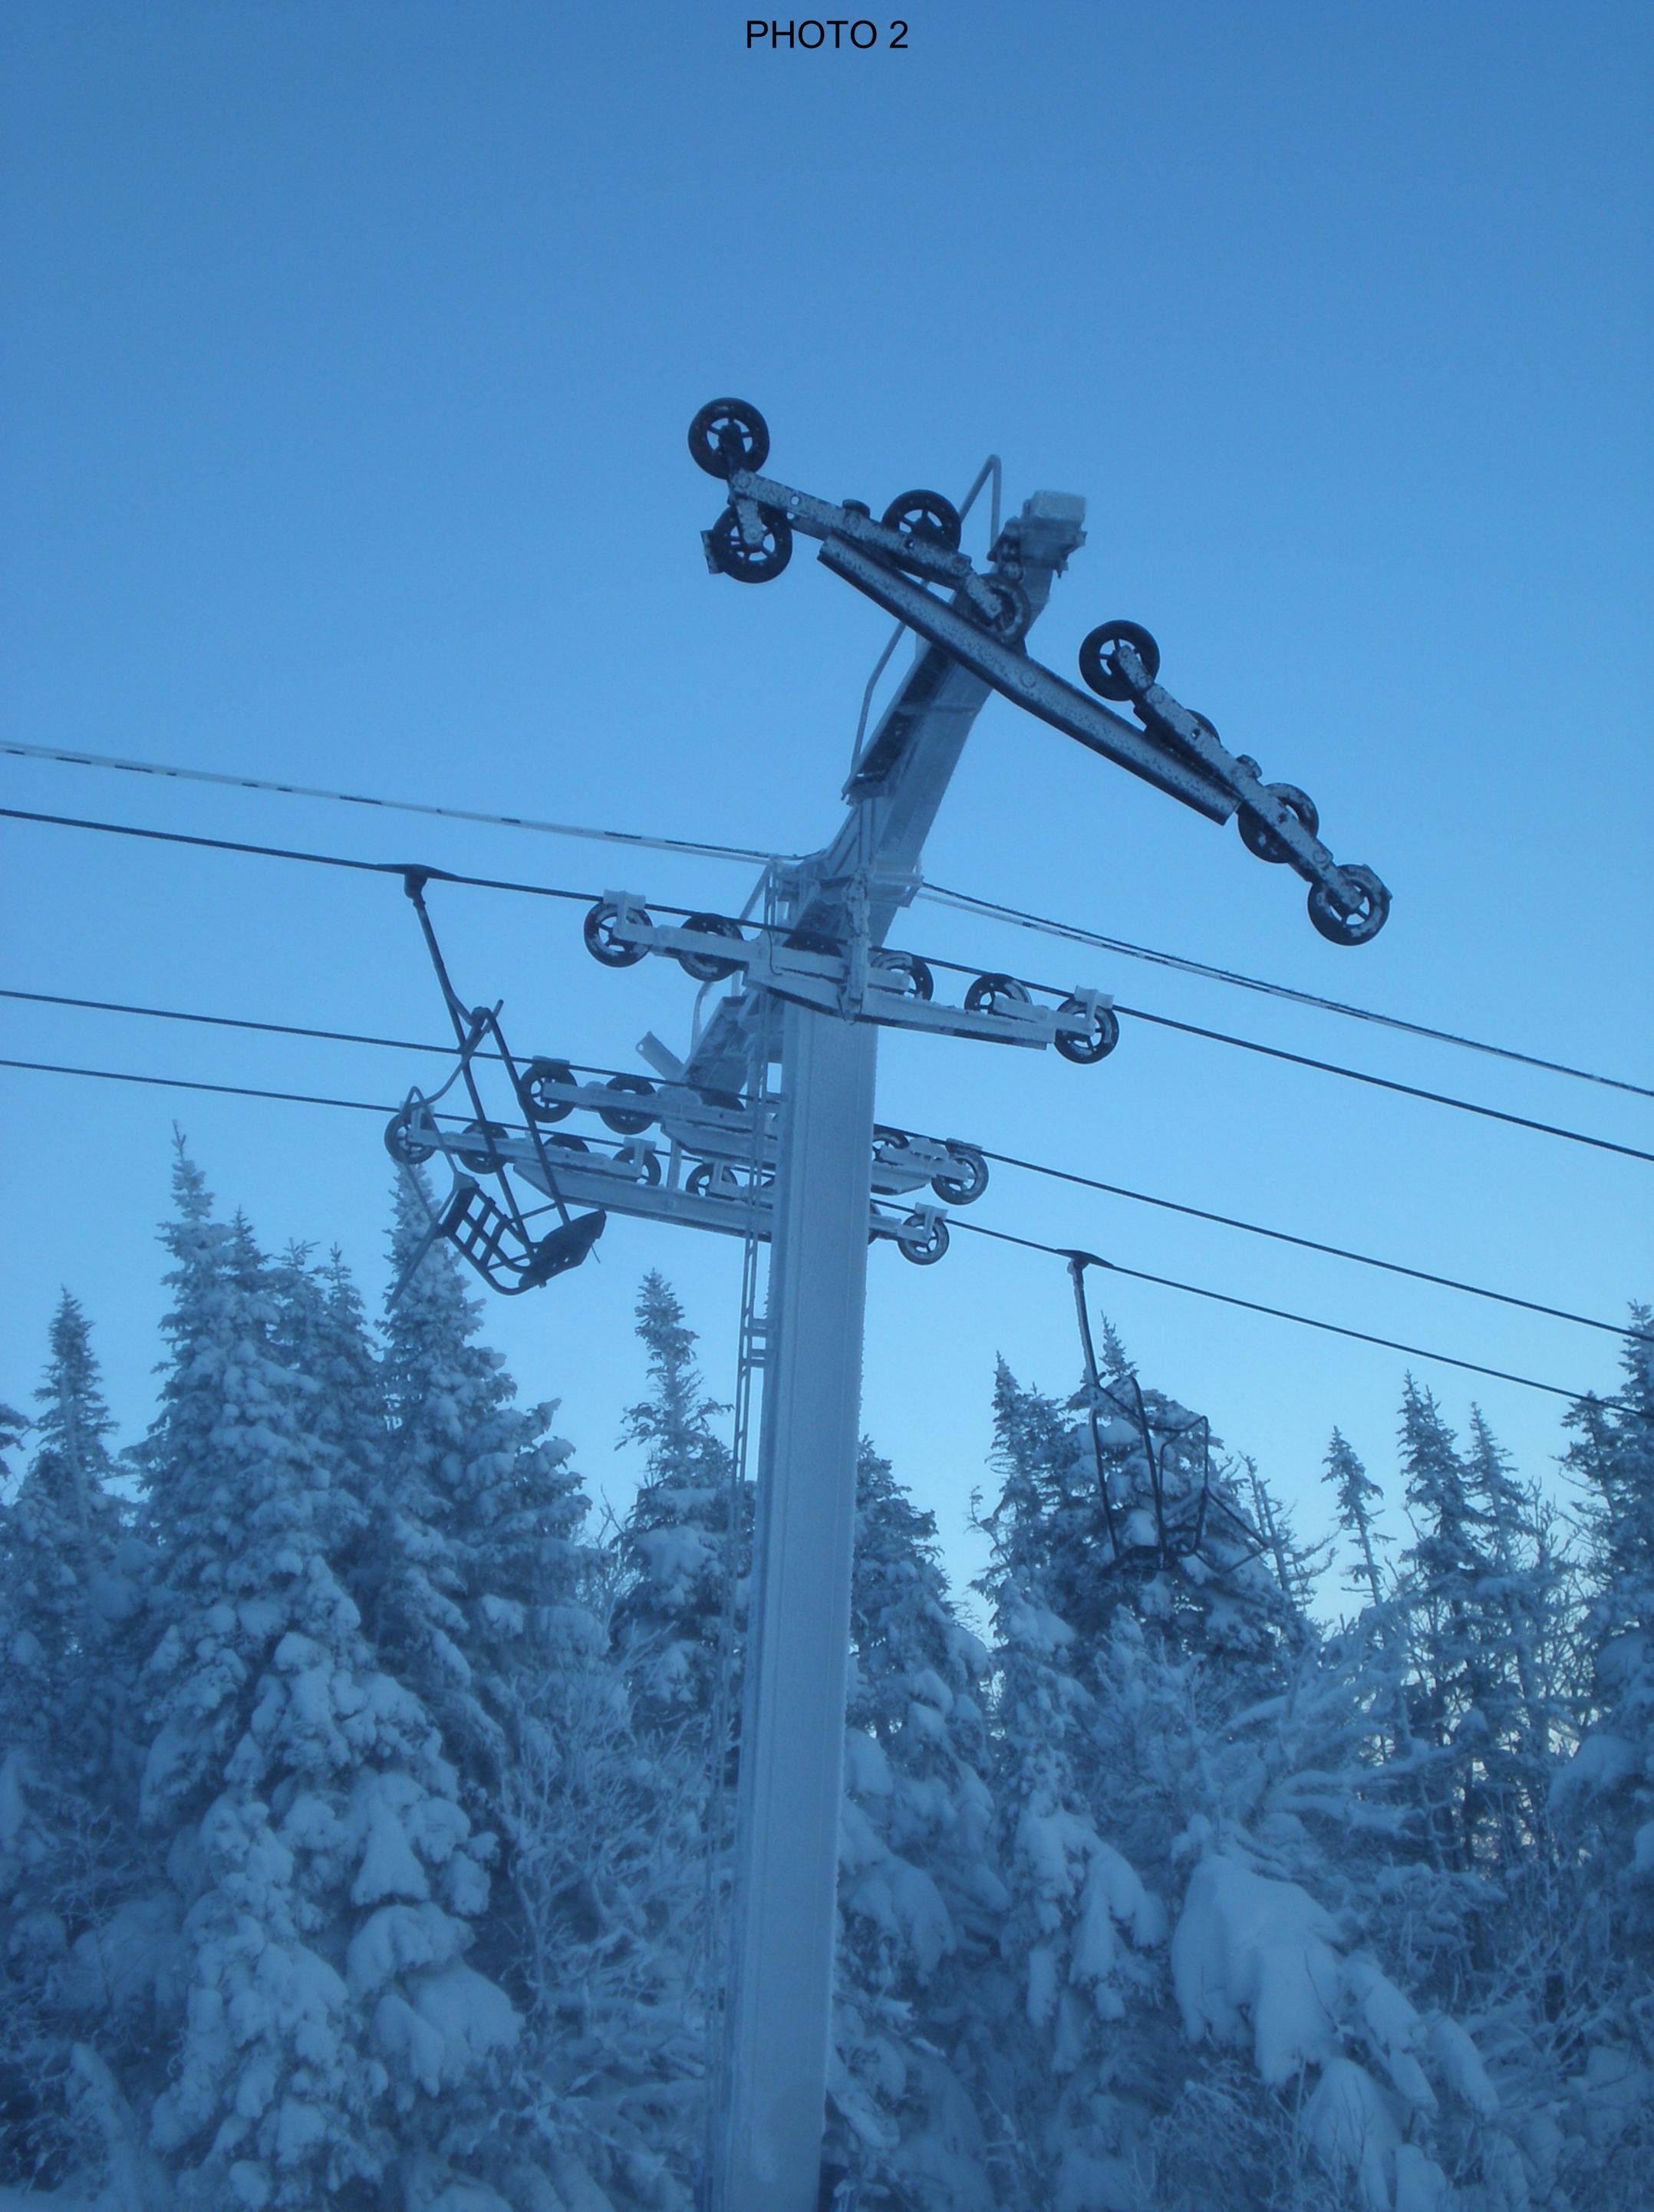
PHOTO 2

Photo 2 - Tower 8 after deropement

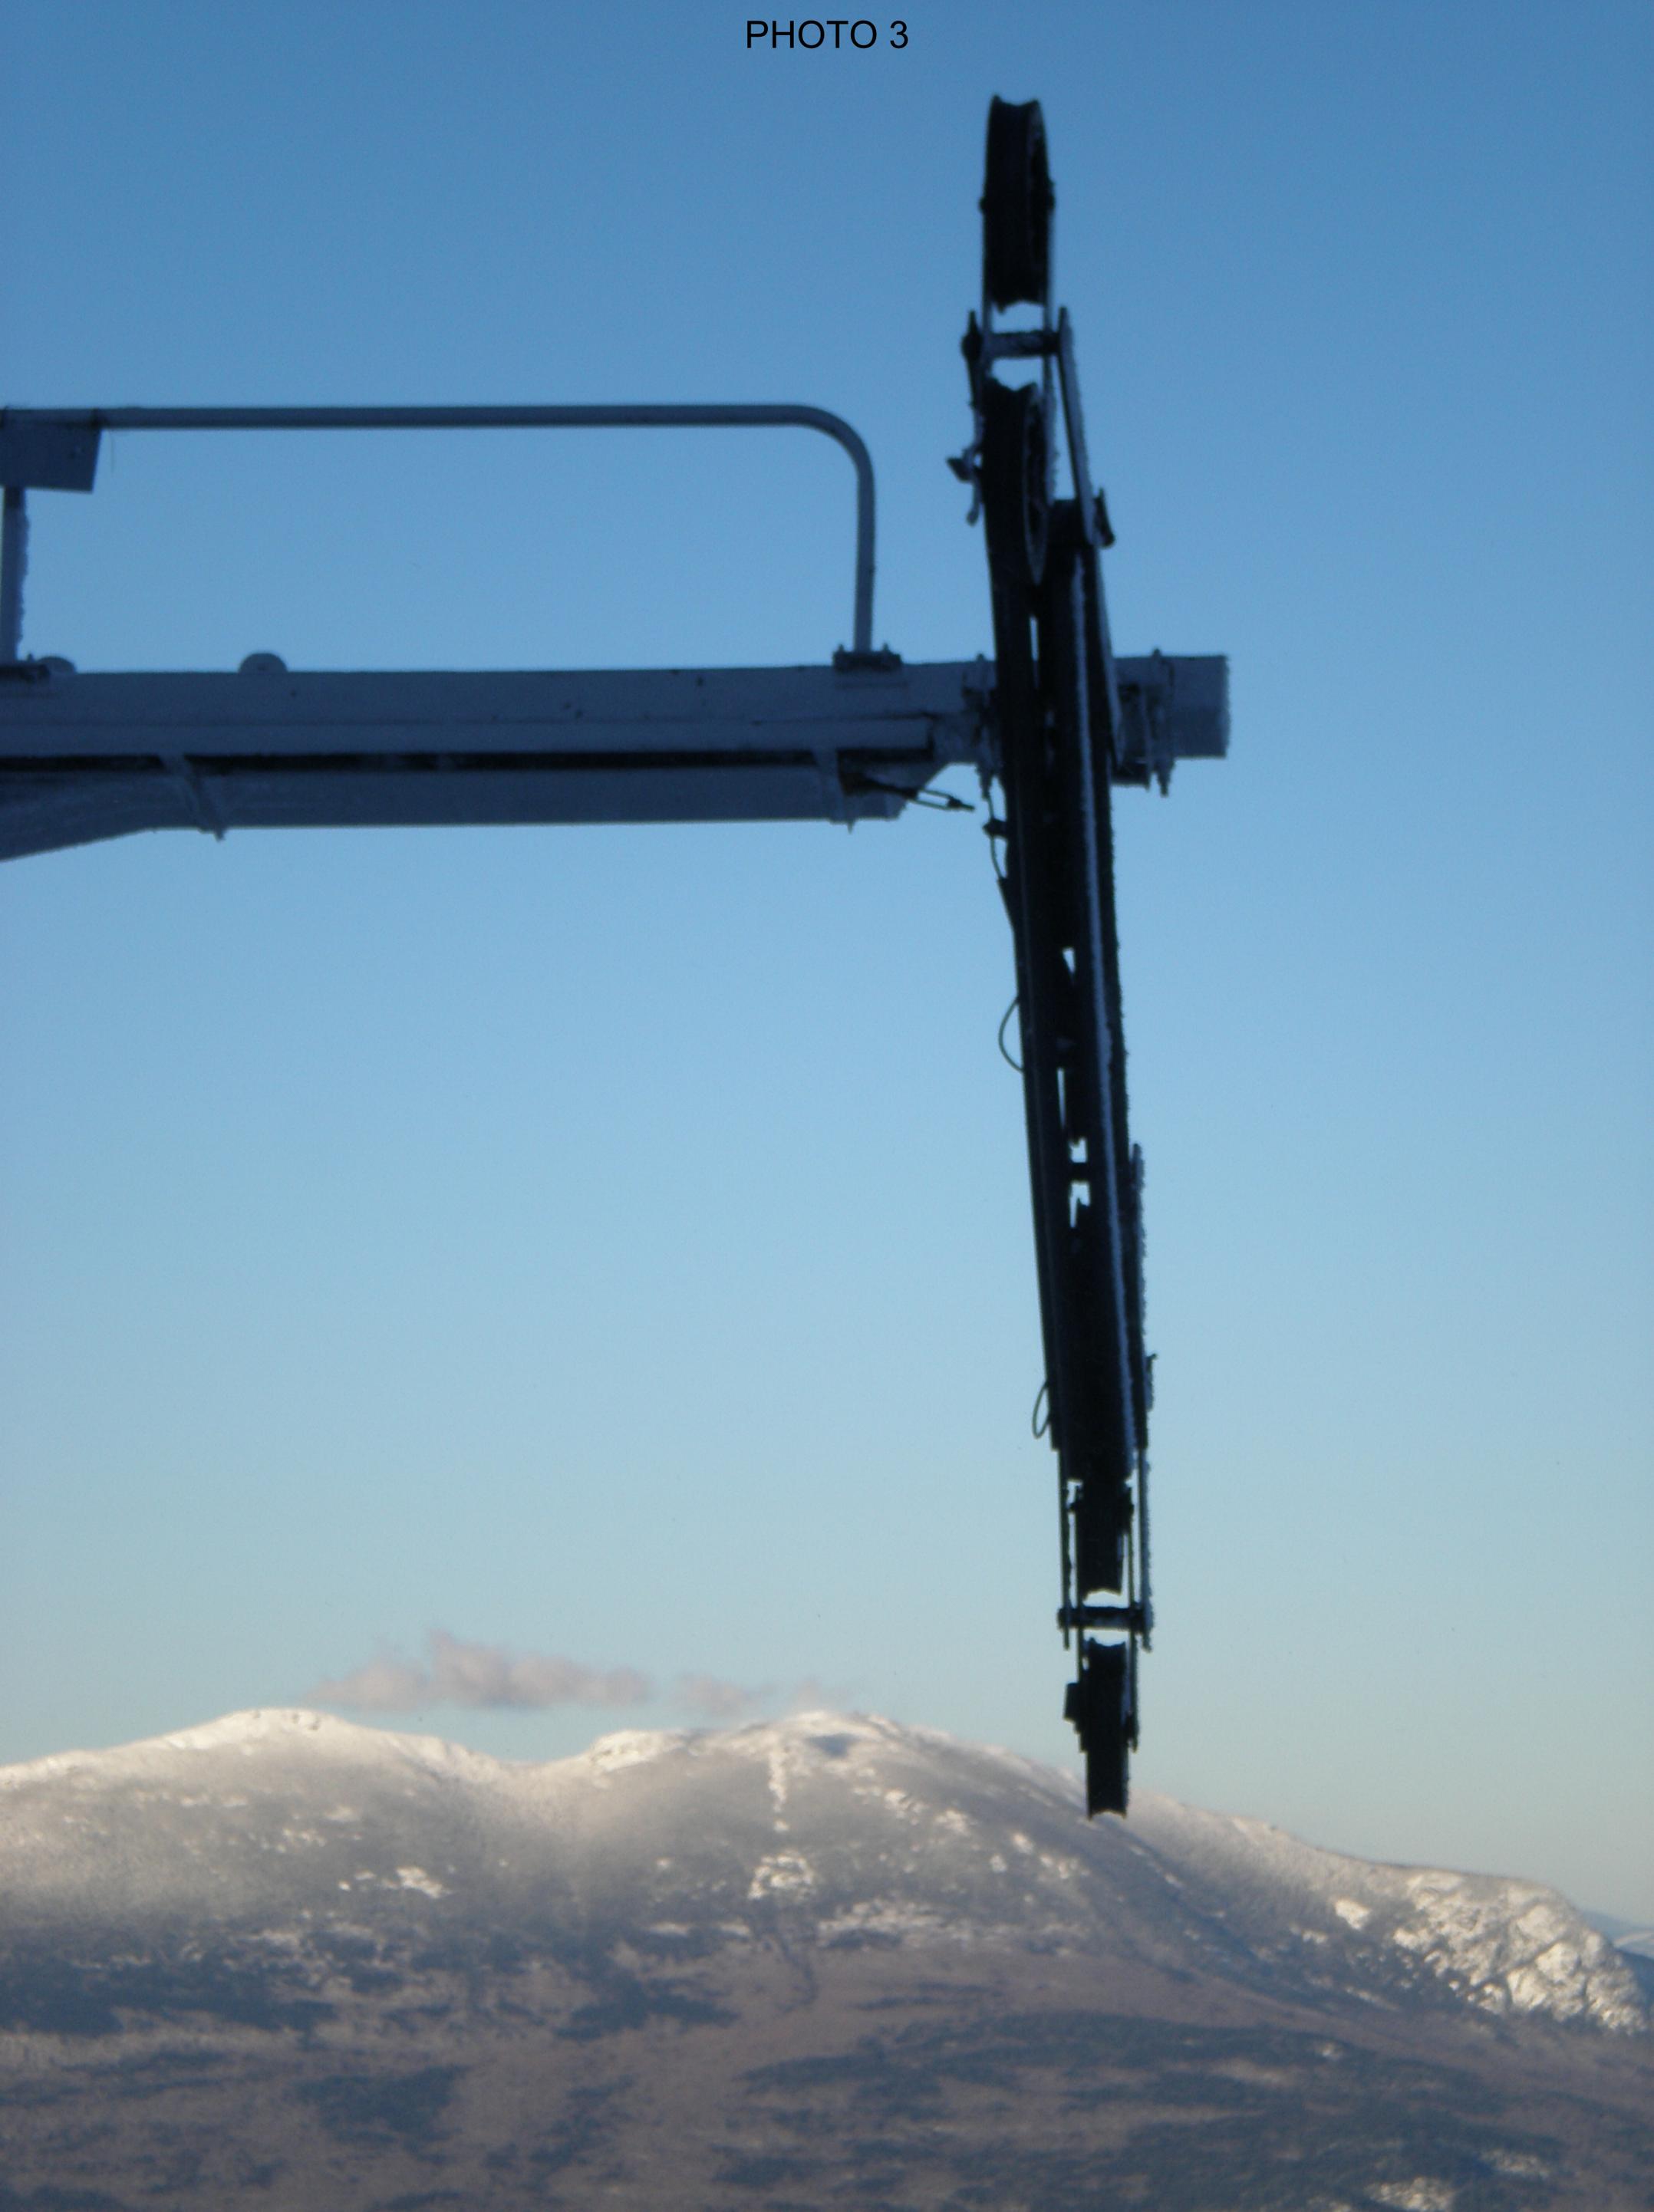
PHOTO 3

Photo 3 - Tower 8 showing broken stiffener

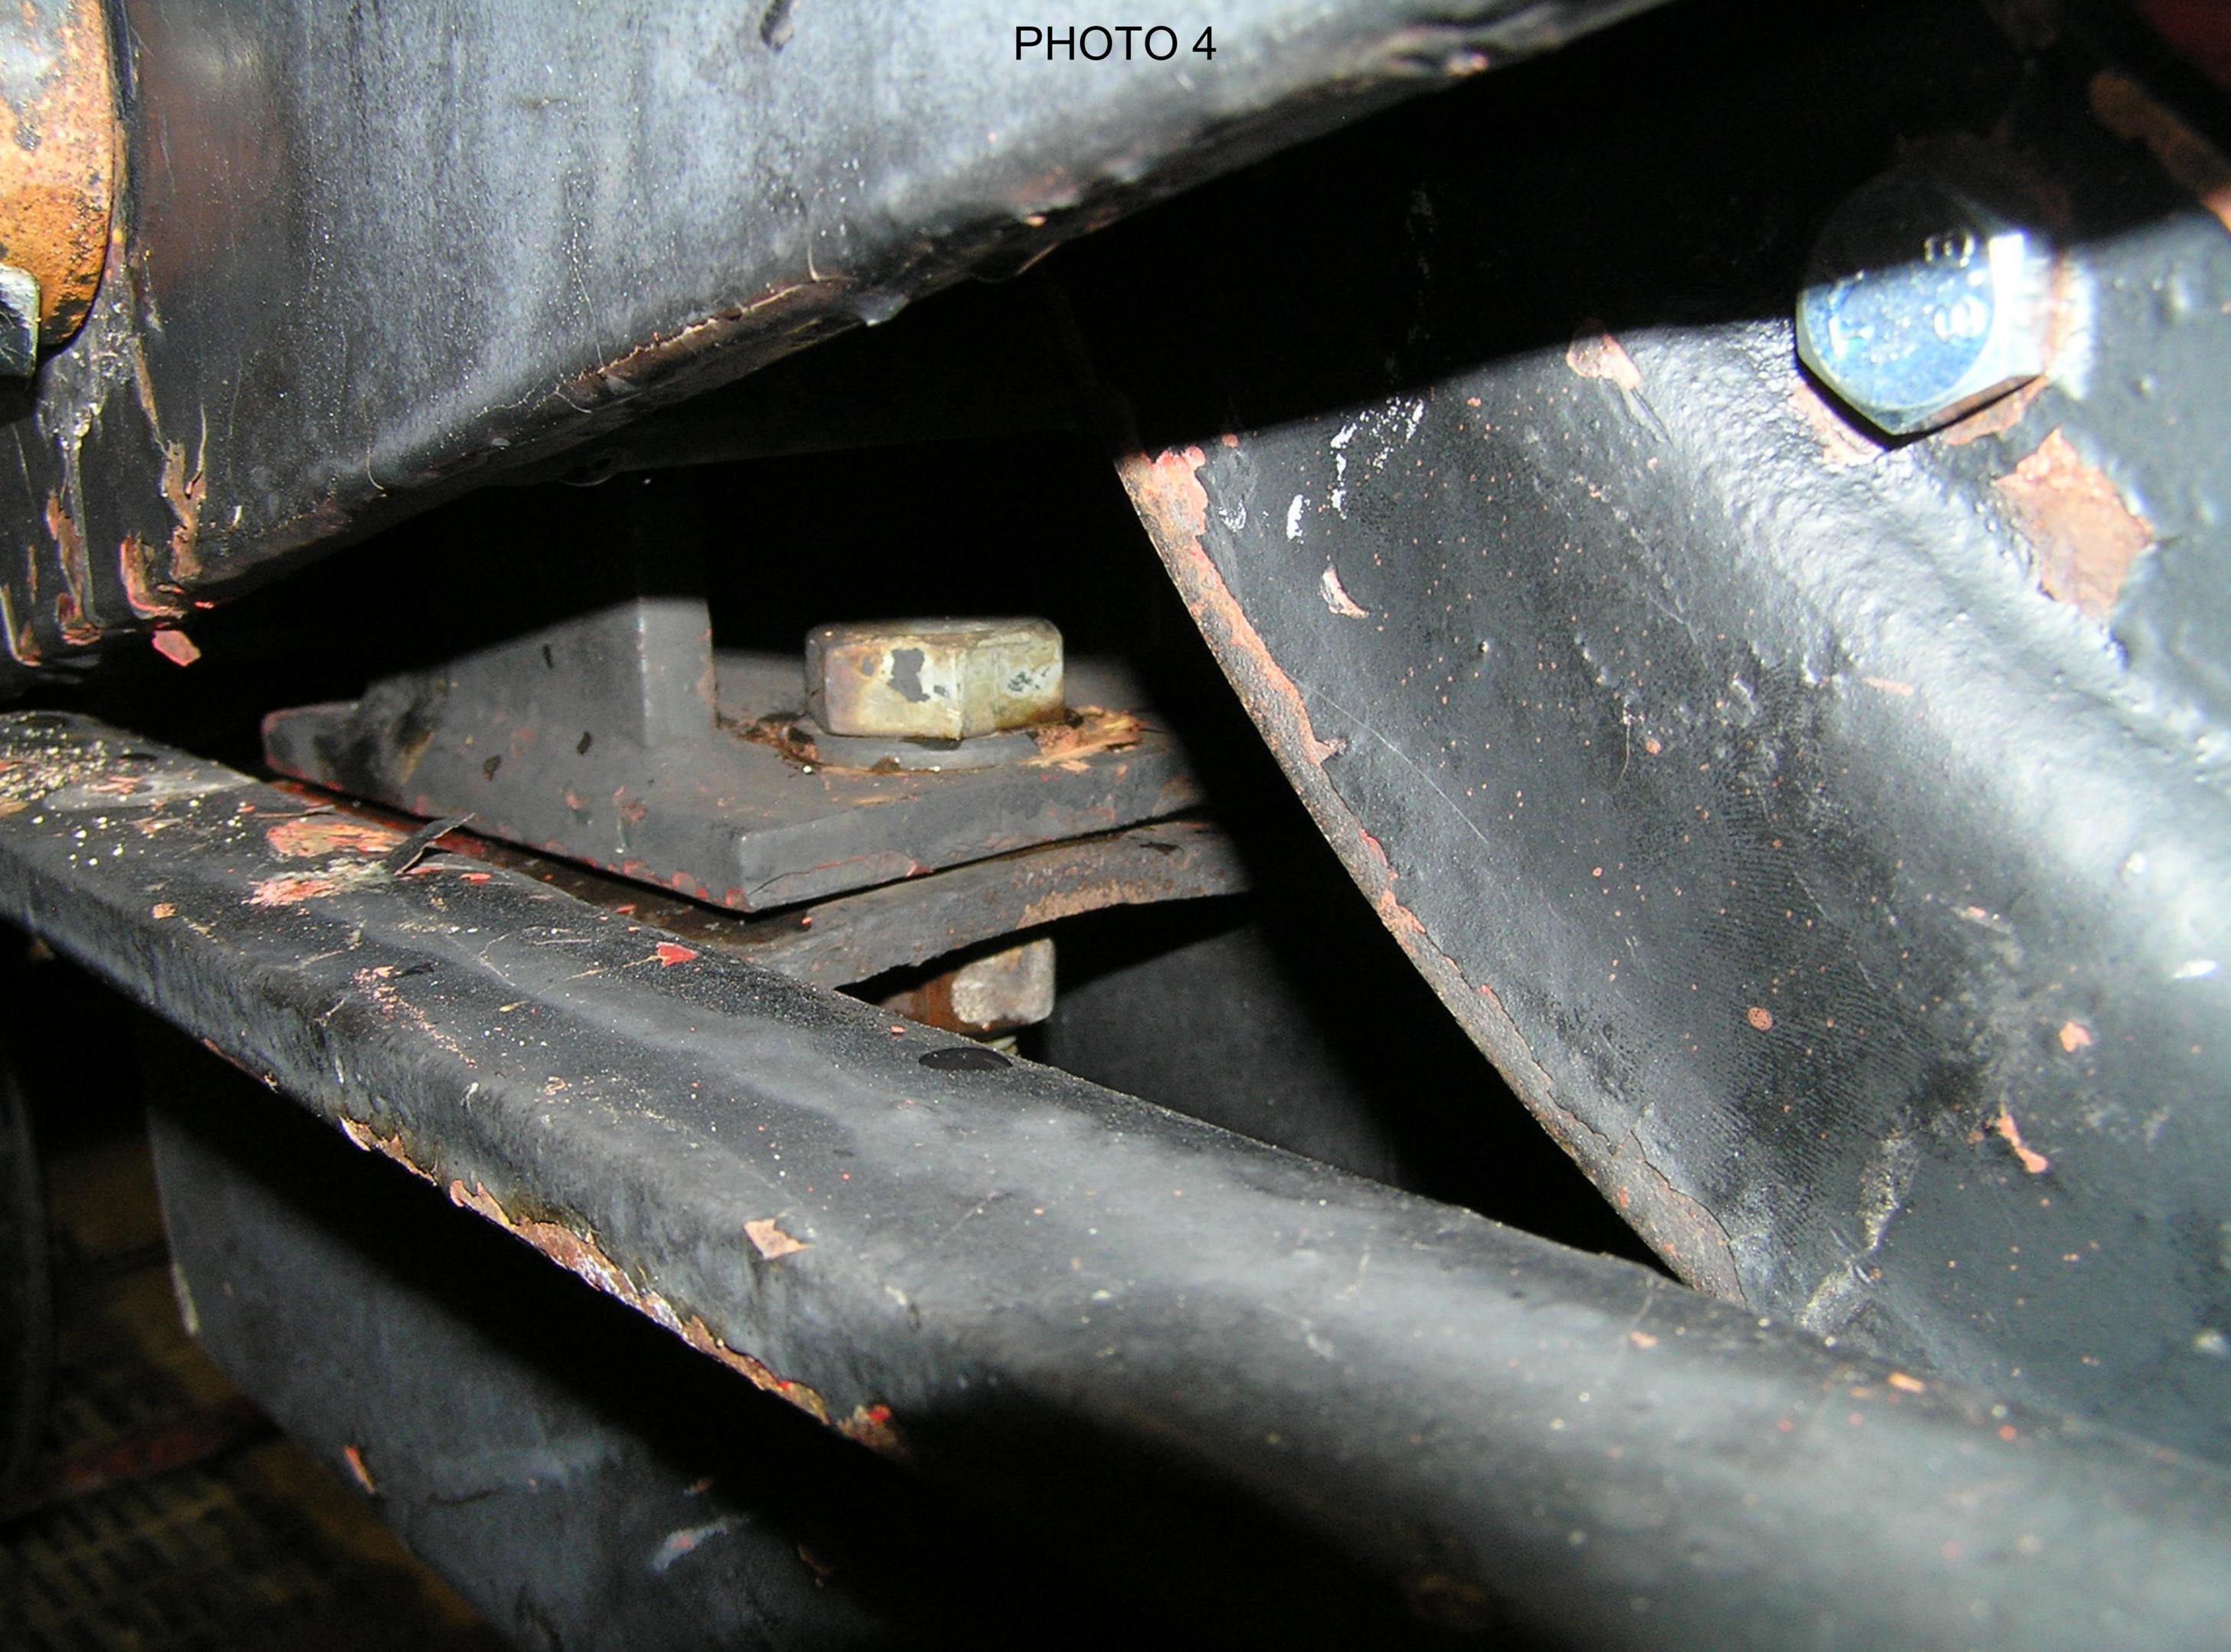
PHOTO 4

Photo 4 -Attachment point of incoming 4-sheave assembly to the main walking beam on the outgoing side

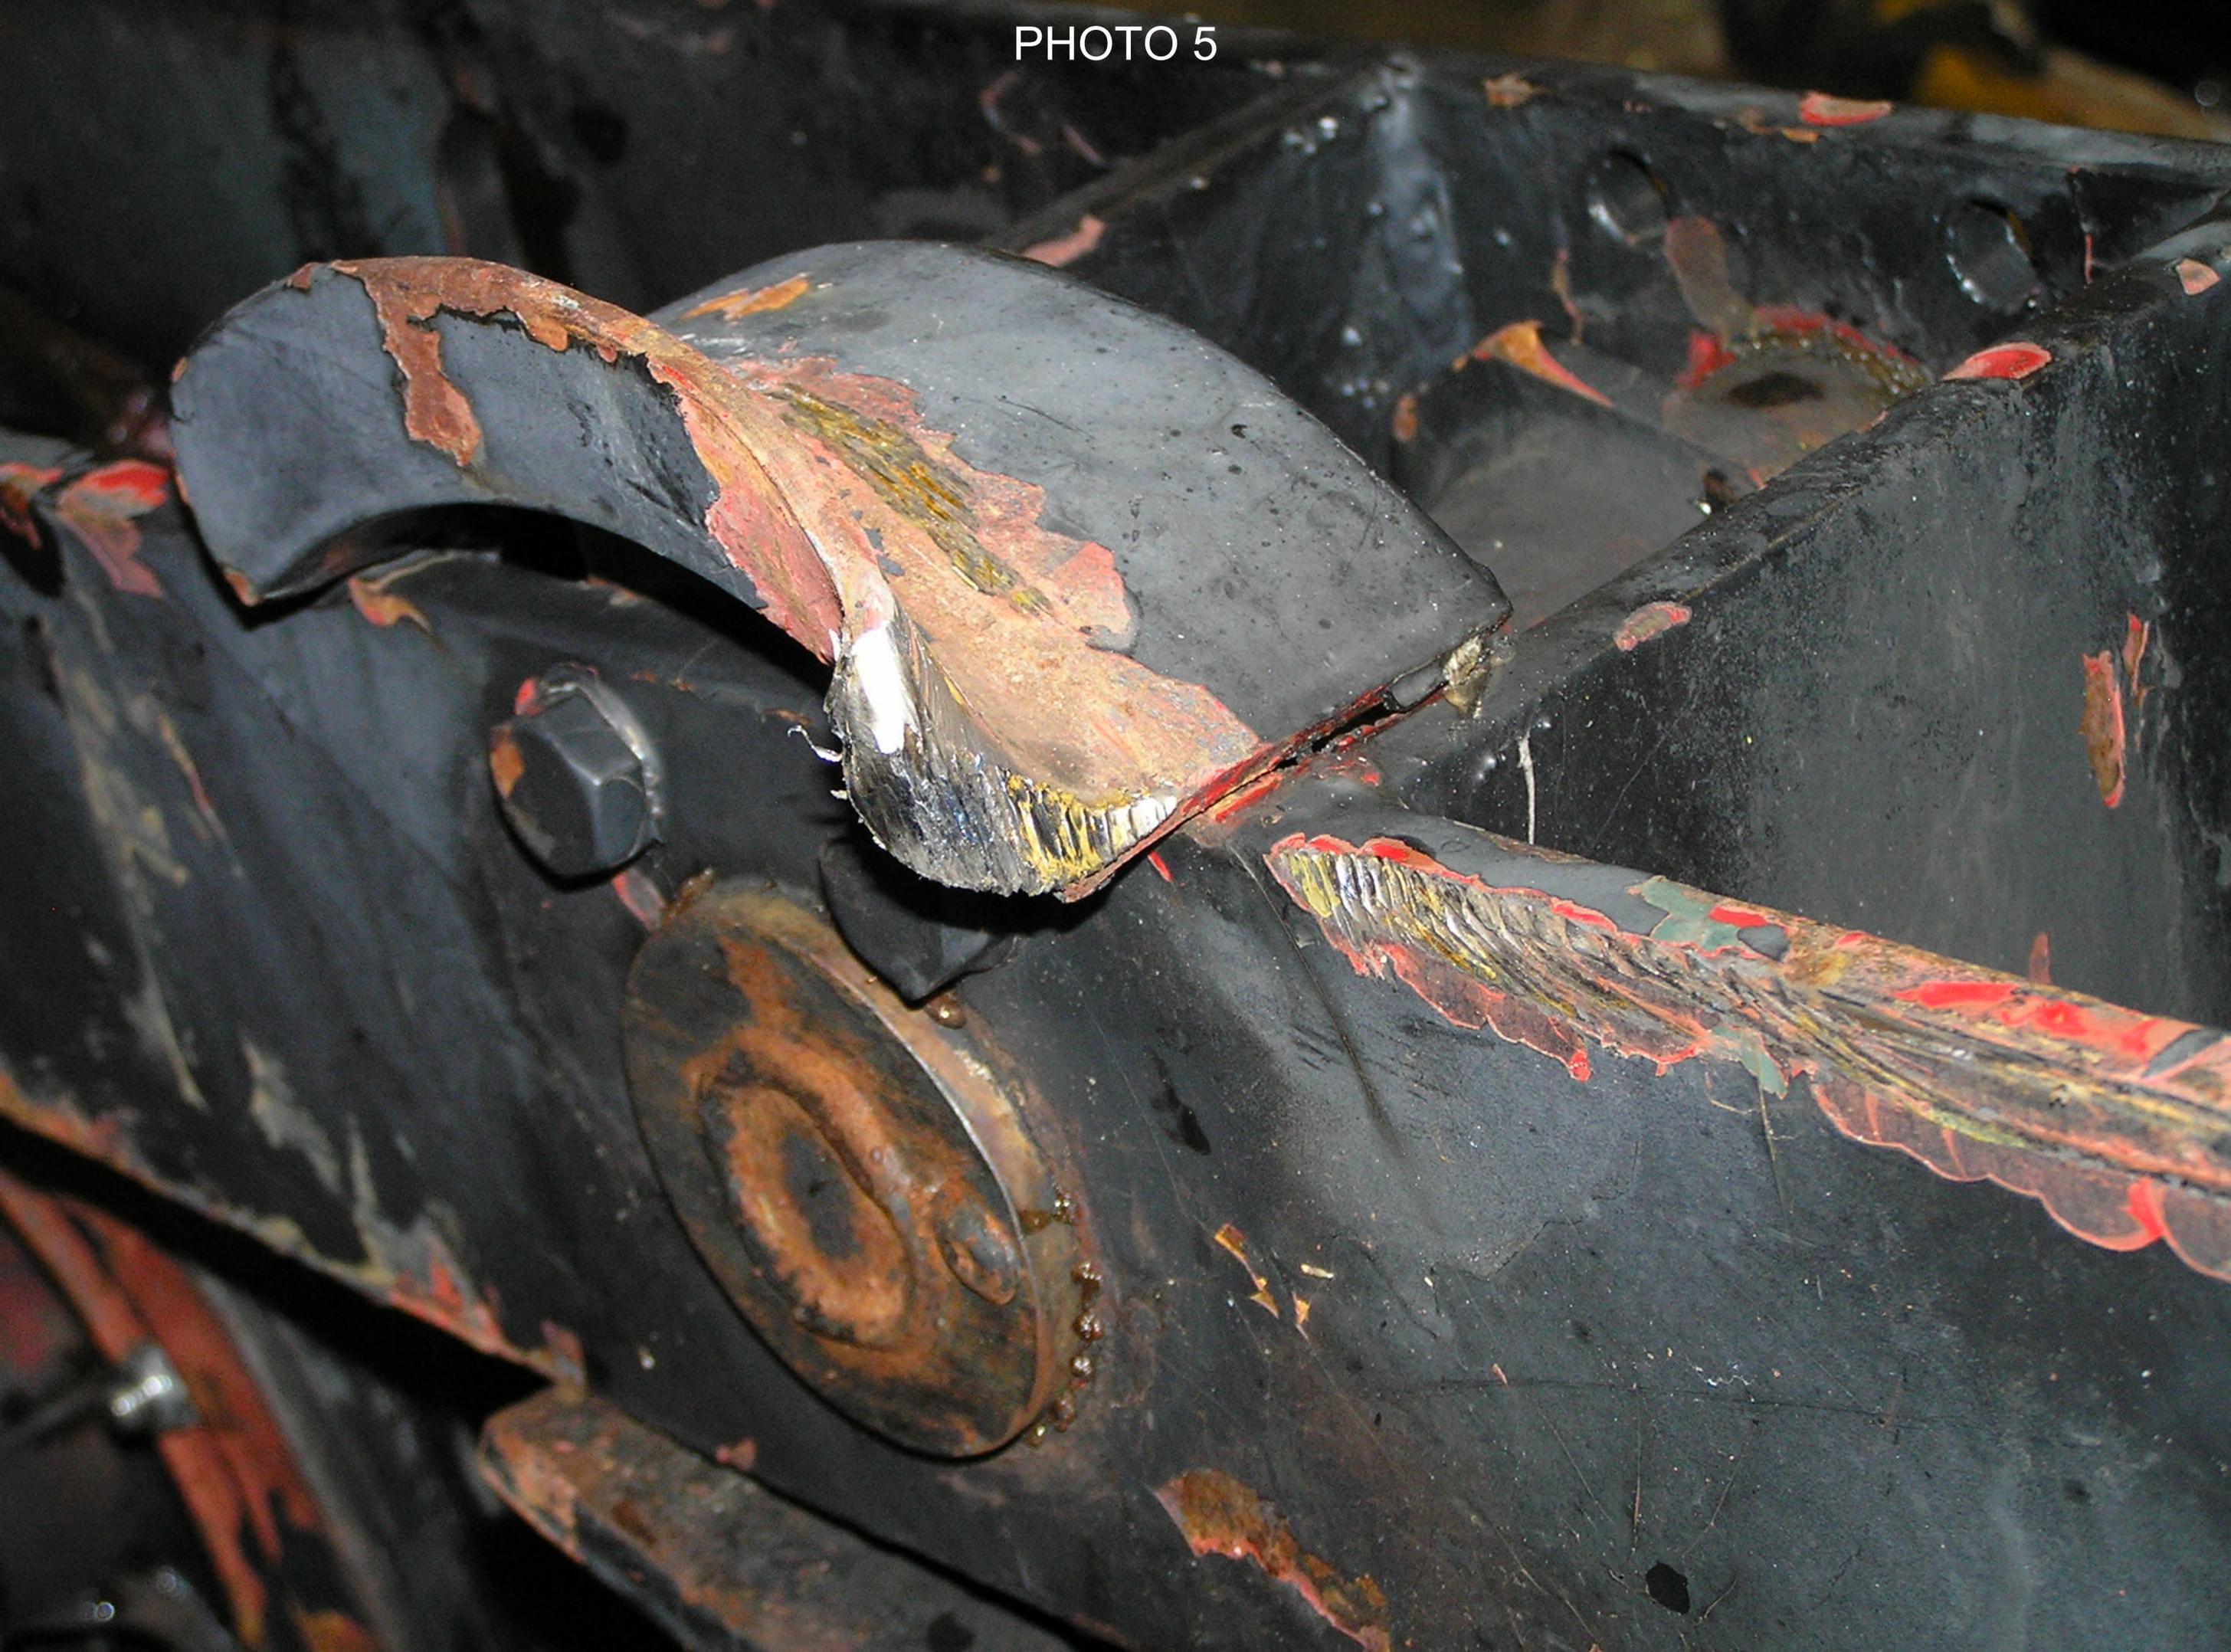
PHOTO 5

Photo 5 -Rope catcher on the outgoing 4-sheave assembly

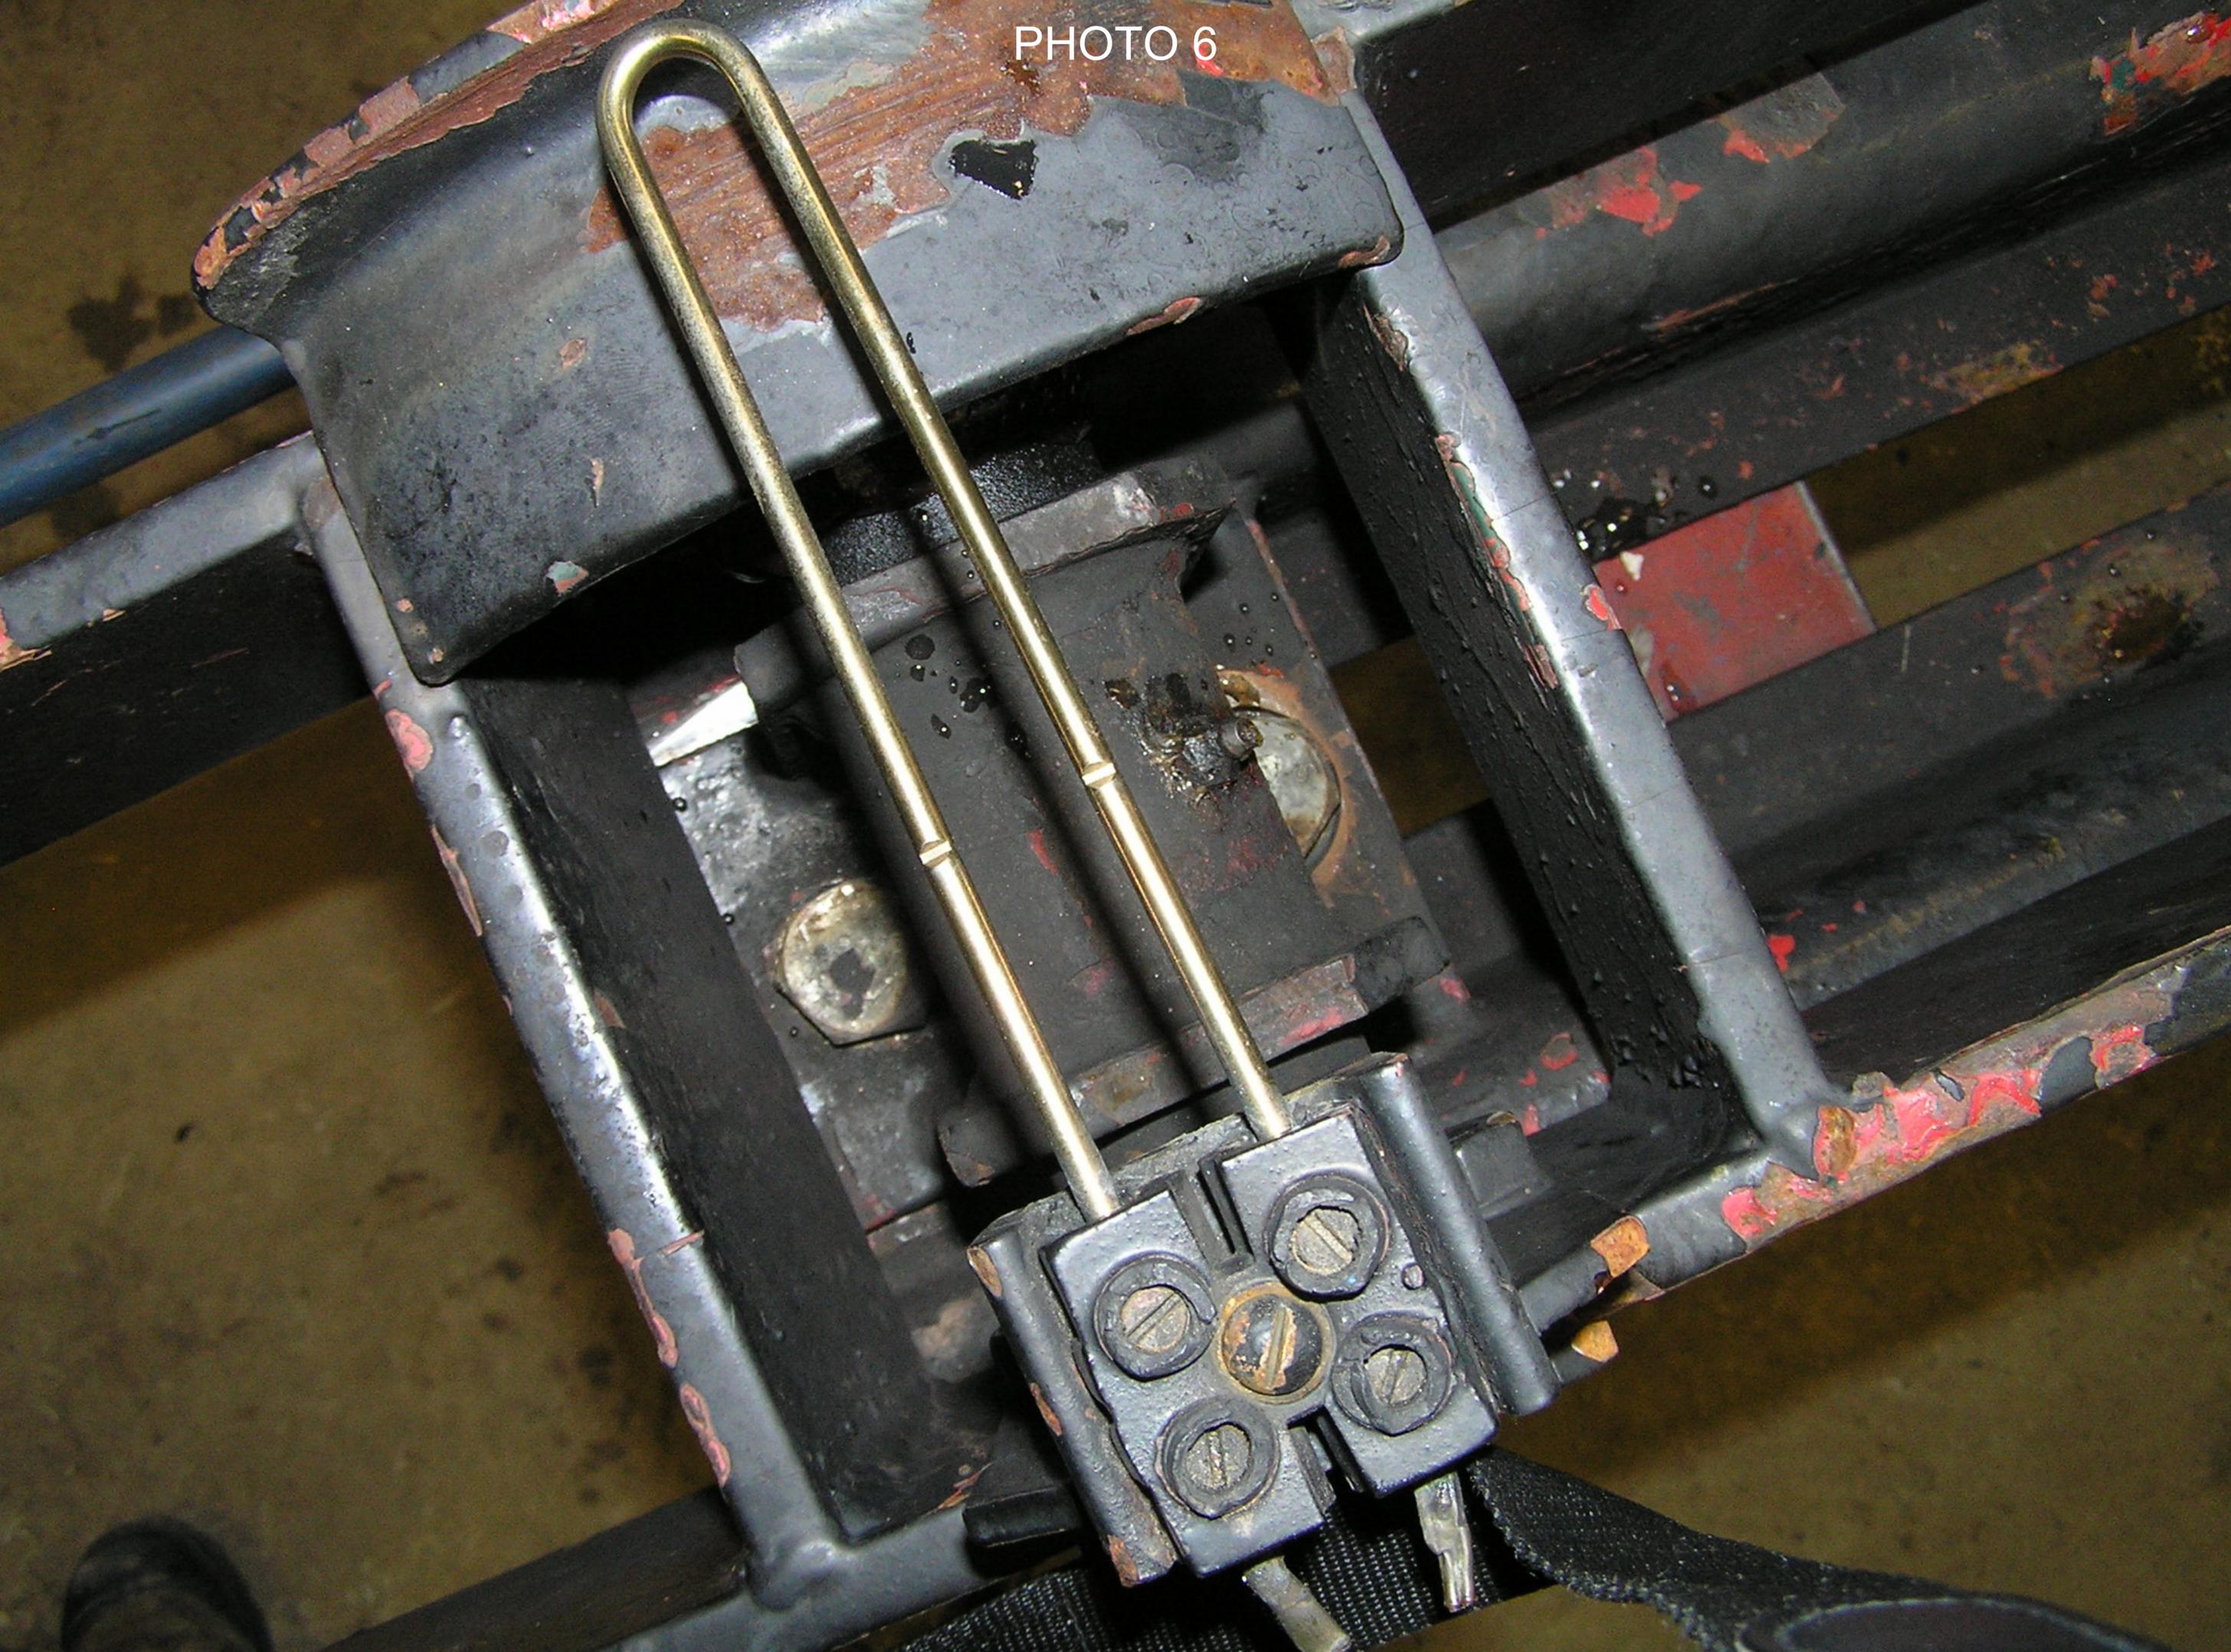
PHOTO 6

Photo 6- Brittle bar and rope catcher on the incoming 4-sheave assembly
