Photo Log for Accident Investigation for Deropement of Spillway East

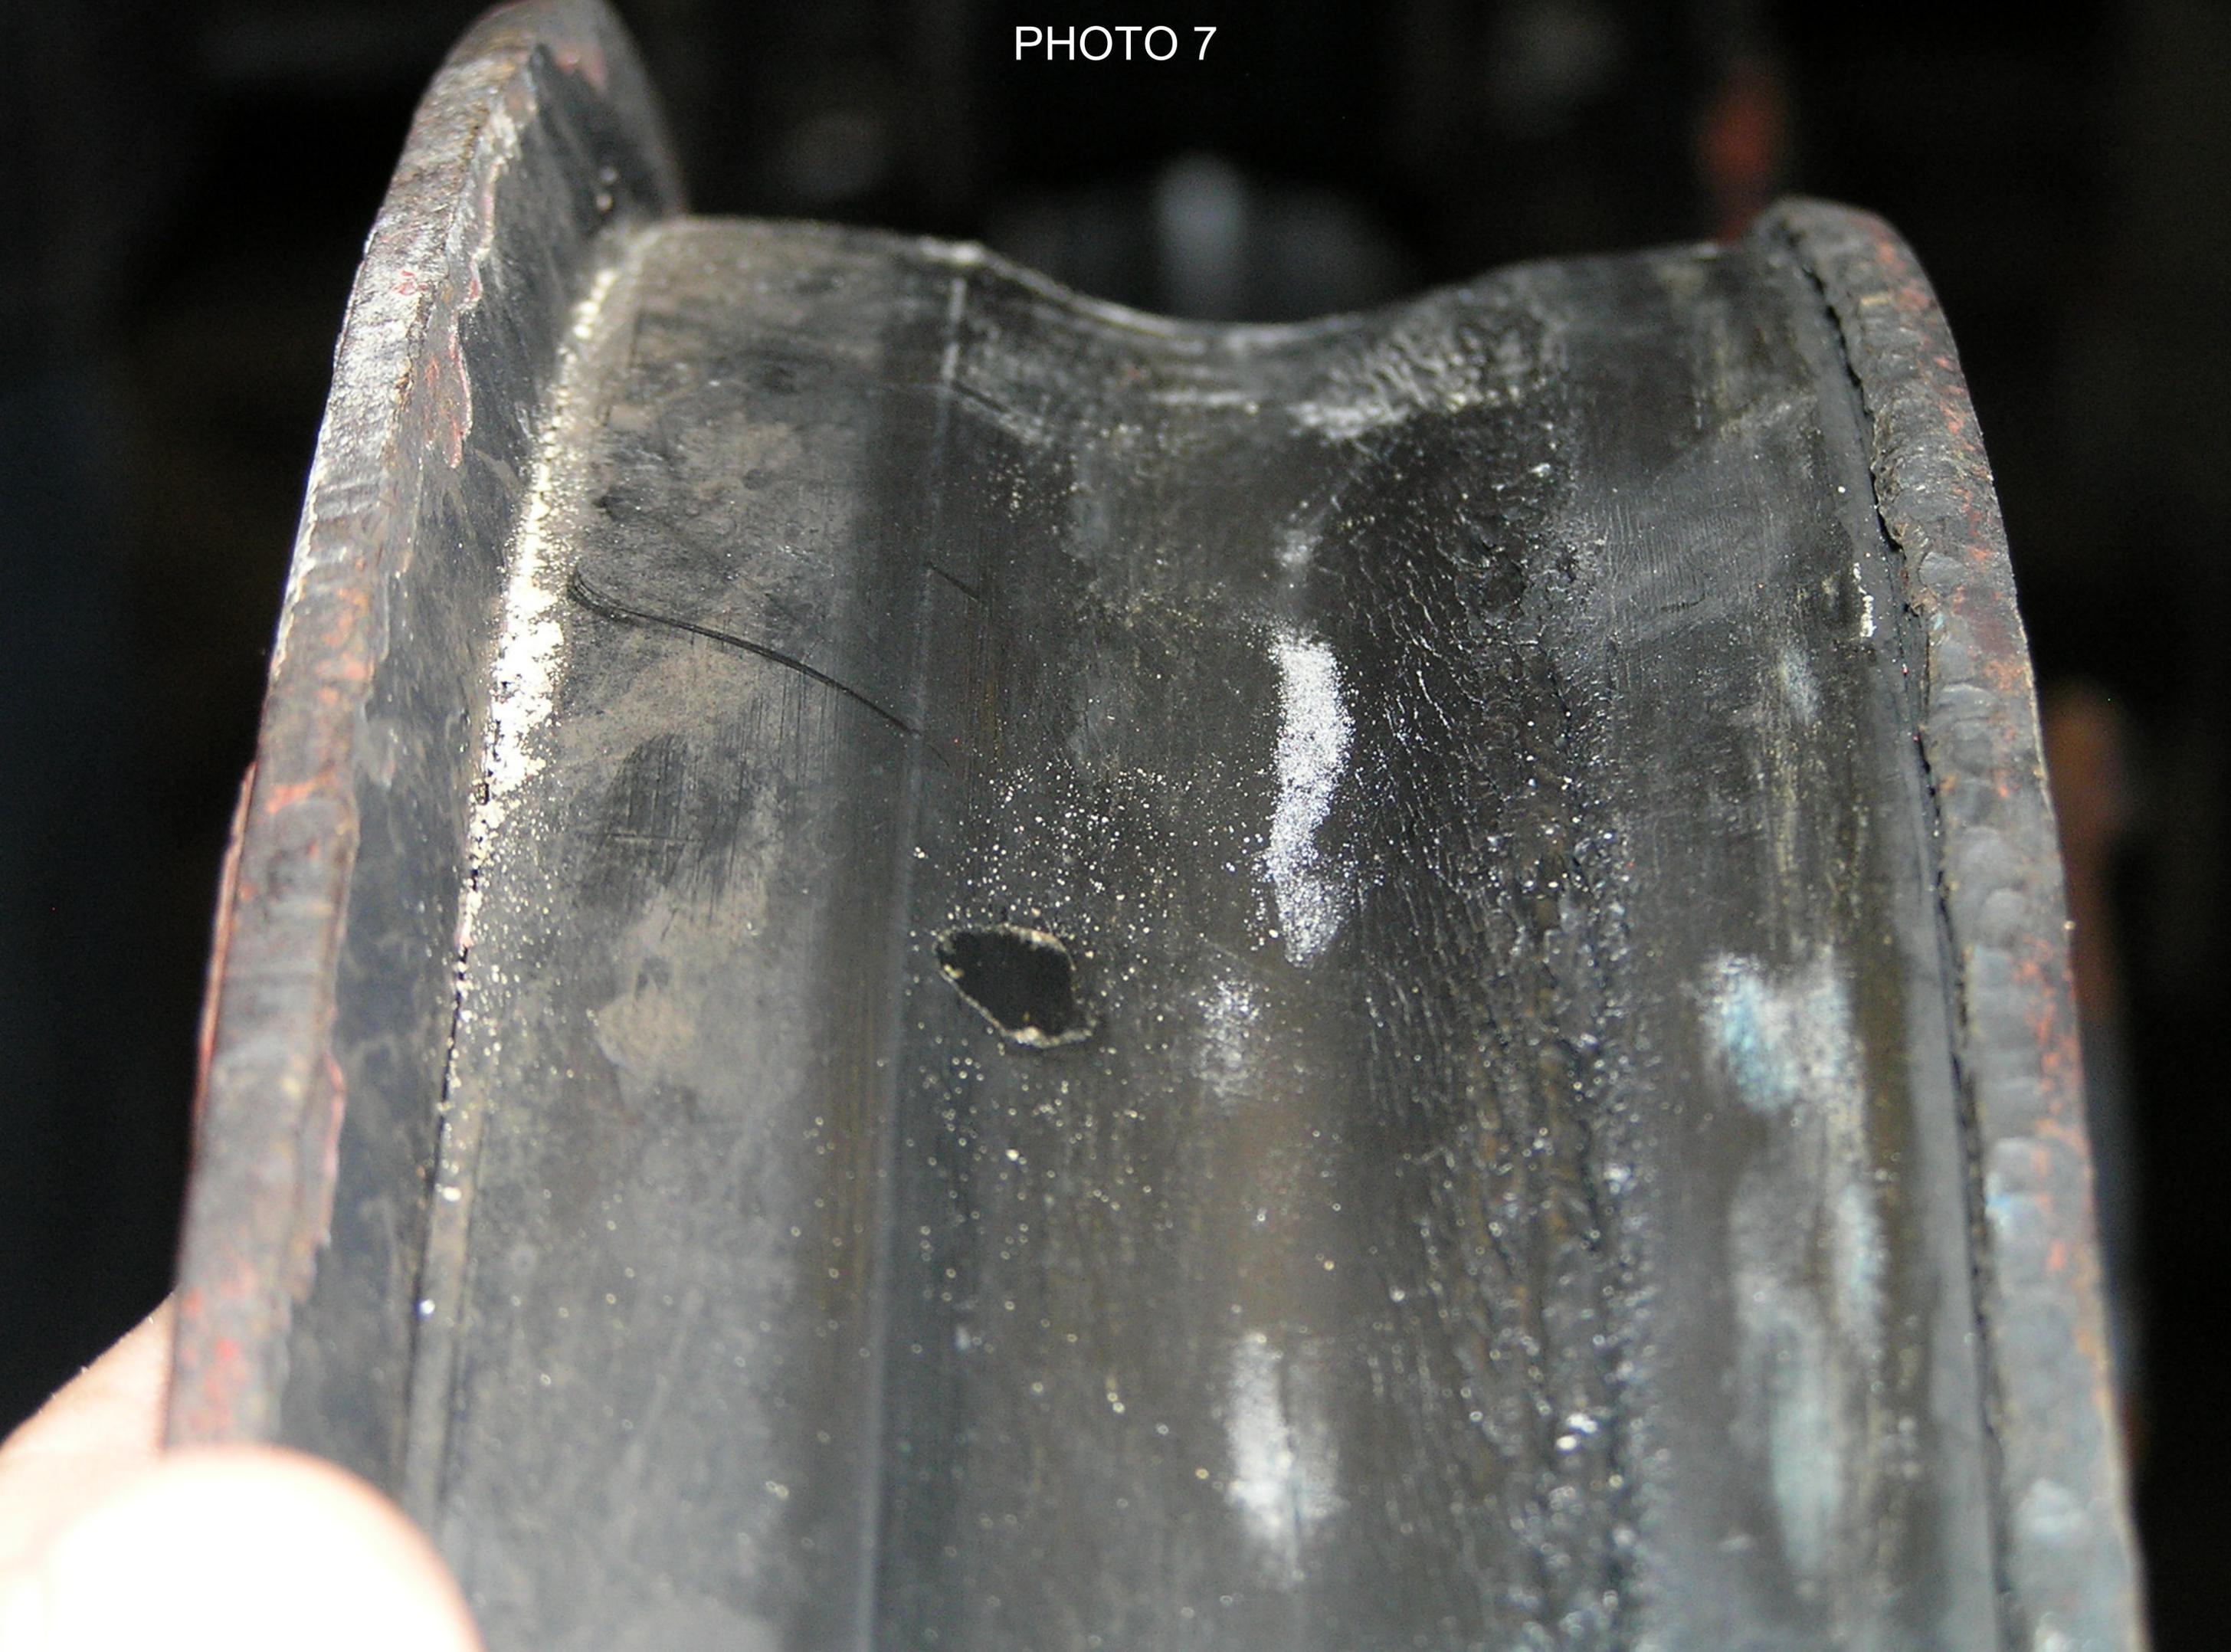
PHOTO 7

Photo 7- Sheave showing low outside flange

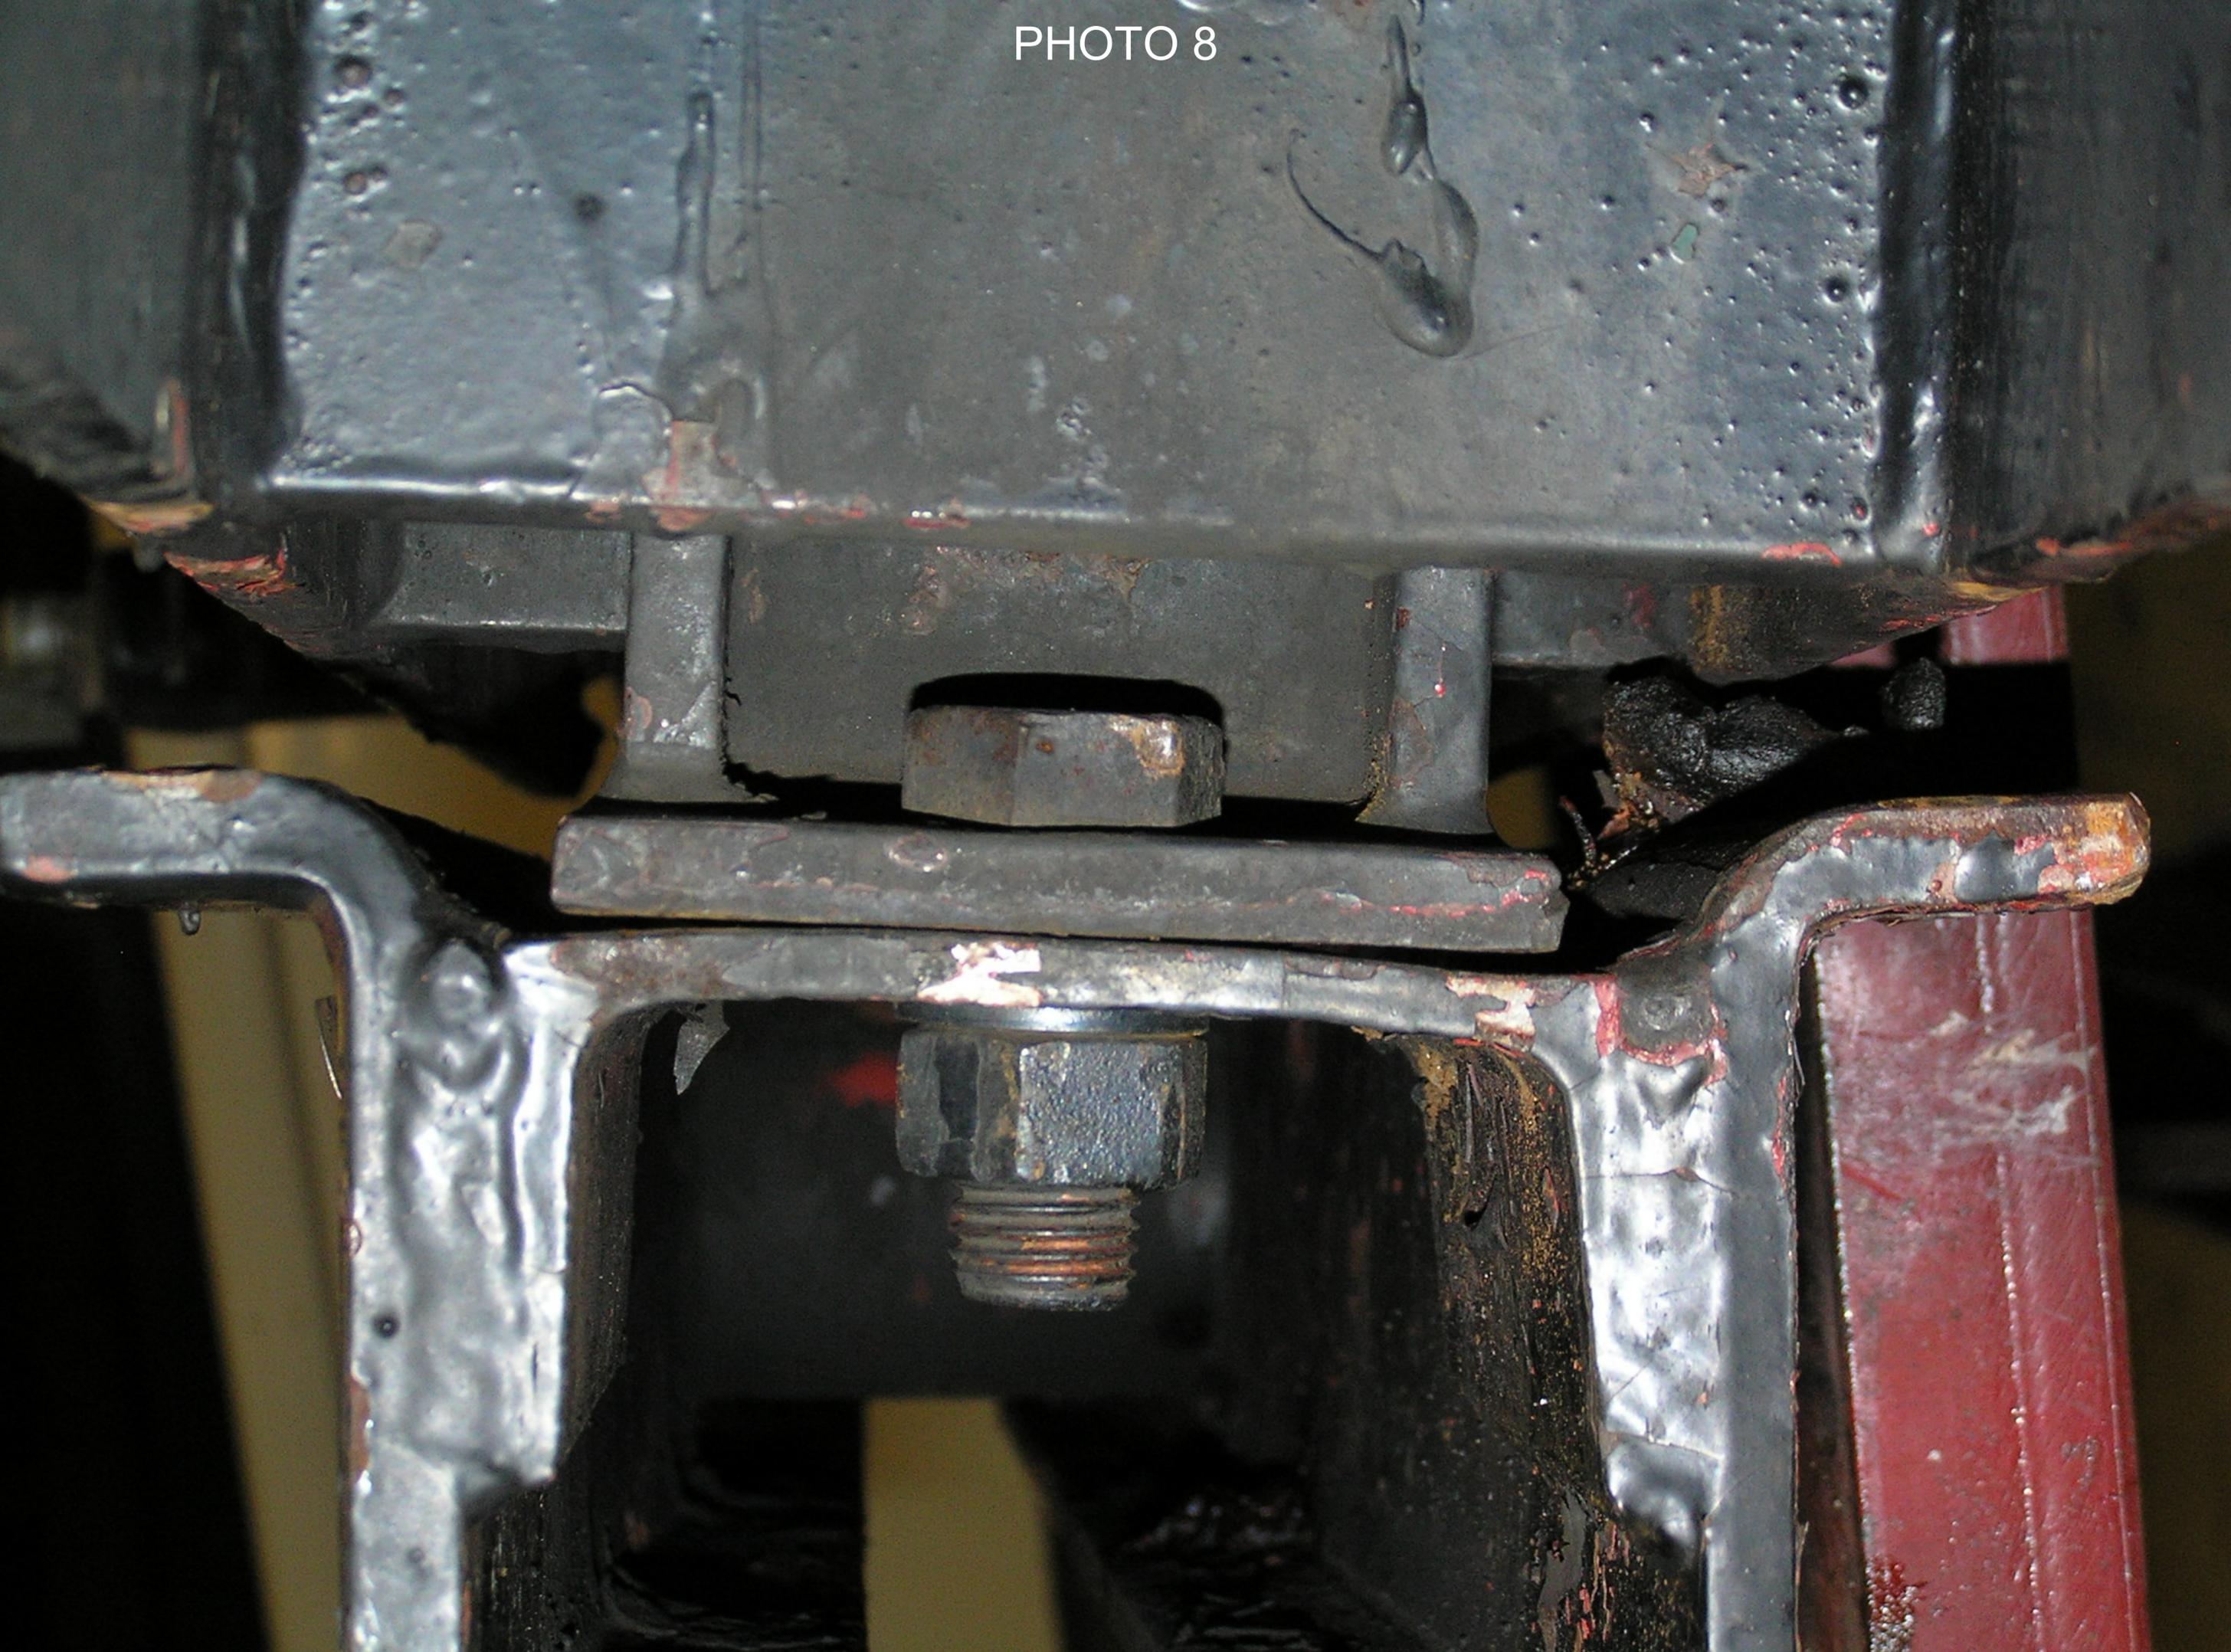
PHOTO 8

Photo 8 - Main walking beam attachment point to outgoing 4-sheave assembly

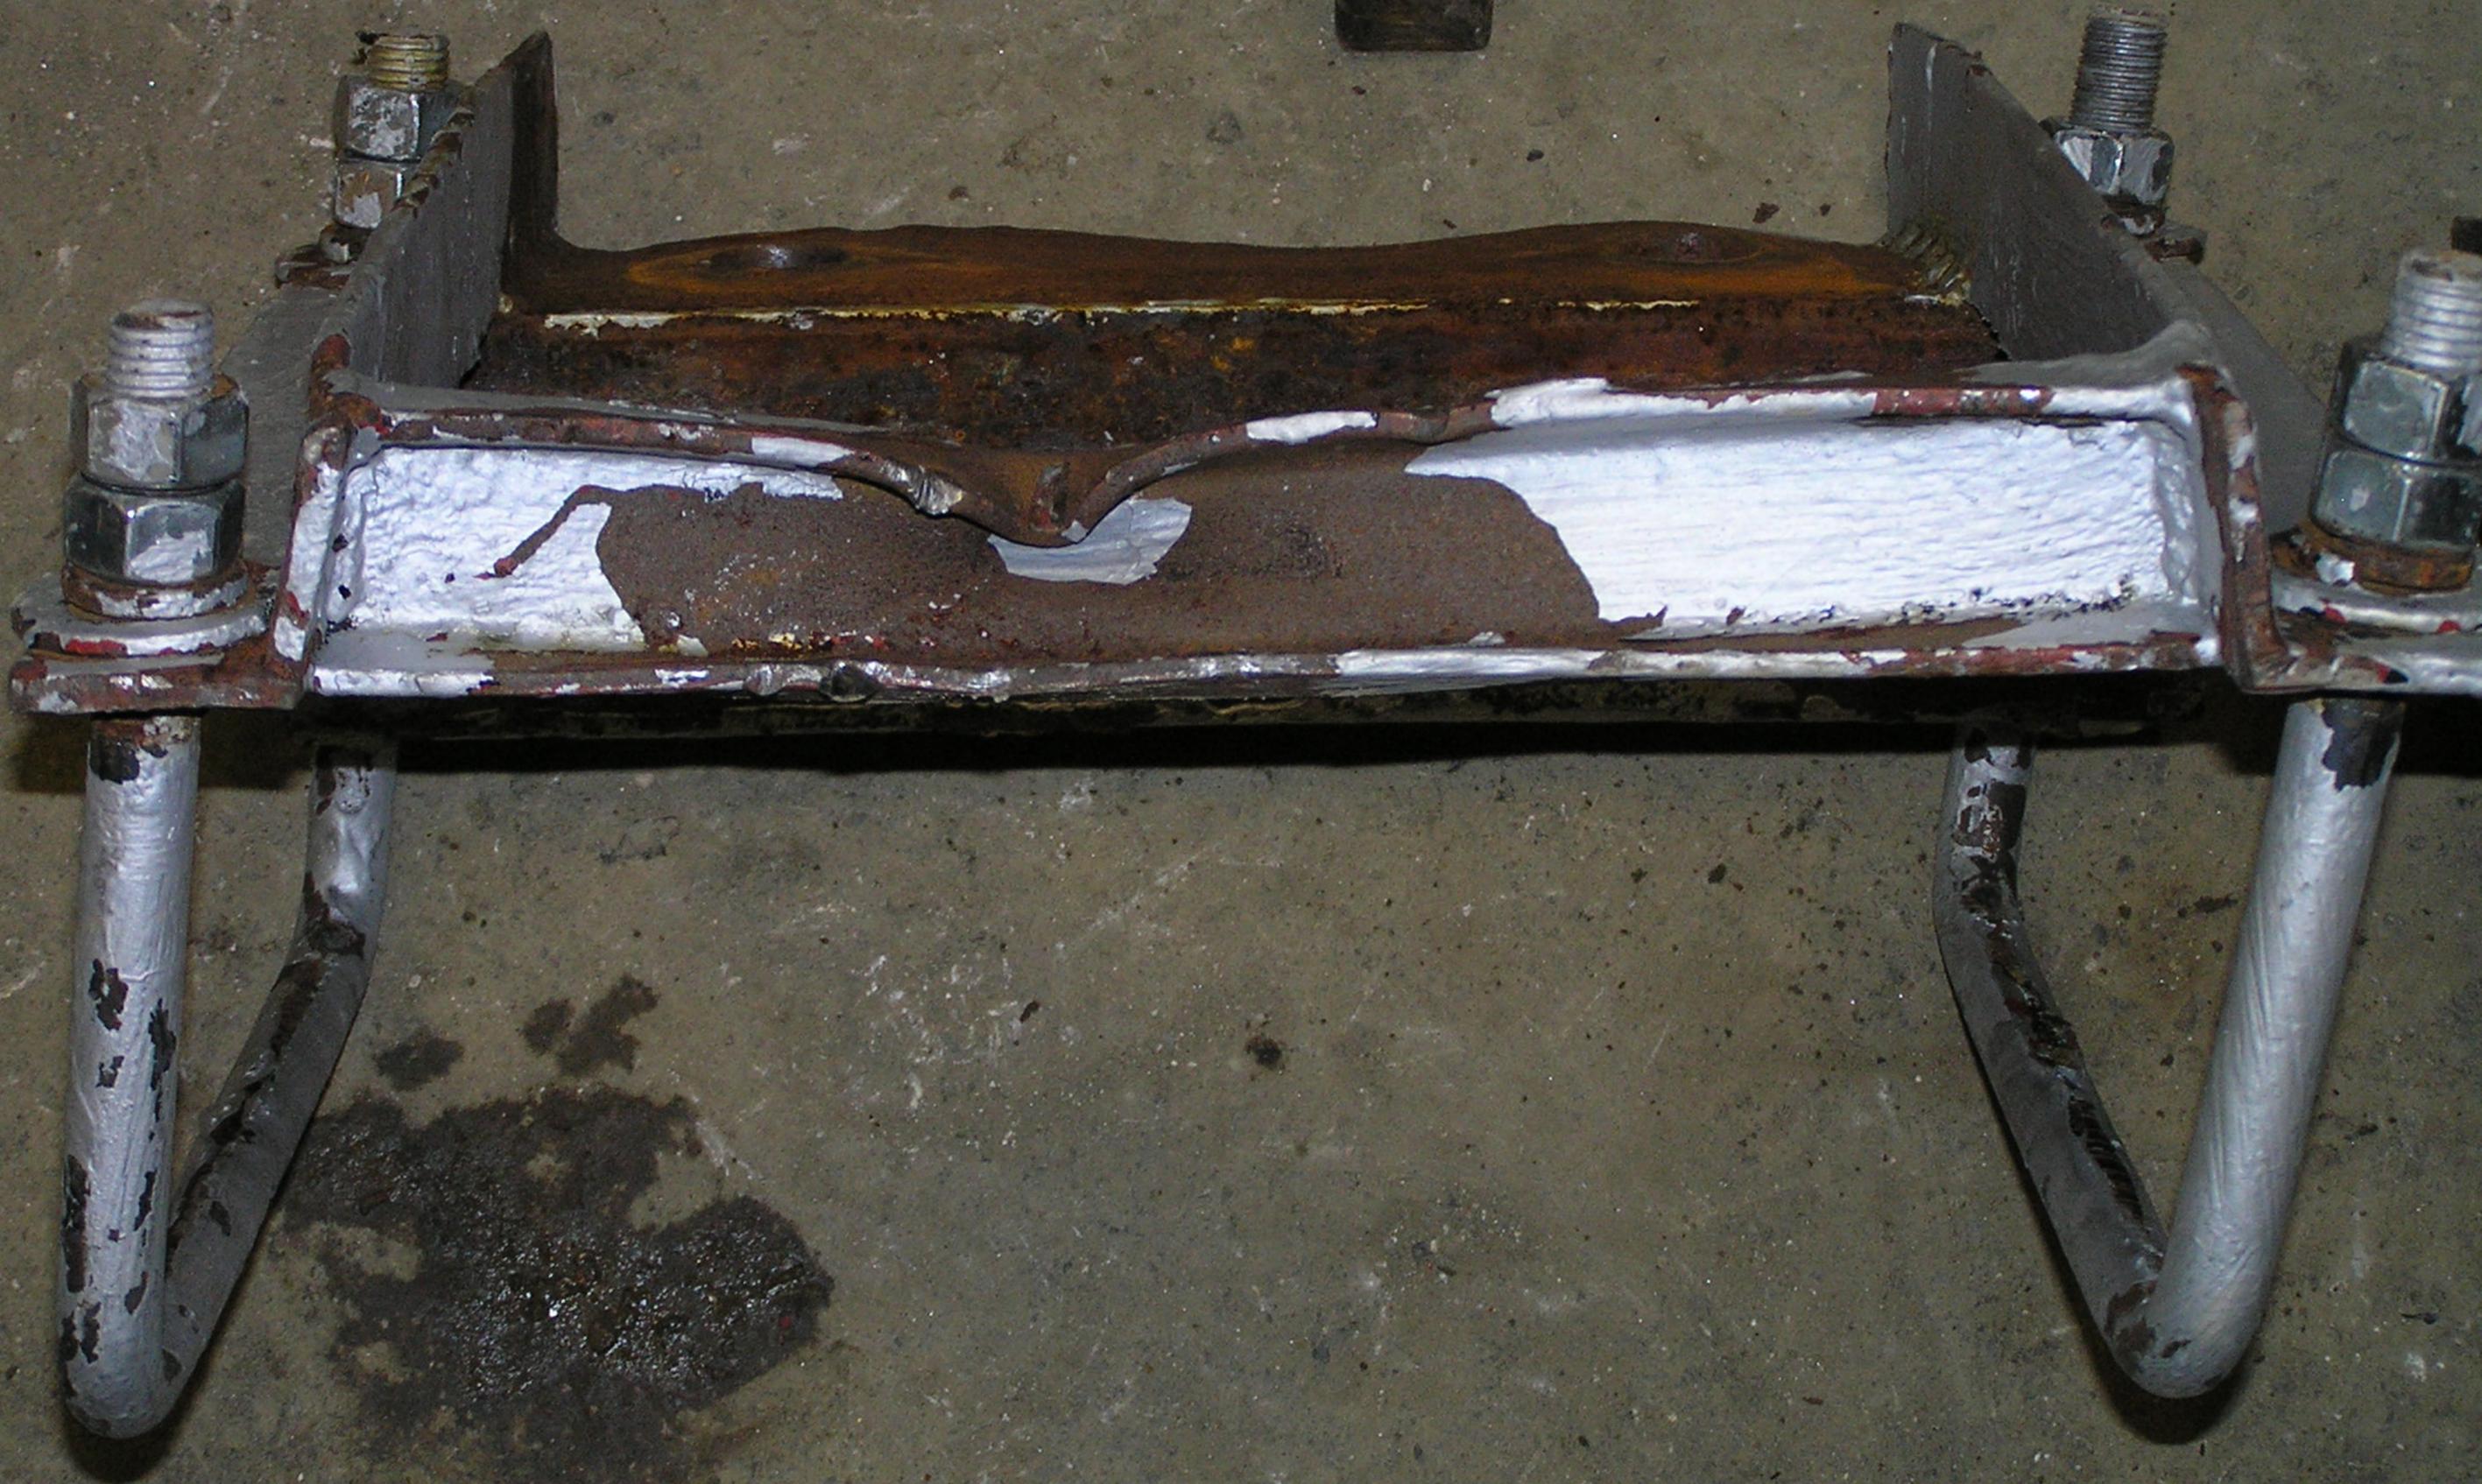
PHOTO 9

Photo 9- Damaged crossarm mounting bracket

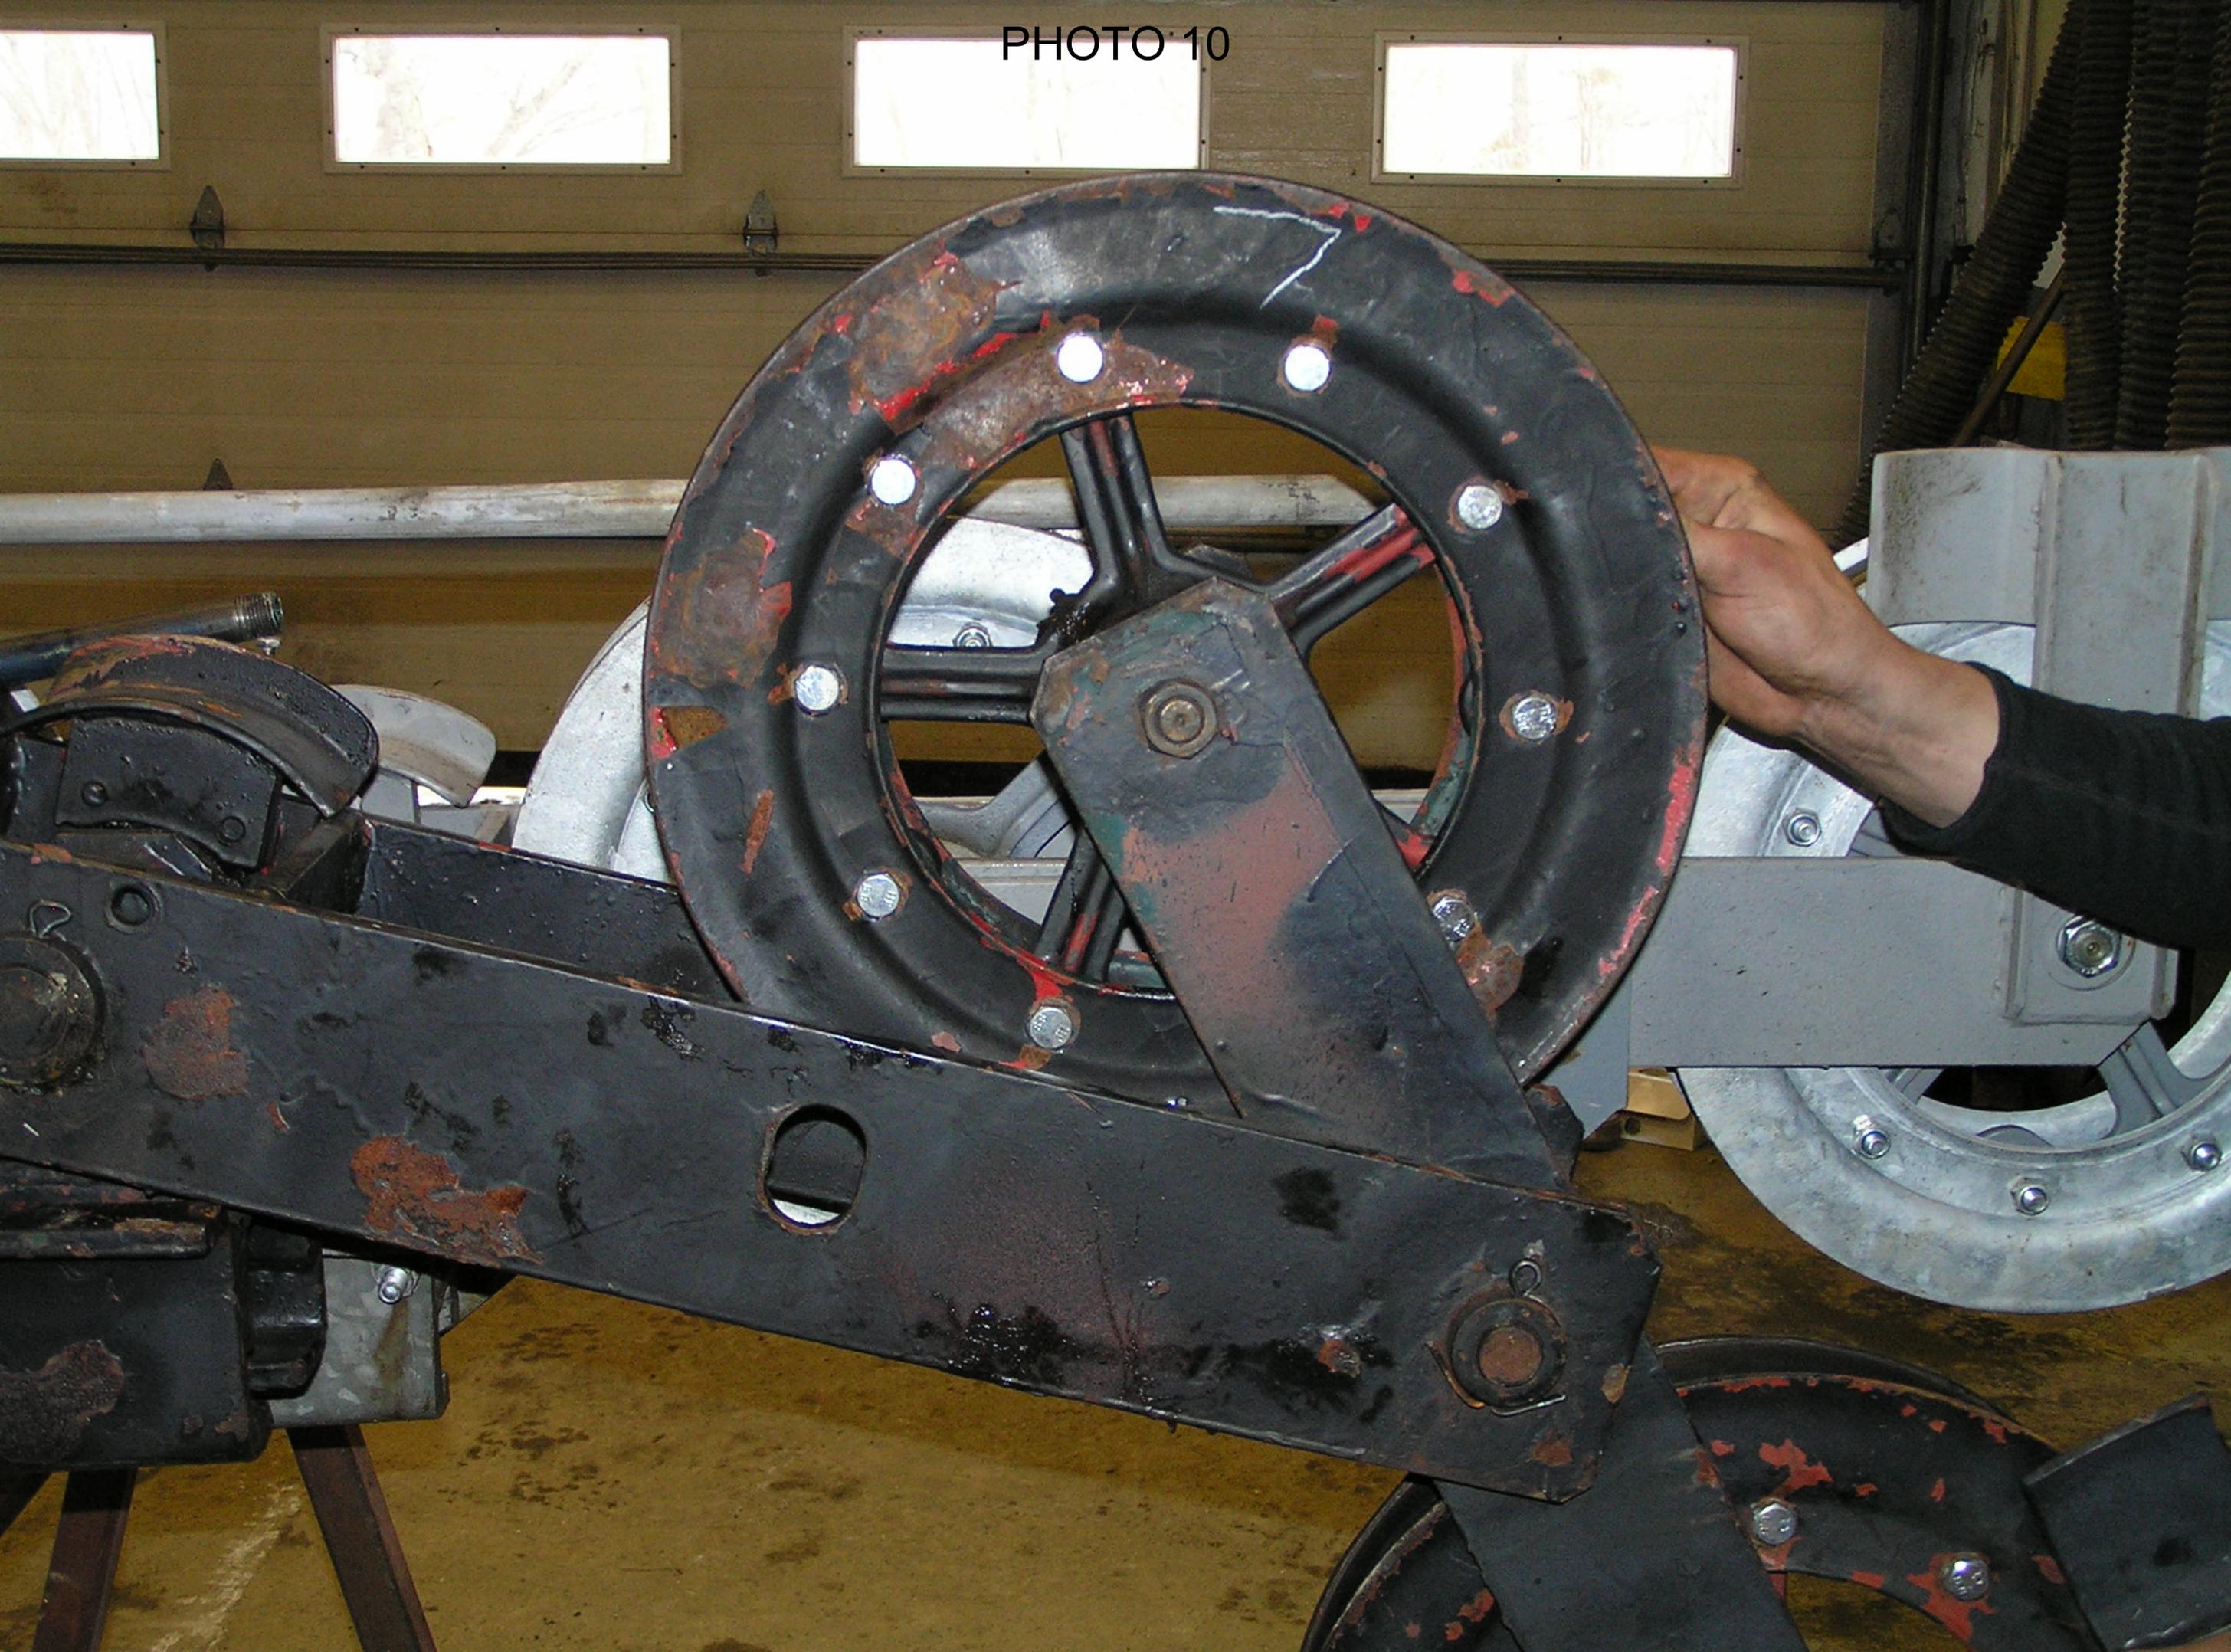
PHOTO 10

Photo 10 -Sheave number 7, pairing beam arrangement and connection to 4-sheave assembly walking beam and new fasteners for retaining the sheave liner
