Maine Geological Survey
DEPARTMENT OF CONSERVATION
Walter A. Anderson, State Geologist

OPEN-FILE NO. 85-72

Title: Faulting in the Grand Falls Area, Kellyland 15-Minute
 Quadrangle, Eastern Maine

Author: Allan Ludman

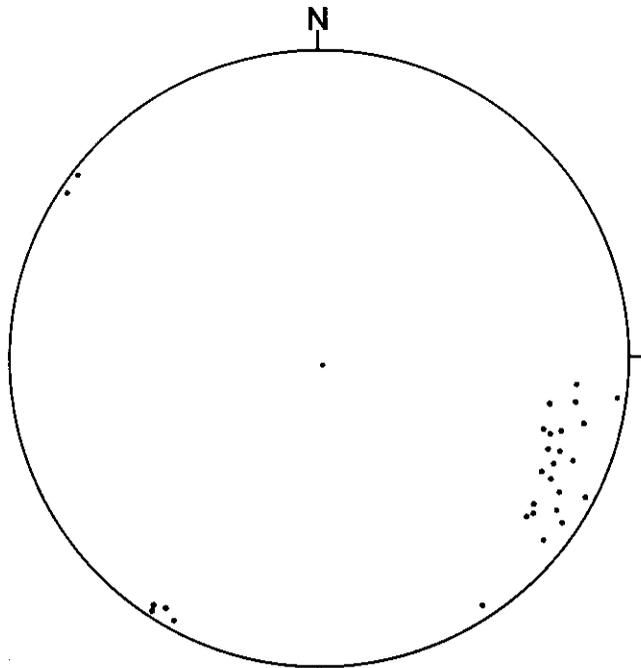
Area 1 - Dam exposures: Beds at the dam vary somewhat in their attitudes, but in general strike NNE and dip steeply to moderately to the northwest. Figure 3 is a stereonet showing poles to 25 beds from a representative study area close to the dam. The spread in the diagram is misleading; attitudes are not random, but are instead controlled by location relative to numerous faults that cut bedding at a high angle and produce drag folds. These drag folds are well defined by both the beds and cleavage, indicating that the faults postdated the upright isoclinal folding of the region. Figure 4 shows the typical relationships, with beds striking approximately 010° far from the faults and dragged into $030-040^\circ$ attitudes along the faults.

Figure 3.
Stereonet showing poles to bedding from
representative study area near Grand Falls Dam.

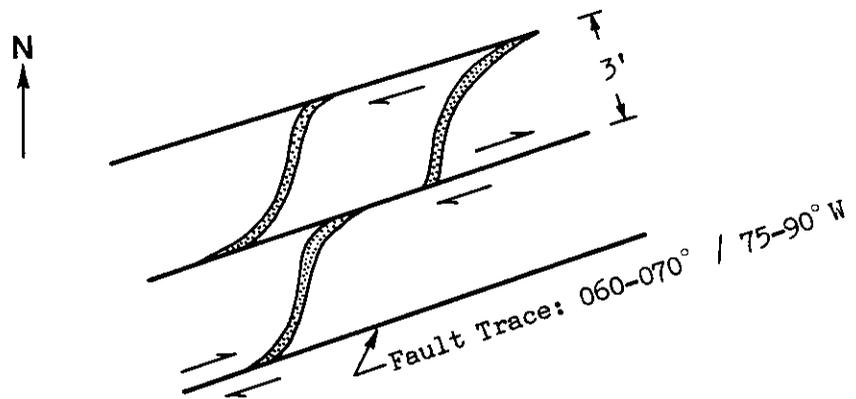
Figure 5 is a stereonet showing poles to faults observed in the northern part of the Grand Falls Dam exposure. The slickensides also shown in Figure 5 clearly indicate the strike-slip nature of the faulting, and the ubiquitous drag folds such as those shown in Figure 4 demonstrate that the faults were dextral (right lateral). The faults are readily identified in the field by a combination of features: systematic rotation of bedding as shown in Figure 4; quartz veins filling the fault zones; small amounts of fine-grained gouge; slickensides; and differential weathering. The fault zones are typically narrow, generally less than $1/2$ inch wide, but the secondary porosity provided by the broken rock has permitted enough water flow through the faults to preferentially dissolve the calcareous sandstones in the fault zones. A definite crack or notch develops along the traces of the faults, and is most easily observed in those exposures with the greatest vertical relief. Several individual faults can be traced for 150 to 200 feet across the outcrop.

Figure 4.
Sketch showing typical drag folds
at Grand Falls Dam (Map view).

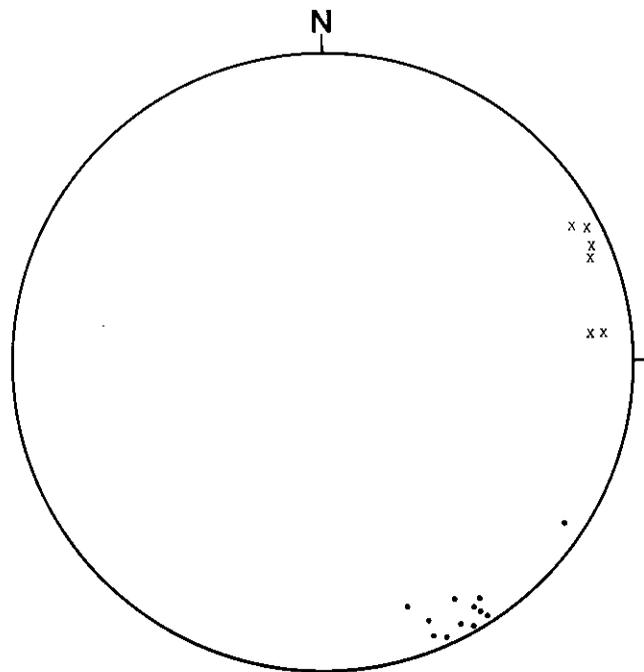
Figure 5.
 Stereonet showing attitudes of fault planes and
 slickensides from representative area at Grand Falls Dam.

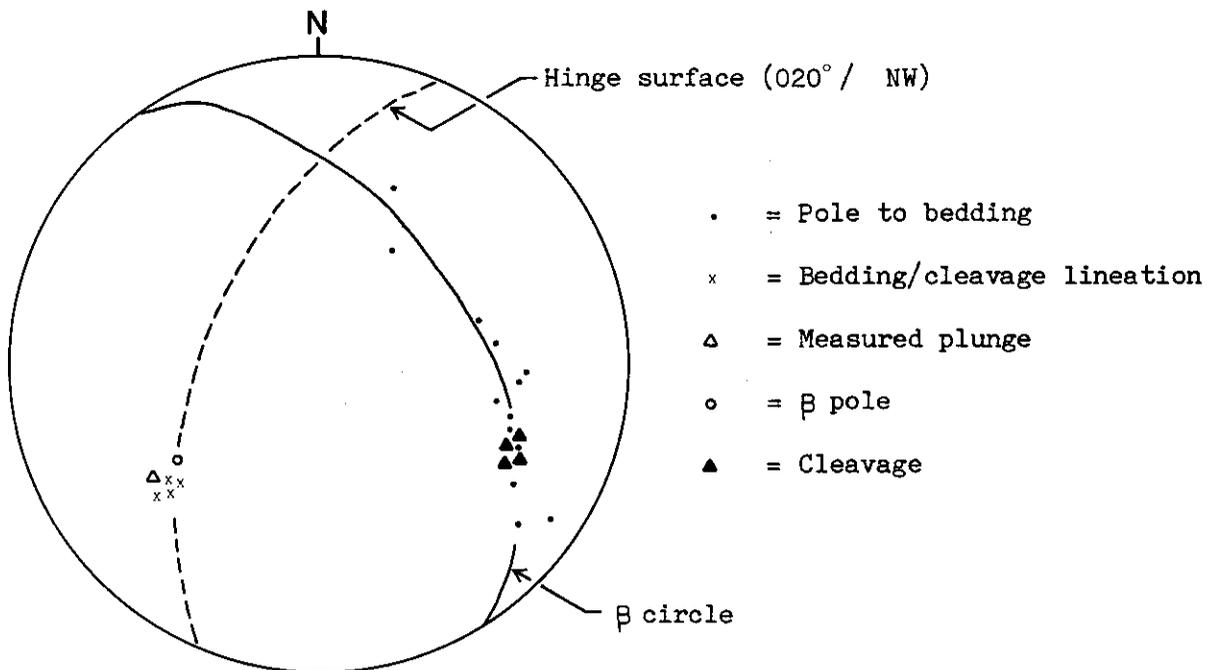
Figure 7.
Stereonet of poles to bedding from.
major isoclinal anticline shown above.

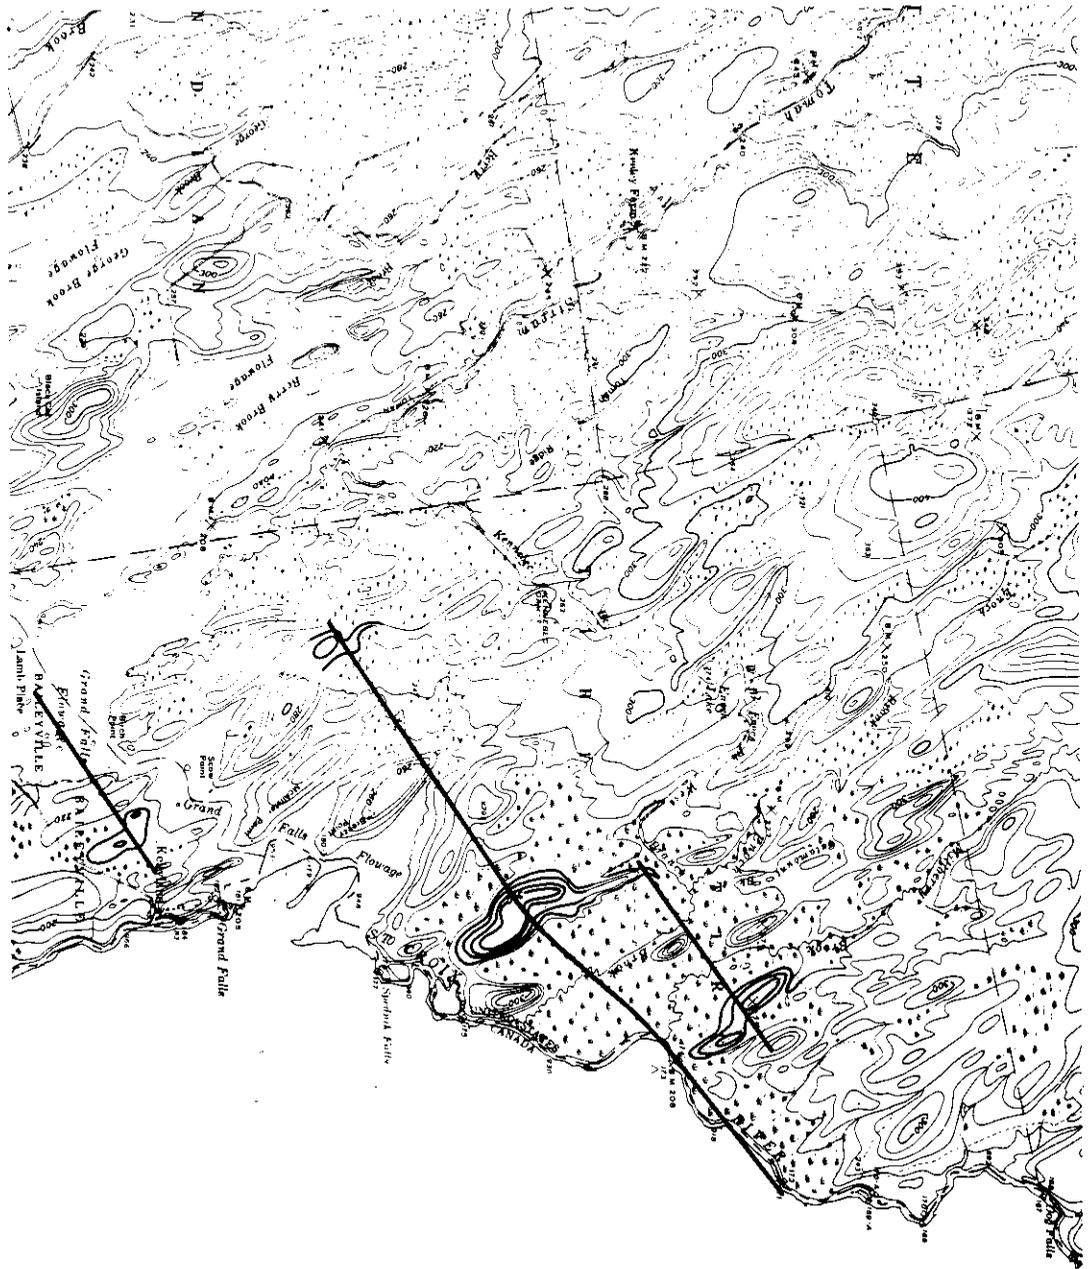
Analysis of topographic maps for the area suggests the possibility, albeit very weak, of recent offsets. Figure 8 is a somewhat reduced version of portions of the Kellyland and Waite 15-minute quadrangles in the vicinity of Grand Falls, and shows the distribution of glacial hills whose contour lines might be interpreted as indicating sinistral offset along faults parallel to the Norumbega system. Alternate contouring, however, might remove these apparent offsets. That Norumbega-related faults are present in the Grand Falls area is unarguable, but the sinistral sense of separation is contrary to all the evidence collected at the dam and described above. These apparently offset hills probably do not represent postglacial deformation.

Portions of Waite and Kellyland quadrangles (reduced scale) showing possible offset hills and faults inferred through these areas.
