Geologic Site of the Month
December, 2015

***The Cribstone Bridge, Harpswell, Maine
and its Granite Source Quarries***

Text by
Daniel B. Locke

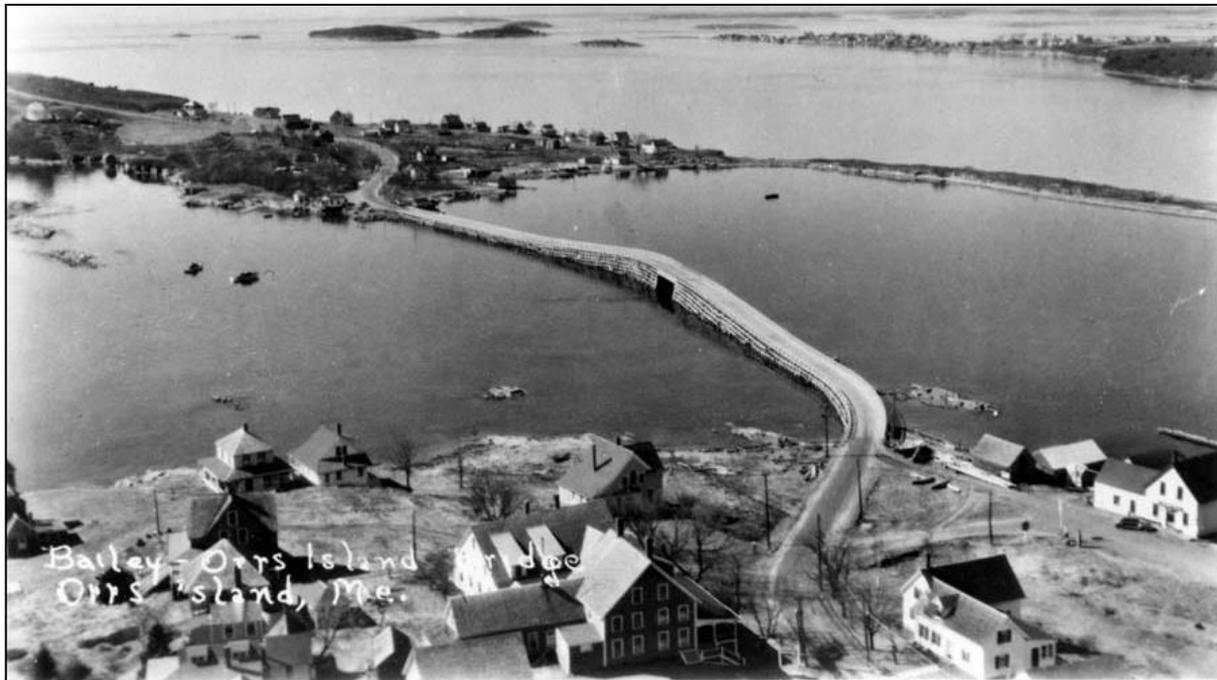
Figure 1. A 1946 aerial photograph of the Cribstone Bridge at high tide looking south with the south end of Orr's Island in the foreground and north end of Bailey Island in the background.

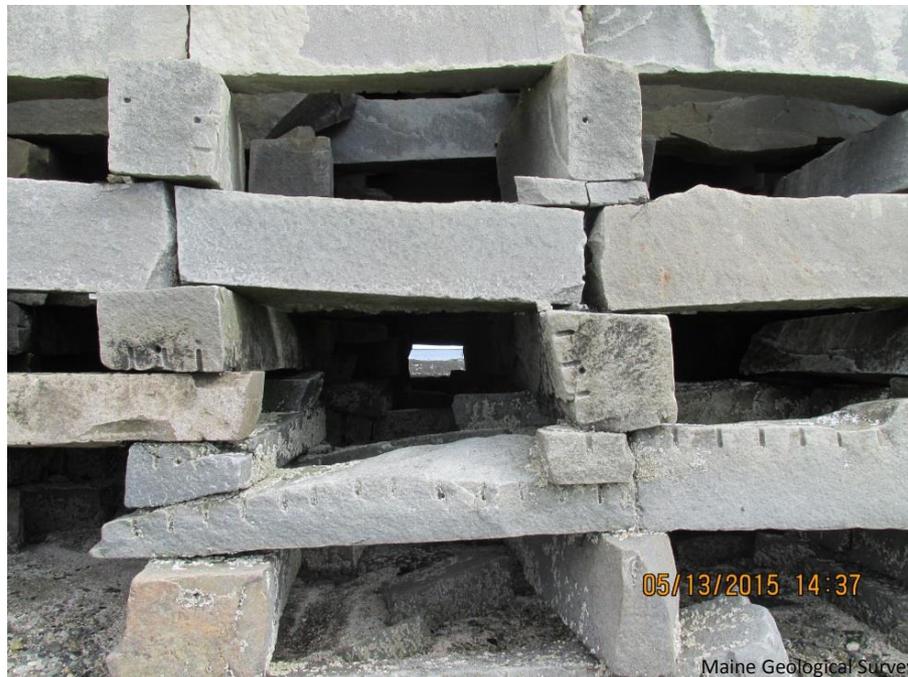
Figure 2. A view of the crib configuration of the granite slabs

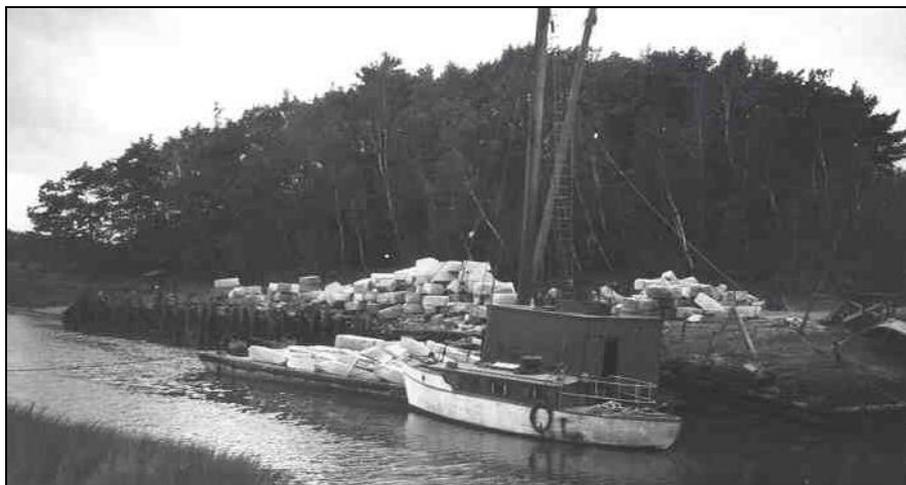
Figure 7. This October 20, 1927 photograph shows granite being loaded onto a barge at high tide along the Cousins River at the end of Granite Street.

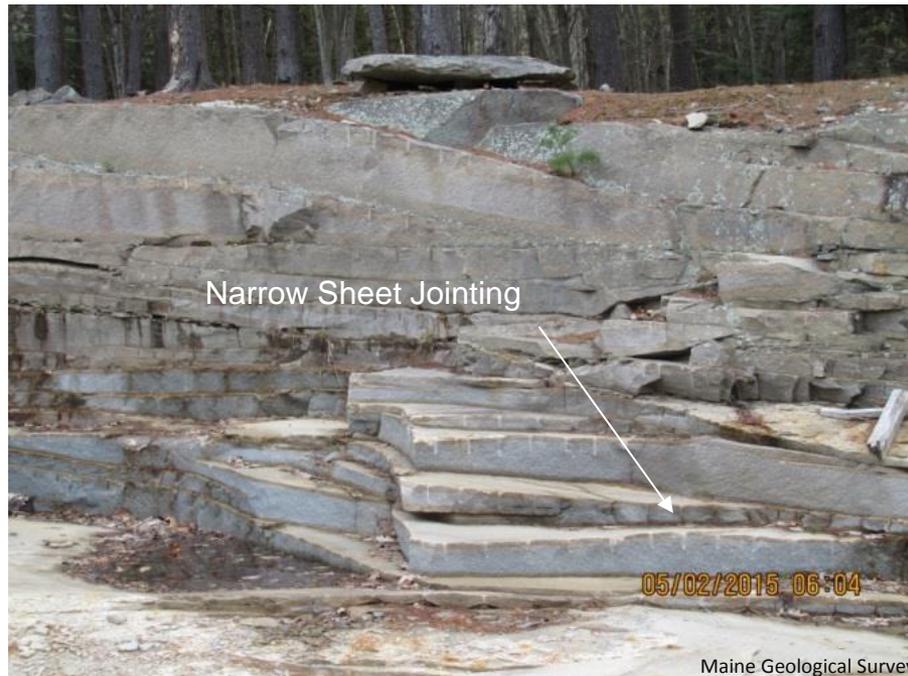
Figure 9. Image of active quarry (marked on Figure 6) and the narrow sheet jointing which is very conducive to the mining of rectangular slabs for the bridge construction.

The Pownal quarries yielded granite with relatively narrow [horizontal jointing patterns](#) that produced the uniform 12-foot rectangular slabs required for the cribstone bridge structure. The granite from these quarries is described as biotite granite of light gray shade and very fine, even-grained texture containing very smoky quartz, potash feldspar (microcline), soda-lime feldspar (oligoclase) and black mica (biotite) (Rand, 1958). This even-grained and uniform texture in combination with relatively narrow horizontal (sheet) jointing makes the granite from the quarries in this area ideal as a building material. The [Granite Quarrying in Maine](#) (Johnston, 2003) provides a broad overview of the granite industry in Maine.

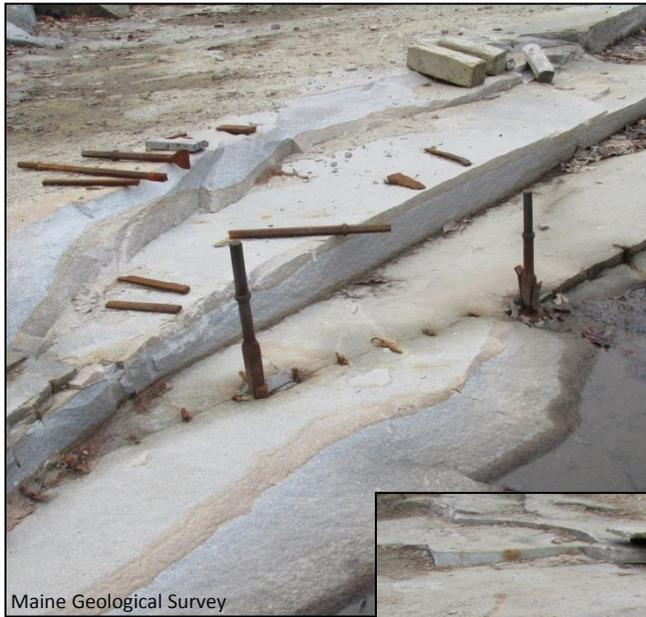
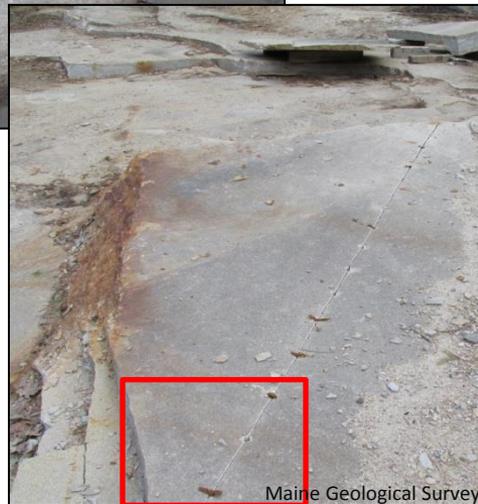
Figure 10. Placement of small and large wedge and feathers in the splitting of granite at the Taplin Quarry in Pownal, Maine. Photo with red border is close-up of area in red box. Watch a video of [splitting granite with wedge and feathers](#).

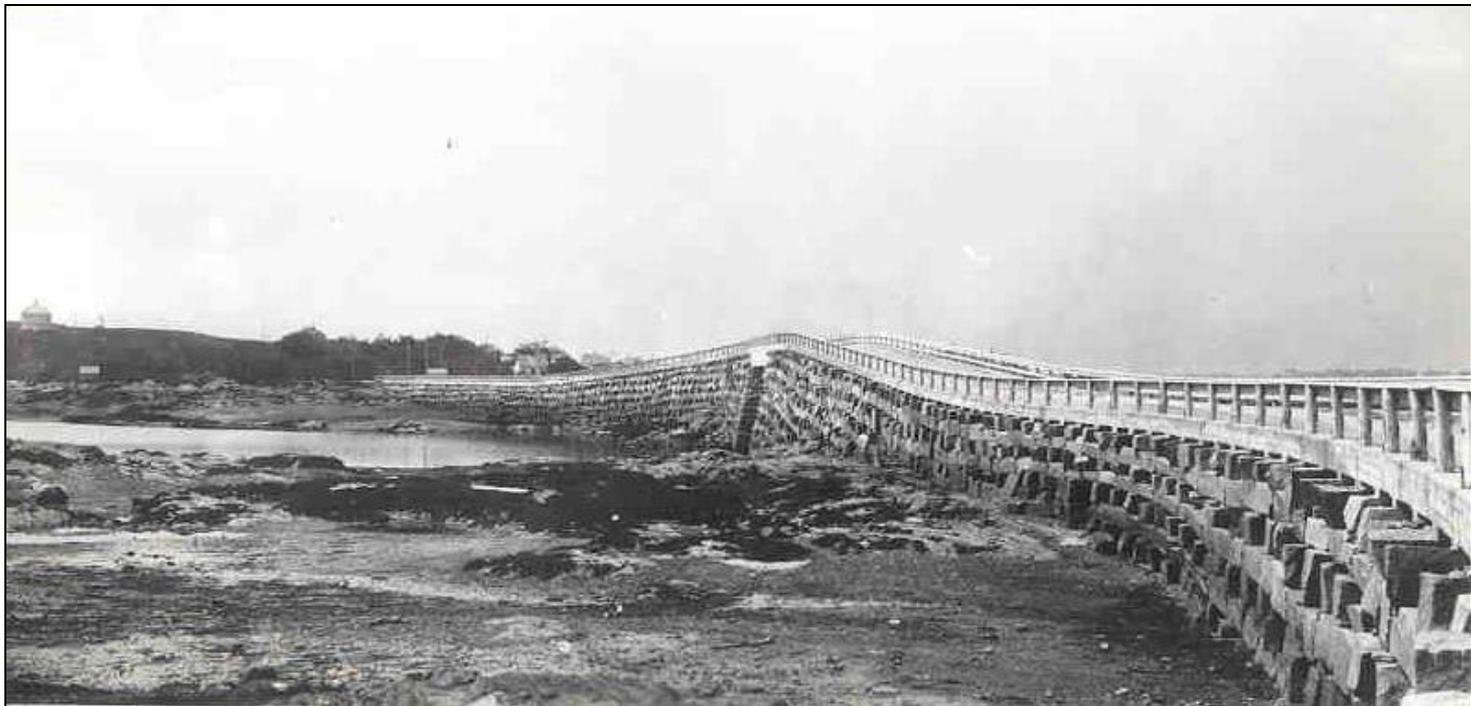
Figure 11. Photograph of what appears to be the completed bridge looking south toward Bailey Island.

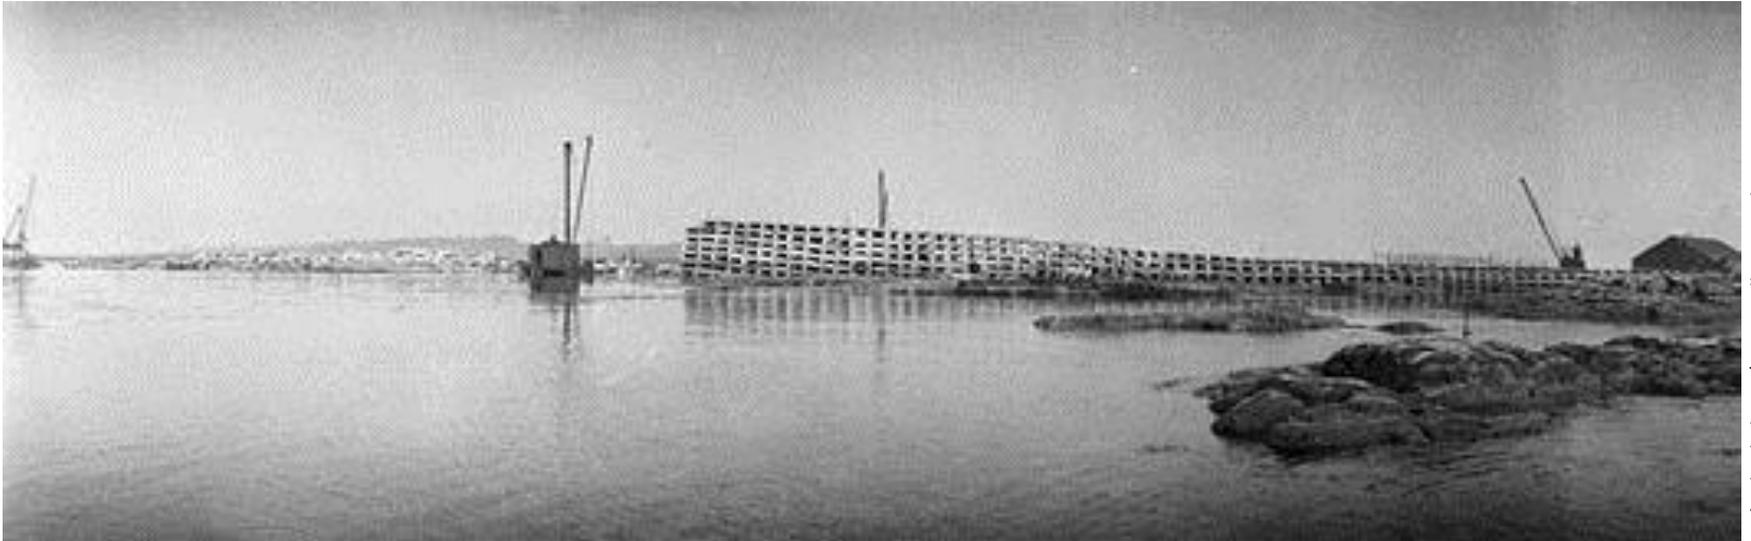
Figure 12. Photograph taken during the time of construction showing the building of the bridge starting from the north (Orr's Island) side first.

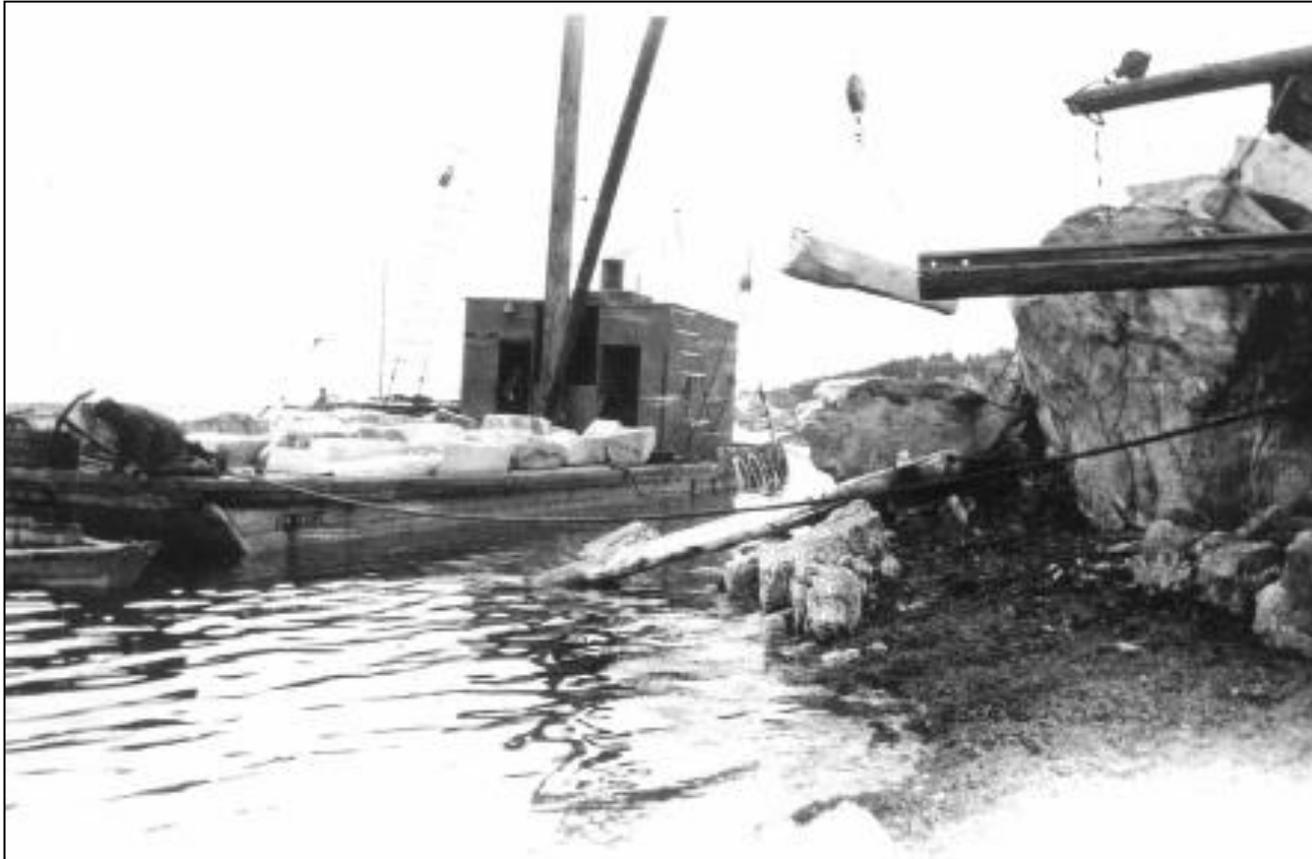
Figure 13. Photograph showing the offloading of granite from a barge.

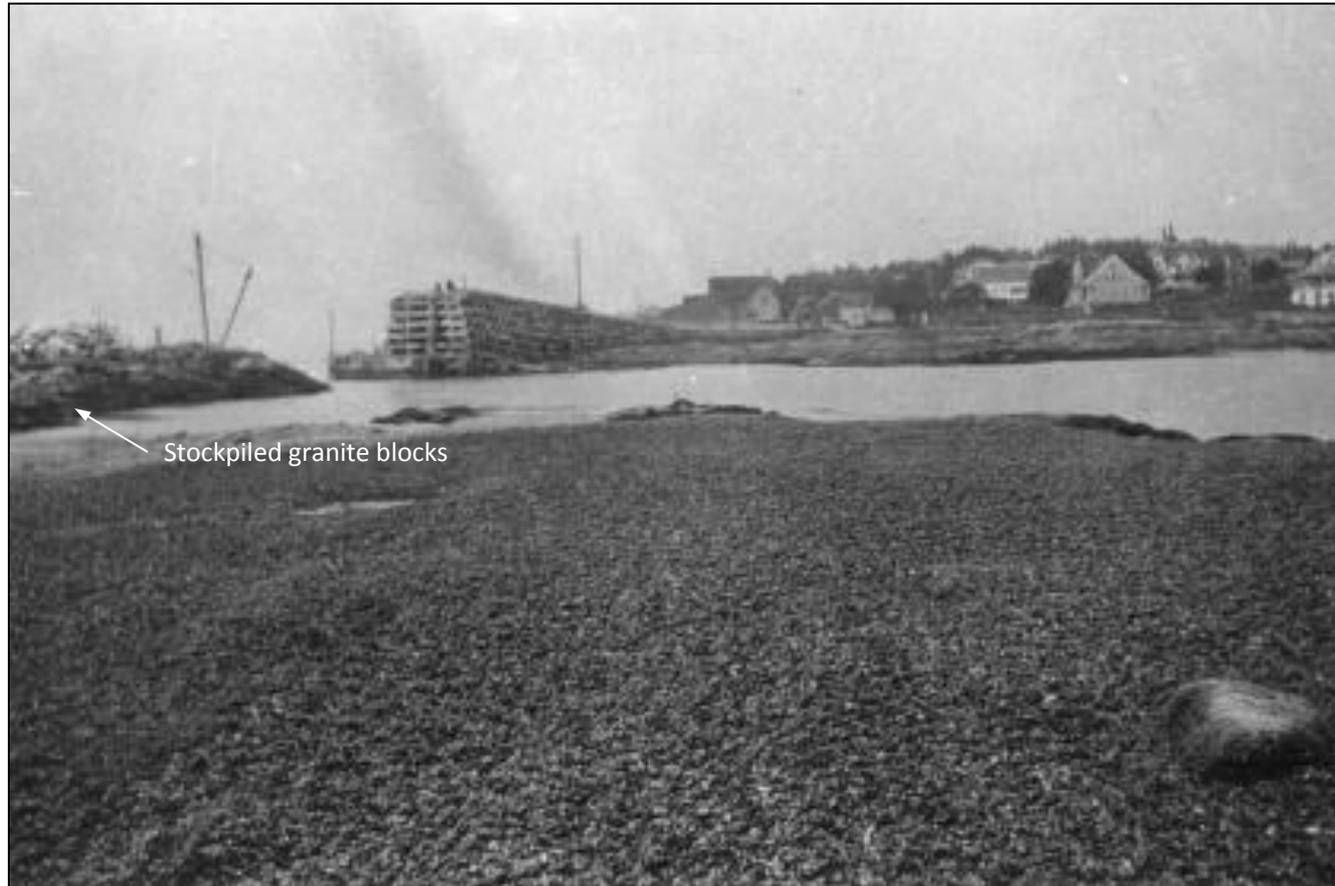
Figure 14. Photograph of the granite blocks that were stockpiled directly within the footprint of the bridge during the construction process

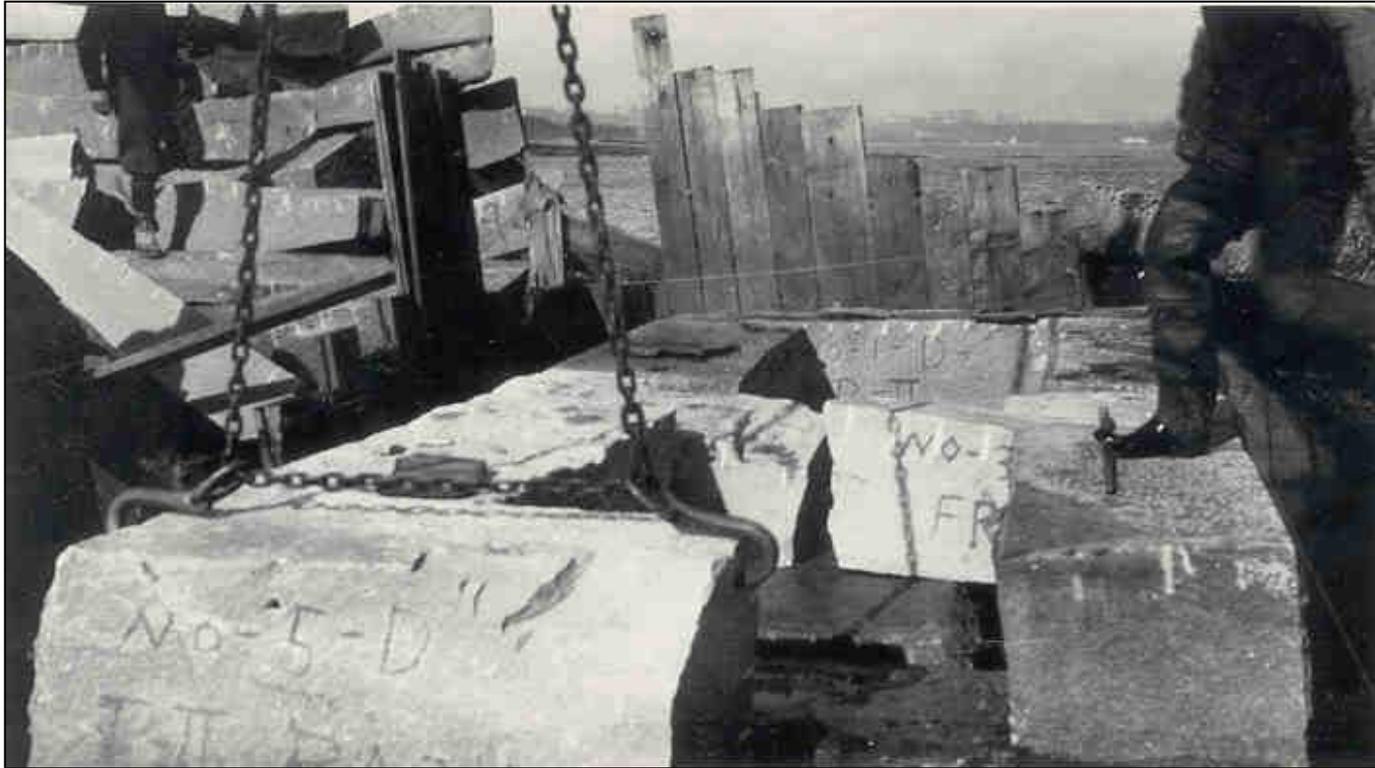
Figure 17. Photograph of the crane lifting granite from a barge onto the bridge.

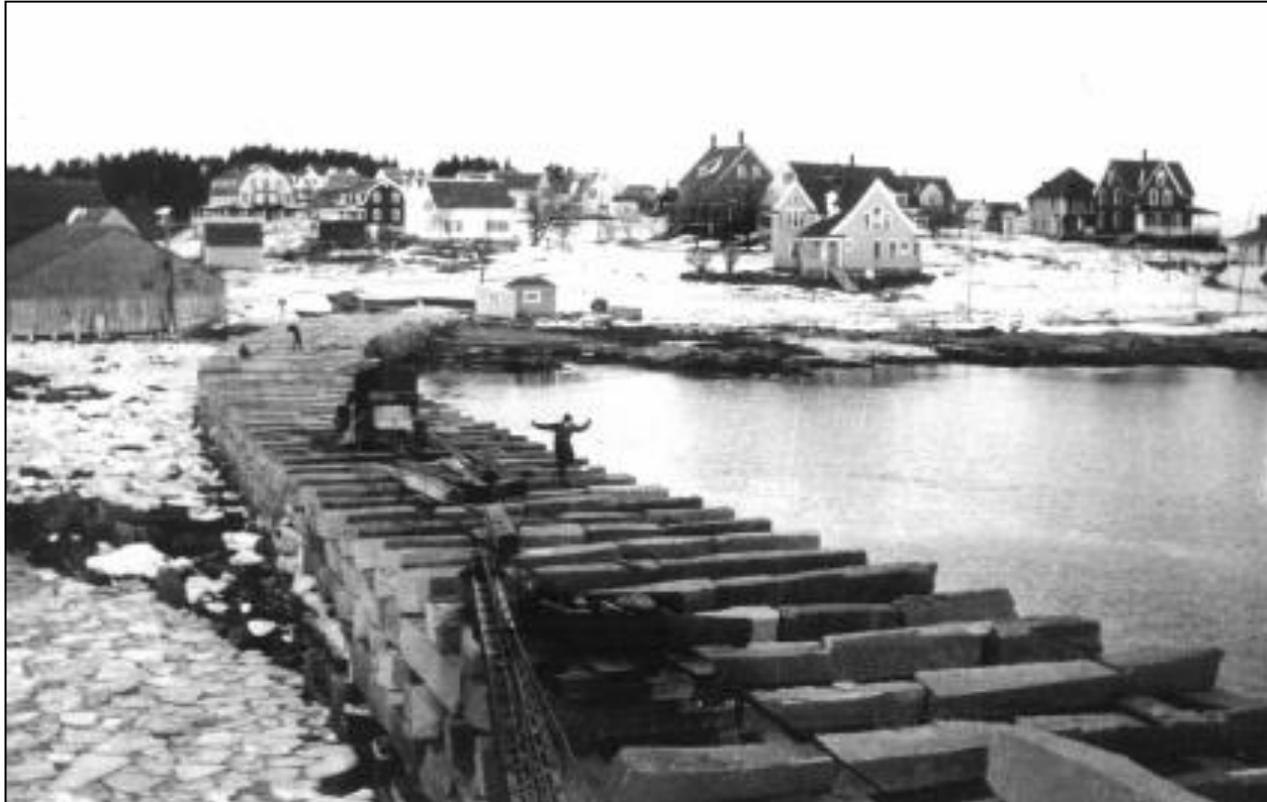
Figure 18. Photograph with ice flow formation clearly evident during bridge construction on the west side of the bridge.

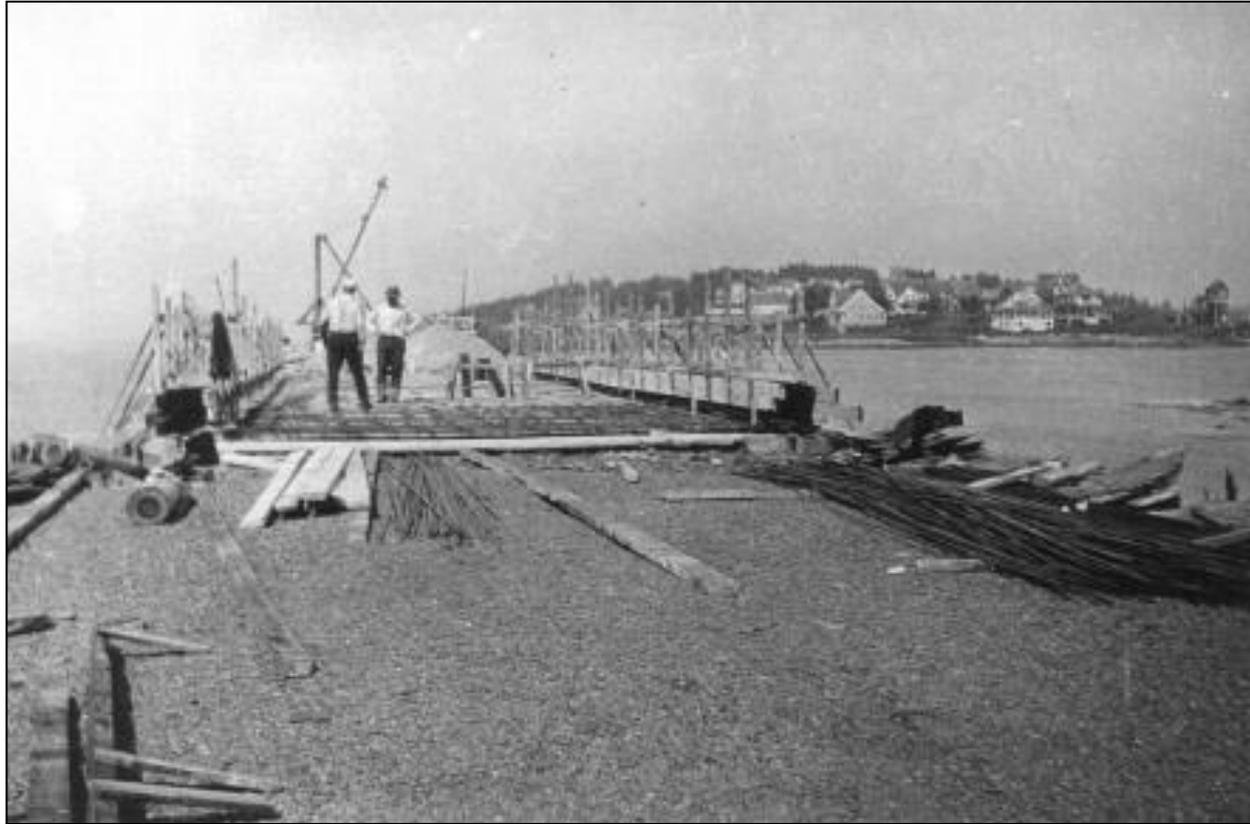
Figure 19. Photograph showing placement of steel reinforcement bars in preparation of pouring concrete surface.

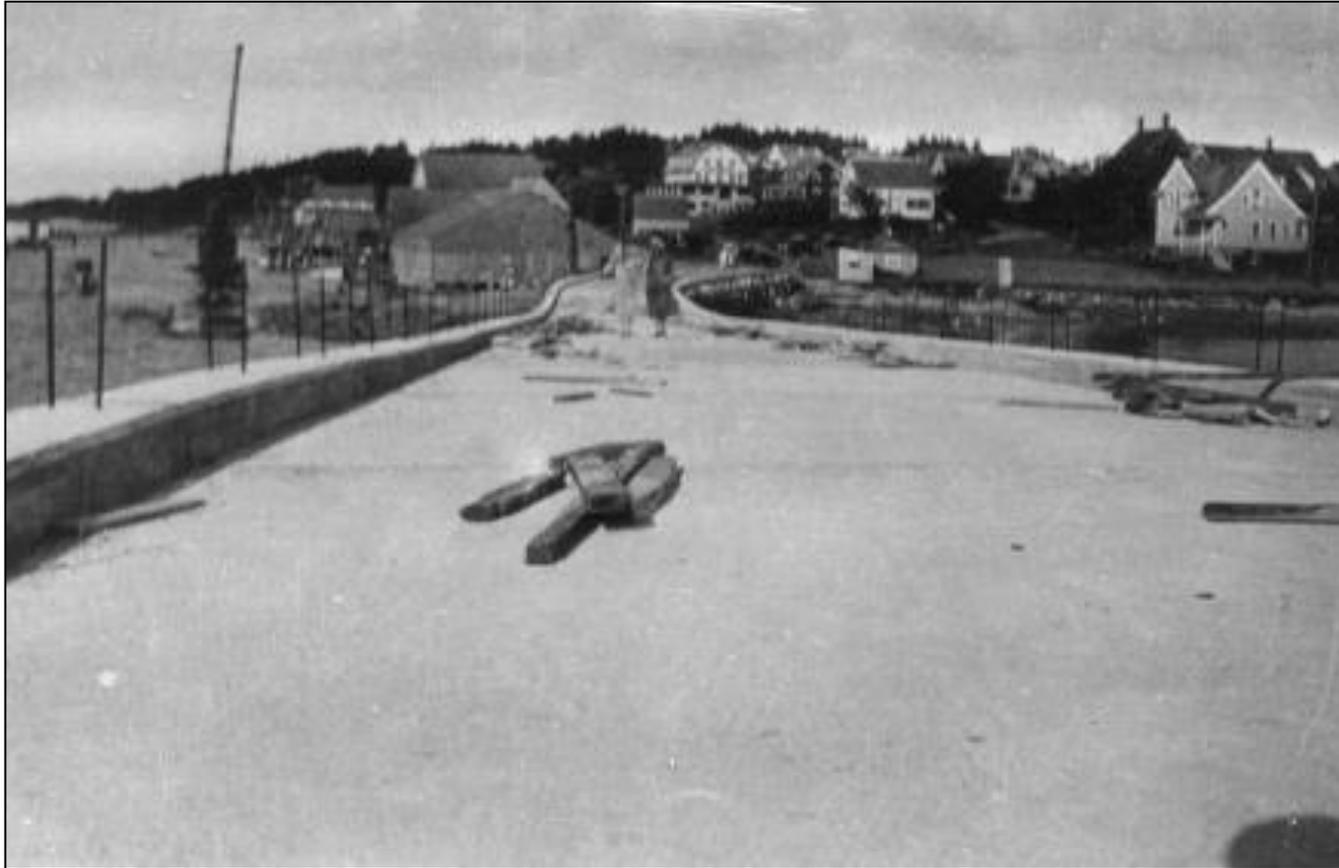
Figure 20. Photograph of the north end of the bridge with the road surface installed.

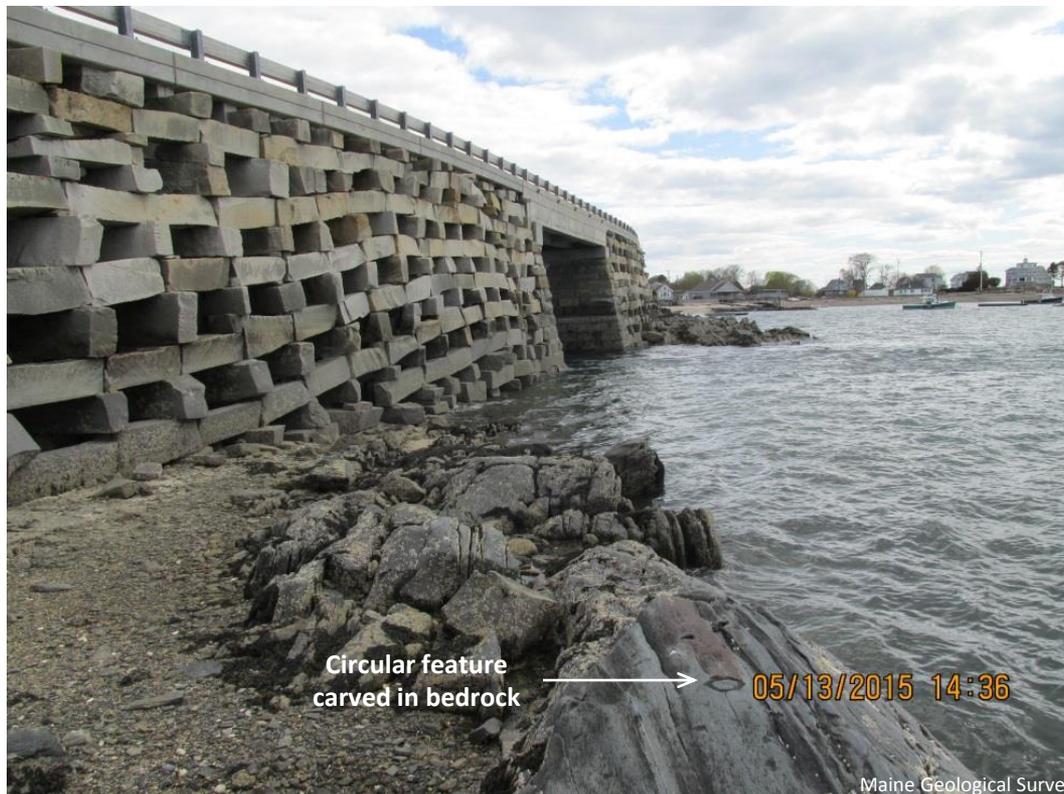
Figure 21. Present-day photograph of the bridge and small circle carved in the rock, possibly a benchmark used in construction.

There is a curious circle carved into the bedrock in Figure 21 just to the left of the date stamp. The Maine Department of Transportation has no record of this being a benchmark or survey reference point. If anyone knows what this feature is, please let us know!!

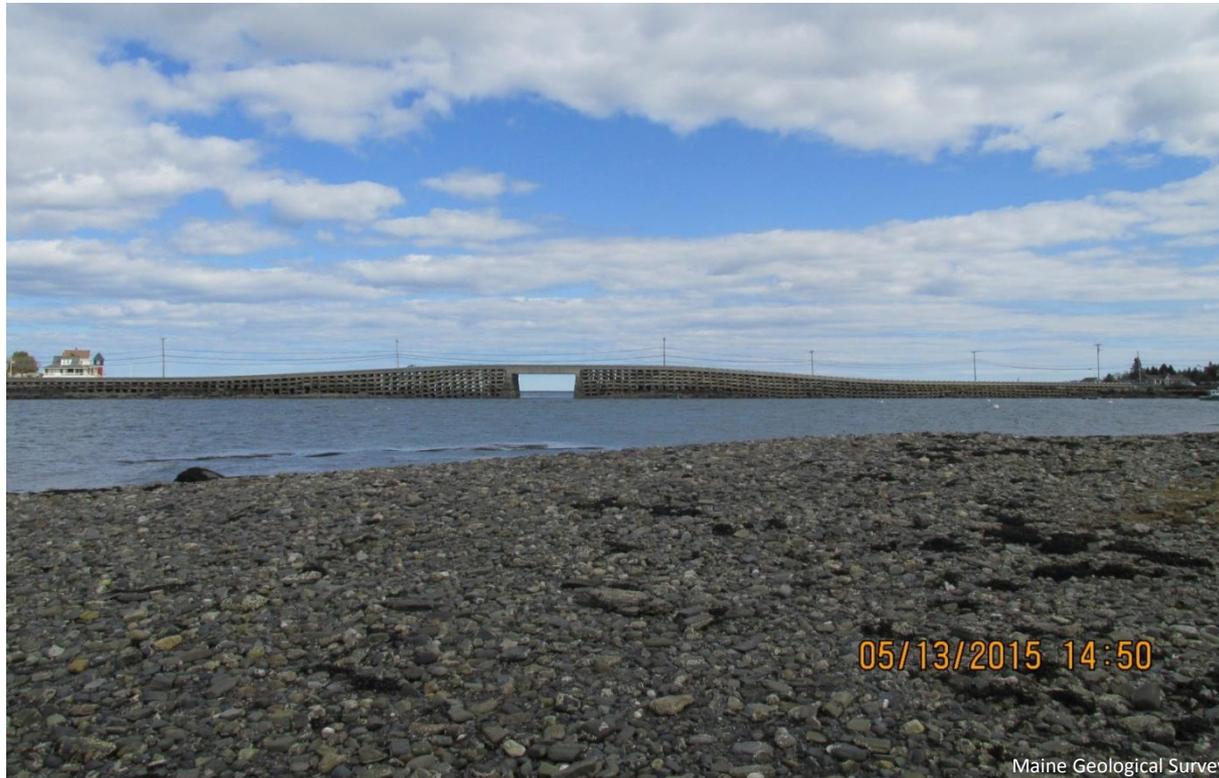
Figure 22. View looking east to the Bailey Island Cribstone Bridge. Note the gradual and graceful lines of this masterpiece of engineering blended into the geology of the setting.

In 2009-2010, the Bailey Island Cribstone Bridge underwent a major refurbishment to address broken and shifted granite slabs. All repairs retained the original appearance of the bridge and even utilized granite from one of the original source quarries in Pownal, Maine.
