# *State of Maine's Beaches in 2009*

**Open-File 09-57**

2009

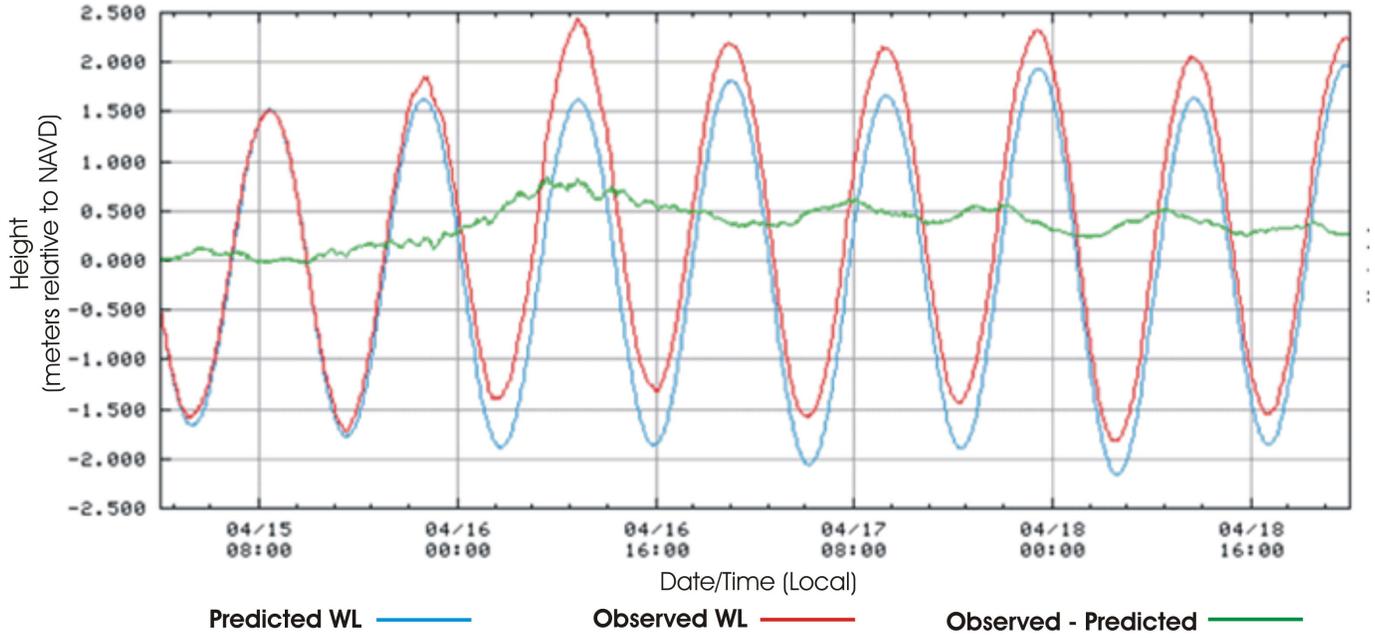
Figure 3. Tide gauge recordings of water levels in Portland Harbor during the Patriots' Day Storm of 2007.

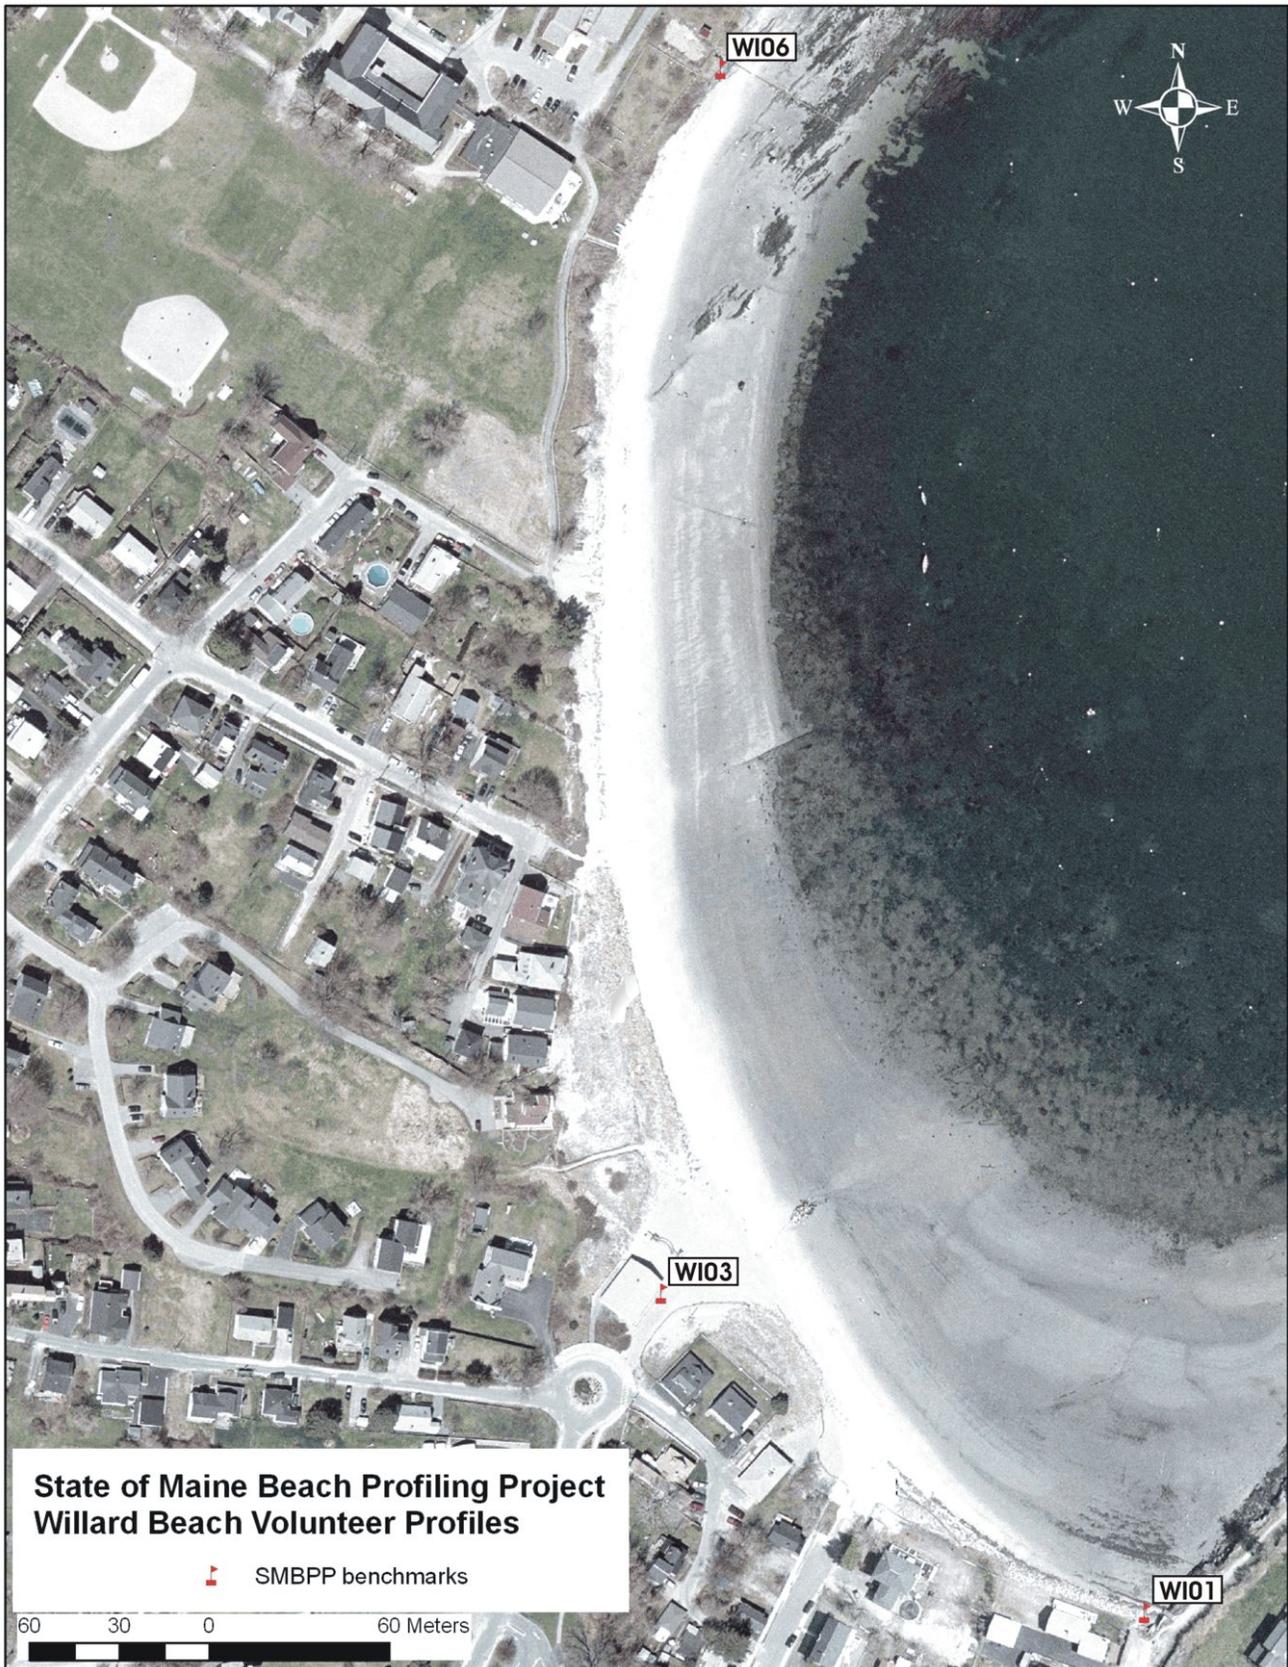
Figure 4. Location of beach profiles on Willard Beach, South Portland.

Three beach profiles (WI01, WI03, and WI06) were available for comparison of post-Patriots' Day Storm recovery (Figure 4). The closest dates to the preferred dates where data were available were November 11, 2006, April 20, 2007, April 11, 2008, and March 10, 2009.

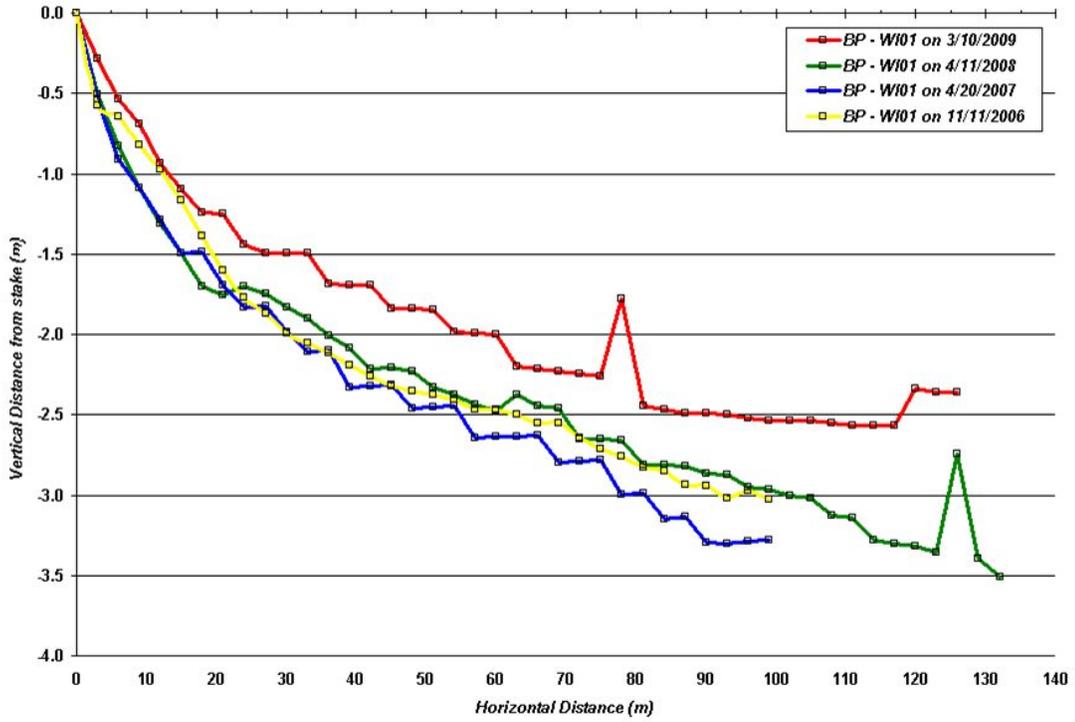
Prior to the Patriots' Day event, WI01 (Figure 5) exhibited a developed berm, which is apparent in the profile from 3 to 24 m from the pin; this then led to a flatter intertidal portion of the profile. This profile is located at the southeastern end of Willard Beach and is adjacent to a seawall and concrete ramp. After the storm, the profile responded with extensive loss of the berm, and loss of sand into the offshore portion of the profile. Note the wavy appearance of the lower portion of the profile – from about 30 m from the pin seaward. This could represent dispersed sand waves that are in the subaerial portion of the profile, and actually indicate some beach recovery. By one year post-storm, the mid to lower portions of the profile have fully recovered to pre-storm conditions, with just a slight gain in elevation above the November 2006 profile. The berm which existed pre-storm has still not recovered. However, by March 2009, the berm and entire profile exhibits excellent recovery, with a sand elevation that is approximately 0.5 m (1.6 feet) above the immediate, post-storm profile. This represents excellent recovery. We are not clear what the large anomalous elevation rises present in the 2008 and 2009 profiles represent.

Figure 5. Beach profiles from Willard Beach profile line WI01.

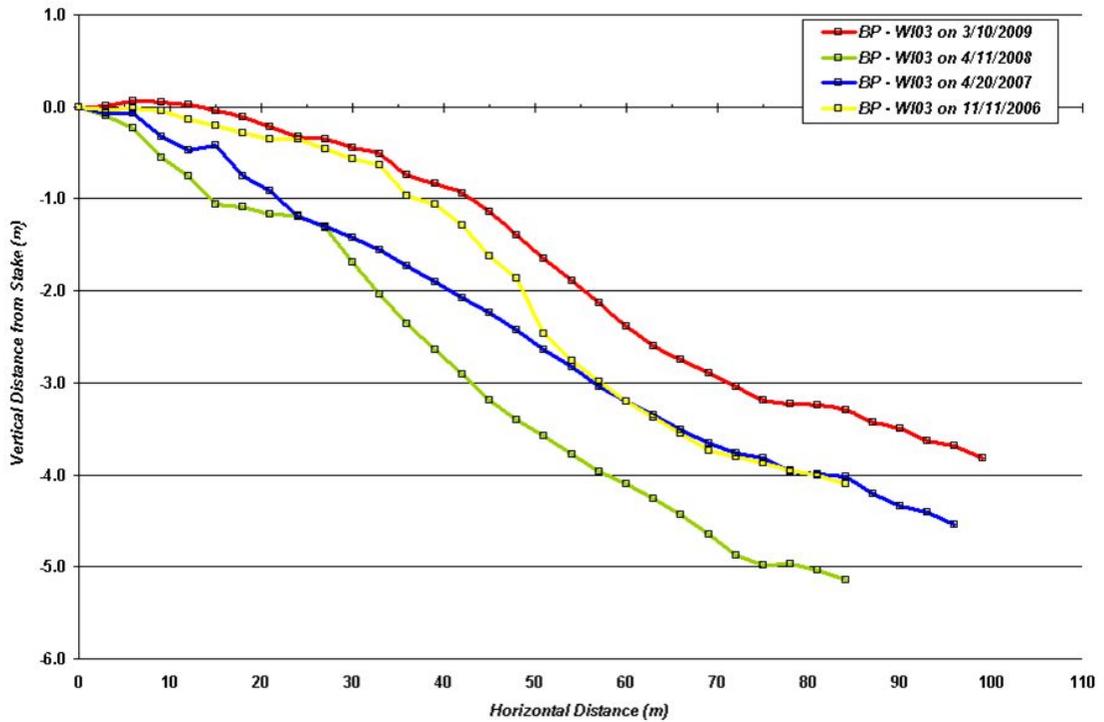
WI03 (Figure 6) exhibited a very large, well defined berm extending to about 55 m from the pin, prior to the storm. This profile is located across the large berm near the jungle gym at the center of the beach. The post-storm profile showed dramatic erosion and lowering of the entire volume of sand in the berm out to 55 m; seaward of this, there was very little change in the pro-

file shape. Interestingly, the one year post-storm profile from April 2008 exhibited an even leaner profile, with loss of additional volume across the entire profile. Surprisingly, however, by March 2009, the profile had recovered fully, and actually gained elevation along its entire length as compared to the pre-storm profile. This profile exhibited dramatic recovery from the storm within the two-year period.

Figure 6. Beach profiles from Willard Beach profile line WI03.

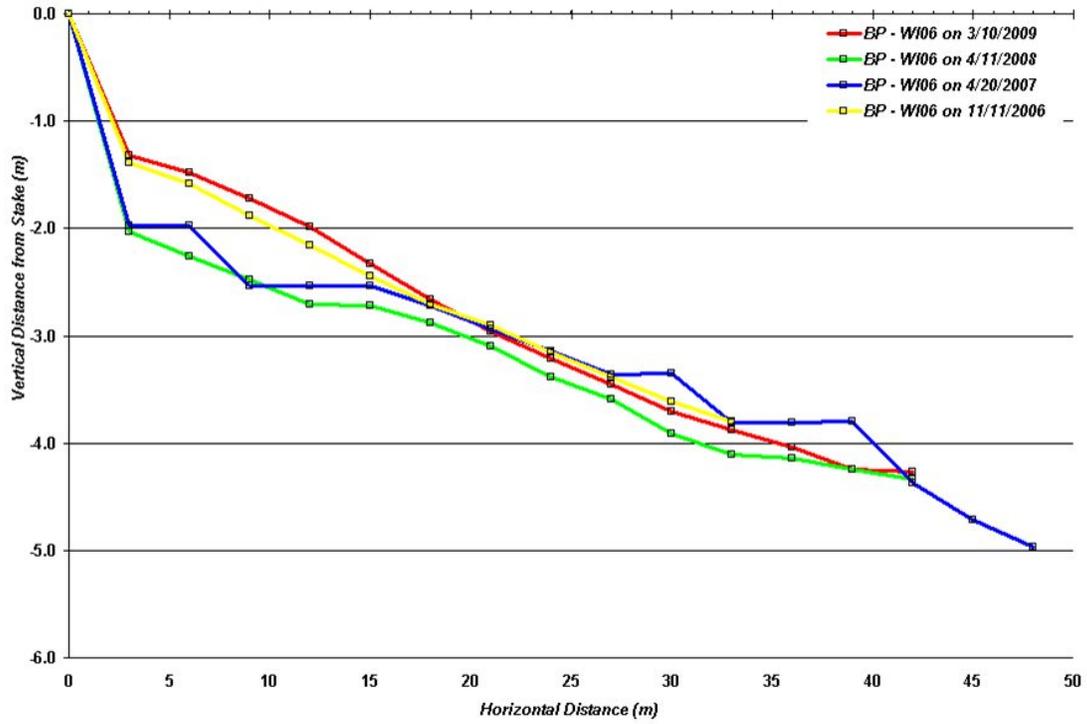
WI06 (Figure 7), located adjacent to the rock ledge at the northwestern end of the beach, showed a very steep upper section down to about 1.2 m below the pin, then flattened into the offshore. The post-storm profile showed a deepening of the sand elevation below the rock ledge starting point – by about 0.8 m (down to 2 m below the pin), and showed additional volumetric loss along the profile out to about 17 m. Seaward of this, the pre- and post-storm profiles appeared similar until the offshore, where several large bars were apparent. By the one-year post-storm mark, the profile overall appears very similar, with slight additional loss along the profile length. However, consistent with the other profiles, by March 2009, large gains of sand led to profile elevations very similar to the 2006 pre-storm profile shape, with slightly more sediment in the upper portion of the profile than the offshore.

Figure 7. Beach profiles from Willard Beach profile line WI06.

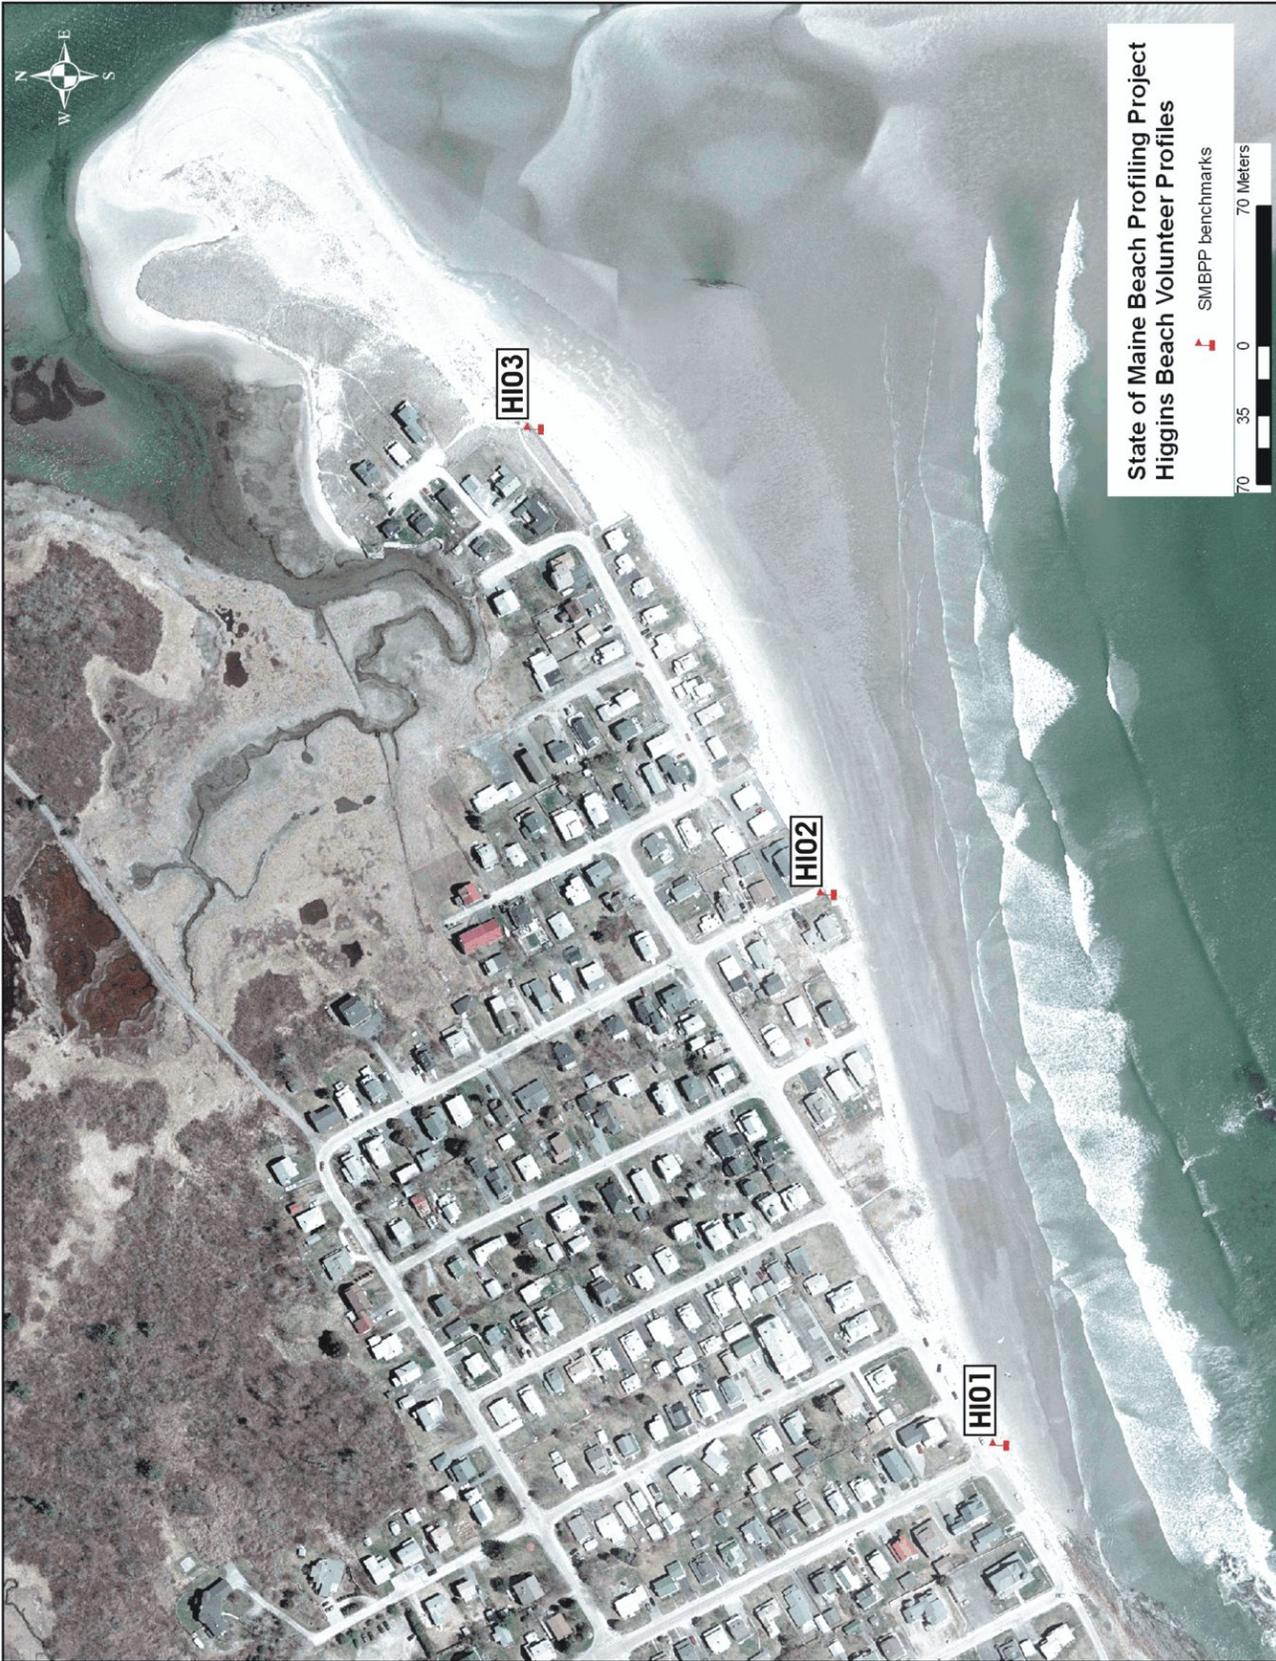
Figure 8. Location of beach profiles on Higgins Beach, Scarborough.

Three beach profiles (HI01, HI02, and HI03, Figure 8) were available for comparison of Patriots' Day Storm impacts and recovery. Beach profile data were available from April 2, 2006, April 22, 2007 (immediately post-storm), April 11, 2008, and April 5, 2009.

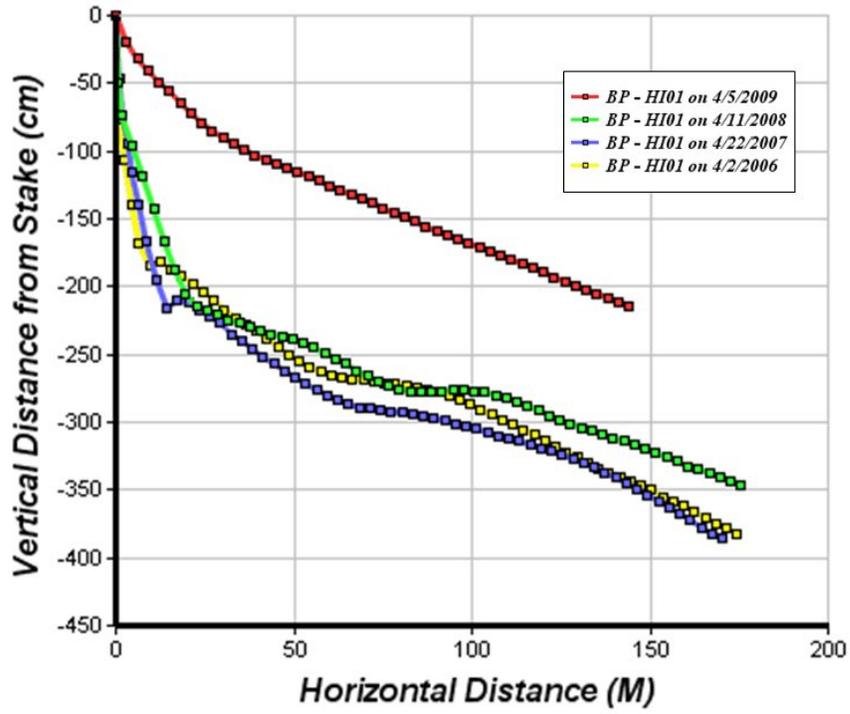
Profile HI01 (Figure 9), which was located along the seawall at the end of Ocean Avenue, underwent clear erosion – especially from about 175 cm below the starting pin, or roughly 10 m seaward of the pin. Sediment was lost along this entire seaward length of profile, and the berm that was somewhat apparent in the April 2006 profile was completely eroded by the Patriots' Day Storm. By 2008, the profile showed marked recovery from April 2007, with large gains in sediment along the uppermost portion of the profile, and at the 50 m mark and seaward of the 100 m mark. Recovery from the Patriots' Day Storm event seems to have occurred within one year, with the profile actually slightly exceeding the pre-storm shape. Unfortunately, it is impossible to compare the profiles between 2008 and 2009 since the seawall where the pin was located was reconstructed.

Figure 9. Beach profiles from Higgins Beach profile line HI01.

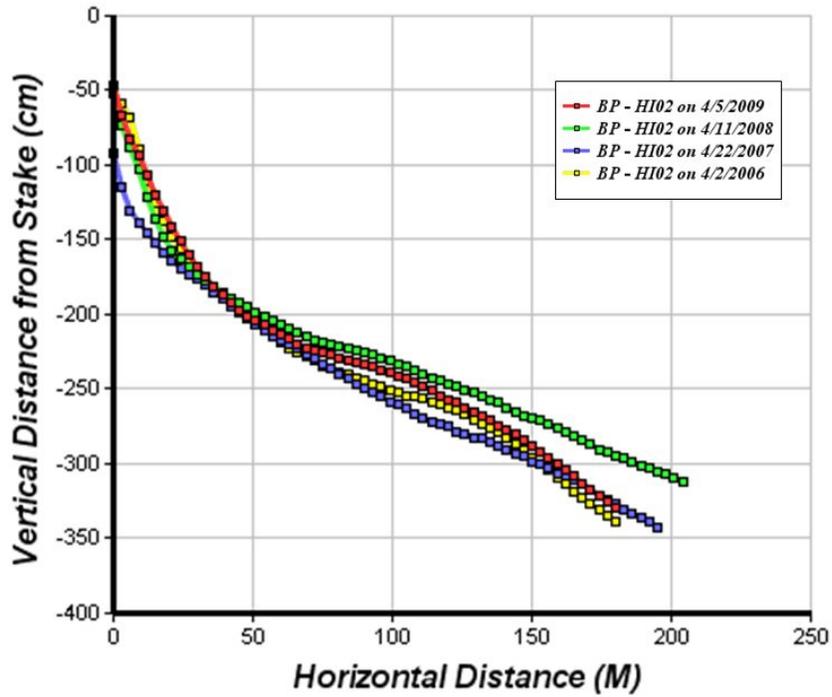
Profile HI02 (Figure 10), located along the middle of Higgins Beach, lost a berm and sediment in the offshore, resulting in a post-storm Patriots' Day Storm profile that was low in elevation and flat. However, within one year, the profile appears to have responded very well, with growth back to pre-storm elevations in the upper portion, and elevation gains in the offshore portion of the profile. By 2009, the profile seems to have achieved a shape very similar to the 2006 pre-storm shape, with a slight increase in elevation in the offshore.

Figure 10. Beach profiles from Higgins Beach profile line HI02.

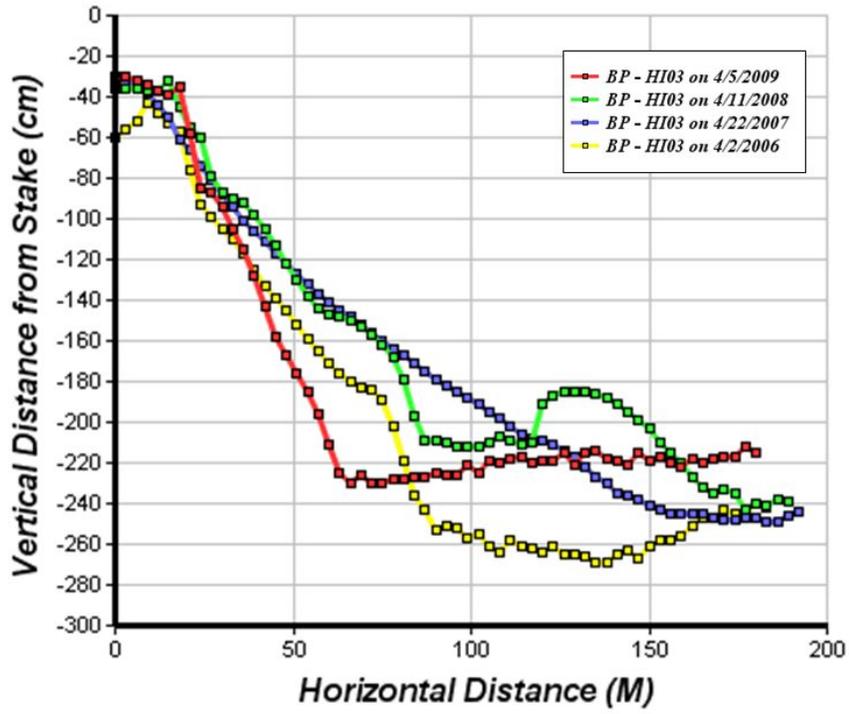
Profile HI03 (Figure 11), located at the Spurwink River, clearly displays the influence of the Spurwink River on trapping sediment moving in an easterly-directed longshore drift. The 2006, pre-storm profile was actually significantly lower than the immediate post-storm profile from 2007. It appears that large amounts of sediment – potentially sourced from loss that occurred within the upper portions of the profile or other areas of the beach (or both) – were deposited along the profile as a result of the storm. The 2008 profile showed additional dune and beach berm building, along with a large offshore bar. However, the 2009 beach profile showed significant loss of sediment along the profile, especially starting near the -60 cm elevation, though there was additional seaward growth of the dune. This profile is highly variable because of its proximity to the Spurwink River, whose channel migrates rapidly. This profile underwent accretion immediately after the Patriots' Day Storm, and its offshore portions have been losing sediment since the storm; however, the upper portion (berm and dune) have been growing seaward, indicating recovery and stability. If we base the grade on the upper portion of the profile, it would be given a B; if we base it on the offshore portion of the profile, which has been losing sediment since the Patriots' Day Storm, it would receive an F. However, because of the variability and influence of the river, we assign HI03 a C, because it is clear that the storm actually positively influenced the offshore portion of the profile, and the upper portion has recovered in a satisfactory way.

Figure 11. Beach profiles from Higgins Beach profile line HI03.

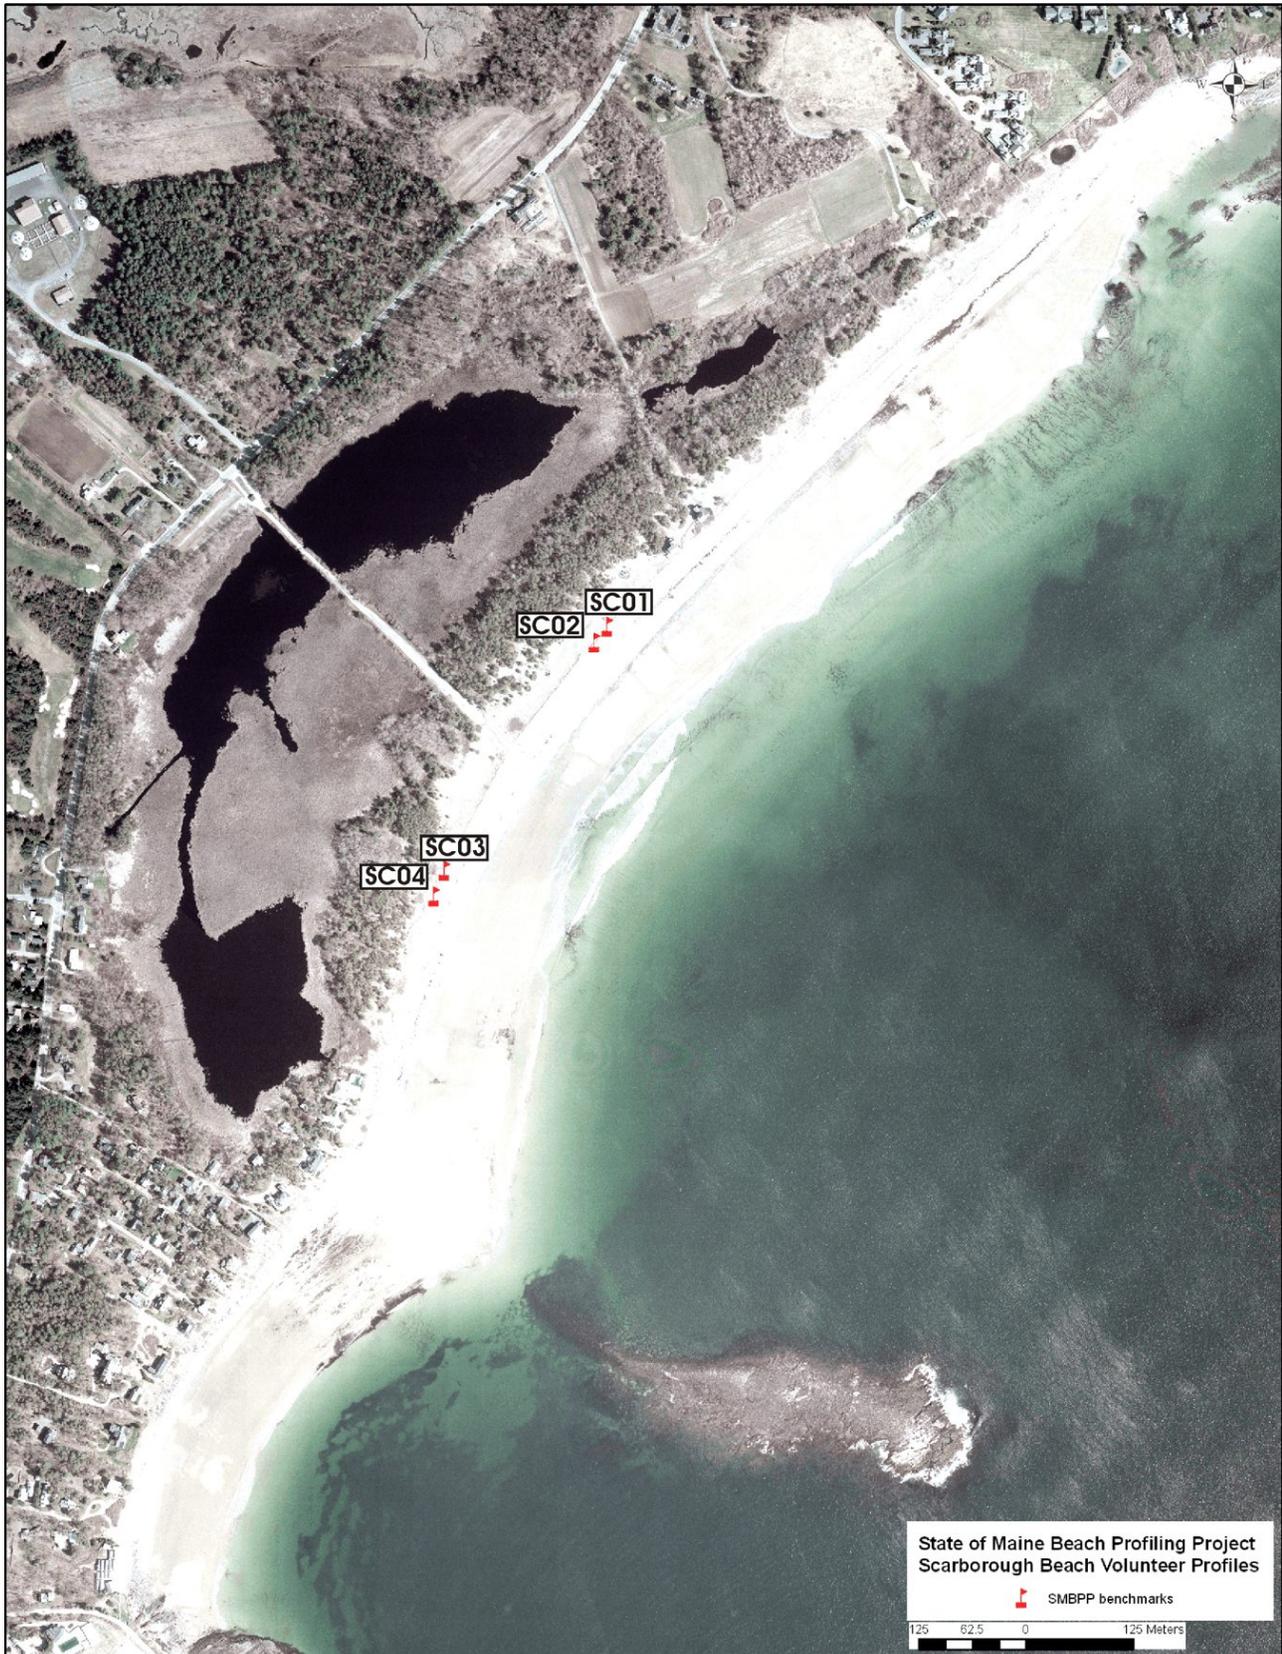
Figure 12. Location of beach profiles on Scarborough Beach, Scarborough.

Four beach profiles (SC01 to SC04, Figure 12) were available for comparison of pre-storm profile shape and post-Patriots' Day Storm impacts. Stakes at SC02-SC03 were lost after the Patriots' Day Storm and relocated in the approximate area of the previous stakes. Beach profile data were available from April 3, 2006, April 21 and 24, 2007 (immediately post-storm), April 14, 2008, and May 3, 2009.

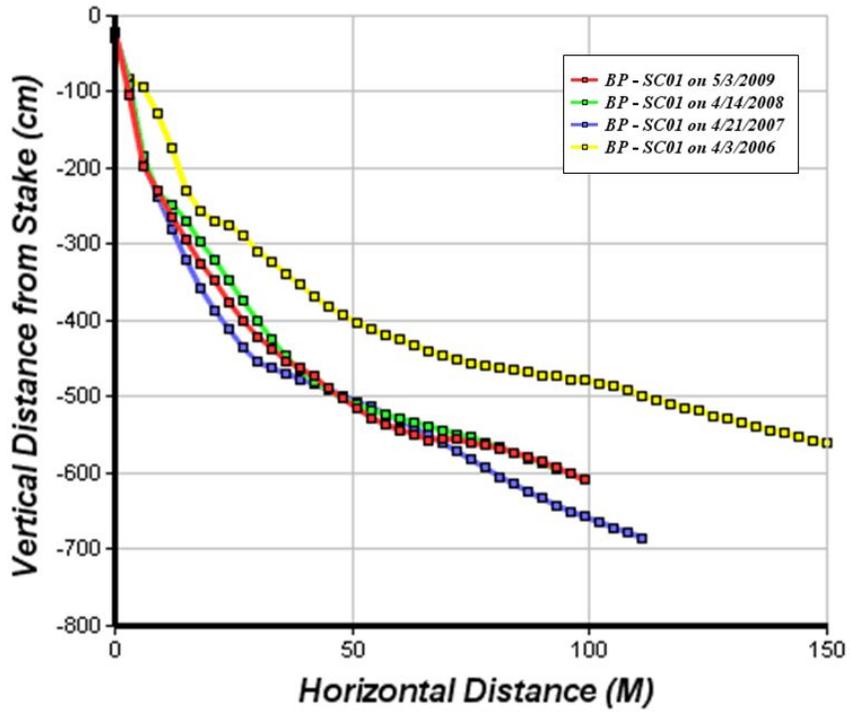
The pre-storm profile at SC01 (Figure 13) was dramatically impacted by the Patriots' Day Storm, with the post-storm profile exhibiting the loss of approximately 1 m of sediment along the profile, from about 25 m along the profile in a seaward direction. The loss of volume along the profile was astounding – review of data sheets indicates that the starting pin for SC01 was not lost in the storm. By 2008, the beach profile had gained slight sediment along its length, mostly at the berm. The 2009 profile indicated some loss from the slight recovery that occurred in 2008. Although the profile never neared the pre-storm shape in terms of recovery, it did show some stability and slight recovery from the storm.

Figure 13. Beach profiles from Scarborough Beach profile line SC01.

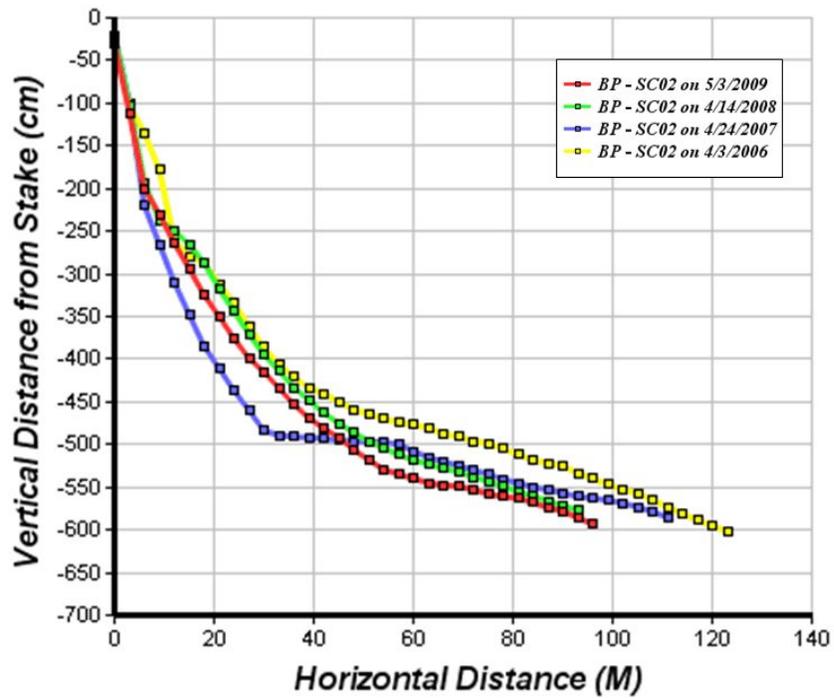
Profile SC02 (Figure 14) lost between 25-50 cm of sediment along its length, based on comparison between the pre- and post-storm profiles from 2006 and 2007, especially in the offshore portion of the profile. Recovery was noted along the upper portion of the profile – between 10 and 50 m from the pin in 2008 (berm), though the offshore portion underwent little change. The upper portion of the 2008 profile matches that of the 2006 pre-storm profile, but there is less recovery in the offshore. Notes from the volunteers state that the pin was lost in 2009 and reset in May 2009, so it is difficult to use the 2009 data for comparison. However, it appears that the profile underwent some additional loss between 2008 and 2009. The profile did recover

in its nearshore portion, out to about 40 m; seaward of this, additional loss has occurred.

Figure 14. Beach profiles from Scarborough Beach profile line SC02.

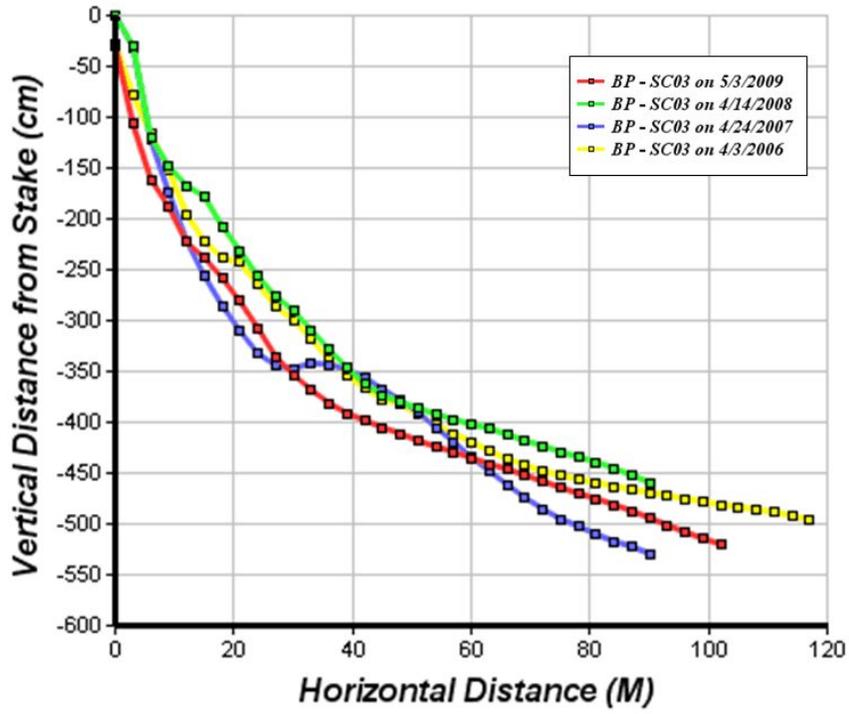
According to volunteer notes, the profile starting pin at SC03 (Figure 15) was lost during the Patriots' Day Storm. The pre-storm 2006 profile, which was slightly concave, was eroded along its nearshore and offshore portions, with the formation of a bar immediately post-storm. A new pin position was located in March 2008 – this is likely the cause of the dramatic difference in the starting point elevation from the post-storm 2007 profile and the 2008 profile. The May 2009 profile has an erosive shape, and actually shows additional erosion below the immediate post-storm profile at several locations. Based on this data, SC03 is showing some signs of recovery.

Figure 15. Beach profiles from Scarborough Beach profile line SC03.

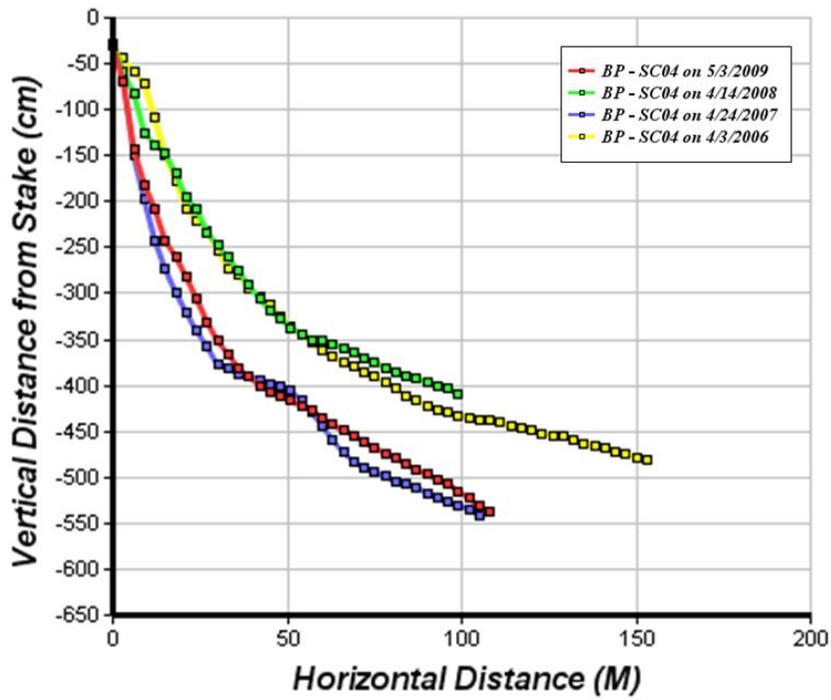
SC04 (Figure 16) lost incredible amounts of sediment and elevation along its length in response to the storm – close to a full meter. The profile dramatically recovered by 2008 to near pre-storm conditions, even maintaining a similar overall shape to the pre-storm profile. However, by 2009, the profile had been eroded back to near the post-storm 2007 shape. This was likely due to a series of storms in mid April and early May 2009. The dramatic variation in shape may indicate SC04's response to storm events. Recovery has occurred slightly, but the highly variable nature gives this site a conditional grade of C.

Figure 16. Beach profiles from Scarborough Beach profile line SC04.

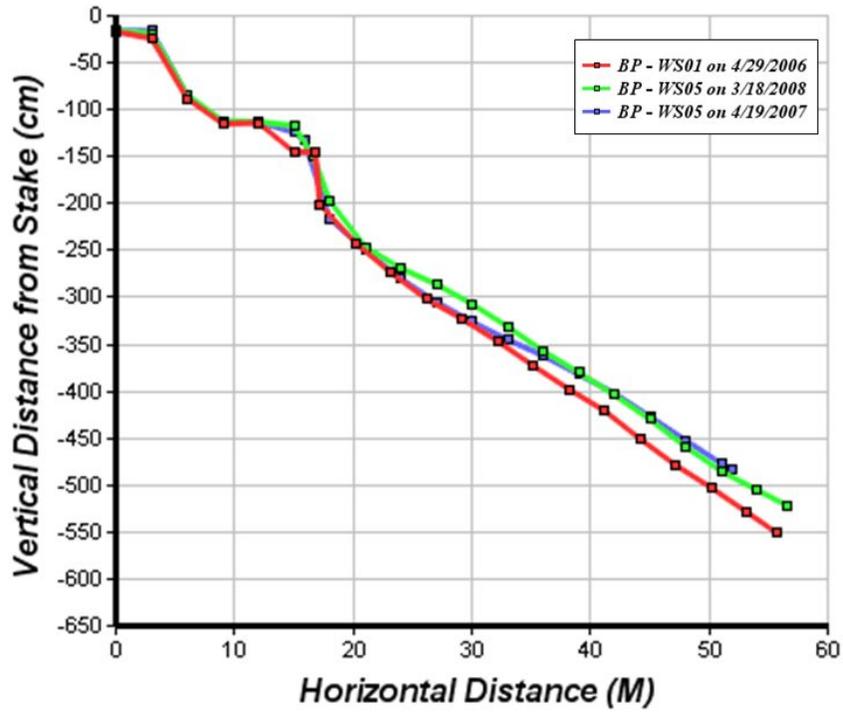
WS01/05 is located along Ferry Beach (Figure 18), which is sheltered and along the Scarborough River. The 2006 profile underwent minimal changes as a result of the storm. In fact, it appears that lower portions of the profile actually gained elevation immediately post-storm. By 2008, some additional elevation gain was noted.

Figure 18. Beach profiles from Western Beach profile line WS01 (WS05).

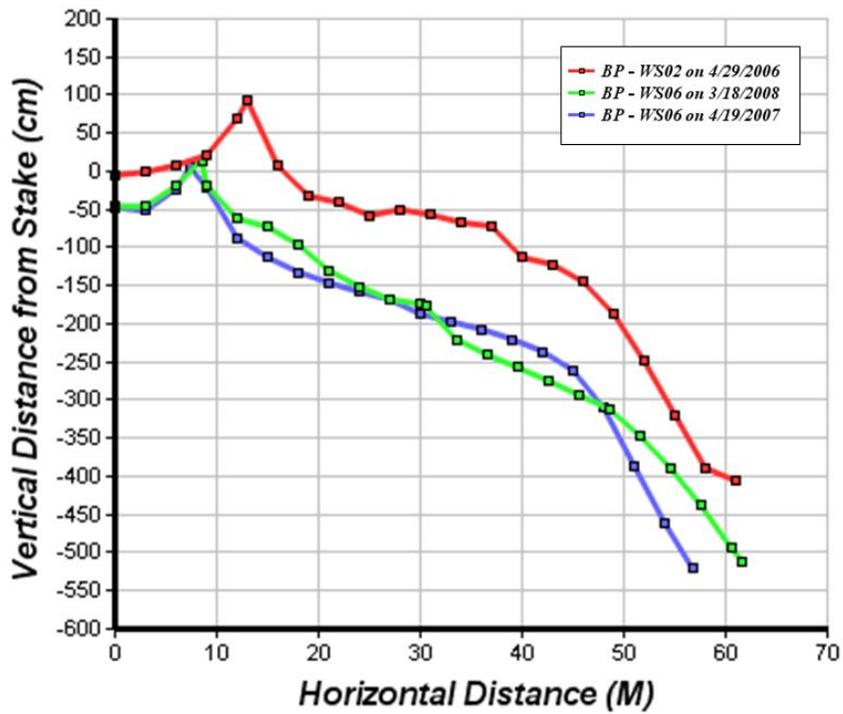
WS02/06 is also located in a sheltered area (Figure 19). The pre-storm profile, which is from April 2006, was positively impacted by the Patriots' Day Storm. The profile gained elevation along its entire length, especially between the 35-55 m marks. It also gained elevation at the dune crest. In 2008, the upper portion of the profile –from about 30 m and landward – con-

tinued to gain elevation, including the dune crest. However, the offshore portion of the profile lost some elevation.

Figure 19. Beach profiles from Western Beach profile line WS02 (WS06).

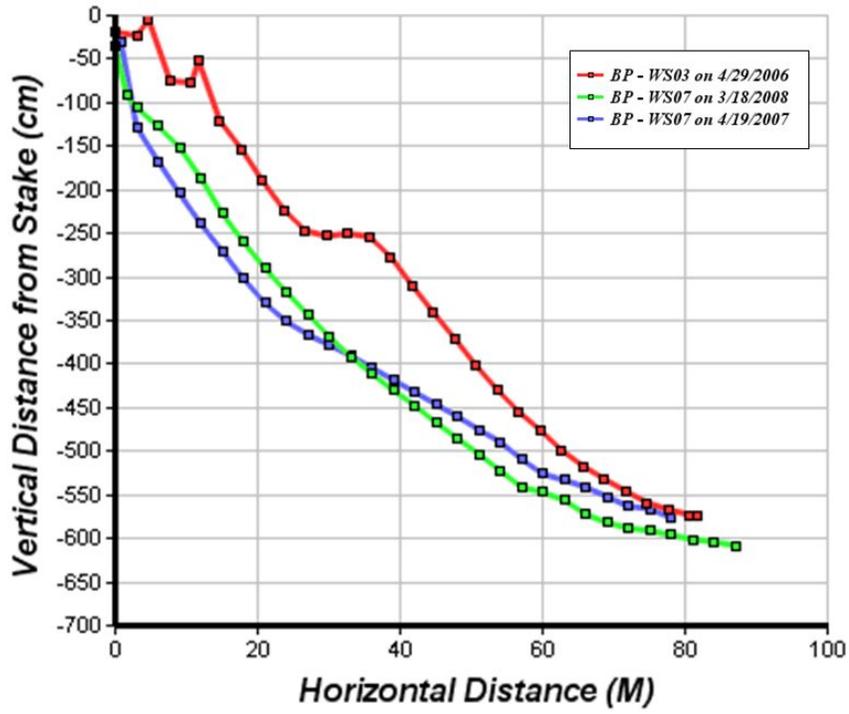
At WS03, which is located on the more exposed Western Beach (Figure 20), the profile underwent large losses of sediment and subsequent elevation along its entire length. Large, well developed dunes were lost, as was a well defined berm (between about 25-35 m offshore). The post-storm profile was flat, and had few beach features. The 2008 profile showed some recovery, along the upper portion of the profile, landward from about the 25 m mark. Seaward of this, the profile had not recovered from the post-storm shape.

Figure 20. Beach profiles from Western Beach profile line WS03 (WS07).

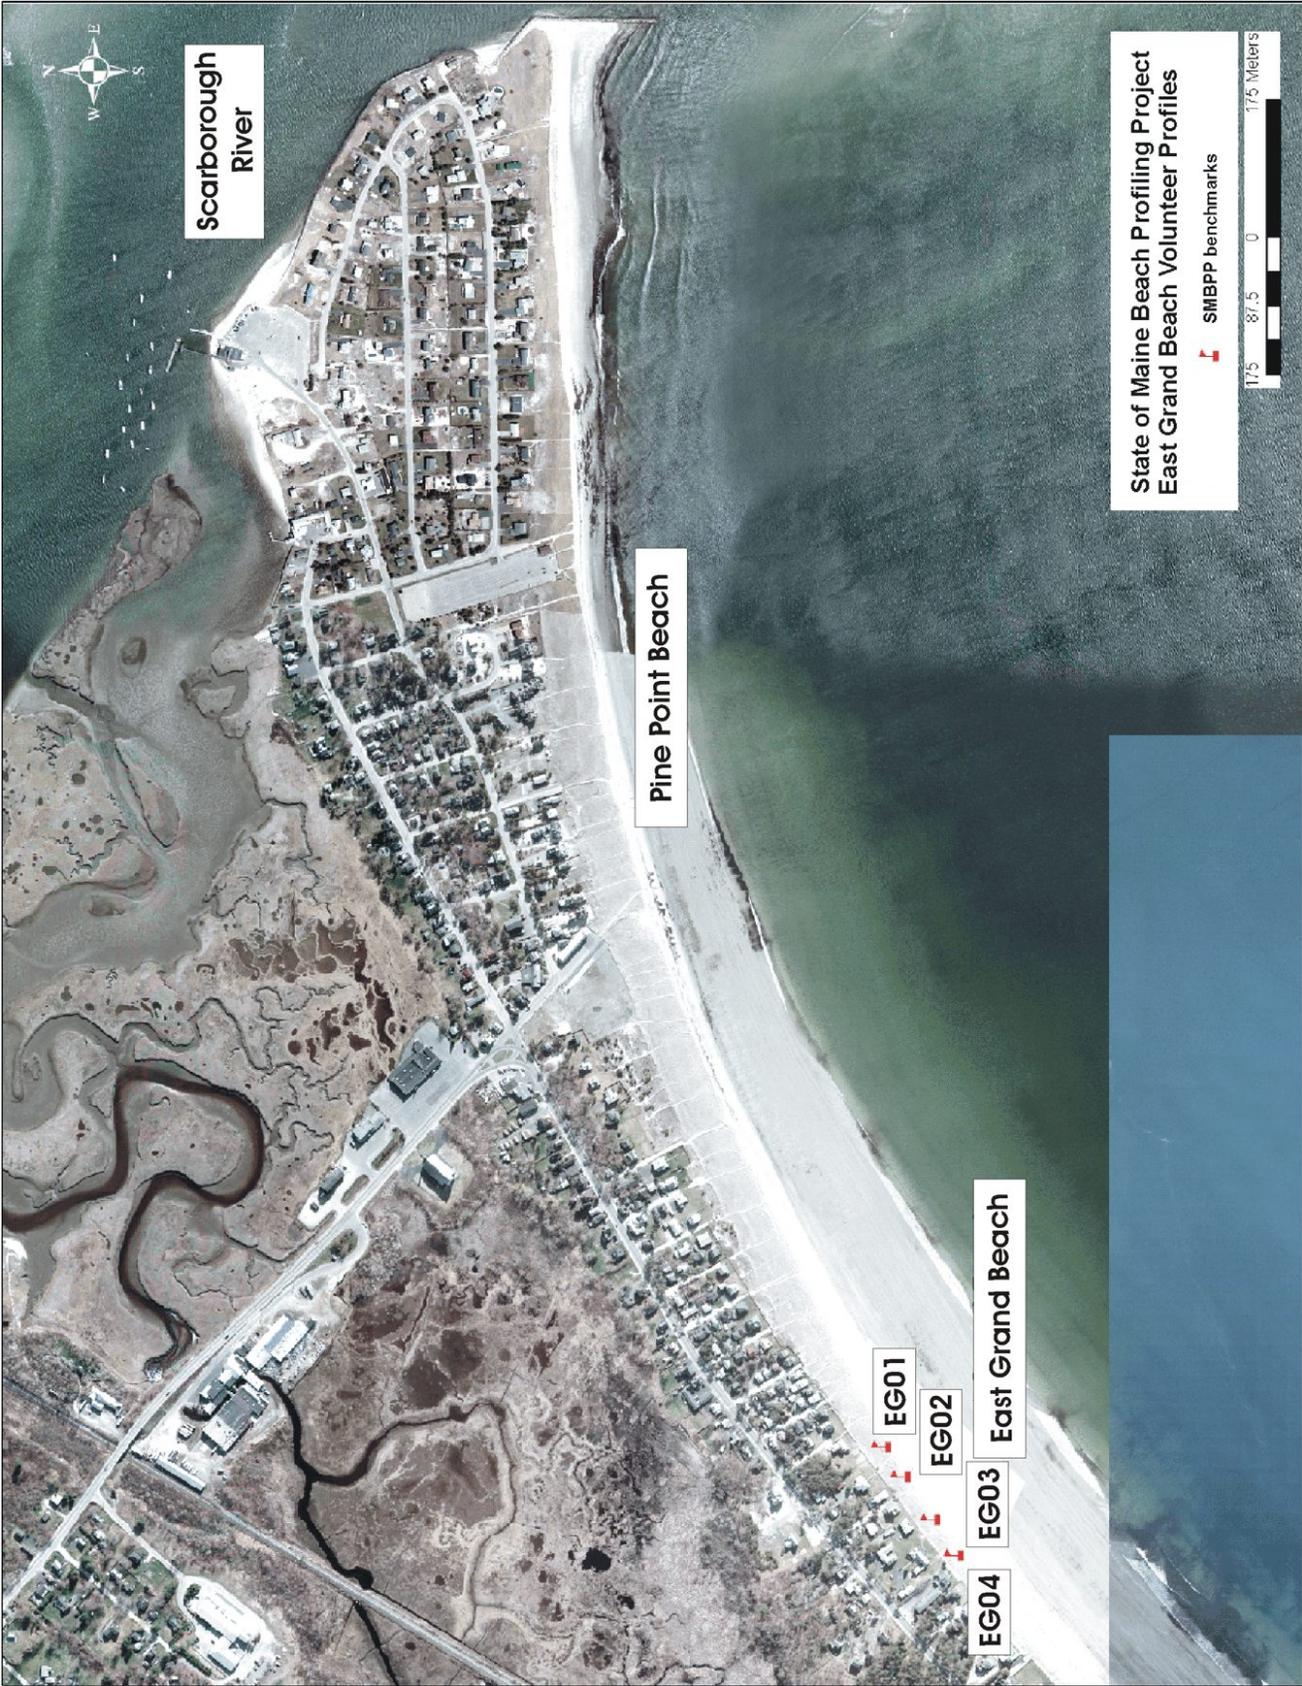
Figure 21. Location of beach profiles on East Grand Beach, Scarborough.

Four beach profiles (EG01 to EG04, Figure 21) were available for comparison of pre-storm profile shape and post-Patriots' Day Storm impacts. Volunteer notes indicate that the profiling stakes at all four locations were lost in the storm. New stakes were established in approximate previous locations. Beach profile data were available from April 14, 2006, April 21, 2007 (immediately post-storm), September 18, 2008, and April 5, 2009.

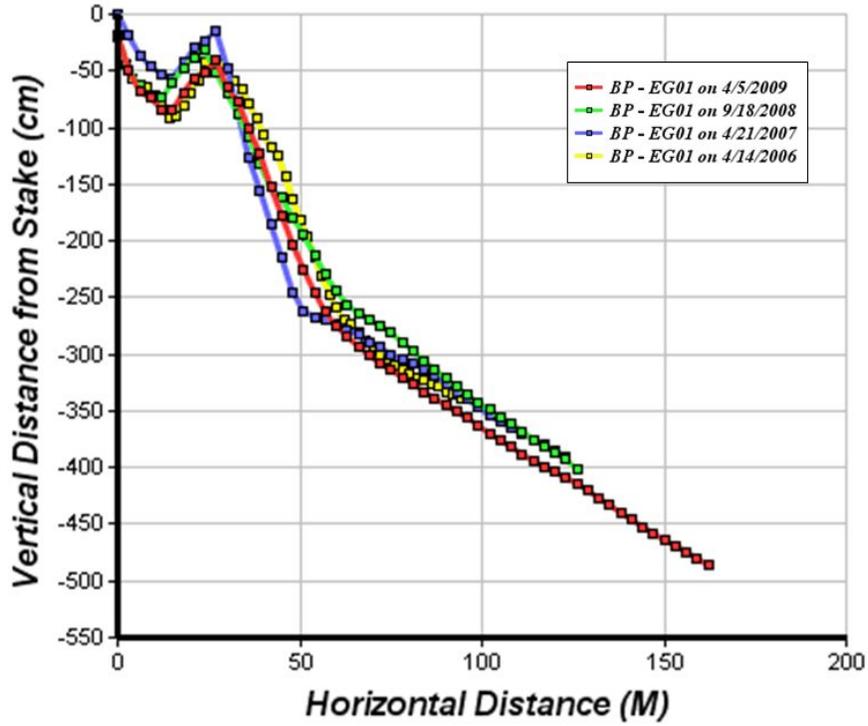
The pre-storm profile of EG01 (Figure 22) was eroded, and transgressed in a landward direction in response to the storm. The post-storm profile exhibited a higher dune crest (due to overwash), and a more landward and slightly steeper beach slope, with loss of sediment along the profile from about seaward of the 40 m mark. By 2008, it appears that the dune crest had further receded in a landward direction and lost some of its elevation. However, the middle and lower portions of the profile exhibited growth and elevation gains. Although the 2009 profile exhibited a slightly lower dune crest, it had grown (accreted) seaward slightly. The lower portion (seaward of 60 m) of the 2009 profile had slightly less elevation than the 2007 post-storm profile.

Figure 22. Beach profiles from East Grand Beach profile line EG01.
