# *State of Maine's Beaches in 2009*

**Open-File 09-57**

2009

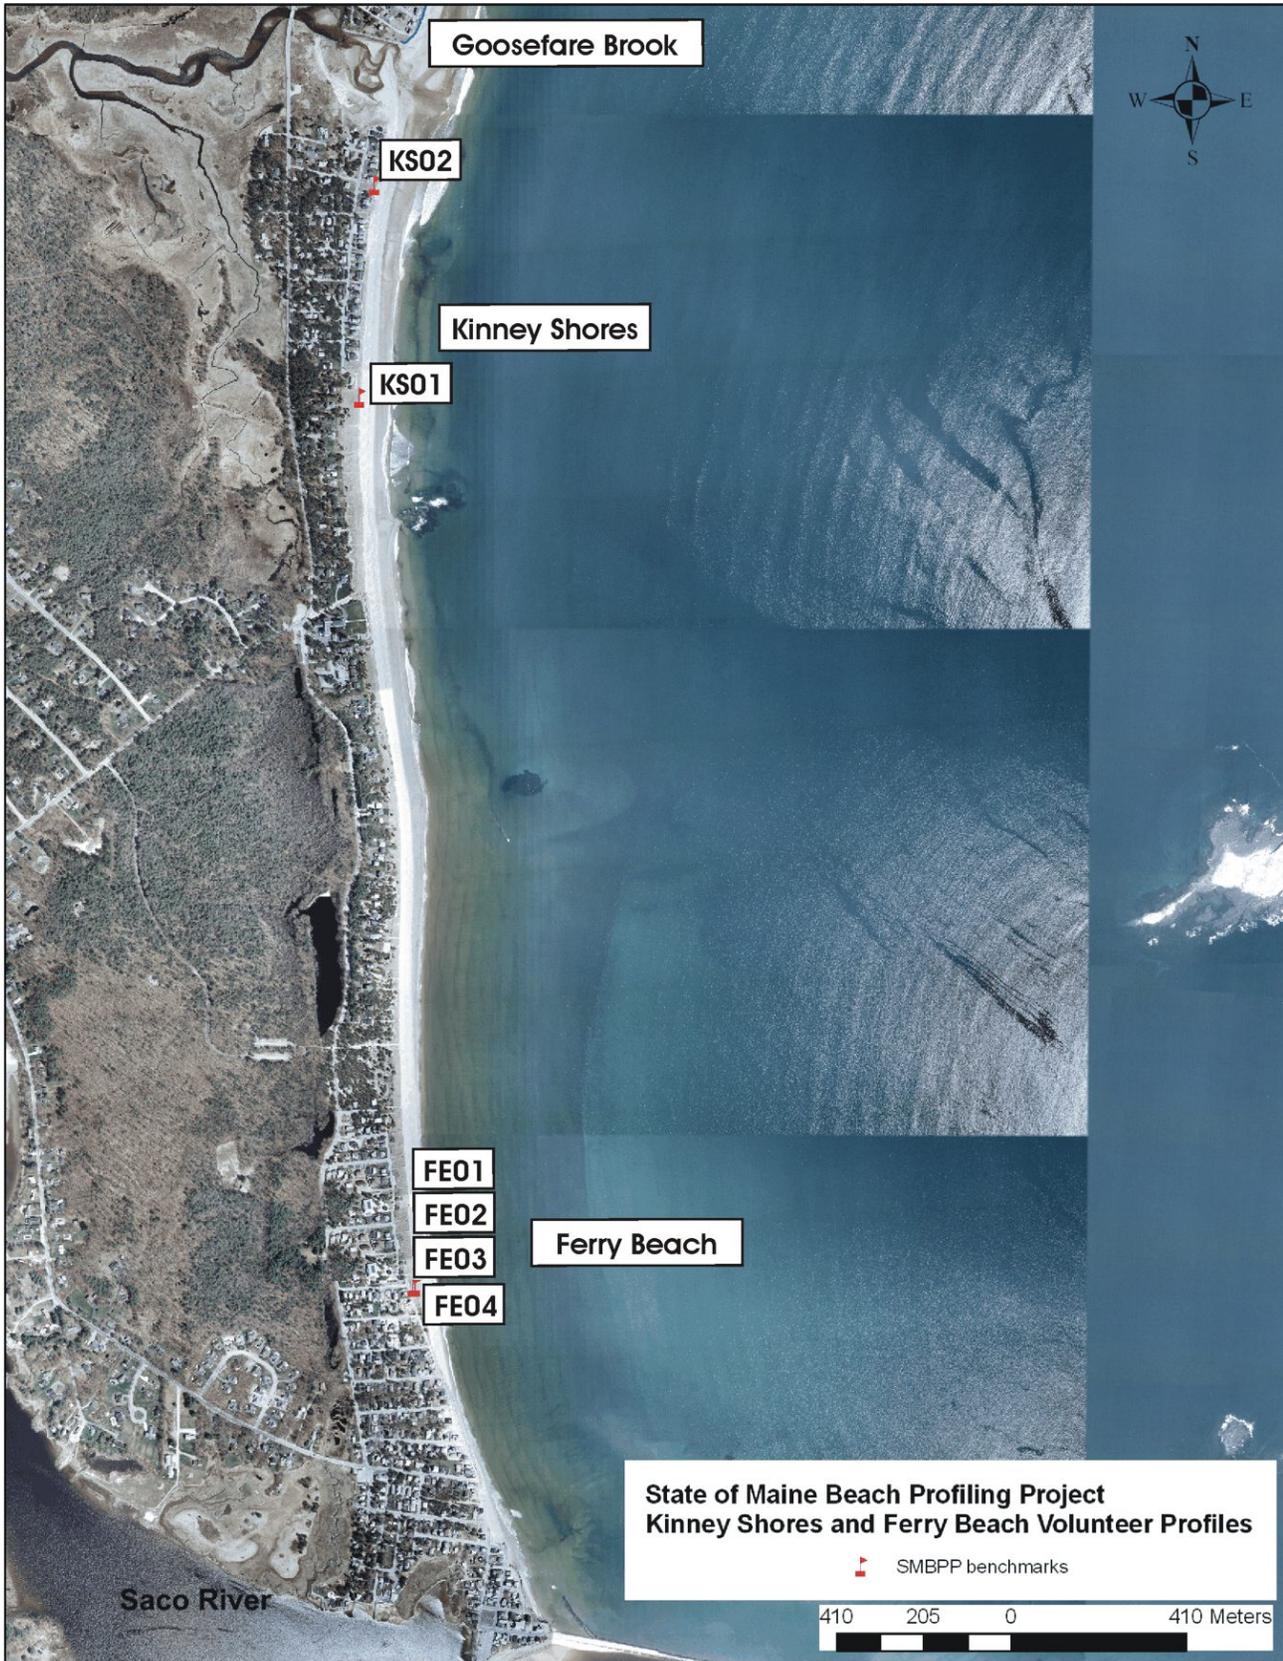
Figure 26. Location of beach profiles on Kinney Shores and Ferry Beach, Saco.

Two beach profiles (KS01, KS02, Figure 26) were available for comparison of pre-storm profile shape and post-Patriots' Day Storm impacts. Beach profile data were available from March 31, 2006, April 22, 2007 (immediately post-storm), March 6, 2008, and March 16, 2009.

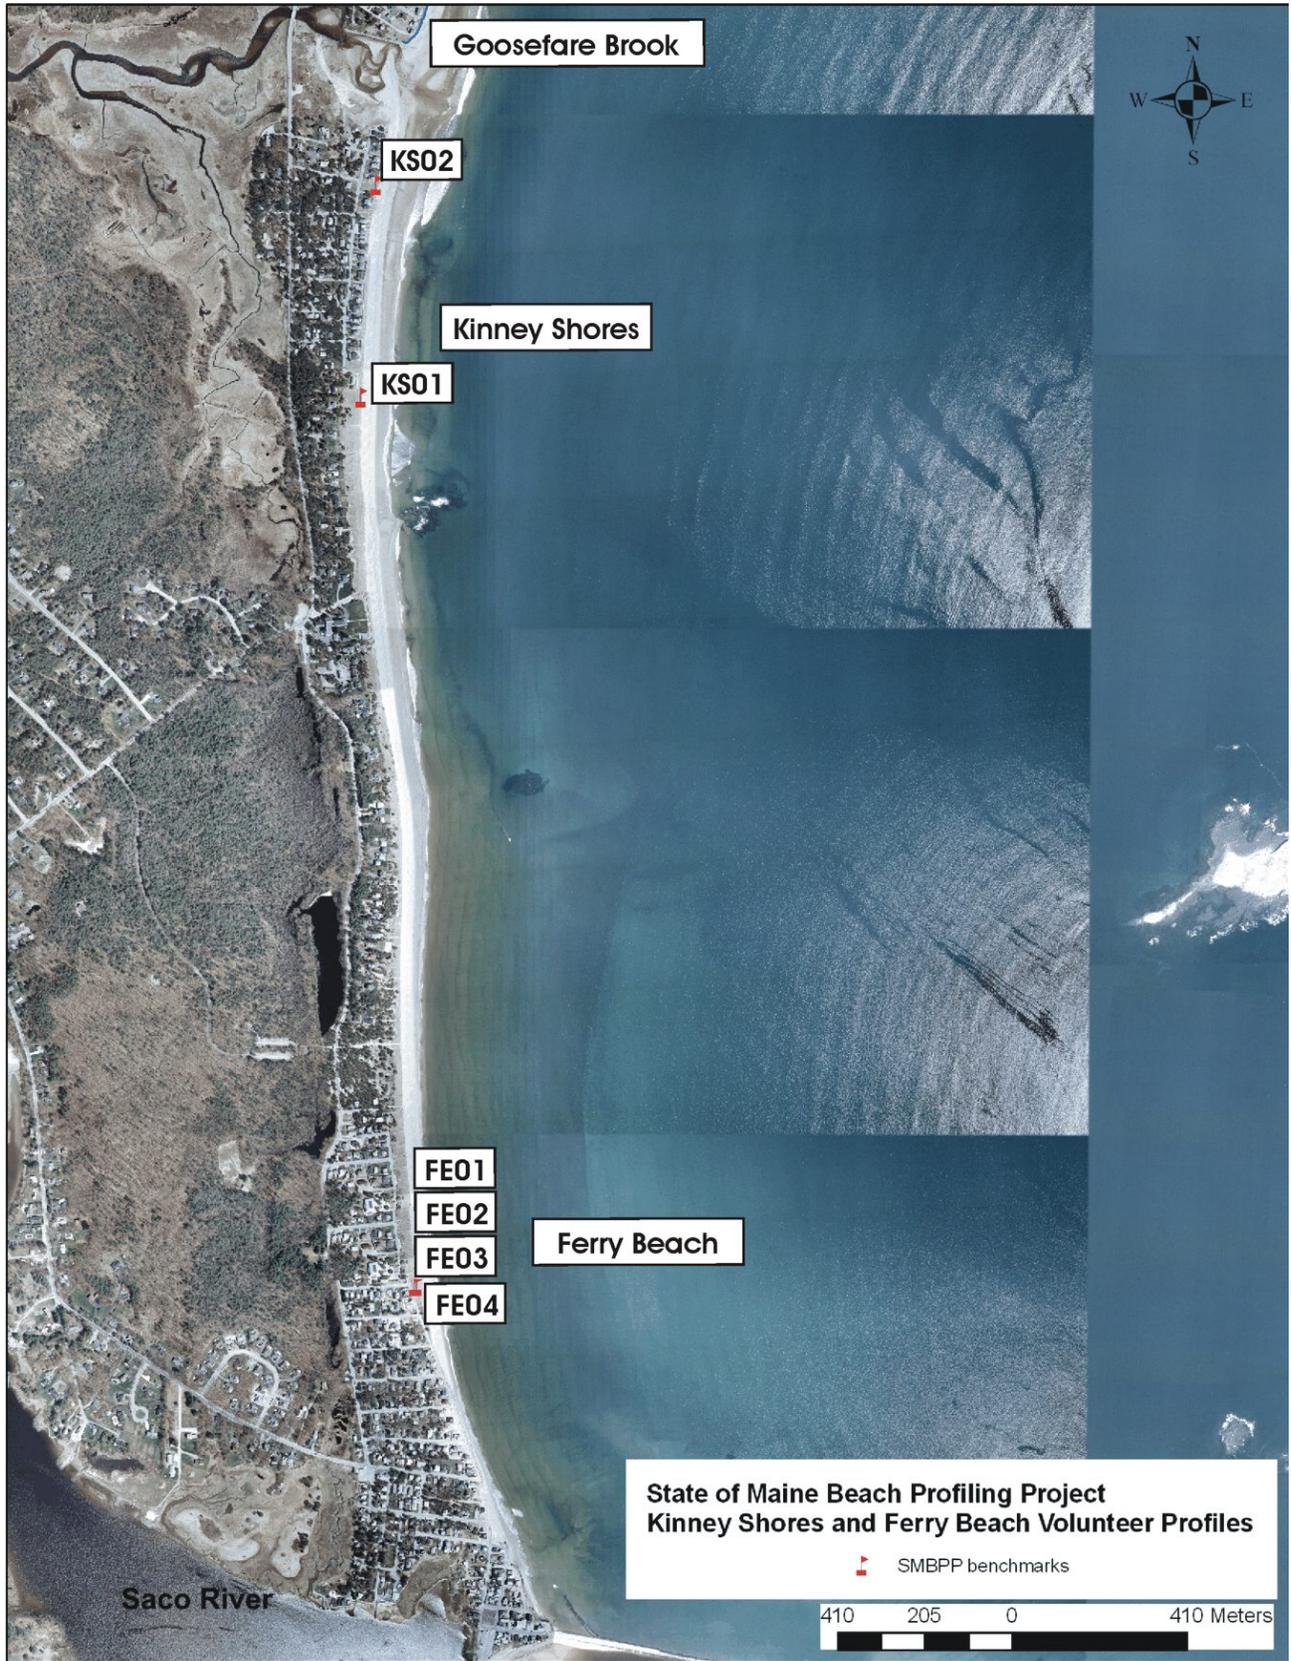
Figure 29. Location of beach profiles on Kinney Shores and Ferry Beach, Saco.

Four beach profiles (FE01 to FE04, Figure 29) were available for comparison of pre-storm profile shape and post-Patriots' Day Storm impacts. It is important to note that the front stake at FE04 was lost during the storm, and profiling was re-established at a back stake. Beach profile data were available from March 31, 2006, March 22 and April 20, 2007 (immediately post-storm), April 15, 2008, and May 1, 2009.

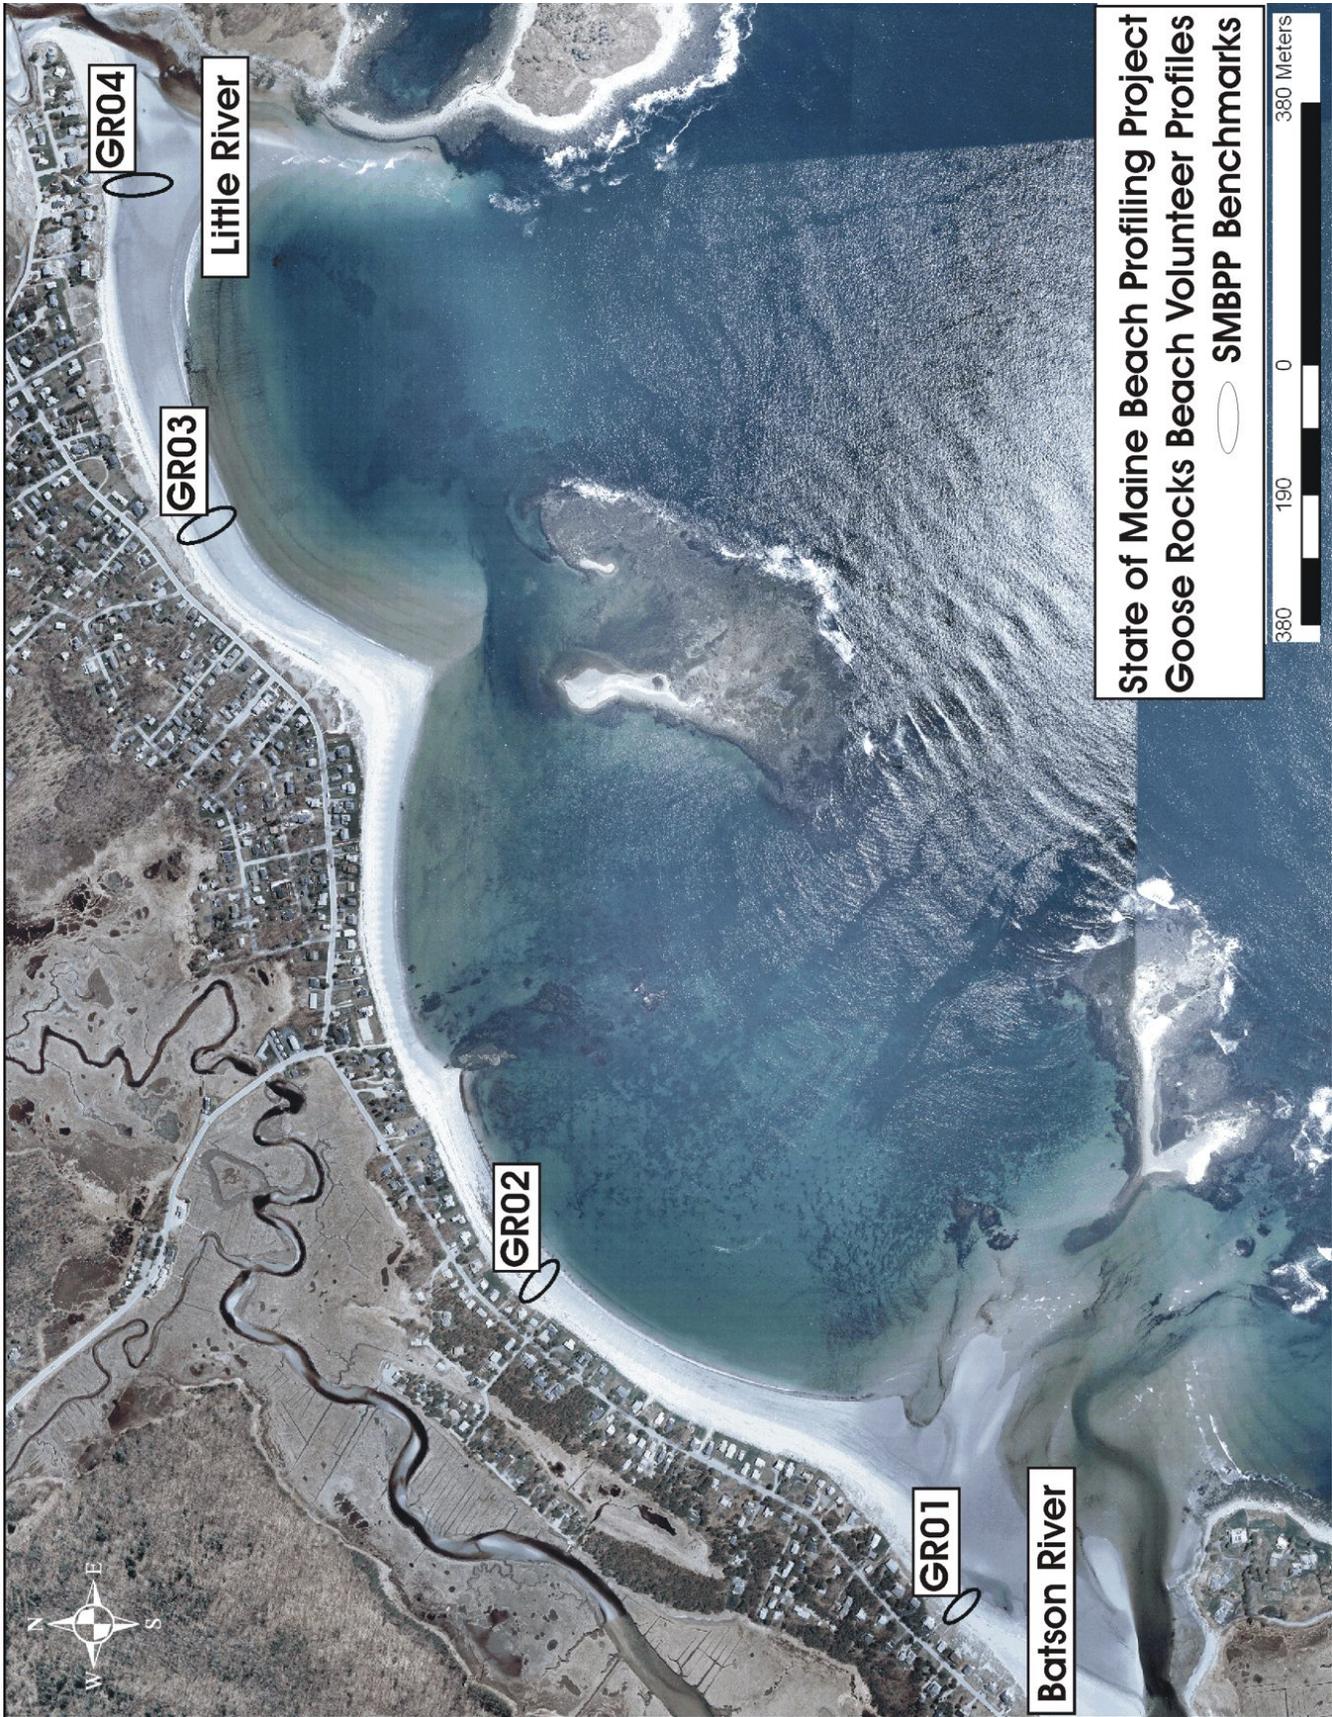
Figure 34. Location of beach profiles on Goose Rocks Beach, Kennebunkport.

Four beach profiles (GR01 to GR04, Figure 34) were available for comparison of pre-storm profile shape and post-Patriots' Day Storm impacts. It is important to note that all starting stakes were lost in the storm; however, new stakes were established by volunteers in *approximate* previous locations. Beach profile data were available from April 5 and 6, 2006, April 21 and 23, 2007 (immediately post-storm), April 14 and 15, 2008, and April 4 and 7, 2009.

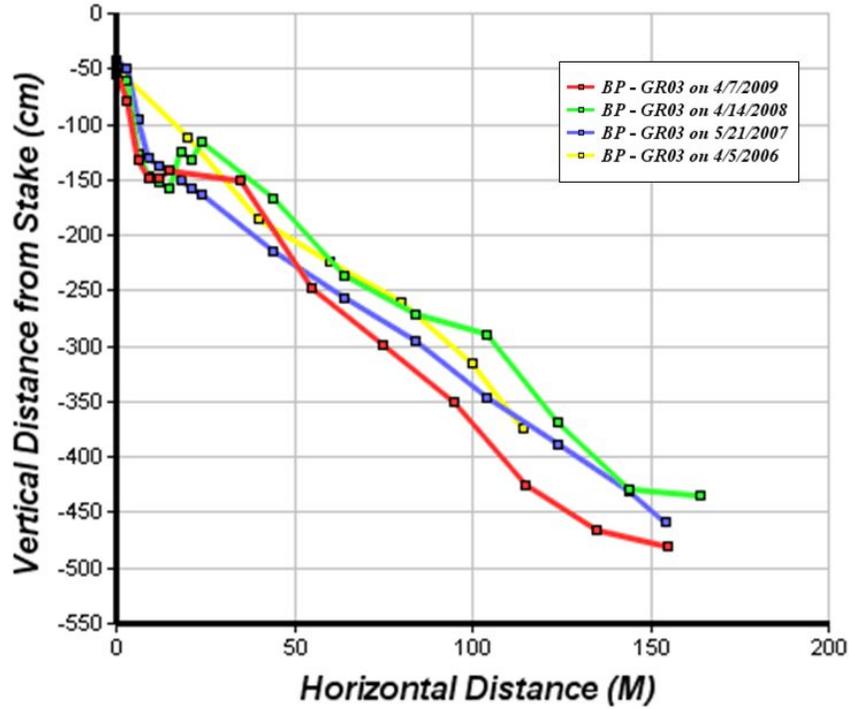
(Figure 37). Therefore, we used the May 21, 2007 profile data as our post-storm profile. The storm clearly eroded sediment from the profile along its length out to approximately 100 m offshore. Noted recovery occurred in 2008, with the profile developing a well-defined berm, and elevation increase along the length of the profile. However, the profile was eroded by April 2009. A high berm remained, but the offshore portion of the profile was at elevations below the 2007 post-storm profile. This may be due to an early April 2009 storm. Based on 2008 recovery, we would give GR03 an A, but based on the 2009 profile, it would receive a C-, as this kind of response suggests that the profile is now vulnerable to additional storm events.

Figure 37. Beach profiles from Goose Rocks Beach profile line GR03.

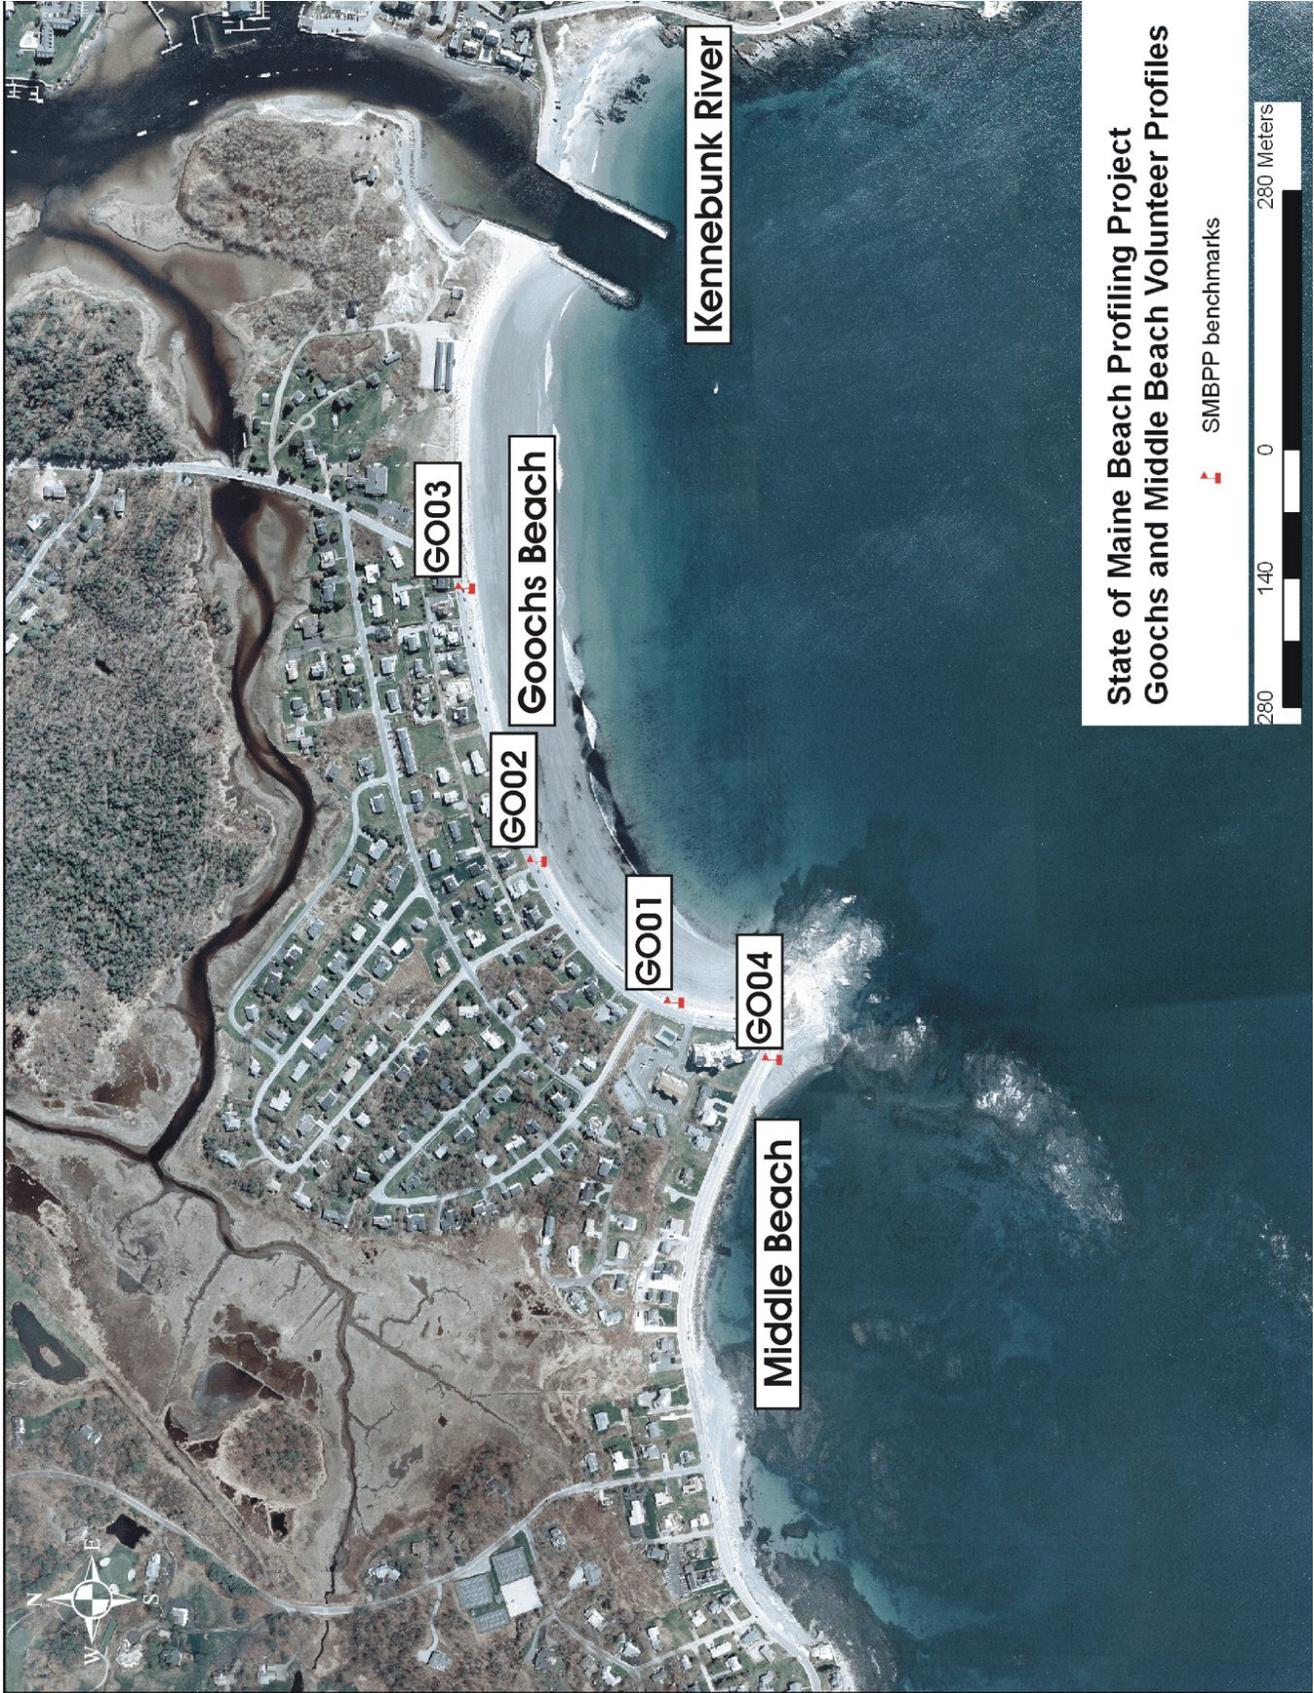
Figure 39. Location of beach profiles on Goochs Beach and Middle Beach, Kennebunk.

Three of four beach profiles (GO02 to GO04, Figure 39) were available for comparison of pre-storm profile shape and post-Patriots' Day Storm impacts. Profile GO01 was lost during the storm, and profiling was not resumed until June 2007 at this point – for this point, we use the June 2007 profile for comparison. Beach profile data were available from April 1, 2006, April 22 and June 25, 2007 (immediately post-storm), April 13, 2008, and April 4, 2009.

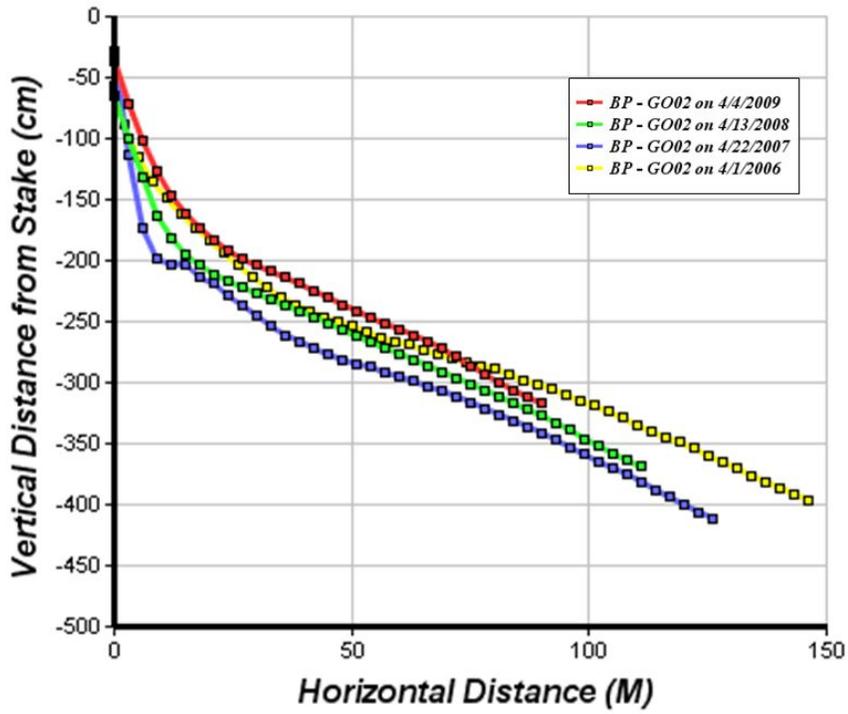
At GO02, which is somewhat centrally located along the beach, it is clear that the storm led to dramatic loss of sediment along the entire profile (Figure 41). The 2006 beach profile was flattened and sediment lost from the entire profile. However, by 2008, good recovery from the storm was noted, though it did not reach the pre-storm conditions. By 2009, the beach appeared to have fully recovered.

Figure 41. Beach profiles from Goochs Beach profile line GO02.

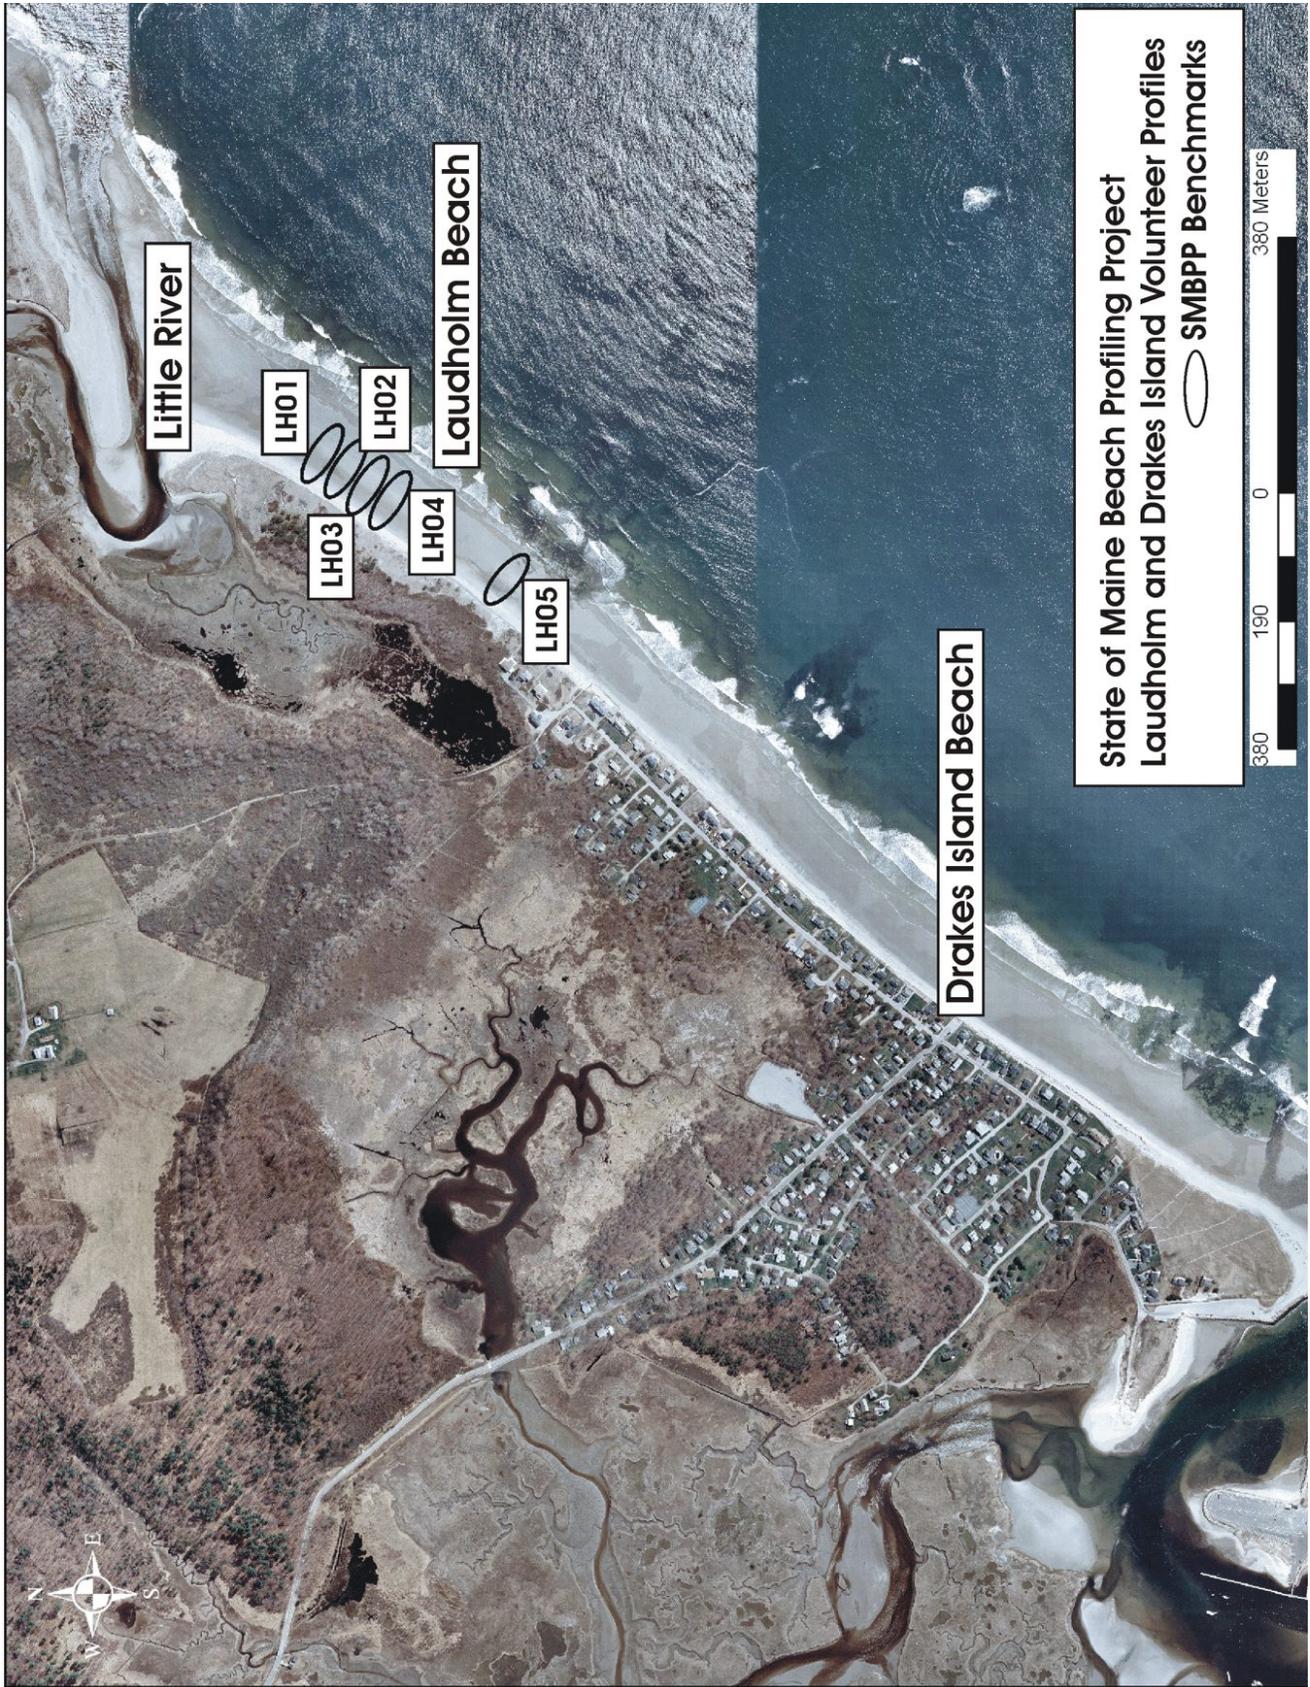
Figure 44. Location of beach profiles on Laudholm Beach, Wells.

Four of five beach profiles (LH01-03, LH05, Figure 44) were available for analysis of beach recovery. LH04 was abandoned in 2006. At LH01, the front profile stake was lost, and profiling was resumed at the back stake in June 2007. Profile data were available from April 1 and May 20, 2006, April 20 and June 23, 2007 (immediate post-storm), April 11, 2008, and May 1, 2009.

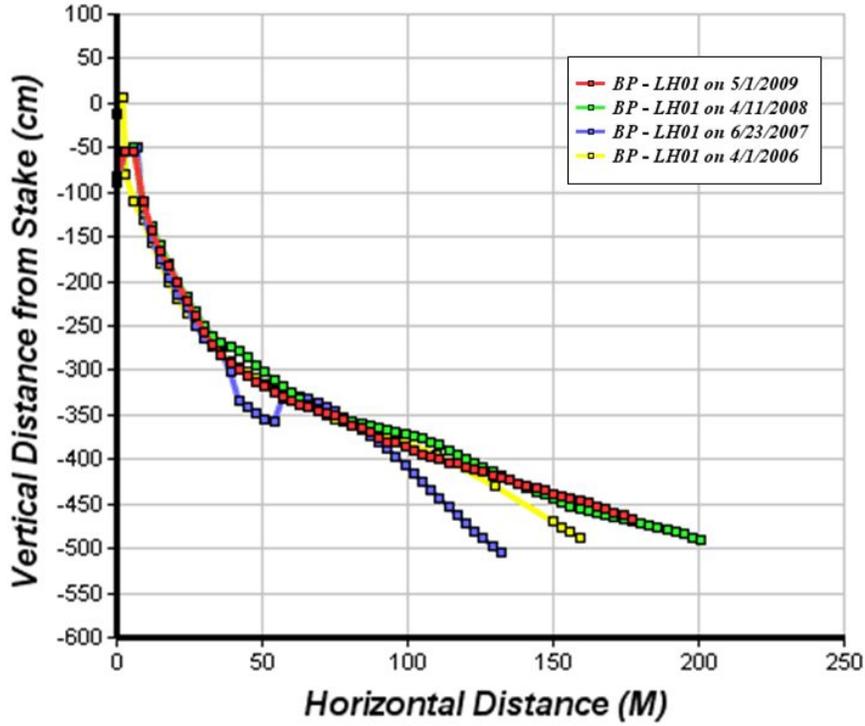
At LH01, the profile stake was lost during the Patriots' Day Storm, thus it is impossible to compare the profiling started in June 2007 (back stake) with pre-storm profiling from 2006 (Figure 45). Using the June 2007 profile as the baseline, by April 2008, the post-storm profile had recovered, most notably at the 50 m mark, where the storm caused the formation of a trough, and in the offshore (seaward of 100 m), where the sand elevation recovered. The 2009 profile maintained roughly the same shape as the 2008 profile. The profile seems stable since the 2007 storm, but has only undergone slight increases in elevation.

Figure 45. Beach profiles from Laudholm Beach profile line LH01.

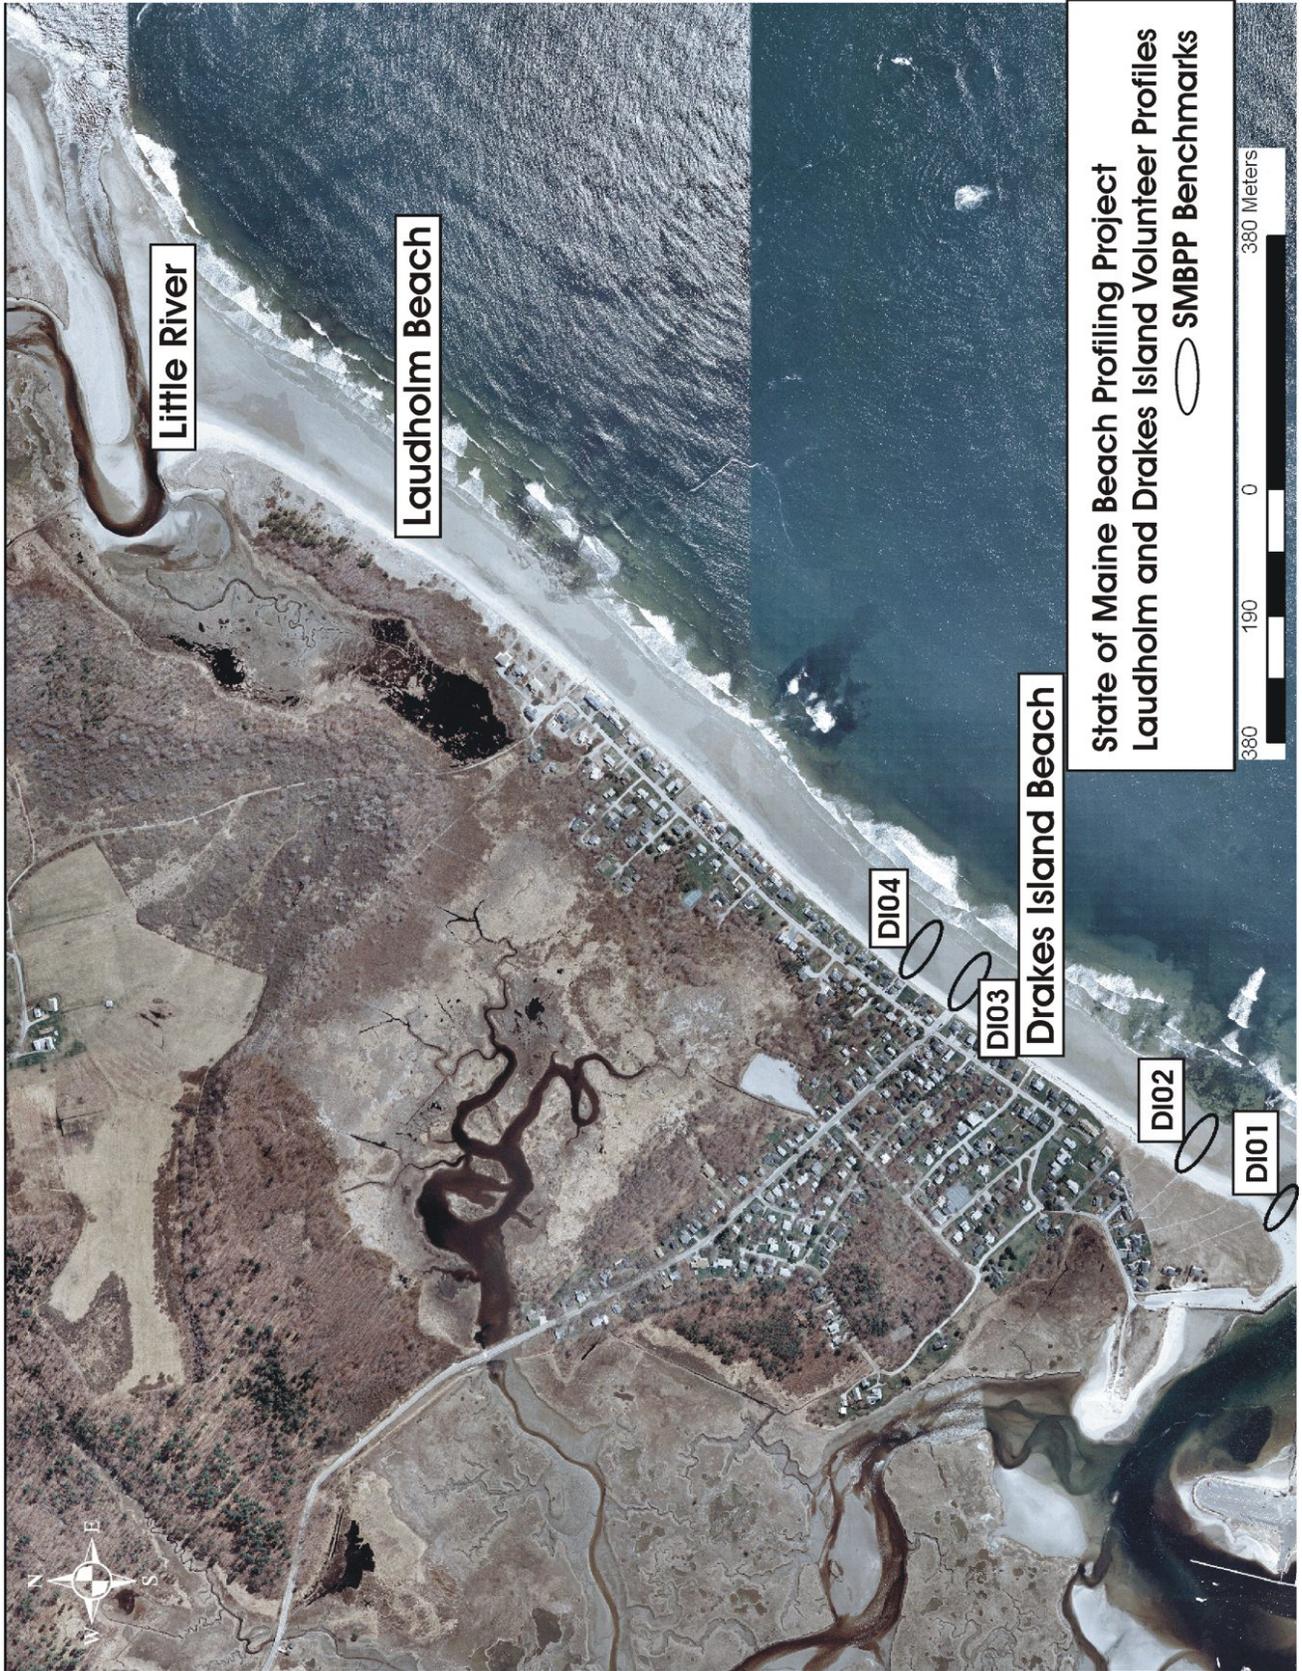
Figure 49. Location of beach profiles on Drakes Island Beach, Wells.

Four beach profiles (DI01-DI04, Figure 49) were available for analysis of beach recovery. Profile data were available from May 22, 2006, May 14, 2007 (immediate post-storm), May 1, 2008, and May 20, 2009.

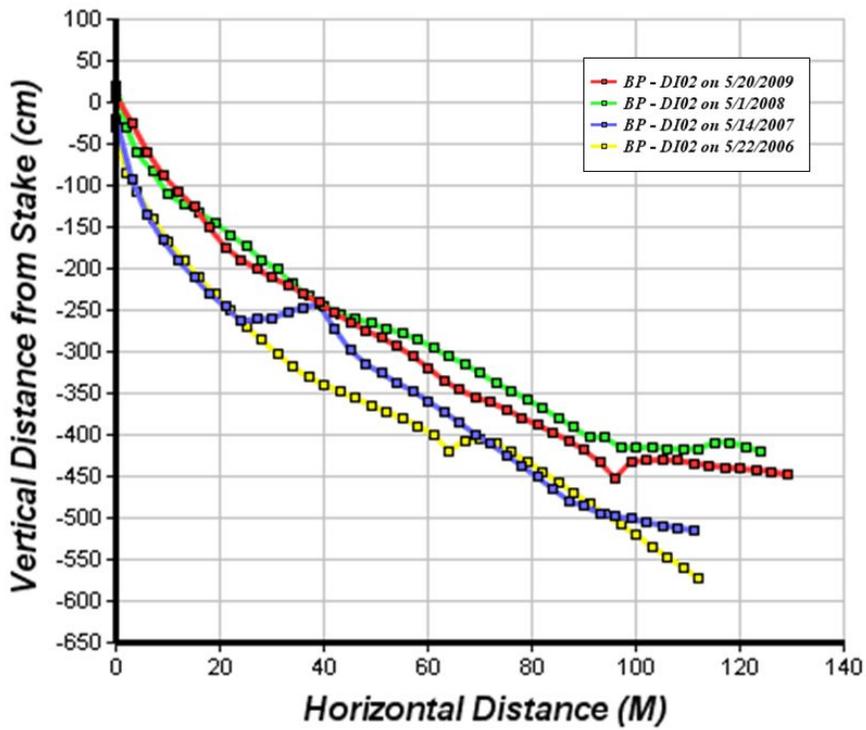
At DI02, the storm actually caused the movement of sediment (likely cobbles) from the lower portions of the profile (apparent in 2006 near 70 m offshore), to the upper portion of the profile in 2007 (near 25 m offshore, Figure 51). The uppermost portion of the profile did not appear to change. By 2008, the entire profile underwent accretion, with elevation being gained along the entire length. Some slight erosion of the profile is apparent in 2009, but the extensive recovery that appears to have occurred remained.

Figure 51. Beach profiles from Drakes Island Beach profile line DI02.

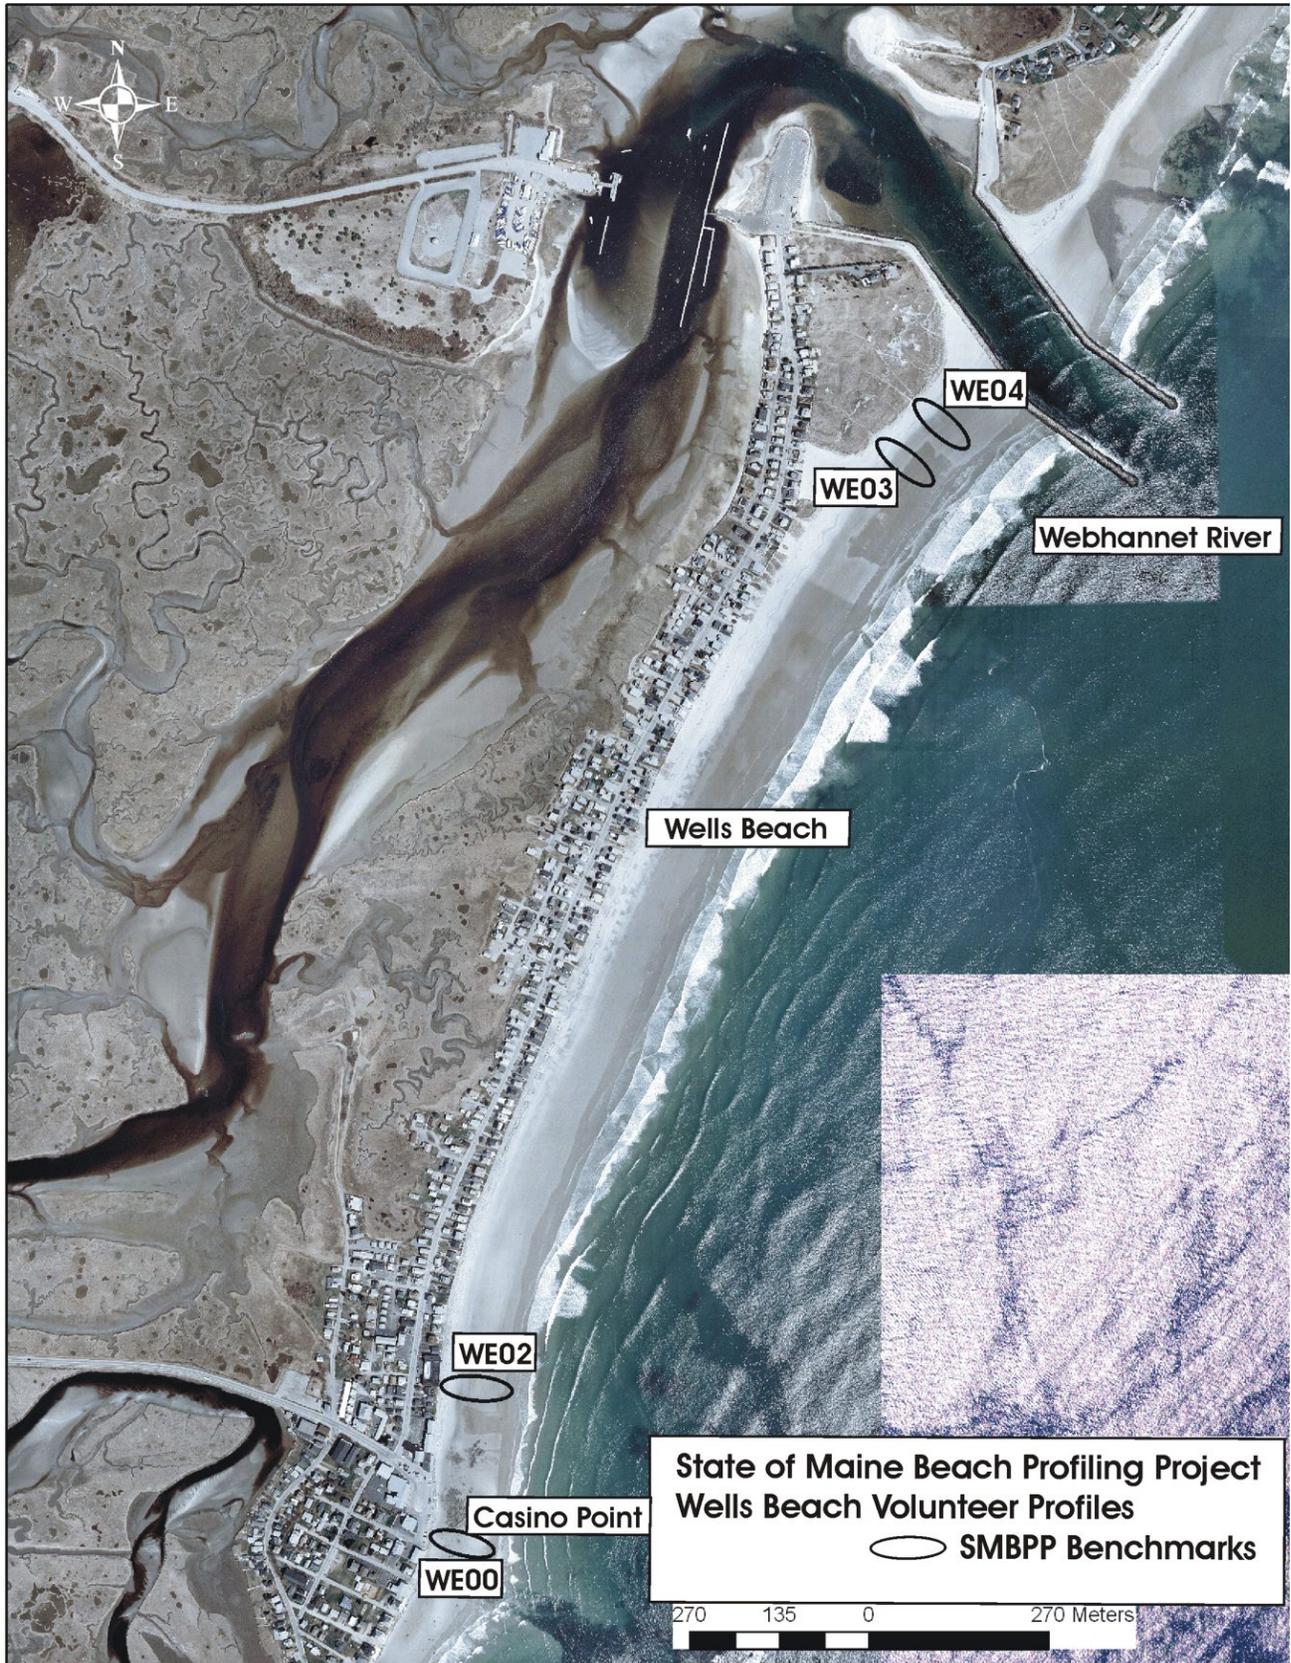
Figure 54. Location of beach profiles on Wells Beach, Wells.

Four beach profiles (WE00, WE02-WE04, Figure 54) were available for analysis of beach recovery. Profile data were available from April 2, 2006, April 21, 2007 (immediate post-storm), April 12, 2008, and April 4, 2009.

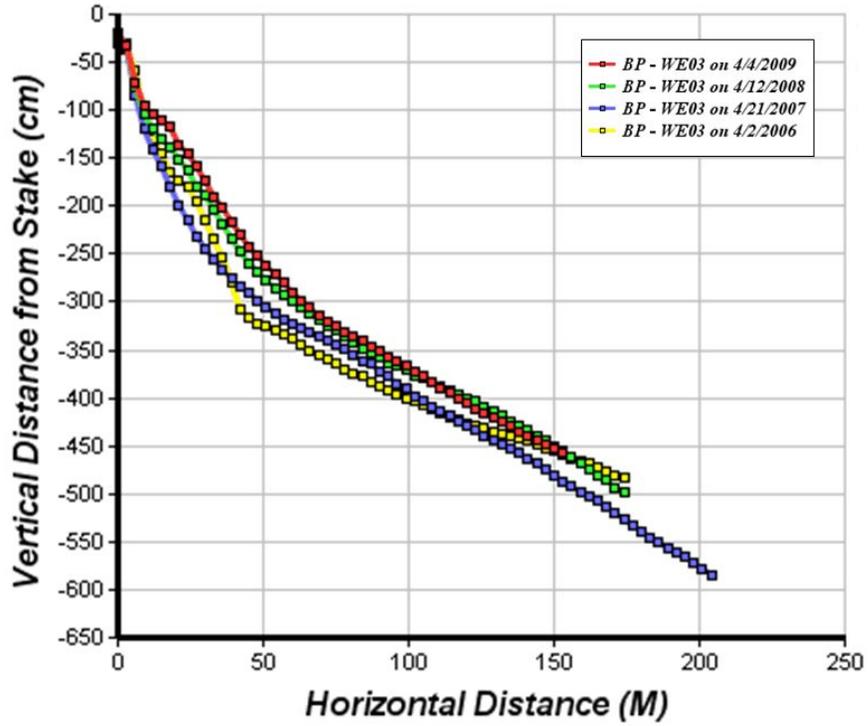
WE03 is located south of the Webhannet River jetties. As a result of the storm, the upper portion of the profile (berm) was eroded, while there was some elevation gain in the middle portions of the profile (Figure 57). Recovery by 2008 occurred, with the profile gaining elevation along its entire length. Similarly, berm development was noted in the 2009 profile.

Figure 57. Beach profiles from Wells Beach profile line WE03.

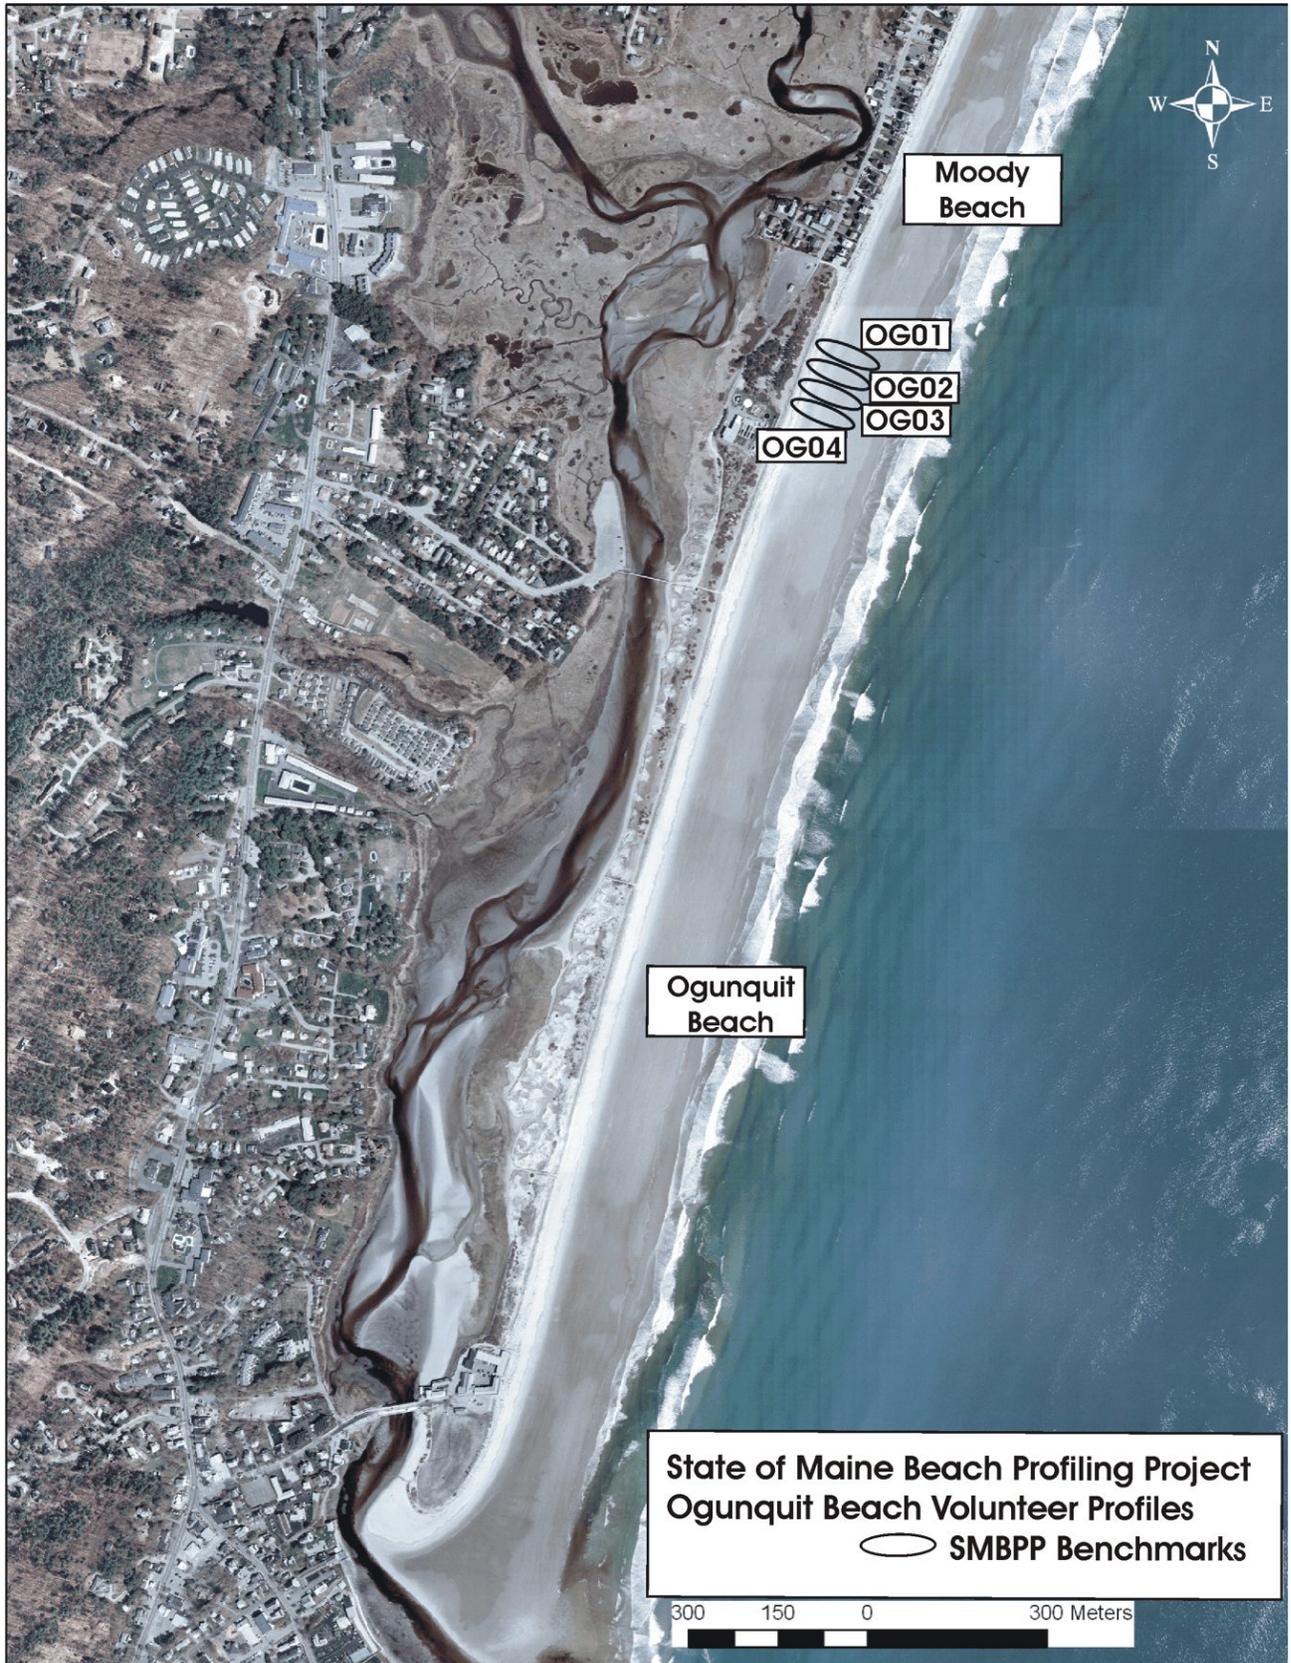
Figure 59. Location of beach profiles on Ogunquit Beach, Ogunquit.

Four beach profiles (OG01 to OG04, Figure 59) were available for comparison; however, at each location, profiling had been occurring at the front stake, and post-storm, profiling was initiated from the back stake. It is difficult to relate front-to-back stake profiling, thus we have not included the pre-storm (2006) profile shapes for the Ogunquit beaches, so it is impossible to describe the immediate impacts of the storm. Also, no data from profiles collected in 2009 were available via the Shore Stewards website. Therefore, we chose to use the latest available data for each profile, which varied from July to November 2008. Beach profile data were available from April 21 and May 19, 2007 (post-storm), and May 24, 2008, along with subsequent July, September, or November 2008 dates.
