# *State of Maine's Beaches in 2009*

**Open-File 09-57**

2009

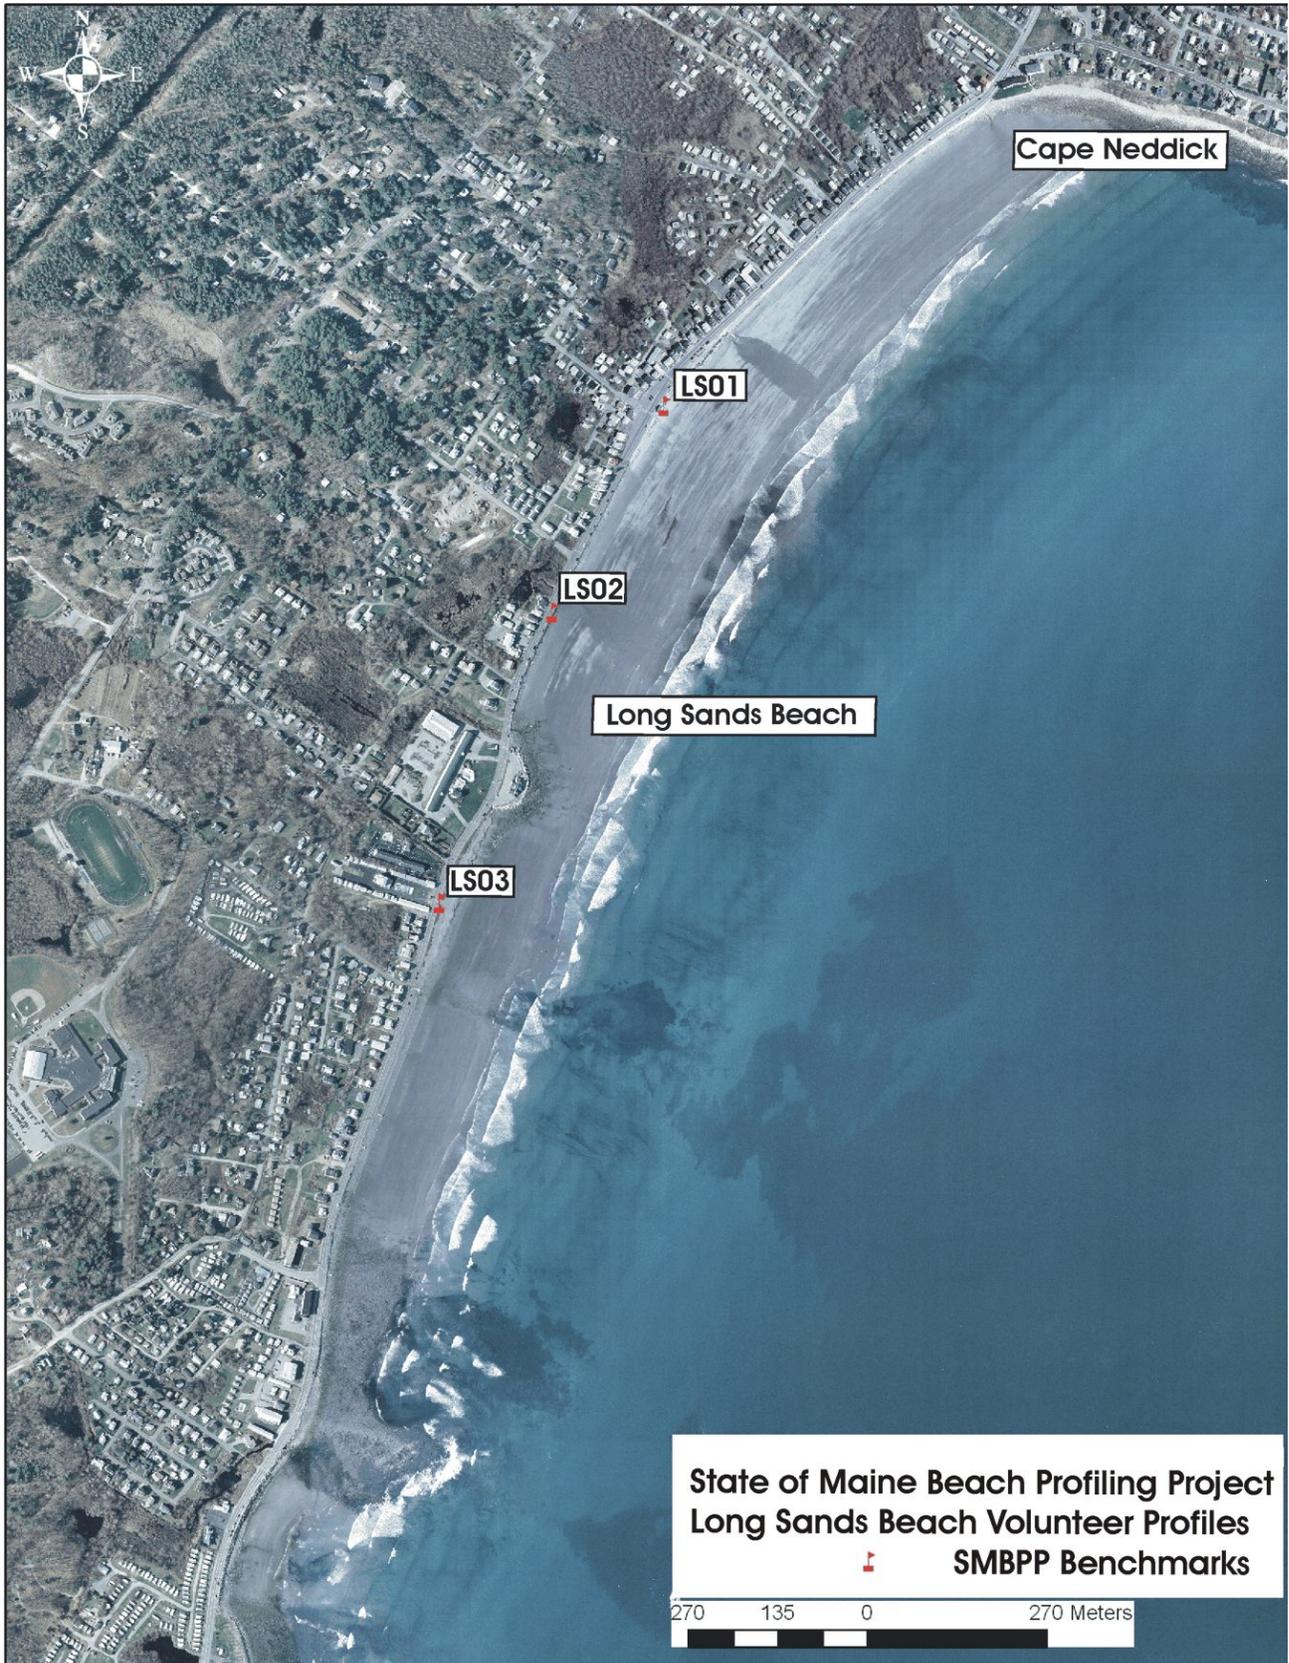
Figure 64. Location of beach profiles on Long Sands Beach, York.

Two of three beach profiles (LS01 and LS03, Figure 64) were available for comparison. Profile LS02 was lost during the storm, and profiling not resumed. Beach profile data were available from April 1, 2006, April 22, 2007 (immediately post-storm), April 13, 2008, and April 15, 2009.
