Geologic Site of the Month  
December, 2013

***Coastal Change in Holmes Bay, Whiting, Maine***

Text by  
Stephen M. Dickson

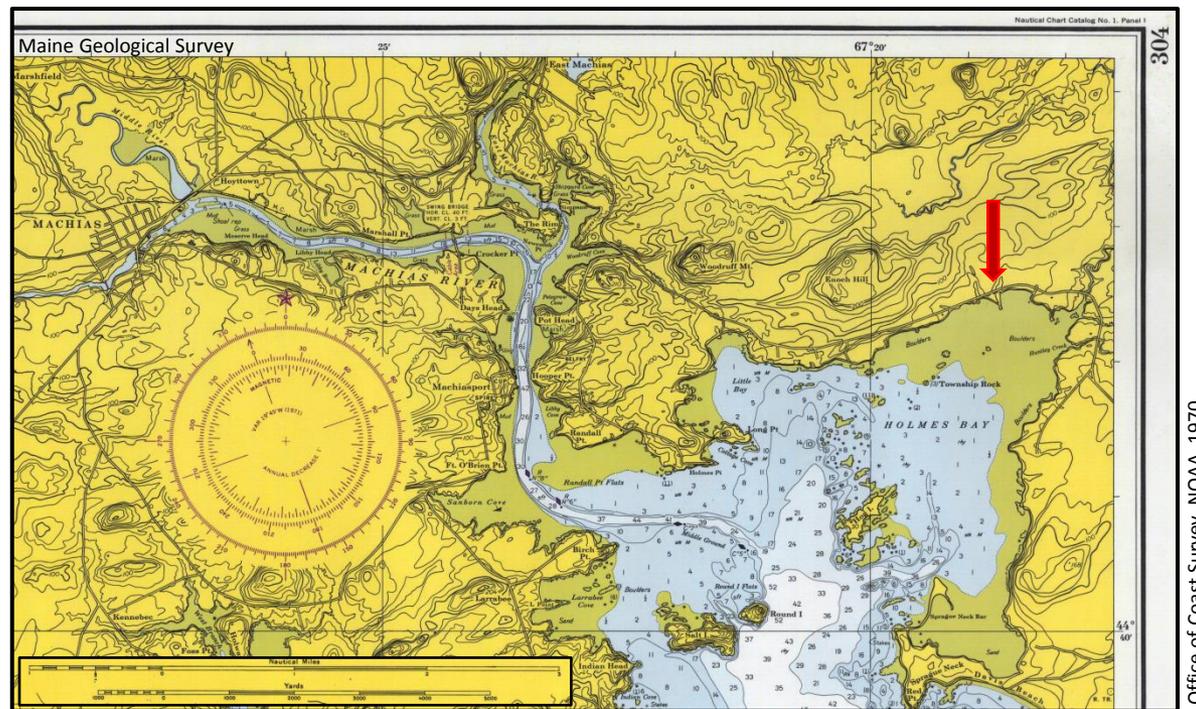
**Figure 1.** Holmes Bay as charted in 1970 by the U.S. Coast and Geodetic Survey on nautical chart No. 304. A small peninsula (red arrow) extends south off the mainland in this chart (and subsequent charts). Water depth soundings are in feet Mean Low Water (blue) and land (yellow) elevations are in contour intervals of 20 feet. The green color illustrates the intertidal area that becomes exposed at low tide. To view the entire chart or more recent ones, see link to the Office of Coast Survey (2013) in the references.

**Figure 4.** In 1885 the U. S. Coast and Geodetic Survey Chart No. 1687 (top) showed a peninsula that would retreat and leave an island (lower left arrow). In the east of the bay it appears that two islands disappeared, although they may have been too small to map in 1979 (right arrows) (From Kelley et al., 1987). See also Figure 1 for a 1970 chart.

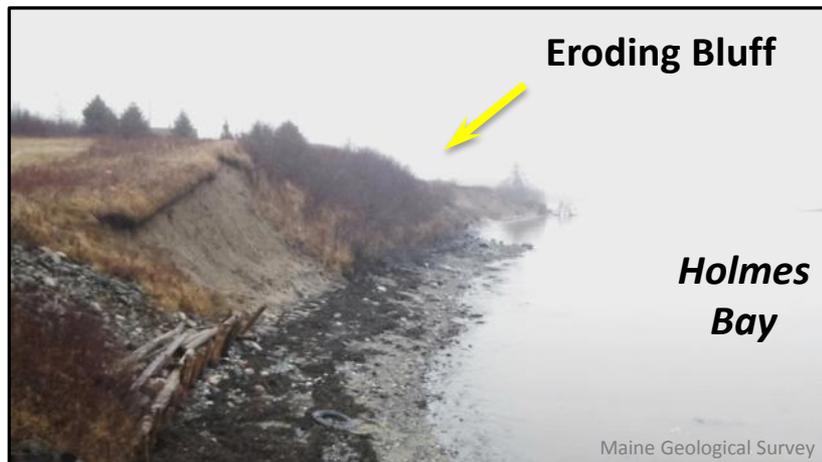
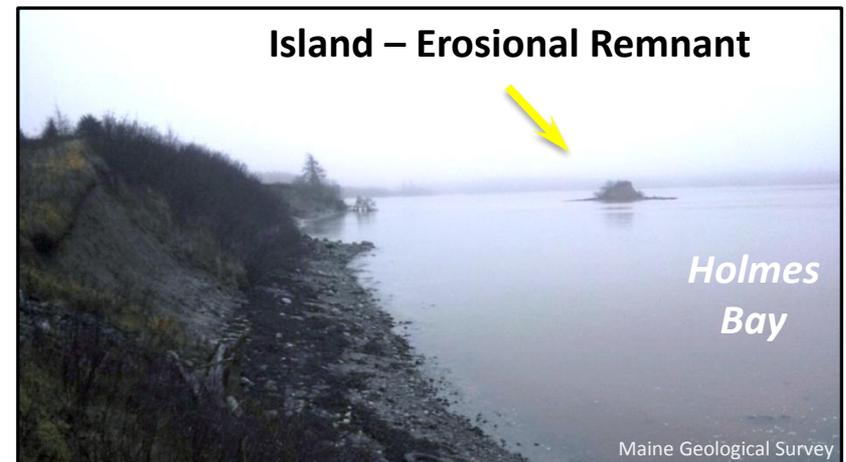
**Figure 2.** These two photographs were taken on December 3, 2013. The one on the left shows an eroding bluff of glaciomarine mud. On the right is a small island created by bluff erosion and shoreline retreat. Views are looking east toward the Town of Cutler. To learn more about evaluating coastal bluff erosion visit the MGS [web pages](#) or Maine Sea Grant's [Property Owner's Guide](#).

Coastal bluffs can erode several ways. Most coastal bluffs experience wave action along the base of the bluff. This erosion removes sediment and steepens the face of the bluff. Sometimes the bluff is so steep (as in the left photo below) that vegetation cannot grow before more sediment is removed. Vegetation overhangs the top of the bluff and also indicates sediment loss. Groundwater can seep out the face of a bluff and lead to additional erosion. Surface water runoff can also lead to erosion hot spots along a bluff as water flows down to the ocean. Seasonal freeze-thaw cycles can also dislodge sediment on a bluff and lead to erosion.

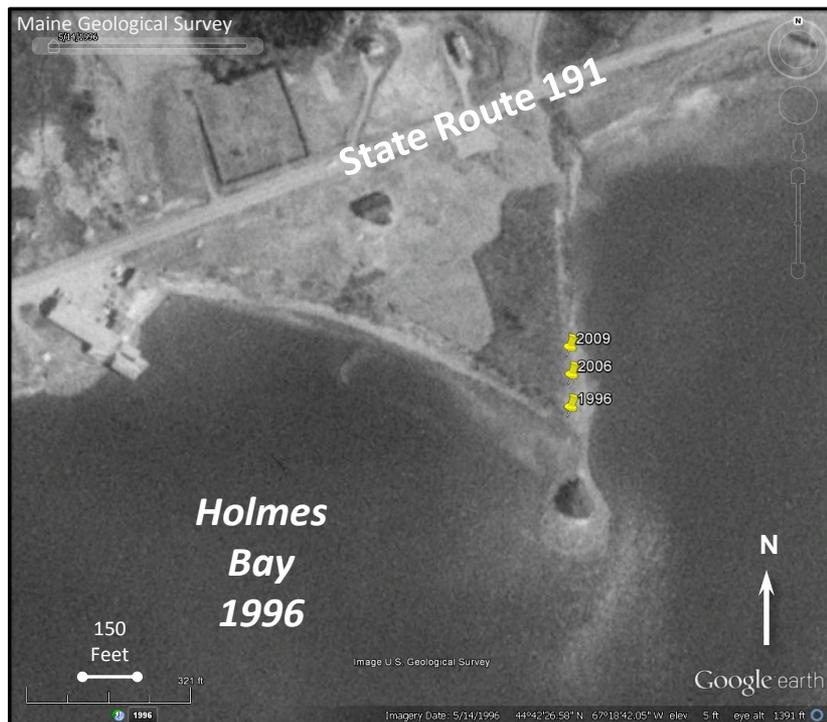
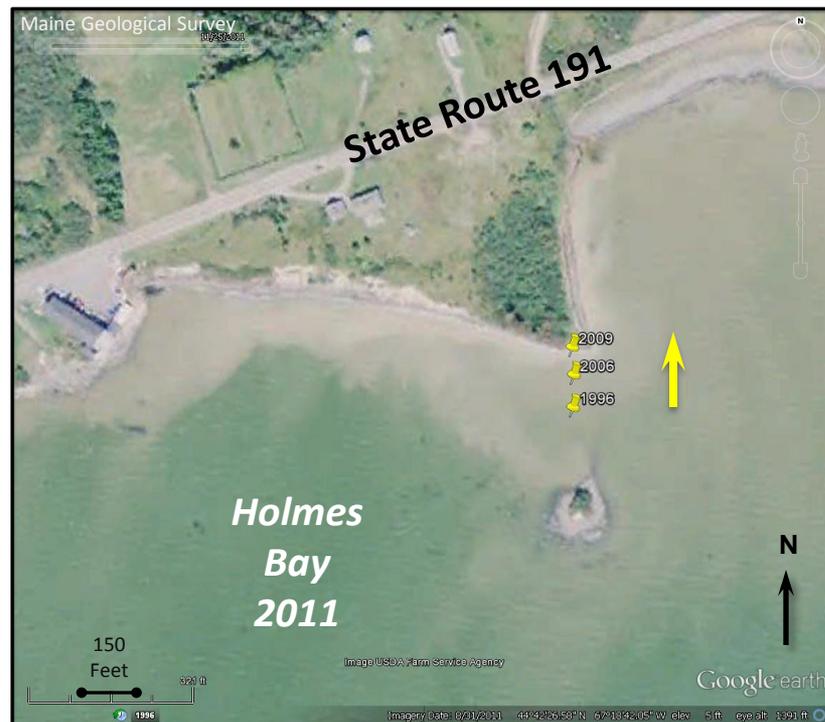
**Figure 3.** Compare these two historical photographs. The one on the left was taken on May 14, 1996 and the one on the right on August 31, 2011. The small island is still intact but appears smaller. The bluff shoreline has retreated north. Maine DOT installed riprap along the bluff (upper right corner) to protect Route 191. This area by the road has experienced both bluff retreat and a landslide in August 1962 (Ault and Bigelow, 1966).

Over a period of 15 years, the shoreline along Route 191 in Holmes Bay has retreated north approximately 150 feet (46 meters). The erosion rate at the point is about 10 feet per year. The yellow pins mark the high tide position at the southern point on the bluff in 1996, 2006, and 2009. Notice that the retreat (yellow arrow) has been primarily along the southwest facing shore and not the eastern one.

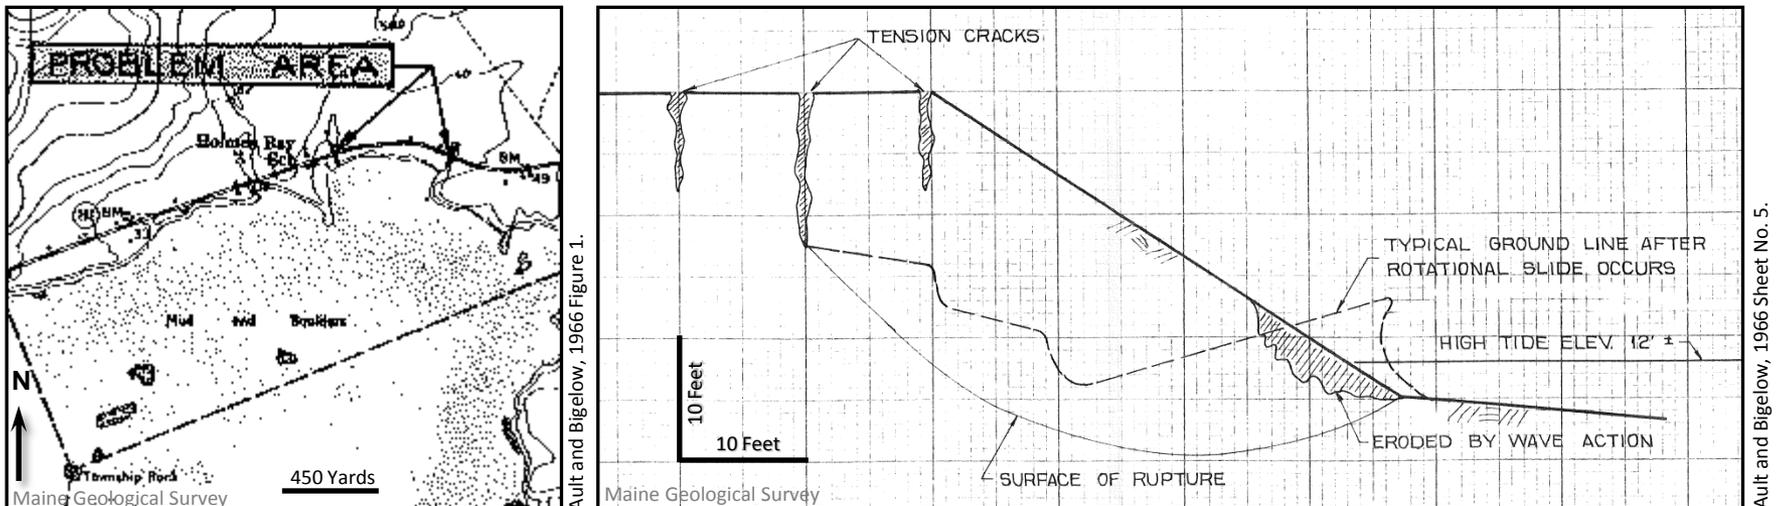
**Figure 5.** The “Problem Area” (left) shows the shoreline of existing and potential landslides identified by Ault and Bigelow (1966). Their study illustrated a typical cross-section of the rotational failure (right). This movement is similar to that in the 1973 and 1996 Rockland landslides (Berry et al., 1996). For more information on landslides visit the MGS [Coastal Landslide web pages](#).

Landslides have occurred in many [locations](#) in Maine where the ground is underlain by glaciomarine clay called the [Presumpscot Formation](#) (Novak, 1987). In August 1962 a rotational slide occurred in Holmes Bay east of the eroding peninsula and island described here. The landslide resulted in down-dropped blocks of intact soil with trees leaning in a shoreward direction (Ault and Bigelow, 1966). The slide left a vertical headwall scarp about 20 feet high about 40 feet from State Route 191. Borings just landward of the slide headwall determined that the Presumpscot Formation was as much as 65 feet thick (Ault and Bigelow, 1966), so the soft silt and clay extended well below the low-tide elevation.

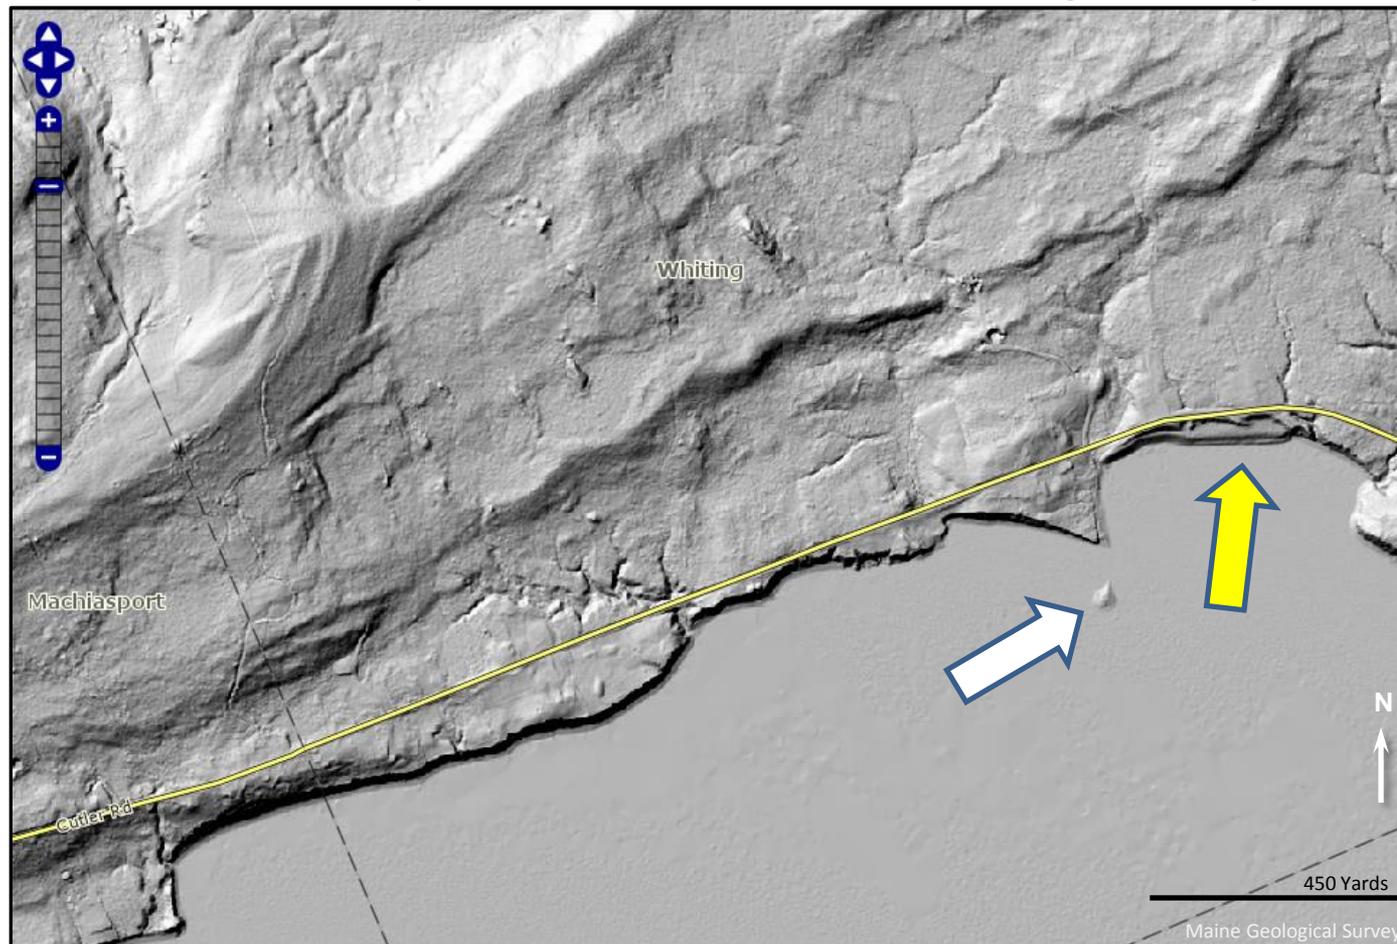
**Figure 6.** Holmes Bay relief imaged in 2010 with LiDAR (aircraft-borne laser). For more interesting examples of Maine landscapes revealed by LiDAR see Thompson (2011).

Topography illustrated with shaded relief. The island remnant shown by the white arrow. Former landslide area shown above the yellow arrow. Glacial moraines form ridges trending ENE-WSW.
