Geologic Site of the Month
January, 2010

***Migration of the Morse River into Back Dunes at
Popham Beach State Park, Phippsburg, Maine***

Text by
Stephen M. Dickson

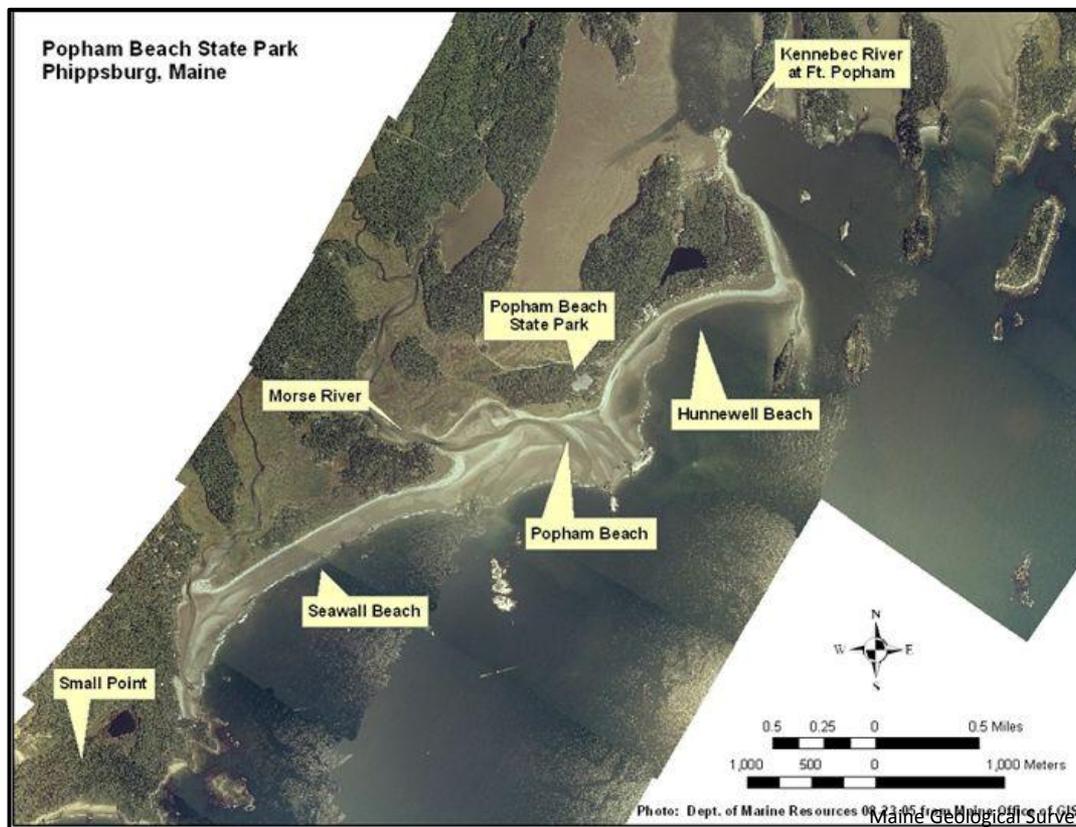
Figure 1. Aerial view of Popham Beach as part of a continuous sand system from the mouth of the Kennebec River in the east to Small Point in the west. This photograph mosaic was taken August 23, 2005 for the Maine Department of Marine Resources and is available via the Maine Office of GIS [web site](#)

[Popham Beach State Park](#) is part of a large and complex beach system at the mouth of the Kennebec River (Figure 1). Hunnewell Beach is a continuous strand of sand from the east side of Popham Beach. Seawall Beach is a natural beach system and preserve west of the Morse River and the state park. Small Point is a natural beach system and preserve west of the Morse River and the state park.

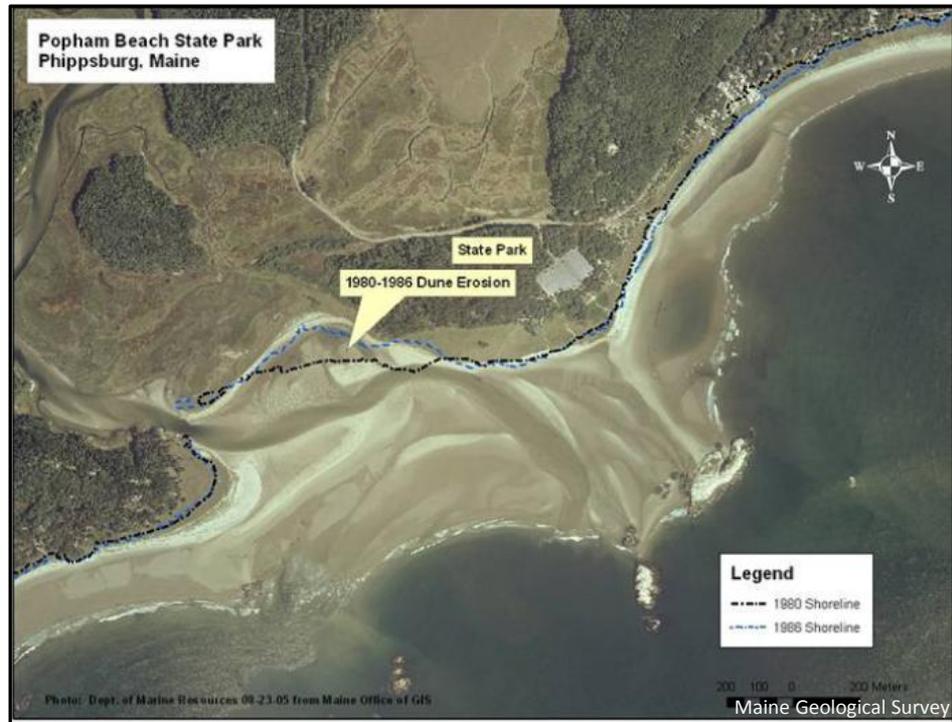
Figure 2. A large area of dunes was lost between 1980 and 1986 as seen by comparison of the two historical shorelines. The base air photo is from 2005 so both historical shorelines appear in the channel.

Over 6 years the dunes eroded significantly on the western portion of Popham Beach. This loss is adjacent to the Morse River and, with an understanding the movement and migration of rivers, we can be confident that the loss is due, in part, to an easterly shift in the river's course toward the park's dunes. The outer bend in the river (during its flow to the sea on a falling or ebb tide) is called a "cut bank" and it is this portion of the channel that has eroded the dunes. As we will see in the following few figures, the cut bank shifts position over time - demonstrating a geological process called meandering.

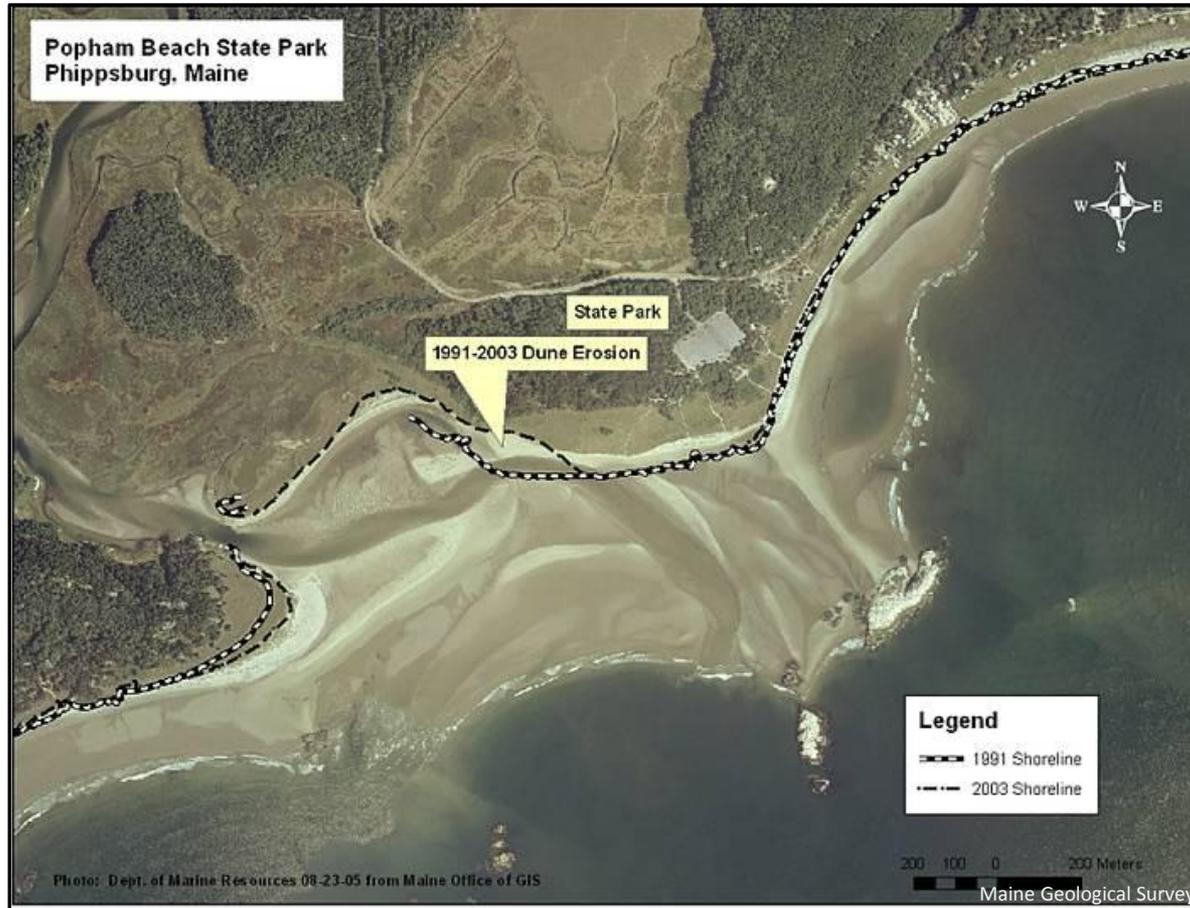
Figure 4. Shoreline change from 1991-2003.

From 1991 to 2003 the Morse River eroded some of the dunes created after 1986 (Figure 4). The rest of the dunes remained remarkably stable for this 12-year period. West of the Morse River the dunes on the east end of Seawall Beach expanded slightly.

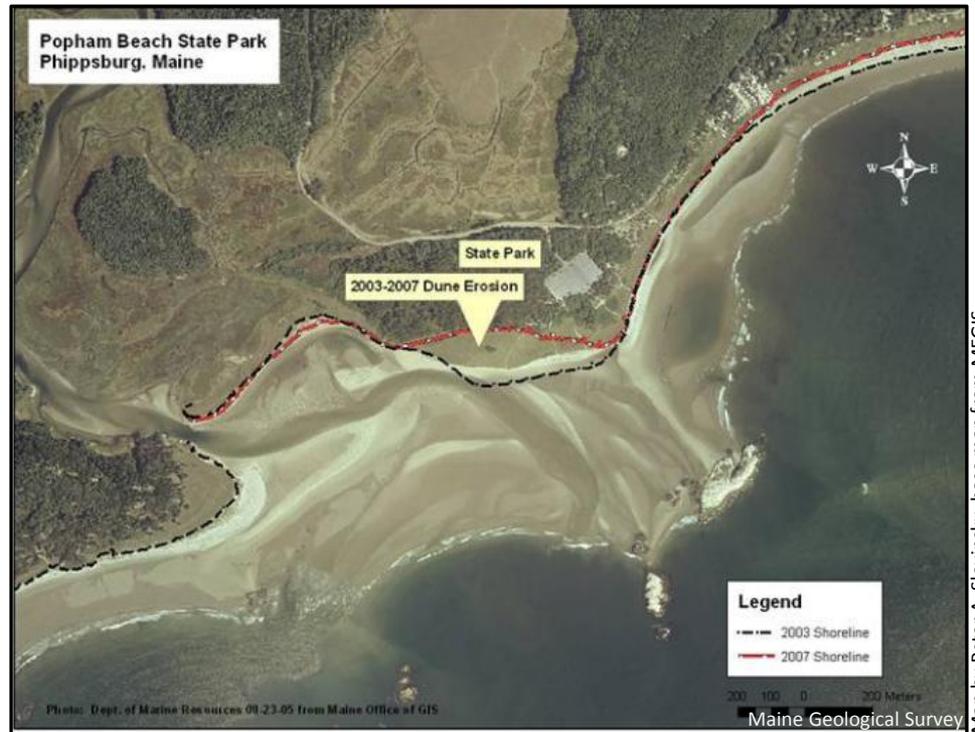
Figure 5. Shoreline change from 2003-2007 on a 2005 base image. The 2003 shoreline is from air photographs and the 2007 shoreline was recorded in the field with RTK-GPS.

From 2003 to 2007 the Morse River removed a large area of dunes along the west beach (Figure 5). Initially, park dunes in the center beach lost area from 2003 to 2005. Erosion worsened after 2005 and removed dunes for two more years, bringing the shoreline up to the edge of the pitch pine maritime forest. The Morse River reoccupied a location not seen since perhaps the 1950s ([Figure 12 of Dickson, 2008a](#)). While the dunes of the west and central beach areas were lost, the east beach shoreline was relatively stable. Hunnewell Beach also lost dunes in this interval.

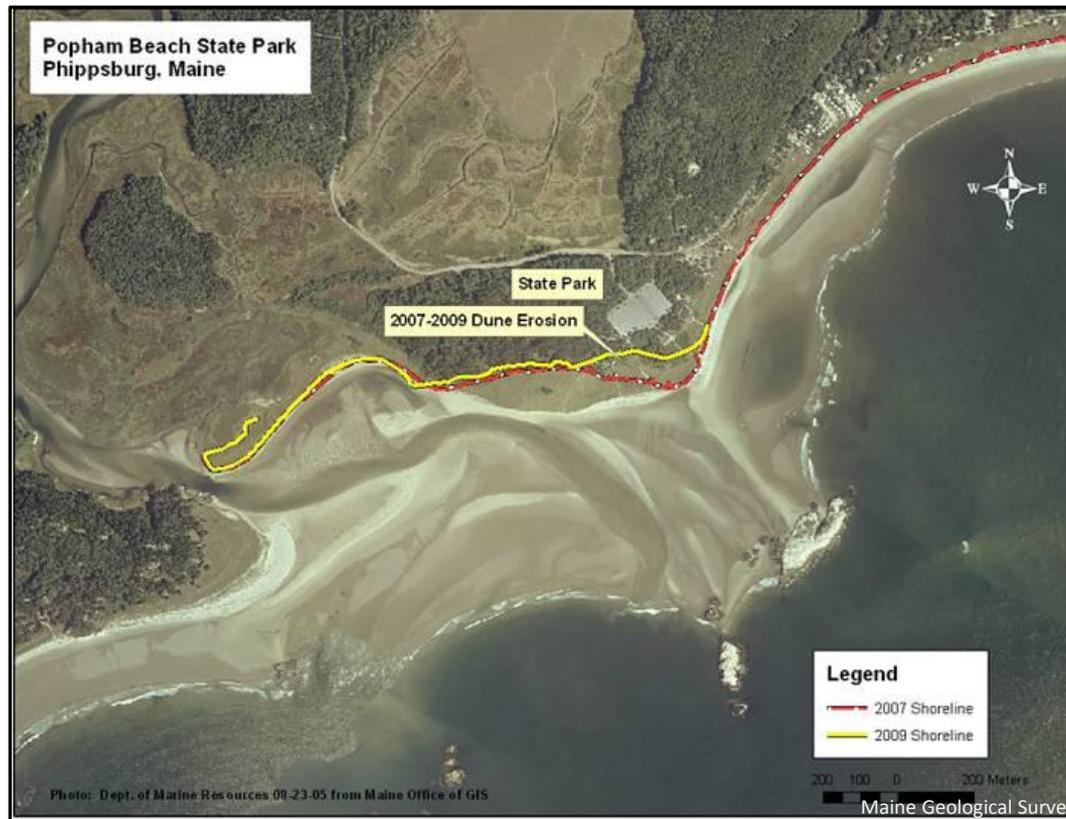
Figure 6. Shoreline change from 2007-2009. The 2007 shoreline is from July and recorded with a high-precision RTK-GPS. The 2009 shoreline is from November and with a less precise hand-held GPS so not as accurate.

From 2007 to 2009 the Morse River continued to remove both dunes and topple trees in the pitch pine forest (Figure 6). Erosion came closer and closer to the parking lot and new bath house facilities built in the spring and summer of 2009 at the southwest corner of the parking lot. The Morse River continued to meander closer and closer to park infrastructure.

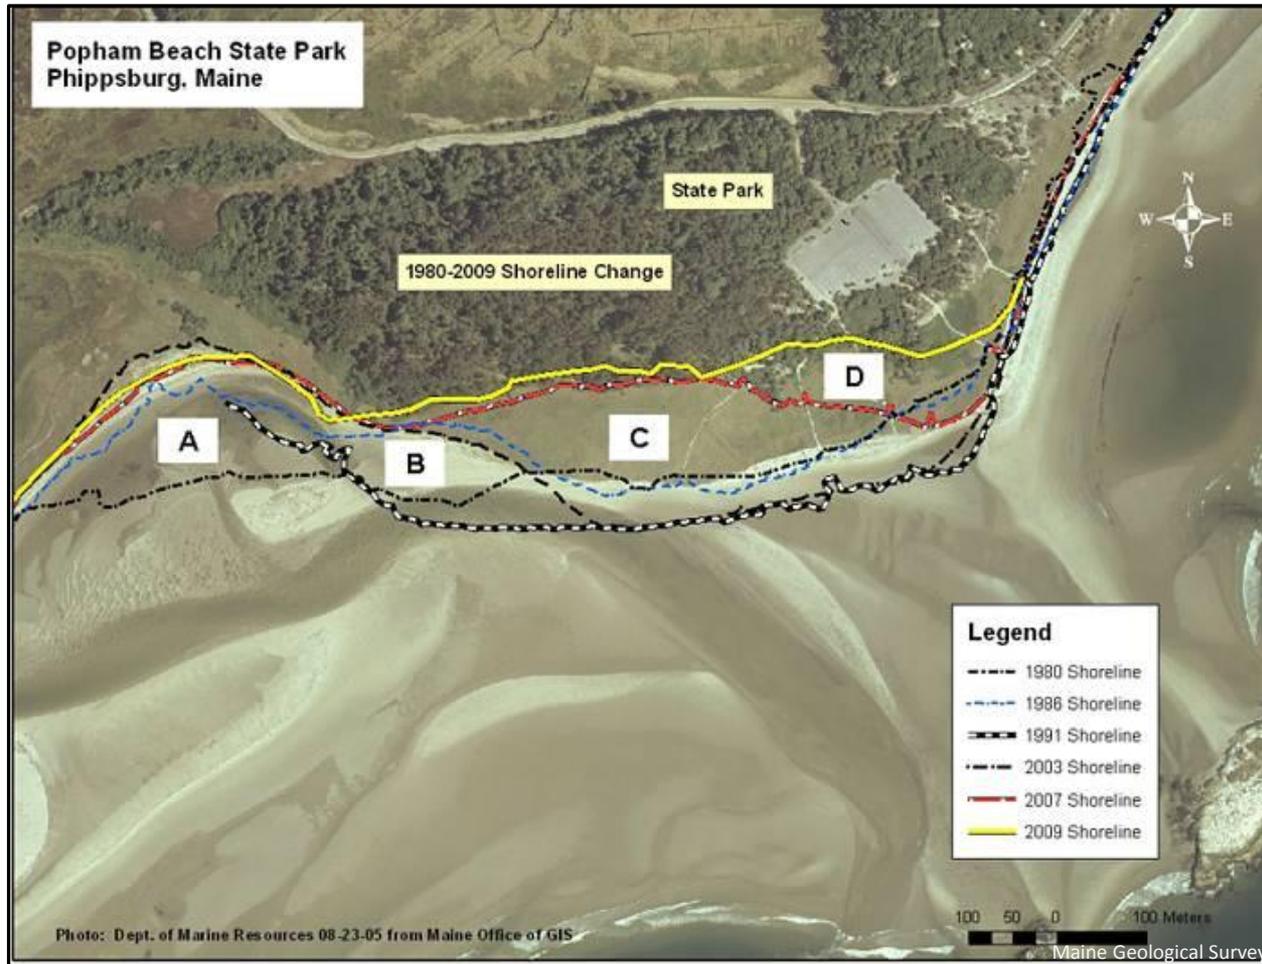
Figure 7. Complete series of shoreline change positions from 1980 to 2009 at Popham Beach State Park. Note the loss of dunes progresses from west (A) to east (D) over time as the Morse River channel meanders east.

Figure 7 summarizes shoreline changes since 1980 shown individually in Figures 2 through 6.

Since 1980 when the dunes were at their largest extent, Popham Beach State Park has lost a lot of sand dunes and pitch pine forest. The pattern of dune loss is one of cutting by the Morse River from west to east over nearly three decades. During that time, however, there was a period from about late 1980s through the 1990s when the Morse River did not erode the park's dunes in any large way. Early in the new millennium the Morse River became more active in its easterly meandering and more damaging to the state park dunes. The most dramatic loss of park land happened from 2005 to 2007, a relatively short period of time.

The summary figure shows how very significant land loss can take place in only a few years as dunes are eroded by swift currents at a tidal inlet associated with a small river system.

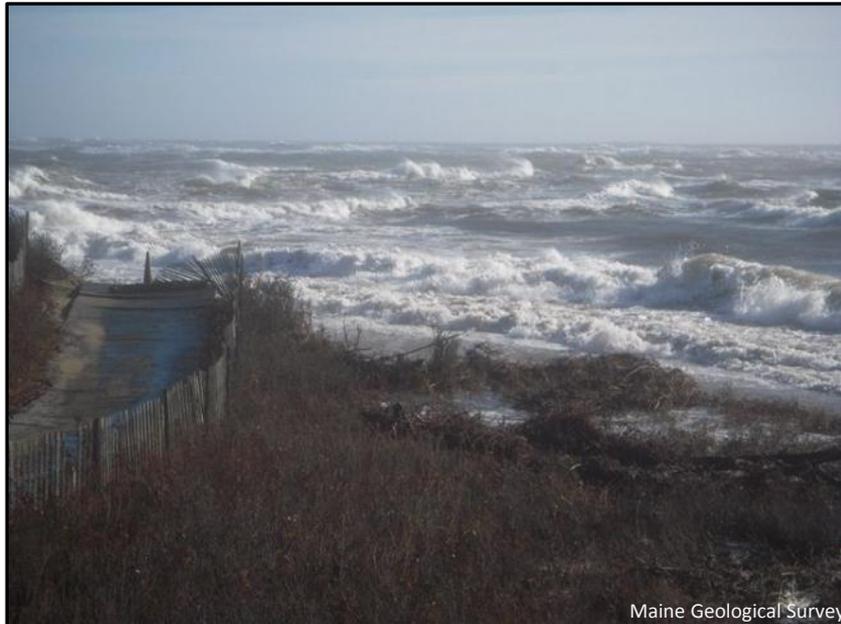
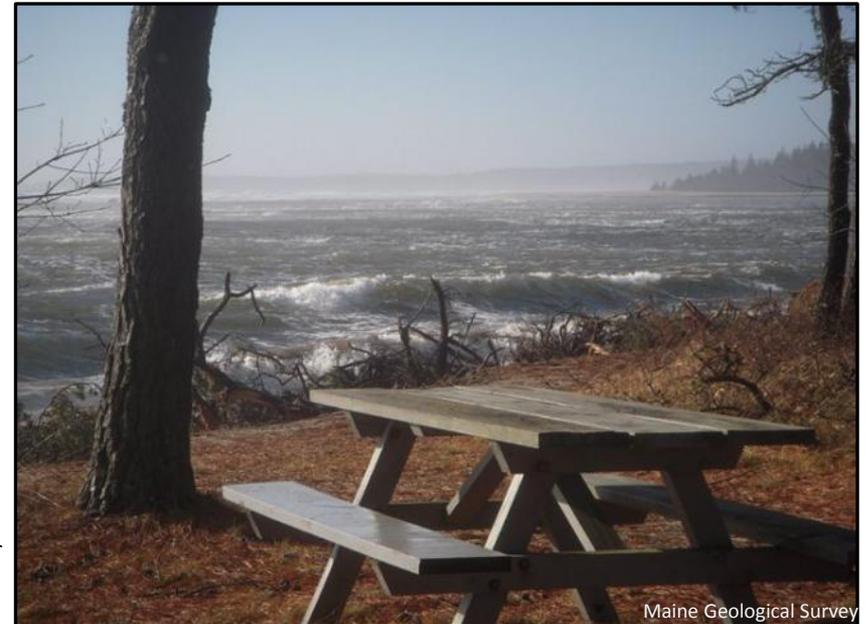
Figure 9. (Left) Surf crashes over the Fox Islands tombolo from two directions. The Morse River ebbs along the dunes from right to left carrying sand suspended by the surf toward West Beach from the central portion of the dunes. (Right) The Morse River cuts directly into the pitch pine forest with a vertical drop just beyond the picnic table. Fallen trees have been grouped into bundles (creating a "tree wall") to dissipate waves and slow river currents along the bank.

Offshore waves in this storm were 12 feet high and they broke offshore of Popham Beach State Park and moved ashore as smaller waves that eroded the dunes (Figure 9).

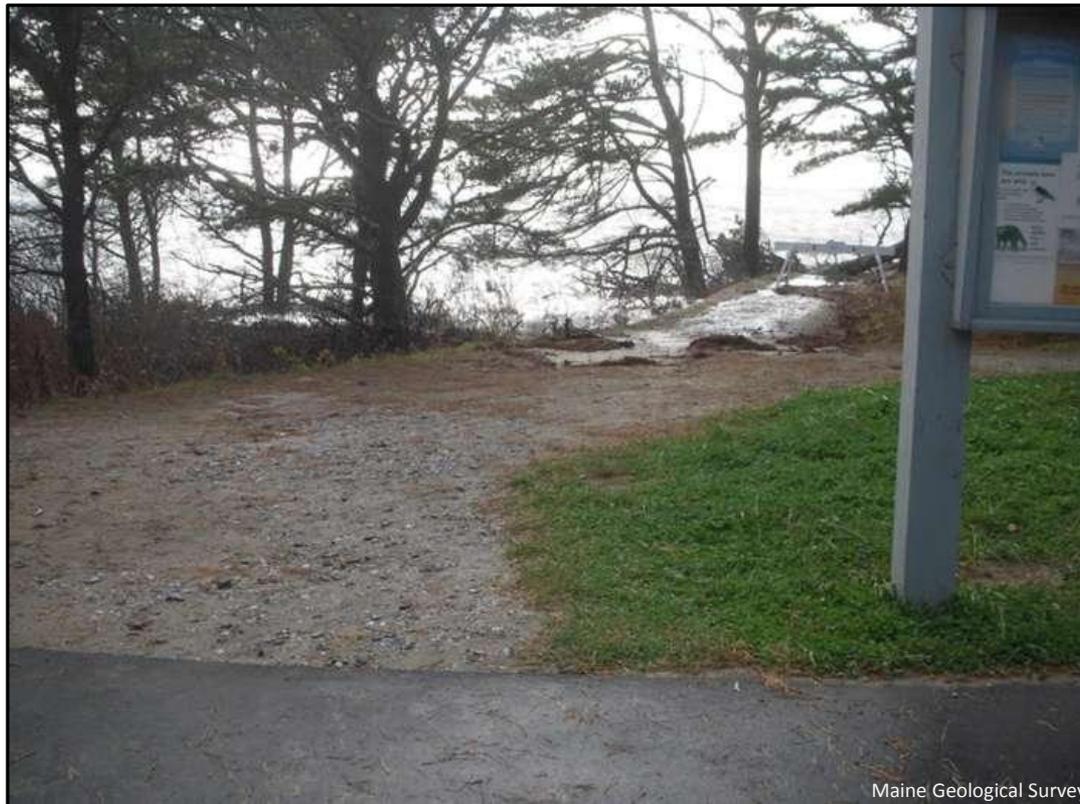
Figure 10. A view from the seaward side of the bath house looking south toward the beach. Note the pavement in the foreground surrounds the bath house and shows how near the overtopping and erosion is from the new infrastructure.

Along low dunes, waves overtopped them and flooding extended inland (Figure 10). Five minutes after this photograph was taken two trees along the shoreline (just left of the barricade on the path) fell into the surf. The Morse River runs along the dunes and storm flooding helped undermine the trees.

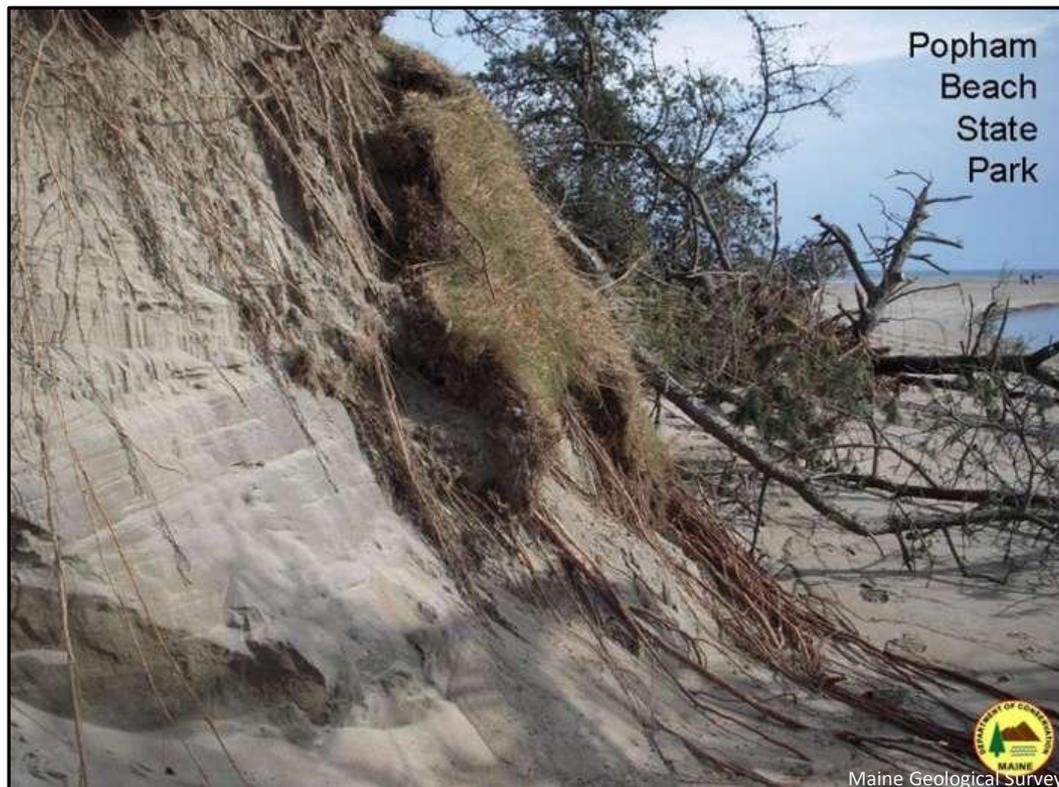
Figure 11. Erosion continues to narrow the beach, increase risk to swimmers, remove a mature pitch pine forest in the back dunes, and threaten park infrastructure including new bath houses. The Fox Islands tombolo (sand bar) is on the right beyond the bend in the Morse River.

In consultation with resource and regulatory agencies, the Department of Conservation decided to take action in December 2009 to slow the effects of storms with the goal of keeping the shoreline from reaching the bath house (Figure 11).

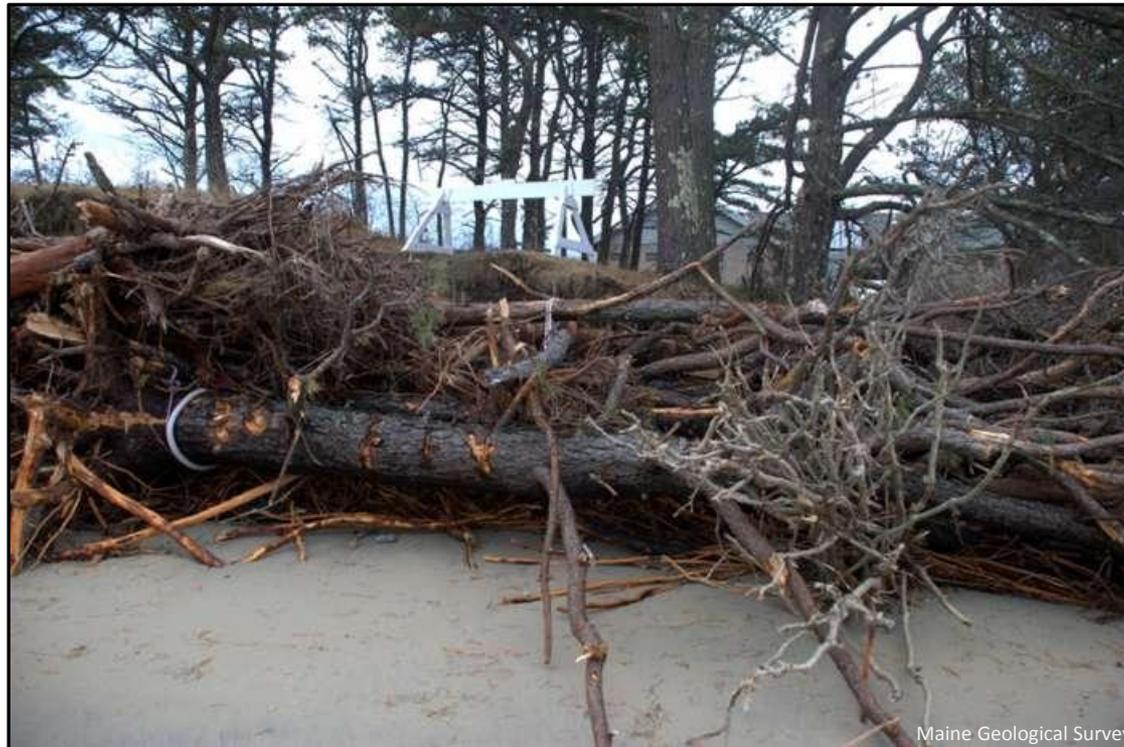
Figure 13. View from the west beach area of the tree bundle, path barricade, and bath house in the background. Trees were grouped in December 2009 to slow cut-bank erosion and surf action along the Morse River at Popham Beach.

Ropes were used to tie the bundles to upright trees farther inland to hold them in place and to keep them from floating out to sea in storms (Figure 13). The goal of the "tree wall" was to slow the speed of the Morse River on the cut bank so less sand could be removed in storms and to help break the surf action on the dunes at high tide to minimize scour.

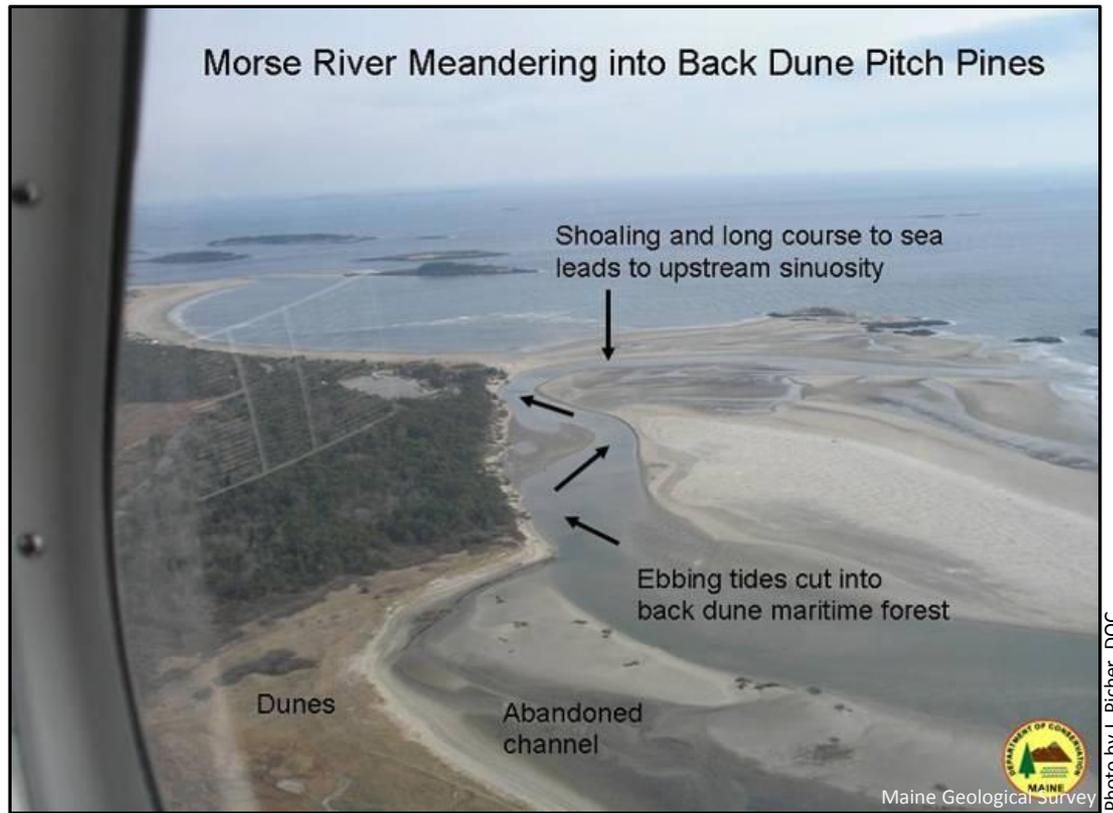
Figure 14. Meandering of the Morse River channel as seen from the air.

A photographic flight by the Department of Conservation in November 2009 over Popham Beach State Park provides a different perspective of the tidal inlet, channel course, and dune system. From overhead it is possible to trace out the curved Morse River channel and see where the outer cut banks of the meanders are (Figure 14).

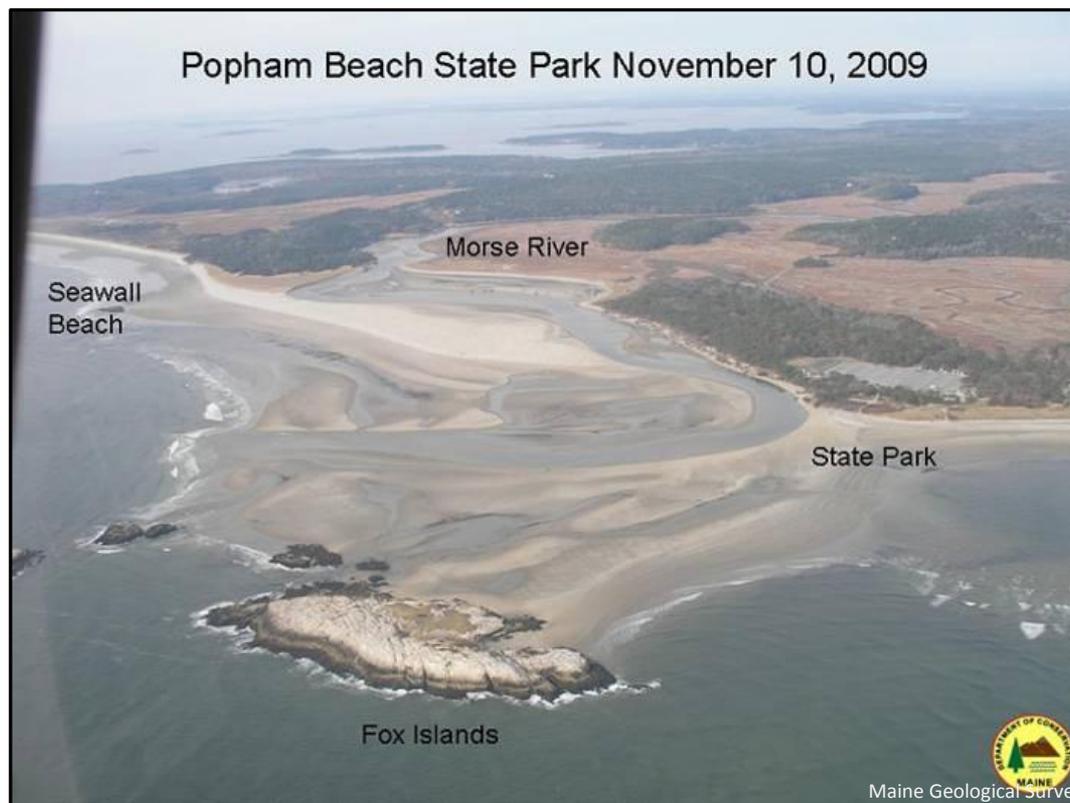
Figure 15. Air view looking up the Morse River.

Looking upstream to the back-barrier salt marsh system and Seawall Beach it is possible to see how the river flows out from behind the dunes and takes a sharp bend on the ebb-tidal delta and turns toward the state park (Figure 15). It is estimated that the pitch pine maritime forest trees are about 100 years old. This may be the farthest inland the Morse River has meandered since the mid 1800s or earlier.

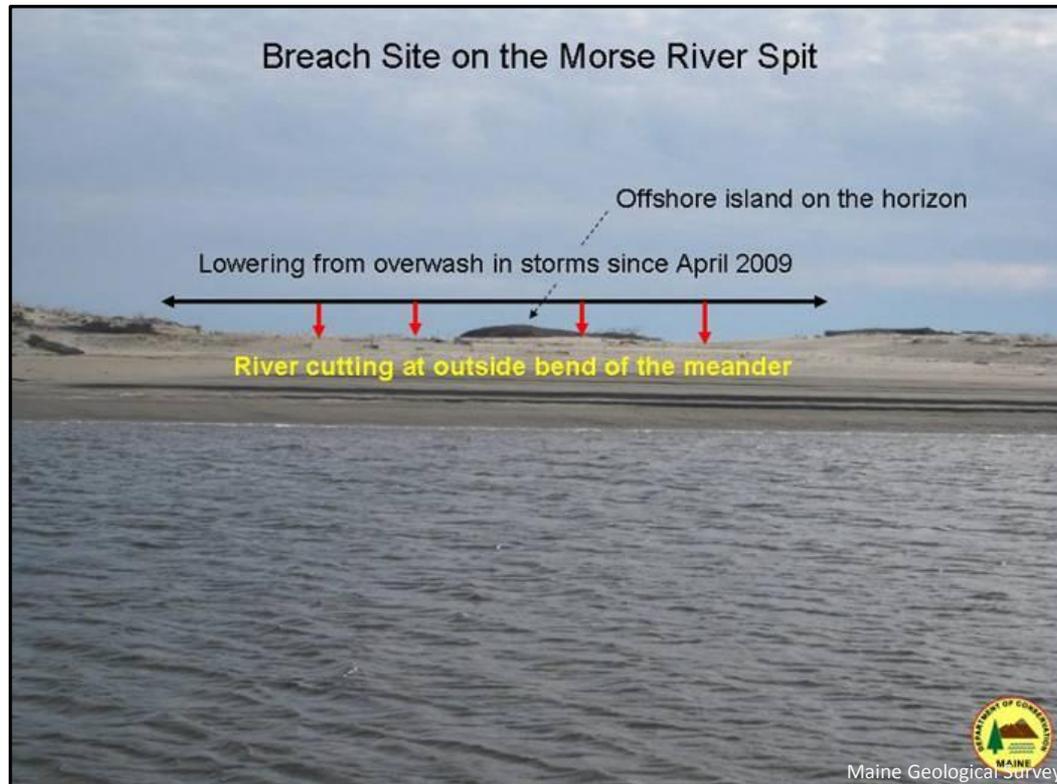
Figure 17. View of potential breach site and recent spit lowering. Photo taken at 1:55 p.m. when the Portland tide gauge was 4.8 ft MLLW about two hours after low tide. The lowest spit elevation may be 10 to 11 ft Mean Lower Low Water and showing 5 ft of relief above the river level. The river channel is a few feet deeper than MLLW in some places.

In November the spit appeared to show signs of being cut by the river (Figure 17). This area appears to have lowered and widened in the same area where downcutting had been previously noted in April (Dickson, 2009 Figure 12, Figure 13, and Figure 14).
