Geologic Site of the Month

June, 2014

Status of Beach and Dune Restoration at Western Beach, Scarborough

Text by
Peter A. Slovinsky

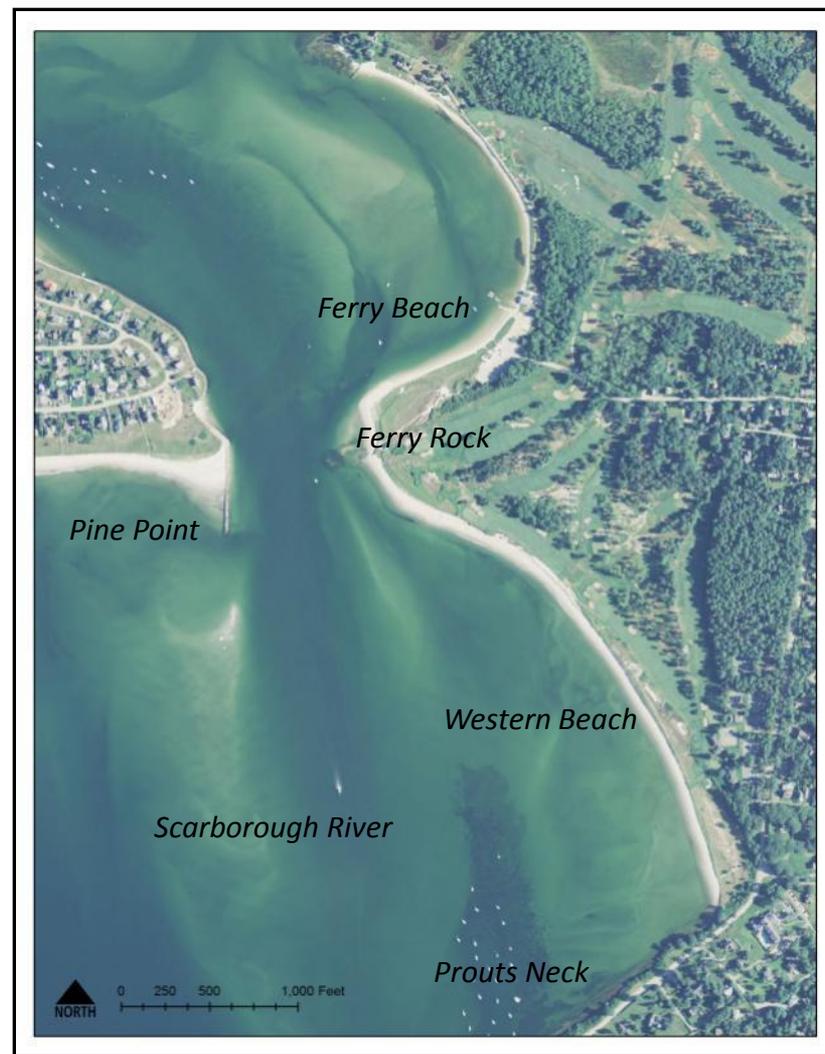
Figure 1. Western Beach in Scarborough, Maine.

Western Beach is a small pocket beach between Ferry Rock to the northwest and the Prouts Neck headland to the southeast (Figure 1). It lies on the eastern side of the Scarborough River inlet, across the inlet from Pine Point, and is adjacent to the municipally owned Ferry Beach. Although Western Beach is privately owned by the Prouts Neck Country Club, it is open to the public and is a popular destination for sunbathers, fishermen and beach and dog walkers. In a larger context, the Scarborough River and Western Beach are located at the northern end of Saco Bay, Maine's largest expanse (approximately 7 miles) of contiguous beach and dunes in the State.

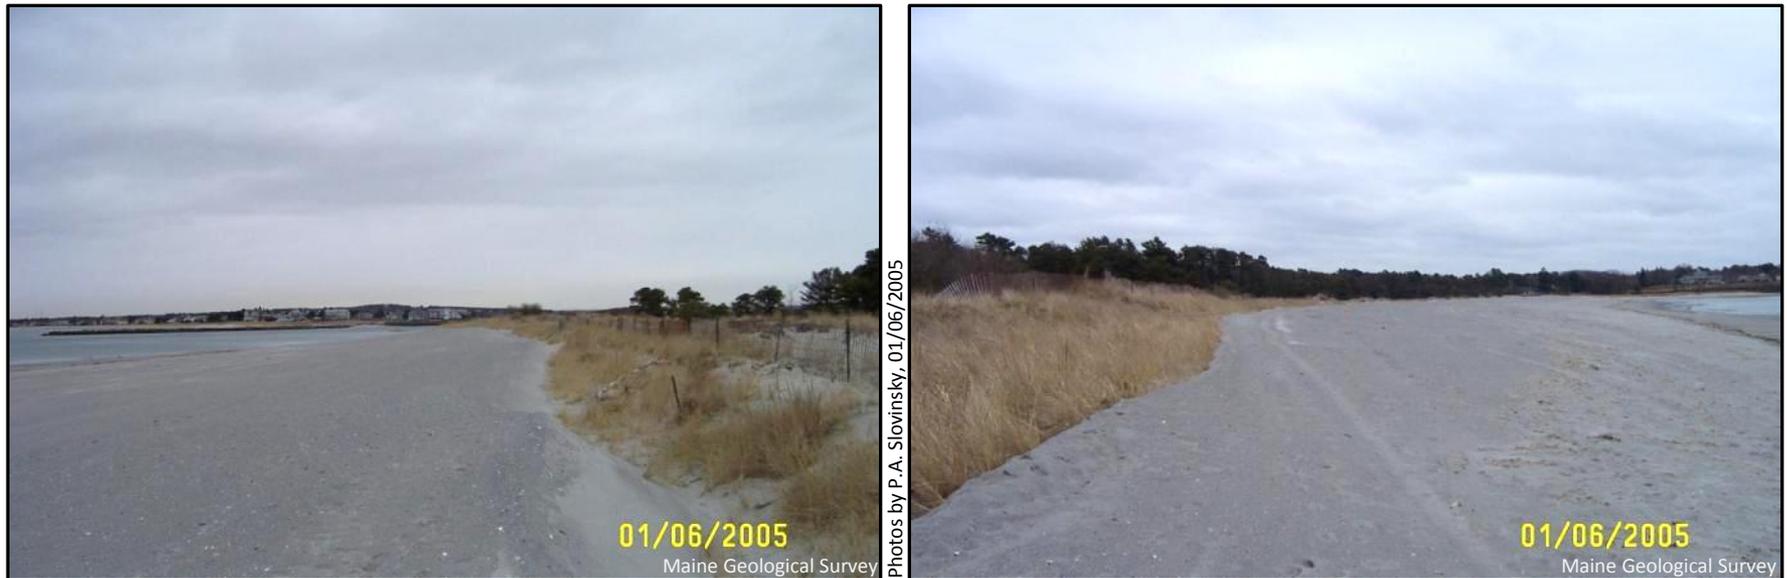
Figure 2. Views looking northwest (left image) and southeast (right image) along Western Beach after the 2004 beach nourishment project was completed. Note the large, flat "dry beach" or berm that was created as a result of the project.

The Maine Geological Survey published a [Site of the Month in June 2006](#) on Western Beach that detailed much of the site's history including dominant inlet processes, shoreline change, and dredging. Western Beach was "nourished" with 90,000 cubic yards of sand dredged from the Scarborough River federal channel by the US Army Corps of Engineers in late 2004. The project resulted in a wide beach berm (also known as the "dry beach") but did not include the creation or restoration of sand dunes. Figure 2 shows views of the beach after nourishment was completed in December 2004.

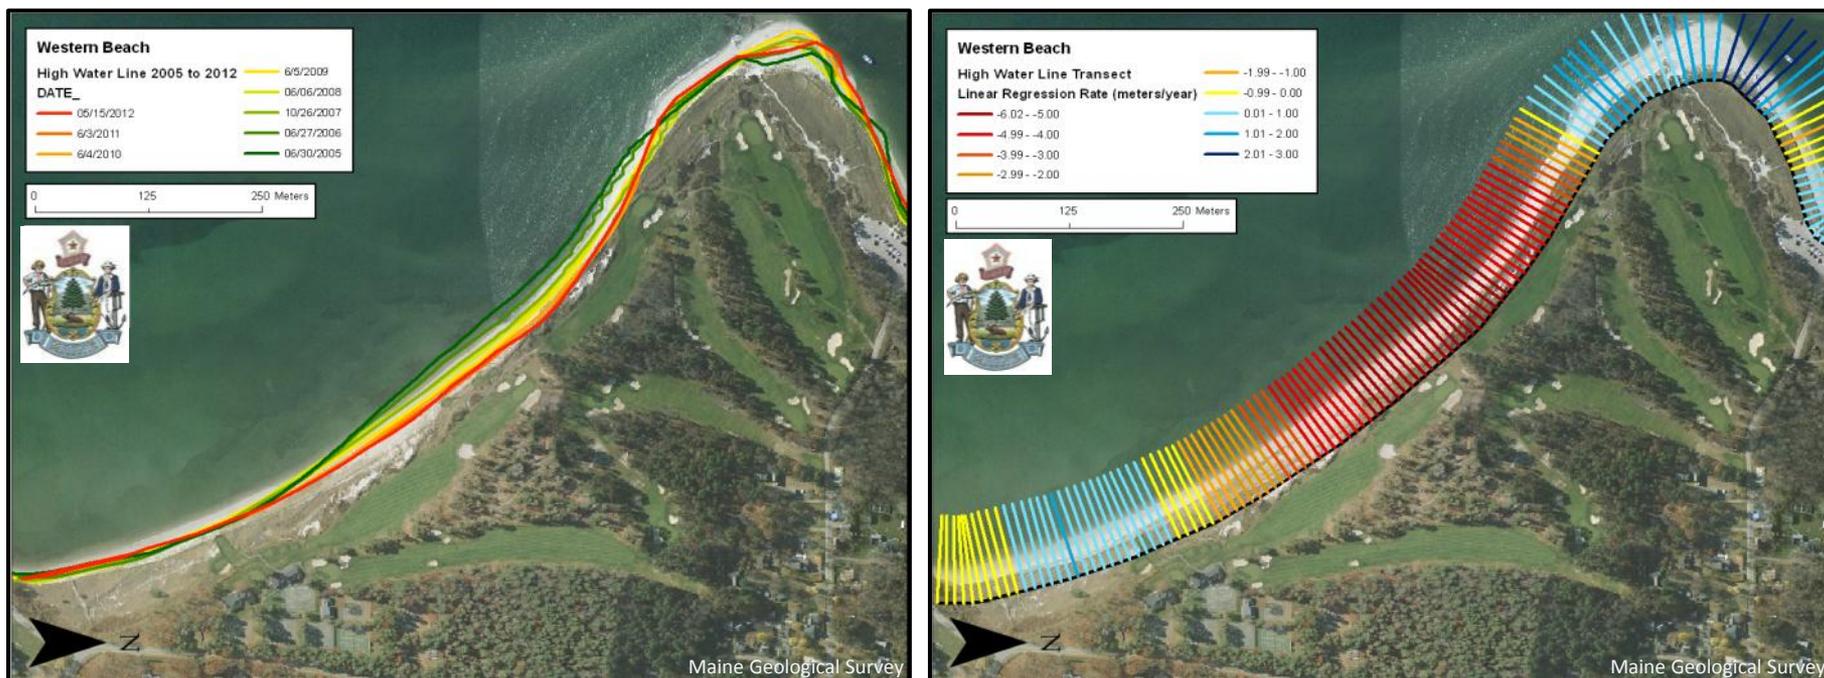
Figure 3. Comparison of high water line positions along Western Beach from 2005 through 2012 (left image). Calculated shoreline change rates (in meters per year) at transects along Western Beach (right image). The central portion of the beach eroded at up to 15 feet per year. Meanwhile, nearby beaches at Prouts Neck, Ferry Rock and Ferry Beach were either stable or grew.

Since the beach nourishment of 2004, Western Beach has steadily eroded at a high rate, which is documented in the [Maine Geological Survey August 2011 Site of the Month](#). Using Real Time Kinematic Global Positioning System (RTK-GPS), the MGS surveys the seaward edge of the vegetation line, in addition to the landward extent of the latest high tide line. Comparison of surveys from 2005 through 2012 (Figure 3) shows the beach eroded inland at a rate of up to 5 meters (over 16 feet) per year!

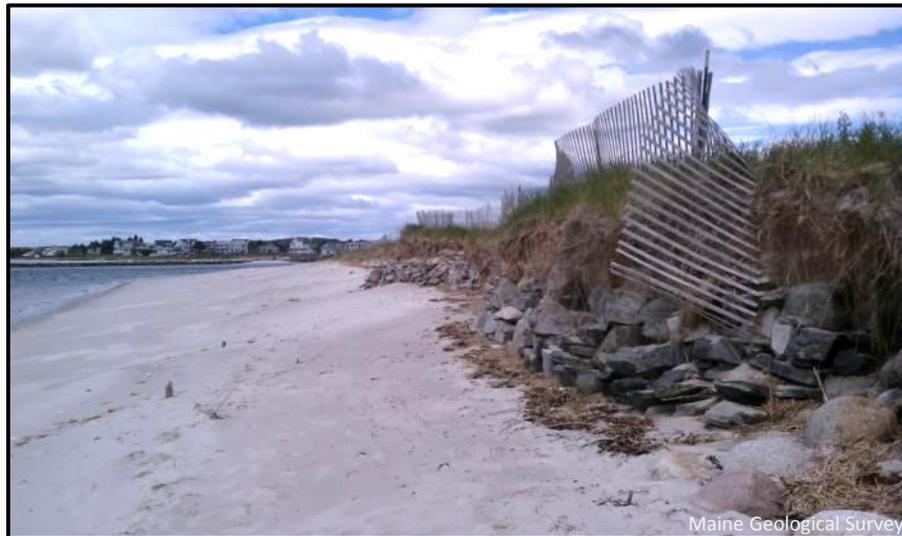
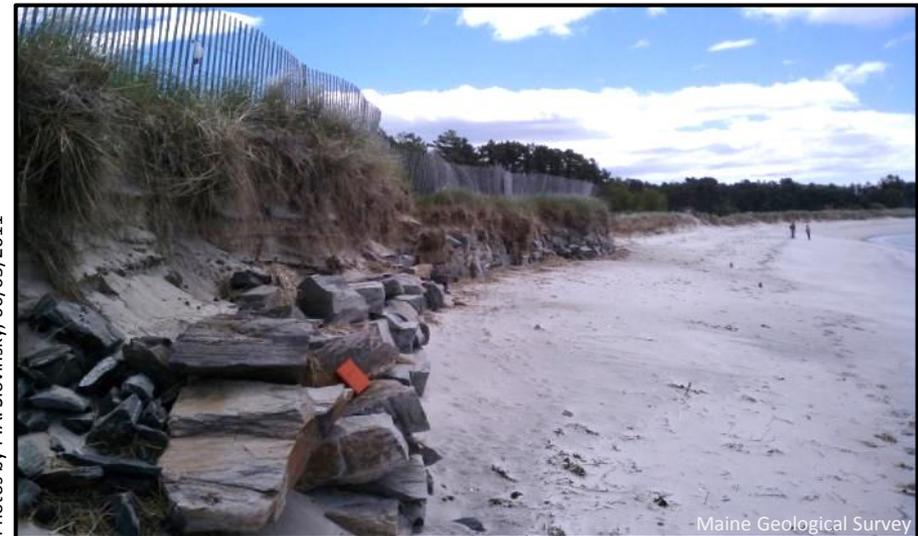
By 2011, shoreline erosion along Western Beach had exposed a large section of an old rock seawall, which according to the Country Club, was built sometime in the 1930s (Figure 4). Erosion had also reached and was threatening to impact the 2nd hole tee box and a portion of a green. As a result, the Prouts Neck Country Club applied for and received permission from the Maine Department of Environmental Protection (DEP) to temporarily stabilize this stretch of shoreline, including the dune system to the southeast, with sand bags until seawall reconstruction could be permitted and reconstructed, in conjunction with an expected dredge of the federal harbor by the US Army Corps of Engineers in the winter of 2013/2014.

Figure 4. 1930's seawall exposed by erosion in 2011 along Western Beach. Left image: view to the northwest. Right image: view to the southeast.

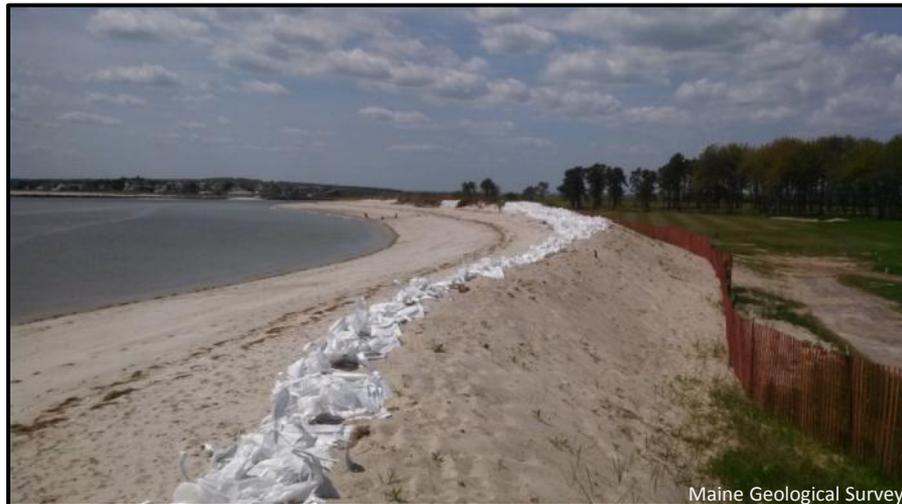
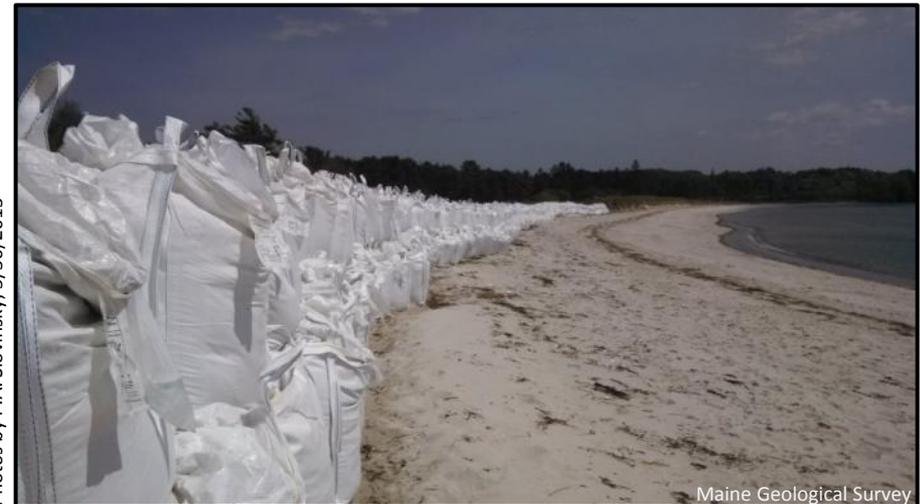
Figure 5. Temporary sandbags and placed sand along a section of rapidly eroding shoreline in 2013. Left image: view to the northwest. Right image: view to the southeast.

In 2013, the country club placed permitted temporary sandbags along the seaward side of the eroding dune at two separate locations; 1) where the dilapidated seawall was, and 2) where the sand dune had eroded to the southeast of the seawall (Figure 5). Beach-compatible sand from upland sources was trucked in and placed on the landward side of the sandbags. Figure 5 shows the temporary sandbags and sand trucked into the site. The sandbags remained in-place until the seawall was replaced and sand was available for dune reconstruction in conjunction with the federal dredging of the Scarborough River channel in the winter.

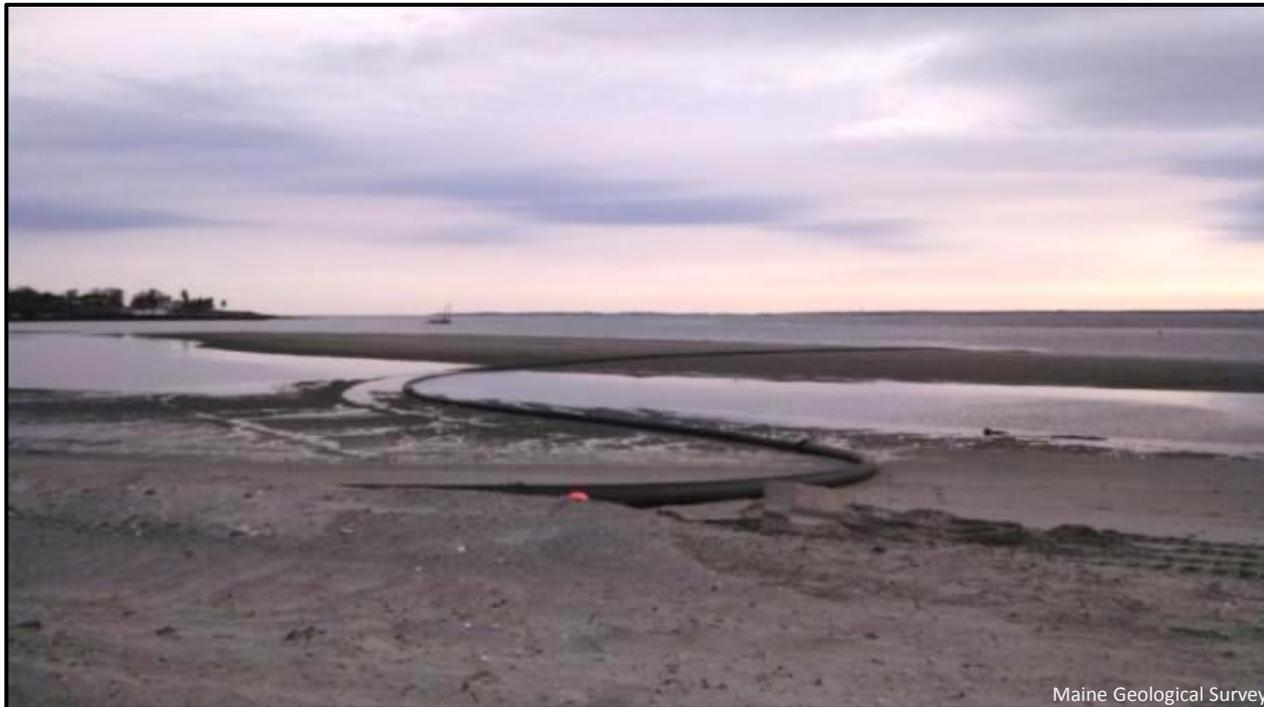
Figure 6. View looking southeast of the dredging operation. The dredge platform is visible in the river channel and the pumping pipeline is in the foreground.

Dredging of the federal channel of the Scarborough River in the winter of 2013/2014 underwent significant delays due to contractor timing, weather, and other factors. The dredging used a platform dredge with suction (also known as a “cutterhead”) which lifted water and sand from the channel, and pumped it onto the beach using a long pipeline. Once on the beach, the material was dewatered in a large mound, and then shaped with equipment.

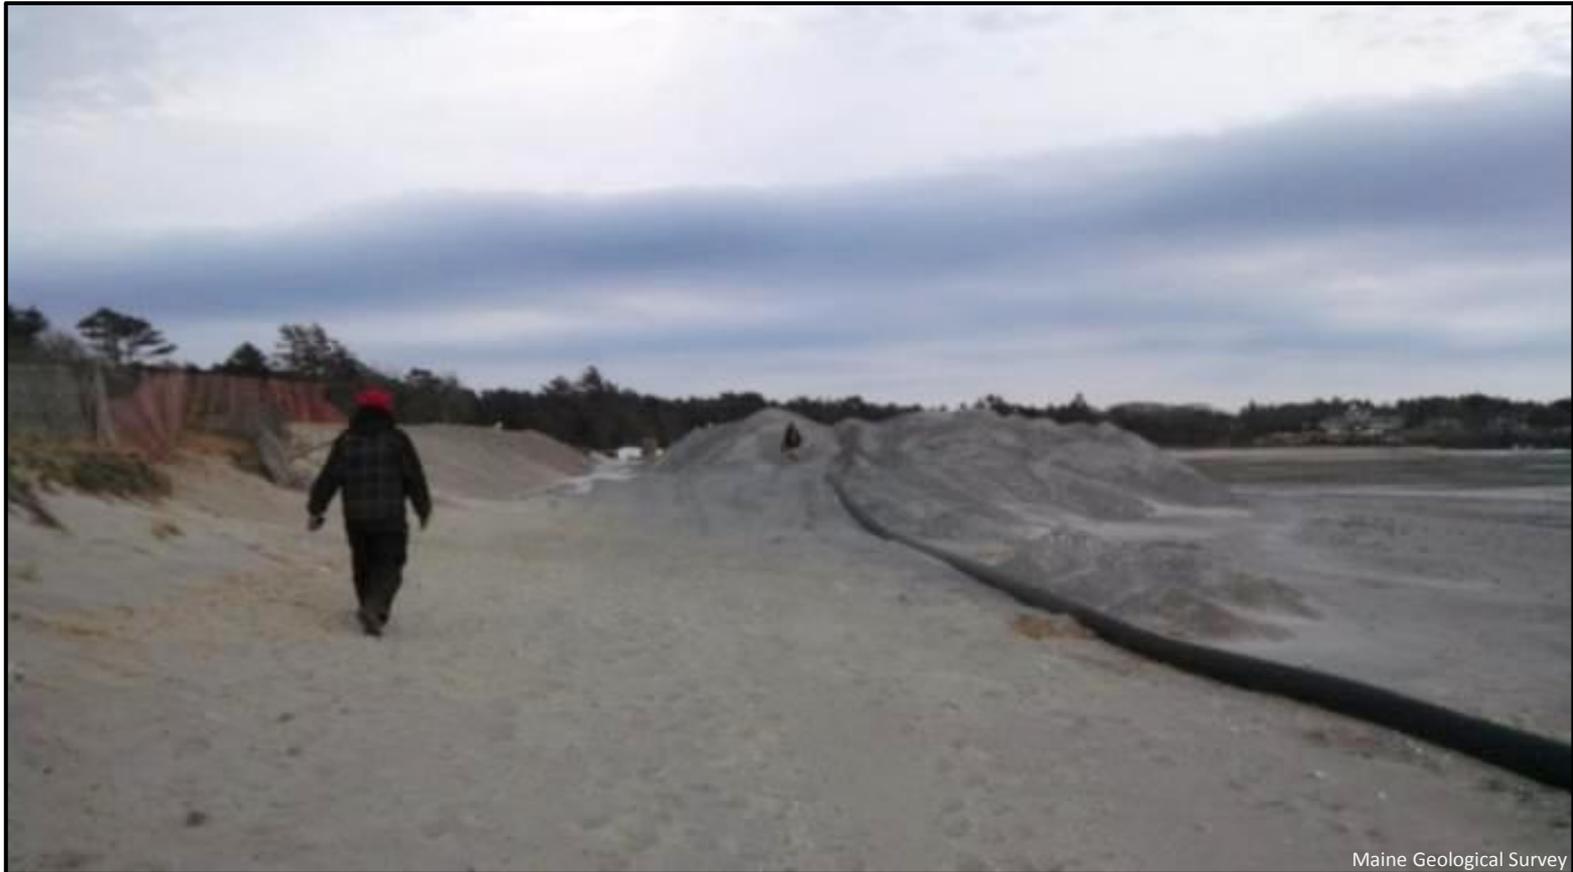
Figure 7. Pumped material is mounded on the beach via the pipeline.

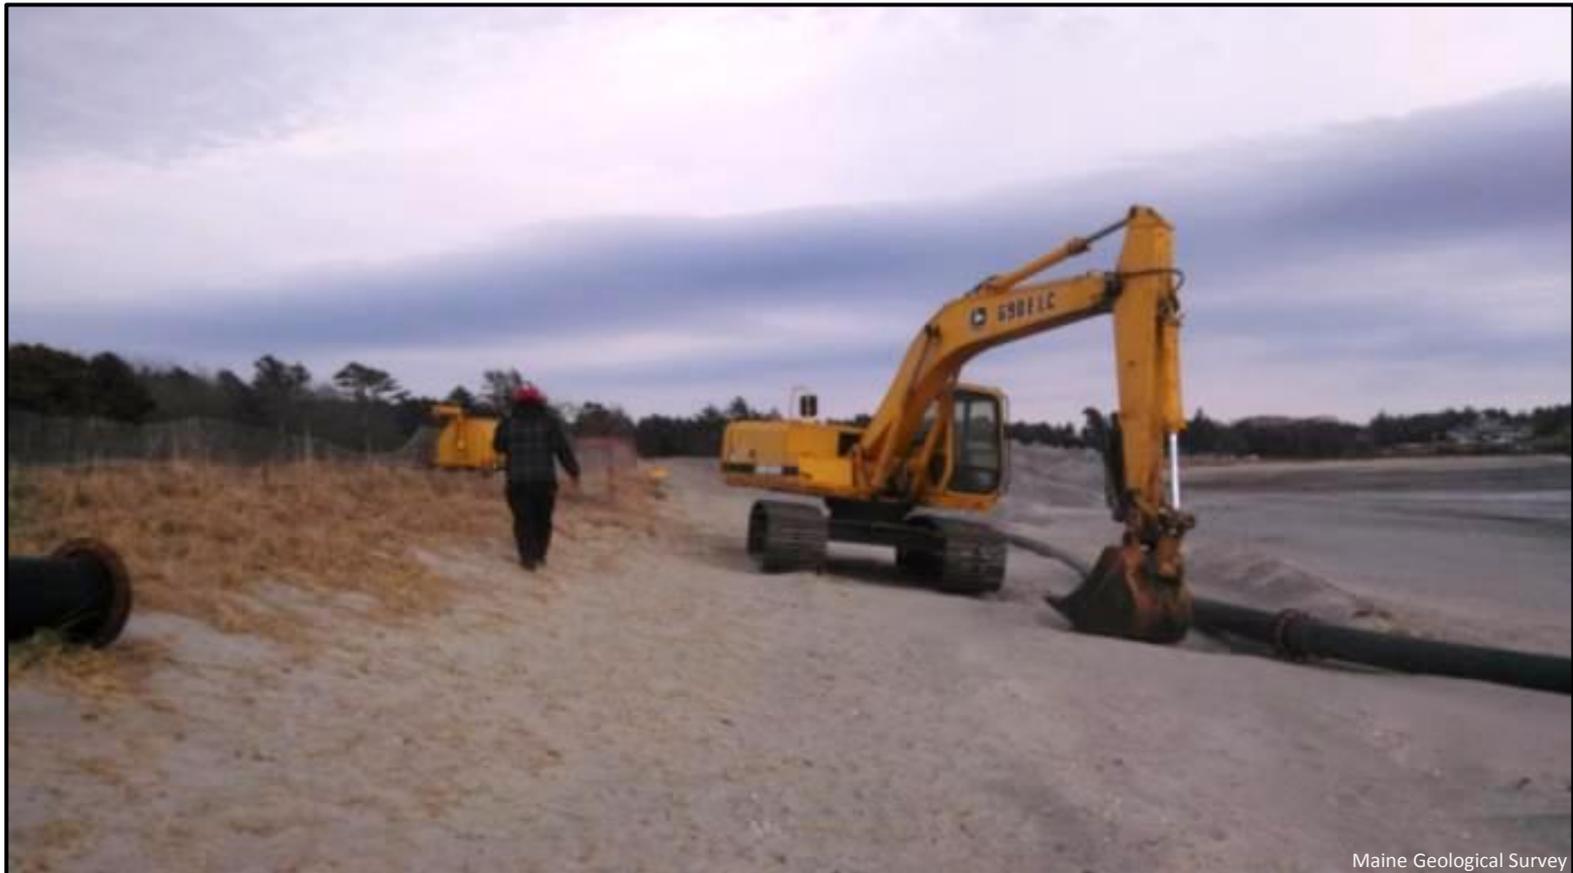
Figure 8. Excavator digging pits for the material dewatering.

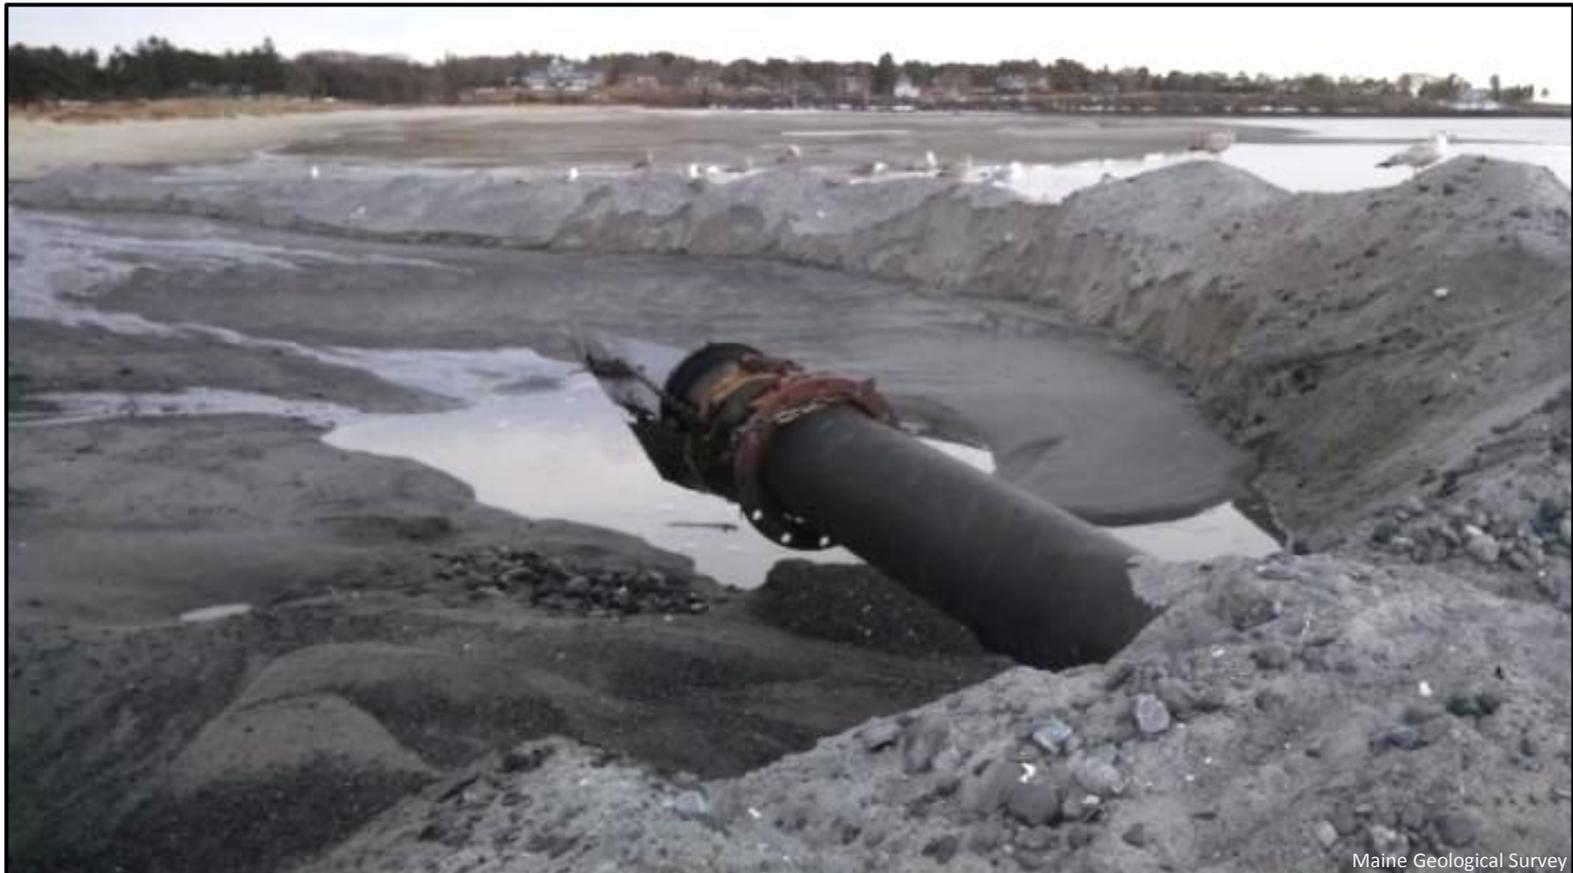
Figure 9. Pipe end where sand is pumped onto the beach for dewatering.

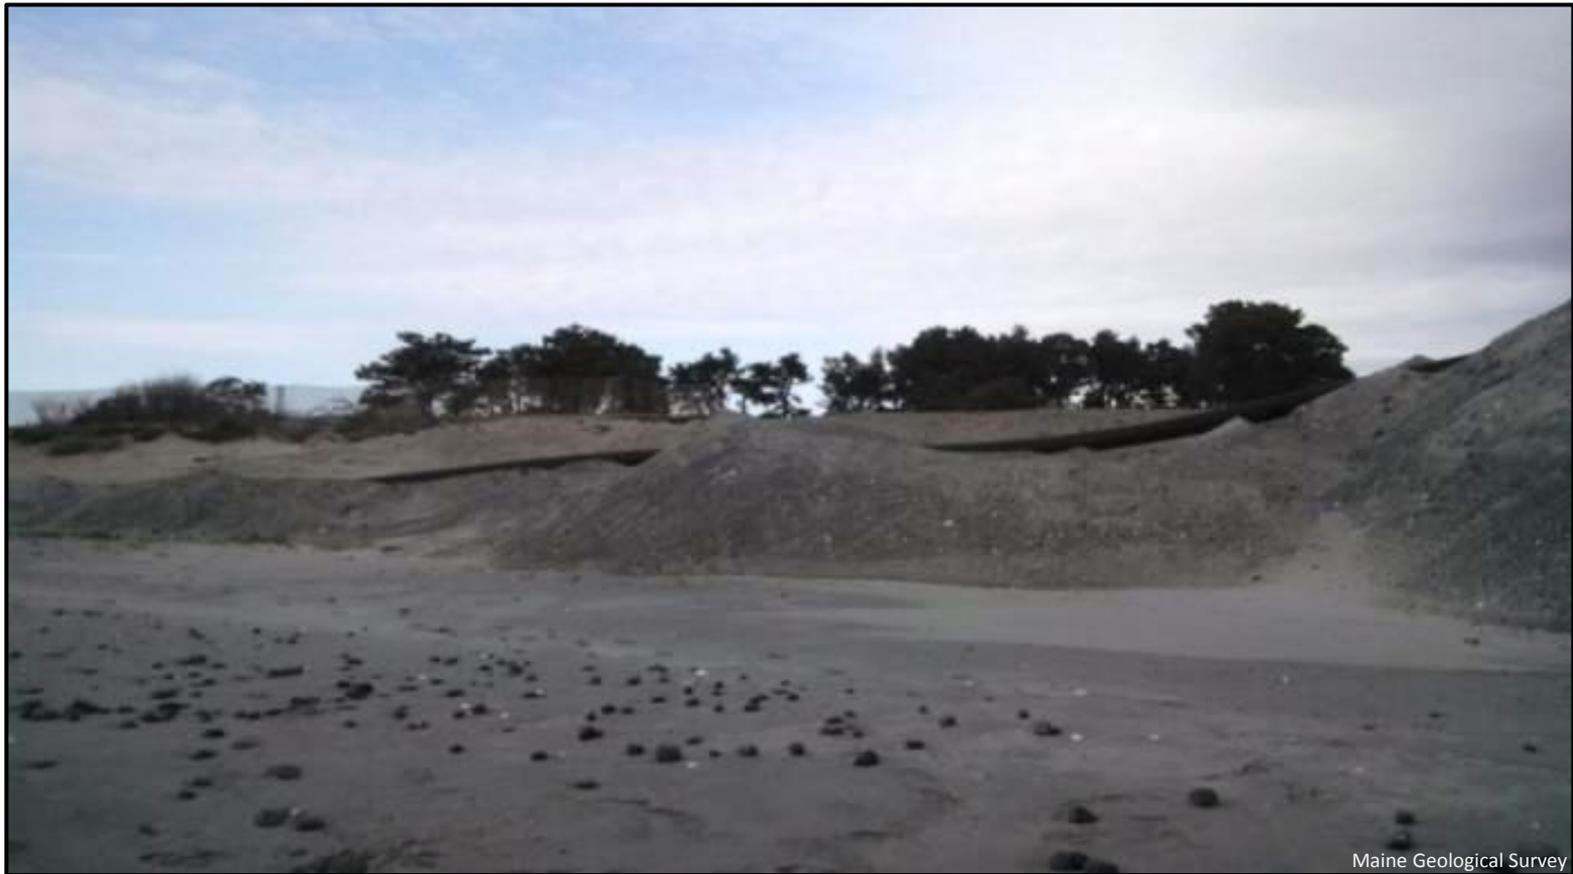
Figure 10. Dewatered sand on the beach before shaping.

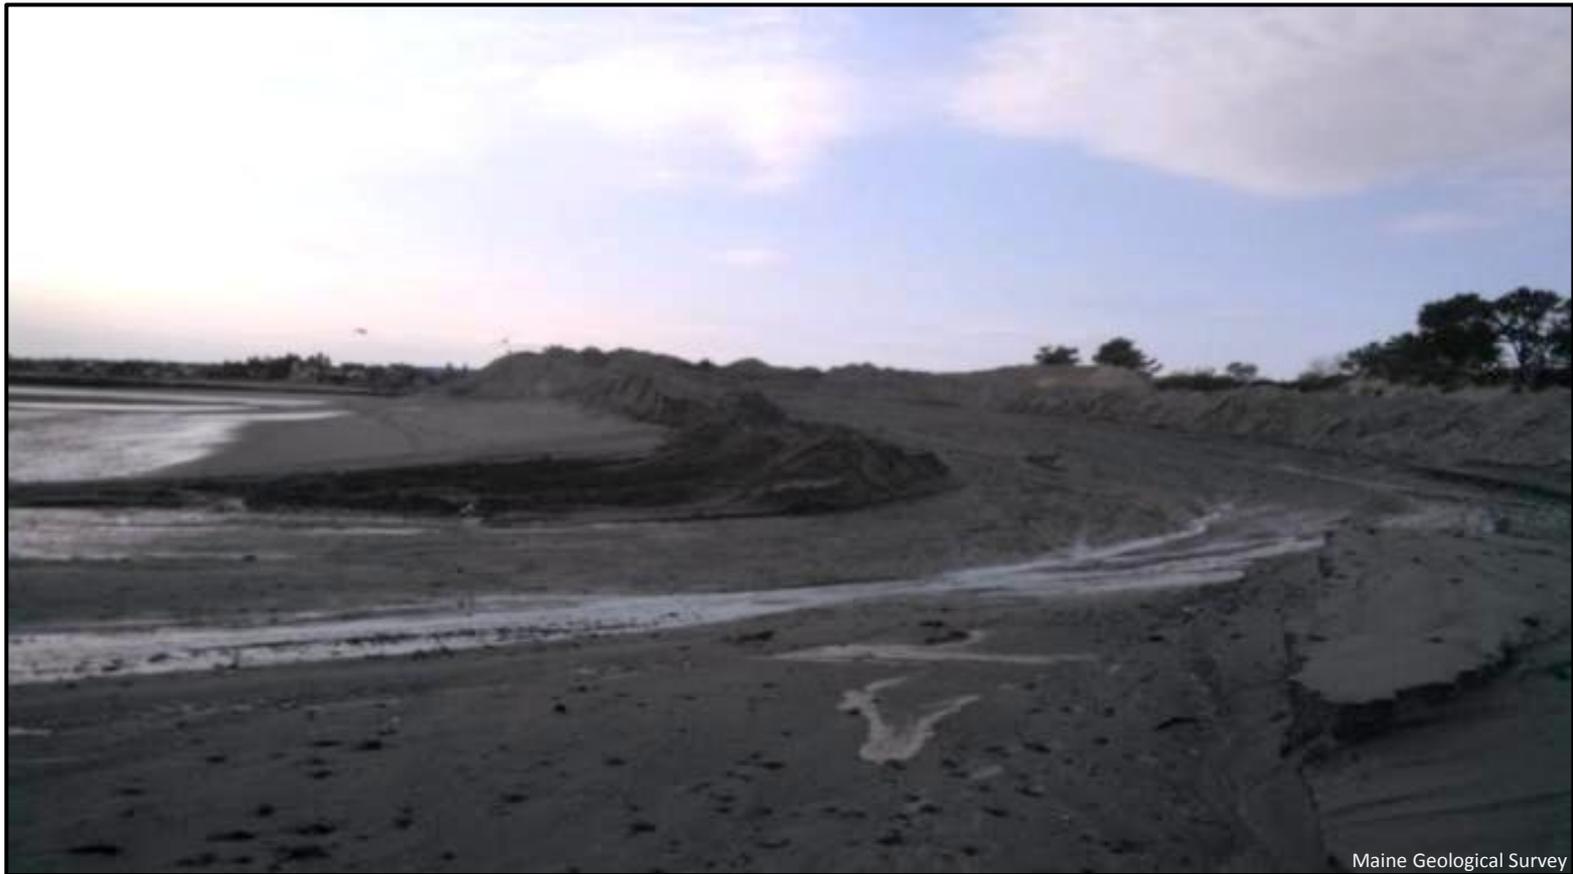
Figure 11. Water draining from dewatering sand on the beach.

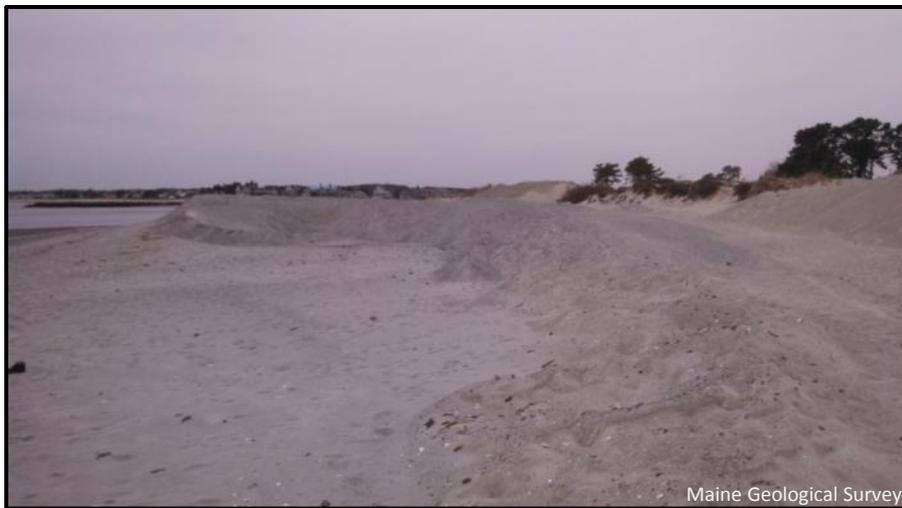
Figure 12a. View northwest of mounded dredged sand, waiting to be shaped.

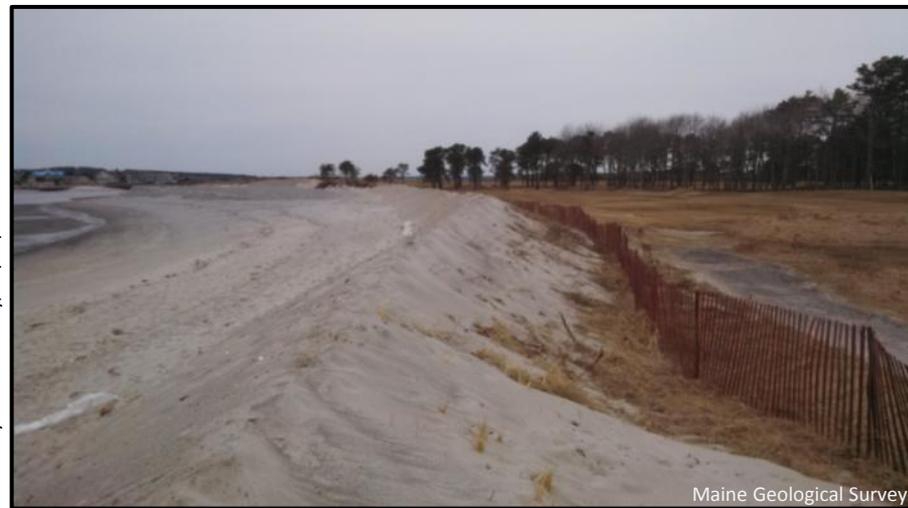
Figure 12b. View of the dune ridge that was created with dredged and trucked in material along the edge of the golf course. It has yet to be planted with beach grass. Same area shown in Figure 5.

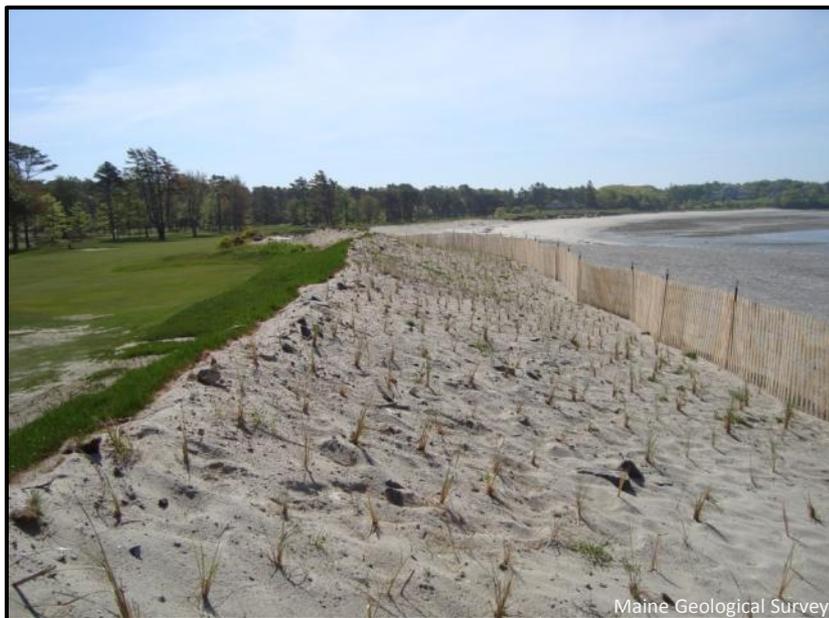
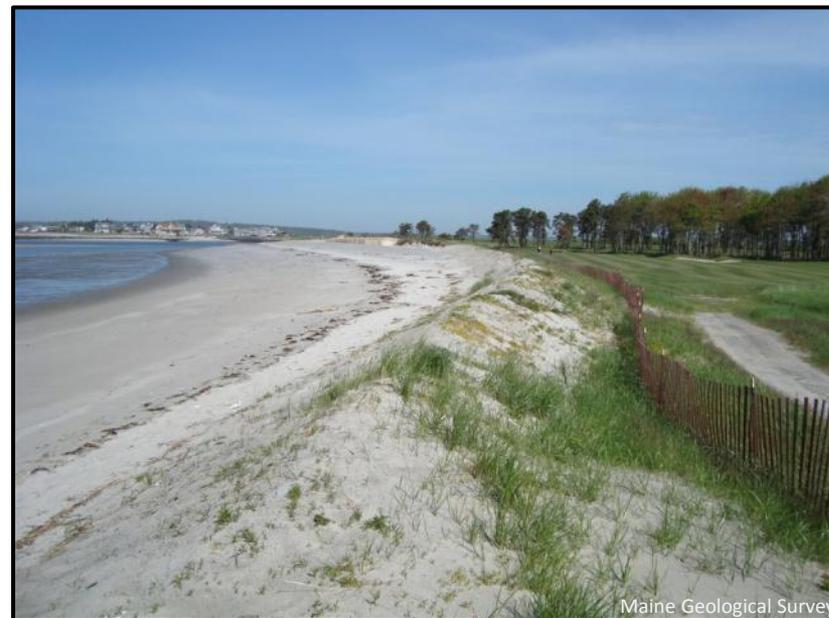
Figure 13. View southeast (left image) of artificial dune built on the reconstructed seawall. The stretch of reconstructed dune in the right image is in the background. View northwest (right image) of reconstructed dune ridge.

The country club completed its seawall reconstruction at the same time as the federal dredge was occurring. As a condition of the permit, the wall had to be covered with trucked-in, beach-compatible sand and planted with beach grass. The completed project as of June 2014 is shown below in Figure 13 (left image). The country club also completed a dune restoration project along a significant stretch of the beach that included creation of a frontal dune, and planting with American beach grass. This is shown in the right image, below.

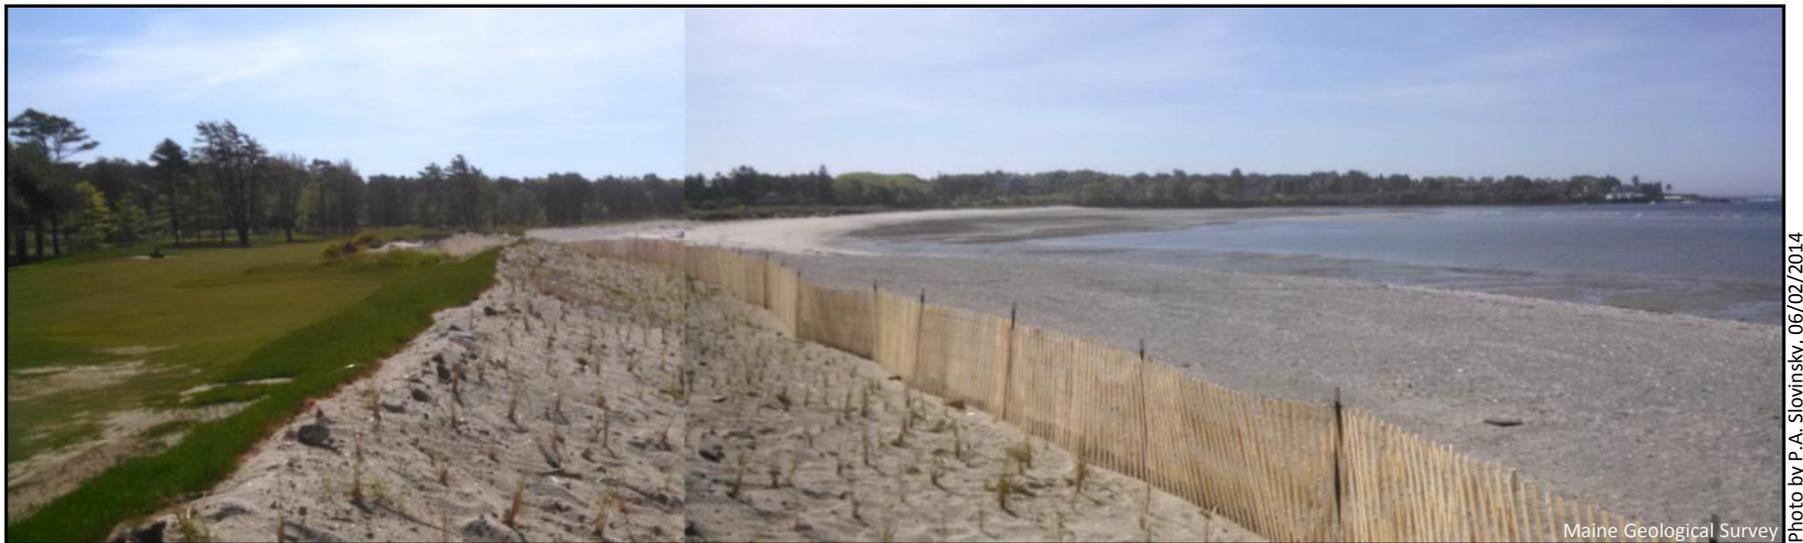
Figure 14. Panoramic view looking southeast towards Prouts Neck. The artificial dune is built on the reconstructed seawall as well as on an area of nourished beach to the right.

As of June 2014, the beach had been graded and the dune construction completed. The wall is covered with sand dune that now protects an area of the Prouts Neck Country Club golf course. Sand fencing protects the new vegetation from foot traffic and also traps wind-blown sand at the toe of the new dune. Seaward of the dune is an area of nourished beach with a wide berm. The berm helps protect the dune from wave action while the American beach grass gets established.

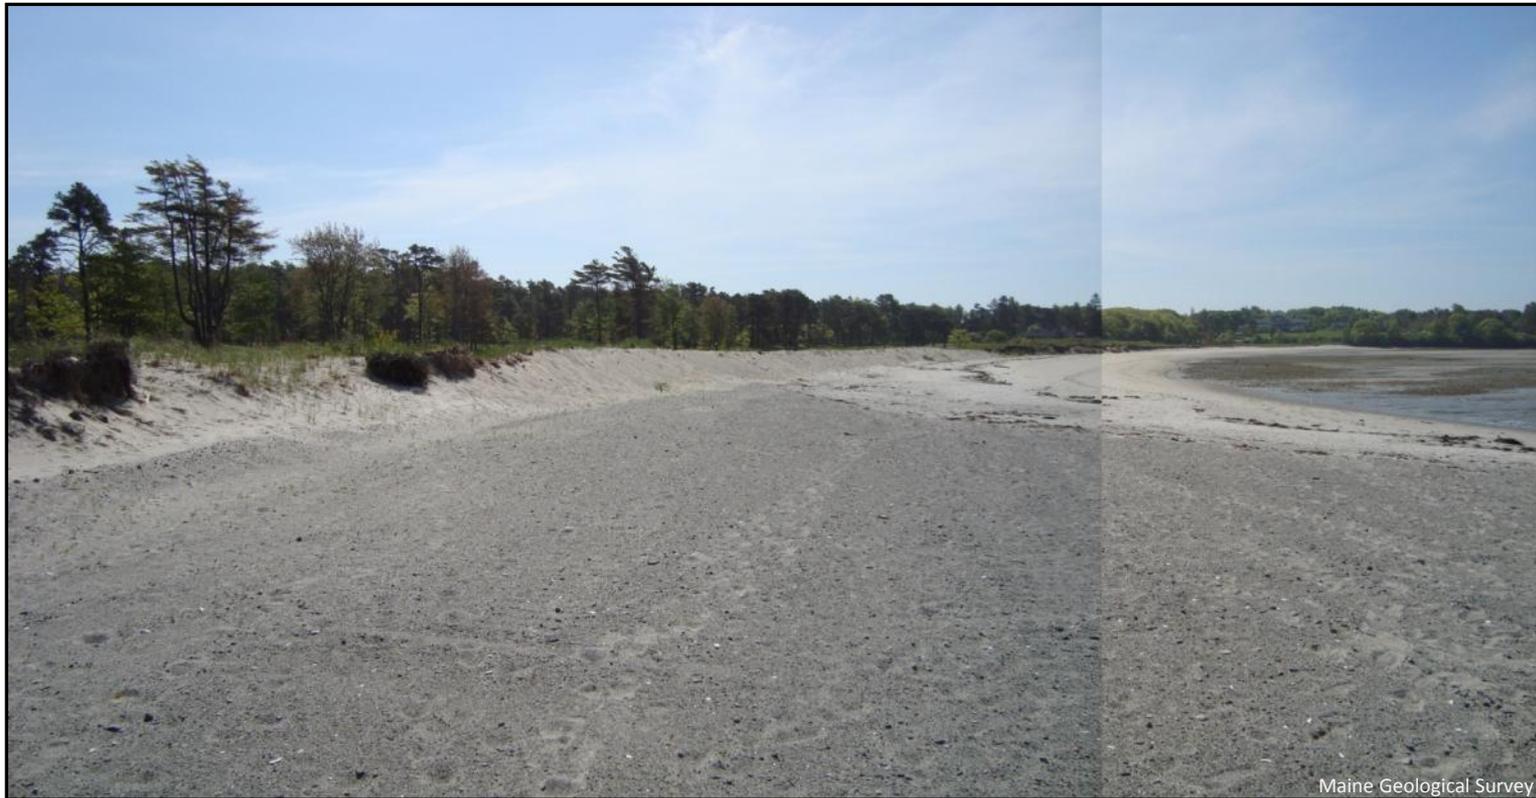
Figure 15. Panoramic view looking southeast, of a section of the nourished dry beach. The reconstructed and planted sand dune is visible in the middle of the image. The Prouts Neck Country Club golf course is behind the dune, to the left.

The photograph below shows the nourished dry beach (berm) and reconstructed and planted sand dune along the Prouts Neck Country Club golf course.

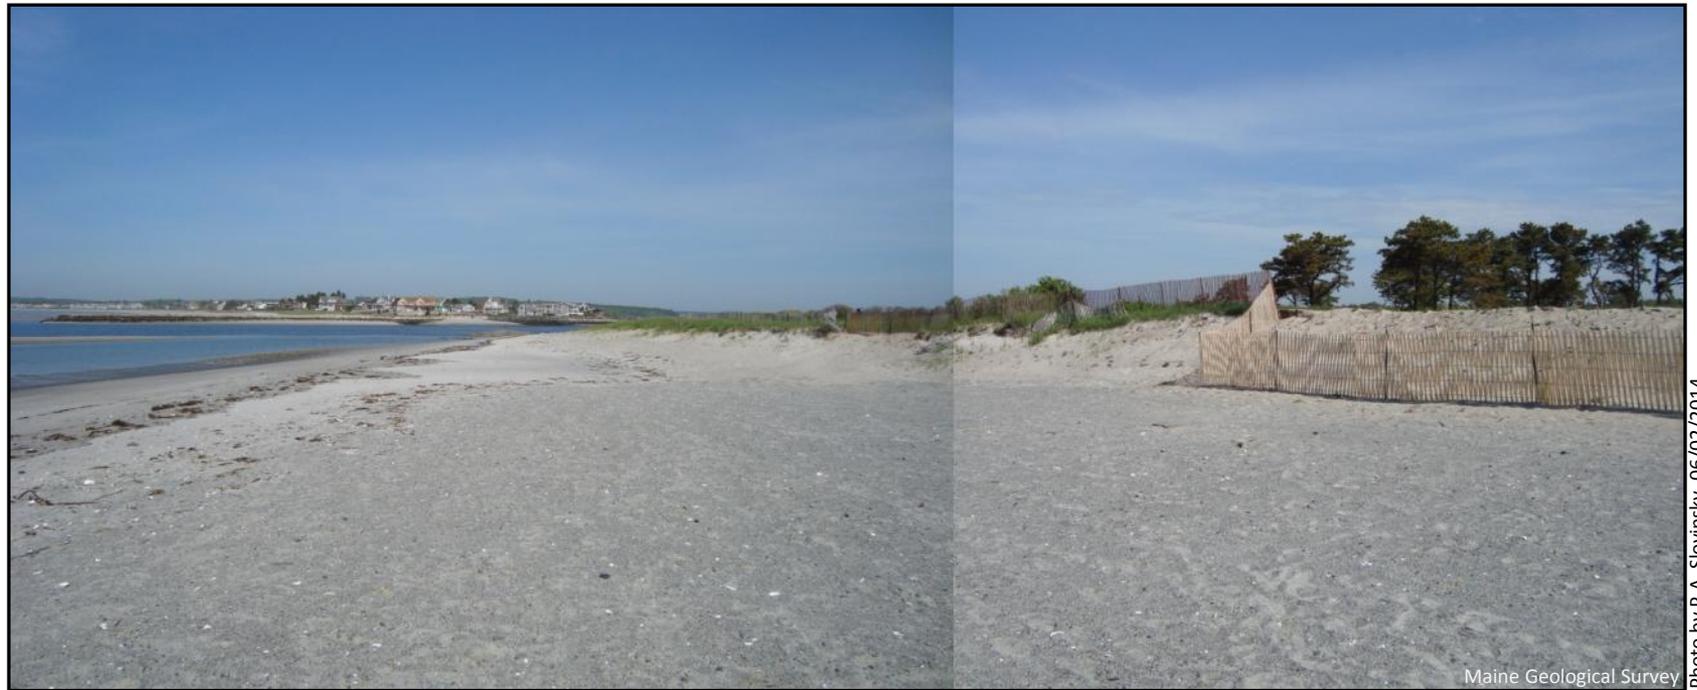
Figure 16. Panoramic view looking northwest, of a section of the nourished dry beach (berm). The reconstructed and planted sand dune that is covering the seawall is to the right in the image. Pine Point is in the distance.

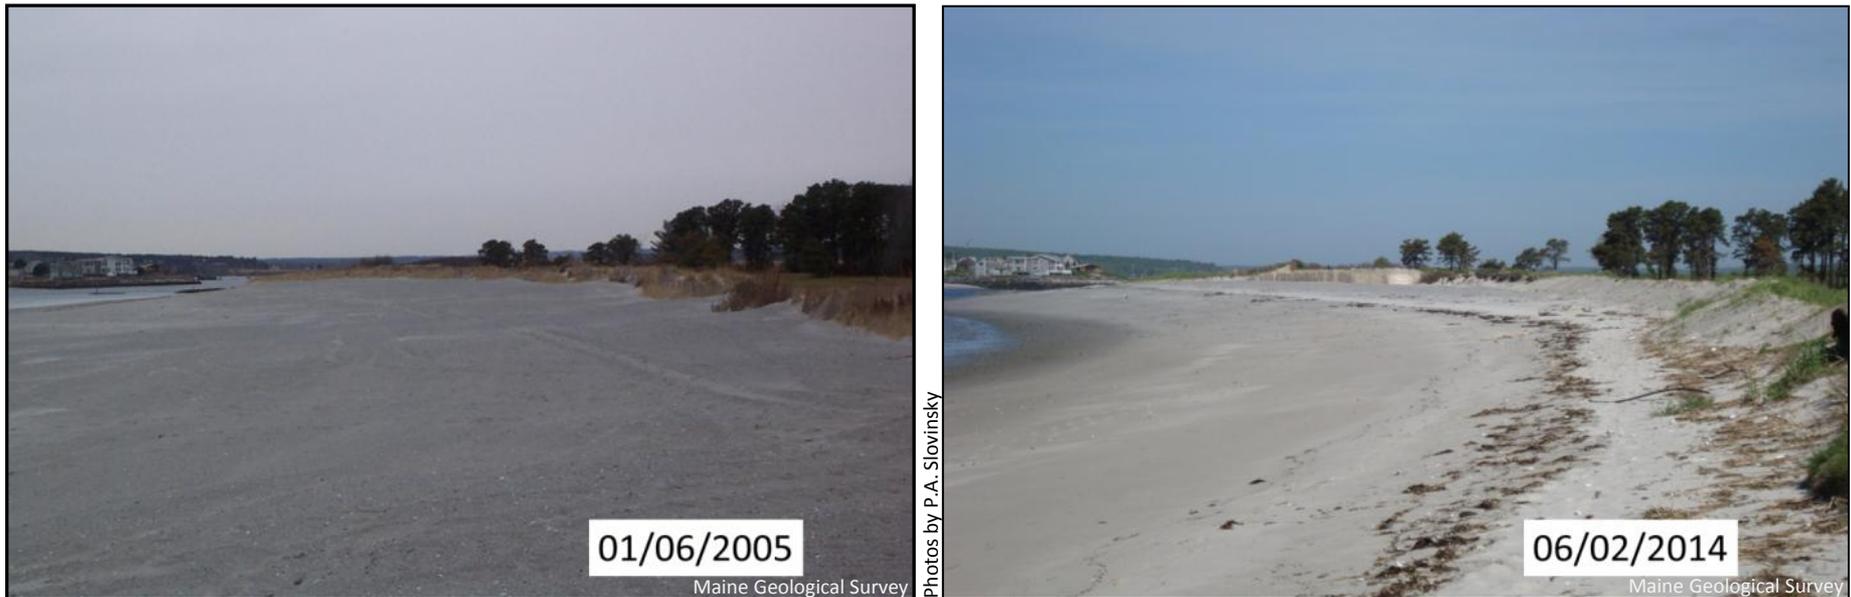
Figure 17. The left image shows the northwest view of the completed beach nourishment in January 2005. Note the wide, flat, dry beach or “berm”. In the right image, from June 2014, note the lack of a beach berm, signified by the wrack line near the dunes, but a clear increase in the frontal dune crest elevation as a result of dune restoration efforts.

The next few pages compare images along certain sections of Western Beach from directly after the beach nourishment project in January 2005, with images from June 2014. Note that the images may not be taken from the exact same location, but are close enough for qualitative difference assessment between the results of the two projects. Figure 17 compares views looking northwest along Western Beach towards Pine Point.

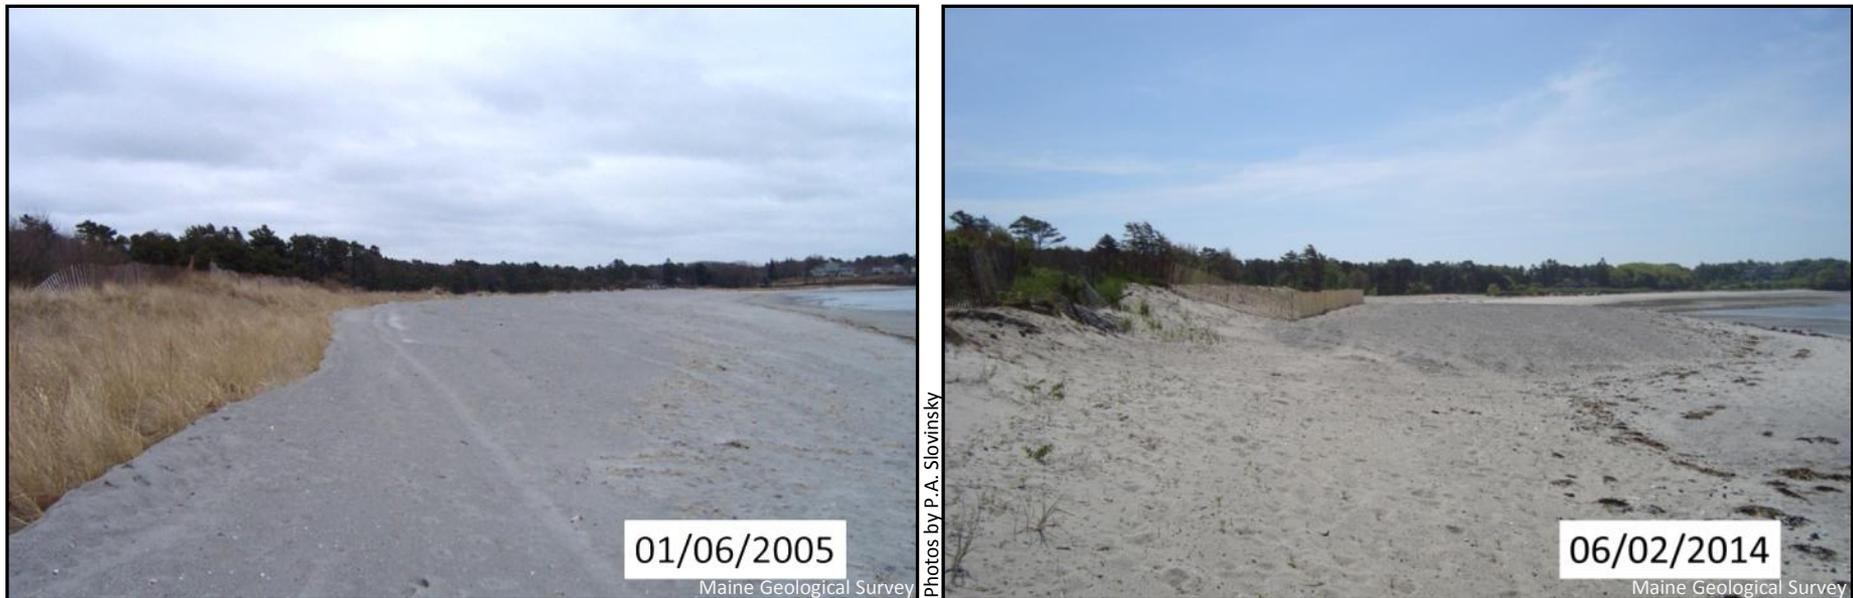
Figure 18. The left image shows the southeast view of the completed beach nourishment in January 2005. Again, note the flat, wide dry beach or “berm”. In the right image, from June 2014, note that the beach berm created from the dredged material is much smaller, and stops in the foreground of the image since the project was not completed.

The photos below compare the 2005 and 2014 views looking southeast along Western Beach towards Prouts Neck. Note the differences in the dry beach width. Also, note that the 2005 project did not include any dune restoration efforts – just the construction of a berm to the base of the existing dunes. The 2014 project integrates restoration of the dunes with beach nourishment.
