Geologic Site of the Month

June, 2014

Status of Beach and Dune Restoration at Western Beach, Scarborough

Text by
Peter A. Slovinsky

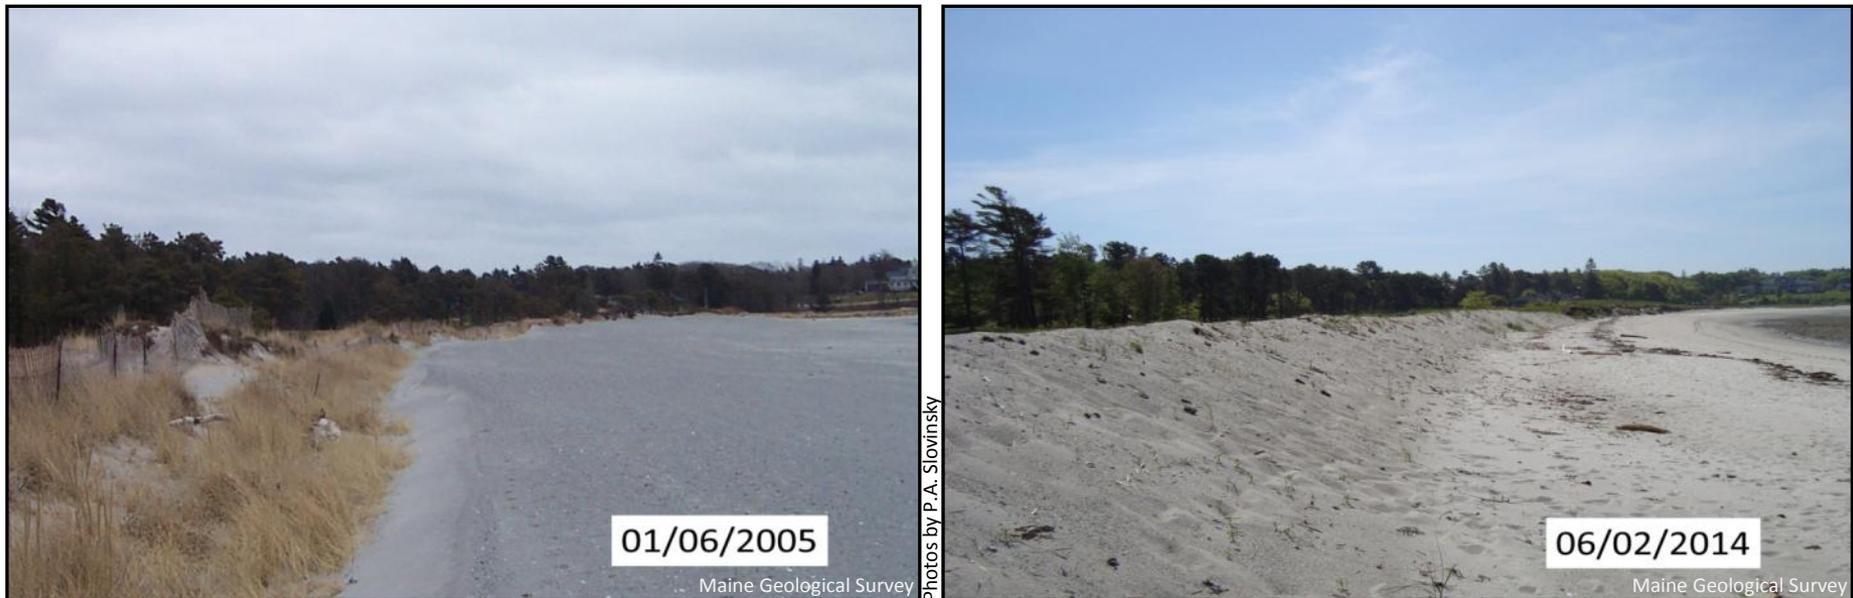
Figure 19. The left image shows the view southeast, of the completed beach nourishment in January 2005. The right image shows approximately the same view in 2014. This shows the extent of the dune restoration project along a portion of the beach. Note the lack of dry beach in the 2014 image.

The photos below compare the 2005 and 2014 views looking southeast along Western Beach towards Prouts Neck. Note the differences in the dry beach width. The entire berm and dunes that existed in 2005 post-nourishment had been eroded. The new dunes are visible in the image on the right.
