Geologic Site of the Month  
May, 2005

## *Ogunquit Beach and Dunes Over Time*

Text by  
Stephen M. Dickson

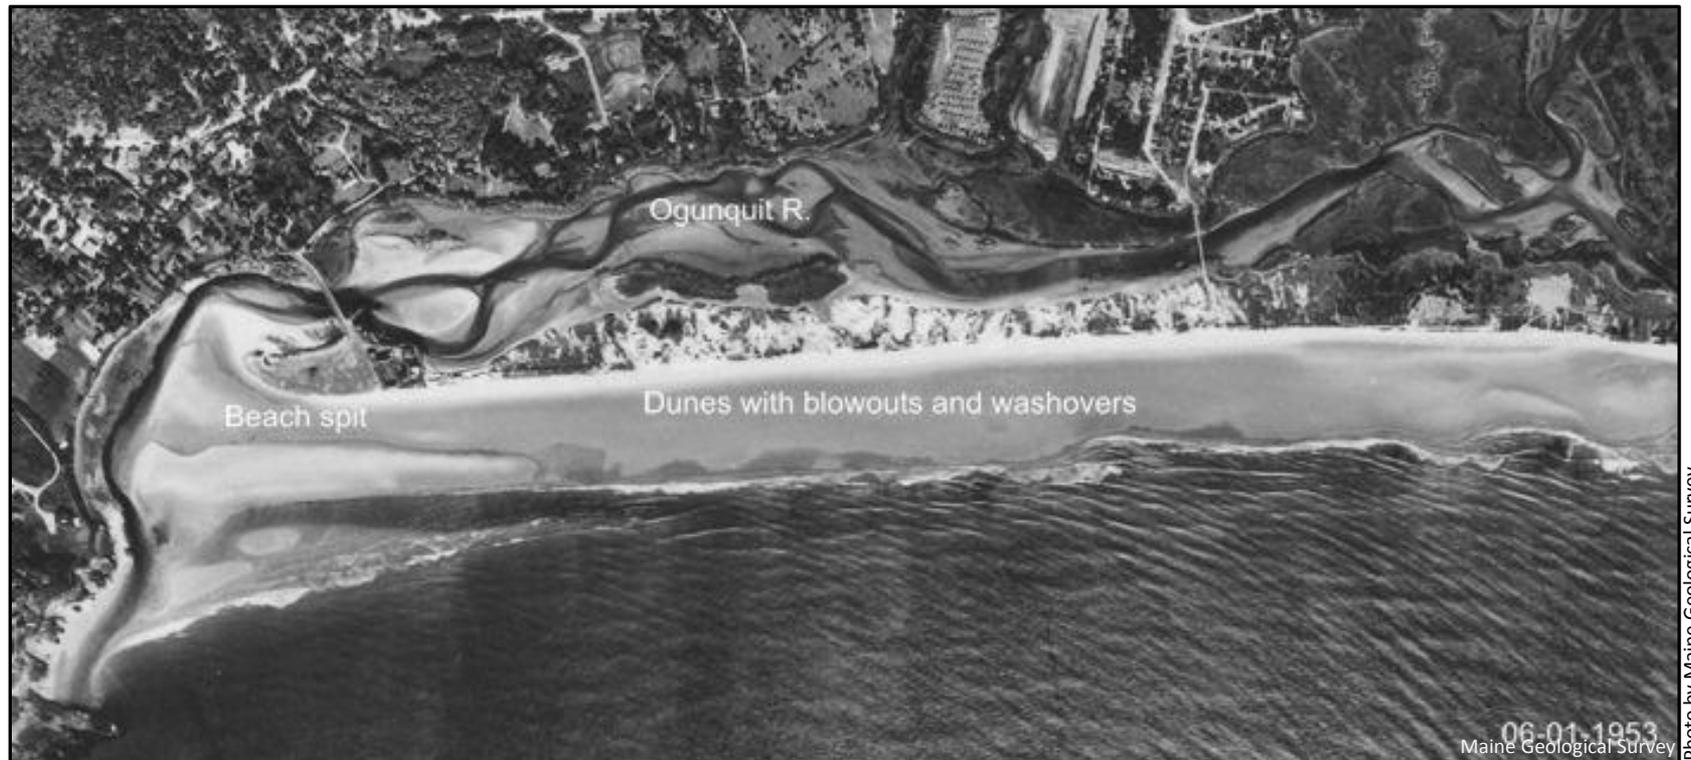
In 1953 the central portion of the Ogunquit dune field was an equal mix of vegetated dunes and open sand surfaces (Figure 1). The open areas appear to be a combination of blowouts created by wind and washouts where surf and coastal flooding washed sand into the dune field. The entire beach and dune system was very dynamic and responsive to the forces of nature.

**Figure 1.** Aerial photograph of the dunes in 1953

The northern segment of Ogunquit Beach (Figure 4) is the location of the Ogunquit Sewer District treatment plant. This facility was built in the back dunes. Close examination of the 1953 air photo (Figure 1) shows the alteration of the dunes in preparation for plant construction. The treatment facility once discharged into the Ogunquit River. Since 1993, the discharge has been through a pipe that is buried under the frontal dune and beach and extends offshore to an ocean outfall. Over time the plant's capacity has been expanded within the existing footprint in the dunes to accommodate a growing coastal population. The natural beach and dunes end at the Wells town line at Moody Beach.

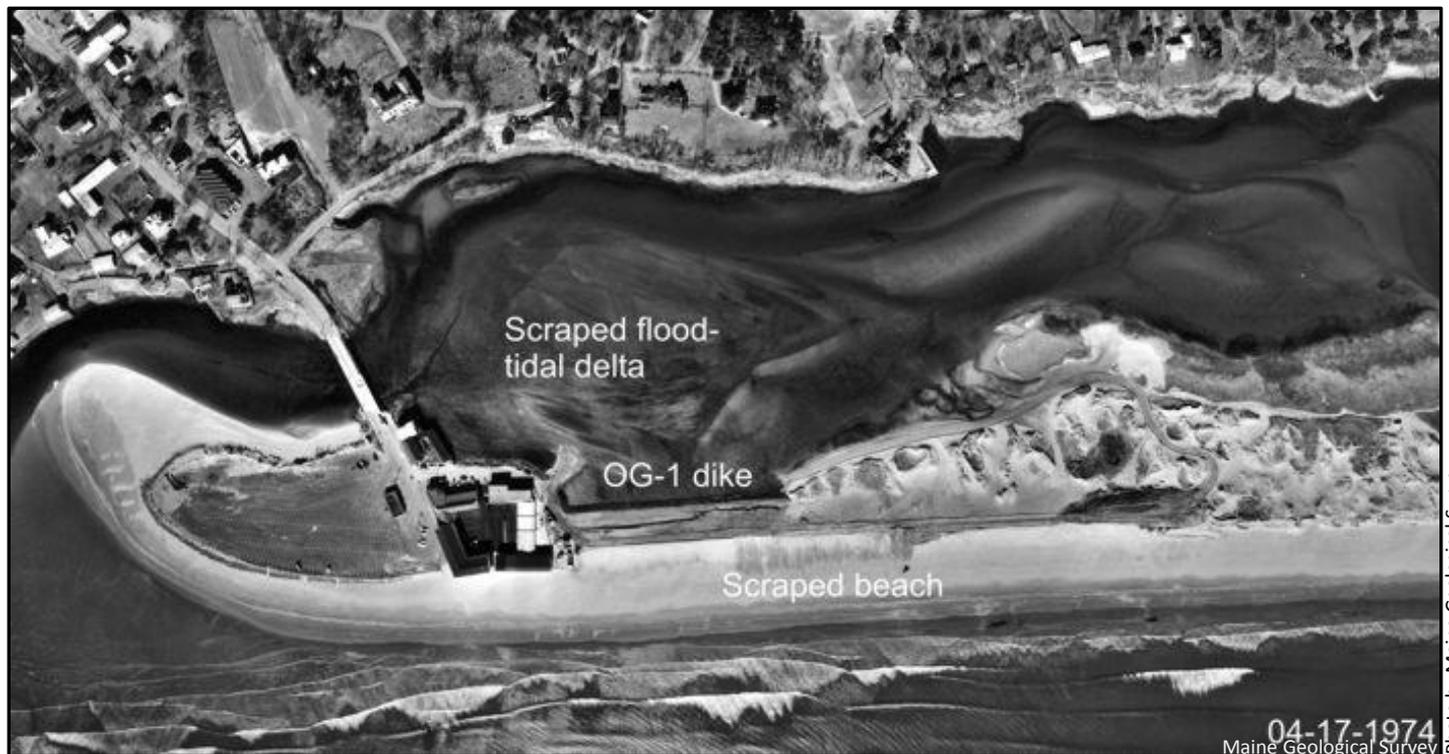
In the 1970s the U.S. Department of Agriculture, Soil Conservation Service led an effort to stabilize the dunes at Ogunquit. In 1974 construction of the OG-1 dike replaced the natural dunes with a linear ridge built of sand scraped from the flood-tidal delta in the Ogunquit River and sand from the beach profile. Close examination of Figure 2 shows a bulldozer at work on the beach. A network of roads to move sand appears in the back dunes along the river. By the summer of 1974 work on OG-1 was complete.

**Figure 2.** Aerial photograph of the dunes in 1974

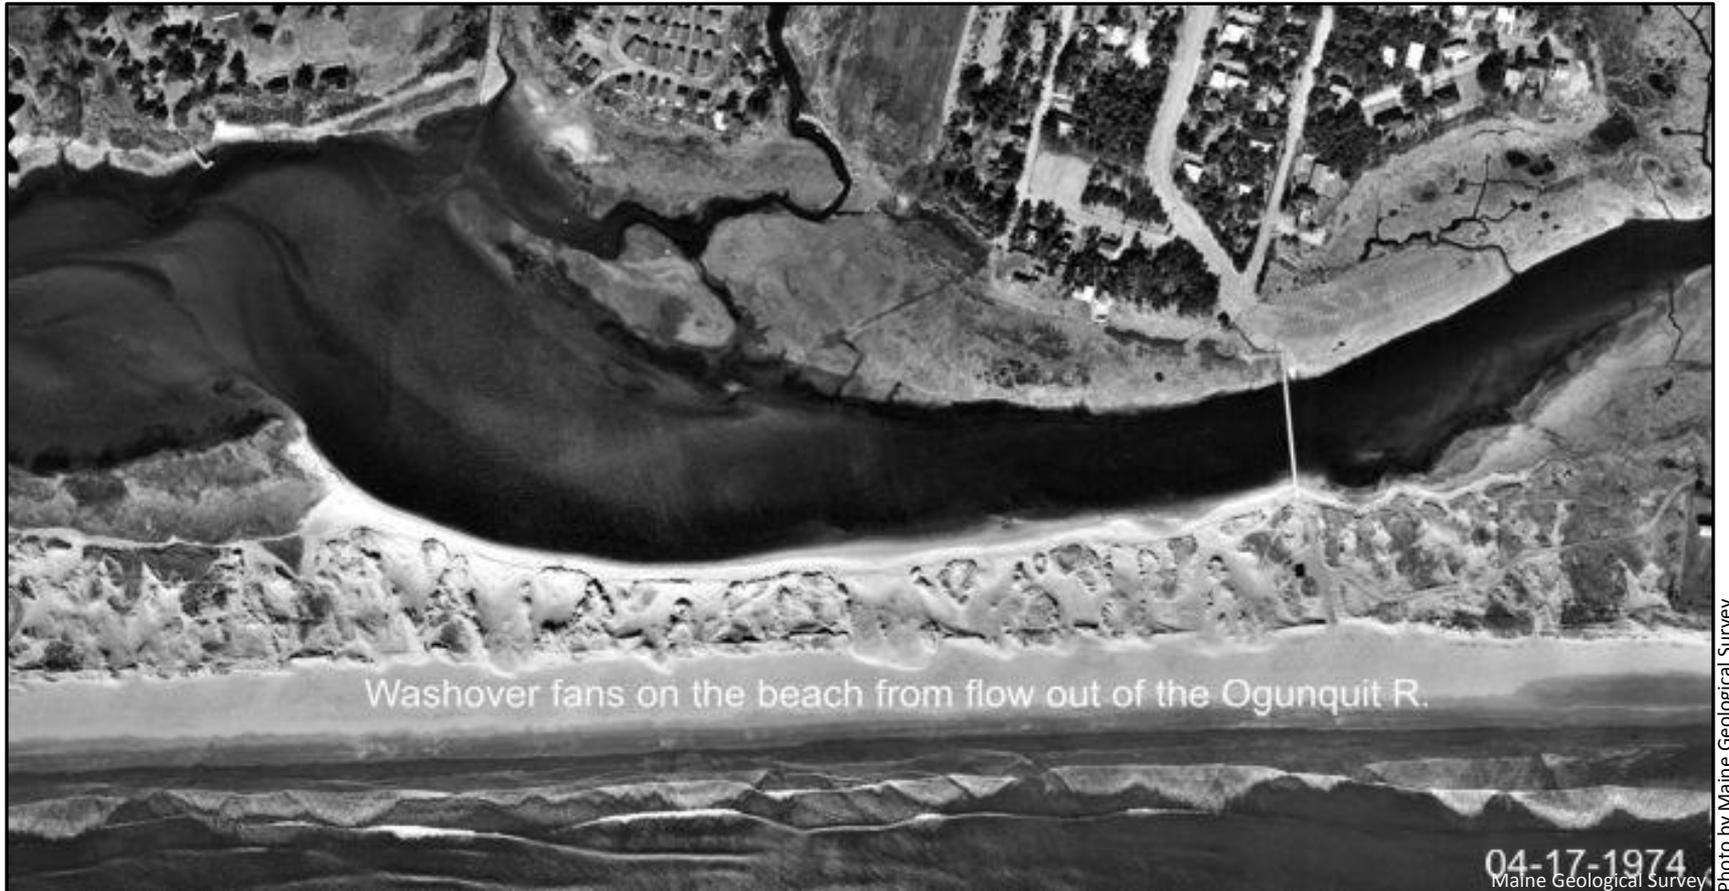
The central Ogunquit dune field shows signs of sand washing onto the beach from the dunes (Figure 3).

**Figure 3.** Aerial photograph of the dunes in 1974 showing washover fans.

High water levels in the Ogunquit River during a storm can cause flooding in the dunes and, as shown here, sand can be transported seaward and back to the beach. The washover fans form small delta-like aprons on the upper beach profile just seaward of the dune vegetation line. If a breach of the dunes is extensive, a new tidal inlet can form. Such occurrences are rare since waves and tides tend to seal the opening with sand from the beach soon after a storm has passed. There are historical accounts of the Ogunquit River having its tidal inlet at the northern end of the beach in 1760. By 1879 the inlet was charted to the south in the vicinity of where it is today.

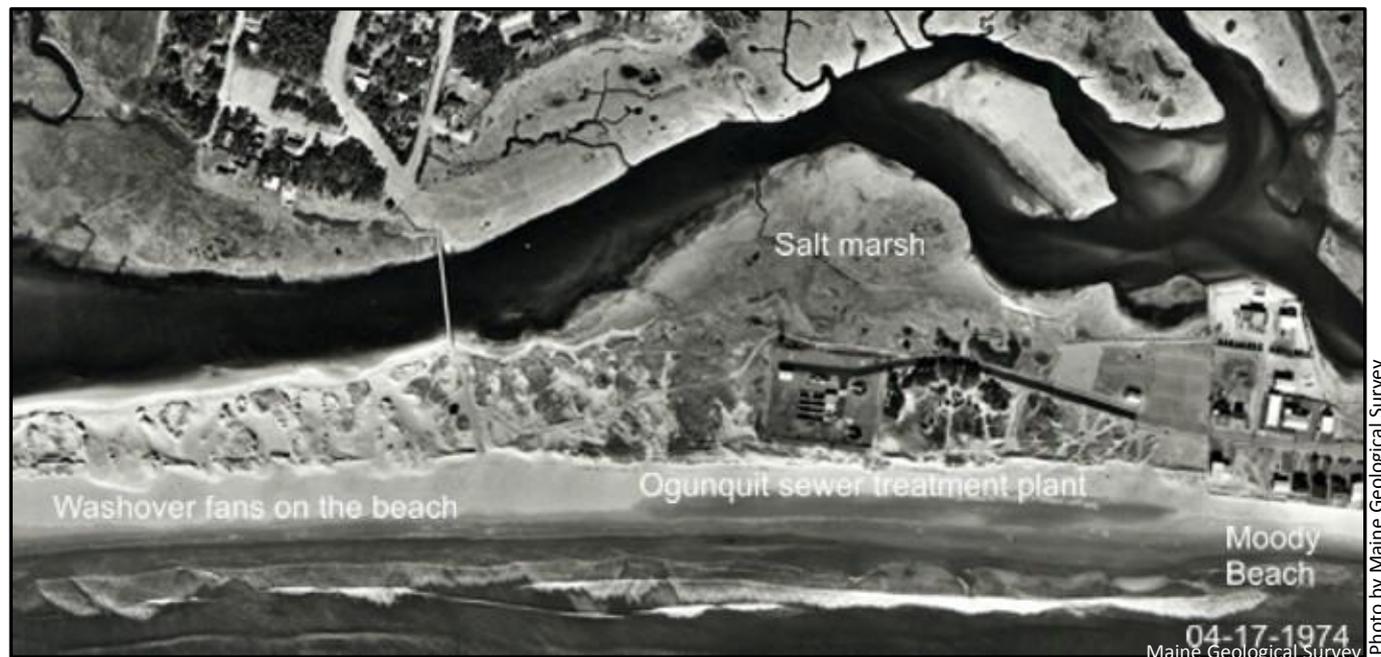
**Figure 4.** Aerial photograph of the dunes in 1974 showing the Ogunquit sewer treatment plan.

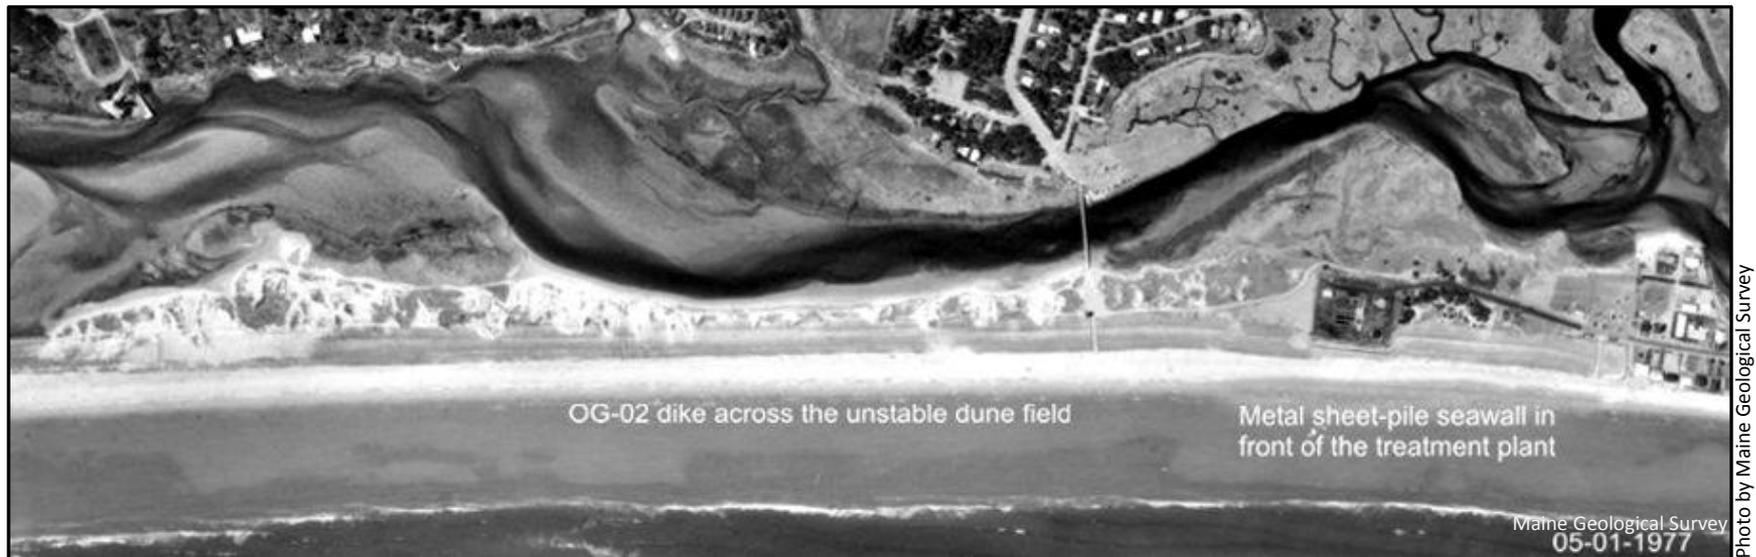
The second phase of construction in the dunes at Ogunquit was the much longer OG-2 dike. This linear ridge was built with a core of glacial gravel brought in from an upland gravel pit between December 1974 and March 1975 (Figure 6). The ridge is also higher than the previous frontal dune ridge crest and higher than waves can run up in a 100-year storm. The ridge is a strong and rigid barrier to breaching in storms from both the ocean and river, but it also impedes the natural movement of sand that once existed between the frontal dune and back dunes. To protect the Ogunquit sewer treatment plant from extreme erosion events, a metal sheet-pile wall was driven into the frontal dune seaward of the plant. This engineering structure has remained buried in the frontal dune over the years because the beach has not been eroding significantly.

**Figure 6.** Aerial photograph of the dunes in 1977 showing the OG-2 dike.

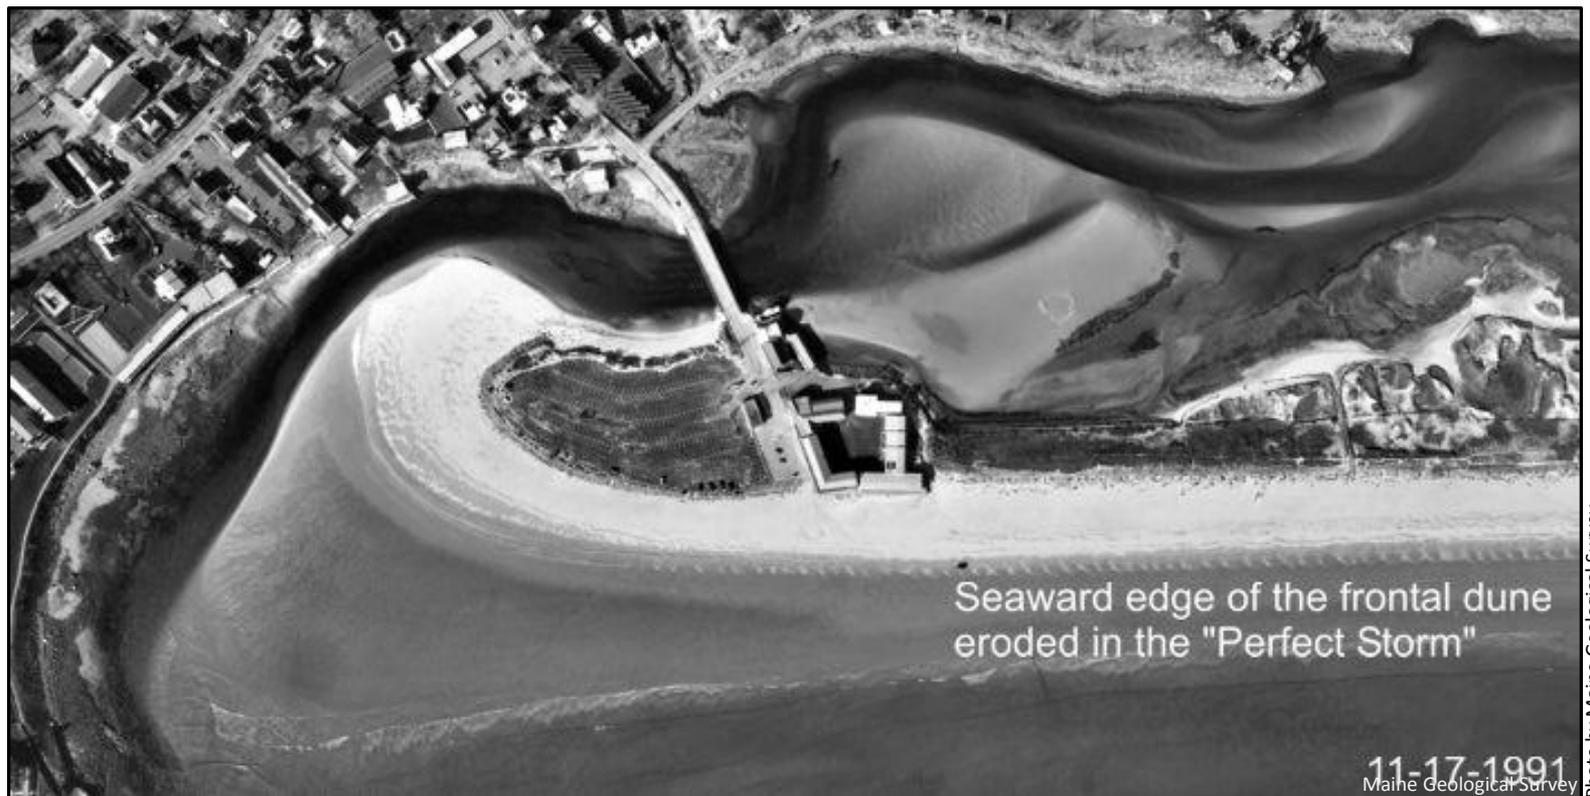
In Figure 7 and Figure 8 the ragged edge of the frontal dune can be seen 18 days after the Perfect Storm. It appears that there was very little overwash or flooding over the top of the OG-1 or OG-2 dikes. Large blocks of dune vegetation are visible on the beach profile. Erosion did not reach the seawall at the sewer treatment plant (Figure 8).

**Figure 7.** Aerial photograph of the dunes in 1991 after the Perfect Storm.
