Geologic Site of the Month

March 2016

Ice Jam on the Kennebec River in Augusta on Wednesday, February 17, 2016

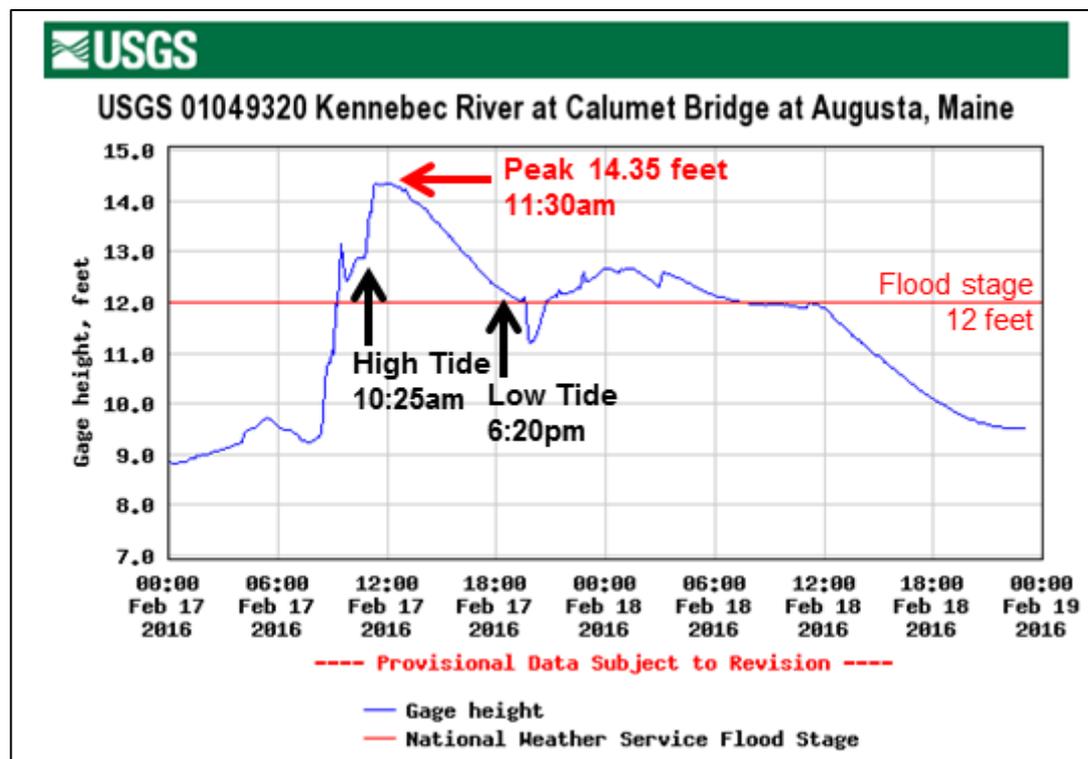
Figure 1. USGS river gage data showing the height of the river and the timing of tides during the ice jam and flood.

In the morning of Wednesday, February 17, an ice jam formed on the Kennebec River near the Memorial Bridge in Augusta, damming the river flow and raising the water level (stage) at the Calumet Bridge by about five feet in the three hours between 8:30 and 11:30 am. The peak stage of 14.3 feet was well above the 12-foot flood stage (USGS, 2016).

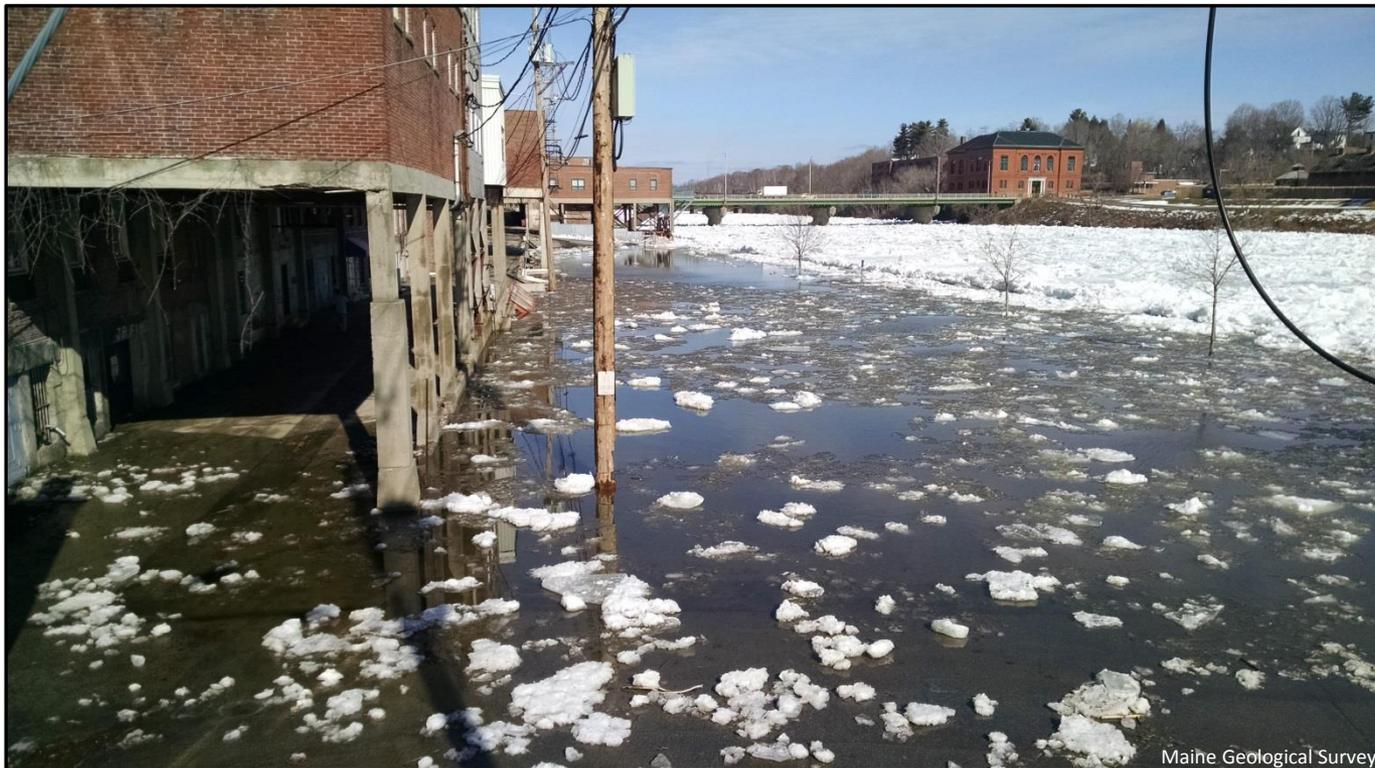
Figure 5. Flood waters in the Front Street parking lot at noon on Wednesday, February 17, 2016.

The peak stage was high enough to cover a section of the parking lot along Front Street with water and floating ice. It was reported that several cars that were parked in harm's way were removed just in time to avoid being damaged (Edwards, 2016). The river in Augusta has exceeded flood stage 22 times since 2008, and the highest recorded stage was 34.1 feet on April 2, 1987, although the flood of 1936 was likely even higher (USGS, 2013).

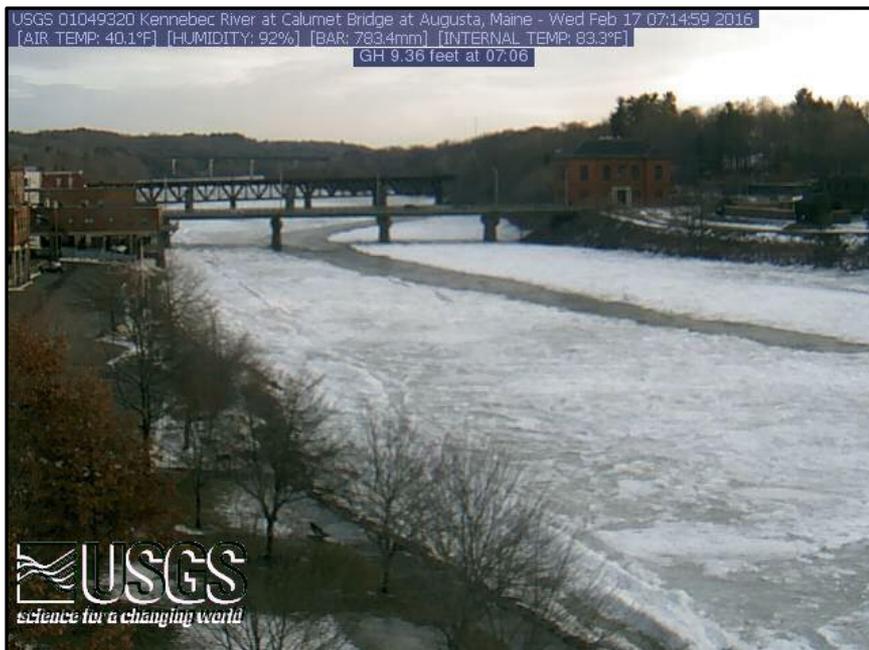
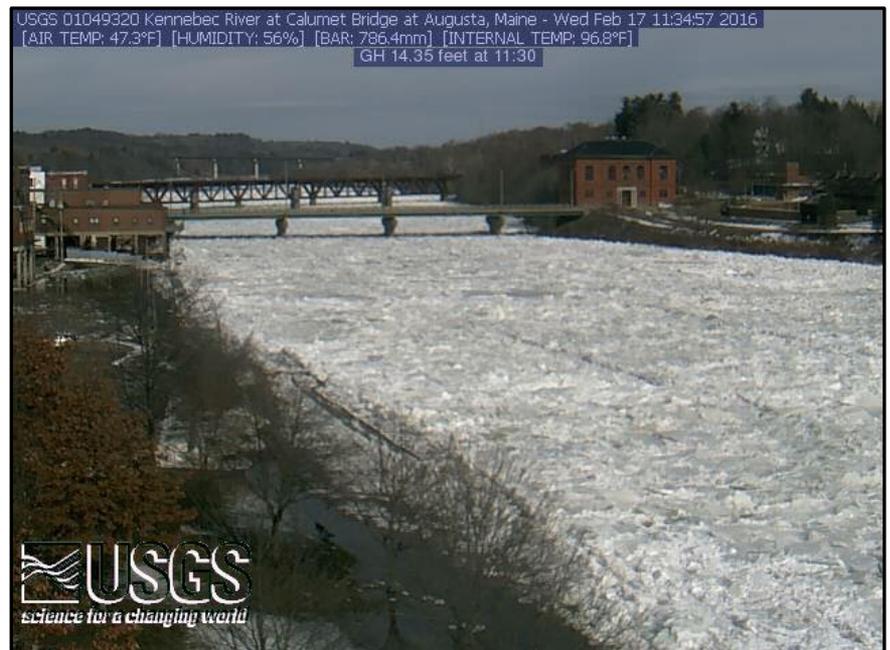
Figure 3. The webcam image on the left shows the river at 7:15am, before the ice jam and flood. The image on the right shows the river at peak height around 11:30am.

The US Geological Survey , in cooperation with the Maine Emergency Management Agency and the Maine River Flow Advisory Commission, maintains a webcam on the Kennebec River at Augusta. The webcam captured the entire event in a series of still images.

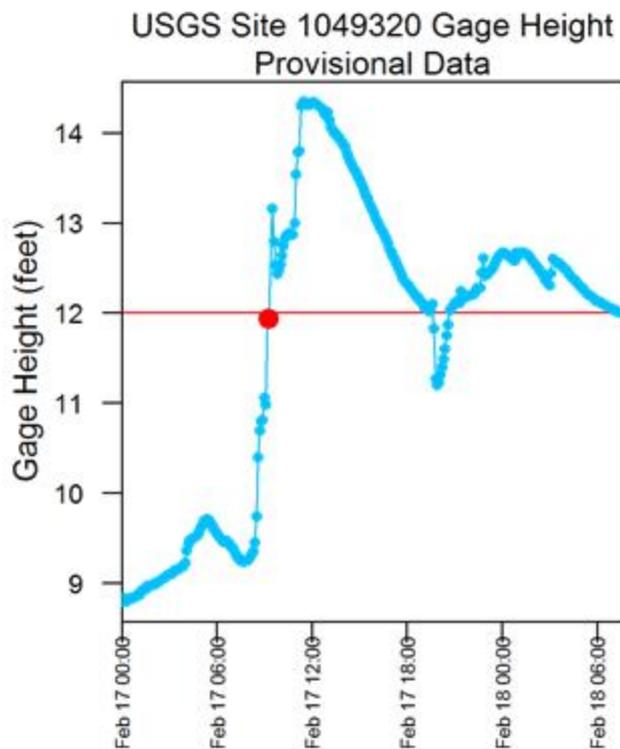
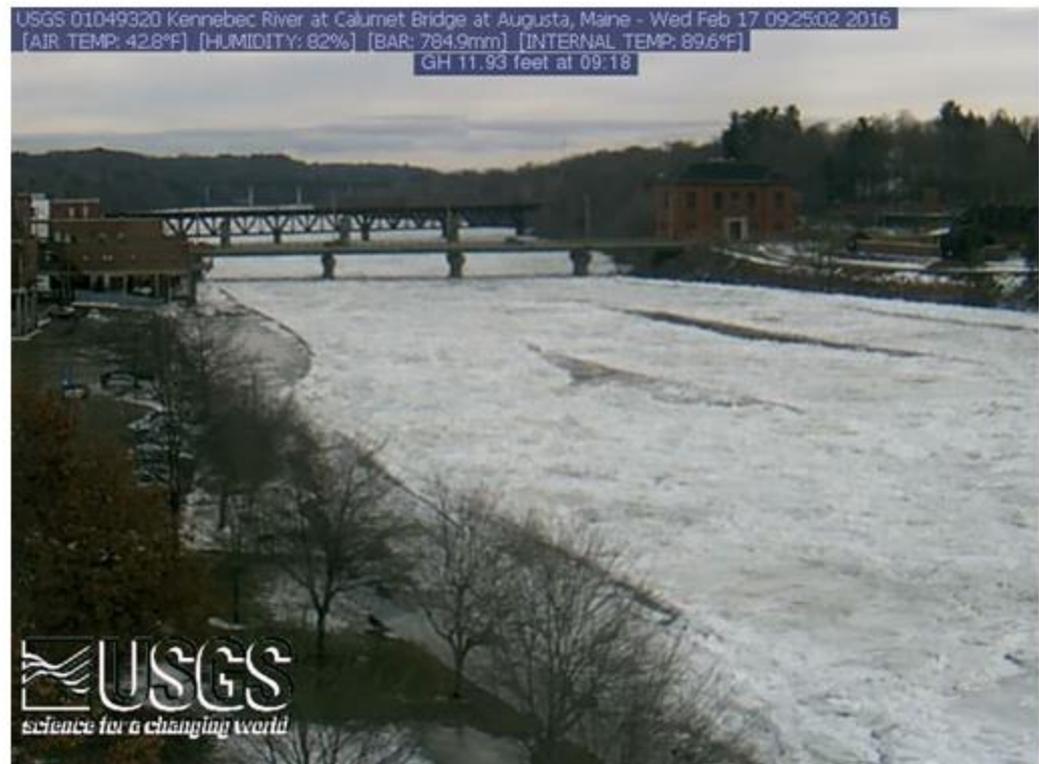
Figure 4: This still image from the video shows the hydrograph on the left with a red dot highlighting the gage height at the time of the webcam image shown on the right. The image shows the river just as it reached flood stage at 9:25 am.

We combined the water level data and the webcam images to produce [a video spanning the entire event](#). The video steps through the webcam images and highlights the associated river gage height at the same time as the image. The sequence clearly shows the formation of the ice jam, the rise of the river, and the flooding of the Front Street parking lot.
