**Hydrogeologic and Petroleum Contamination Assessment  
Whitten Brook site, Skowhegan, Maine  
Maine DEP Spill # A-189-10**

*Prepared for*  
Maine Department of Environmental Protection  
17 State House Station  
Augusta, Maine 04333-0017

*Submitted by*  
C.A. White & Associates LLC  
One Main Street  
Yarmouth, Maine 04096

December 2012

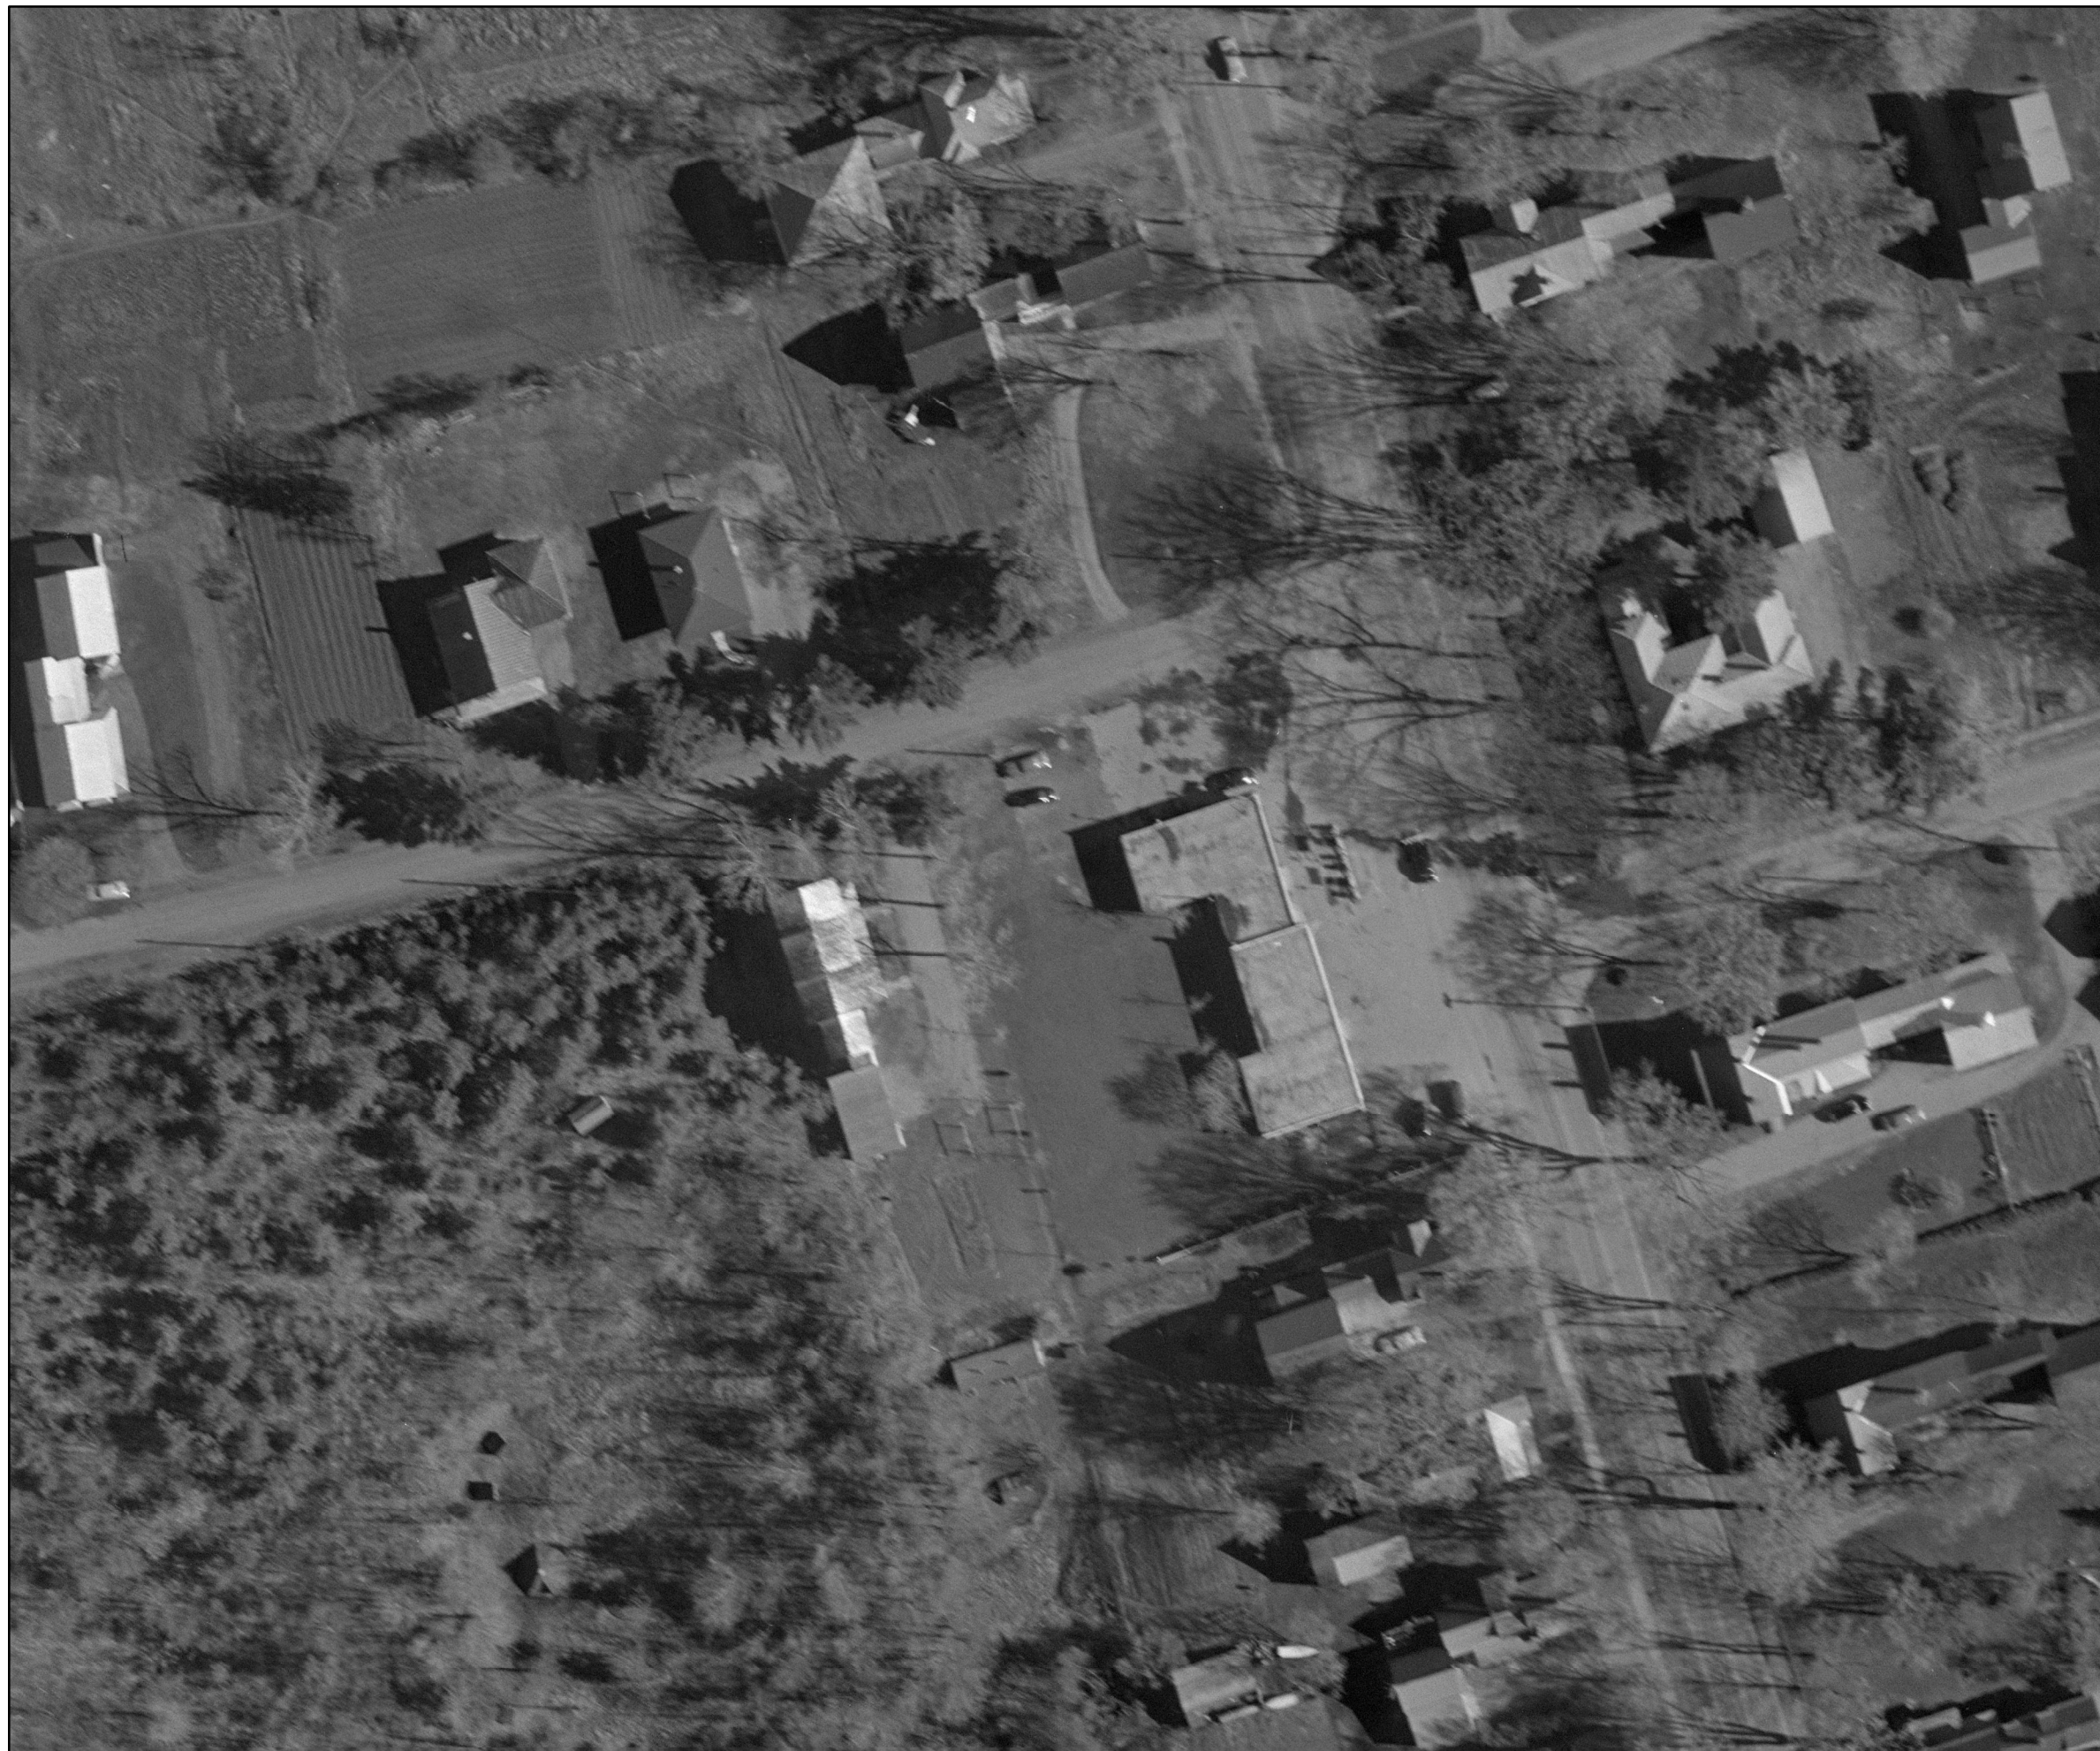
### Figure 3-1

As shown on Figure 3-1, a linear feature can be seen in front of the building on the present day Kyes property – most likely a gas pump island. Also of interest are the square and cylindrical structures in the area of present day detention pond. These could possibly be spring houses associated the former Skowhegan Aqueduct operation; but their purpose remains a mystery. Also seen on this photo, at the corner of York and Madison Ave, are large trucks and a industrial looking building which is consistent with identification of this location as a *Motor Freight* operation and *filling station* on the 1962 Sanborn Map. There appears to be a small building behind the main structure on Heritage Restaurant which is no longer there.

**Aerial Photo  
May 1955  
J.W. Sewall Company**

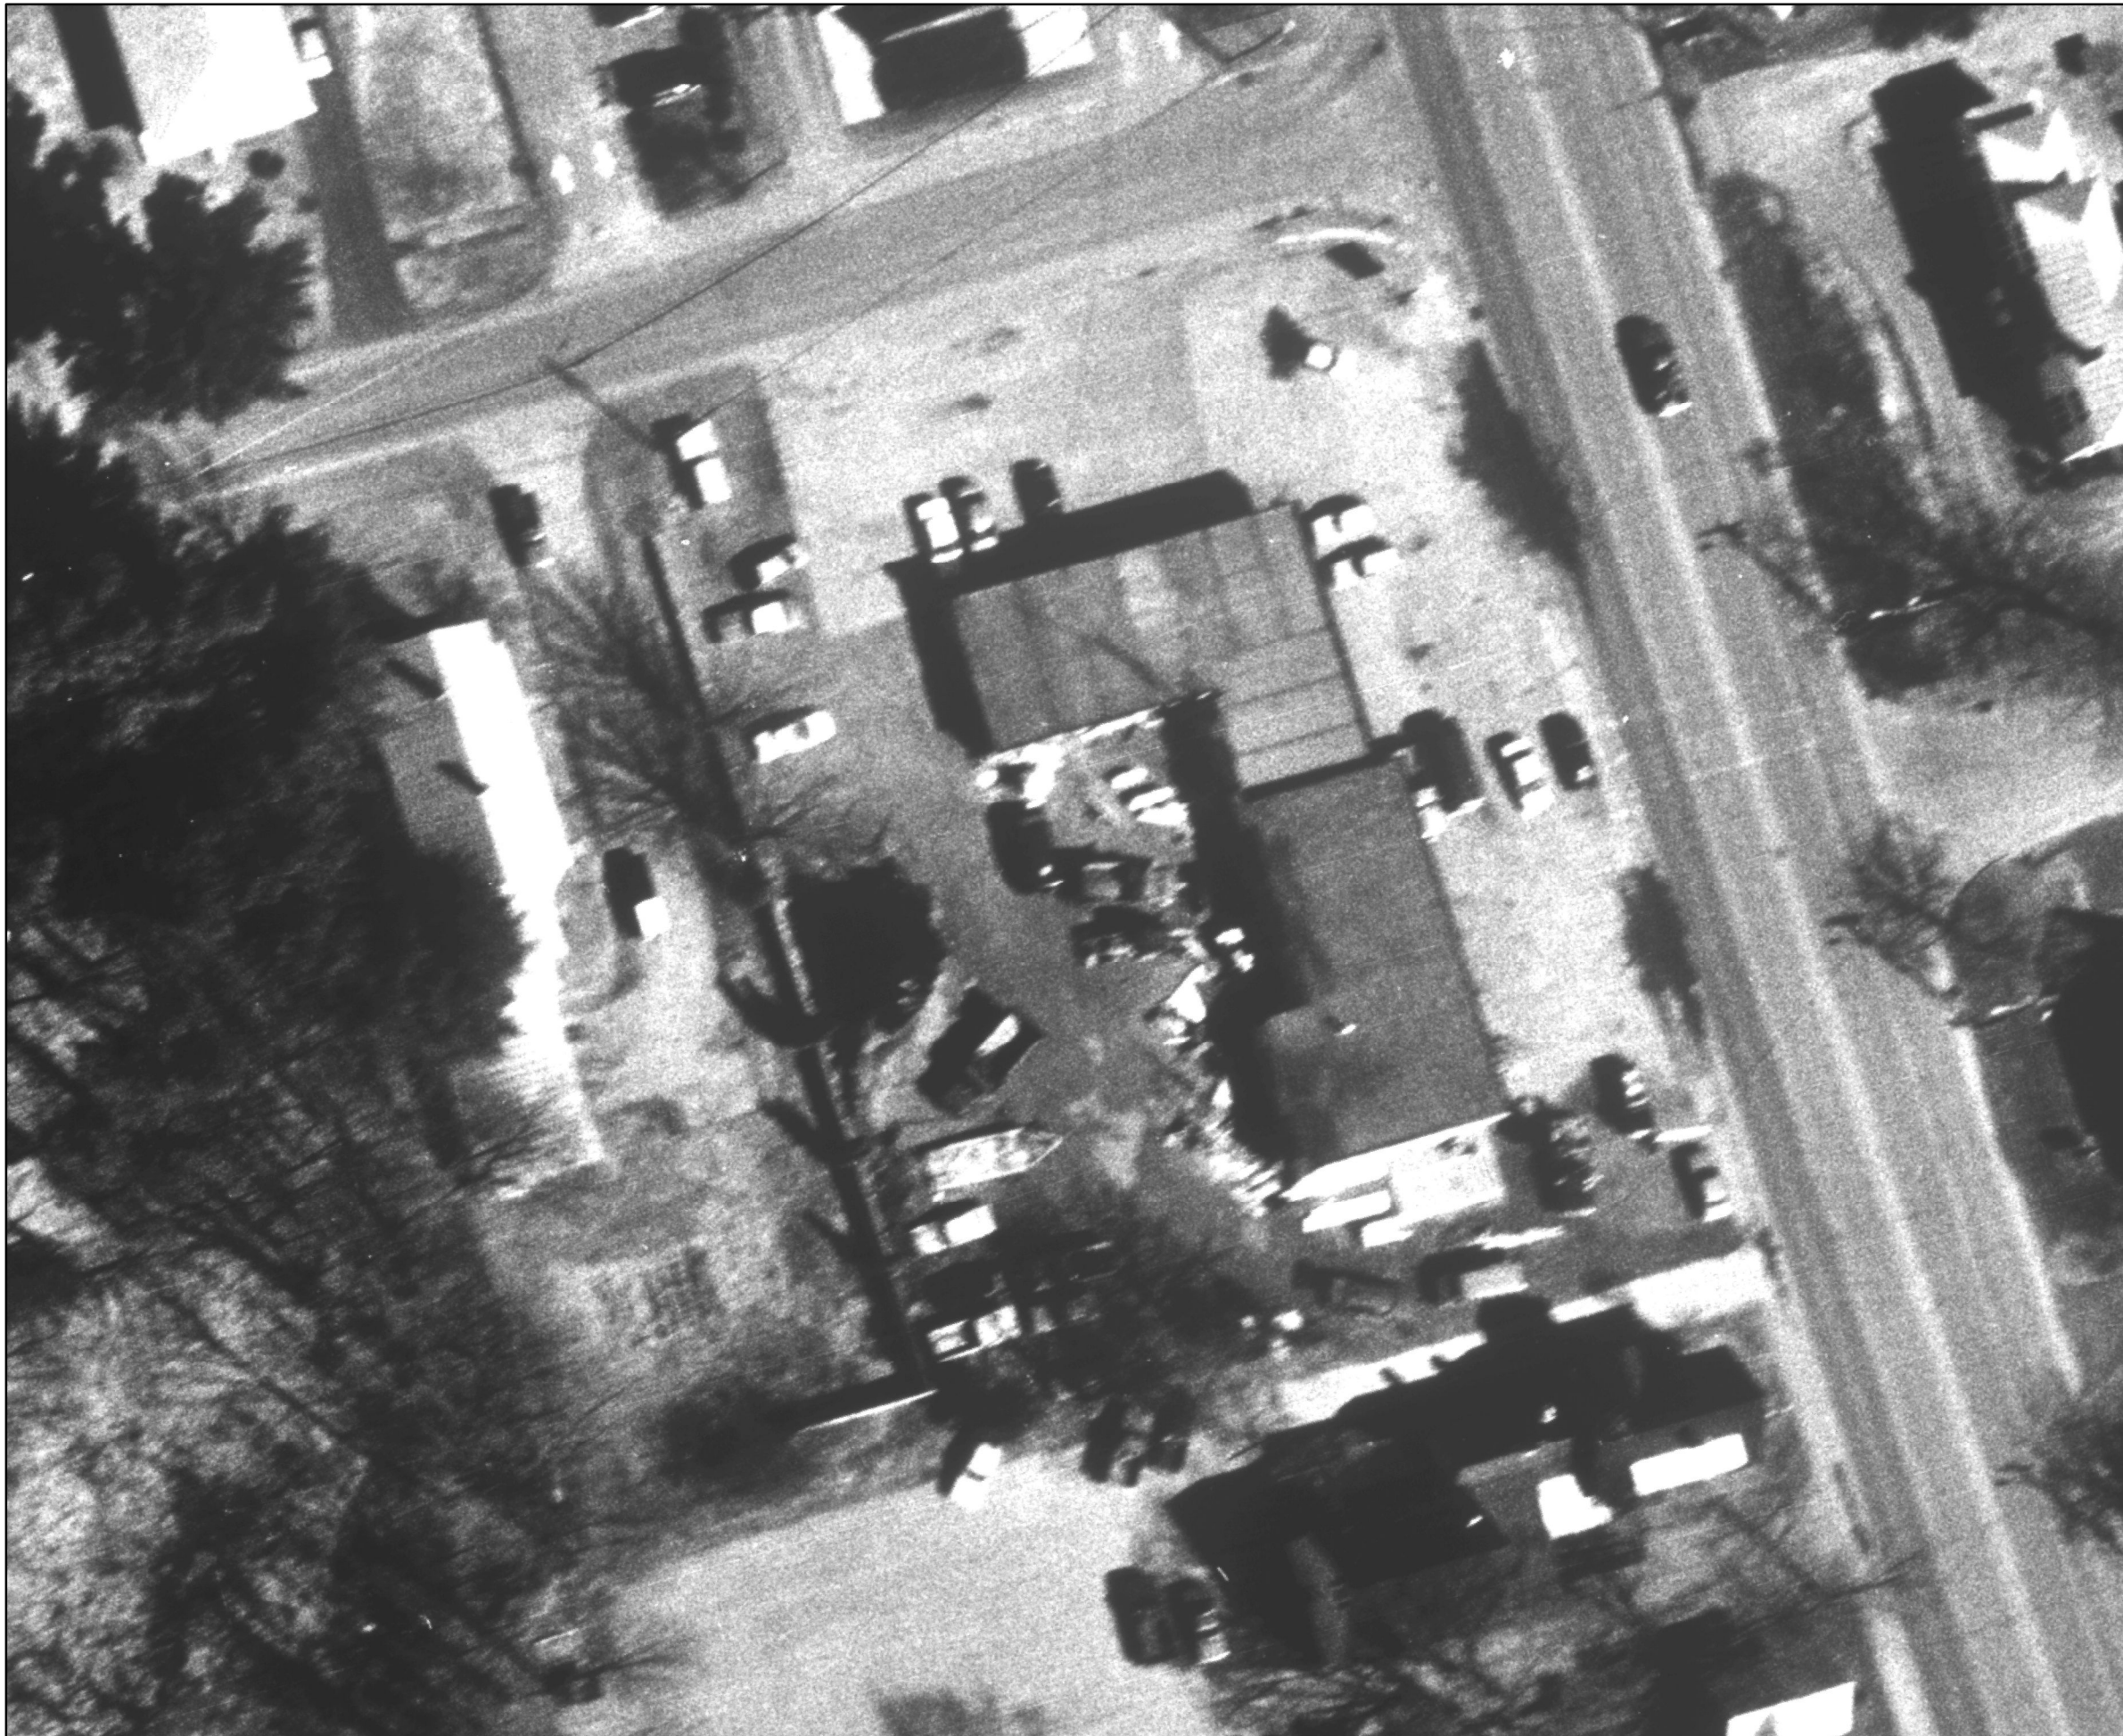
**Figure 3-2**

**Aerial Photo  
April 1990  
Aerial Photo & Survey, Inc.**

As shown on the 1990 photo on Figure 3-2 the notable changes from the previous photo are that that the structure on the Kyes property has expanded and its configuration appears generally consistent with the present day building footprint. The site configuration and the number of cars are consistent with an operating gas station. A pump island canopy (?) may be present in the central portion of the property near Route 201. The photo indicates that the Spring Gardens facility has been not yet built by this time. The tree growth appears more mature than the present day growth around the perimeter of the proposed detention basin.

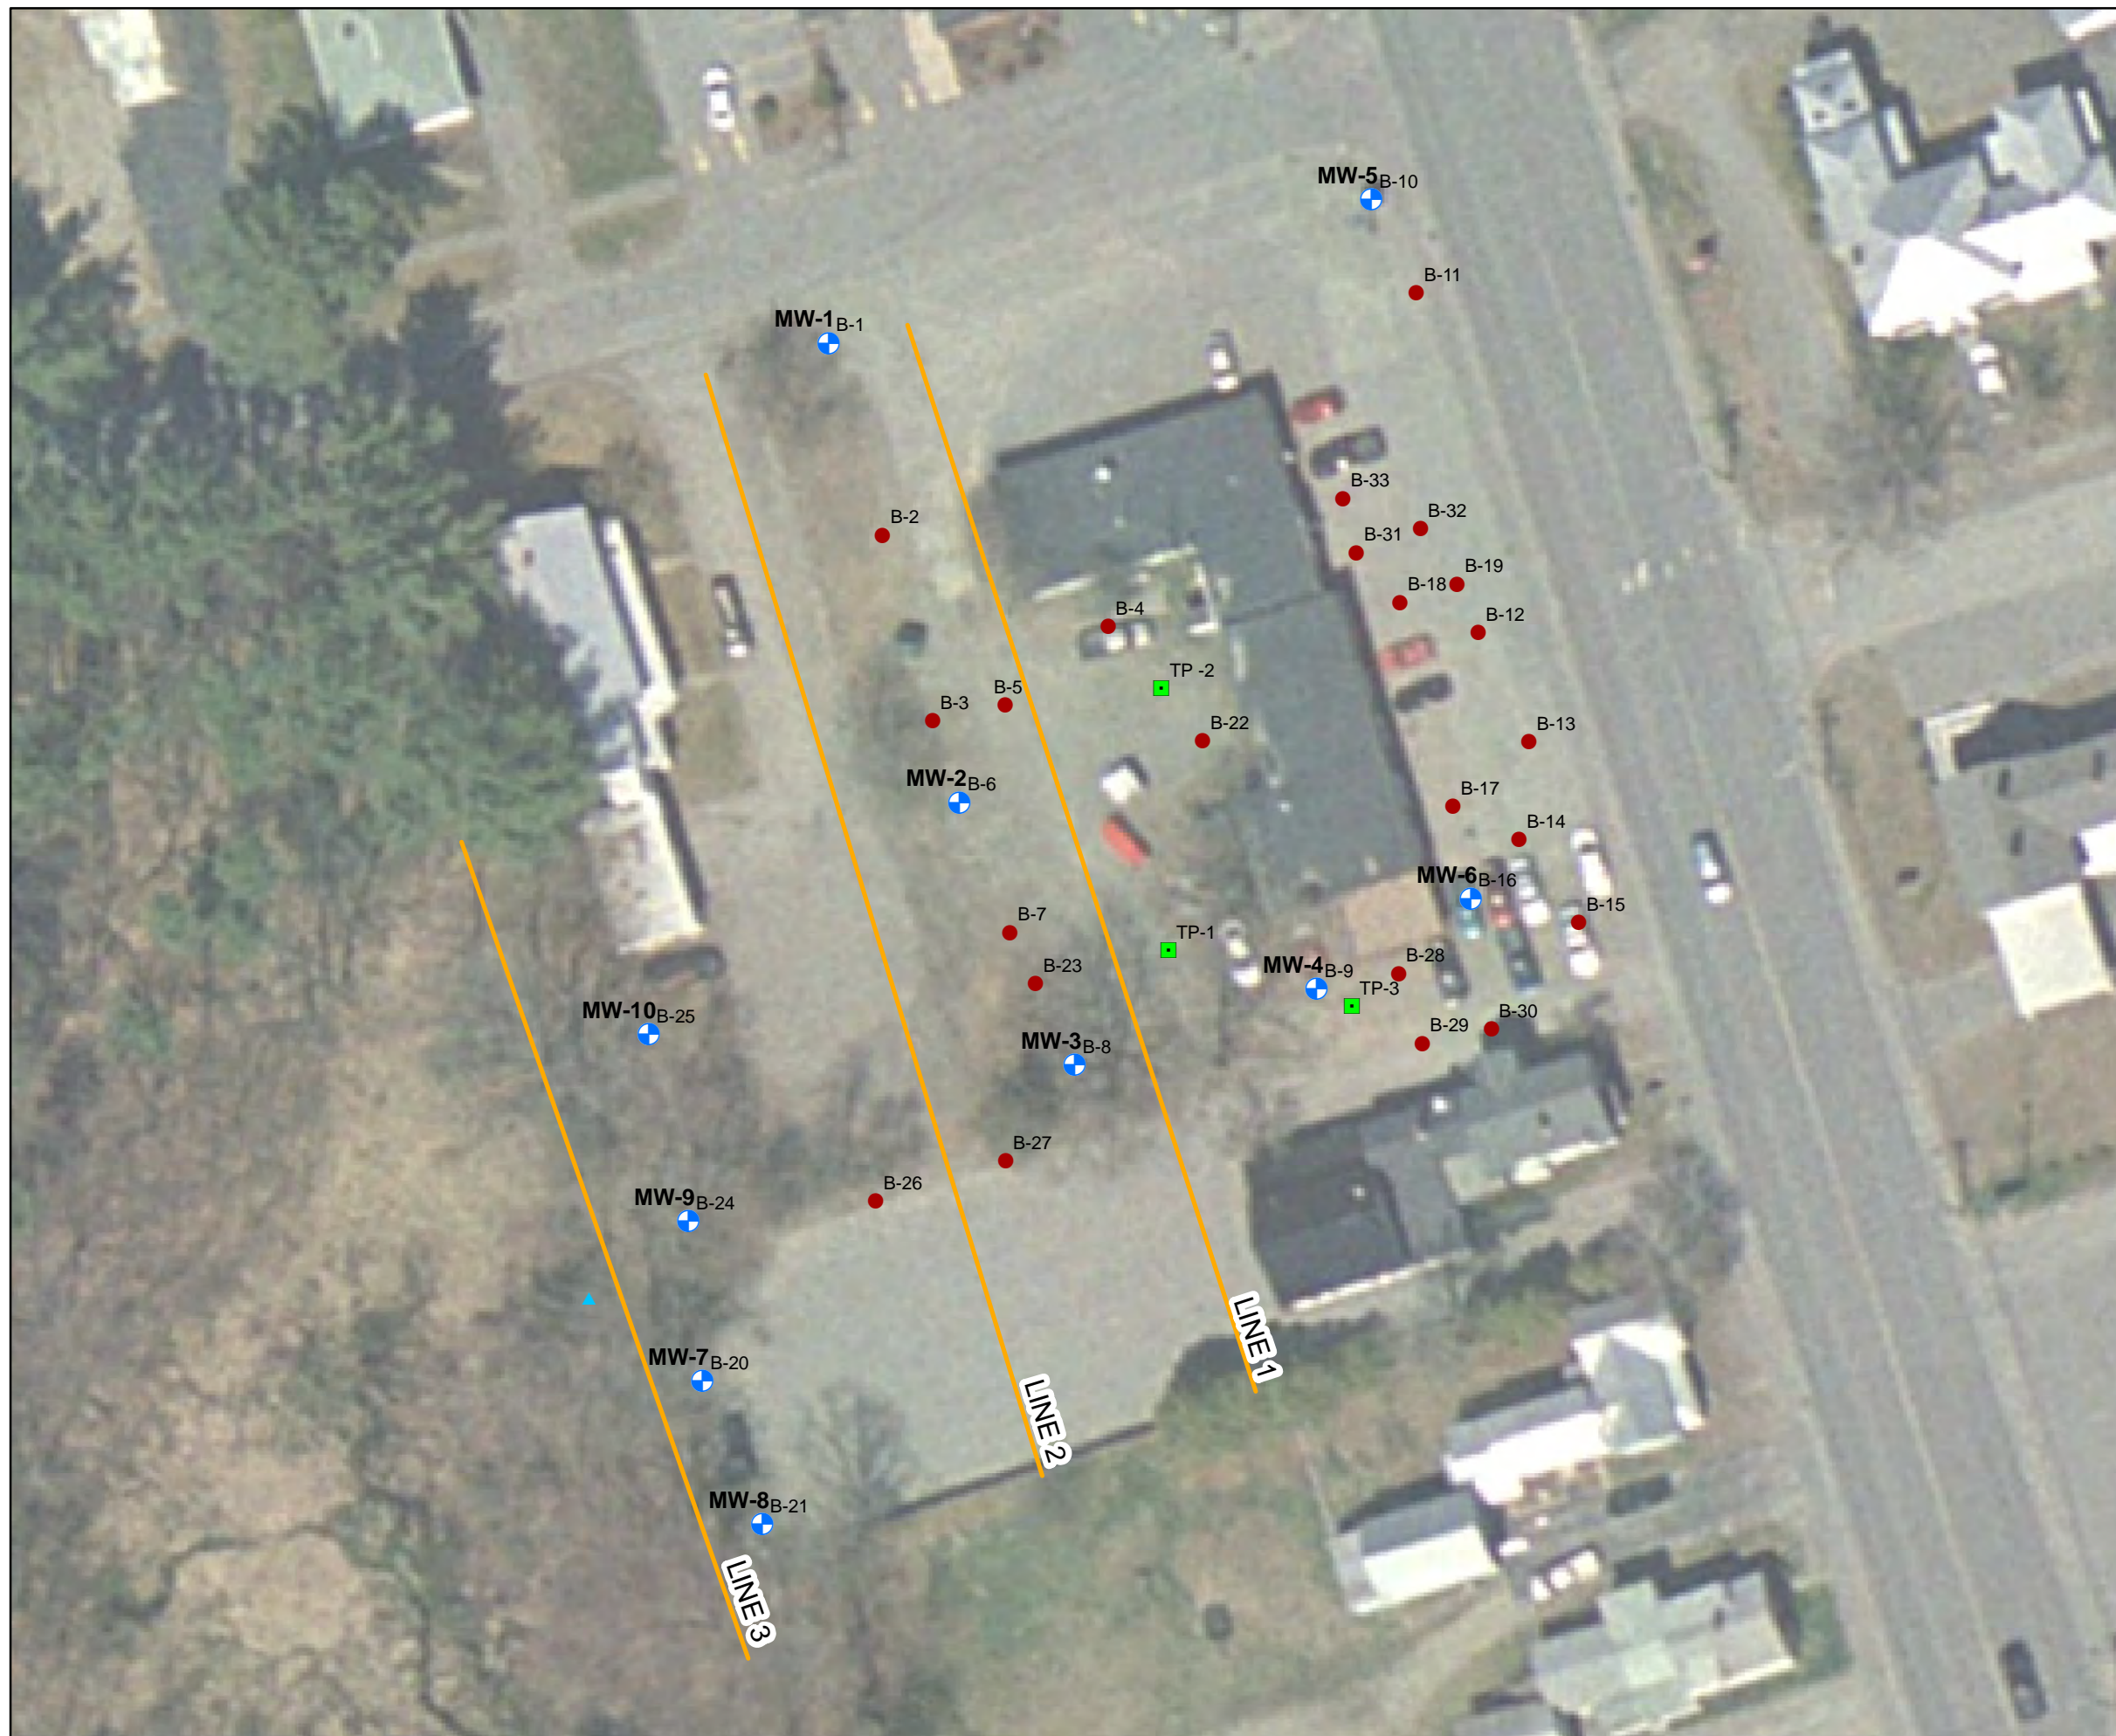
Field investigations were conducted during the summer and early fall months of 2012 and consisted of field reconnaissance, surface geophysics, geoprobe drilling and monitoring well installation, water level measurements, groundwater and soil sampling, test pitting. Surface field investigations focused on the four properties located near the intersection of Silver Street and Madison Avenue (Route 201). The locations of the site explorations are shown on Figure 3-6.

In June 14, 2012 Mike Scully of Northeast Geophysical Services, Inc. (NGS) completed an electromagnetic EM-61 survey and a Ground Penetrating Radar (GPR) survey on the site. The objective of the survey was to locate buried underground storage tanks, piping and other subsurface features that may be a source of contamination or a transport pathway for petroleum. The EM-61 and GPR survey focused on the Kyes property where petroleum tanks were known to exist, but had reportedly been removed. As shown on Figure 3-7 several conductive anomalies were identified during the EM-61 survey; GPR was used to confirm the presence and configuration of these anomalies.

- Two linear features (pipes?) exiting the north end of the building toward Silver street
- Two narrow linear features about 60 feet in length situated between the building and Madison Ave oriented parallel to the building
- A circular shaped metallic anomaly located west (behind) the building

An EM-31 survey was conducted on July 9, 2012 by Rudy Rawcliffe of NGS to look for conductive anomalies that might be indicative of a contaminated ground water plume. Three EM-31 lines were completed on the western portion of site between the building on the Keyes property and Whitten Brook. The locations of the lines are shown on Figure 3-6 and the data plots are presented on Figure 3-7. This survey did not yield any useful information to aid in identifying the lateral extent of the groundwater plume. The EM-31 survey did indentify two discrete conductive anomalies on the southern portions of Lines 1 and 3 which are located on the parking lot behind the Heritage Restaurant. According to Rudy Rawcliffe, these signatures may be indicative of a narrow metallic feature, such as

the site area. The locations of the borings, designated B-1 through B-33, are shown on Figure 3-6. Seth Brown of MAI operated a track mounted rig using direct-push drilling method. A 2-3/4-inch diameter borings was drilled in the overburden to depths ranging from 15 to 35 feet bgs. Continuous soil samples were collected in all borings using a 5-foot geoprobe sampler outfitted with an internal plastic sleeve. Soil samples were retrieved in the tube and the tube was cut open for screening and logging purposes. All soil samples will be collected and logged onsite.

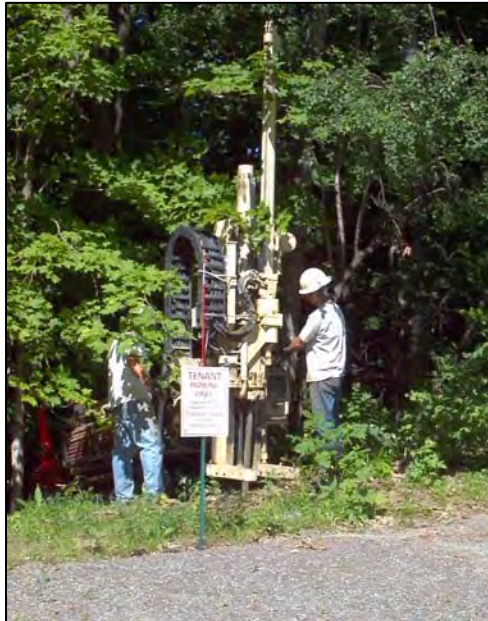
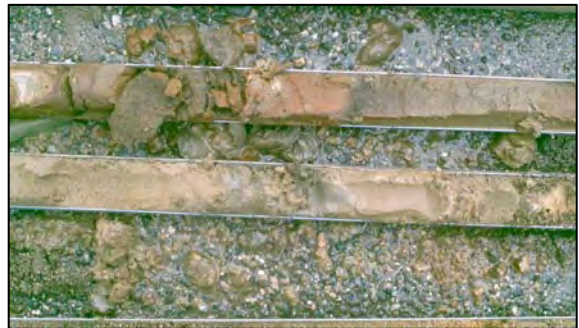
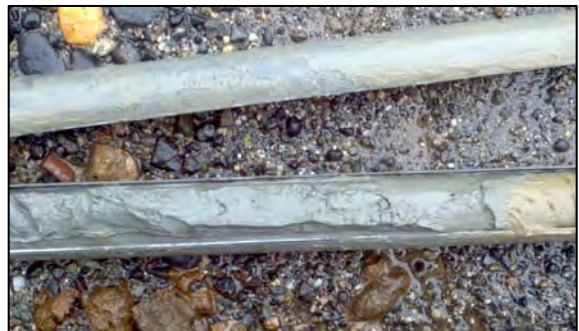
Samples were examined for the presence of free product and screened with a photoionization detector (PID). Select samples were placed in metalized bags and screened with PID in accordance with MDEP SOP TS004. Six confirmatory samples were collected for VPH and TEPH analysis at HETL in Augusta, Maine.

One-inch diameter PVC monitoring wells, designated MW-1 through MW-10, were installed in ten of the geoprobe borings. Screened sections of the monitoring wells were 10 feet in length and generally split the water table. Once the screen was installed, any remaining open portion of the borehole was backfilled with clean sand and a bentonite seal was placed at about 2 depth to ground surface. The majority of wells were secured with flush mount road boxes, but the four wells closest to Whiten Brook, MW-7, MW-8, MW-9 and MW-10, were completed with above ground protective casings. The ten monitoring wells were developed on July 9<sup>th</sup> using a peristaltic pump. Wells were pumped until the discharge water was visibly clear. Boring logs and monitoring well construction diagrams are contained in Appendix B.

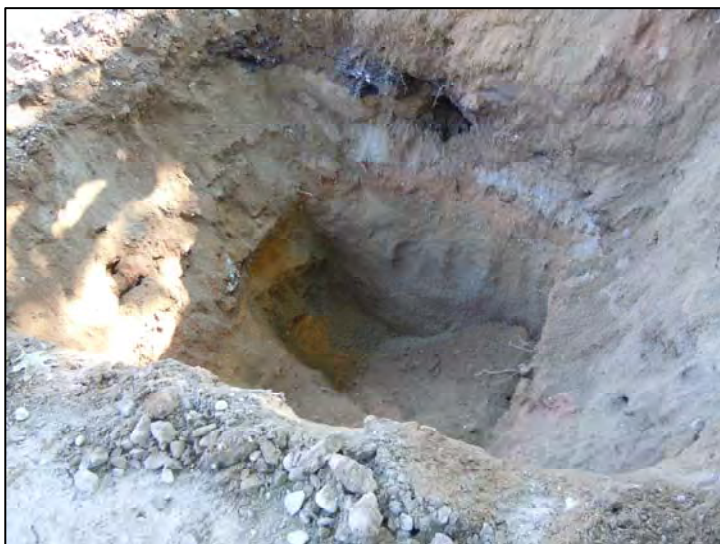
On September 14, 2012 three test pits, designated TP-1, TP-2 and TP-3, were excavated on the Kyes property by R.A. Paradis & Sons of Newport, Maine. The location of the test pits are shown on Figure 3-6. Test pits were excavated to the depths ranging from eight to ten feet below ground surface and did not intersect the water table. Grab soil samples were collected continuously from each test pit at approximately two foot intervals. PID field screening results were non-detect (less than 1 part ppm) for all test pit samples and no odor was detected. TP-1 was located

behind the building in the area of the EM-61 anomaly to assess whether it was a buried tank or structure. The anomaly was created by a buried piece of sheet metal, possibly a car door or hood, but no surface pipes, drains or tanks were uncovered.

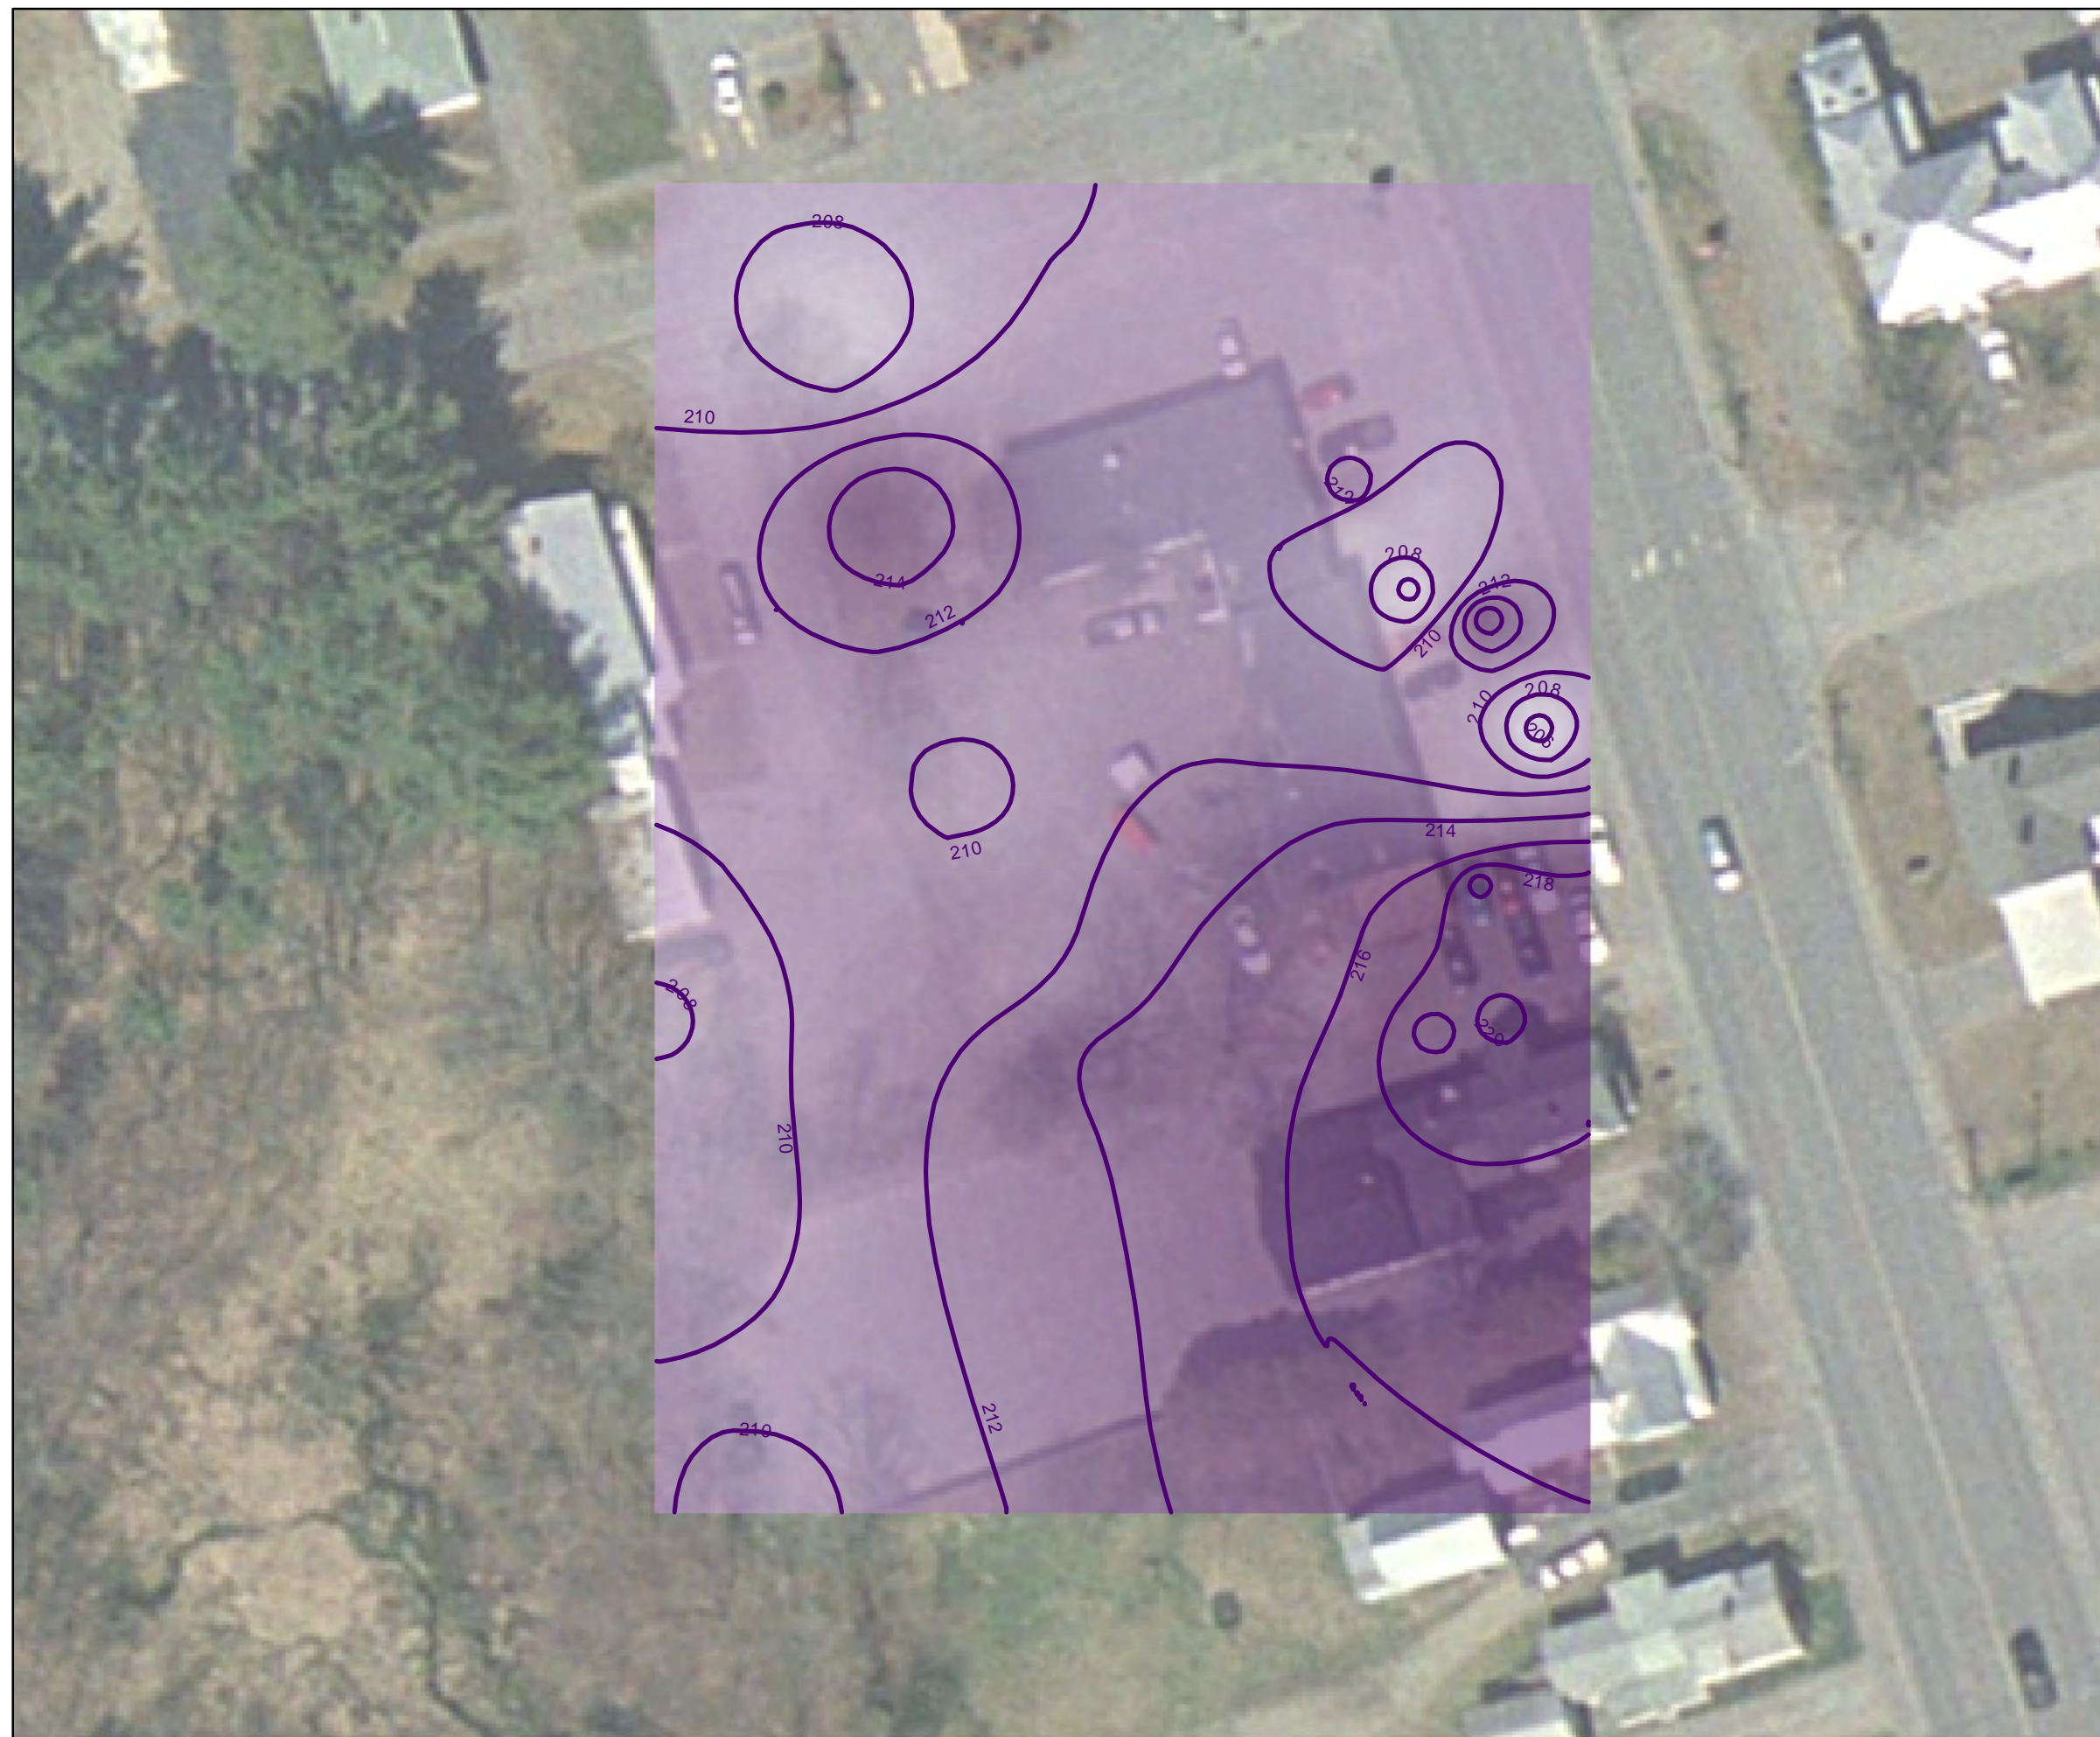
**Figure 4-1**

Water levels measurements in the ten monitoring wells installed as part of the investigation indicate that the groundwater is fairly shallow with depths of 7 to 12 feet below ground surface during the summer months. Calculated groundwater elevations range from about 224 feet MSL near Madison Ave to about 221.5 feet MSL at the seep discharge. As expected, a groundwater contour map of these data, Figure 4- 2, indicates that groundwater flows southwesterly across the site properties towards the upper reach of Whitten Brook. It's likely that the clay elevation controls the shallow groundwater discharge at the contaminated seep and into the headwaters of the brook. Interestingly at MW-8, located near the discharge seep, the clay elevation is about 10 feet below the elevation of the groundwater discharge point.

**Contour Map  
Top of Clay Surface**

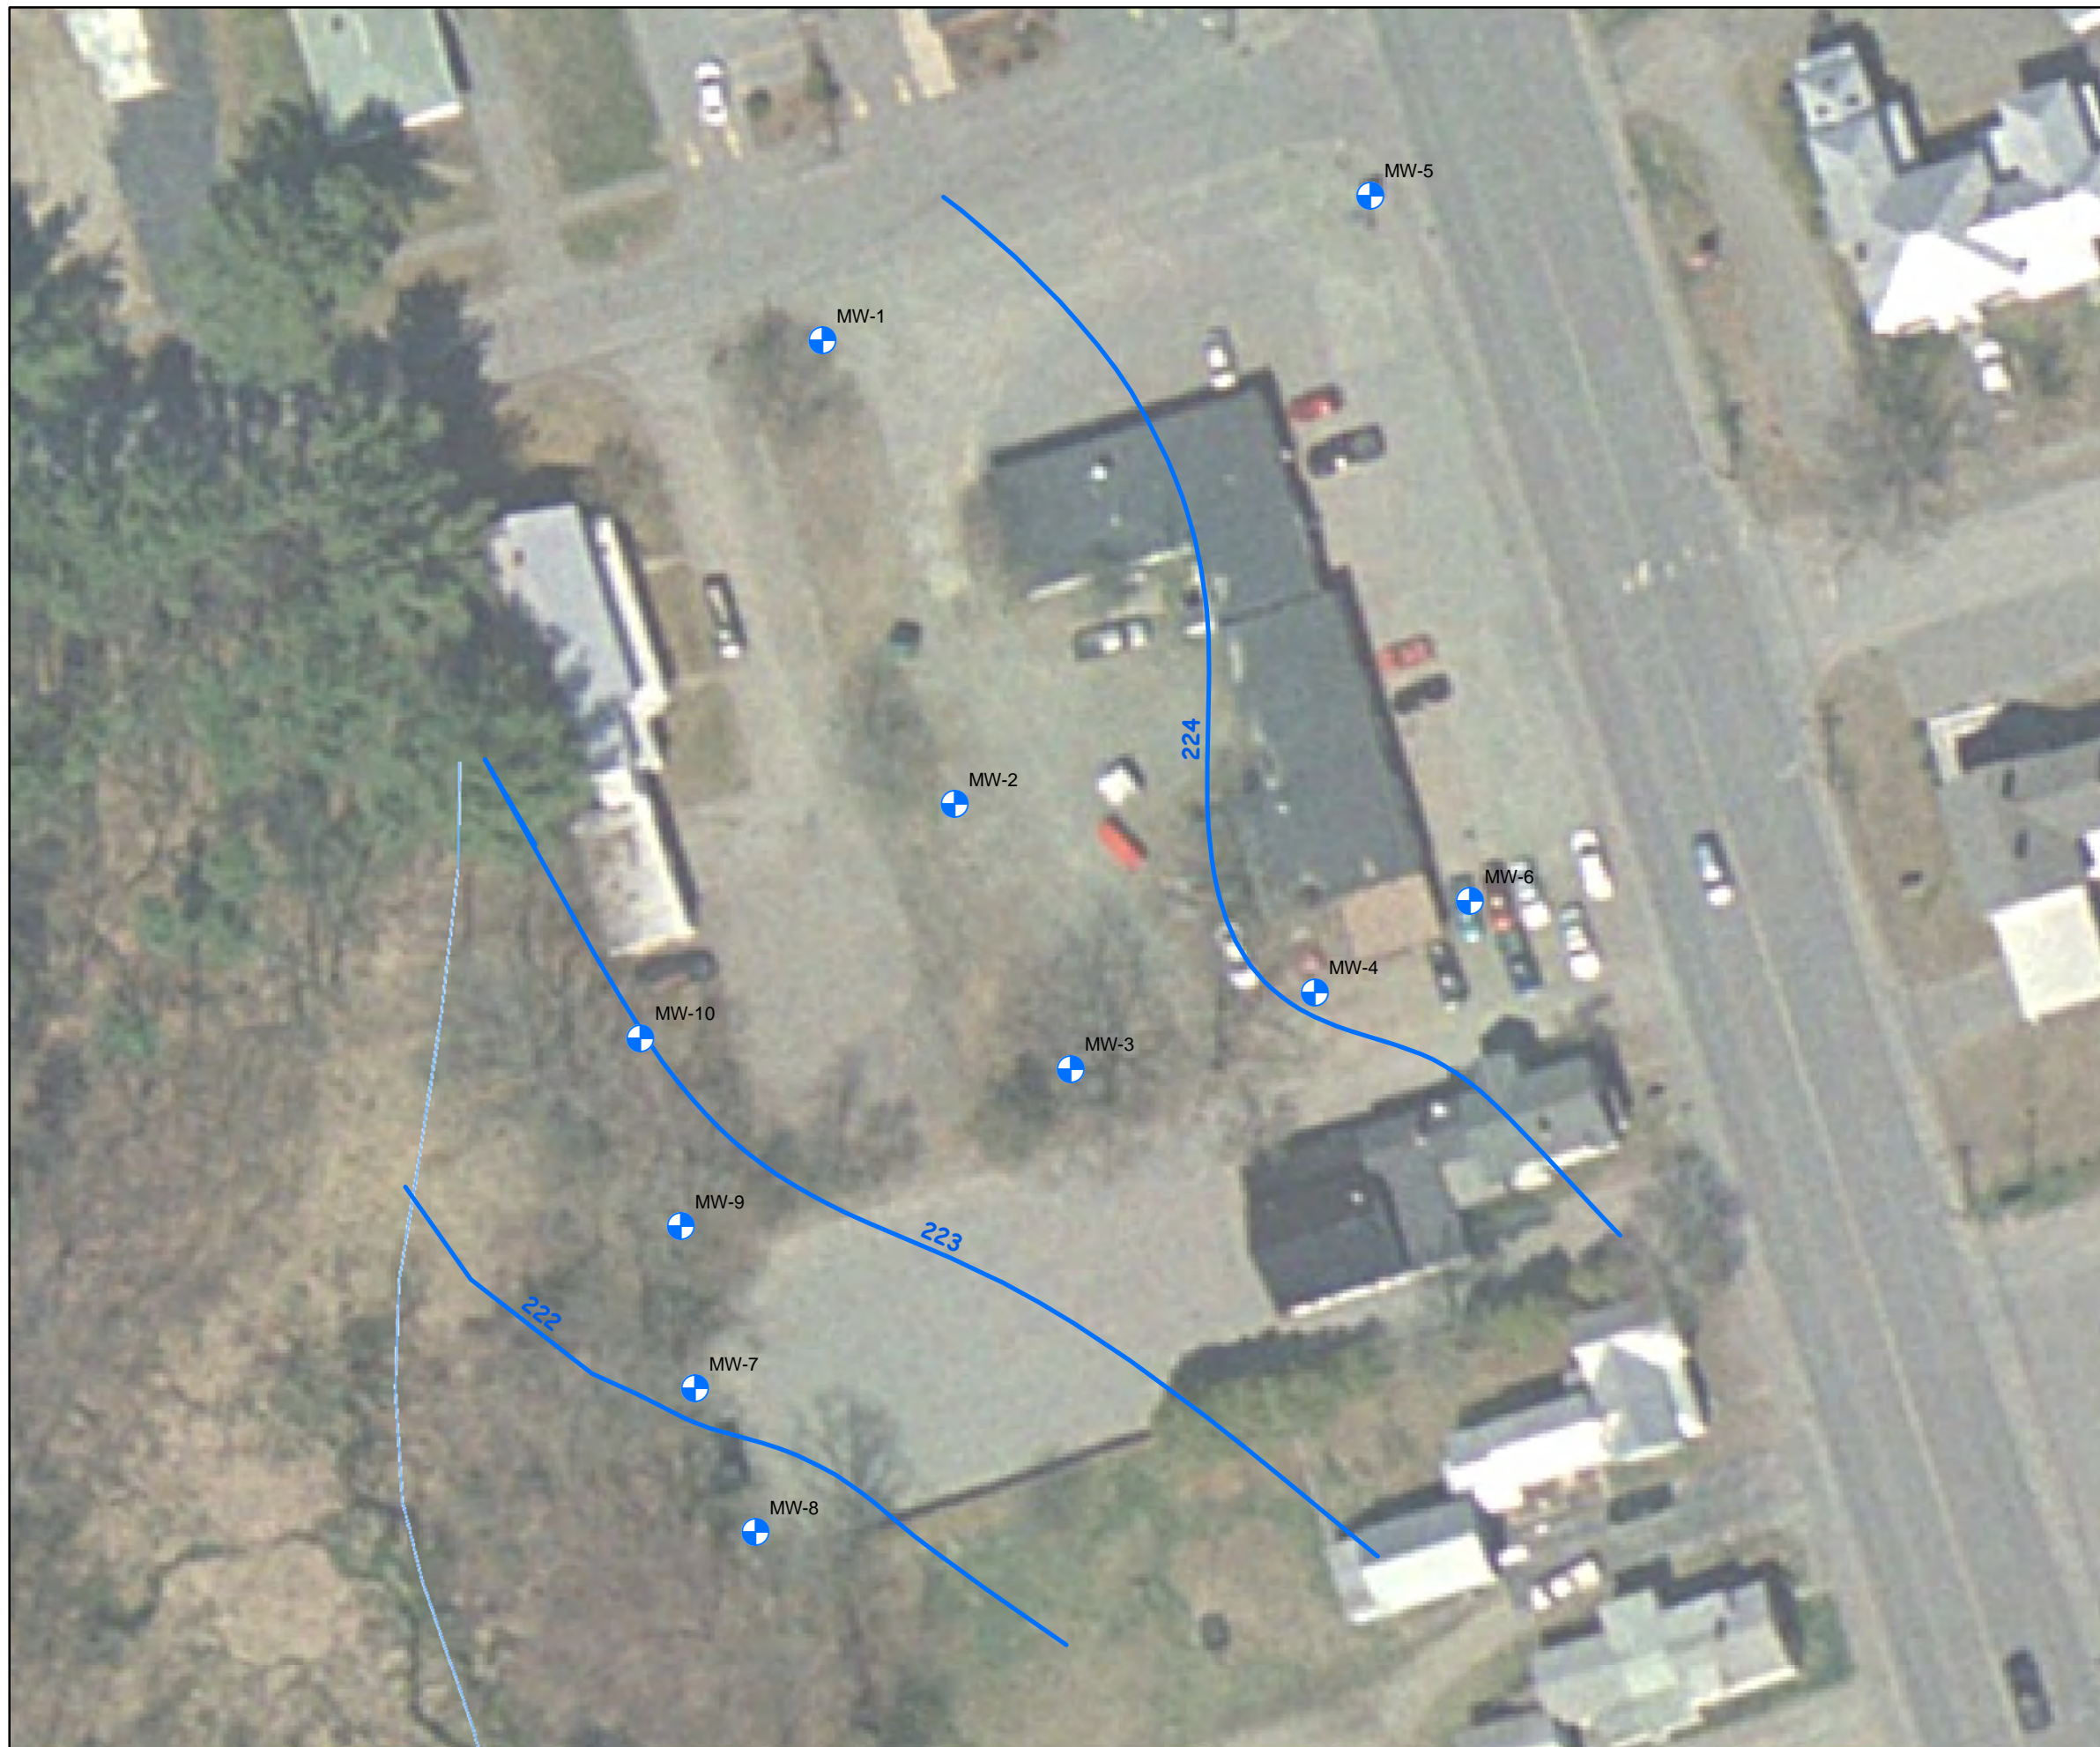
**Figure 4-2**  
**Ground Water Contour Map**  
**Whitten Brook Site**  
 Skowhegan, Maine

Due to the moderately permeable soils, the water table is relatively flat and the calculated horizontal groundwater gradient is 0.008ft/ft. Assuming an average porosity of 30% and an estimated

hydraulic conductivity of  $10^{-3}$  cm/sec, the estimated flow rate of the groundwater is about 10 to 30 feet per year. At this estimated seepage rate, it would take approximately 10 years for groundwater to travel from the location of pump island on the Kyes property to the contaminated seep.
