**Hydrogeologic and Petroleum Contamination Assessment  
Whitten Brook site, Skowhegan, Maine  
Maine DEP Spill # A-189-10**

*Prepared for*  
Maine Department of Environmental Protection  
17 State House Station  
Augusta, Maine 04333-0017

*Submitted by*  
C.A. White & Associates LLC  
One Main Street  
Yarmouth, Maine 04096

December 2012

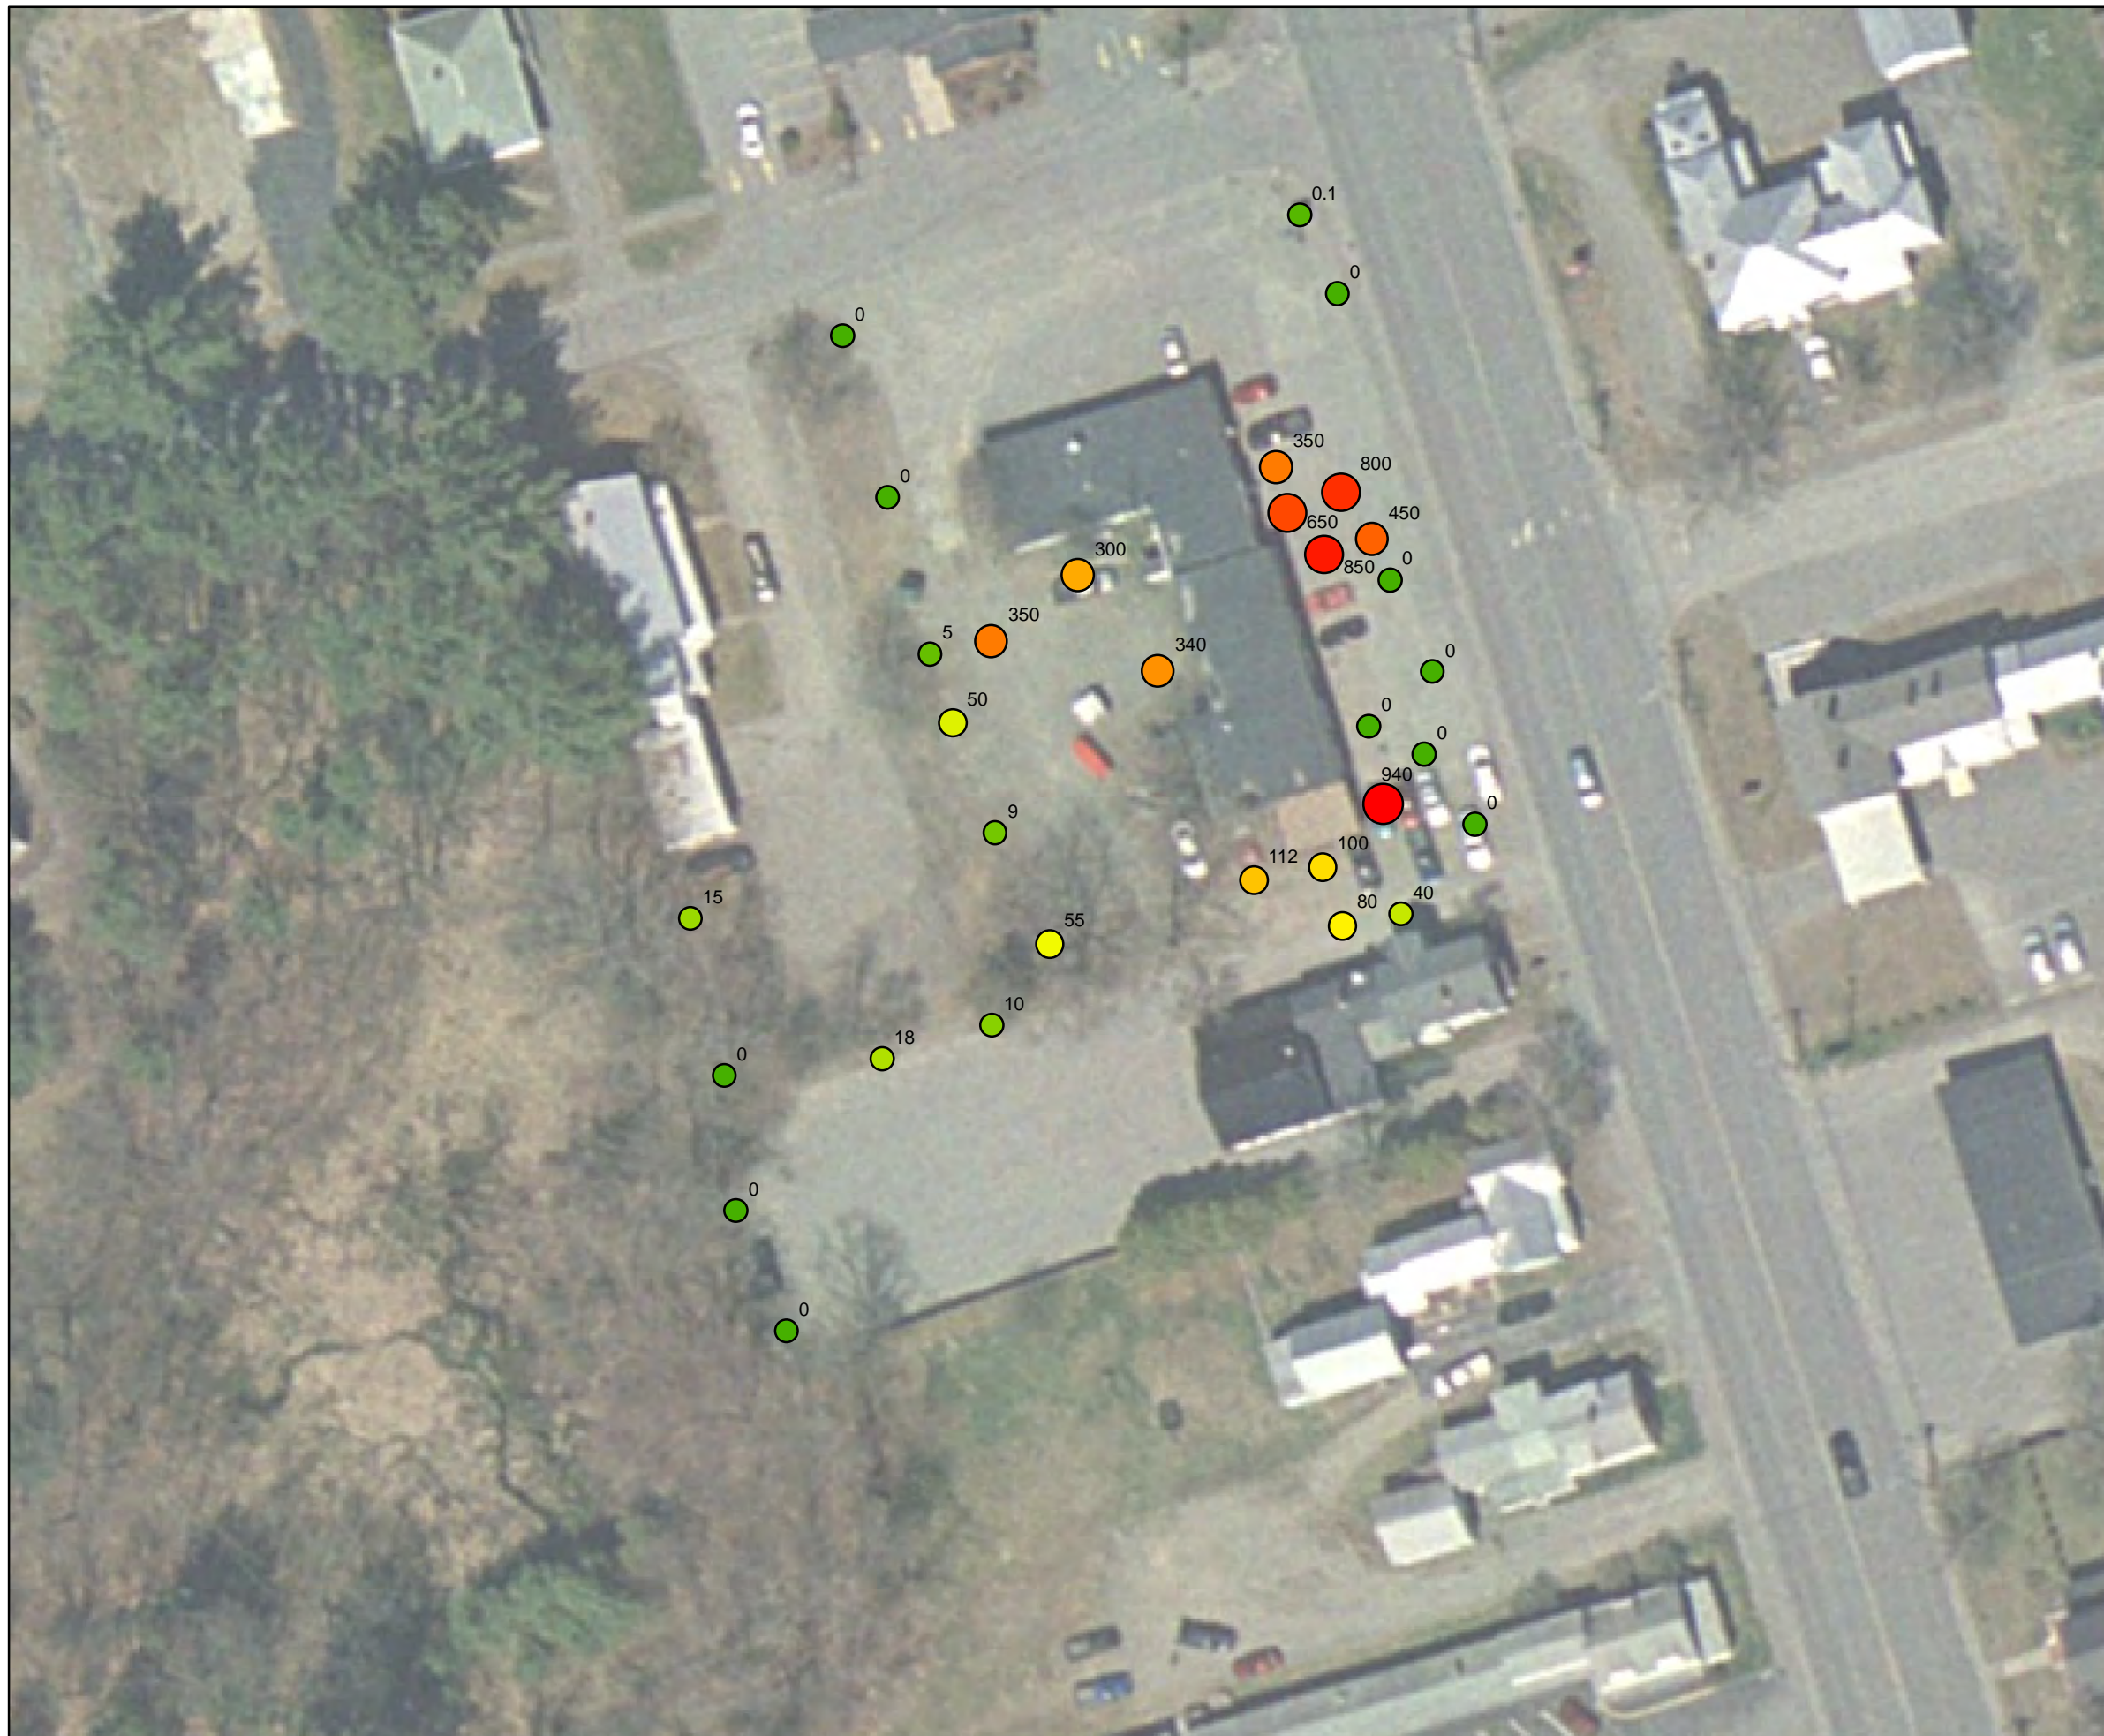
**Figure 4-3**  
**Soil PID Readings**  
**Highest Reading in**  
**each Soil Boring**

Geoprobe borings and associated PID readings indicate that petroleum contamination is present at water table in the sand, especially in the borings completed on the Kyes property. PID readings ranged from 0 to 950 ppm based on bagged headspace readings. The results of the PID soil bag screening (depicting the highest reading in each boring) are shown on Figure 4-3. As evident from this map, the most elevated readings were recorded for samples collected in front of building and at the southeast corner of the building. A third area of heavily contaminated soil is found west of the building on the Kyes property where readings ranged from 300 to 350 ppm. It is important to note that these PID readings are useful for qualitative assessment of the presence of VOCs and cannot be used to represent quantitative identification of specific compounds or concentrations.

**Soil - Bag PID Readings in ppm**

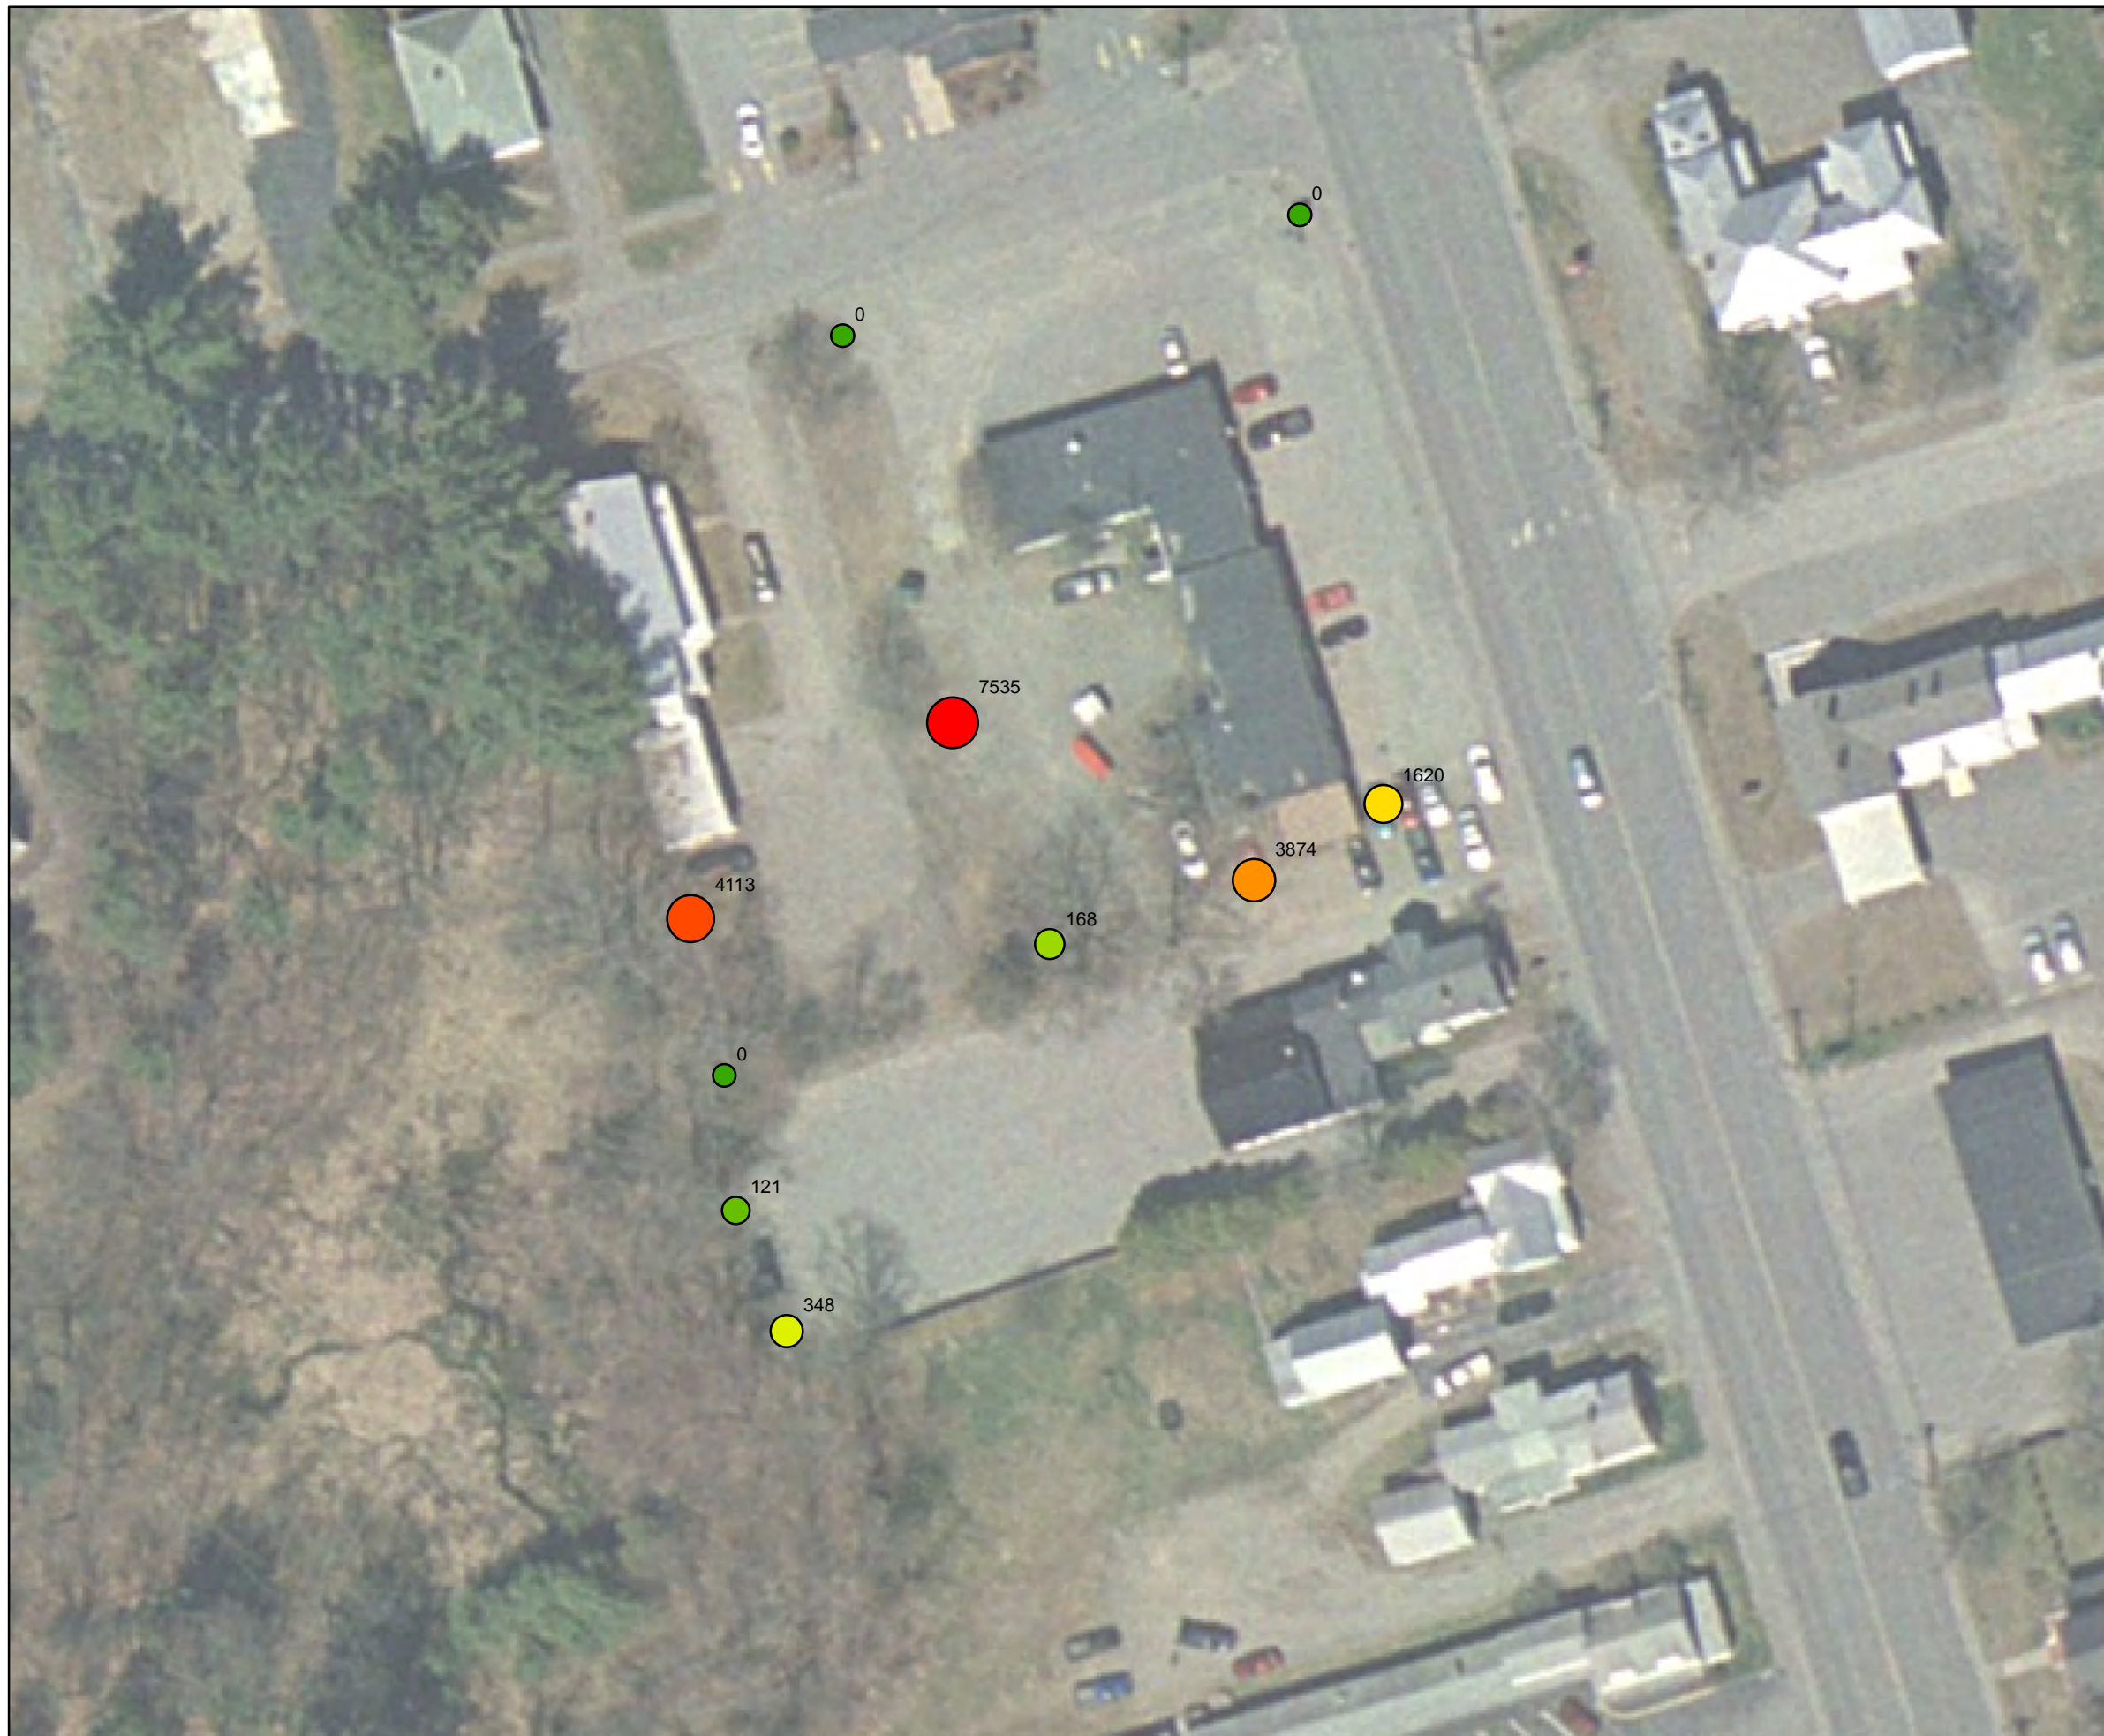
**Figure 4-4**  
**Total Volatile Petroleum Hydrocarbons**  
**In Groundwater**  
**August 2012**  
**Whitten Brook**  
**Site**  
 Skowhegan, Maine

Petroleum contamination was also reported for groundwater samples collected from monitoring wells situated between the corner of Madison Ave and Silver Street and the headwaters of Whitten Brook. No petroleum contamination was detected in samples collected from the two wells located adjacent to Silver Street, MW-1 and MW-5. Low concentrations of total VPH (100 to 300 ug/L) were reported for samples collected from MW-7 and MW-8, located within 50 feet east of the seep discharge. The most elevated VPH concentrations were reported for groundwater samples collected from wells located 100 to 300 feet northeast of the seep - here groundwater concentration ranged from 4113 ug/L to 7535 ug/L in MW-10 and MW-2, respectively.

Volatile Petroleum Hydrocarbons in ug/L
