## STREAM SUMMARY

In the course of project development, Stantec Consulting (Stantec) conducted a variety of ecological surveys within the Bingham Wind Project (project) area, including wetland and stream delineations. Much of the project area occurs within the Piscataquis River watershed (HUC 0102000401), which is designated as critical habitat for Atlantic salmon (*Salmo salar*) (Figure 1). In addition, many of the delineated perennial streams provide potential habitat and, in the case of one stream, documented habitat for the northern spring salamander (*Gyrinophilus porphyriticus*), a State Species of Special Concern. The Applicants, Blue Sky West, LLC and Blue Sky West II, LLC, have made efforts to minimize stream impacts by avoiding direct stream work and proposing managed buffers along the delineated streams. For those streams identified as potential or documented habitat for northern spring salamander, the proposed management buffer will be 250 feet as measured from each stream bank. Those streams within the designated critical habitat for Atlantic salmon will receive a 100-foot buffer unless the more restrictive 250-foot buffer applies. All other streams within the project

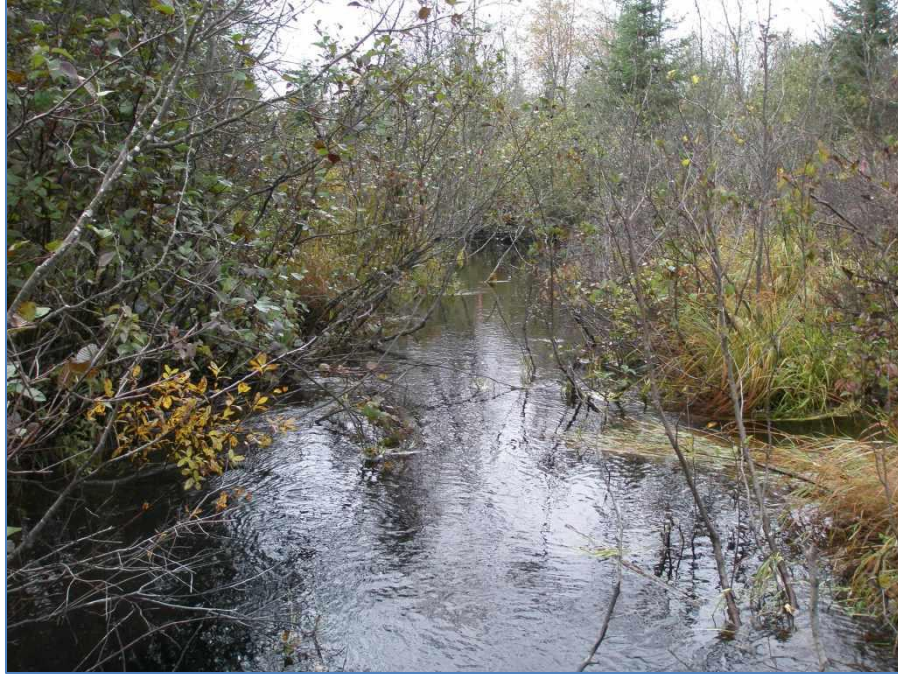
**Photo 1:** Perennial stream S007.  
Stantec Consulting, October 1, 2012.

- Perennial stream impacted by beaver activity.
- Channel substrate is primarily bedrock and cobble with some gravel, sand and muck.
- Aquatic mosses and macro invertebrates occur throughout the stream channel.
- Small fish (1 to 3 inches) observed in stream.
- Physical characteristics (**Photo 1**):
  - Bankfull width is 6-15 feet (Average 10.5 feet);
  - Water depth in August of 2010 was 3-6 inches;
  - Low gradient riffle, run, pool sequence;
  - Overhanging vegetation present.

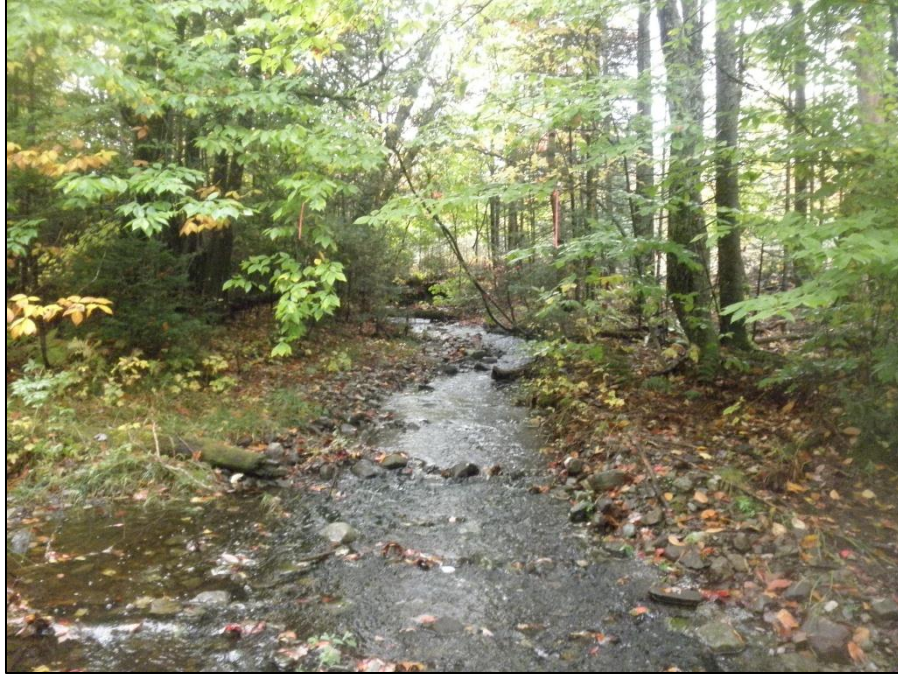
**Photo 2:** Perennial stream S009.  
Stantec Consulting, October 1, 2012.

- Perennial stream occurring in a forested wetland.
- Channel substrate is a combination of cobble, gravel, sand and muck.
- Silt is embedded at 25 percent.
- Aquatic mosses and macro-invertebrates occur throughout the stream channel.
- Physical characteristics (**Photo 2**):
  - Bankfull width is 3-8 feet (Average 5.5 feet);
  - Water depth in October of 2012 was 3-18 inches;
  - Low gradient with only riffles;
  - Overhanging vegetation creates 100 percent cover.

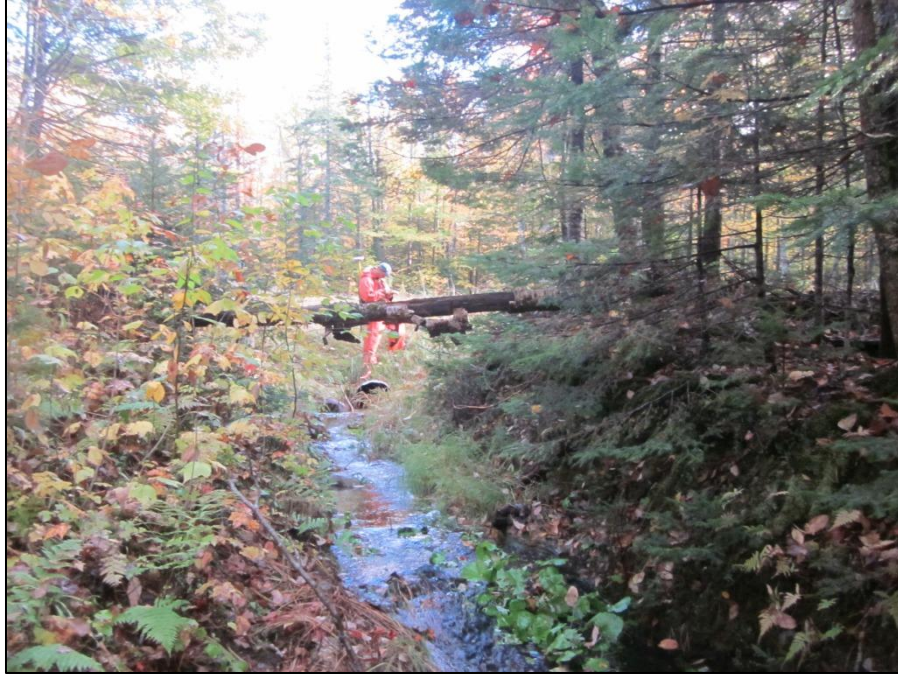
**Photo 3:** Perennial Stream S010  
Stantec Consulting, October 1, 2012

- Perennial stream occurring in forested upland and a forested wetland.
- Channel substrate is primarily gravel with silt embedded at 50 percent.
- Aquatic mosses and macro invertebrates occur throughout the stream channel.
- Physical characteristics (**Photo 3**):
  - Bankfull width is 4-6 feet (Average 5 feet) and depth is 30 inches;
  - Water depth in October of 2012 was 2-4 inches;
  - Low gradient with riffles dominating the flow structure;
  - Canopy cover is 90 percent.

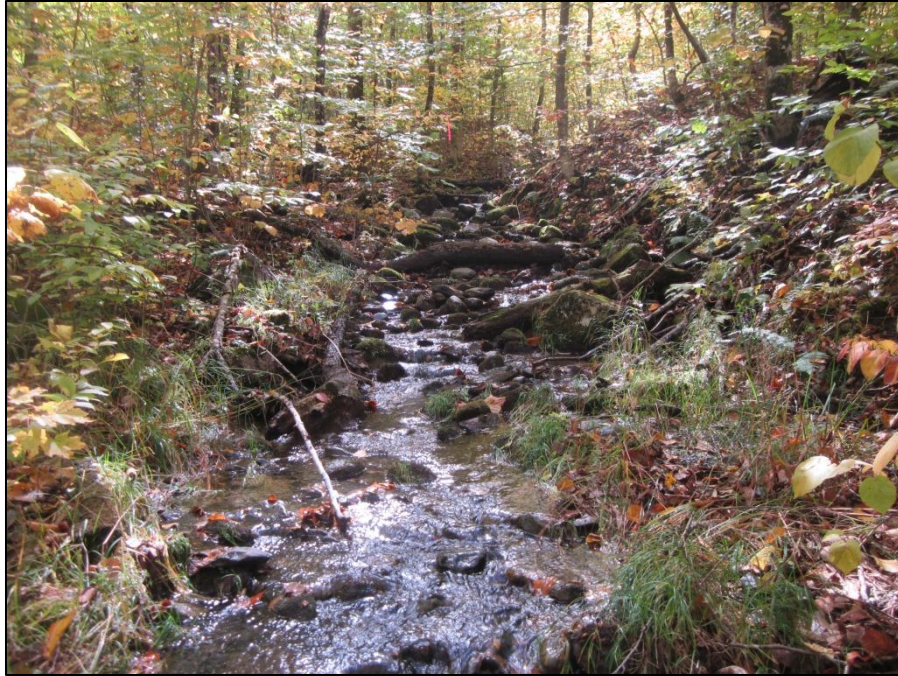
**Photo 4:** Perennial stream S014.  
Stantec Consulting, October 2, 2012.

- Perennial stream occurring in a forested upland.
- Channel substrate is primarily sand, gravel and cobble.
- Macro-invertebrates are present.
- Moderate erosion characterized by vertical to undercut banks.
- Physical characteristics (**Photo 4**):
  - Bankfull width is 6-7 feet (Average 6.5 feet);
  - Water depth in October 2012 was 4-12 inches;
  - Moderate gradient with riffles and occasional pools.

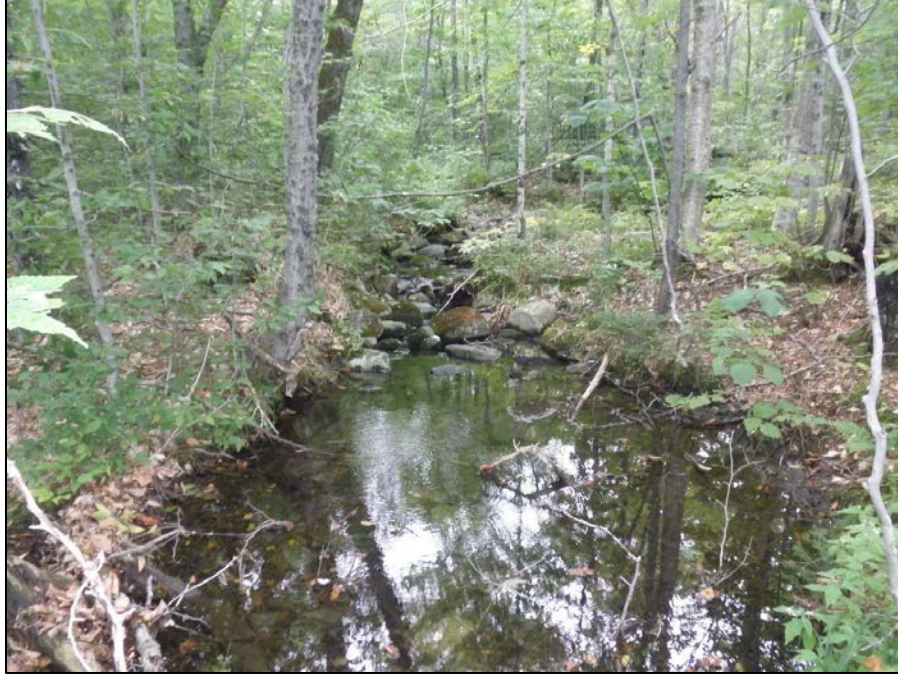
**Photo 5:** Perennial stream S021  
Stantec Consulting, July 27, 2010.

- Perennial stream occurs within a forested upland.
- Channel substrate is primarily rock and cobble with gravel and sand and embedded silt.
- Aquatic invertebrates and aquatic fauna observed.
- Physical characteristics (**Photo 5**):
  - Bankfull width is 0.5-5 feet;
  - Water depth in September 2011 was 3-6 inches;
  - Low to moderate gradient with riffles and pools.

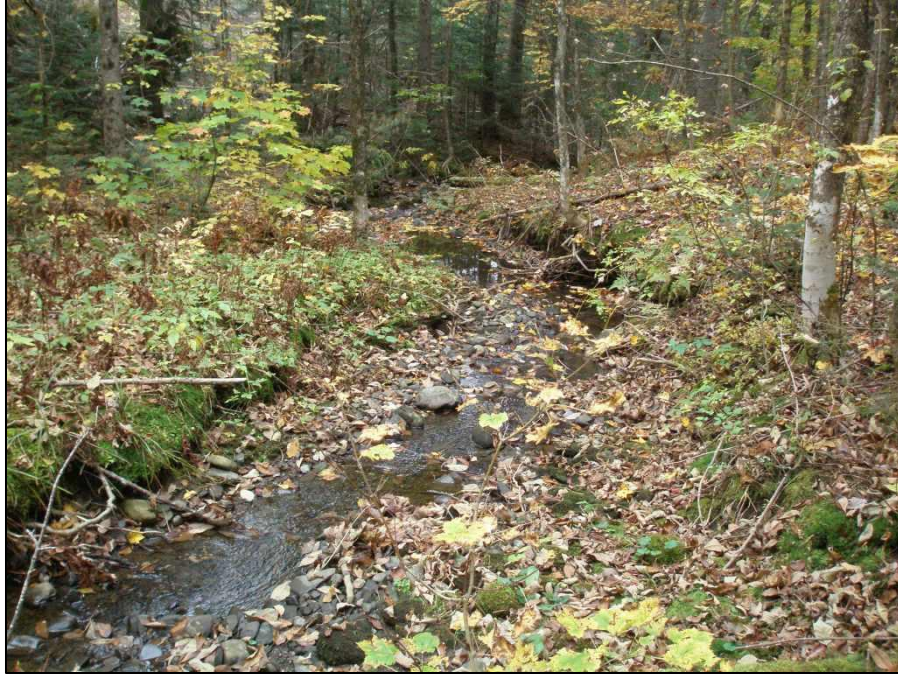
**Photo 8:** Perennial stream S024.  
Stantec Consulting, October 4, 2012.

- Perennial stream occurs within a forested setting.
- Channel substrate consists of gravel and cobble.
- No aquatic invertebrates observed.
- Physical characteristics (**Photo 8**):
  - Bankfull width is 8 feet;
  - Water depth in October of 2012 was 2-4 feet;
  - Undercut banks and drift deposits present.

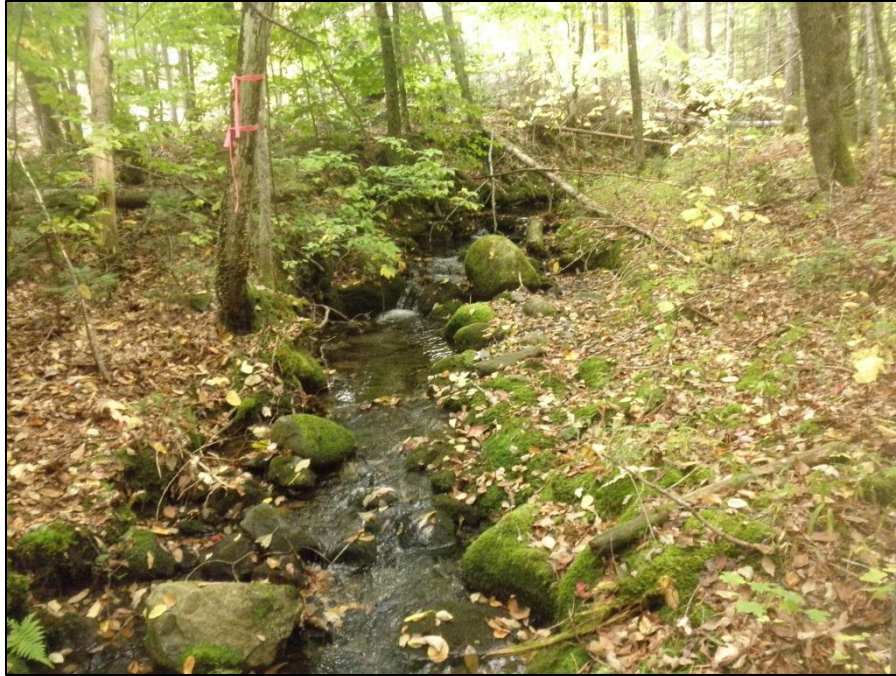
**Photo 9:** Perennial stream S025.  
Stantec Consulting, October 3, 2012.

- Perennial stream occurring in a deciduous forest.
- Channel substrate consists of boulders, cobble, gravel, and woody debris.
- Aquatic mosses and brook trout observed.
- Physical characteristics (**Photo 9**):
  - Bankfull width is 5-8 feet (Average 6.5 feet);
  - Water depth in October of 2012 was 3-12 inches;
  - Low to moderate gradient with riffles and pools.

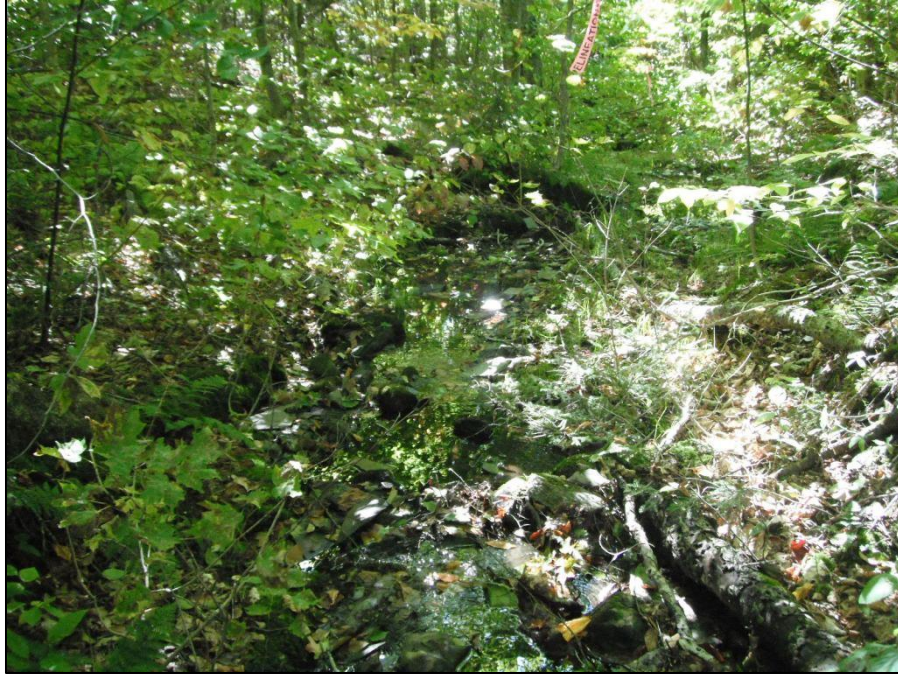
**Photo 12:** Perennial stream S033  
Stantec Consulting, September 25, 2012

- Perennial stream occurring in a mixed forest.
- Channel substrate consists of gravel, cobble, and boulder.
- Aquatic fauna observed.
- Physical characteristics (**Photo 12**):
  - Bankfull width is 5 feet;
  - Very low flow in September of 2012;
  - Moderate slope.

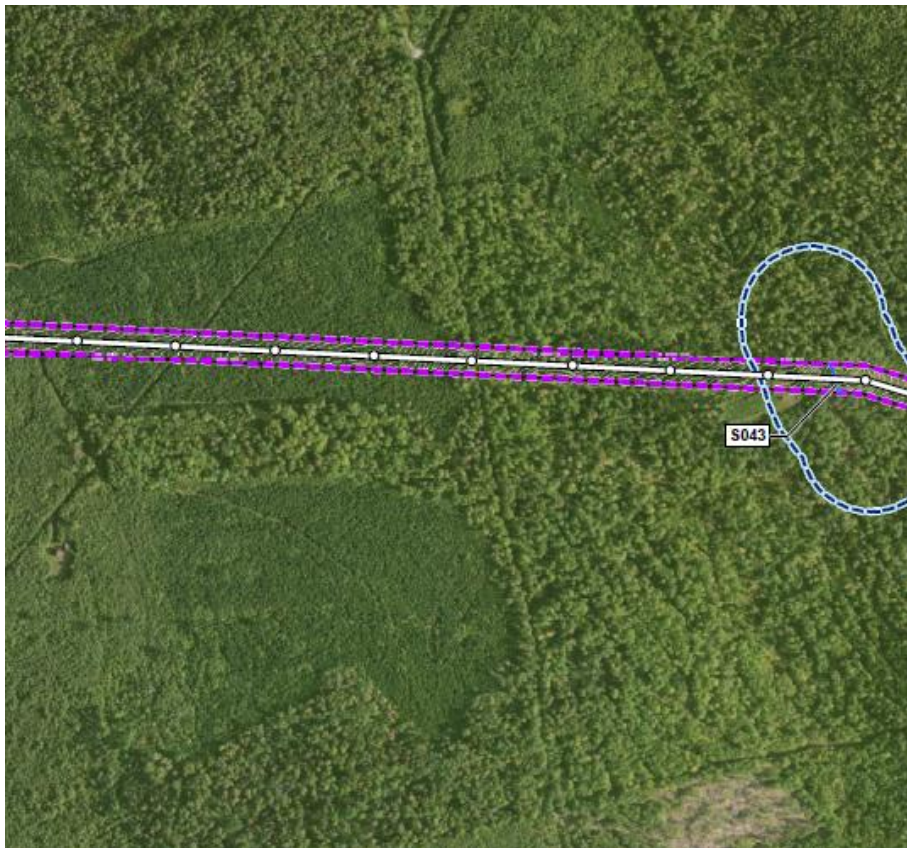
The stream will be crossed by the electrical generator lead corridor. During construction, a temporary timber mat bridge will be used to allow movement of construction equipment across the stream. There will be no direct impact to the stream channel. One pole (structure) will be located within 100 feet of this stream. This stream has the potential to contain northern spring salamanders, and to the extent practicable a 250-foot buffer will be maintained on each side of the stream. During construction and maintenance, capable trees (i.e., those that could grow to within 15 feet of a conductor within 3-4 years) will be topped, but no other vegetation will be cut. If topping individual trees will not leave sufficient foliage to sustain the tree, the tree will be cut at ground level. With regard to the pole (structure) located within the 250-foot buffer, the maximum height of vegetation within the corridor is a function of conductor height. The proximity of the pole to this stream will provide a conductor height that will allow for the establishment of taller vegetation near the stream, which will provide maximum shading of the stream. Herbicide use will not be allowed within this buffer.

Proposed generator lead crossing of stream S043.  
From Figure 19, Delineated Natural Resource Map by Stantec Consulting.

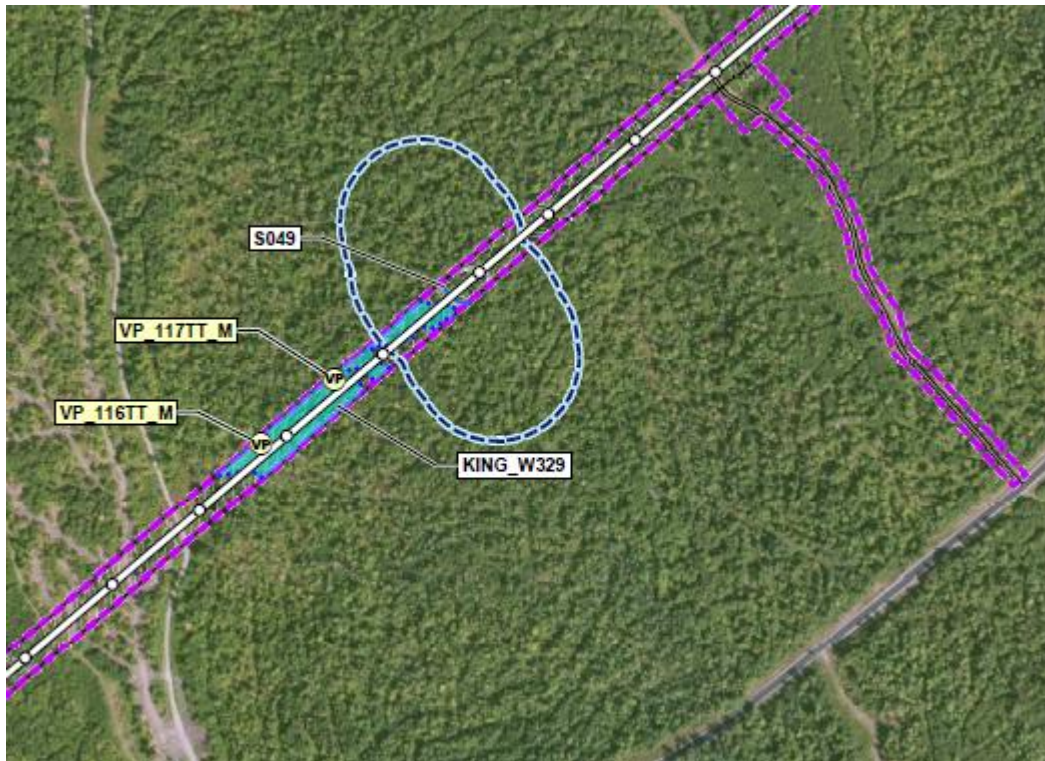
The stream will be crossed by the electrical generator lead corridor. During construction, a temporary timber mat bridge will be used to allow movement of construction equipment across the stream. There will be no direct impact to the stream channel. One pole (structure) will be located within 100 feet of this stream. This stream has the potential to contain northern spring salamanders, and to the extent practicable a 250-foot buffer will be maintained on each side of the stream. During construction and maintenance, capable trees (i.e., those that could grow to within 15 feet of a conductor within 3-4 years) will be topped, but no other vegetation will be cut. If topping individual trees will not leave sufficient foliage to sustain the tree, the tree will be cut at ground level. With regard to the pole (structure) located within the 250-foot buffer, the maximum height of vegetation within the corridor is a function of conductor height. The proximity of the pole to this stream will provide a conductor height that will allow for the establishment of taller vegetation near the stream, which will provide maximum shading of the stream. Herbicide use will not be allowed within this buffer.

Proposed generator lead crossing of stream S049.  
From Figure 21 Delineated Natural Resource Map by Stantec Consulting.

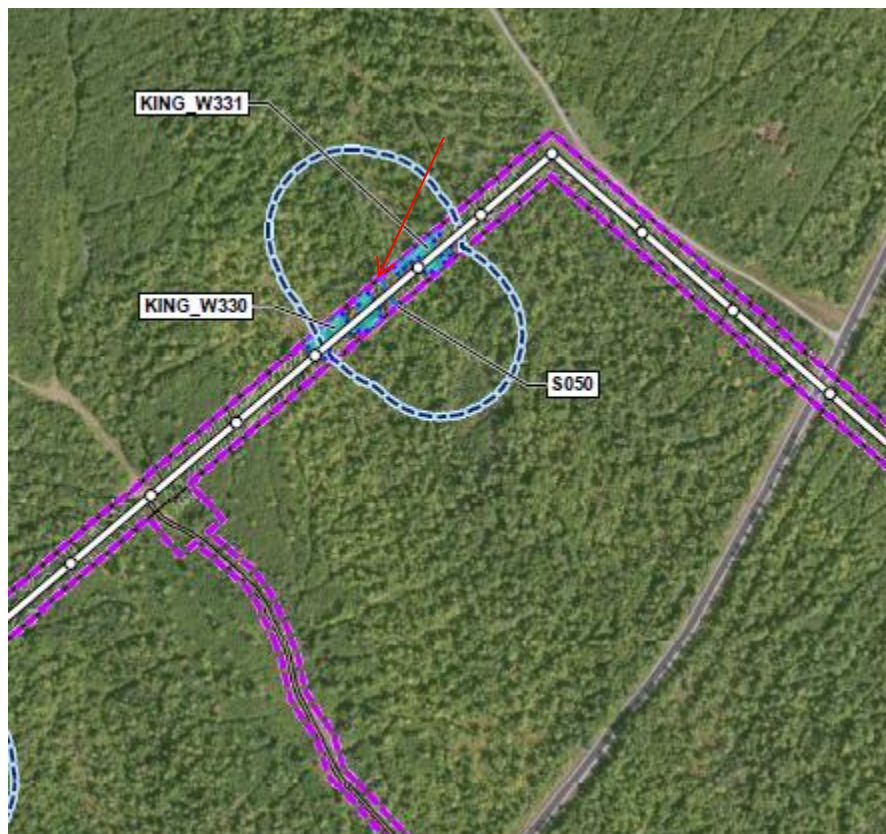
Proposed generator lead crossing of stream S050.  
From Figure 21 Delineated Natural Resource Map by Stantec Consulting.

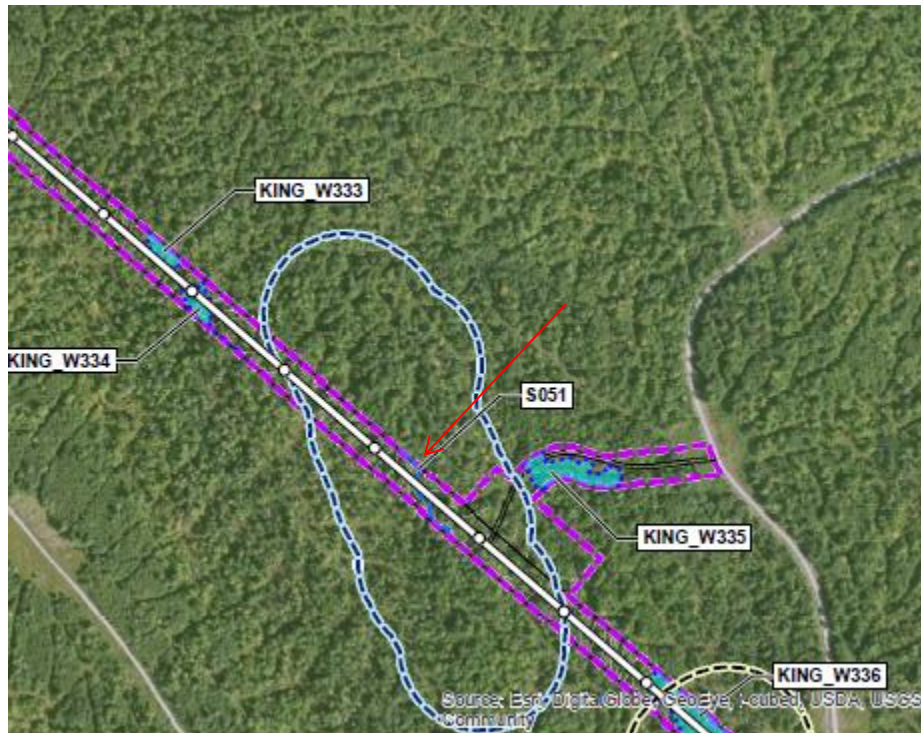
Proposed generator lead crossing of stream S051.  
From Figure 22 Delineated Natural Resource Map by Stantec Consulting.

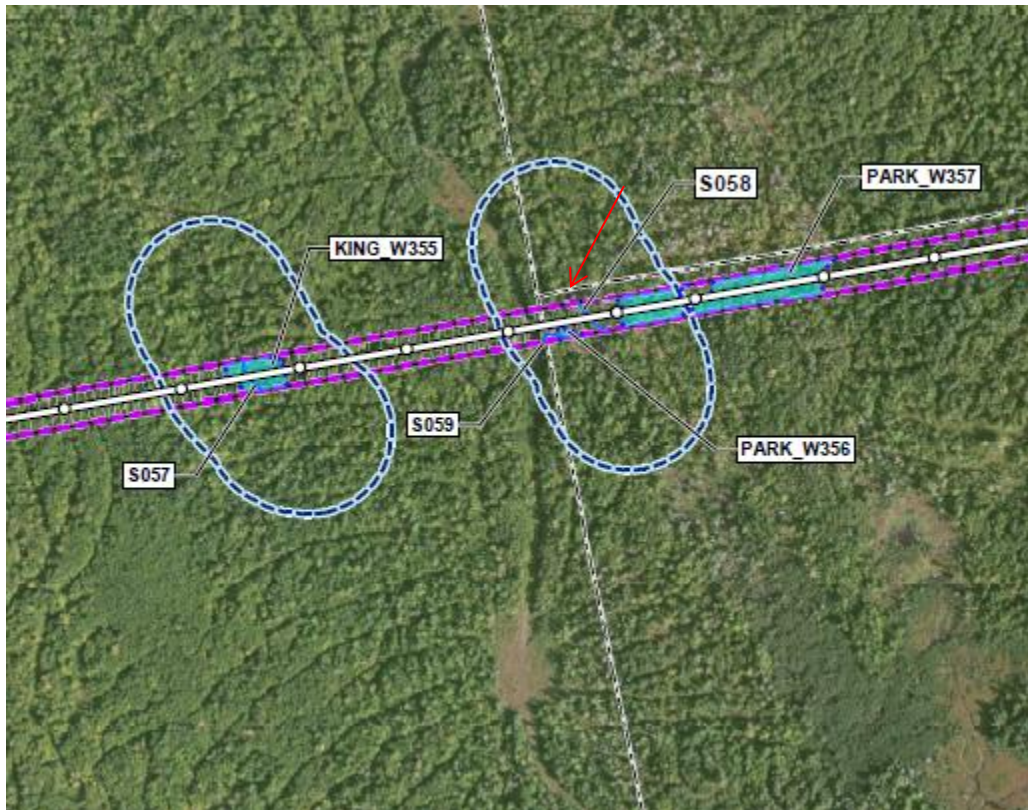
Proposed generator lead crossing of stream S058.  
From Figure 25 Delineated Natural Resource Map by Stantec Consulting.
