APPENDIX B

REPRESENTATIVE WETLANDS PHOTOGRAPHS

Company: Patriot Renewables
Project: Canton Mountain Wind Project – Wetland Delineation Survey

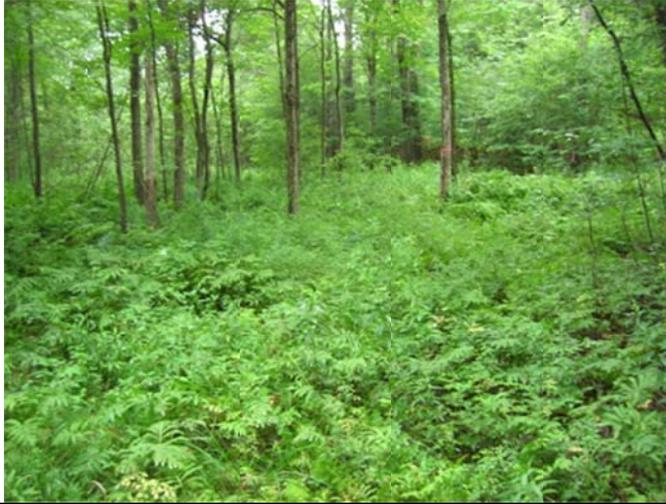
Photo No.: 1
Plan ID: AW5
Field ID: CAWBK12
Date: August 3, 2010
Photographer: Rodney Kelshaw

Comments:
Wetland was classified as PFO1/ PSS1/ PEM. Wetland has been influenced by beaver activity. Photo was taken at the southern tip of the wetland looking at the floodplain.

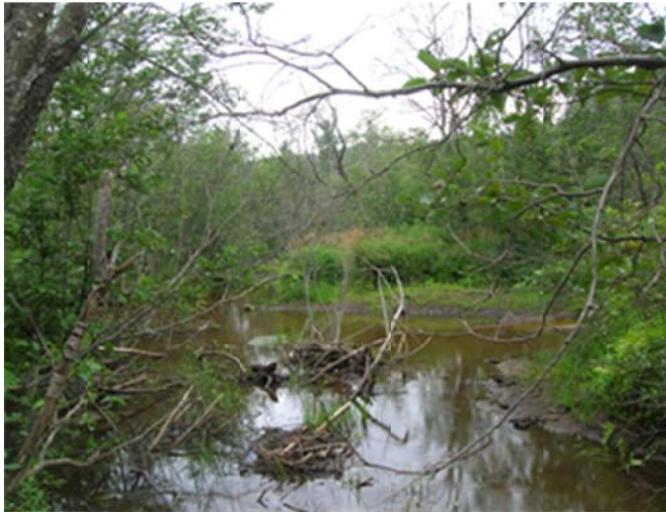
Photo No.: 2
Plan ID: AW5
Field ID: CAWBK12
Date: August 3, 2010
Photographer: Rodney Kelshaw

Comments:
Wetland was classified as PFO1/ PSS1/ PEM. Wetland has been influenced by beaver activity. Photo is looking in west.

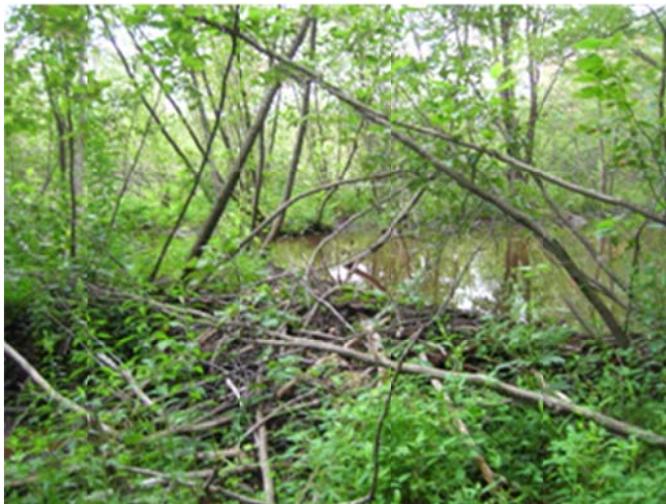
Photo No.: 3
Plan ID: AW5
Field ID: CAWBK12
Date: August 3, 2010
Photographer: Rodney Kelshaw

Comments:
Wetland was classified as PFO1/ PSS1/ PEM. Wetland has been influenced by beaver activity. Photo of the beaver Dam.

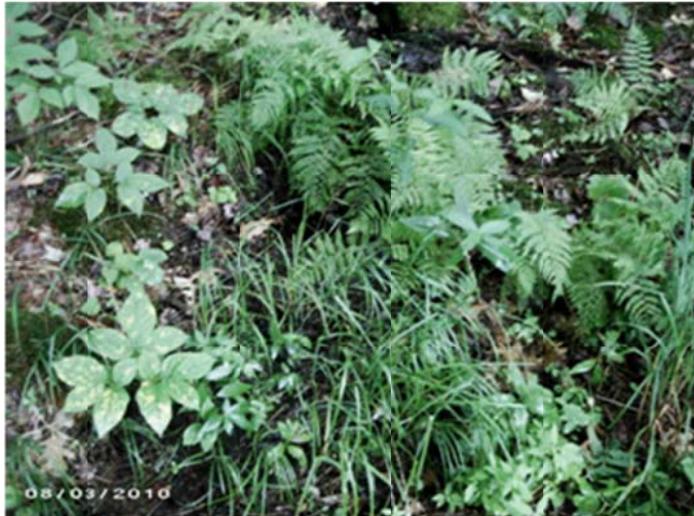
Photo No.: 1
Plan ID: AW8
Field ID: CAWBK15
Date: August 3, 2010
Photographer: Rodney Kelshaw

Comments:
Wetland is located near a spring (mapped separately as CA) on a sideslope with a narrow swale spillway. Classification of this wetland is PFO4/PEM1. Photo looking east.

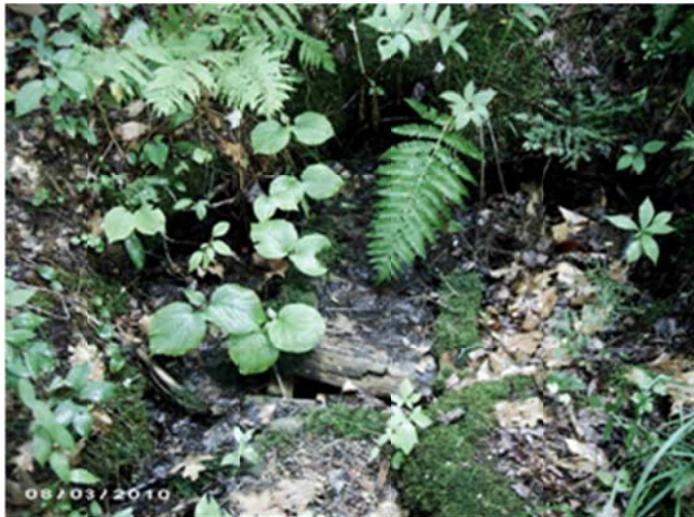
Photo No.: 2
Plan ID: AW8
Field ID: CAWBK15
Date: August 3, 2010
Photographer: Rodney Kelshaw

Comments:
Wetland is located near a spring (mapped separately as CA) on a sideslope with a narrow swale spillway. Classification of this wetland is PFO4/PEM1. Photo looking east.

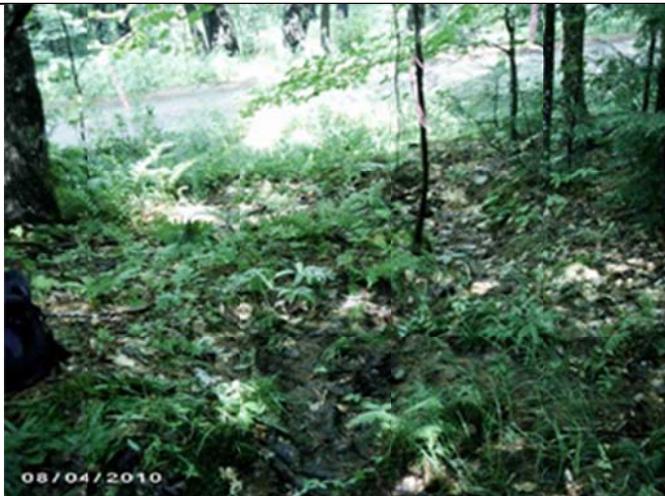
Photo No.: 1
Plan ID: AW10
Field ID: CAWBK17
Date: August 4, 2010
Photographer: Rodney Kelshaw

Comments:
FO1/PEM1 wetland located on a narrow sideslope seep. Photo taken looking west.

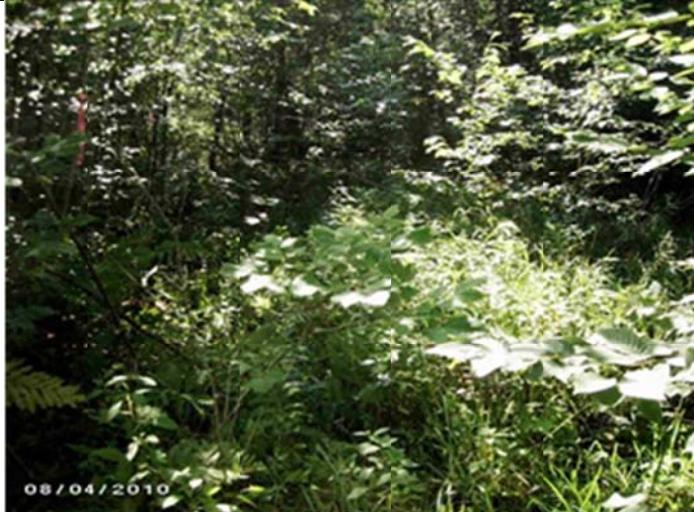
Photo No.: 1
Plan ID: AW12
Field ID: CAWBK20
Date: August 4, 2010
Photographer: Rodney Kelshaw

Comments:
PSS1/PF01 wetland located on the western side of Ludden Lane and the photo was taken looking west.

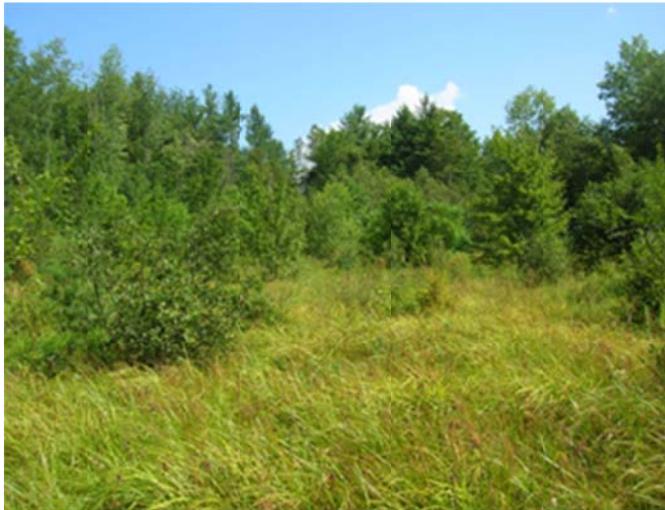
Photo No.: 1
Plan ID: AW27
Field ID: CAWBB1
Date: August 10, 2010
Photographer: Dave Brenneman

Comments:
PFO1/4 / PEM2 wetland, photo was taken in the middle of the wetland looking east. This wetland several small upland islands.

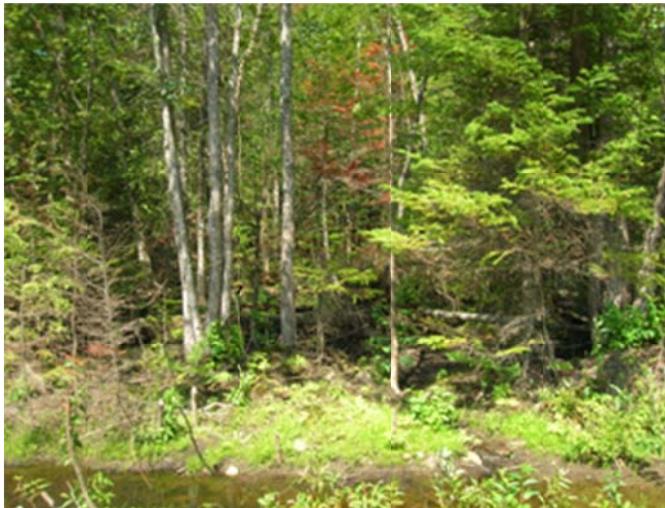
Photo No.: 2
Plan ID: AW27
Field ID: CAWBB1
Date: August 10, 2010
Photographer: Dave Brenneman

Comments:
PFO1/4 / PEM2 wetland, photo was taken in the middle of the wetland looking south.

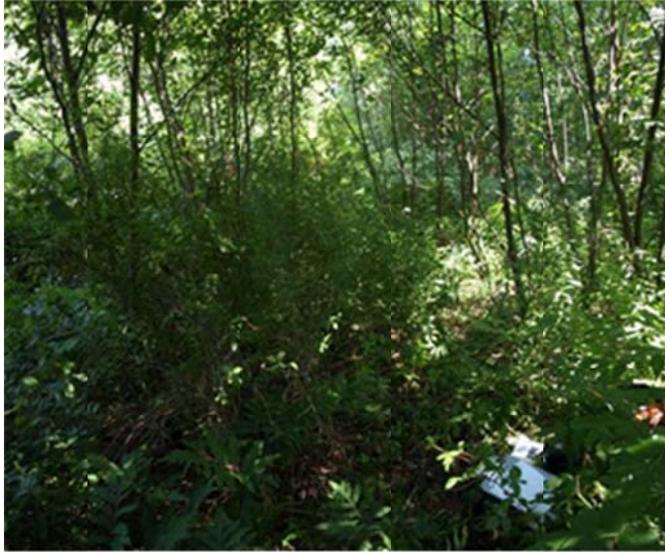
Photo No.: 1
Plan ID: AW30
Field ID: CAWBW10
Date: August 10, 2010
Photographer: Heather Storlazzi Ward

Comments:
A PSS1E wetland. Photo was taken looking north.

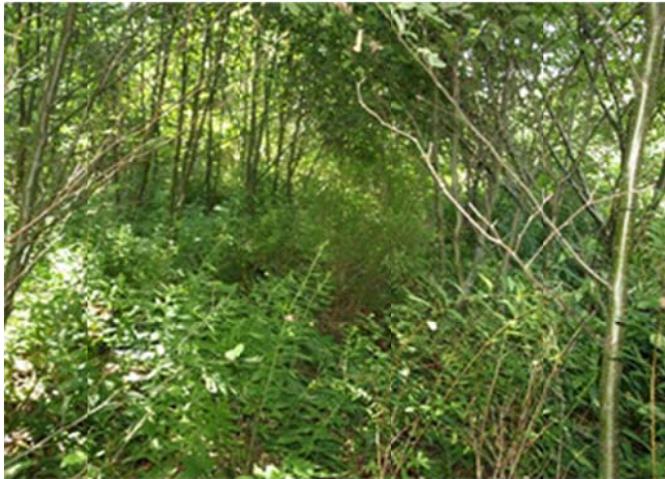
Photo No.: 2
Plan ID: AW30
Field ID: CAWBW10
Date: August 10, 2010
Photographer: Heather Storlazzi Ward

Comments:
A PSS1E wetland. Photo was taken looking south.

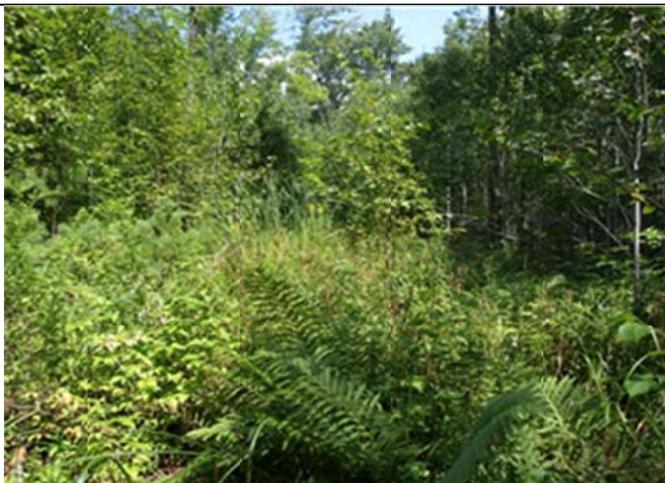
Photo No.: 1
Plan ID: AW32
Field ID: CAWBW11
Date: August 10, 2010
Photographer: Heather Storlazzi Ward

Comments:
A PEM1E with a small component of PFO1E wetland. Photo was taken looking southeast.

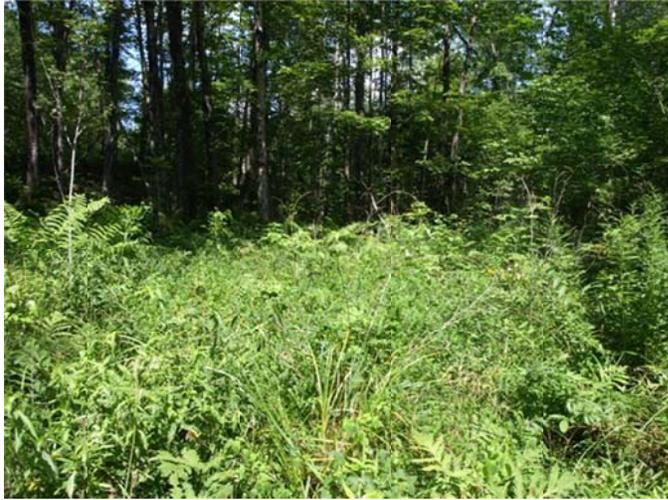
Photo No.: 2
Plan ID: AW32
Field ID: CAWBW11
Date: August 10, 2010
Photographer: Heather Storlazzi Ward

Comments:
A PEM1E with a small component of PFO1E wetland with a small component of PFO1E. Photo was taken looking northeast.

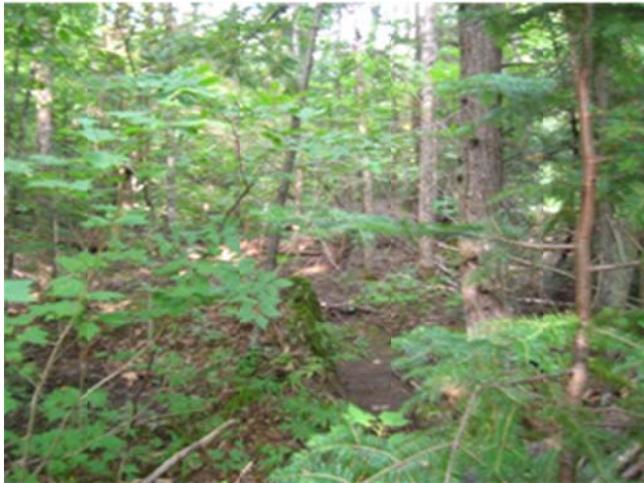
Photo No.: 1
Plan ID: AW36
Field ID: CAWBW14
Date: August 10, 2010
Photographer: Heather Storlazzi Ward

Comments:
A PFO1 wetland. Photo was taken looking north.

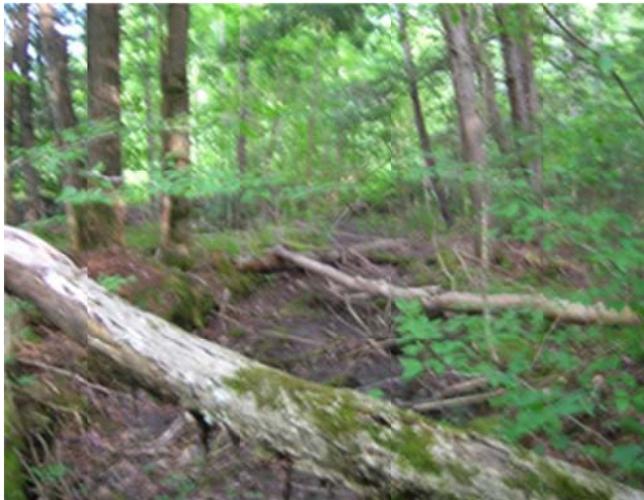
Photo No.: 2
Plan ID: AW36
Field ID: CAWBW14
Date: August 10, 2010
Photographer: Heather Storlazzi Ward

Comments:
A PFO1. Photo was taken looking south.

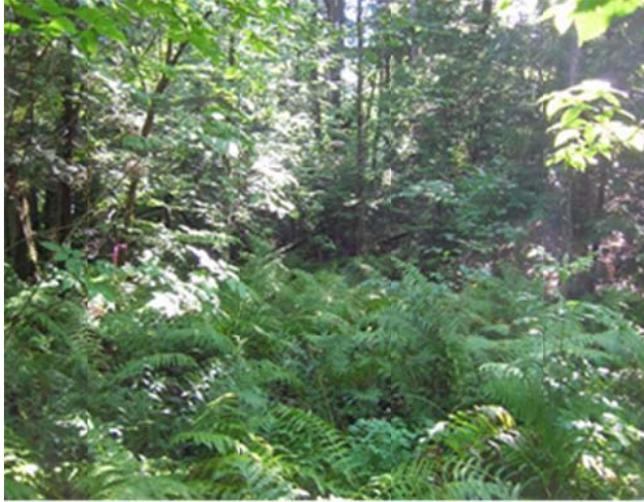
Photo No.: 1
Plan ID: AW40
Field ID: CAWBW16
Date: August 11, 2010
Photographer: Heather Storlazzi Ward

Comments:
A PEM2 / PFO1E wetland that teardrops toward the roadside ditch. Photo is looking northeast.

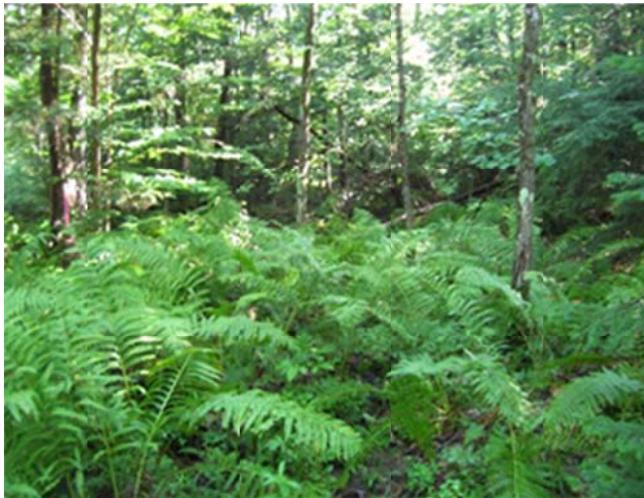
Photo No.: 2
Plan ID: AW40
Field ID: CAWBW16
Date: August 11, 2010
Photographer: Heather Storlazzi Ward

Comments:
A PEM2 / PFO1E wetland that teardrops toward the roadside ditch. Photo is looking northeast

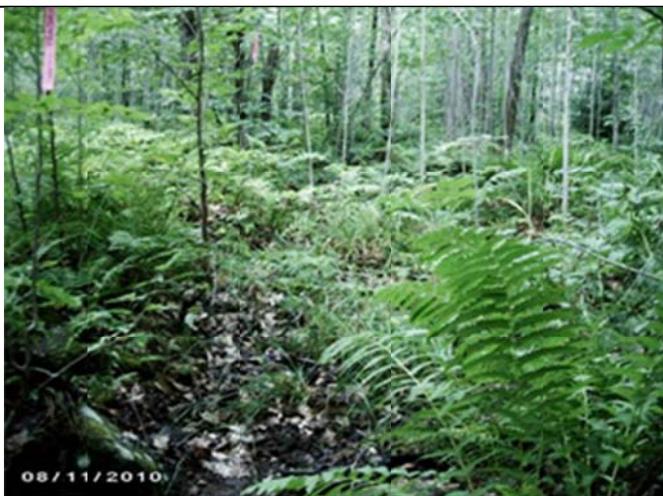
Photo No.: 1
Plan ID: AW50
Field ID: CAWBK54
Date: August 11, 2010
Photographer: Rodney Kelshaw

Comments:
A PEM1 wetland located in a narrow swale with few trees growing within the wetland. Photo is looking east.

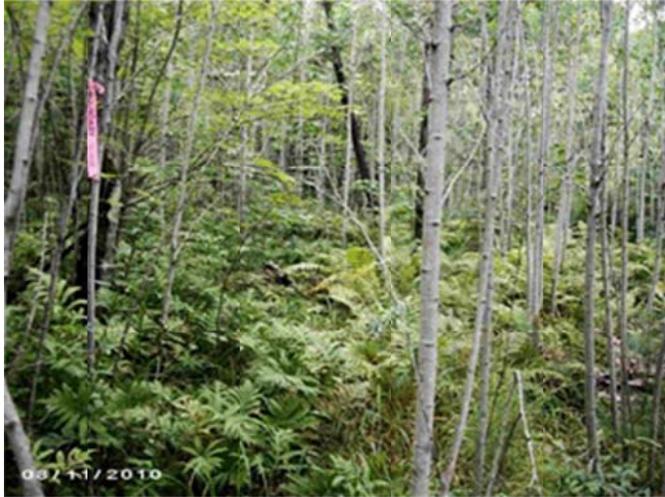
Photo No.: 2
Plan ID: AW50
Field ID: CAWBK54
Date: August 11, 2010
Photographer: Rodney Kelshaw

Comments:
A PEM1 wetland located in a narrow swale with few trees growing within the wetland. Photo is looking east.

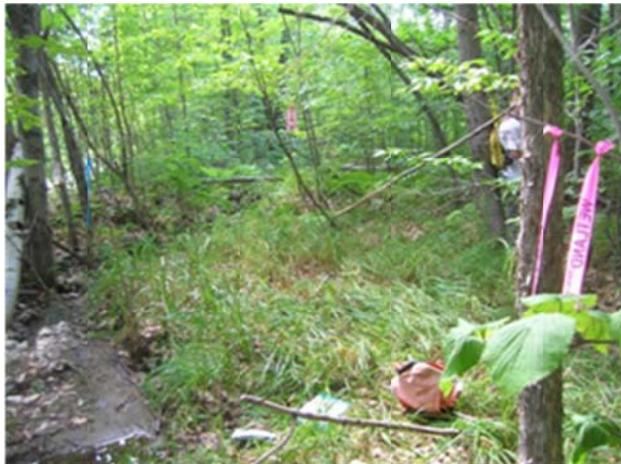
Photo No.: 1
Plan ID: AW56
Field ID: CRWBB7
Date: August 11, 2010
Photographer: David Brenneman

Comments:
A PEM2 wetland adjacent to the stream CRSBW21. Photo was taken looking south

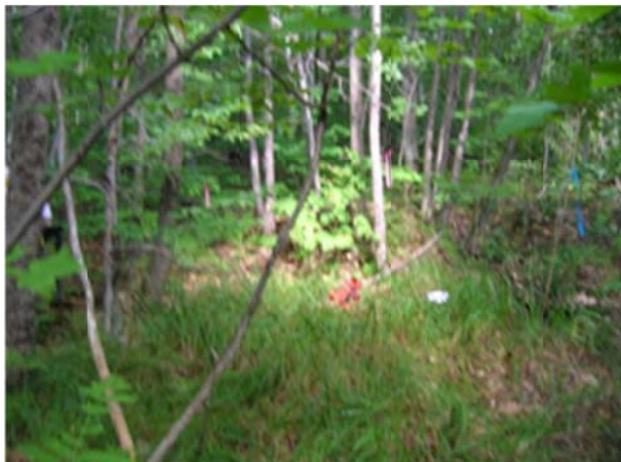
Photo No.: 2
Plan ID: AW56
Field ID: CRWBB7
Date: August 11, 2010
Photographer: David Brenneman

Comments:
A PEM2 wetland adjacent to the stream CRSBW21. Photo was taken looking north.

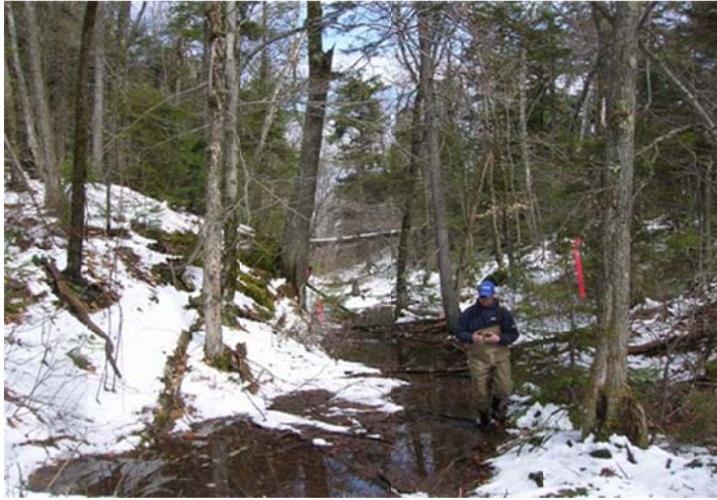
Photo No.: 1
Plan ID: RW77
Field ID: CRWBB15
Date: August 11, 2010
Photographer: David Brenneman
Comments: Looking north.

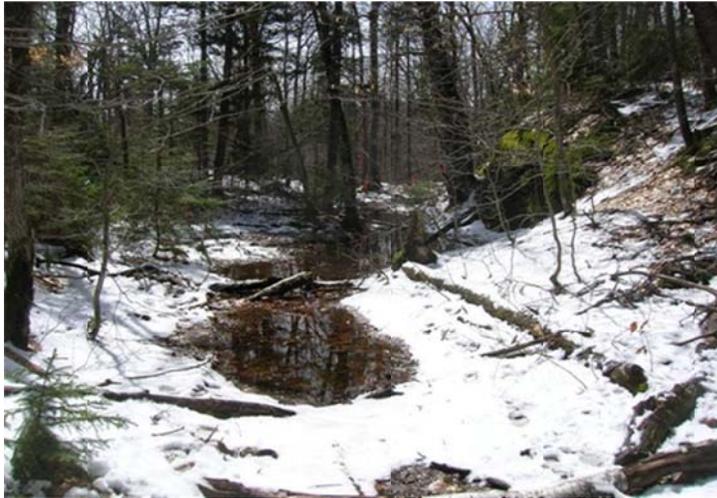
Photo No.: 2
Plan ID: RW77
Field ID: CRWBB15
Date: August 11, 2010
Photographer: David Brenneman
Comments: Looking south.
