October 19, 2018

**RE: New England Clean Energy Connect Project  
Roaring Brook Mayfly and Northern Spring Salamander Survey Results**

**Attachment B**  
**NECEC Roaring Brook Mayfly Field Survey Inspection Records**

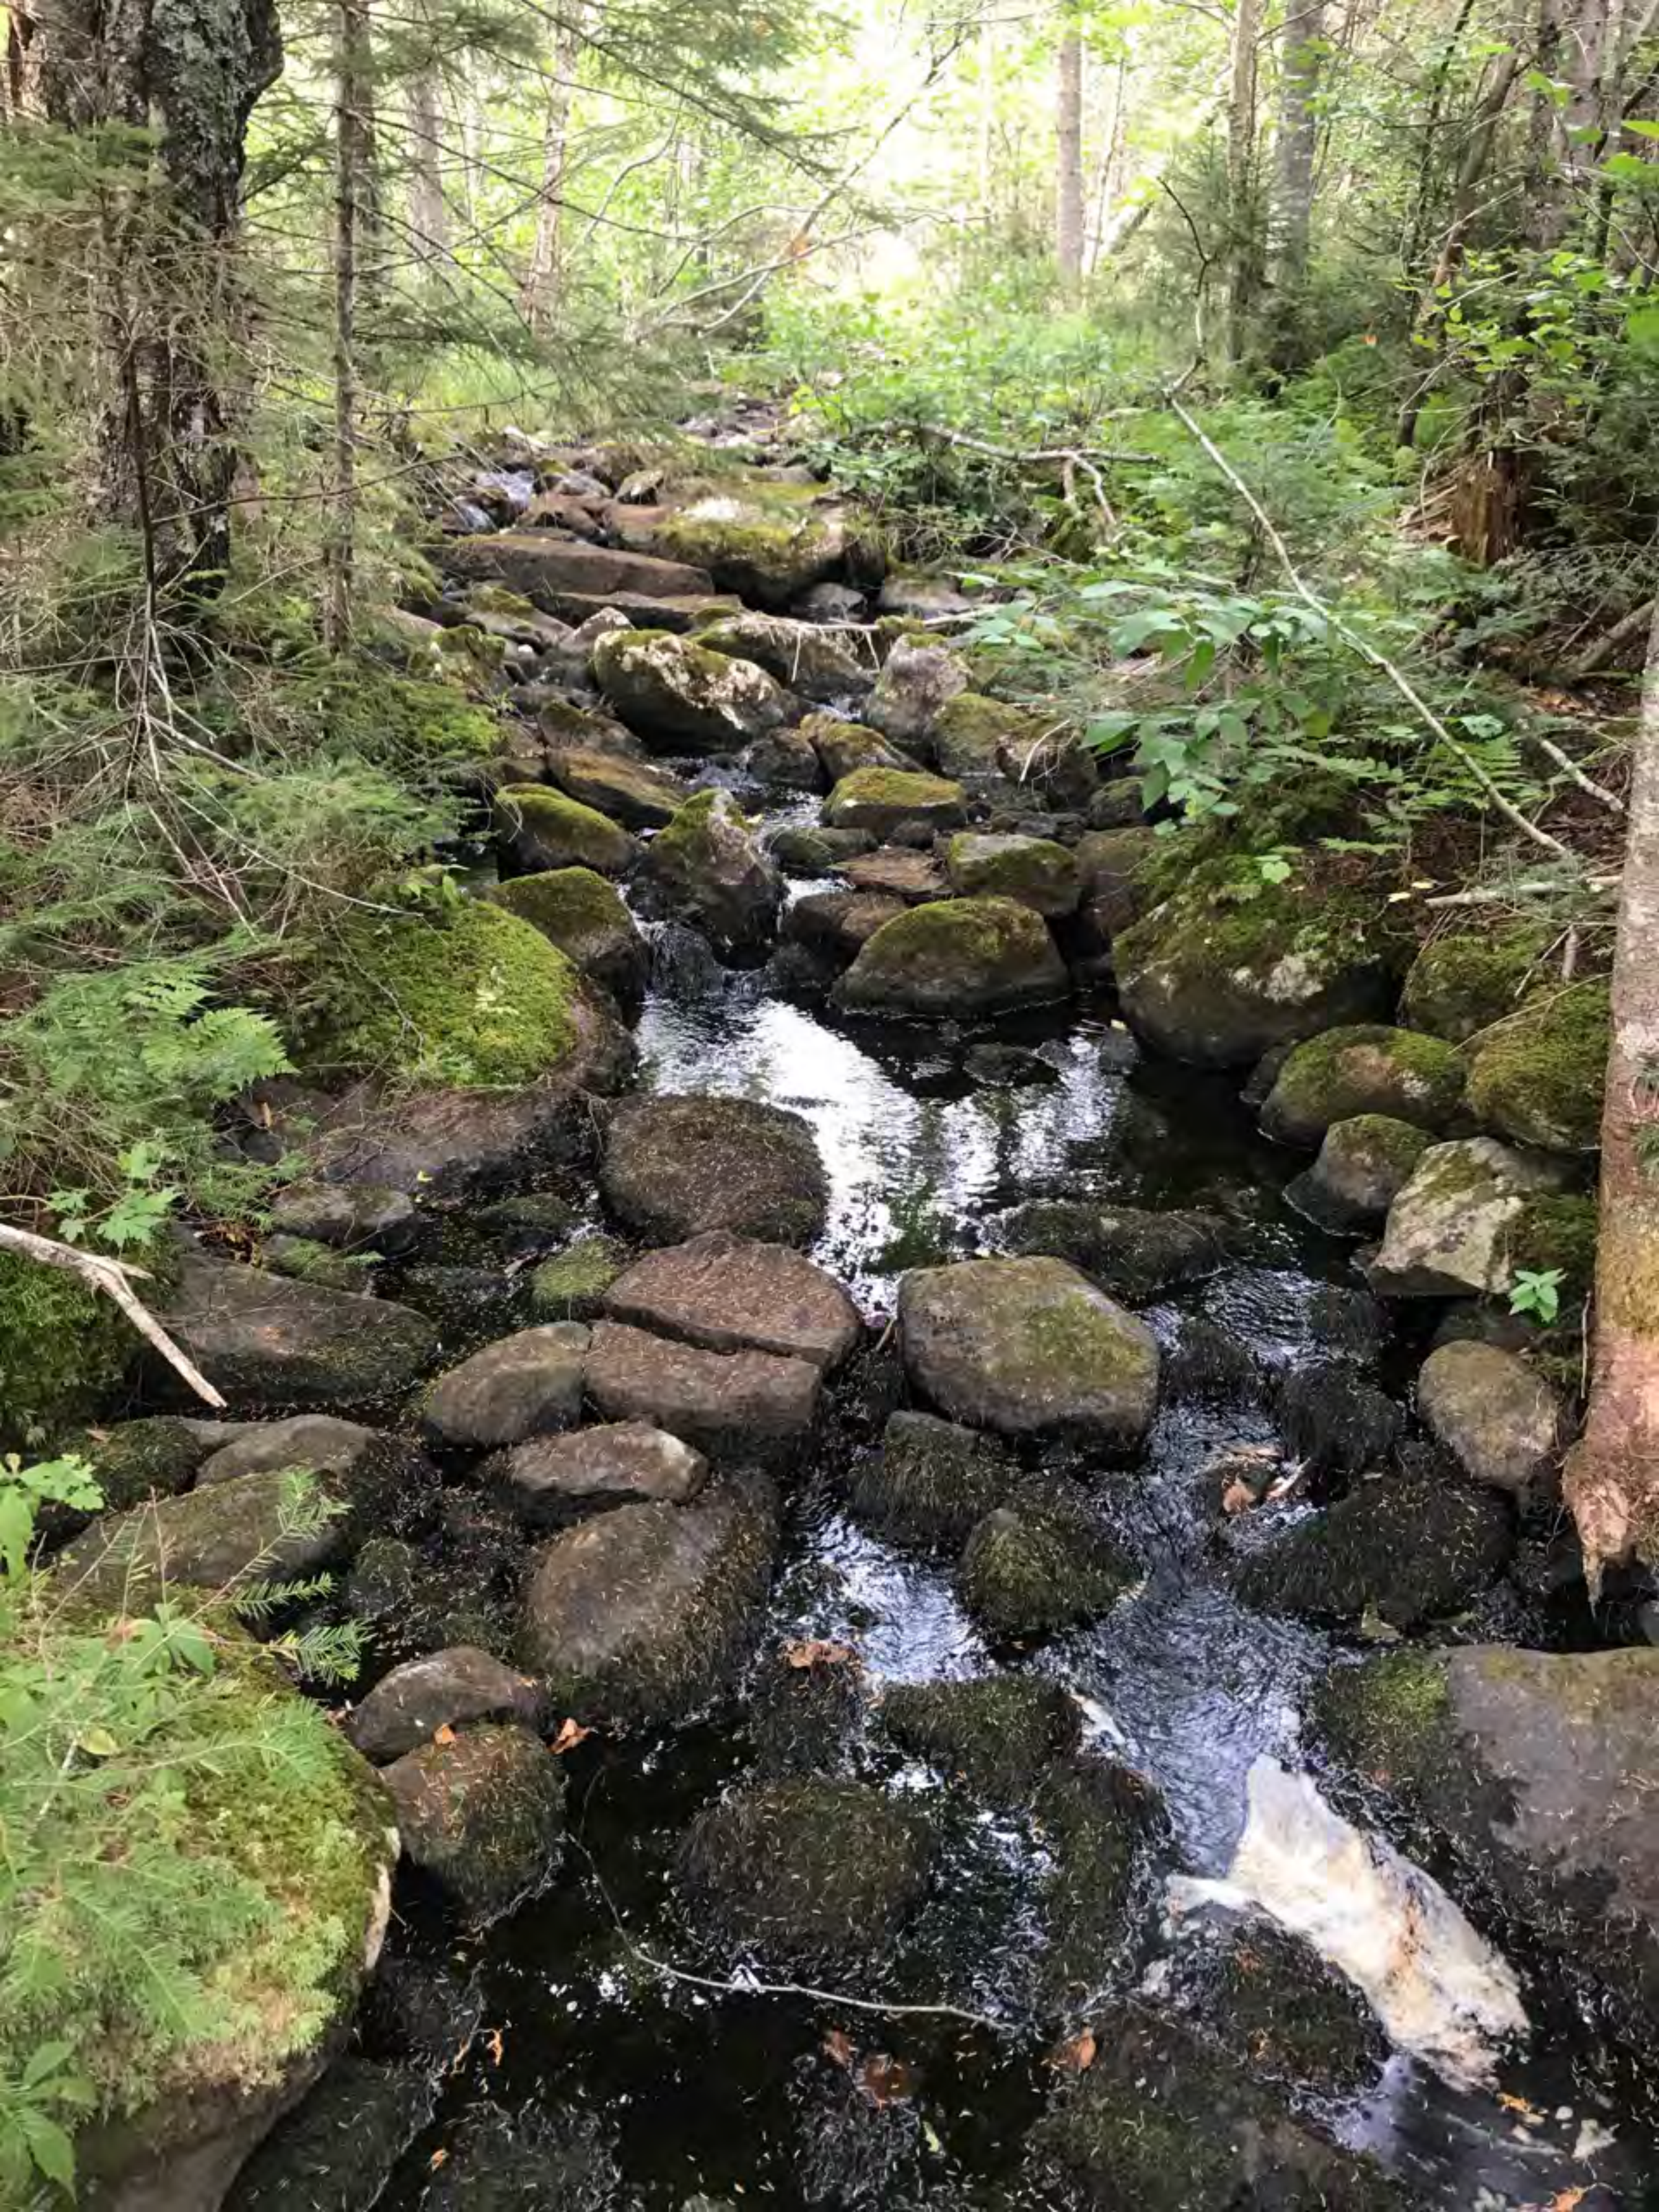
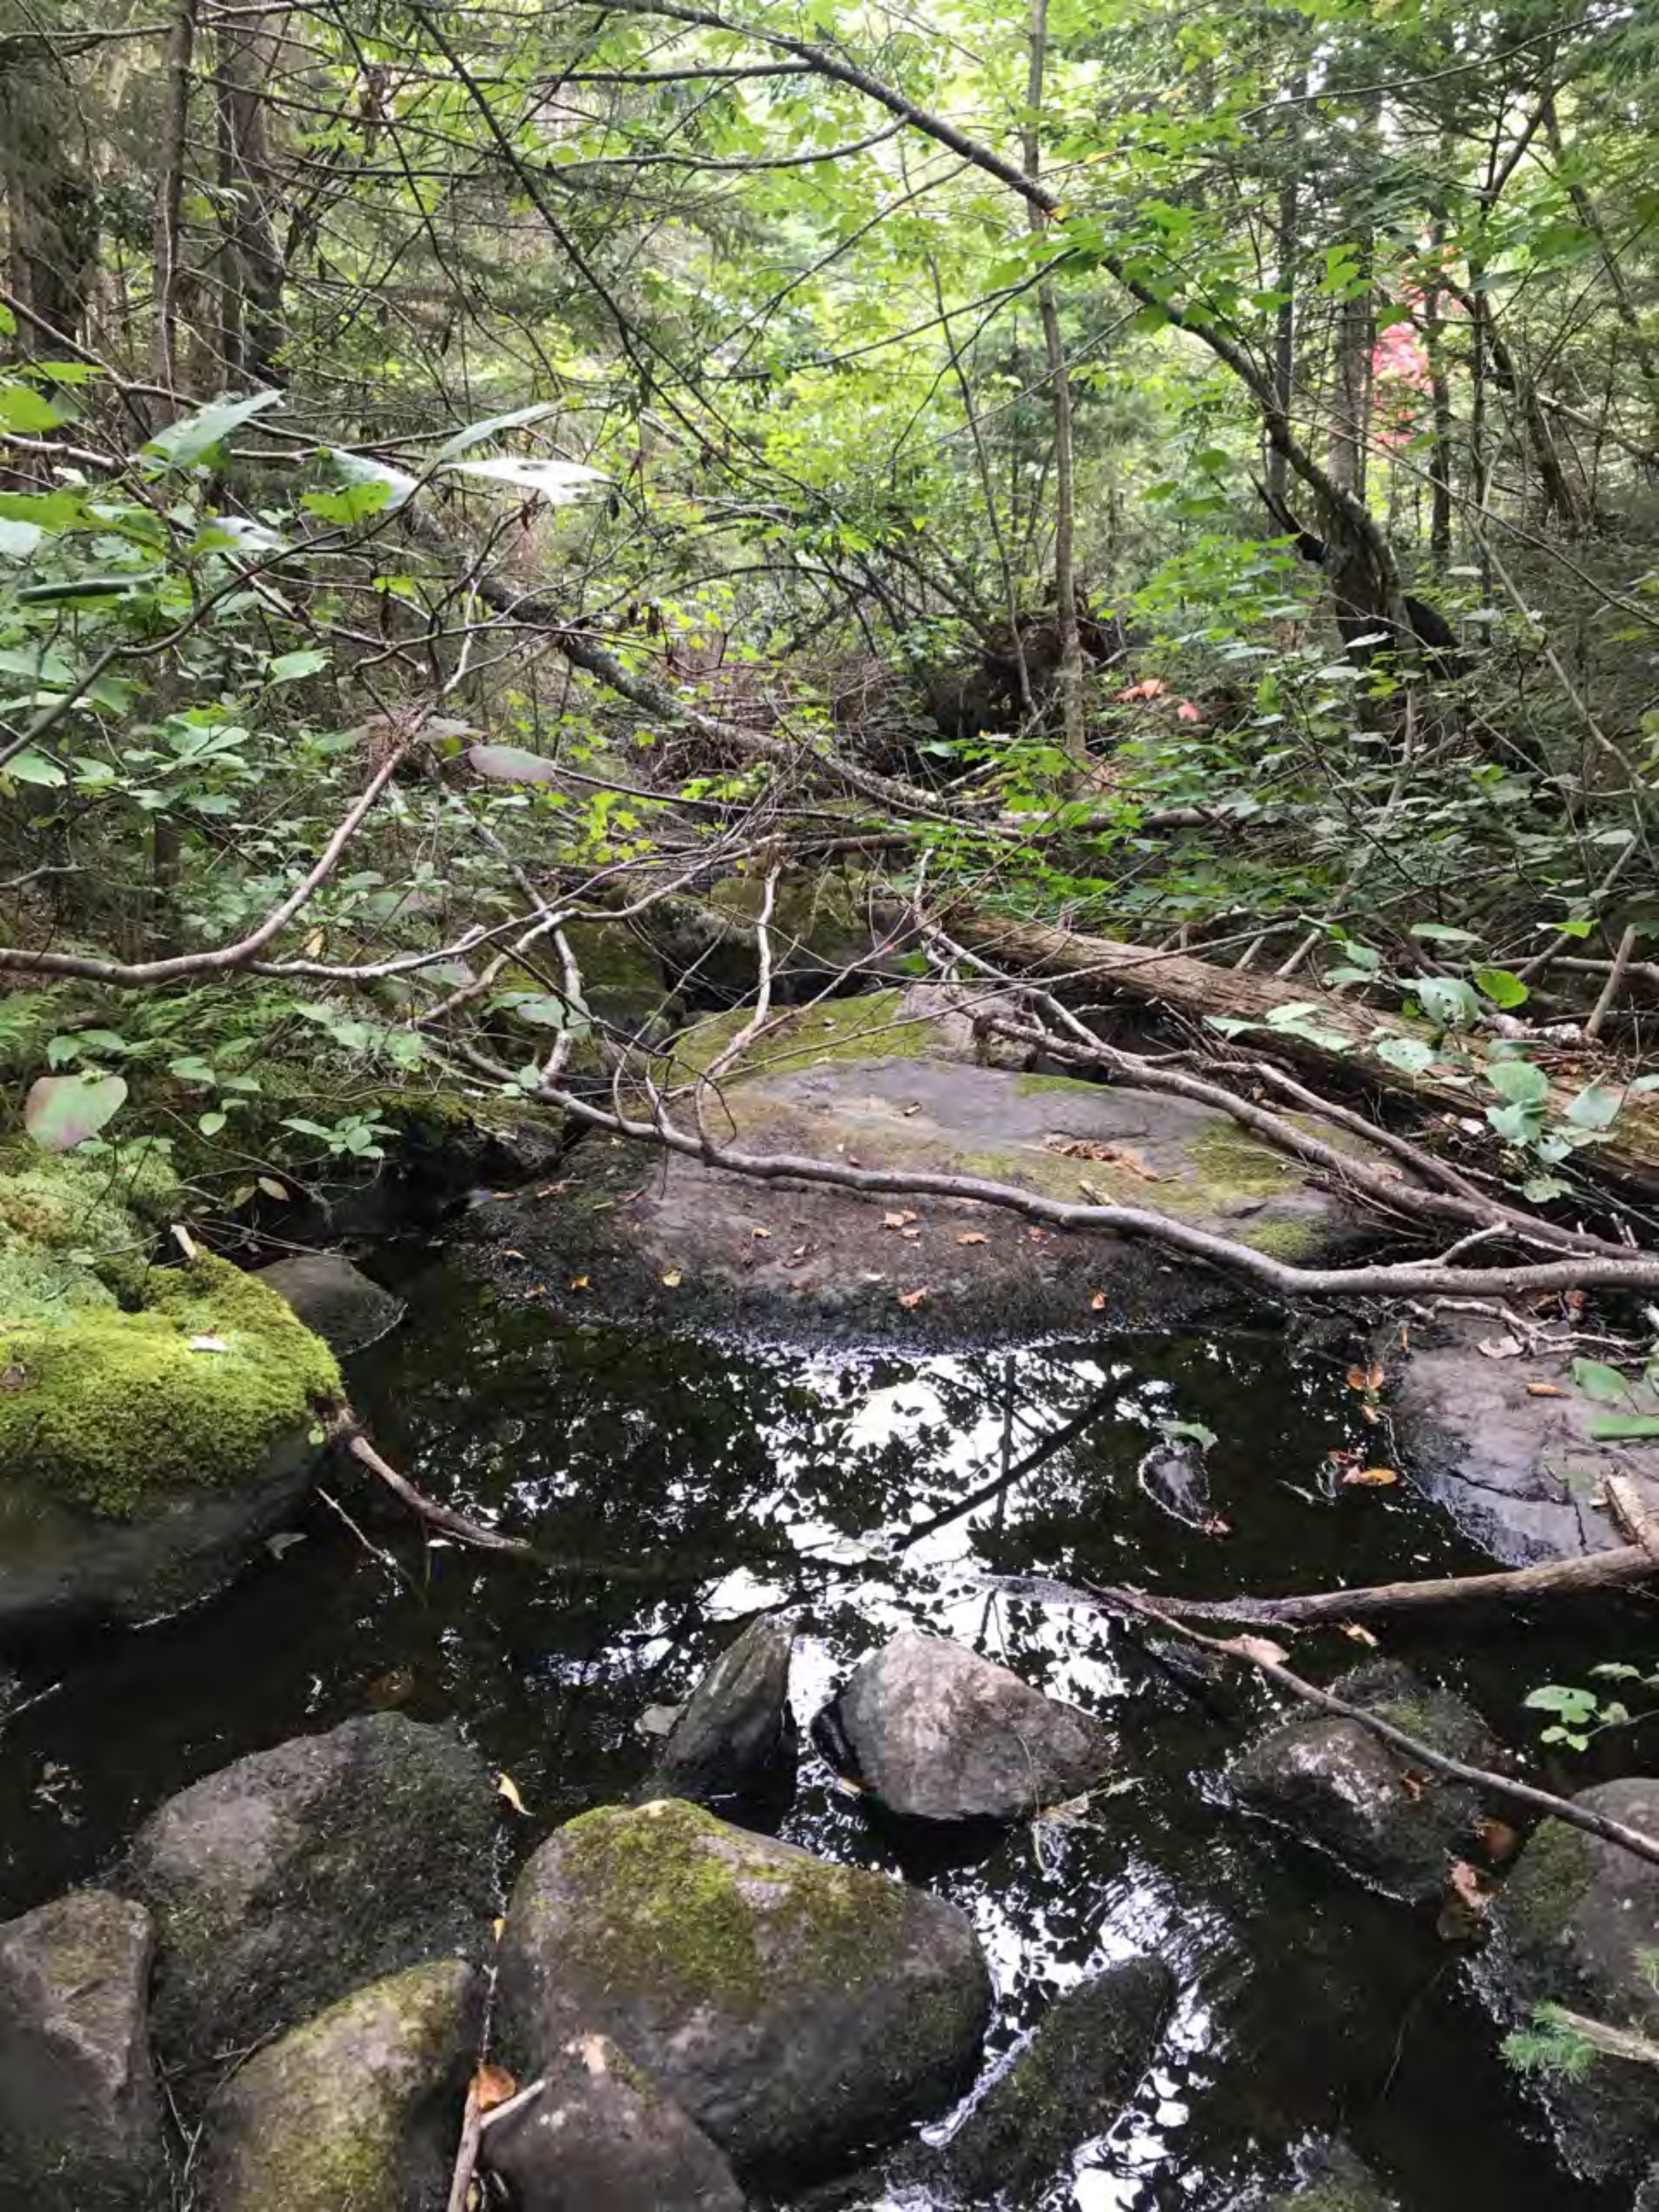
| Stream Site: | PSTR-35-02 | Inspection Begin | Inspection End |

| Collection Notes | Not RBM habitat. Moss covered boulders. Minimal flow. Mixed forest predominantly soft |

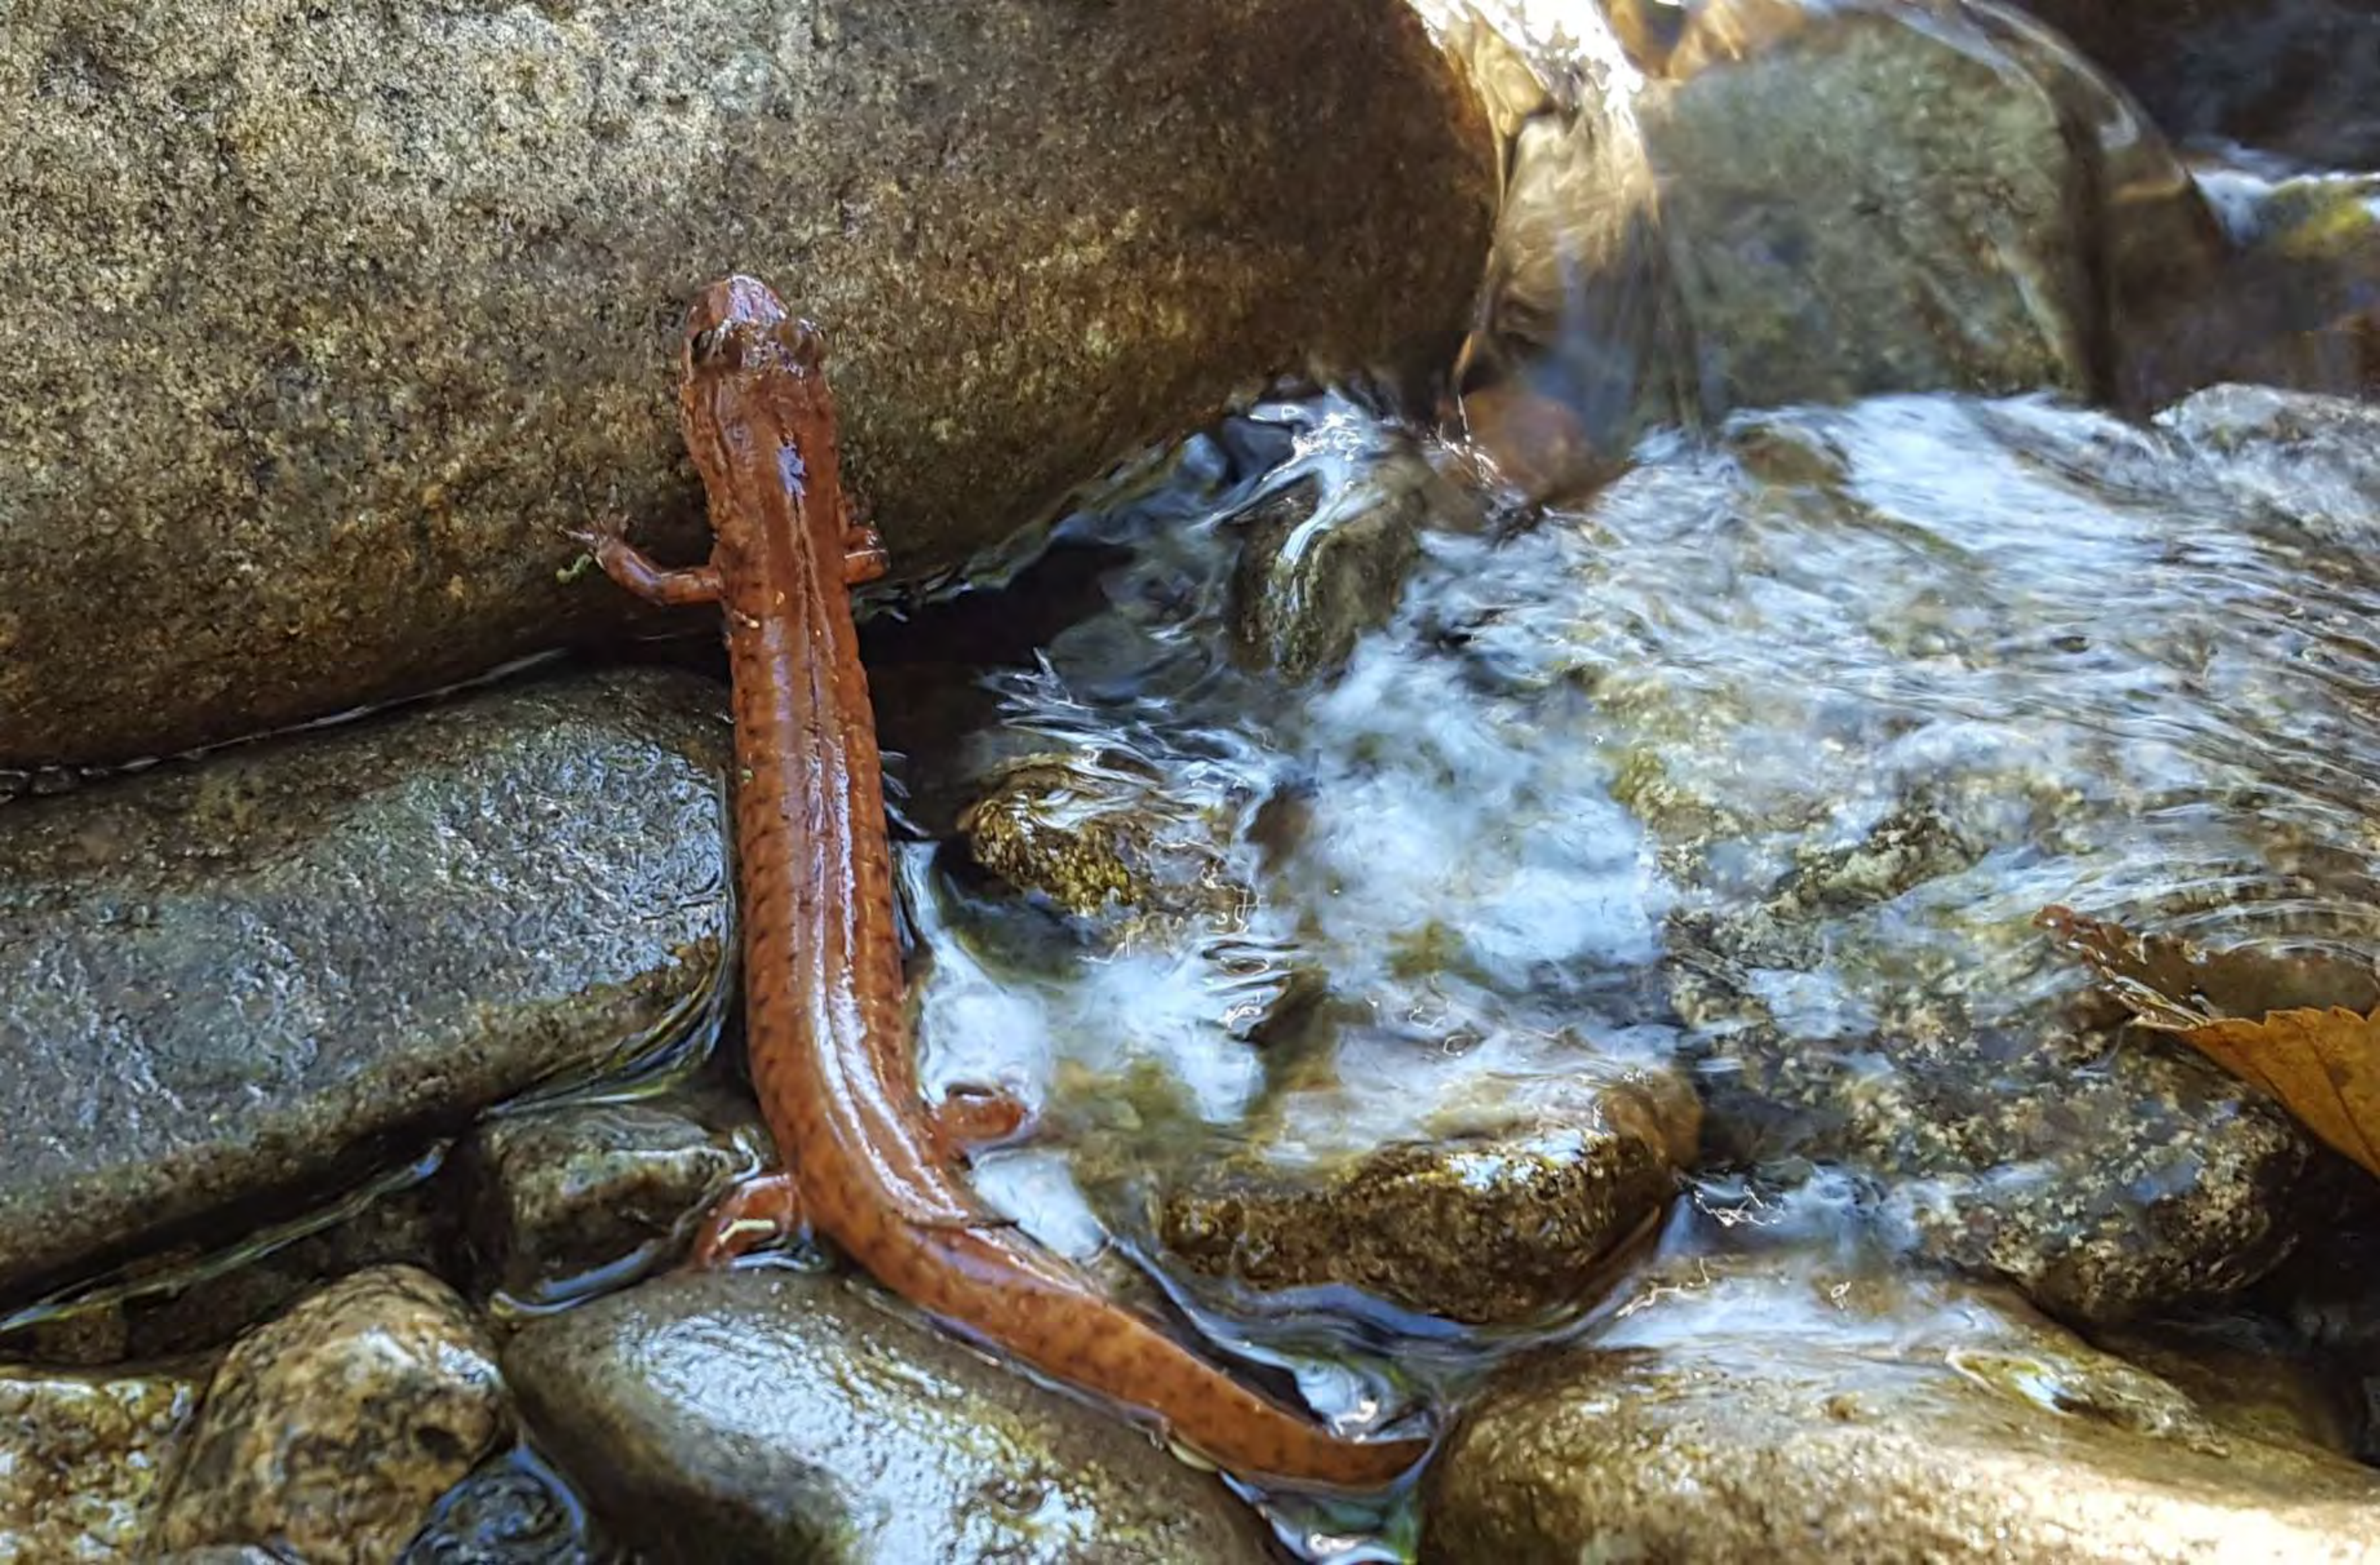
| Collection Notes | Clearcut within 100'. Much blowdown across the stream. Spring Salamander found. |
