PHOTOSIMULATION 42: PARLIN POND, Parlin Pond Twp

Proposed Conditions: Panoramic view looking south to southwest from the northern end of Parlin Pond in Parlin Pond Twp toward the proposed HVDC transmission line. Five proposed HVDC structures, conductors and portions of the corridor clearing will be visible crossing the east shoulder of Coburn Mountain within 3 miles of this viewpoint. Portions of the cleared corridor will be slightly more visible in leaf-off conditions. The weathered steel HVDC structures will generally blend in with the wooded hillside. The conductors will be most visible in early morning light. Non-specular conductors will be used to minimize glare.

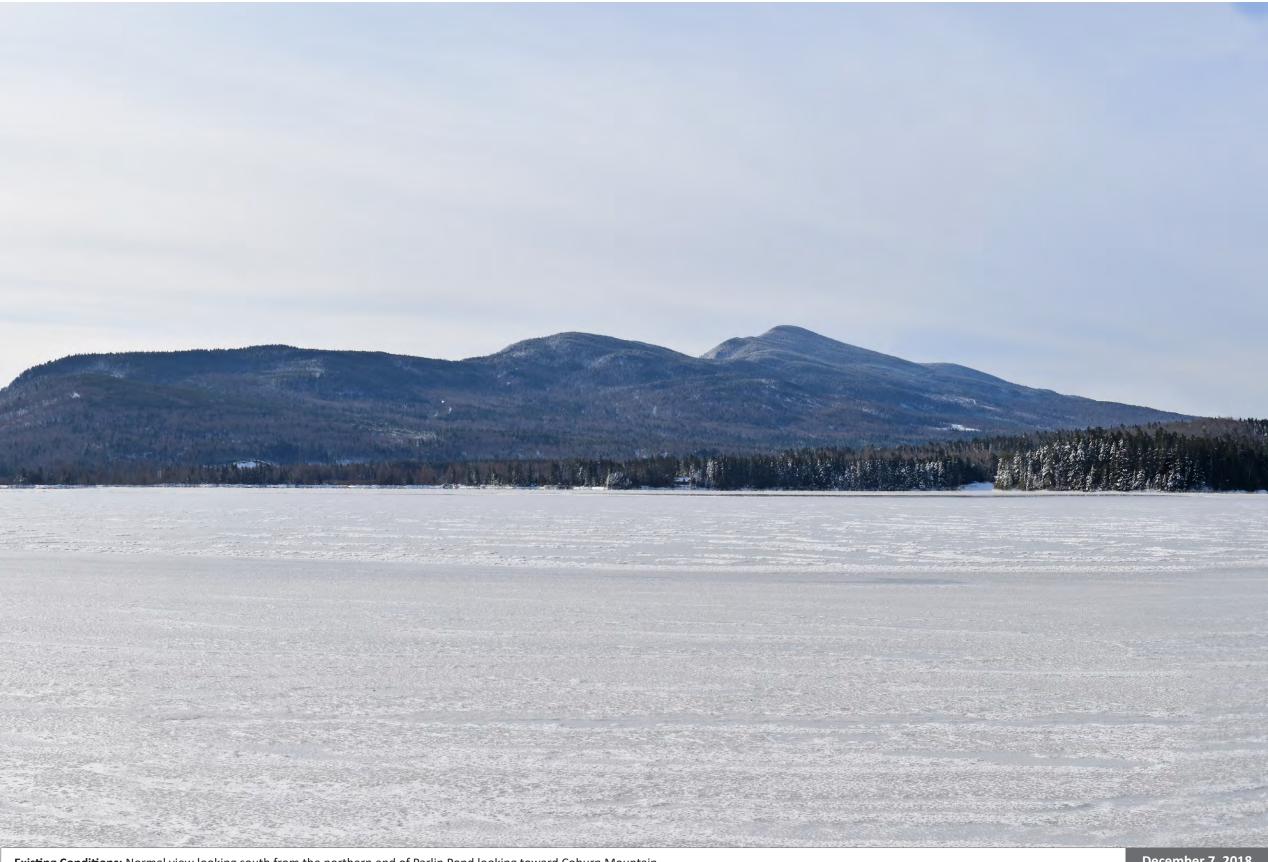
EXISTING CONDITIONS 42A: PARLIN POND, Parlin Pond Twp

Existing Conditions: Normal view looking south from the northern end of Parlin Pond looking toward Coburn Mountain.

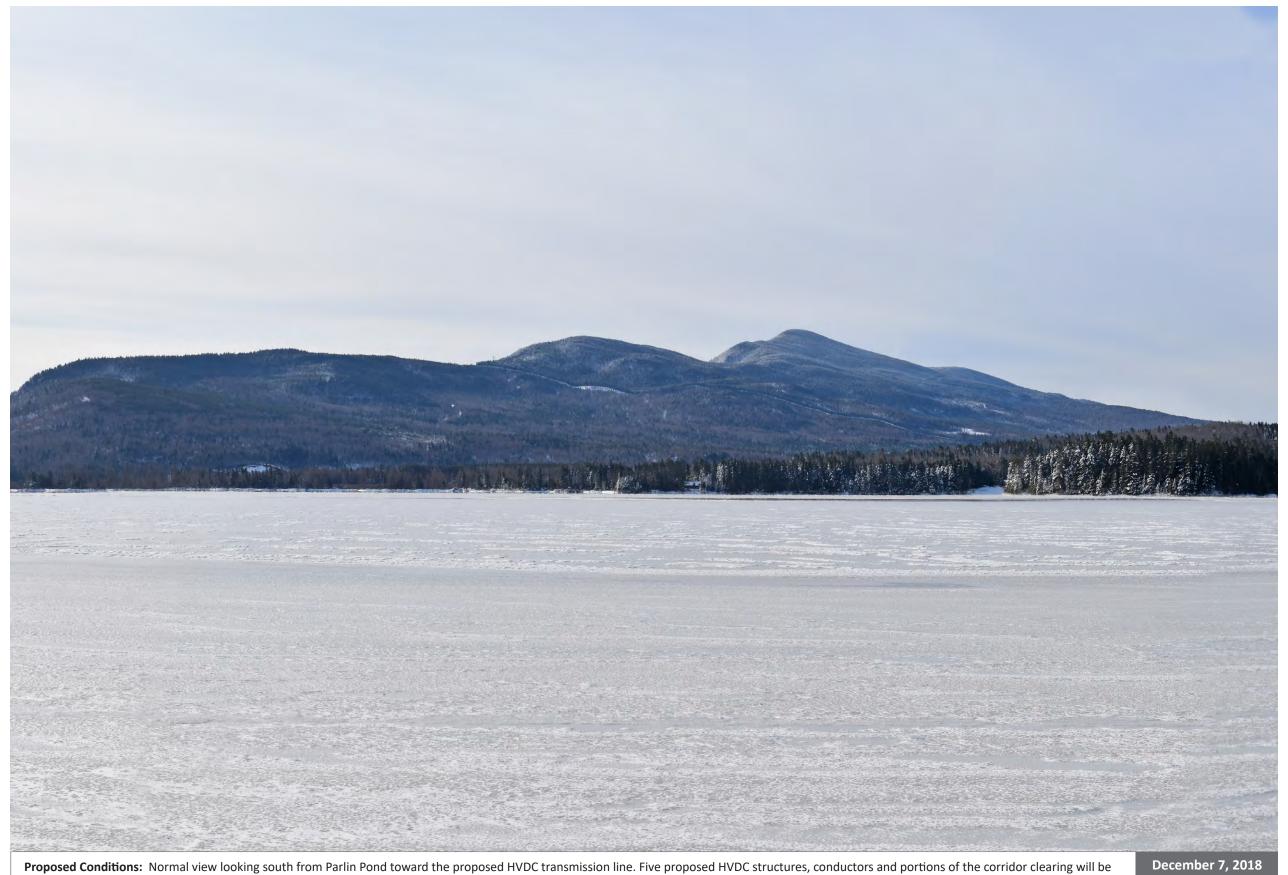
PHOTOSIMULATION 42A: PARLIN POND, Parlin Pond Twp

visible crossing the shoulder of Coburn Mountain within 3 miles of this viewpoint.

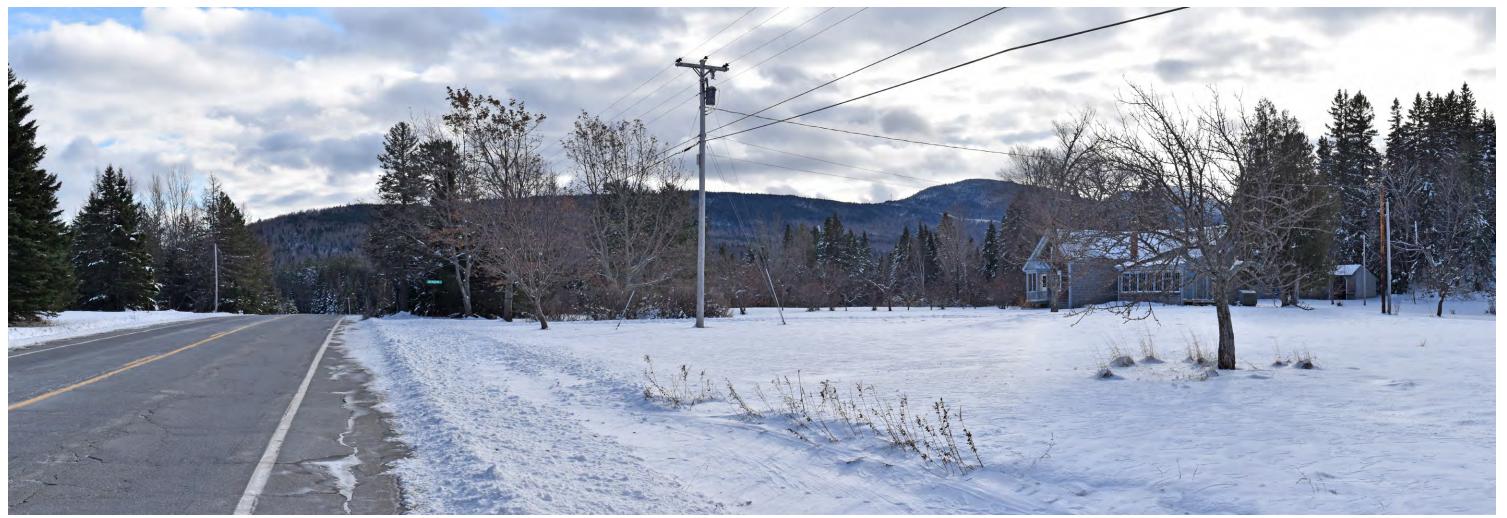
PHOTOSIMULATION 43: ROUTE 201, WEST OF PARLIN POND, Parlin Pond Twp

Proposed Conditions: Panoramic view looking southeast to southwest from Route 201 (west of Parlin Pond) in Parlin Pond Twp toward the proposed HVDC transmission line crossing the eastern shoulder of Coburn Mountain. This viewpoint along Route 201 represents the location with the highest degree of potential visibility adjacent to the open fields on the west side of Route 201. Two proposed HVDC structures, conductors, and portions of the cleared corridor will be visible at distances of 2.0 to 2.1 miles from this viewpoint. One structure will be silhouetted against the sky and one will blend with the wooded hillside. The visible portion of cleared corridor, which follows the profile of Coburn Mountain, will be more noticeable during leaf-off conditions. The conductors will be most noticeable in early morning light.

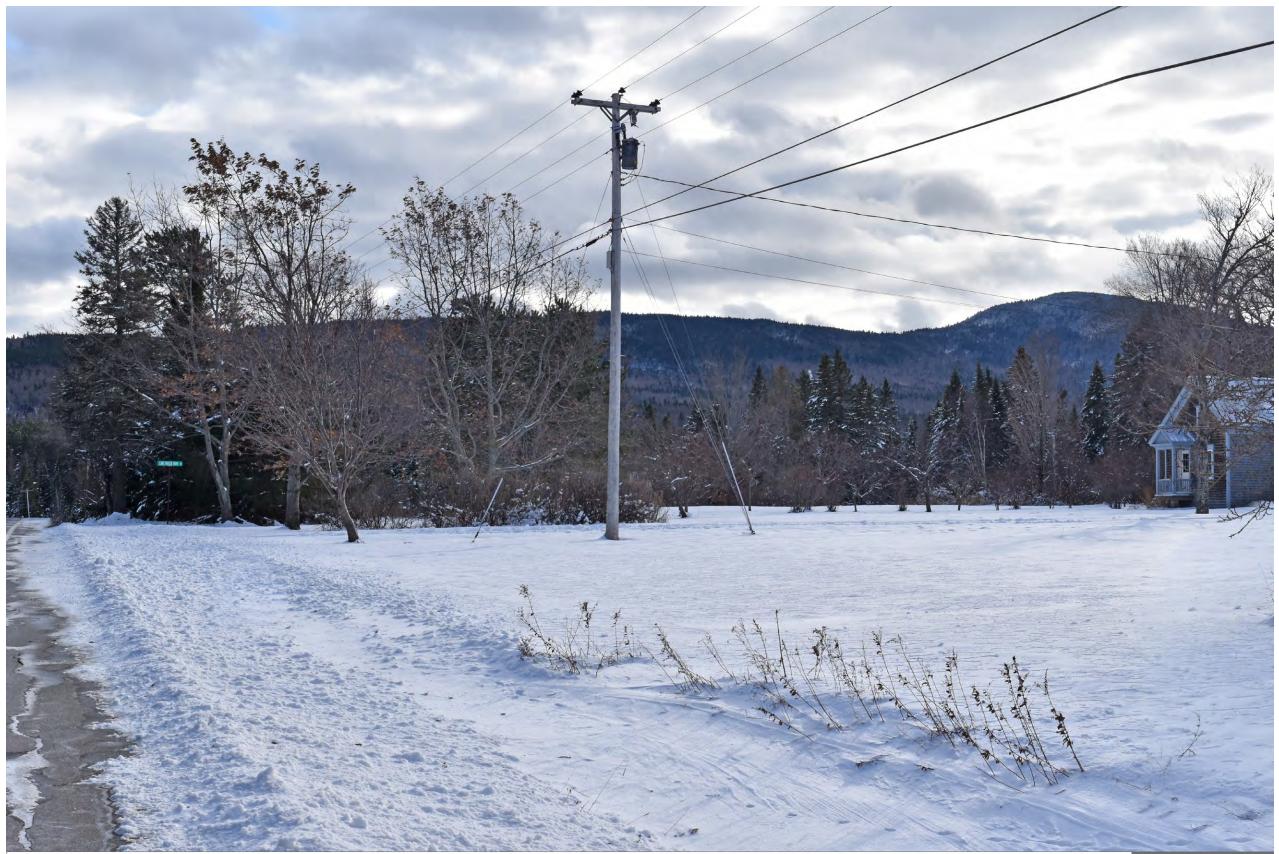
EXISTING CONDITIONS 43A: ROUTE 201, WEST OF PARLIN POND, Parlin Pond Twp

Existing Conditions: Normal view looking south from Route 201 in Parlin Pond Twp toward the eastern shoulder of Coburn Mountain.

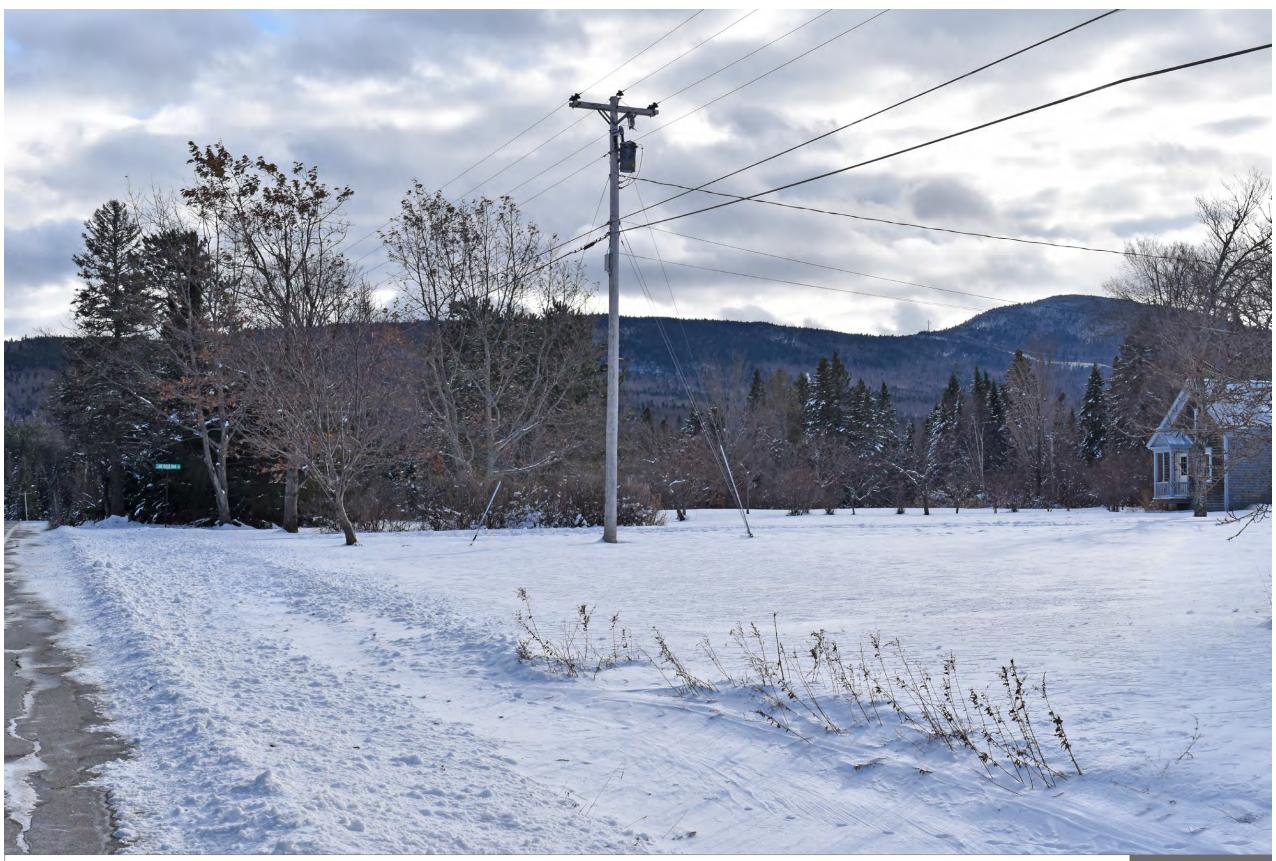
PHOTOSIMULATION 43A: ROUTE 201, WEST OF PARLIN POND, Parlin Pond Twp

Proposed Conditions: Normal view looking south from Route 201 in Parlin Pond Twp toward the proposed HVDC transmission line. Two proposed HVDC structures, conductors, and portions of the cleared corridor will be visible at distances of 2.0 to 2.1 miles from this viewpoint.

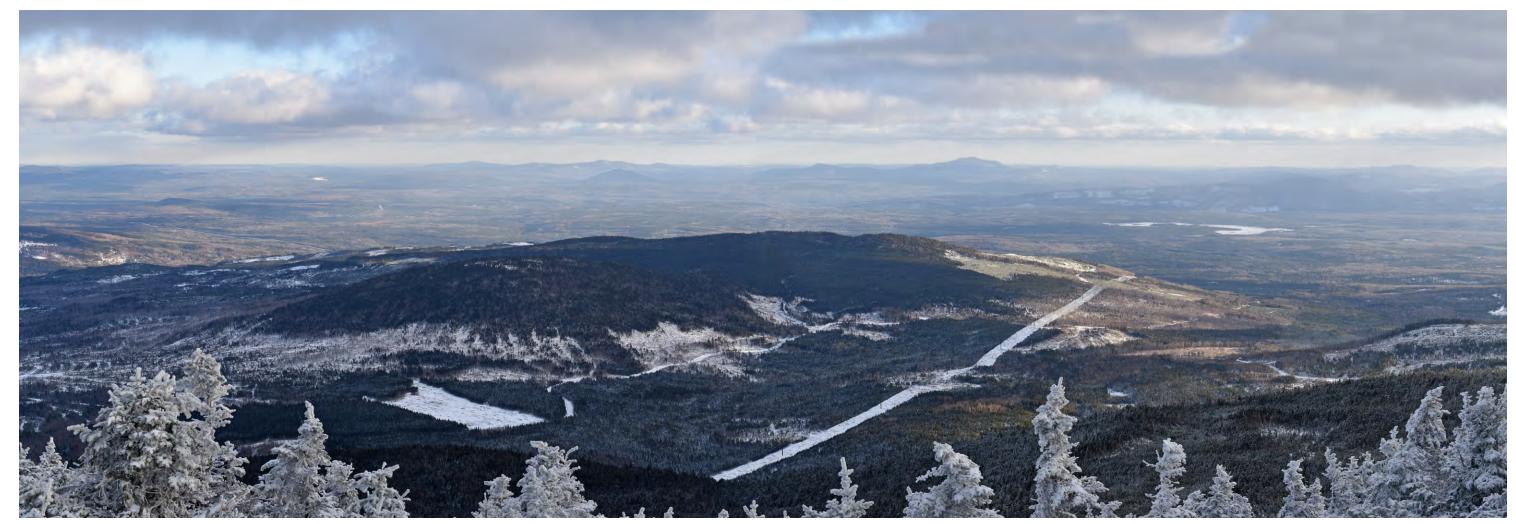
PHOTOSIMULATION 44: COBURN MOUNTAIN, OBSERVATION TOWER, Upper Enchanted Twp

Proposed Conditions: Panoramic view looking east to south from the observation tower at the summit of Coburn Mountain in Upper Enchanted Twp toward the proposed HVDC transmission line. The new 150 ft wide corridor clearing will be visible in the midground on the west side of Johnson Mountain and in the background to the southeast. The closest visible structure will be 1.0 miles from this viewpoint. A local snowmobile trail to the summit is accessed off ITS 89. During snow cover conditions, the most visible portion of the Project will be the cleared corridor from the summit. The corridor will be seen in context with the active timber harvesting areas and haul roads that are typical in a working forest.

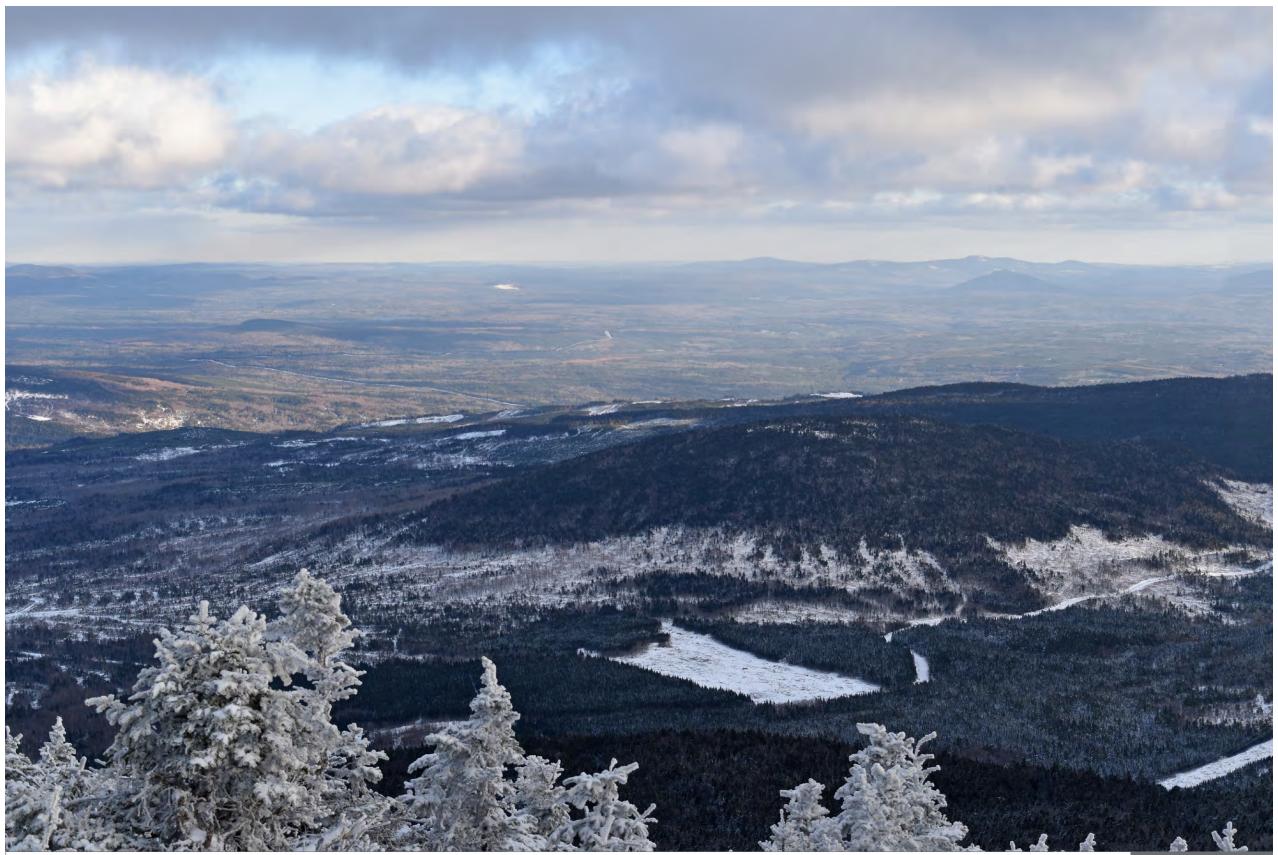
PHOTOSIMULATION 44A: COBURN MOUNTAIN, OBSERVATION TOWER, Upper Enchanted Twp

Proposed Conditions: Normal view looking east from the observation tower at the summit of Coburn Mountain toward the proposed HVDC transmission line. The proposed corridor clearing and HVDC transmission line structures will be minimally visible in the background, to the left of Johnson Mountain in the photograph.

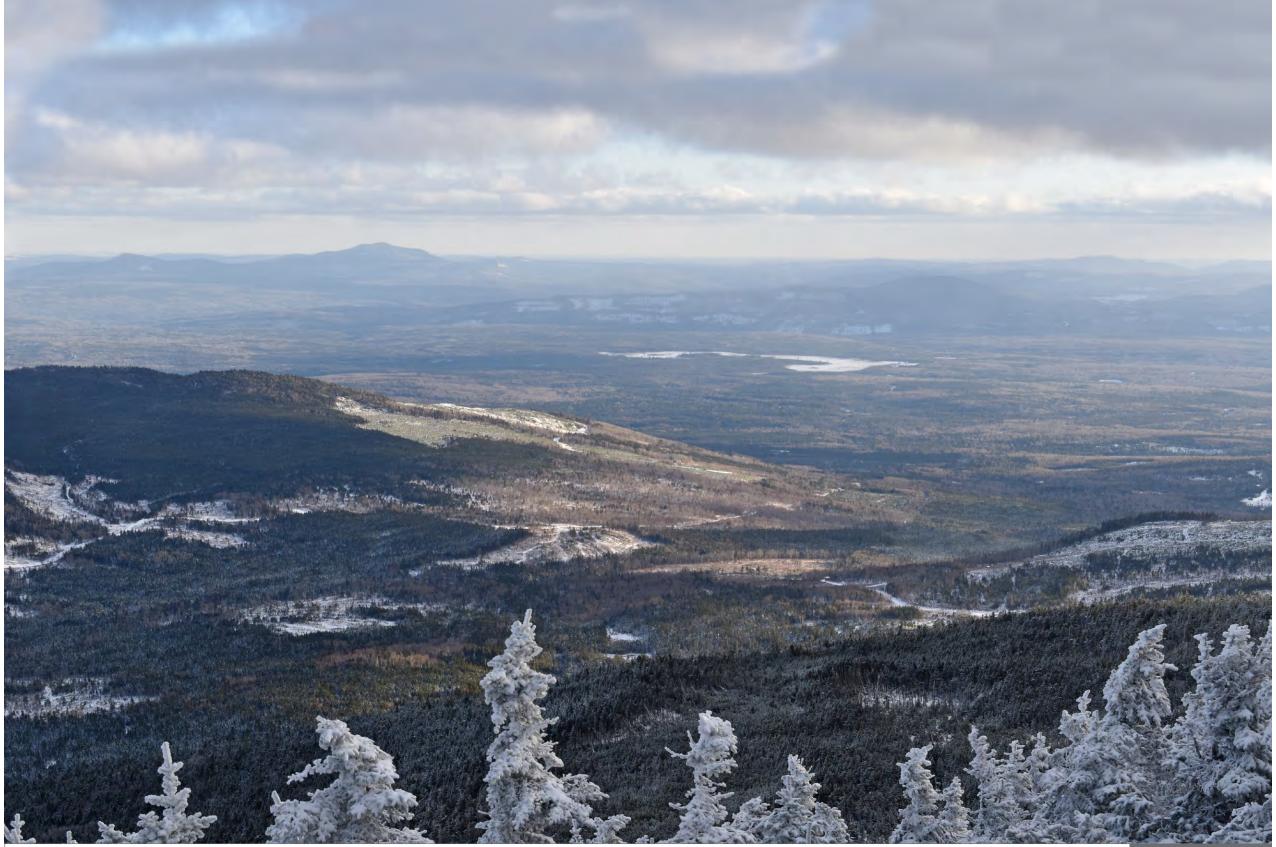
EXISTING CONDITIONS 44B: COBURN MOUNTAIN, OBSERVATION TOWER, Upper Enchanted Twp

Existing Conditions: Normal view looking south from the observation tower at the summit of Coburn Mountain. Evidence of active timber harvesting (patch cuts and haul roads) are visible in the midground on Johnson Mountain off an unnamed road in Johnson Mountain Twp.

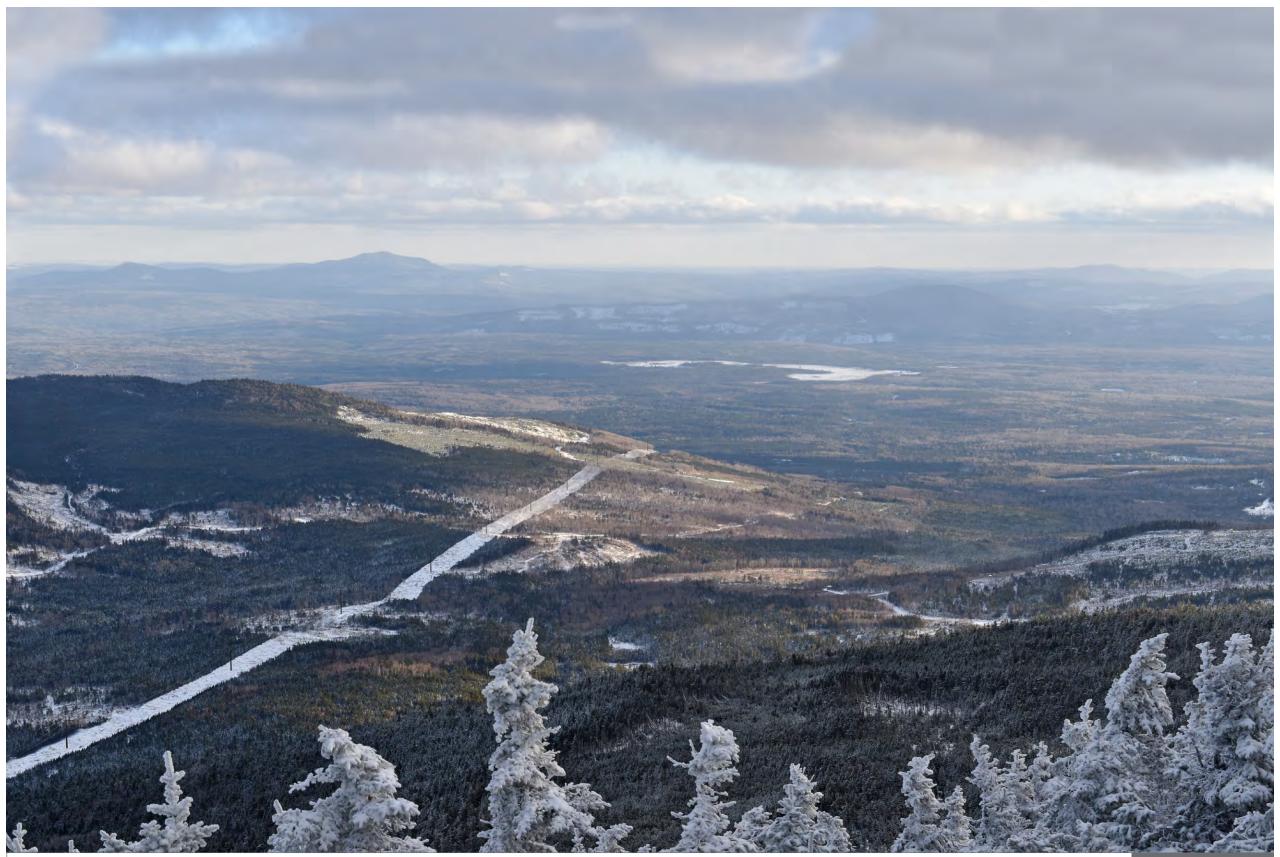
PHOTOSIMULATION 44B: COBURN MOUNTAIN, OBSERVATION TOWER, Upper Enchanted Twp

Proposed Conditions: Normal view looking south from the observation tower at the summit of Coburn Mountain toward the proposed HVDC transmission line. The new 150 ft wide corridor clearing will be visible in the midground on the west side of Johnson Mountain. The closest visible structure and conductors will be 1.0 miles from this viewpoint.

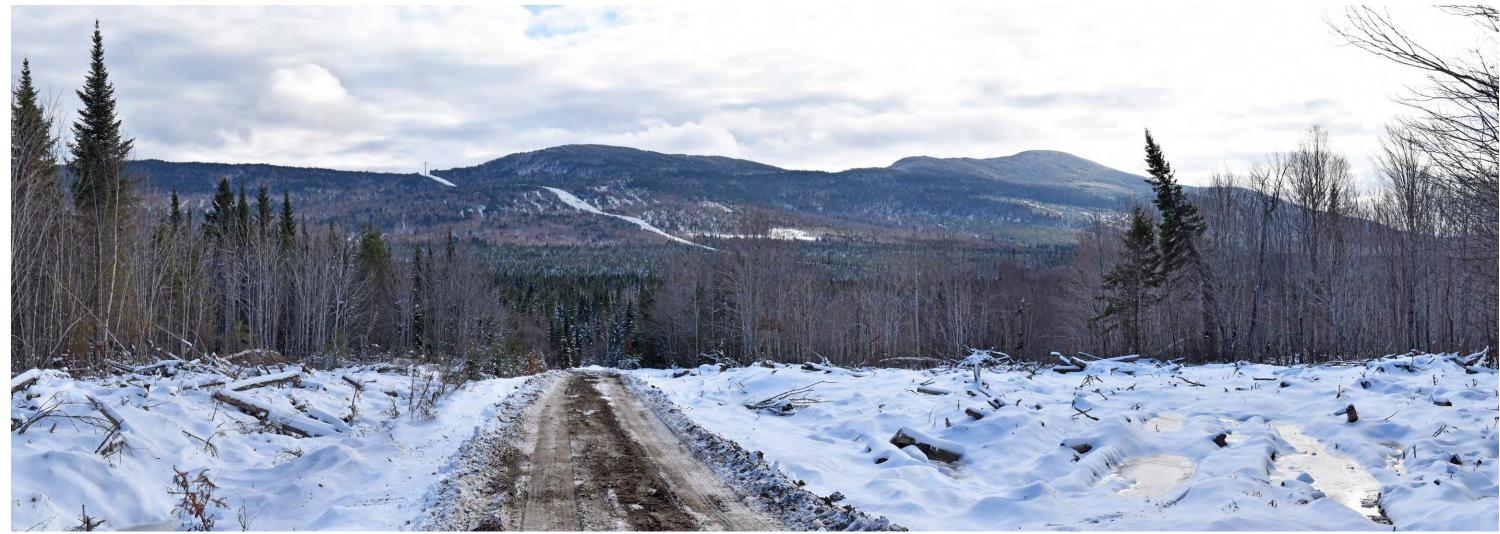
PHOTOSIMULATION 45: ITS 89, Parlin Pond Twp

Proposed Conditions: Panoramic view looking southeast to southwest toward the proposed HVDC transmission line from ITS 89, north of Spencer Road (Hardscrabble Road) in Parlin Pond Twp on Weyerhauser land. Six proposed HVDC structures, conductors, and portions of the corridor clearing will be visible crossing the shoulder of Coburn Mountain at distances of 1.0 to 1.9 miles from this viewpoint. The ITS trail was being maintained as an active haul road by Weyerhauser at time of photo.

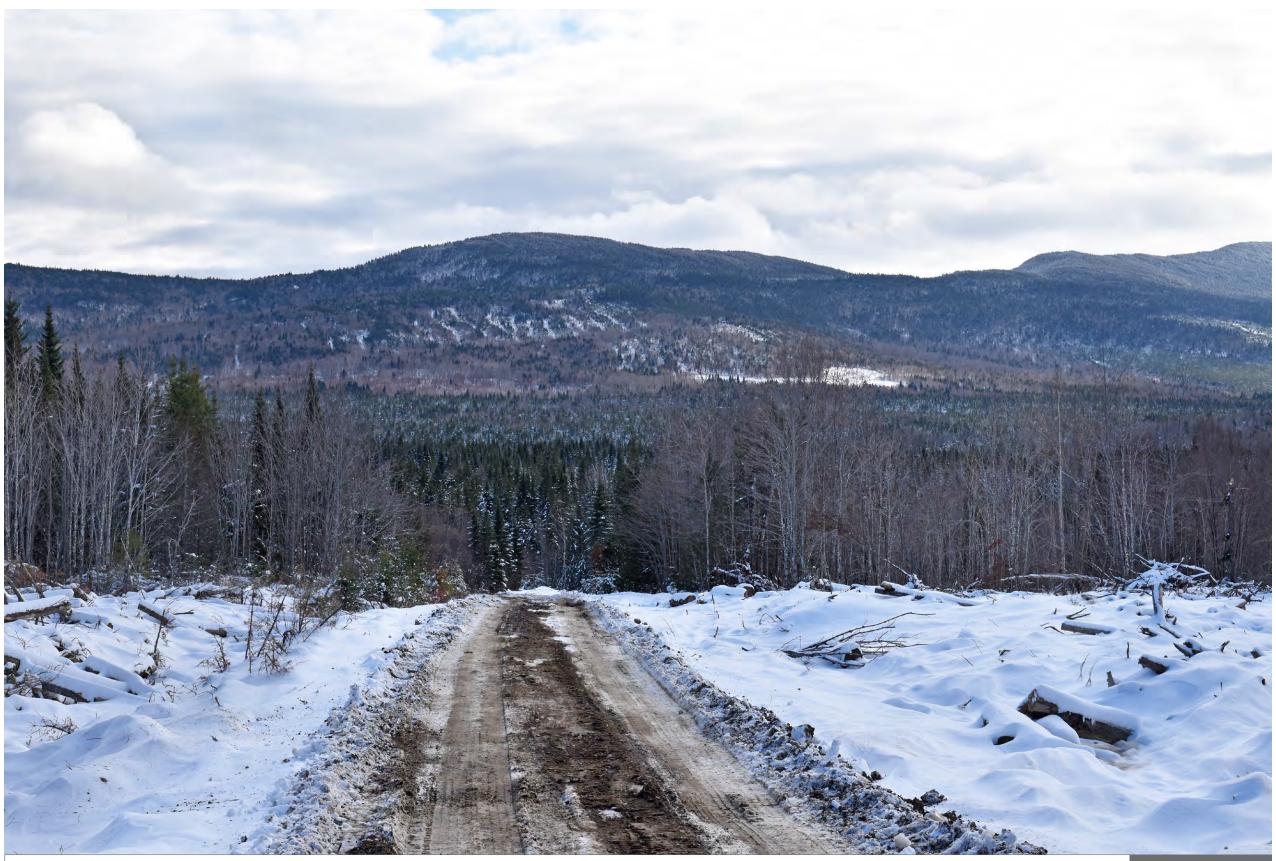
EXISTING CONDITIONS 45A: ITS 89, Parlin Pond Twp

Existing Conditions: Normal view looking south from ITS 89 north of Spencer Road (Hardscrabble Road) on Weyerhauser land toward Coburn Mountain. Viewpoint is located in an active timber harvesting area.

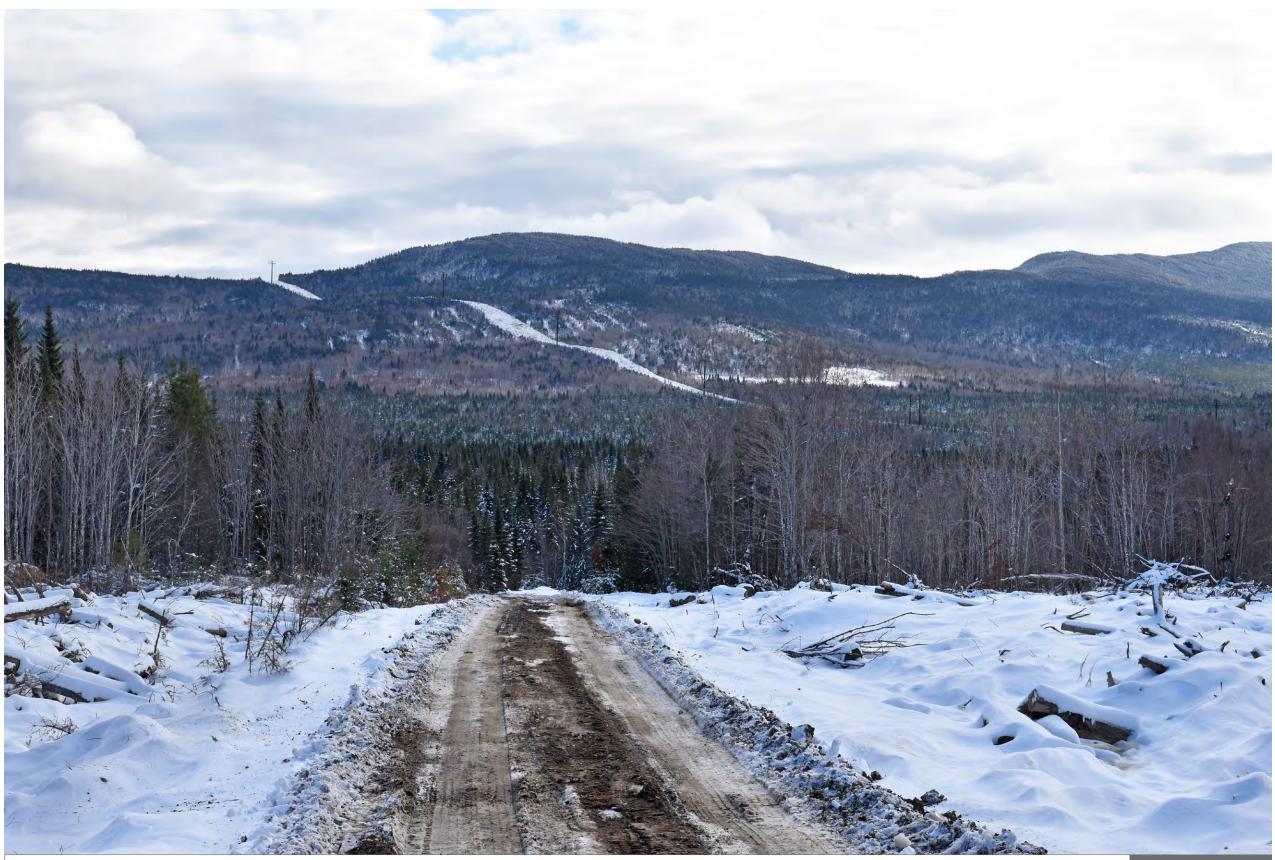
PHOTOSIMULATION 45A: ITS 89, Parlin Pond Twp

Proposed Conditions: Normal view looking south from ITS 89 on Weyerhauser land toward the proposed HVDC transmission line. Six proposed HVDC structures, conductors and portions of the corridor clearing will be visible crossing the shoulder of Coburn Mountain at distances of 1.0 to 1.9 miles from this viewpoint.

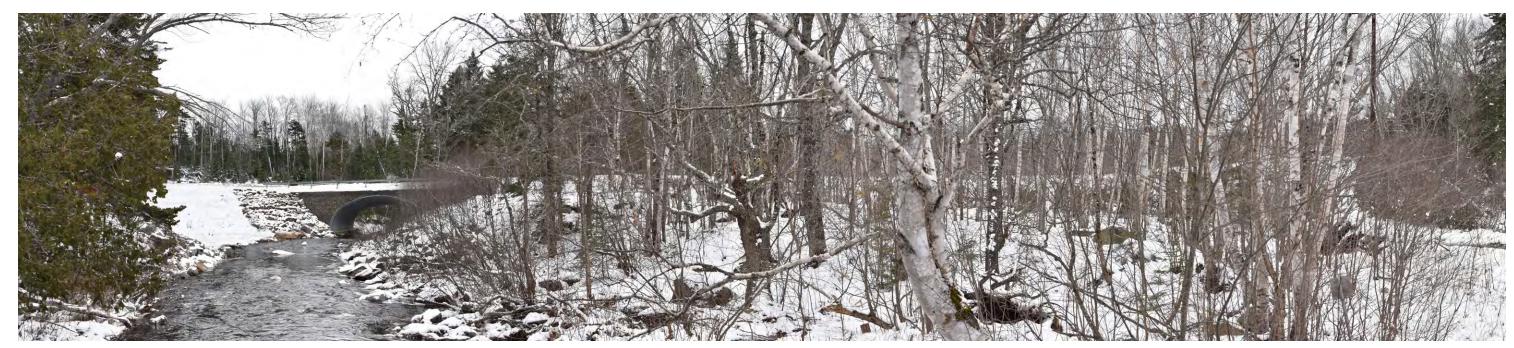
PHOTOSIMULATION 46: ITS 87, Johnson Mountain Twp

Proposed Conditions: Panoramic view looking east to southeast on the ITS 87 bridge over Cold Stream (in the Cold Stream Forest Parcel in Johnson Mountain Twp) toward the Capital Road bridge and the proposed HVDC transmission line. Evergreen vegetation on the north east side of the stream will screen the Project looking east. There will be a filtered views of one structure through the hardwoods in leaf-off conditions looking southeast. Conductors will be visible over Cold Stream at a distance of 250 ft from this viewpoint (visible through branches on overhanging tree at the top of the image). Capital Road and the existing bridge will be more visible from this viewpoint as a result of the corridor clearing. See photos in Attachment J, Capitol Road Photographs in the October 19, 2018 MDEP/LUPC Response.

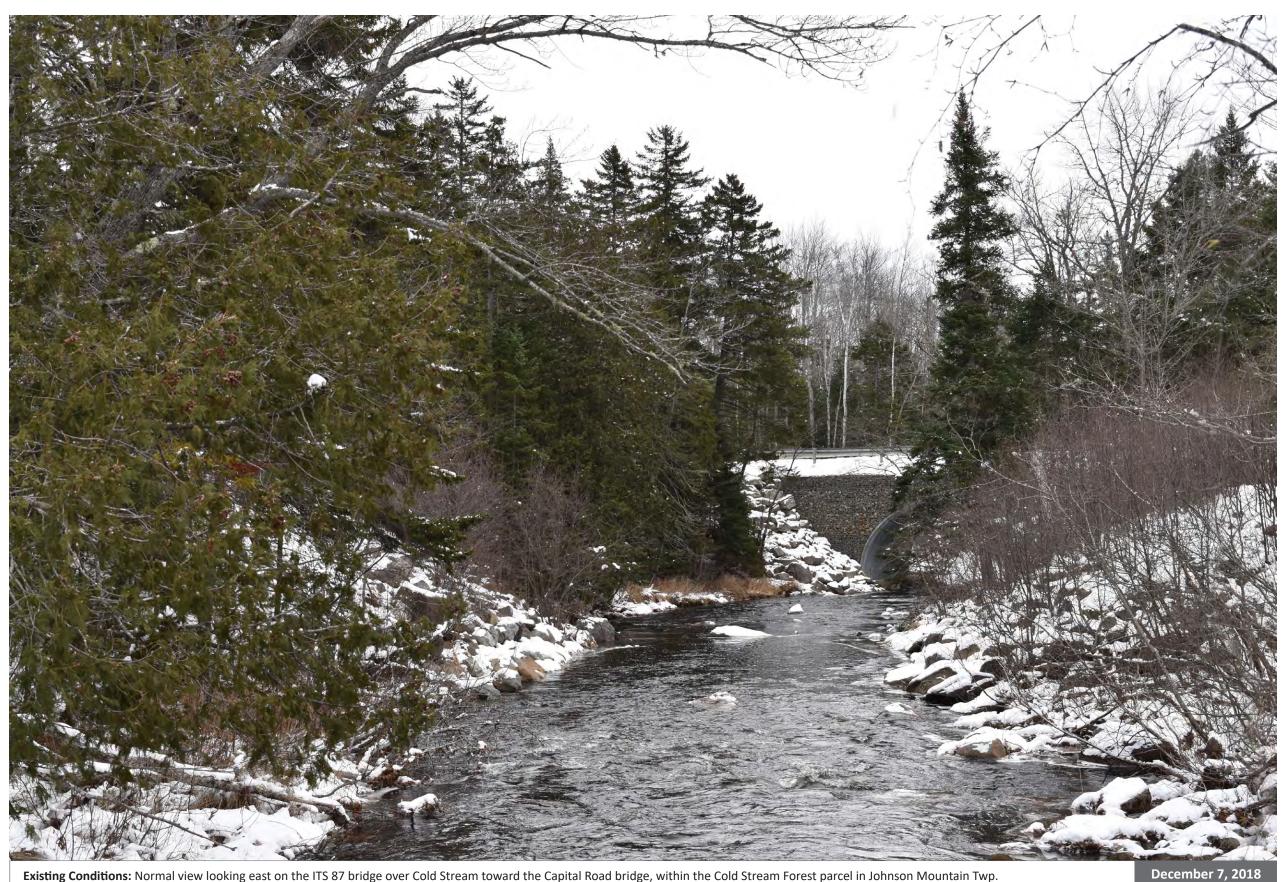
EXISTING CONDITIONS 46A: ITS 87, Johnson Mountain Twp

Existing Conditions: Normal view looking east on the ITS 87 bridge over Cold Stream toward the Capital Road bridge, within the Cold Stream Forest parcel in Johnson Mountain Twp.

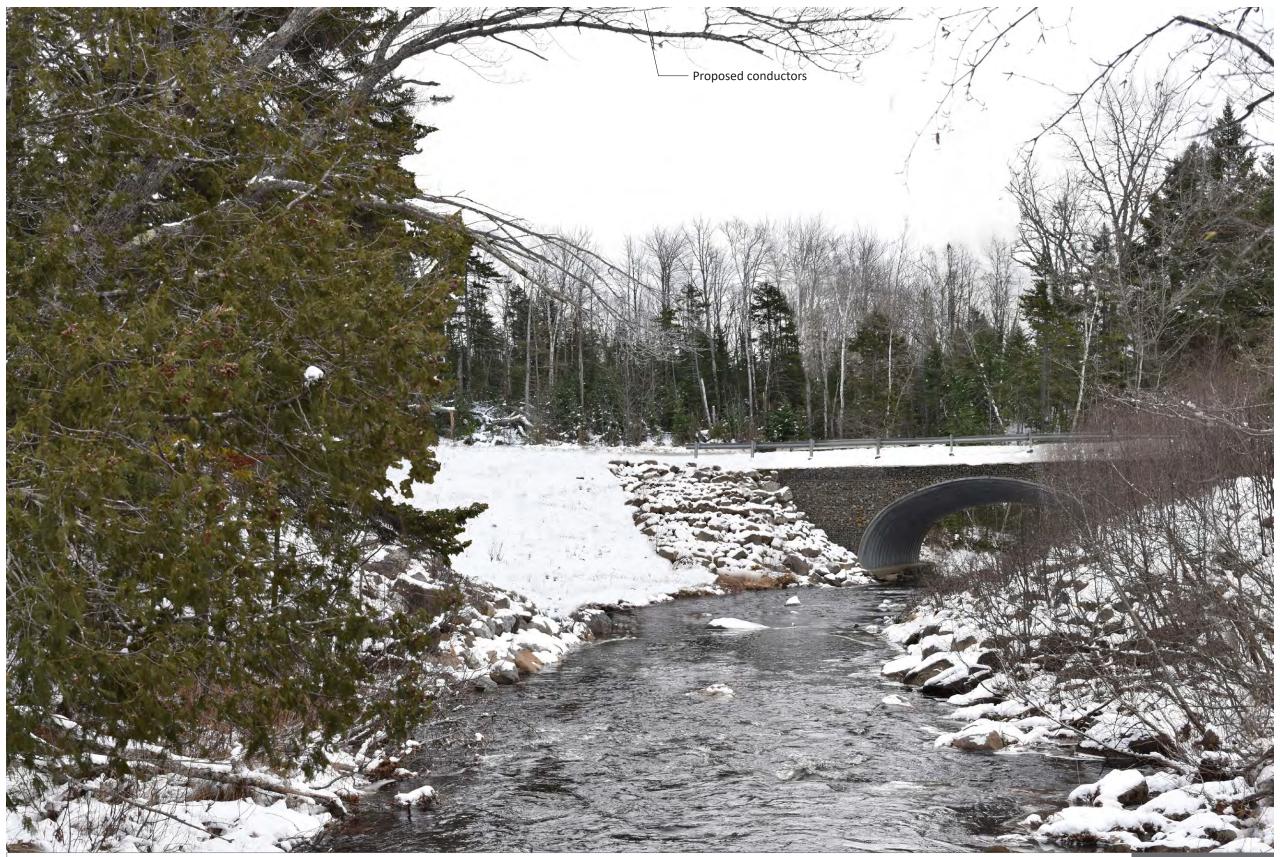
PHOTOSIMULATION 46A: ITS 87, Johnson Mountain Twp

Proposed Conditions: Normal view looking east on the ITS 87 bridge over Cold Stream toward the Capital Road bridge, and the proposed HVDC transmission line. Conductors will be visible crossing above Cold Stream at a distance of 250 feet from this viewpoint.

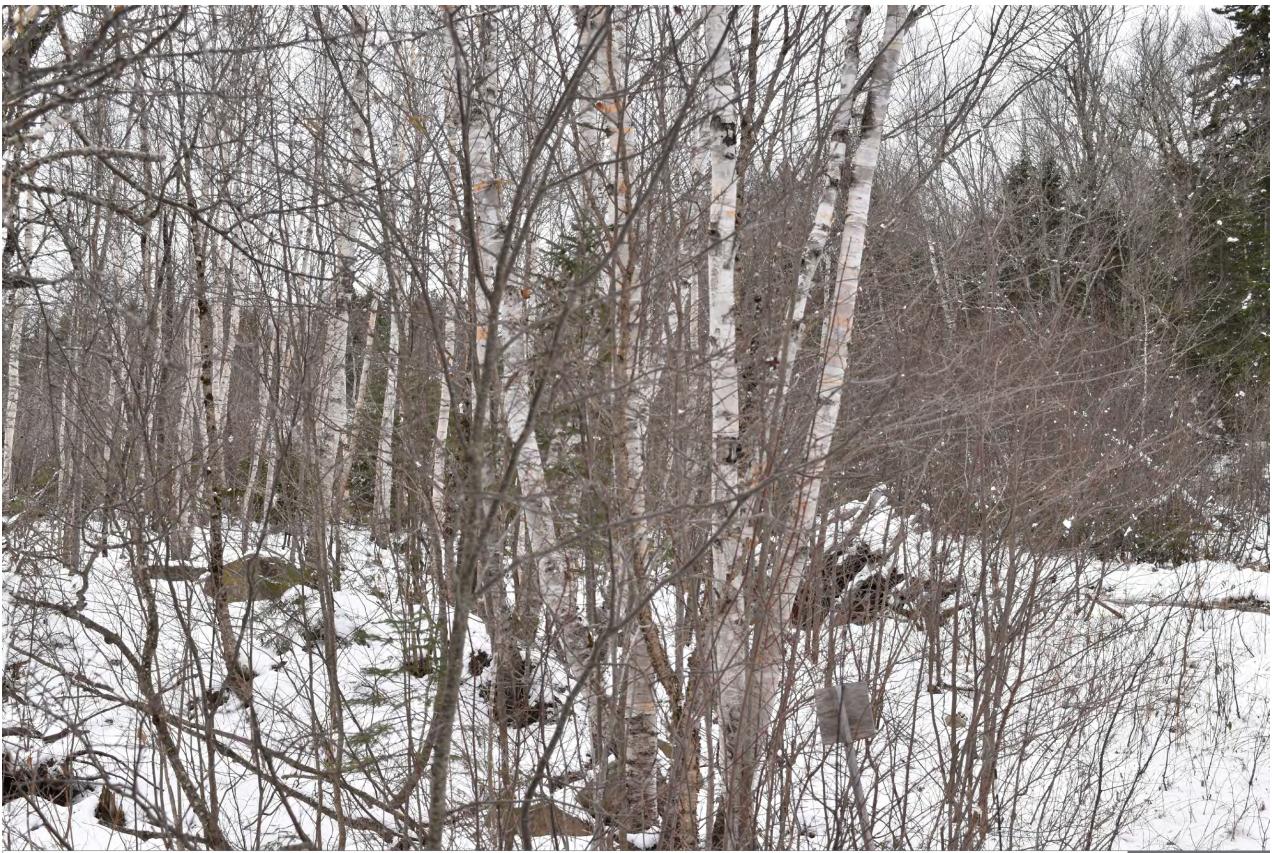
EXISTING CONDITIONS 46B: ITS 87, Johnson Mountain Twp

Existing Conditions: Normal view looking southeast on the ITS 87 bridge over Cold Stream in the Cold Stream Forest parcel in Johnson Mountain Twp.

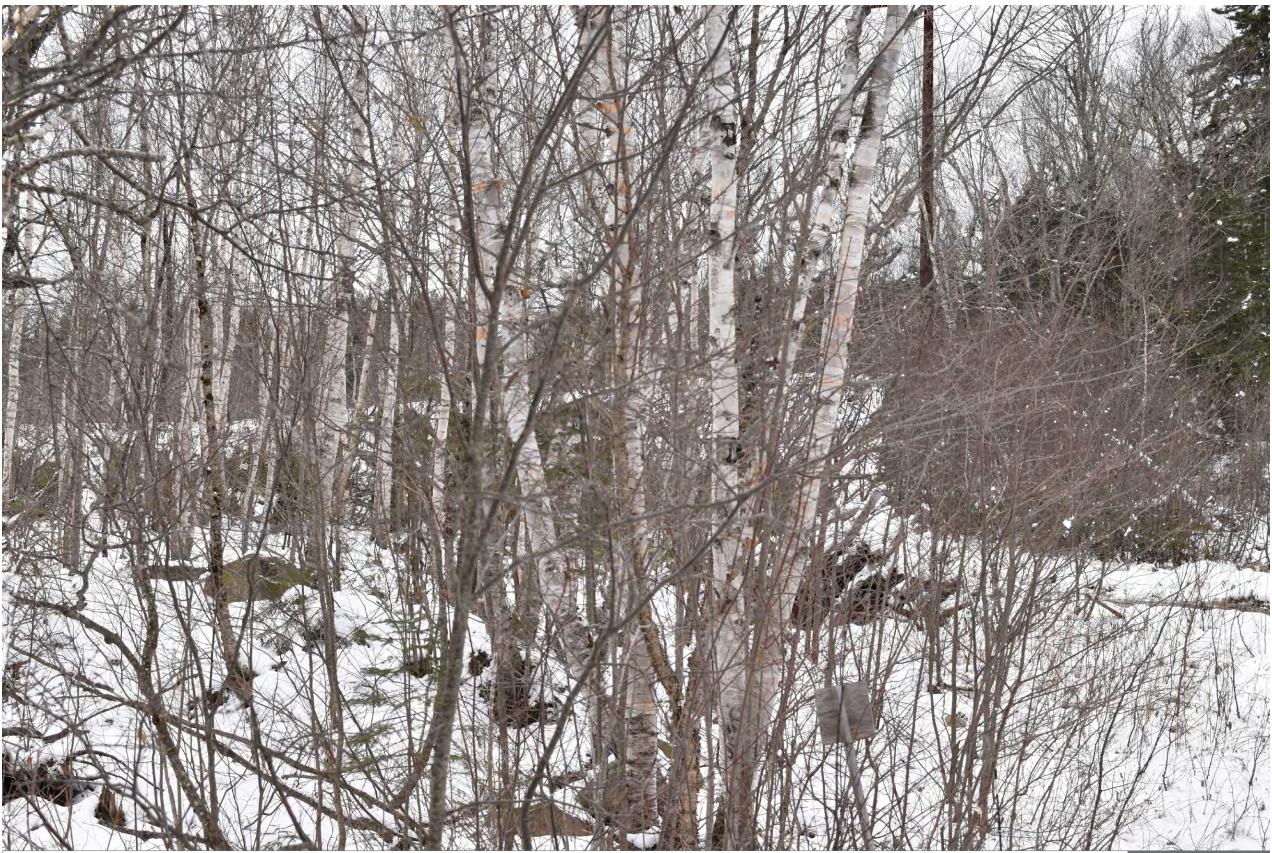
PHOTOSIMULATION 46B: ITS 87, Johnson Mountain Twp

Proposed Conditions: Normal view looking southeast on the ITS 87 bridge over Cold Stream toward the proposed HVDC transmission line. One HVDC structure will be visible 500 ft to the southeast filtered through the hardwood vegetation.

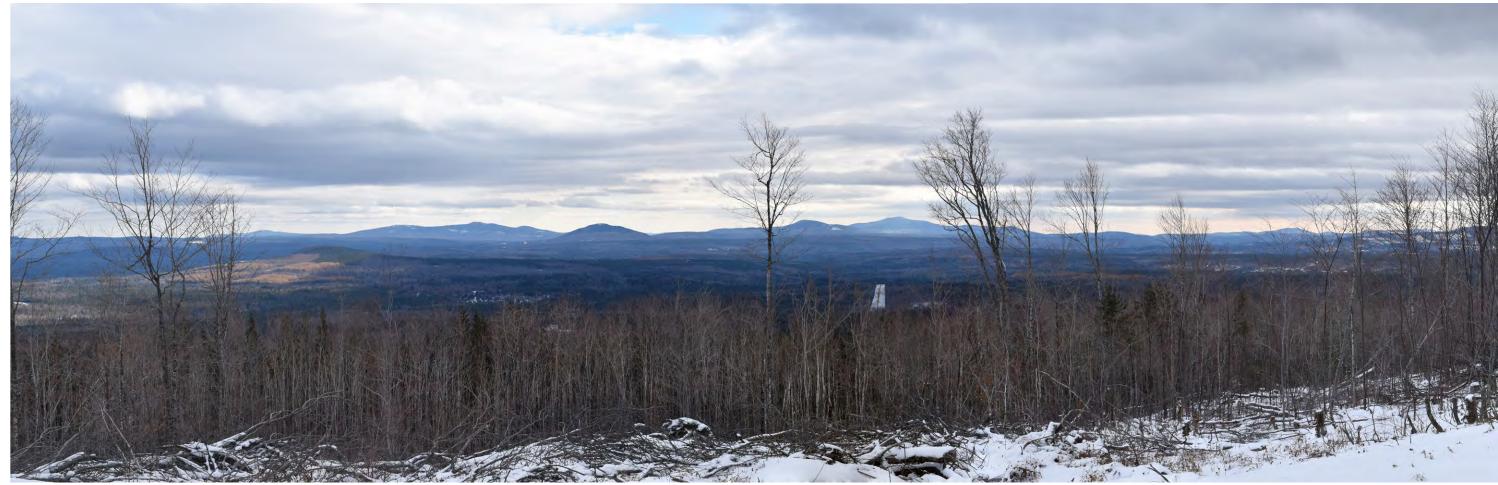
PHOTOSIMULATION 47: COLD STREAM MOUNTAIN, Local Snowmobile Trail, Johnson Mountain Twp

Proposed Conditions: Panoramic view looking southeast to southwest toward the proposed HVDC transmission line from a haul road/local snowmobile trail on Weyerhaeuser land, on Cold Stream Mountain in Johnson Mountain Twp. The closest visible structure is 1.5 miles from this viewpoint. Ten structures will be visible within 3 miles. The most visible portion of the Project will be a 1.7 mile section of the corridor located in the Johnson Mountain and West Forks Original Reservation Parcels. The view of corridor will likely disappear within approximately five years as the trees in the foreground grow.

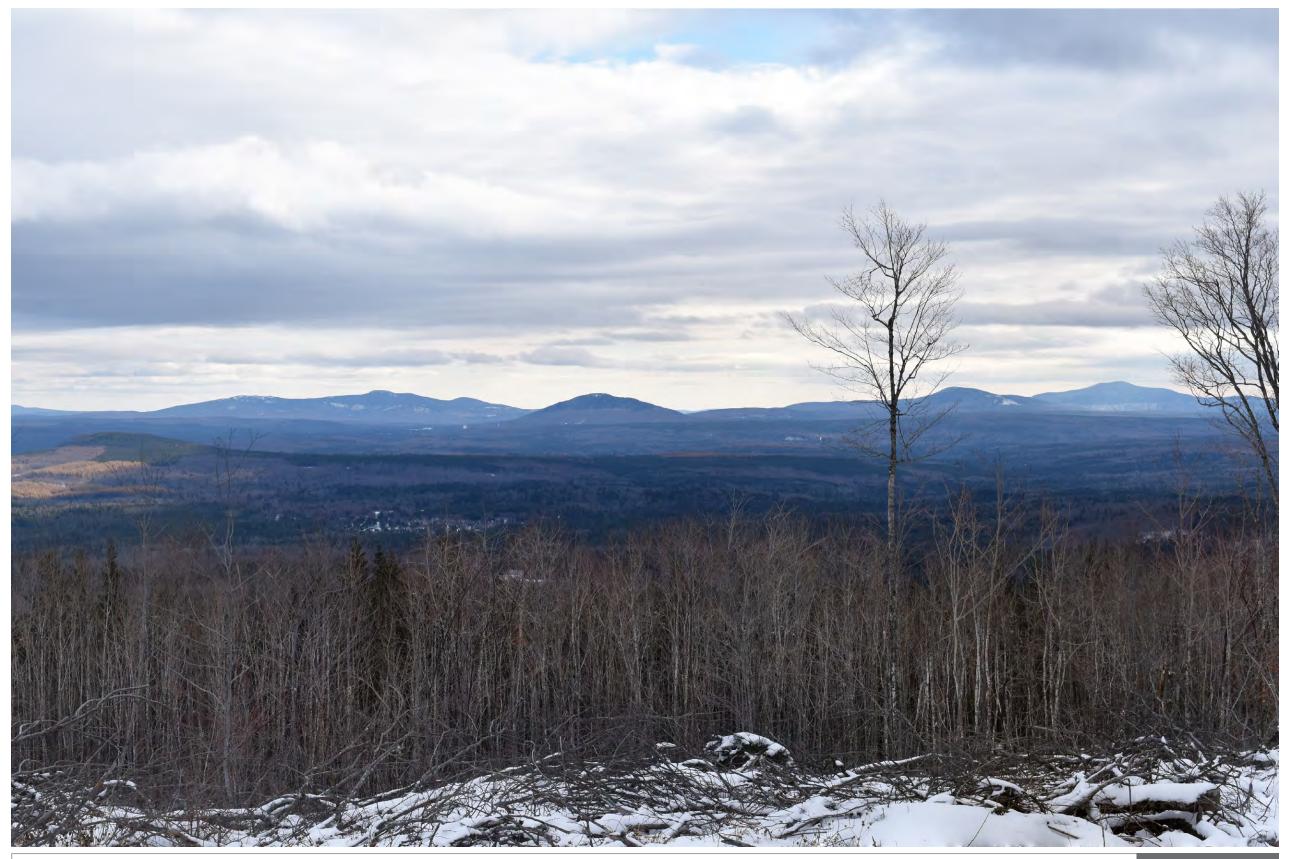
EXISTING CONDITIONS 47A: COLD STREAM MOUNTAIN, Local Snowmobile Trail, Johnson Mountain Twp

Existing Conditions: Normal view looking south toward Moxie Mountain (center of image) from a haul road/local snowmobile trail on Weyerhauser land, on Cold Stream Mountain in Johnson Mountain Twp.

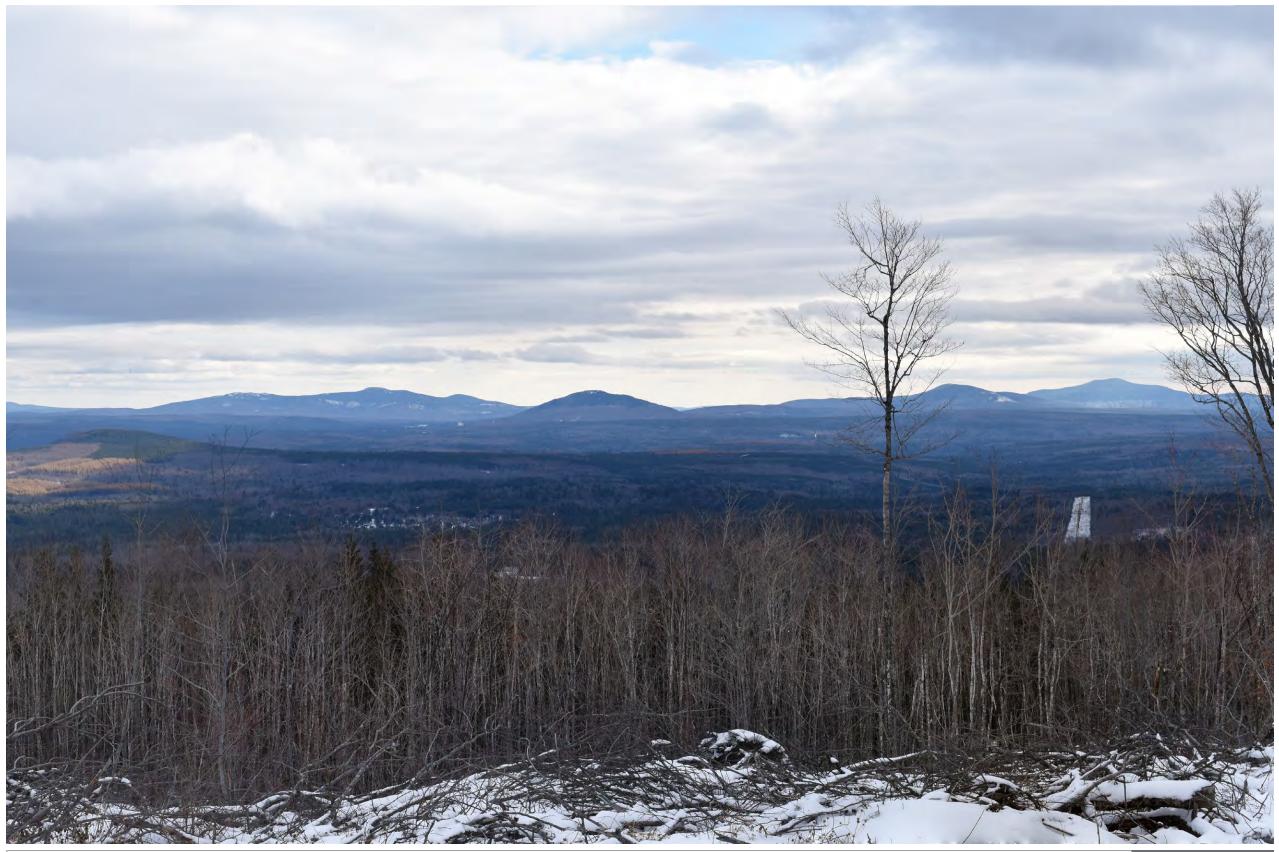
PHOTOSIMULATION 47A: COLD STREAM MOUNTAIN, Local Snowmobile Trail, Johnson Mountain Twp

Proposed Conditions: Normal view looking south toward the proposed HVDC transmission line from a haul road/local snowmobile trail on Weyerhauser land, on Cold Stream Mountain. The closest visible structure is 1.5 miles from this viewpoint. Ten structures will be visible within 3 miles of this viewpoint. The most visible portion of the Project will be a 1.7 mile section of the corridor located in the Johnson Mountain and West Forks Parcels.
