PHOTOSIMULATION 42: PARLIN POND, Parlin Pond Twp

Proposed Conditions: Panoramic view looking south to southwest from the northern end of Parlin Pond in Parlin Pond Twp toward the proposed HVDC transmission line. Five proposed HVDC structures, conductors and portions of the corridor clearing will be visible crossing the east shoulder of Coburn Mountain within 3 miles of this viewpoint. Portions of the cleared corridor will be slightly more visible in leaf-off conditions. The weathered steel HVDC structures will generally blend in with the wooded hillside. The conductors will be most visible in early morning light. Non-specular conductors will be used to minimize glare.

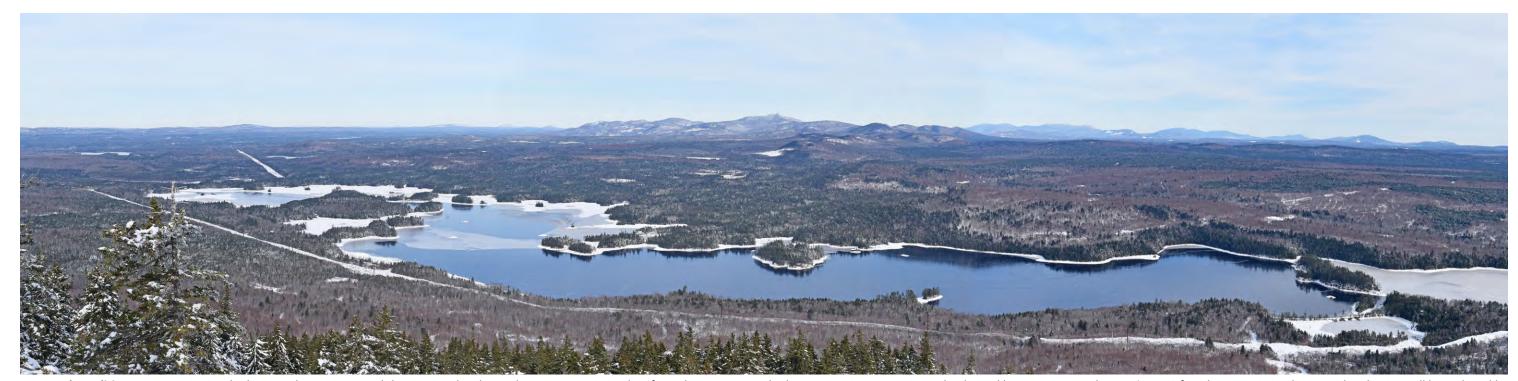
PHOTOSIMULATION 48: MOSQUITO MOUNTAIN - Northeast, The Forks Plt

Proposed Conditions: Panoramic view looking north to east toward the proposed co-located HVDC transmission line from the eastern overlook on Mosquito Mountain, on land owed by Bayroot LLC. The existing 150 ft wide transmission line corridor clearing will be widened by 75 ft on the western side to accommodate the proposed HVDC transmission line. Big Moose Mountain is visible in the center of the image. Moxie Pond is visible across the entire image with Black Narrows on the right side of the image. A total of seventeen HVDC structures in the cleared corridor would be visible from this viewpoint at distances of 0.7 to 3.0 miles. Weathering steel HVDC structures have been selected to blend with the surrounding vegetation. The cleared corridor will be more visible in leaf-off conditions; the majority of users visit the summit between May and October according to Mosquito Mountain log books.

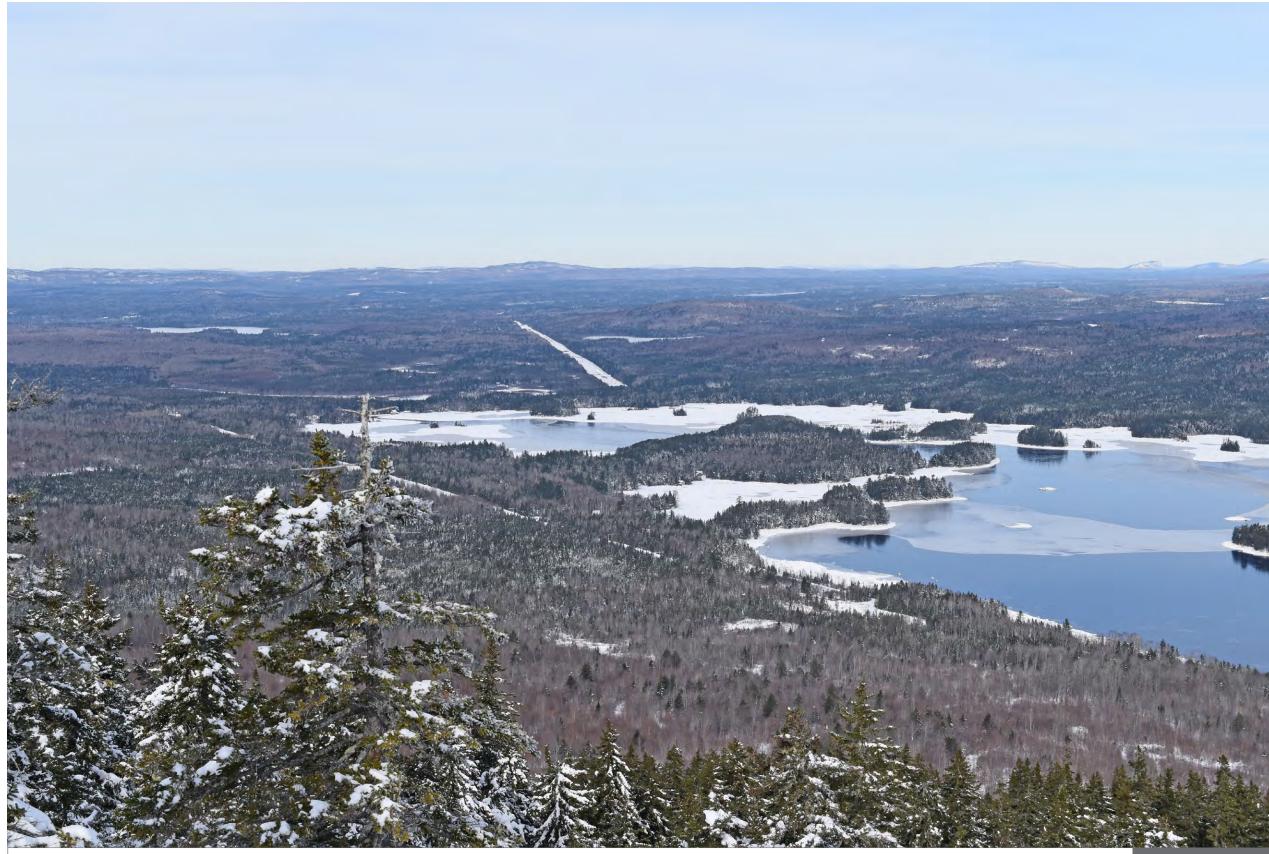
EXISTING CONDITIONS 48A: MOSQUITO MOUNTAIN - Northeast, The Forks Plt

Existing Conditions: Normal view looking north toward the existing 115 kV transmission line and the northern end of Moxie Pond, from Mosquito Mountain on land owned by Bayroot LLC. The existing transmission line corridor and Indian Pond Road to Harris Dam are visible on the left side of the image, north of Moxie Pond, and is not part of the NECEC Project.

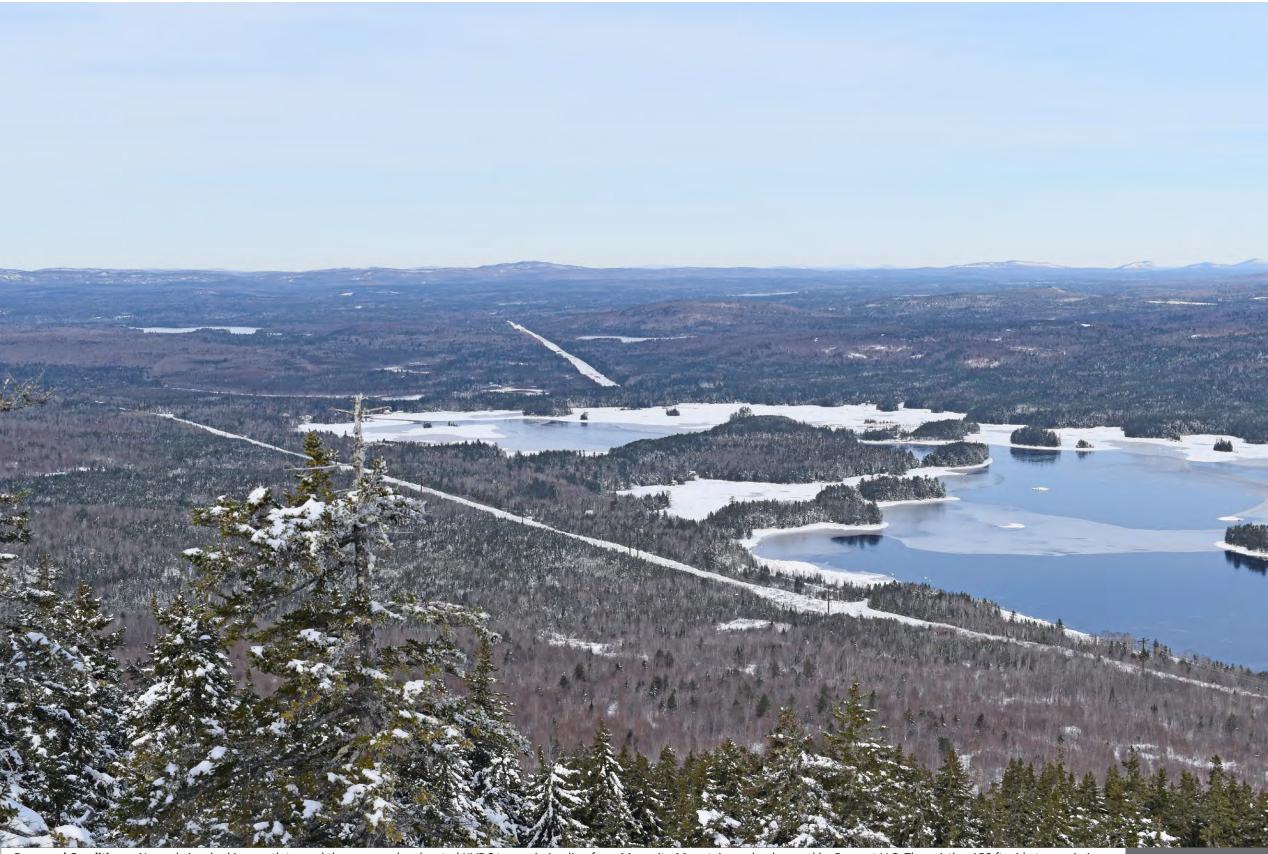
PHOTOSIMULATION 48A: MOSQUITO MOUNTAIN - Northeast, The Forks Plt

Proposed Conditions: Normal view looking north toward the proposed co-located HVDC transmission line from Mosquito Mountain, on land owned by Bayroot LLC. The existing 150 ft wide transmission line corridor clearing will be widened by 75 ft on the western side to accommodate the proposed co-located HVDC transmission line. Twelve structures will be visible looking in this direction at distances of 1.1 to 3.0 miles

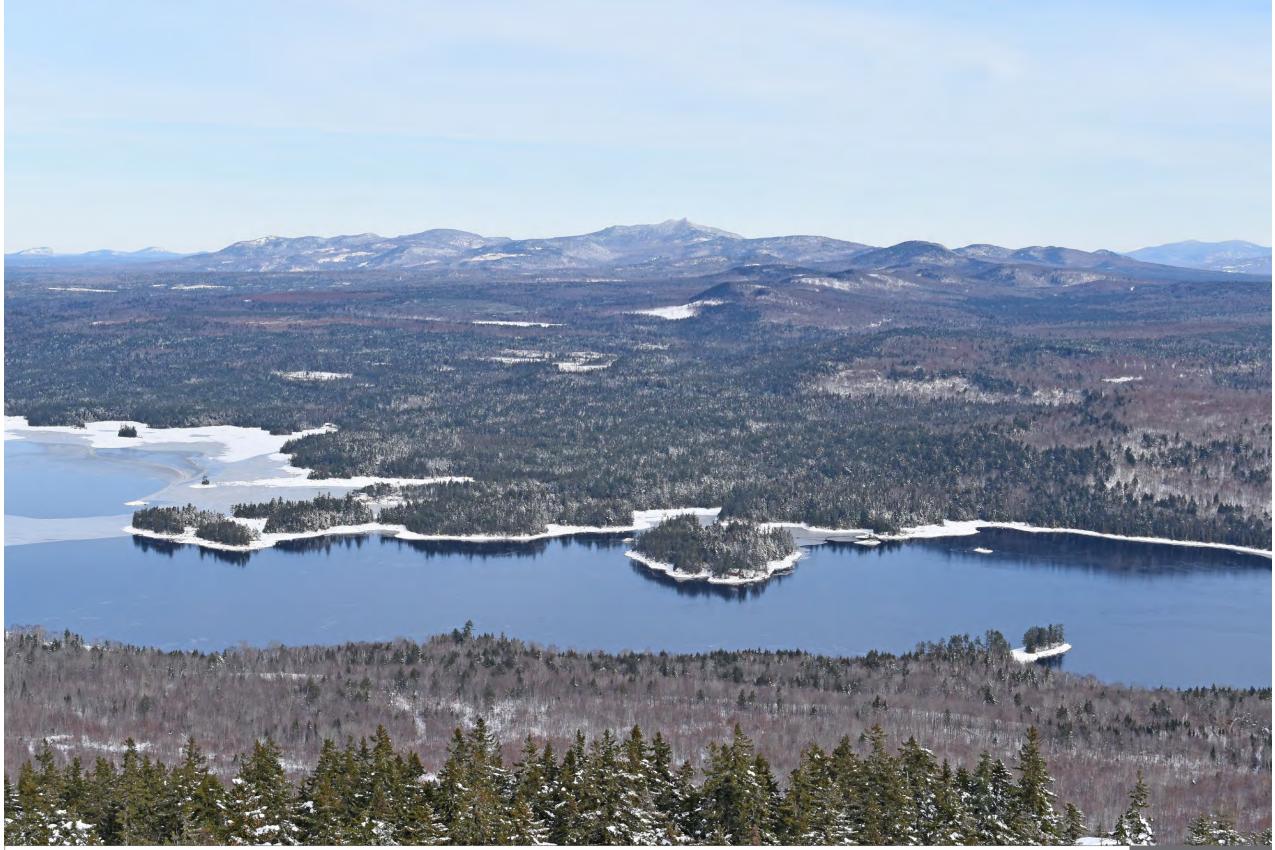
EXISTING CONDITIONS 48B: MOSQUITO MOUNTAIN - Northeast, The Forks Plt

Existing Conditions: Normal view looking northeast from Mosquito Mountain on land owned by Bayroot LLC. Burnt Jacket Island in Moxie Pond is visible right of center in image. The existing 115 kV transmission line is mostly screened by vegetation in this view.

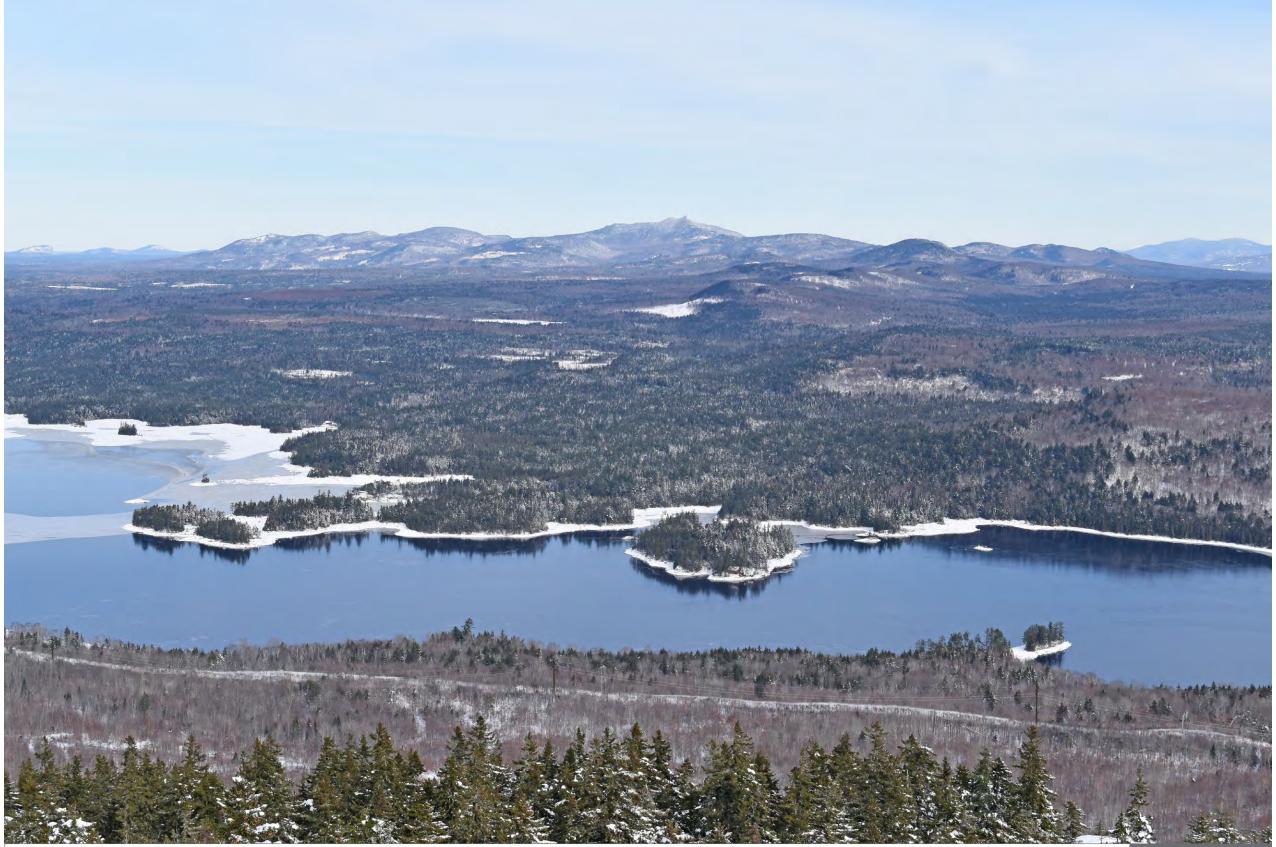
PHOTOSIMULATION 48B: MOSQUITO MOUNTAIN - Northeast, The Forks Plt

Proposed Conditions: Normal view looking northeast toward the proposed co-located HVDC transmission line from Mosquito Mountain, on land owned by Bayroot LLC. The existing 150 ft wide transmission line corridor clearing will be widened by 75 ft on the western side to accommodate the co-located HVDC transmission line. Three structures, conductors and portions of the cleared corridor will be visible from this viewpoint at distances of 0.7 to 0.9 miles.

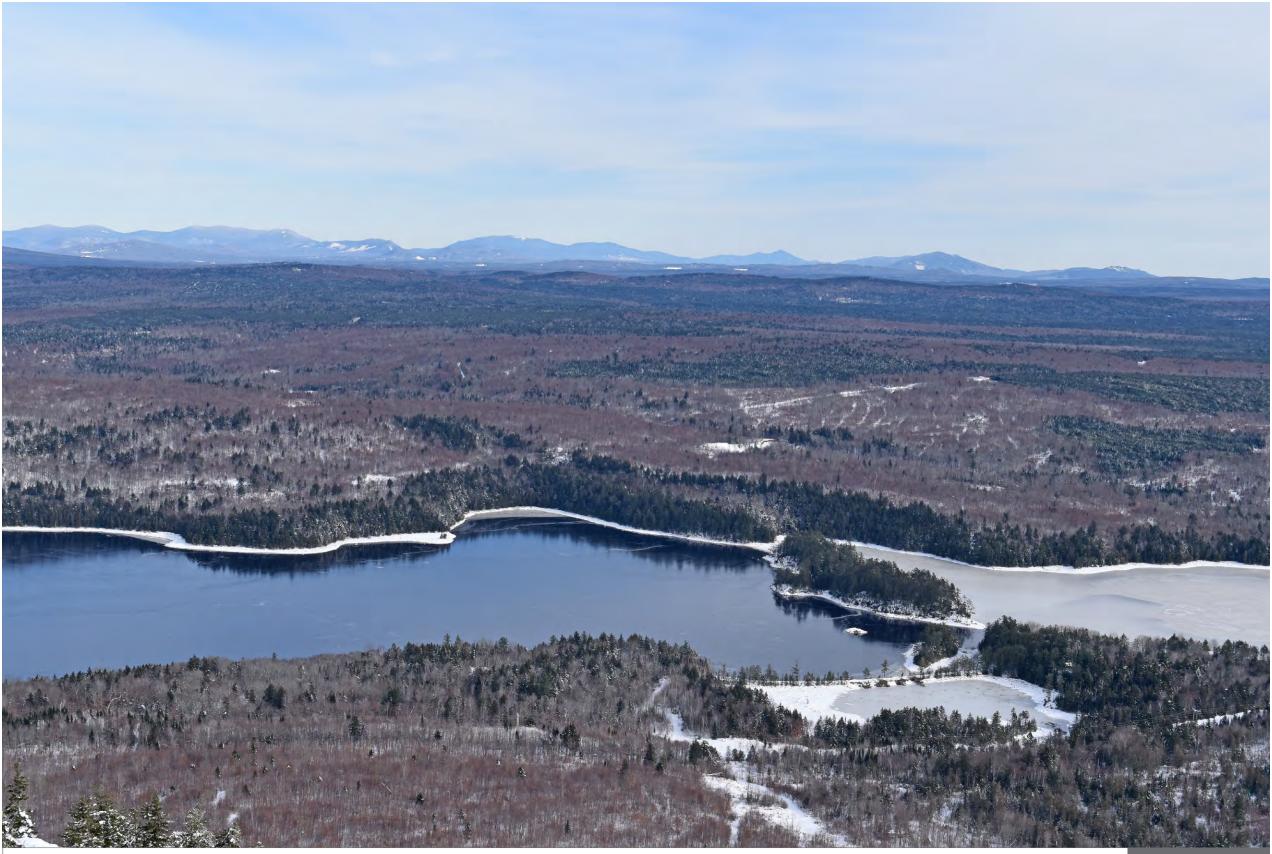
EXISTING CONDITIONS 48C: MOSQUITO MOUNTAIN - Northeast, The Forks Plt

Existing Conditions: Normal view looking east from Mosquito Mountain on land owned by Bayroot LLC. Moxie Pond is visible across the entire image with Black Narrows on right in image. The existing 115 kV transmission line and Troutdale Road are visible in the bottom 1/3 of the photograph.

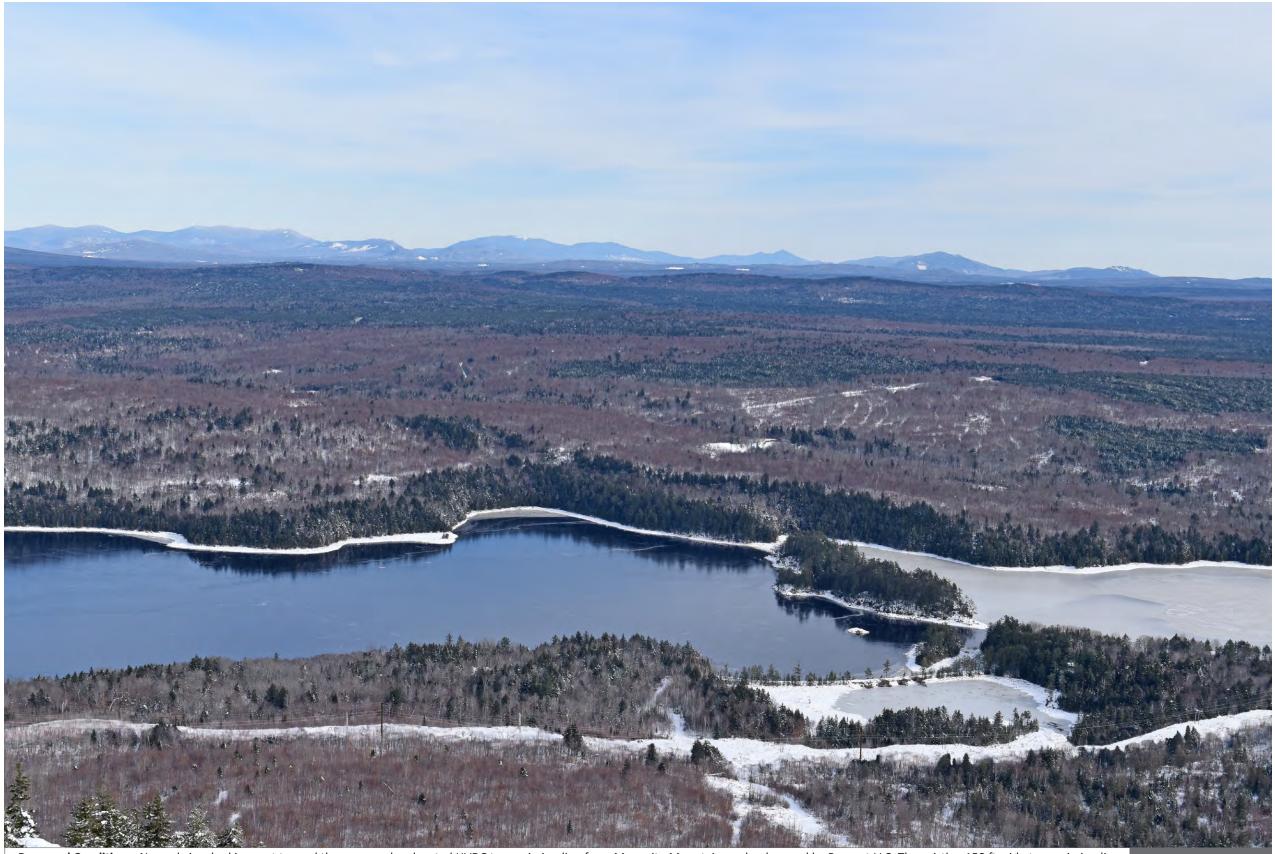
PHOTOSIMULATION 48C: MOSQUITO MOUNTAIN - Northeast, The Forks Plt

Proposed Conditions: Normal view looking east toward the proposed co-located HVDC transmission line from Mosquito Mountain, on land owned by Bayroot LLC. The existing 150 ft wide transmission line corridor clearing will be widened by 75 ft on the western side to accommodate the co-located HVDC transmission line. Two structures and conductors will be visible from this viewpoint at distances of 0.7 to 0.75 miles.

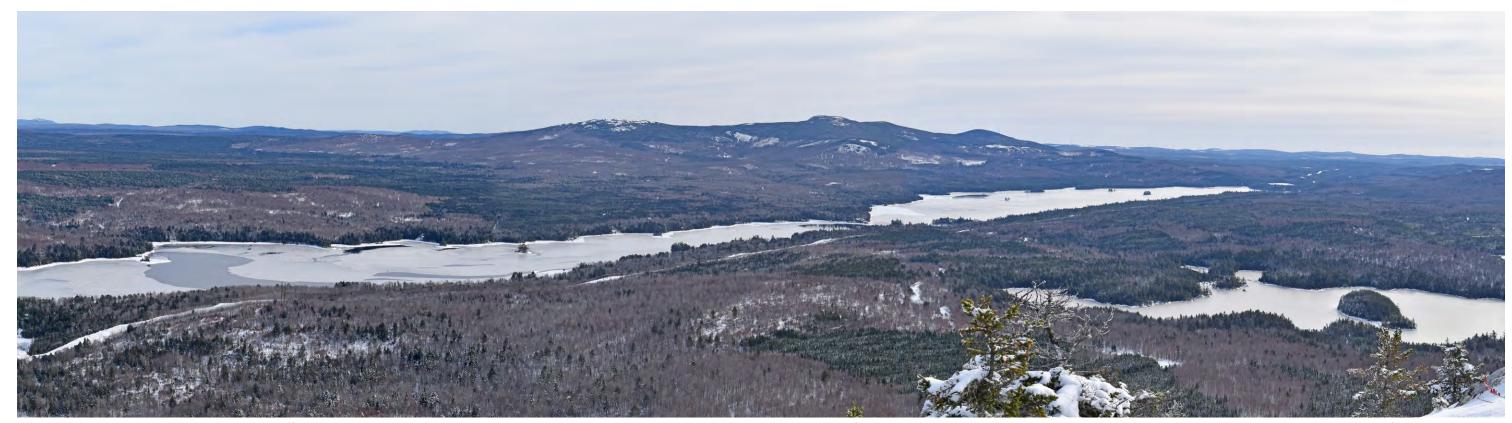
PHOTOSIMULATION 49: MOSQUITO MOUNTAIN - Southeast, The Forks Plt

Proposed Conditions: Continued panoramic view (from Photosimulation 48) looking east to south toward the proposed co-located HVDC transmission line from the eastern overlook on Mosquito Mountain, on land owned by Bayroot LLC. The existing 150 ft wide transmission line corridor clearing will be widened by 75 ft on the western side to accommodate the proposed HVDC transmission line. Bald Mountain is visible in the center of the image. A total of thirteen proposed HVDC structures and conductors would be visible from this viewpoint at distances of 0.7 to 3.0 miles. Weathering steel HVDC structures have been selected to blend with the surrounding vegetation. The cleared corridor will be more visible in leaf-off conditions; the majority of users visit the summit between May and October according to Mosquito Mountain log books.

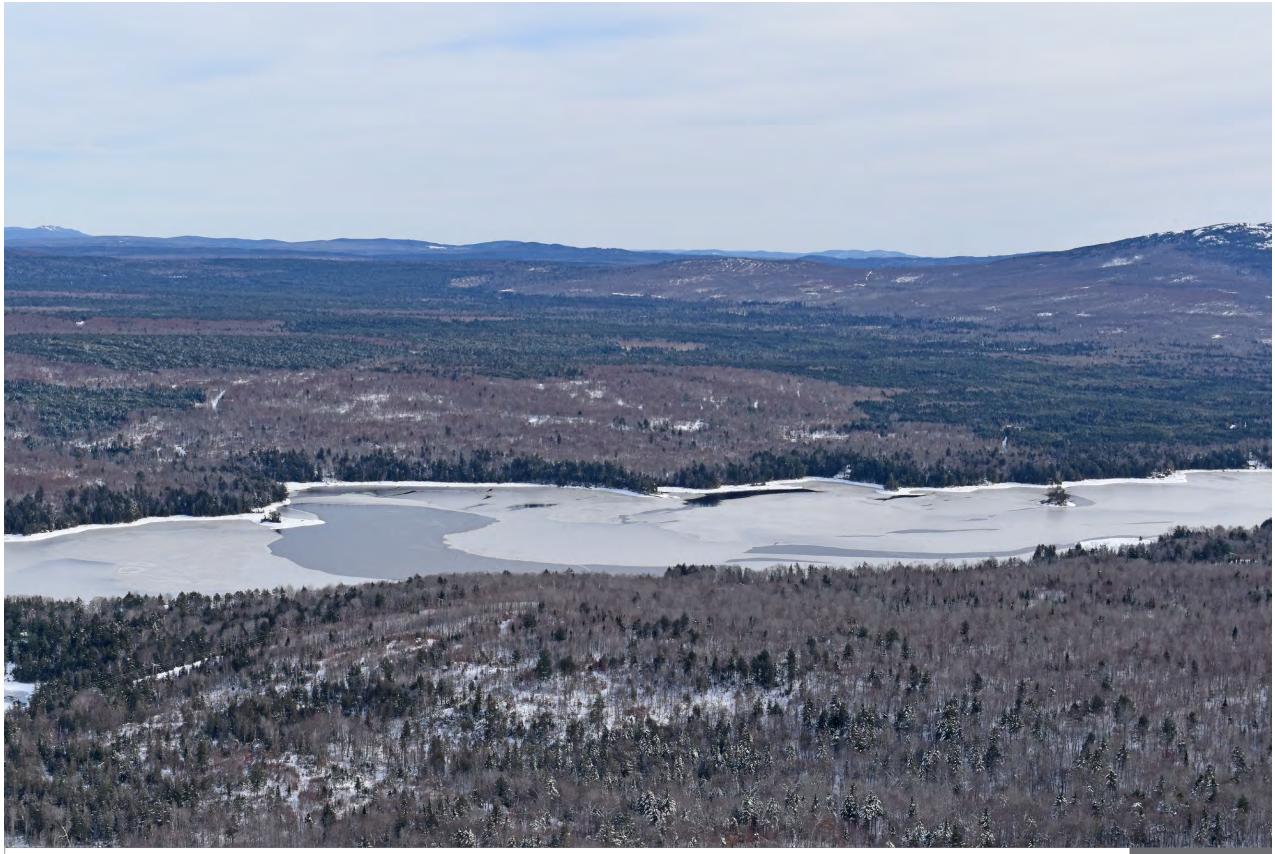
EXISTING CONDITIONS 49A: MOSQUITO MOUNTAIN - Southeast, The Forks Plt

Existing Conditions: Normal view looking east towards the existing 115 kV transmission line and the middle of Moxie Pond, from Mosquito Mountain on land owned by Bayroot LLC.

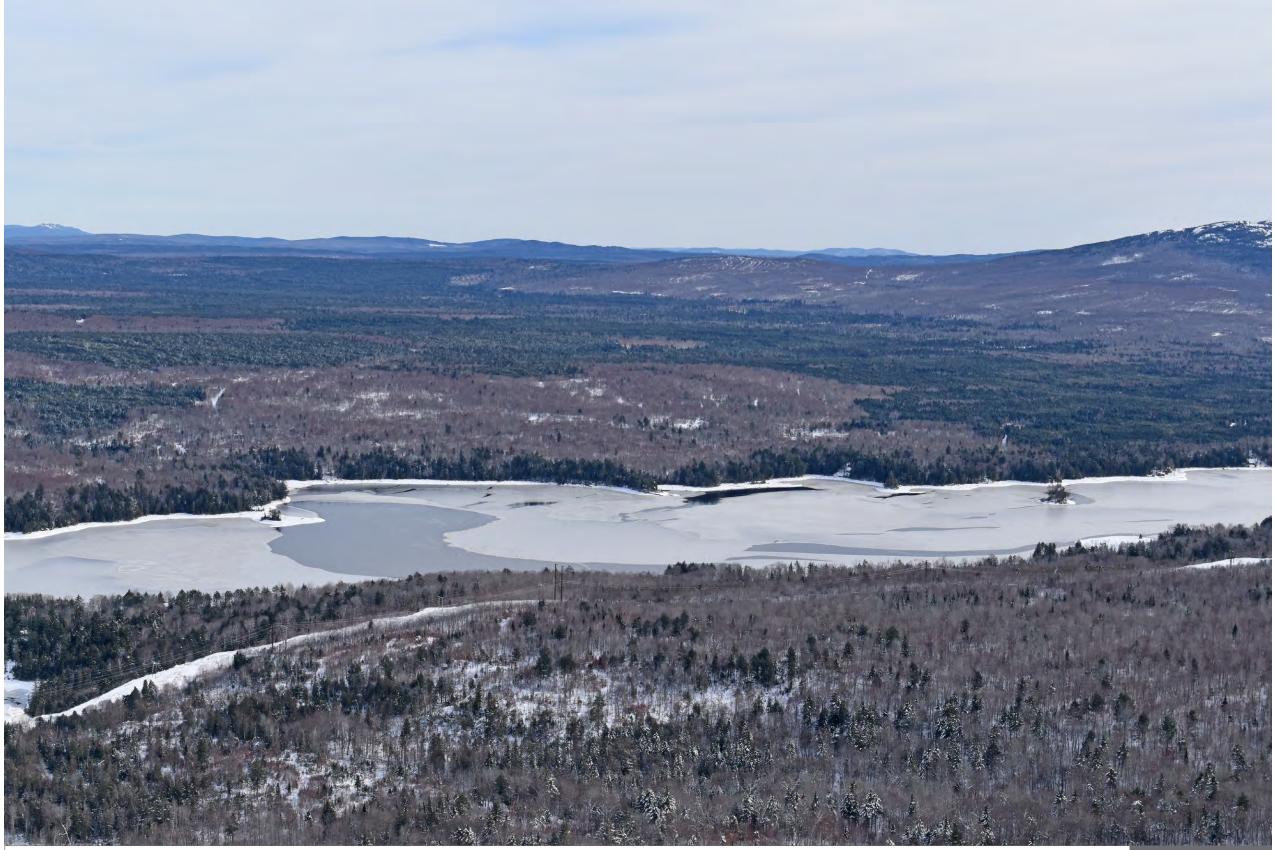
PHOTOSIMULATION 49A: MOSQUITO MOUNTAIN - Southeast, The Forks Plt

Proposed Conditions: Normal view looking east toward the proposed co-located HVDC transmission line from Mosquito Mountain on land owned by Bayroot LLC. The existing 150 ft wide transmission line corridor clearing will be widened by 75 ft on the western side to accommodate the proposed co-located HVDC transmission line. Four proposed HVDC structures would be visible in this direction within 3 miles of this viewpoint.

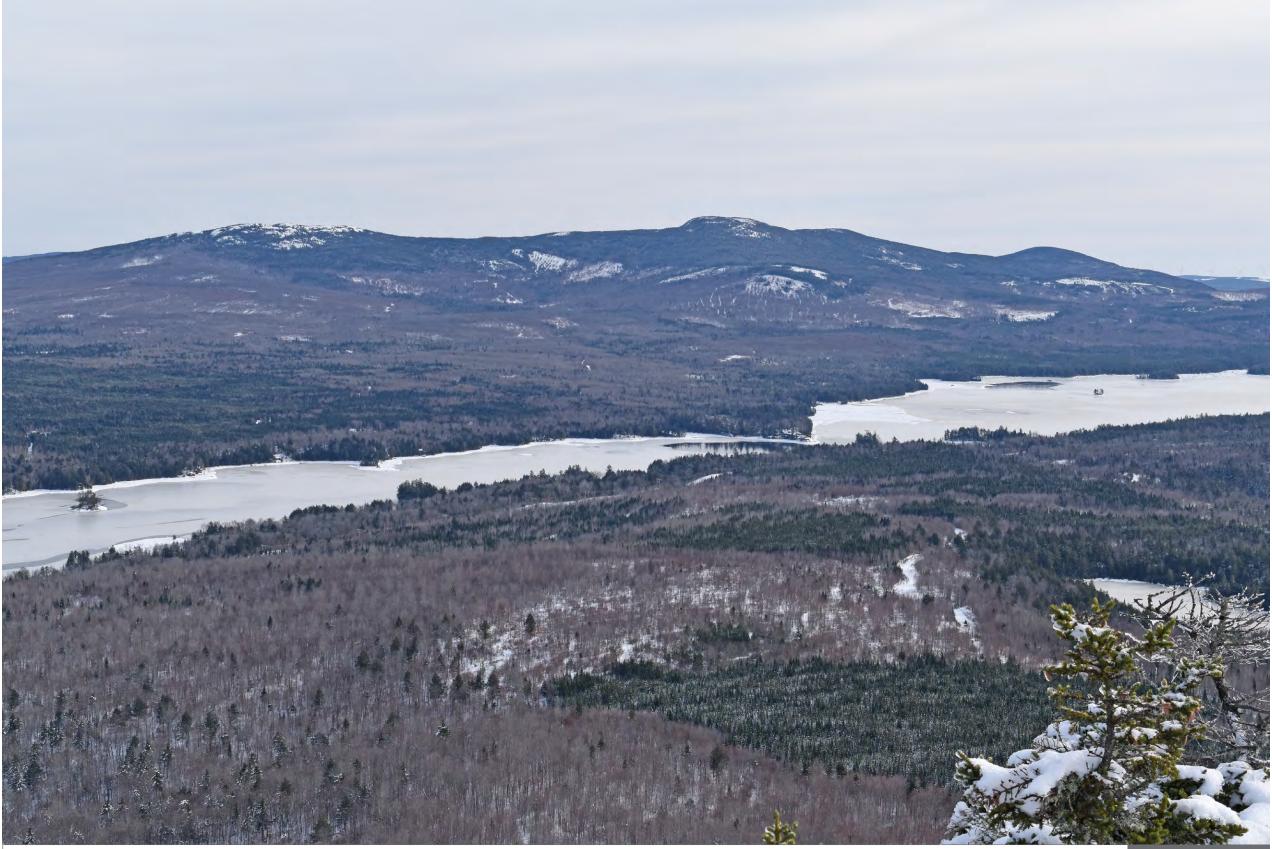
EXISTING CONDITIONS 49B: MOSQUITO MOUNTAIN - Southeast, The Forks Plt

Existing Conditions: Normal view looking southeast toward the existing 115 kV transmission line from Mosquito Mountain on land owned by Bayroot LLC. Bald Mountain is visible in the center of the image.

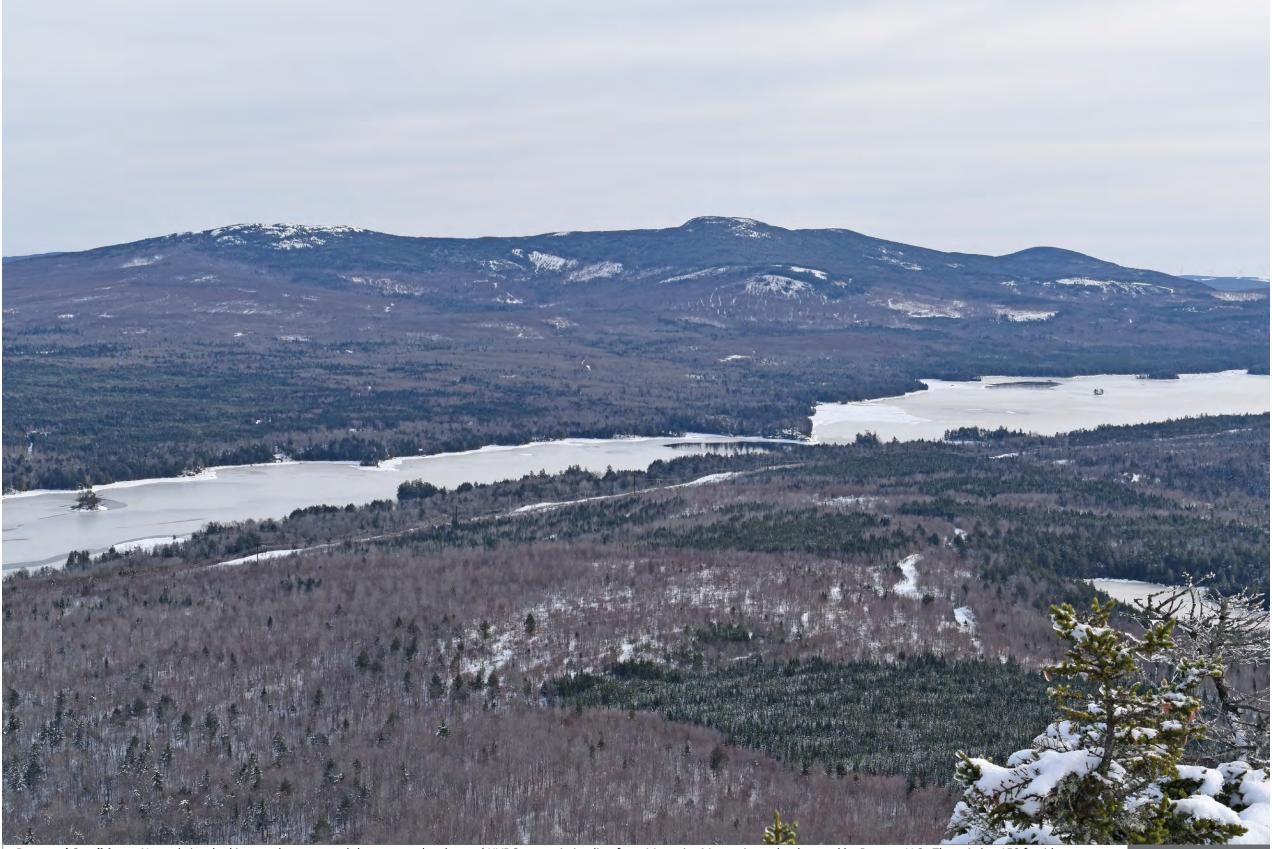
PHOTOSIMULATION 49B: MOSQUITO MOUNTAIN - Southeast, The Forks Plt

Proposed Conditions: Normal view looking southeast toward the proposed co-located HVDC transmission line from Mosquito Mountain, on land owned by Bayroot LLC. The existing 150 ft wide transmission line corridor clearing will be widened by 75 ft on the western side to accommodate the proposed transmission line. Seven proposed HVDC structures and conductors would be visible in this direction within 3 miles of this viewpoint.

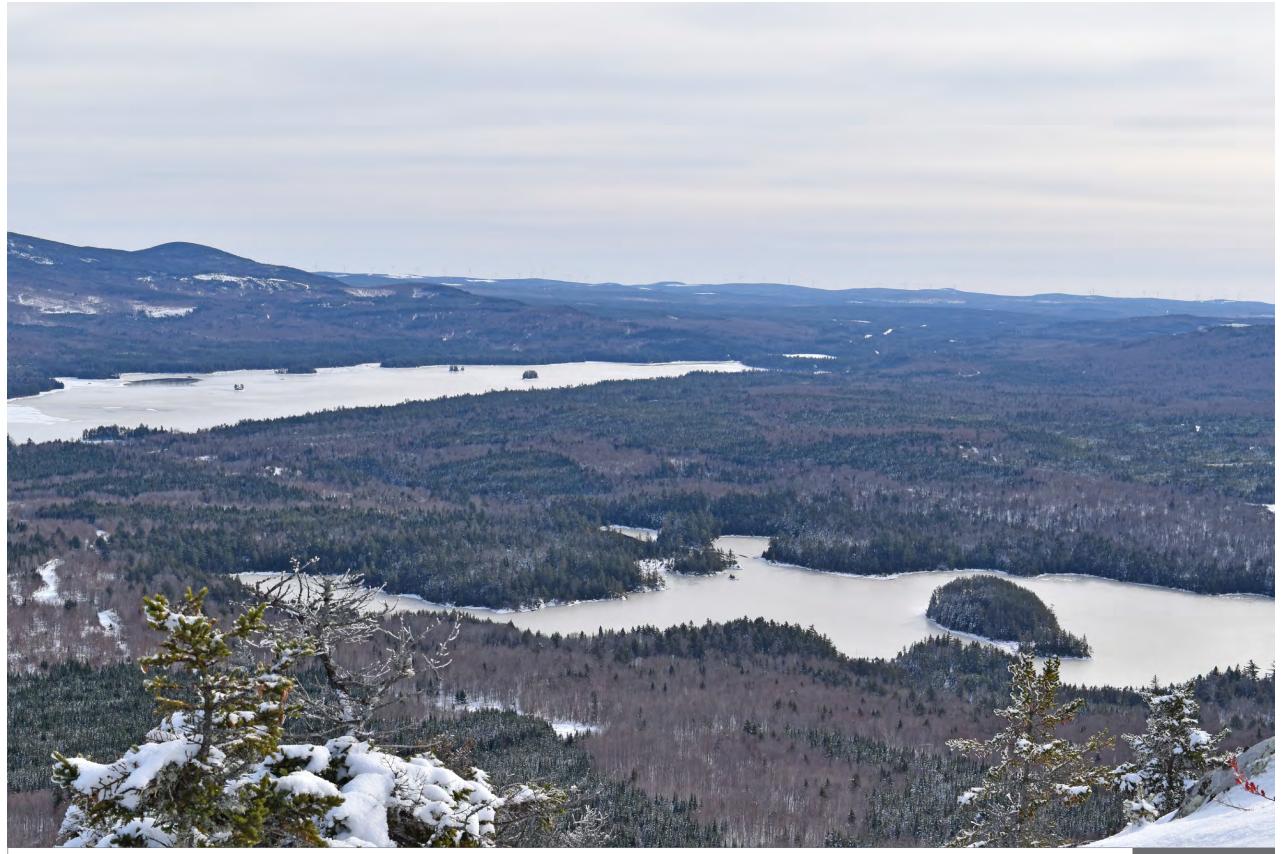
EXISTING CONDITIONS 49C: MOSQUITO MOUNTAIN - Southeast, The Forks Plt

Existing Conditions: Normal view looking east toward the existing 115 kV transmission line and Troutdale Road, from Mosquito Mountain on land owned by Bayroot LLC. Moxie Pond is visible across the entire image with Black Narrows on right.

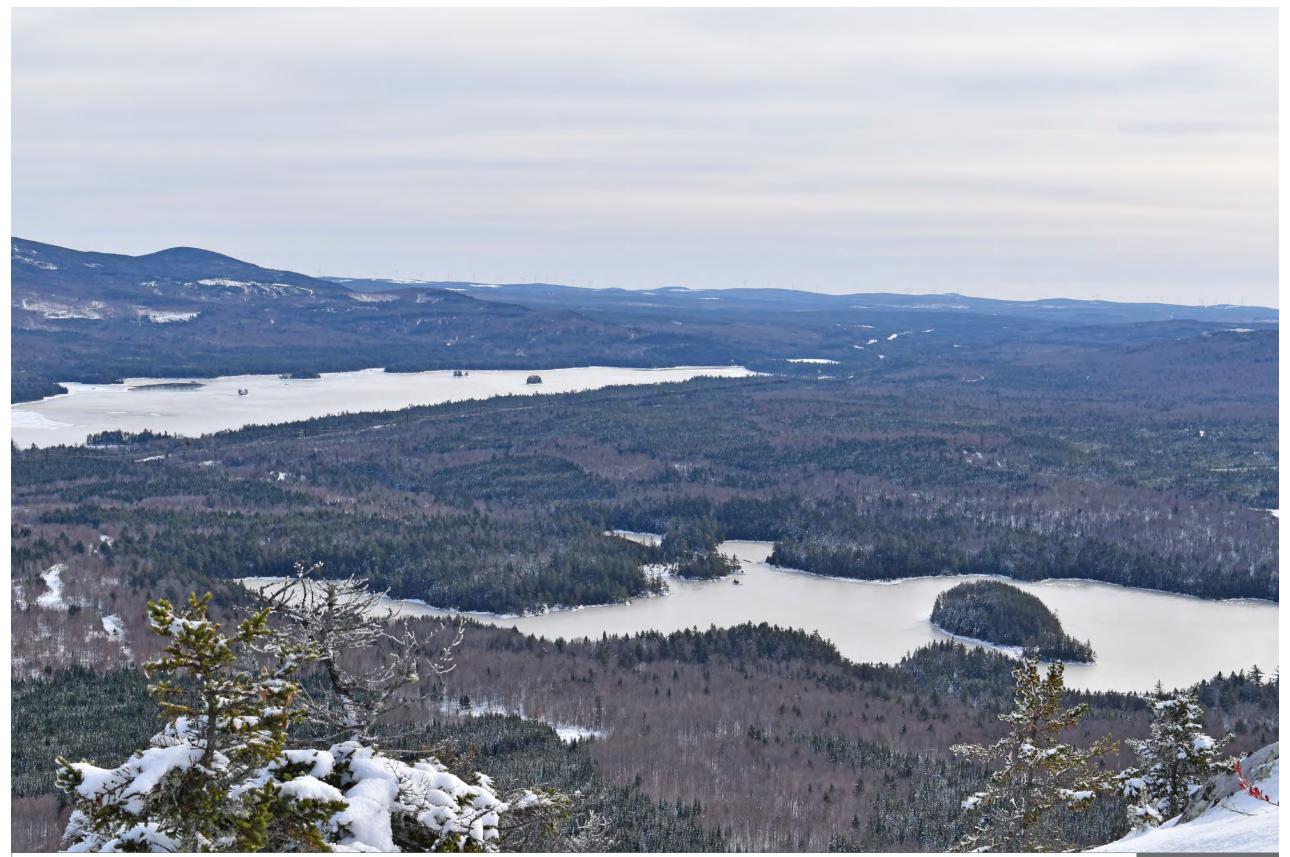
PHOTOSIMULATION 49C: MOSQUITO MOUNTAIN - Southeast, The Forks Plt

Proposed Conditions: Normal view looking east toward the proposed co-located HVDC transmission line from Mosquito Mountain, on land owned by Bayroot LLC. The existing 150 ft wide transmission line corridor clearing will be widened by 75 ft on the western side to accommodate the proposed transmission line. Six proposed HVDC structures and conductors would be visible in this direction within 3 miles of this viewpoint.

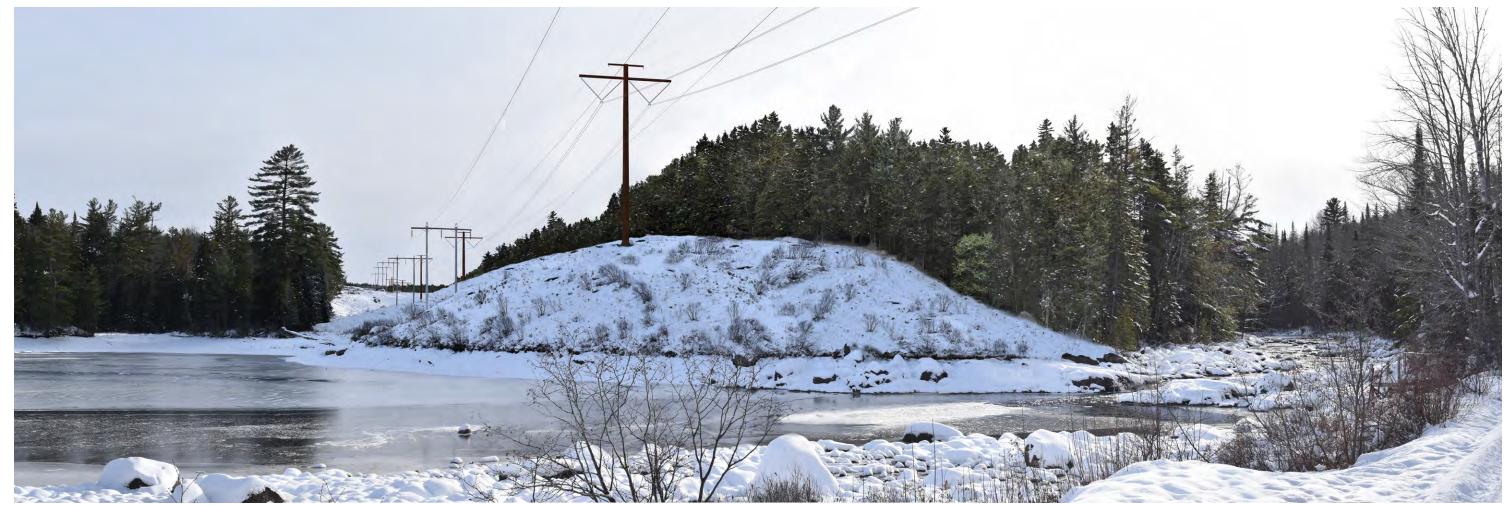
PHOTOSIMULATION 50:TROUTDALE ROAD, Bald Mountain Twp

Proposed Conditions: Panoramic view looking toward the proposed co-located HVDC transmission line from southeast to south on Troutdale Road (private road), looking toward Joes Hole (Moxie Pond) in Bald Mountain TWP. The Appalachian Trail is located on Troutdale Road for approximately 1,000 ft, including this section where the existing transmission corridor crosses. The existing 150 ft wide transmission line clearing will be widened by 75 ft on the western side to accommodate the new HVDC transmission line. Portions of six proposed HVDC structures will be visible from this viewpoint.

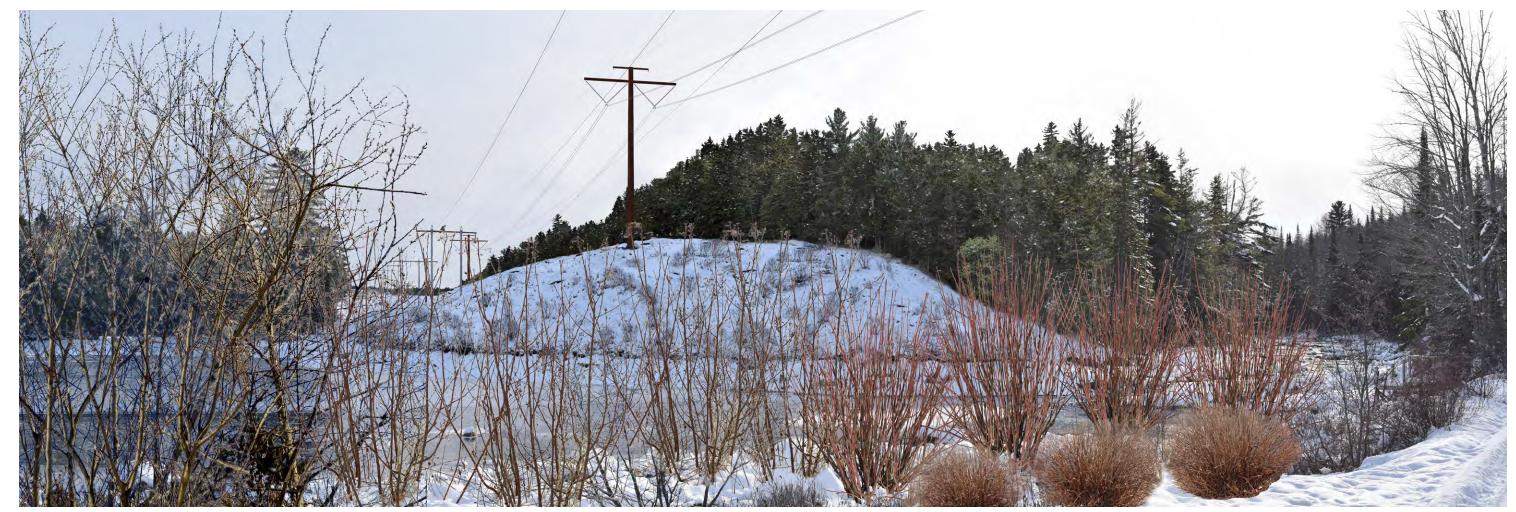
PHOTOSIMULATION 50:TROUTDALE ROAD, Bald Mountain Twp

Proposed Conditions: Panoramic view on Troutdale Road (private road) looking toward Joes Hole (Moxie Pond) toward the proposed co-located HVDC transmission line with proposed Joes Hole (Moxie Pond) buffer plantings in the foreground. The Appalachian Trail is located on Troutdale Road for approximately 1,000 ft including this section where the transmission corridor crosses. The existing 150 ft wide transmission line clearing will be widened by 75 ft on the western side to accommodate the new HVDC transmission line. Portions of six proposed HVDC structures will be visible from this viewpoint (see Buffer Planting Plan as Attachment, submitted in the August 14, 2018 MDEP/LUPC Response). The deciduous shrubs proposed will buffer the view of the existing and proposed clearing.

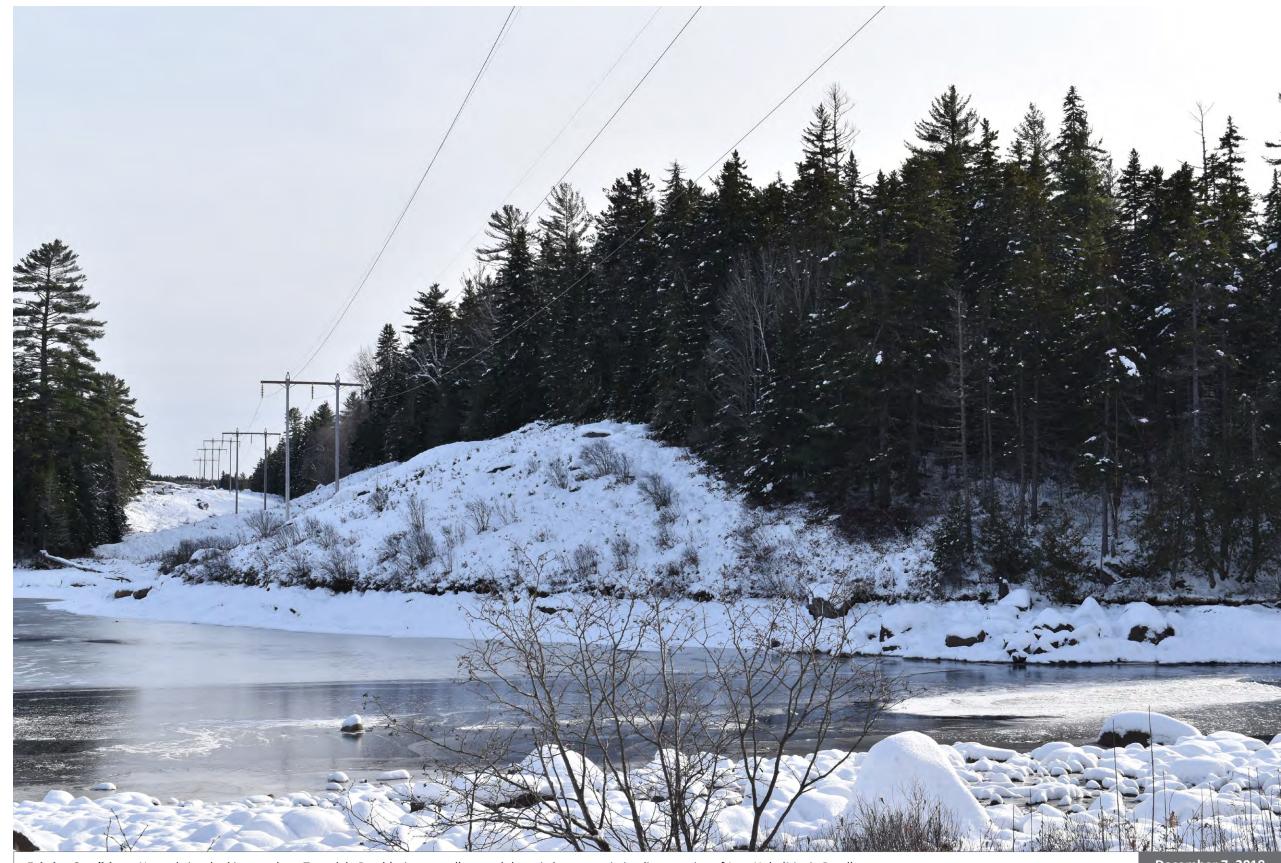
EXISTING CONDITIONS 50A:TROUTDALE ROAD, Bald Mountain Twp

Existing Conditions: Normal view looking south on Troutdale Road (private road) toward the existing transmission line crossing of Joes Hole (Moxie Pond).

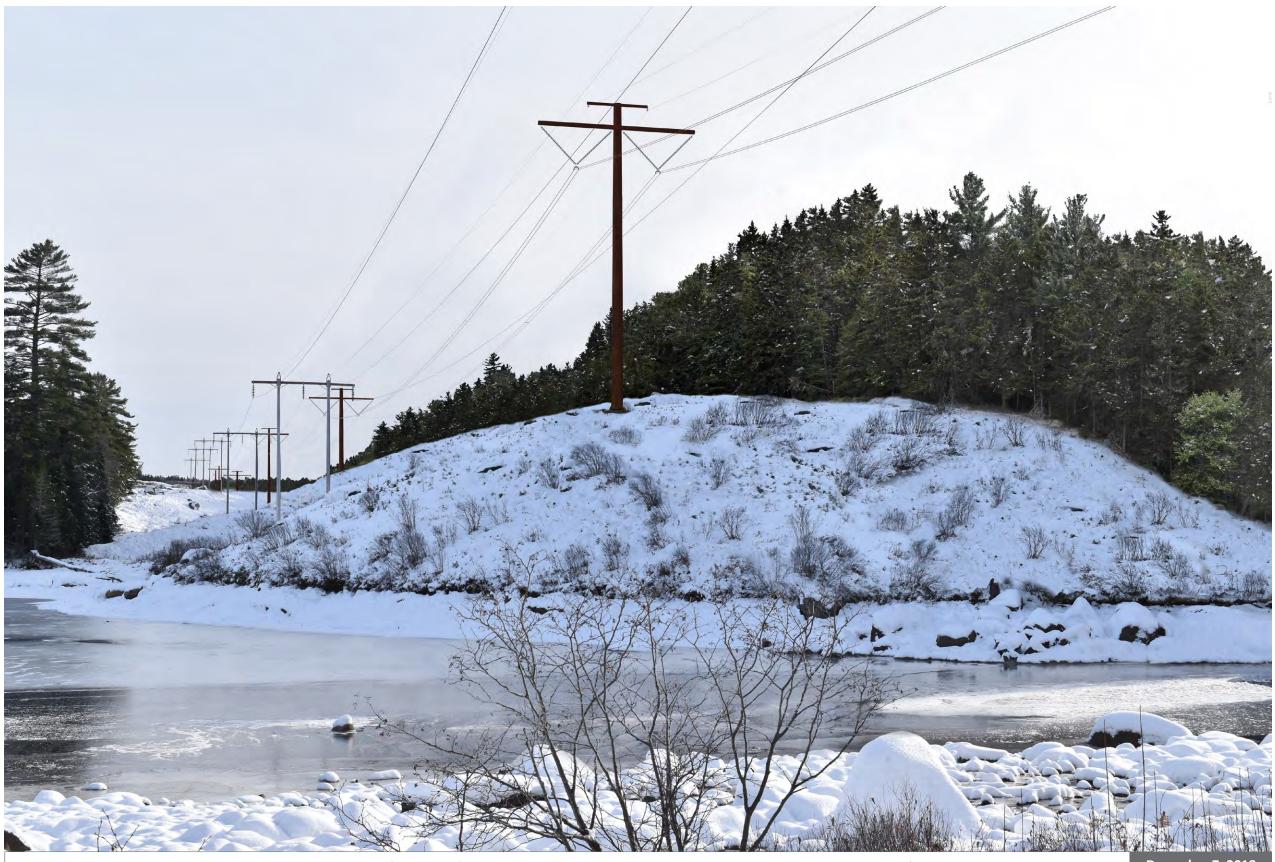
PHOTOSIMULATION 50A:TROUTDALE ROAD, Bald Mountain Twp

Proposed Conditions: Normal view looking south on Troutdale Road (private road) looking toward the proposed co-located HVDC transmission line. The existing 150 ft wide transmission line clearing will be widened by 75 ft on the western side to accommodate the new HVDC transmission line corridor. Portions of six proposed HVDC structures will be visible from this viewpoint.

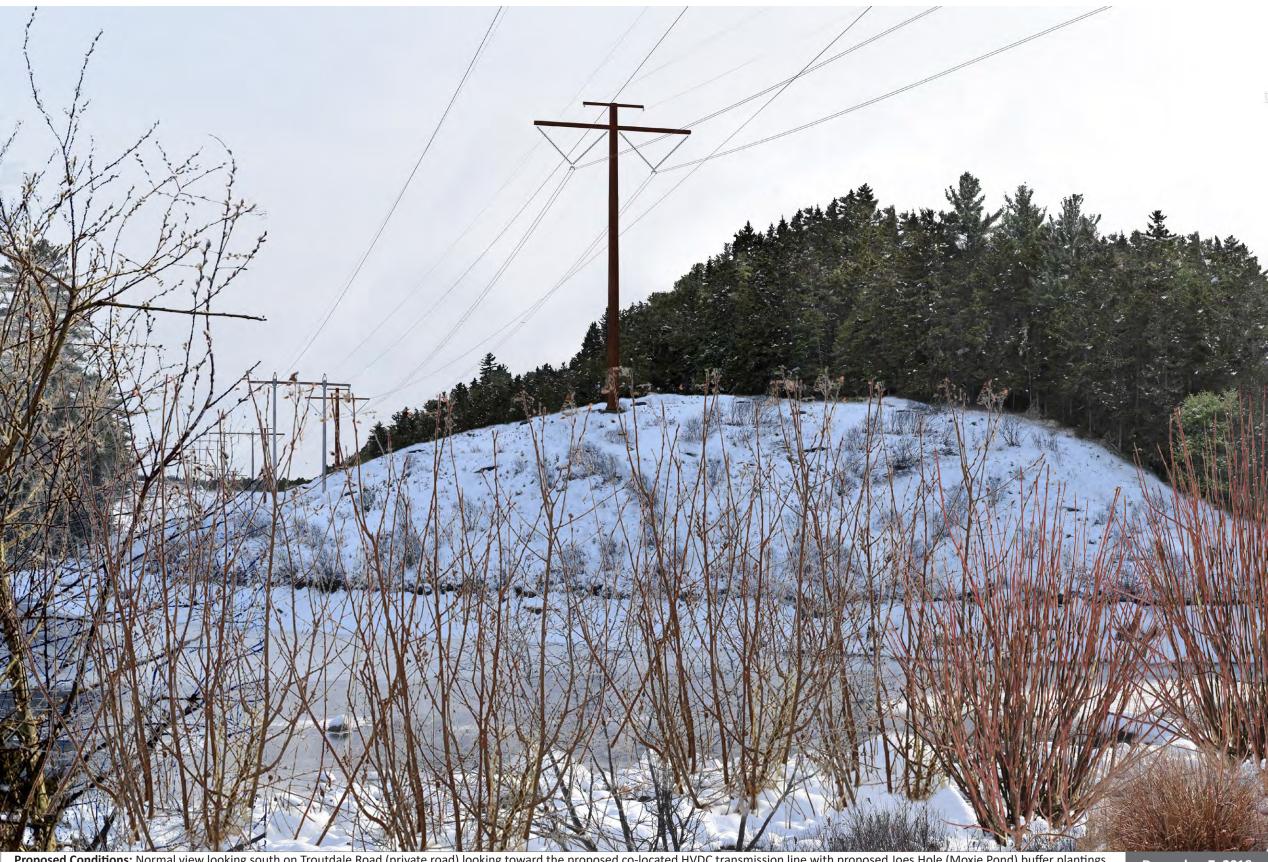
PHOTOSIMULATION 50A:TROUTDALE ROAD, Bald Mountain Twp

Proposed Conditions: Normal view looking south on Troutdale Road (private road) looking toward the proposed co-located HVDC transmission line with proposed Joes Hole (Moxie Pond) buffer plantings in the foreground. The existing 150 ft wide transmission line clearing will be widened by 75 ft on the western side to accommodate the new HVDC transmission line corridor. Portions of six proposed HVDC structures will be visible from this viewpoint.

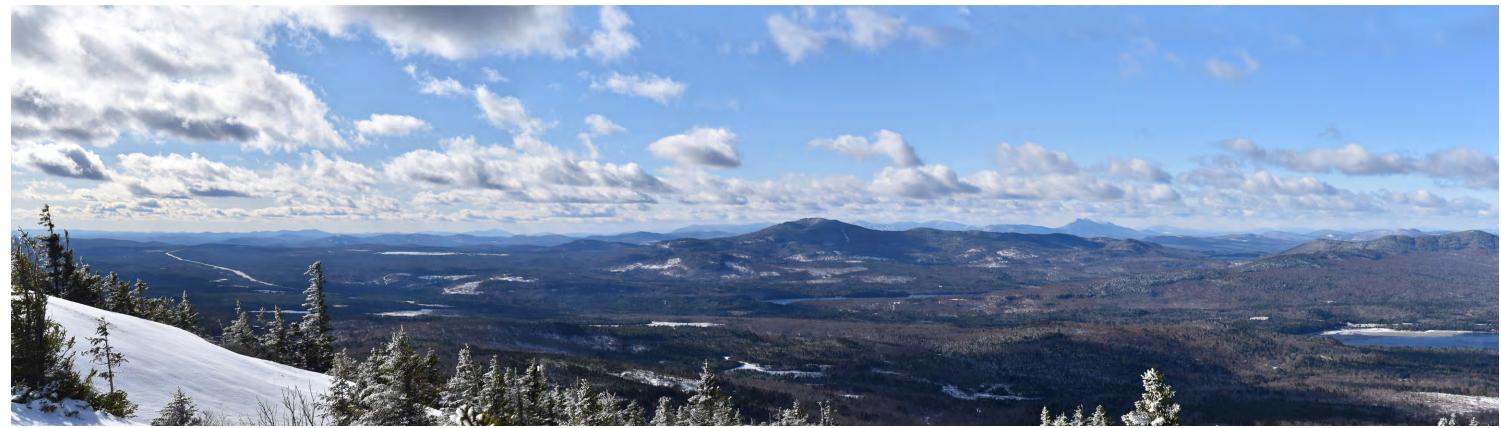
PHOTOSIMULATION 51: BALD MOUNTAIN - Southwest, Bald Mountain Twp T2 R3

Proposed conditions: Panoramic view looking from south to west toward the location of proposed co-located HVDC transmission line, from the summit of Bald Mountain on the Appalachian Trail in Bald Mountain Twp T2 R3. Approximately 800 ft of the AT on Bald Mountain will have Project views. Moxie Mountain is visible in the center of the image. Moxie Pond is visible on the right of the image. A total of eleven structures will be visible within 3 miles from this viewpoint.
