PHOTOSIMULATION 42: PARLIN POND, Parlin Pond Twp

Proposed Conditions: Panoramic view looking south to southwest from the northern end of Parlin Pond in Parlin Pond Twp toward the proposed HVDC transmission line. Five proposed HVDC structures, conductors and portions of the corridor clearing will be visible crossing the east shoulder of Coburn Mountain within 3 miles of this viewpoint. Portions of the cleared corridor will be slightly more visible in leaf-off conditions. The weathered steel HVDC structures will generally blend in with the wooded hillside. The conductors will be most visible in early morning light. Non-specular conductors will be used to minimize glare.

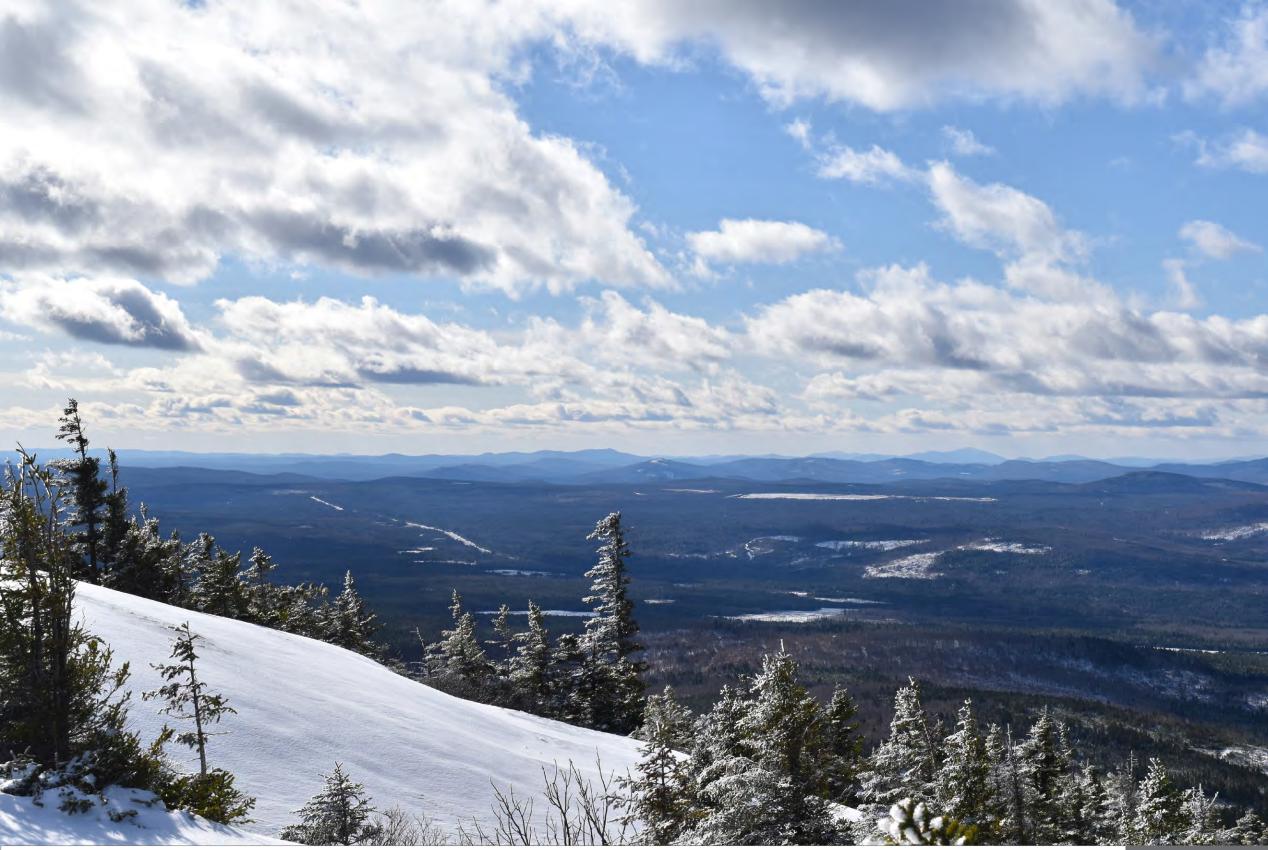
EXISTING CONDITIONS 51A: BALD MOUNTAIN - Southwest, Bald Mountain Twp T2 R3

Existing Conditions: Normal view looking southwest toward the existing 115 kV transmission line from the summit of Bald Mountain, in Bald Mountain Twp T2 R3. The existing corridor in Bald Mountain Twp T2 R3 is visible in the midground.

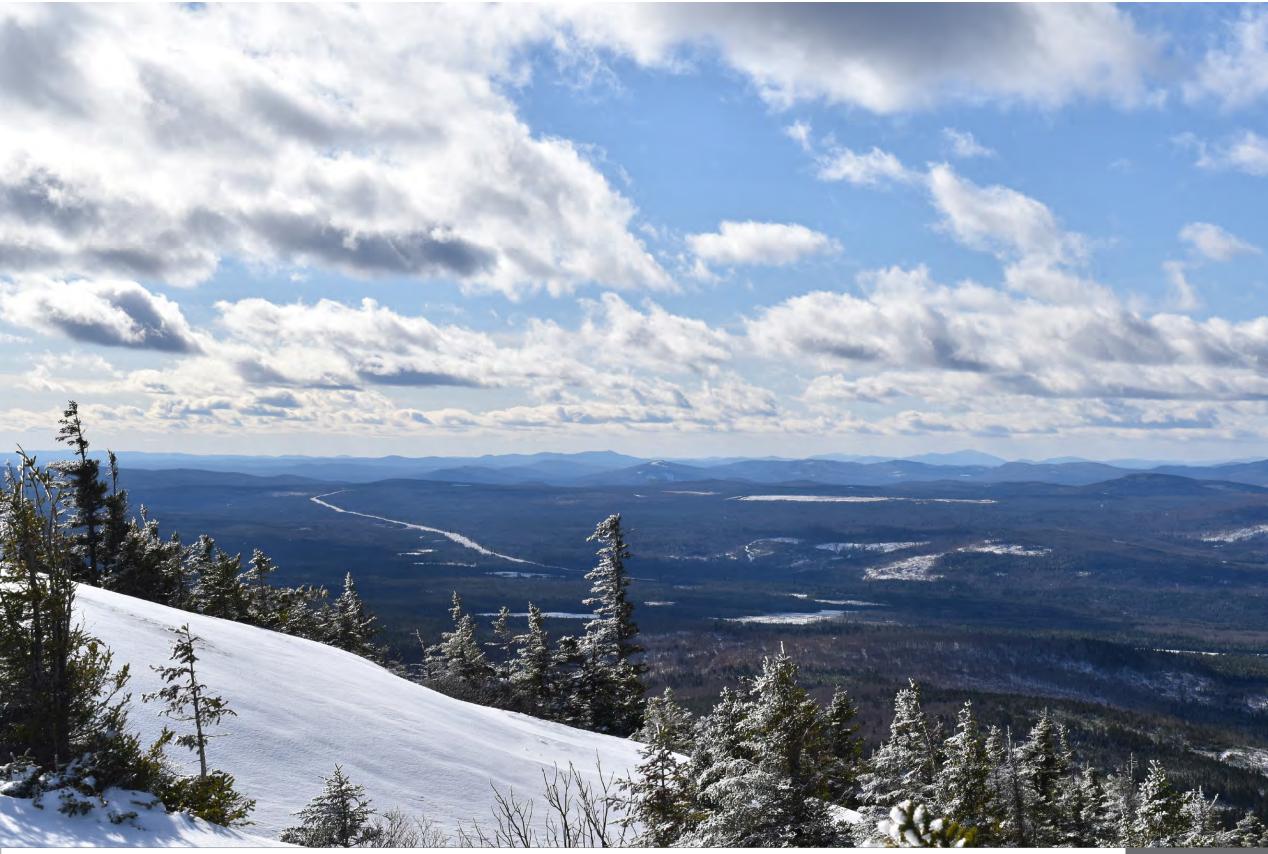
PHOTOSIMULATION 51A: BALD MOUNTAIN - Southwest, Bald Mountain Twp T2 R3

Proposed Conditions: Normal view looking southwest toward the existing 115 kV transmission line from the summit of Bald Mountain in Bald Mountain Twp T2 R3. The proposed structures, conductors, and cleared corridor visible in this direction are beyond 3 miles of this viewpoint.

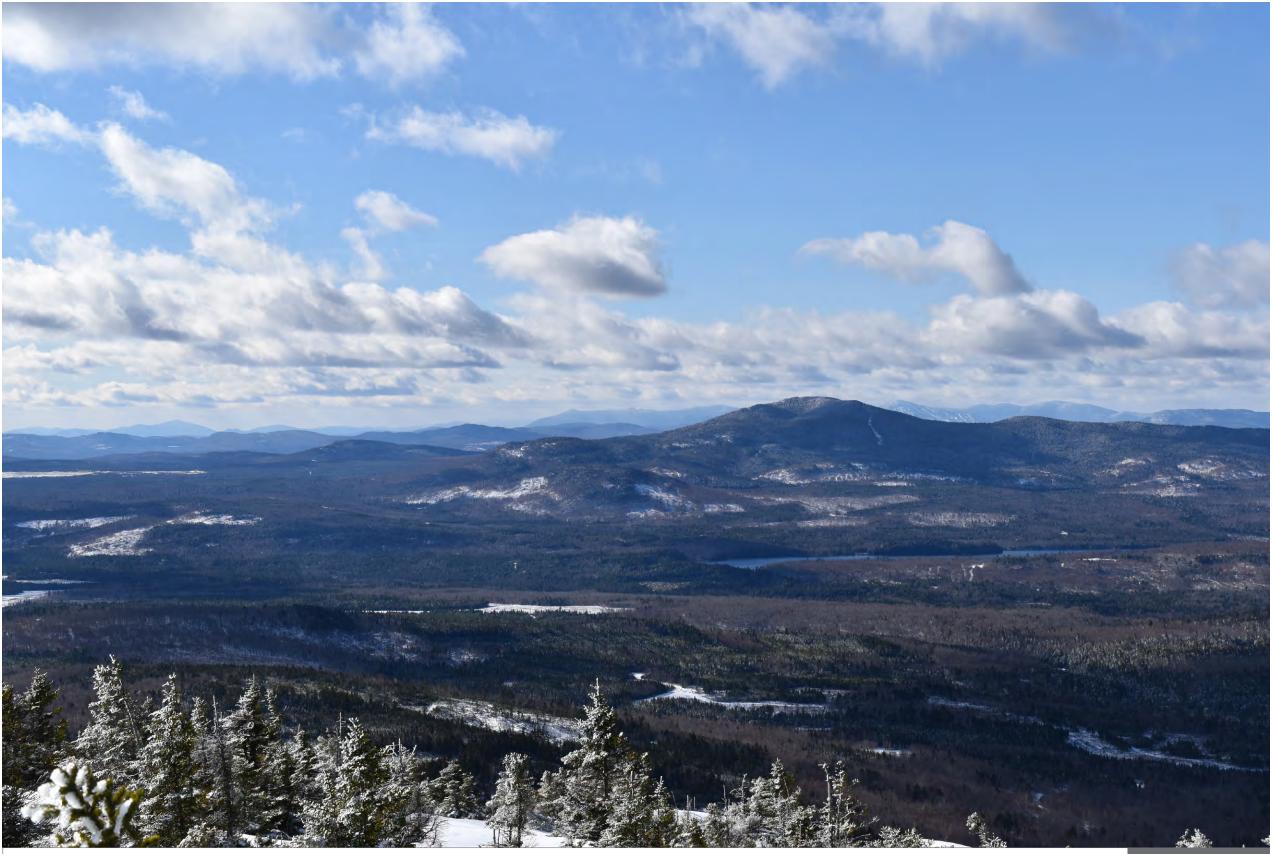
EXISTING CONDITIONS 51B: BALD MOUNTAIN - Southwest, Bald Mountain Twp T2 R3

Existing Conditions: Normal view looking southwest toward the existing 115 kV transmission line from the summit of Bald Mountain, in Bald Mountain Twp T2 R3. Moxie Mountain is visible in on the right side of the image. Baker Pond is visible below Moxie Mountain extending to the right of the image.

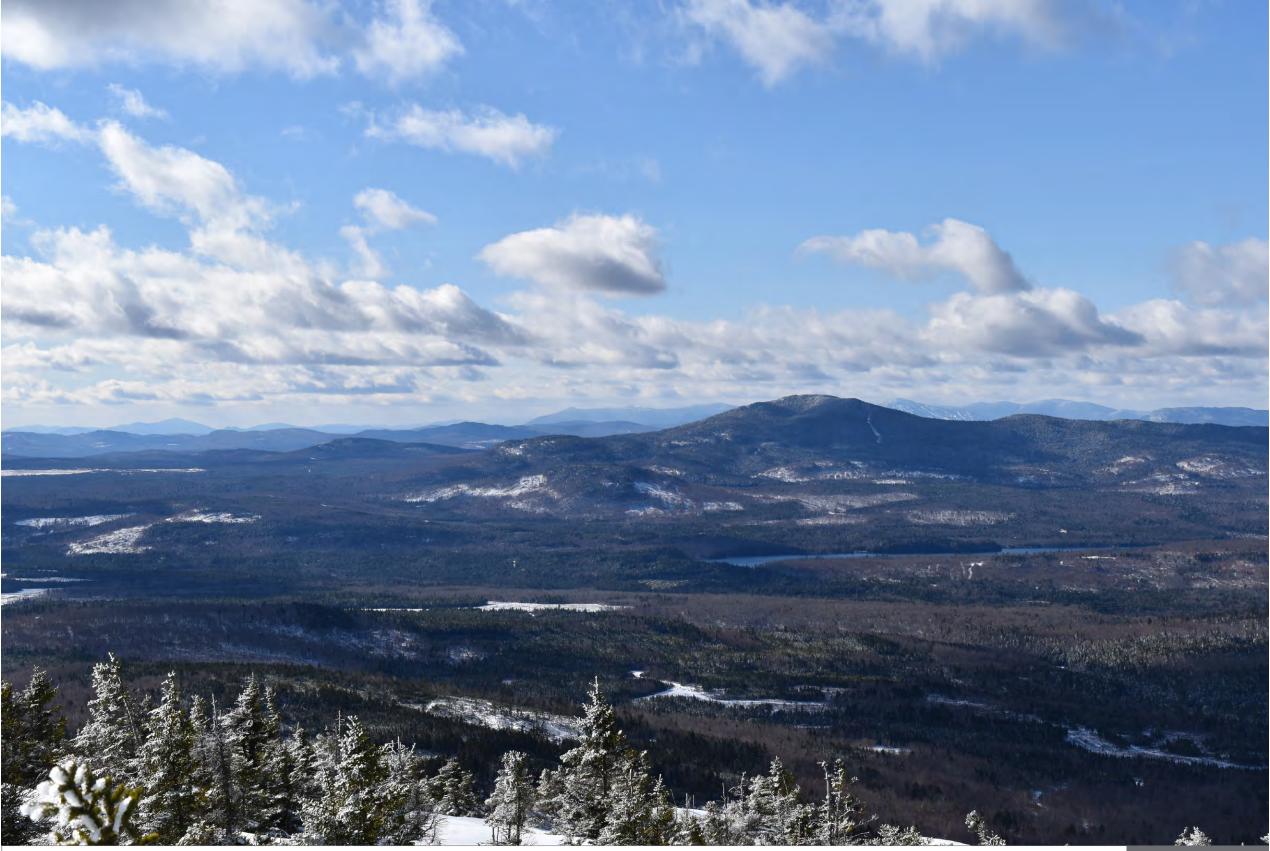
PHOTOSIMULATION 51B: BALD MOUNTAIN - Southwest, Bald Mountain Twp T2 R3

Proposed Conditions: Normal view looking southwest toward the proposed HVDC transmission line from the summit of Bald Mountain, in Bald Mountain Twp T2 R3. Four proposed HVDC structures would be visible within 3 miles of this viewpoint.

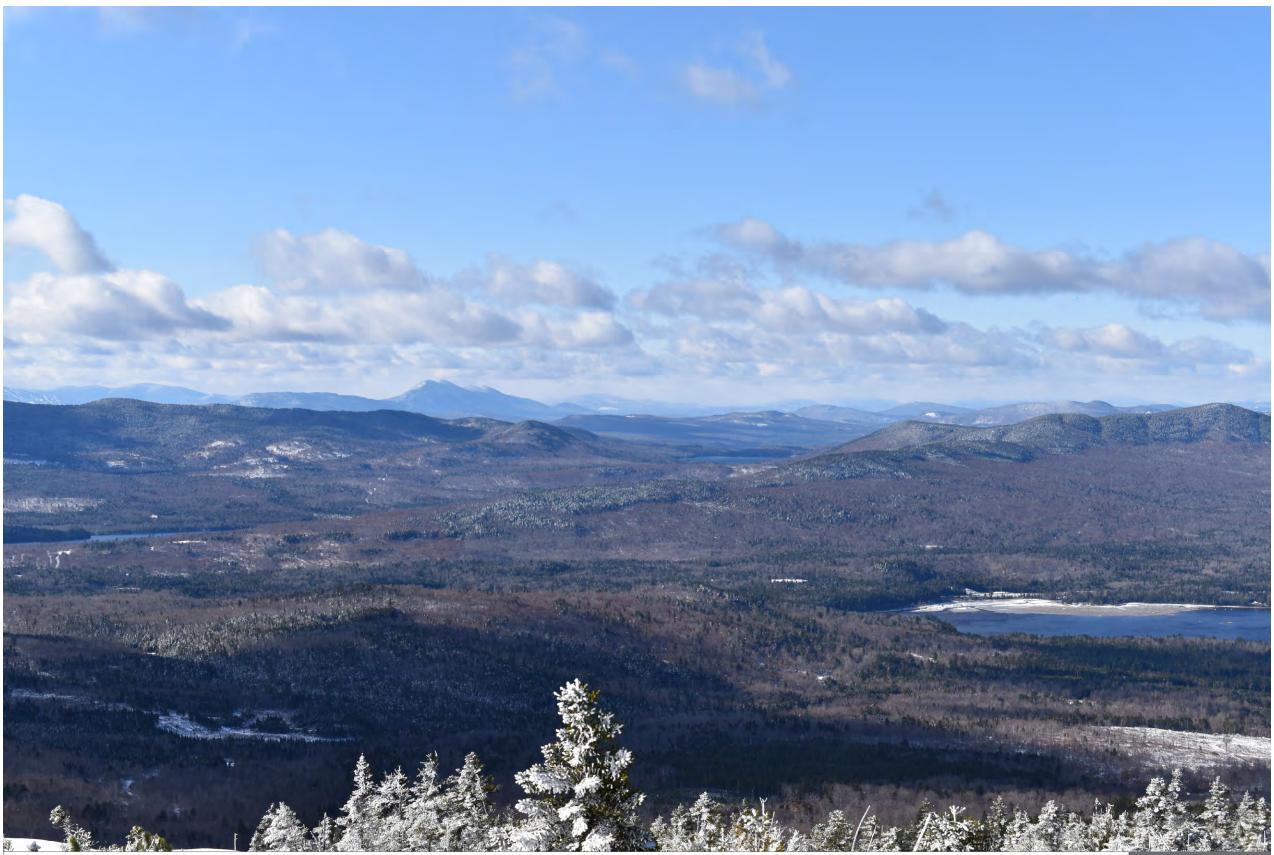
EXISTING CONDITIONS 51C: BALD MOUNTAIN - Southwest, Bald Mountain Twp T2 R3

Existing Conditions: Normal view looking west toward the existing 115 kV transmission line from the summit of Bald Mountain, in Bald Mountain Twp T2 R3. Pleasant Pond Mountain is visible on the right side of the image.

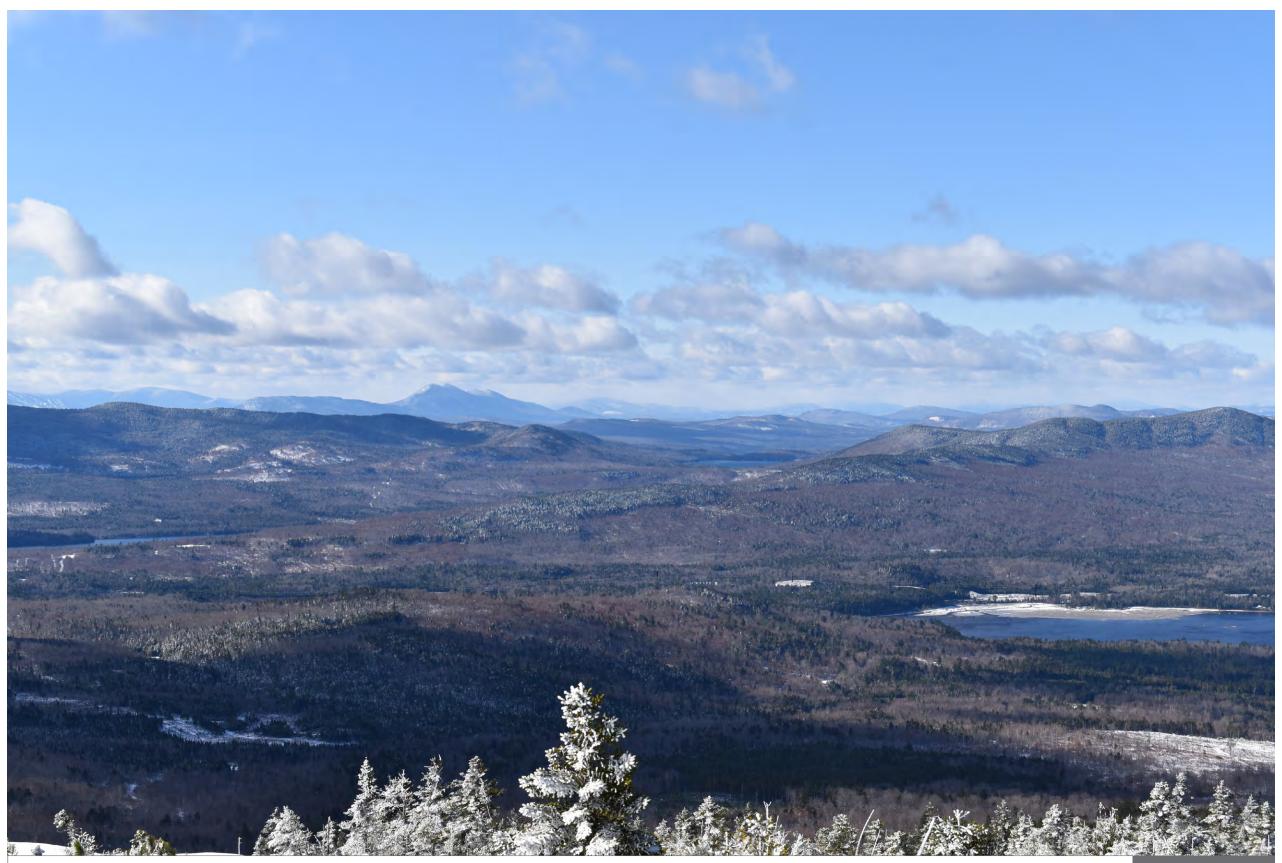
PHOTOSIMULATION 5 IC: BALD MOUNTAIN - Southwest, Bald Mountain Twp T2 R3

Proposed Conditions: Normal view looking west toward the proposed HVDC transmission line from the summit of Bald Mountain, in Bald Mountain Twp T2 R3. Ten proposed HVDC structures and conductors would be visible within 3 miles of this viewpoint.

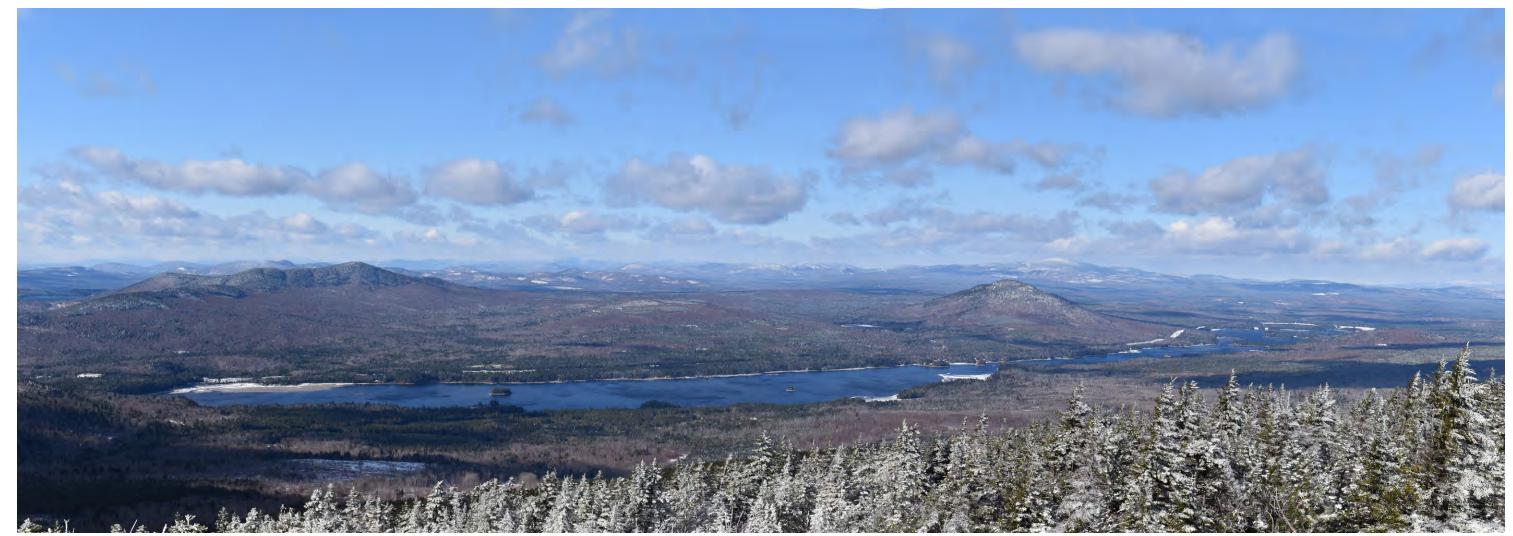
PHOTOSIMULATION 52: BALD MOUNTAIN - Northwest, Bald Mountain Twp T2 R3

Proposed Conditions: Continued panoramic view (from Photosimulation 51) looking from west to north toward the location of proposed co-located HVDC transmission line, from the summit of Bald Mountain on the Appalachian Trail in Bald Mountain TWP T2 R3. Approximately 800 ft of the AT on Bald Mountain will have project views. Moxie Mountain is visible in the center of the image. Moxie Pond is visible on the right side of the image. A total of seven proposed HVDC structures would be visible within 3 miles of this viewpoint on the far side of Moxie Pond.

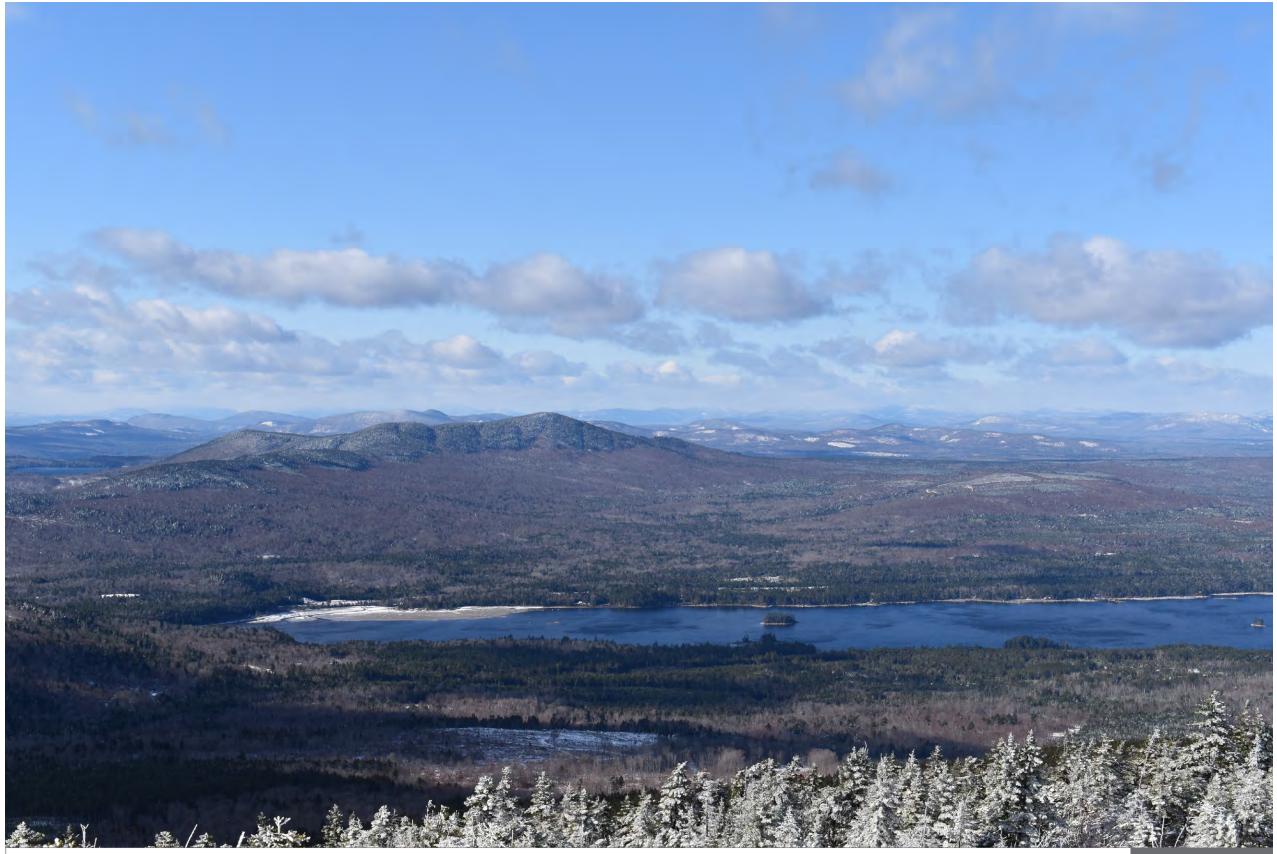
EXISTING CONDITIONS 52A: BALD MOUNTAIN - Northwest, Bald Mountain Twp T2 R3

Existing Conditions: Normal view looking west from the summit of Bald Mountain in Bald Mountain Twp T2 R3 toward the existing 115 kV transmission line on the West side of Moxie Pond. Pleasant Pond Mountain is visible in the center of the image.

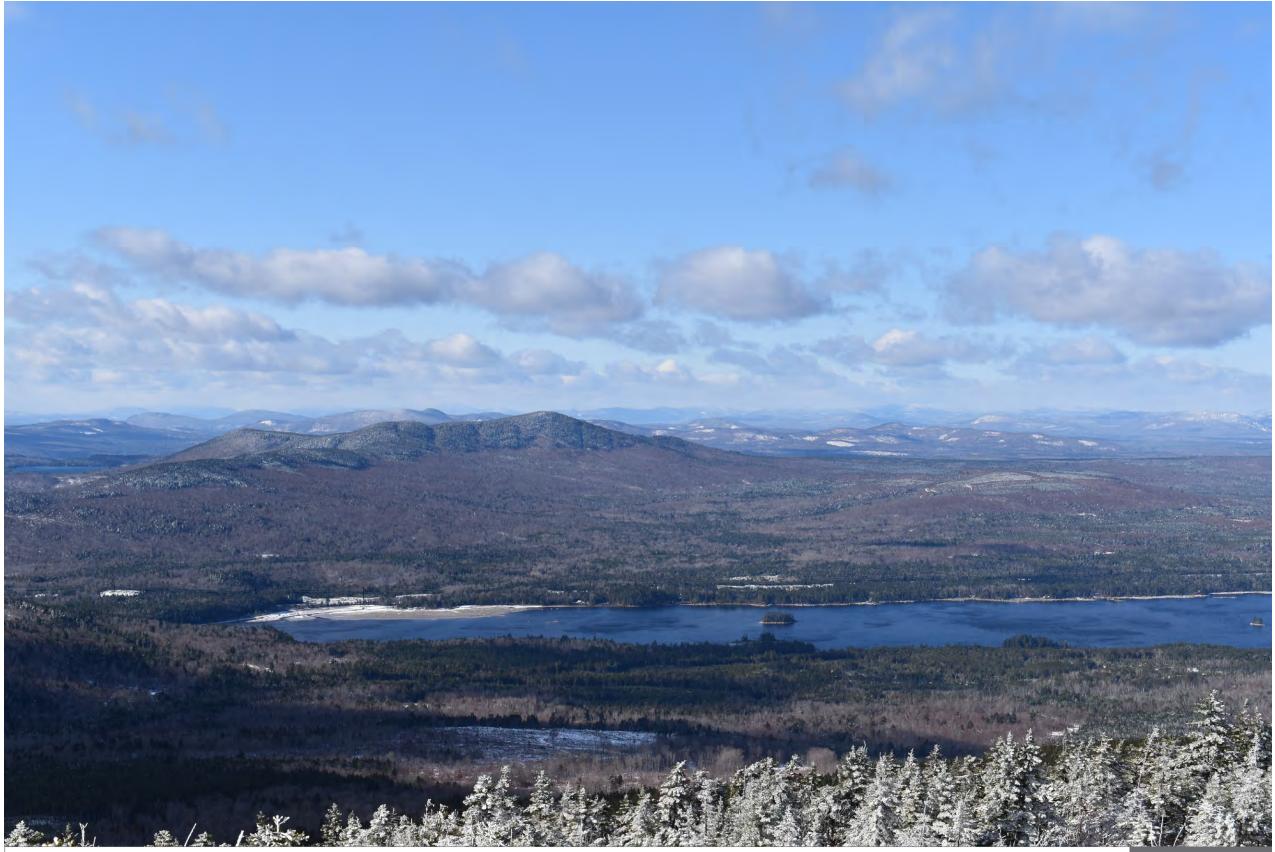
PHOTOSIMULATION 52A: BALD MOUNTAIN - Northwest, Bald Mountain Twp T2 R3

Proposed Conditions: Normal view looking west toward the proposed HVDC transmission line from the summit of Bald Mountain, in Bald Mountain Twp T2 R3. Seven proposed HVDC structures, conductors, and portions of the cleared corridor would be visible from within 3 miles of this viewpoint.

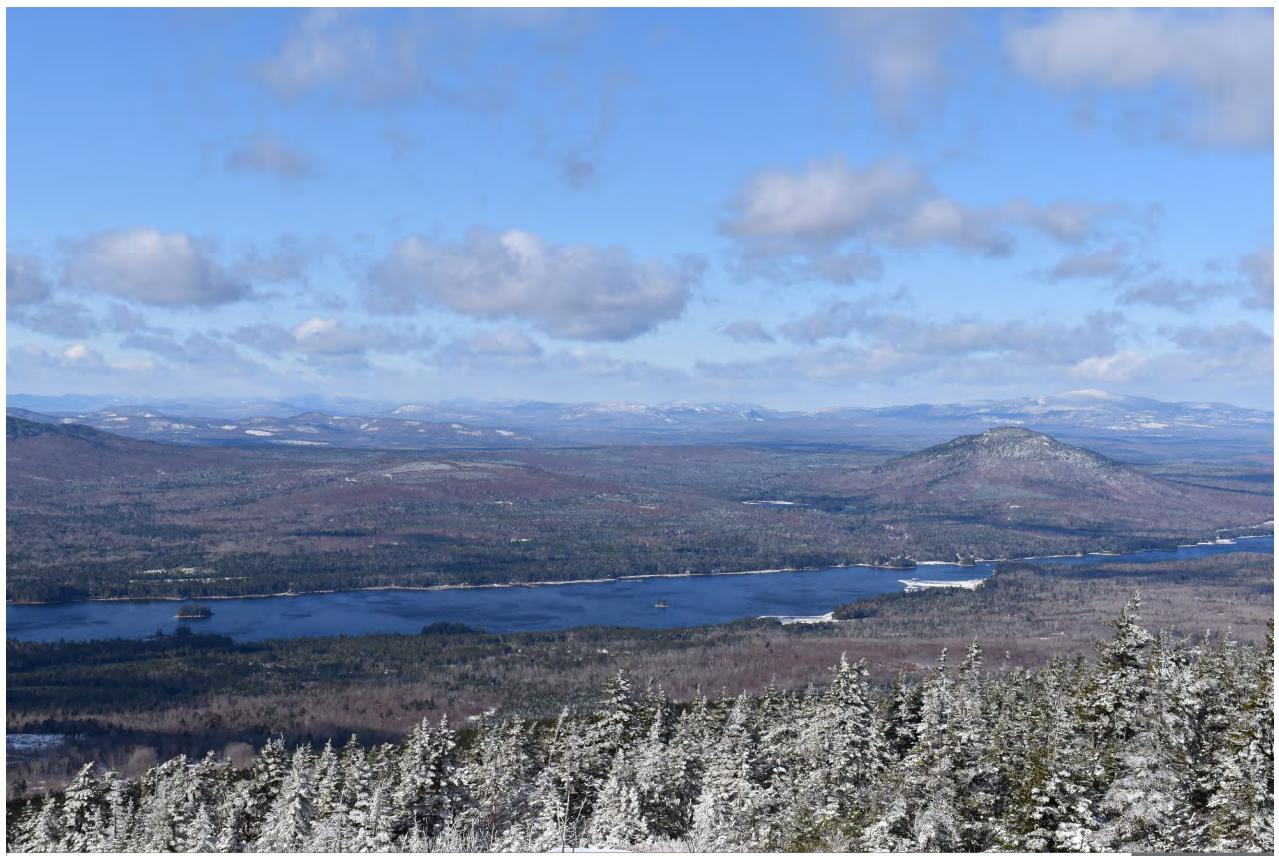
EXISTING CONDITIONS 52B: BALD MOUNTAIN - Northwest, Bald Mountain Twp T2 R3

Existing Conditions: Normal view looking northwest from the summit of Bald Mountain in Bald Mountain Twp T2 R3 toward the existing 115 kV transmission line on the west side of Moxie Pond. Mosquito Mountain is visible on the right side of the image.

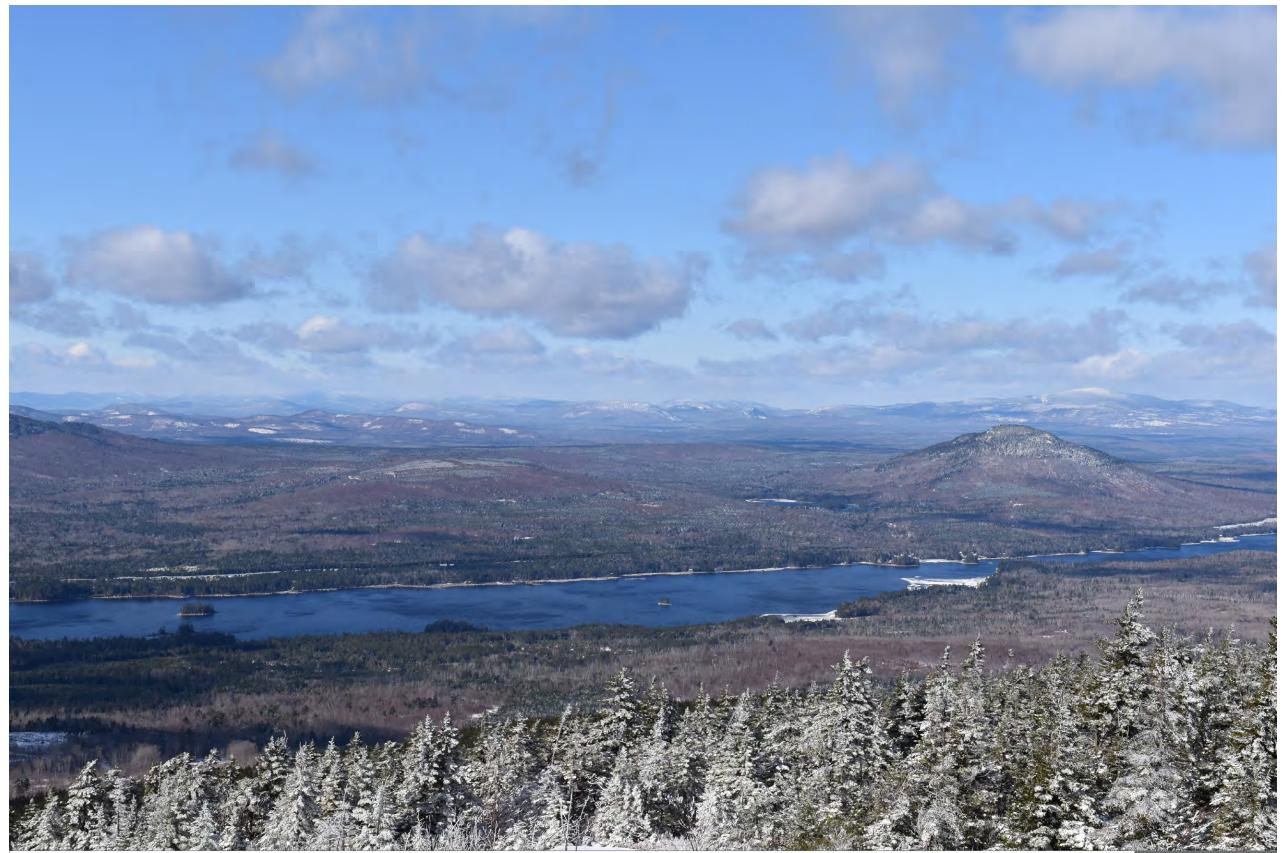
PHOTOSIMULATION 52B: BALD MOUNTAIN - Northwest, Bald Mountain Twp T2 R3

Proposed Conditions: Normal view looking northwest from the summit of Bald Mountain in Bald Mountain Twp T2 R3 toward the proposed HVDC transmission line. Two proposed HVDC structures and conductors would be visible from within 3 miles of this viewpoint. The wider corridor will be more visible during leaf-off conditions.

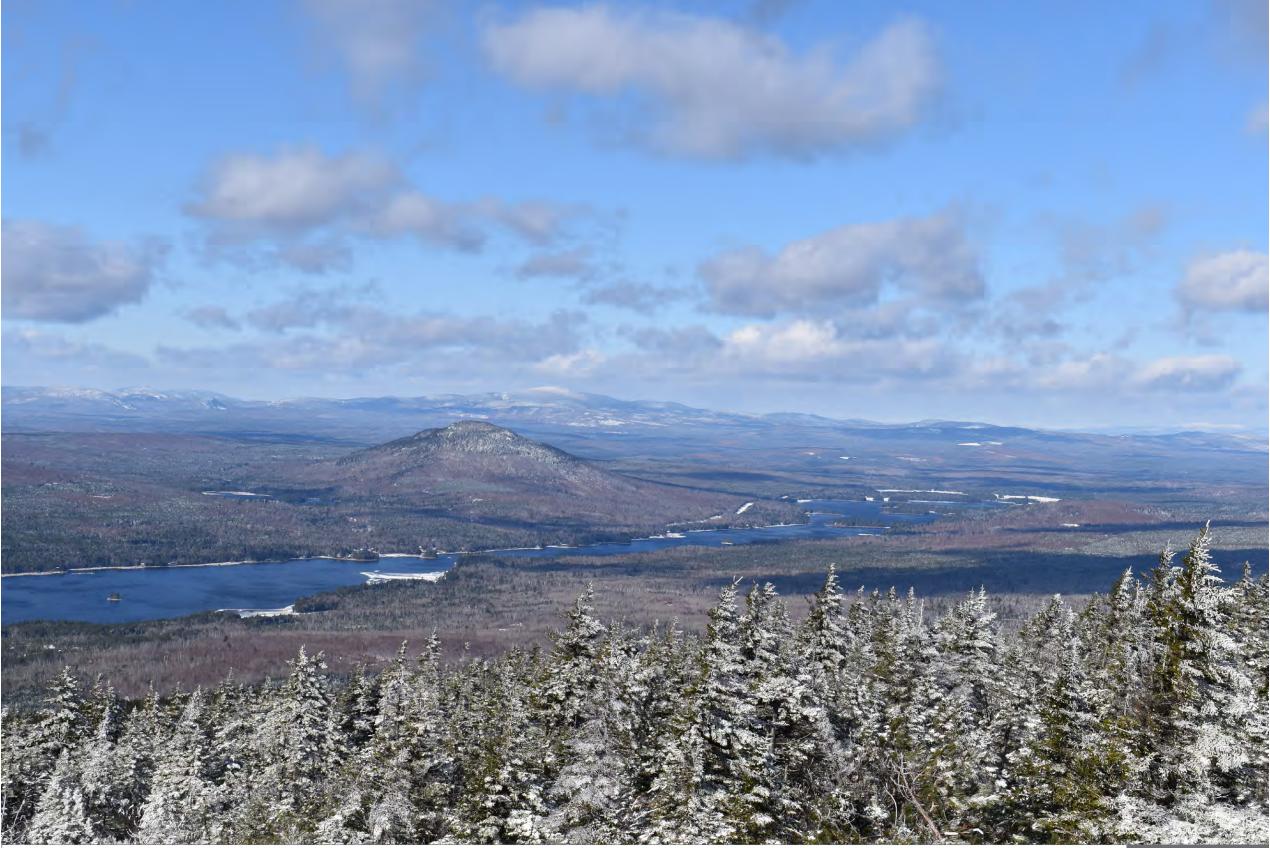
EXISTING CONDITIONS 52C: BALD MOUNTAIN - Northwest, Bald Mountain Twp T2 R3

Existing Conditions: Normal view looking northwest from the summit of Bald Mountain in Bald Mountain Twp T2 R3 toward the existing 115 kV transmission line. Mosquito Mountain is visible in the center of the image.

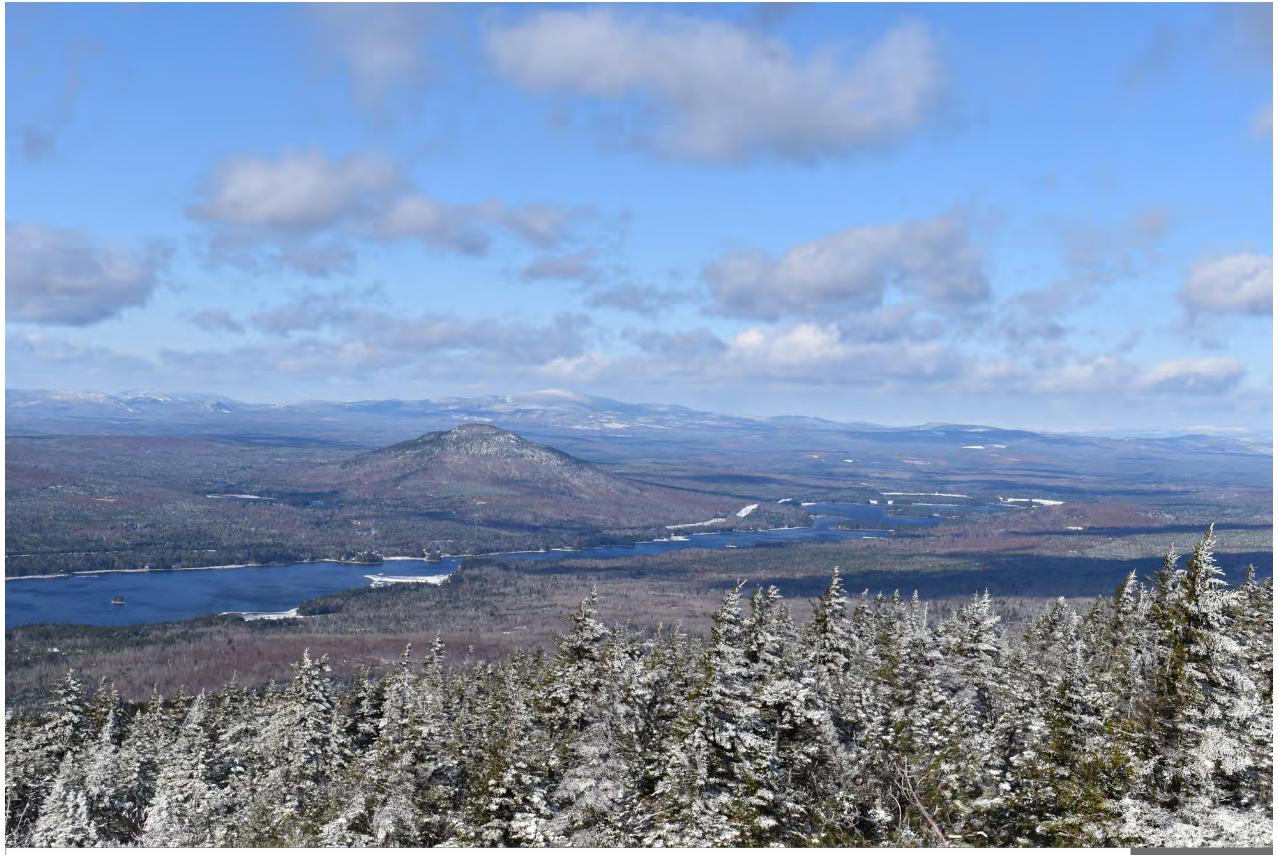
PHOTOSIMULATION 52C: BALD MOUNTAIN - Northwest, Bald Mountain Twp T2 R3

Proposed Conditions: Normal view looking northwest from the summit of Bald Mountain in Bald Mountain Twp T2 R3 toward the proposed HVDC transmission line. The proposed structures and conductors that would be visible are beyond 3 miles of this viewpoint.

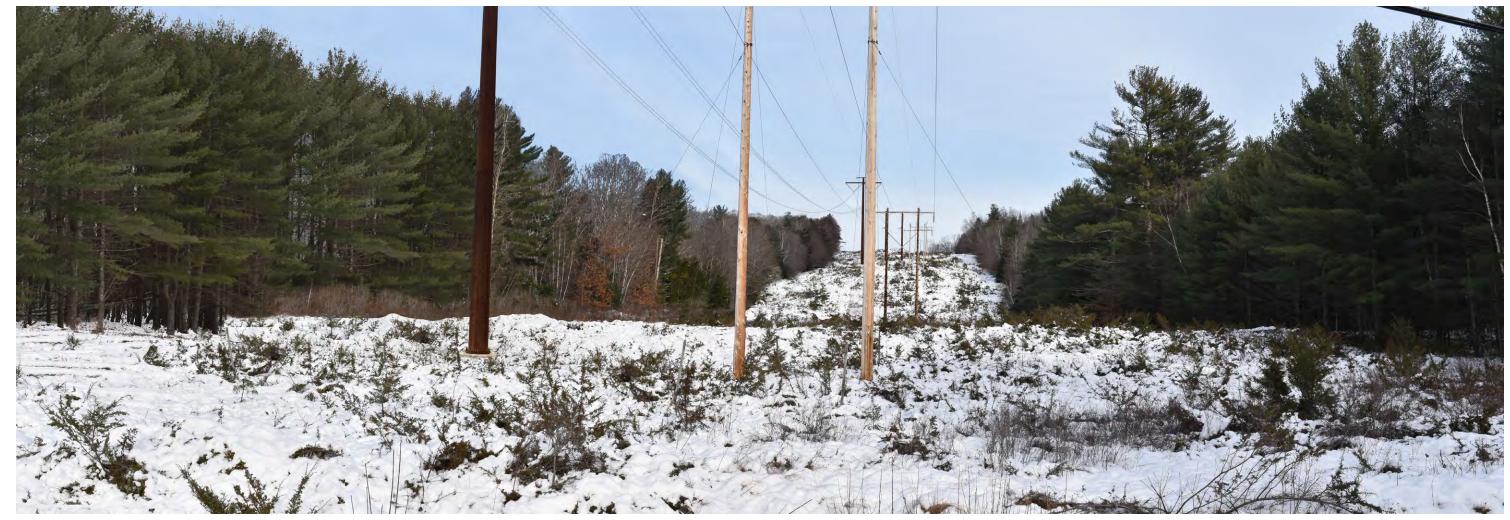
PHOTOSIMULATION 53: ROUTE 201, Moscow

Proposed Conditions: Panoramic view looking from north to east from Route 201 in Moscow toward the proposed co-located HVDC transmission line. The existing 225 ft wide corridor clearing will be widened by 75 ft on the western side (left of corridor in image) to accommodate the proposed transmission line. Three structures will be visible from this viewpoint.

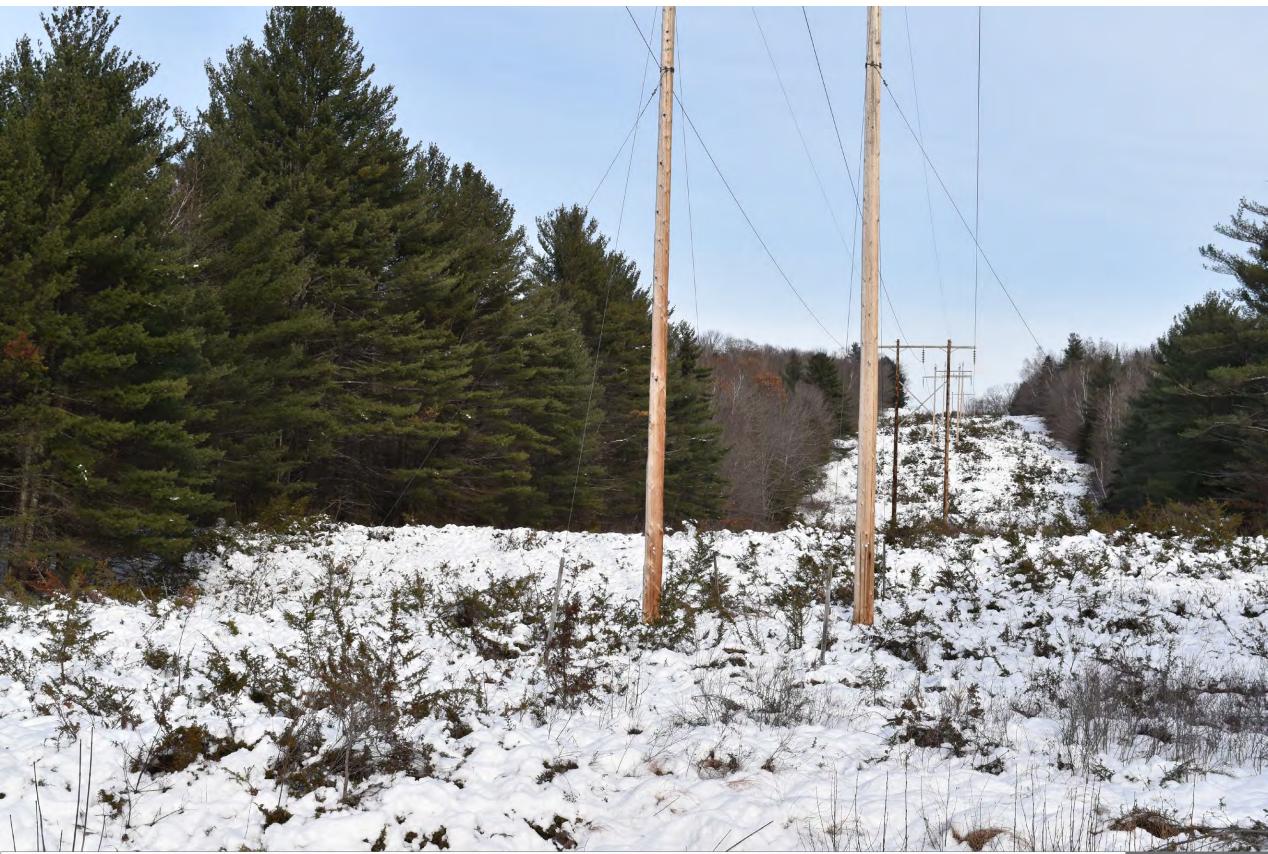
EXISTING CONDITIONS 53A: ROUTE 201, Moscow

Existing Conditions: Normal view looking northeast toward the existing 115 kV transmission line corridor from Route 201 in Moscow.

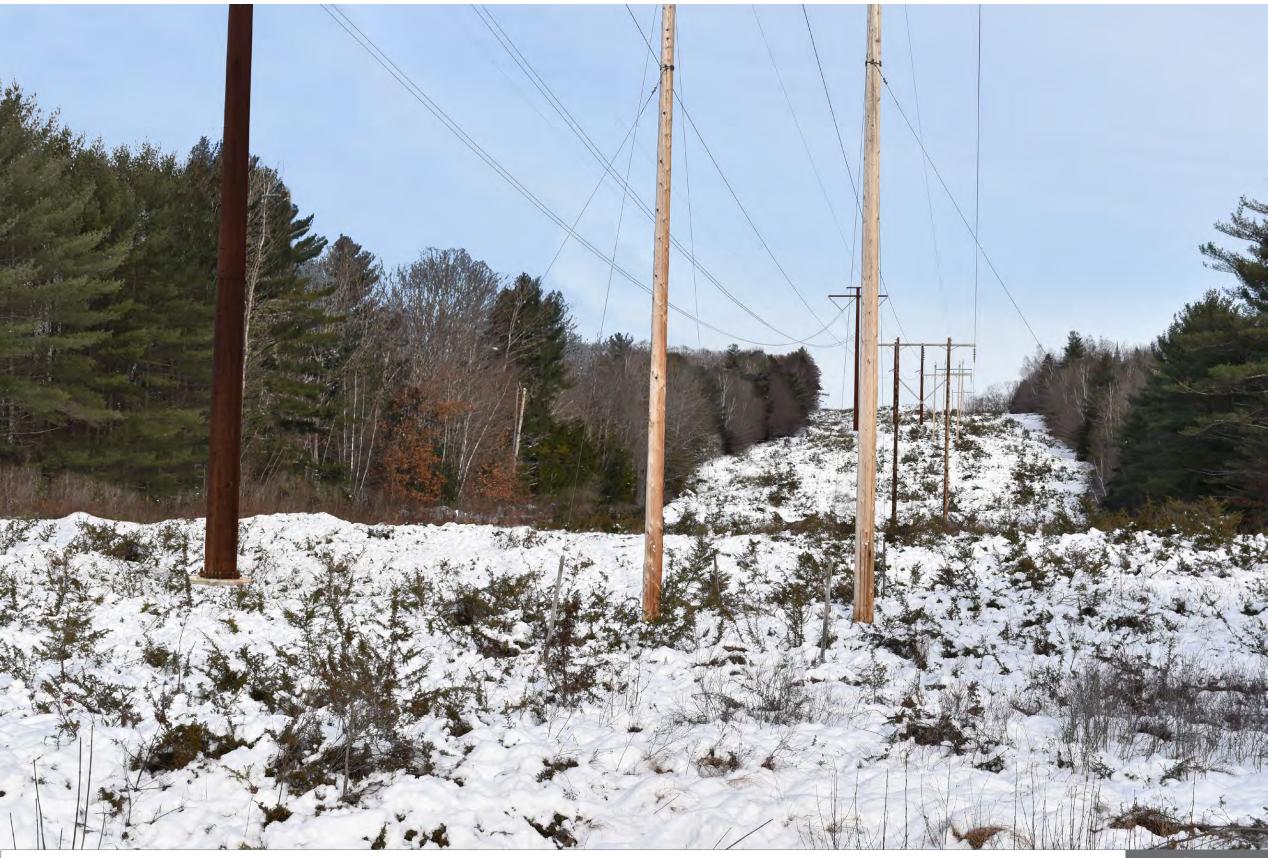
PHOTOSIMULATION 53A: ROUTE 201, Moscow

Proposed Conditions: Normal view looking northeast toward the proposed co-located HVDC transmission line from Route 201 in Moscow. The existing 225 ft wide corridor clearing will be widened by 75 ft on the western side (left of corridor in image) to accommodate the proposed HVDC transmission line. Three structures will be visible from this viewpoint.
