Frenchman Bay Forest Hancock

Site Visit Summary Maine Natural Areas Program, 2019

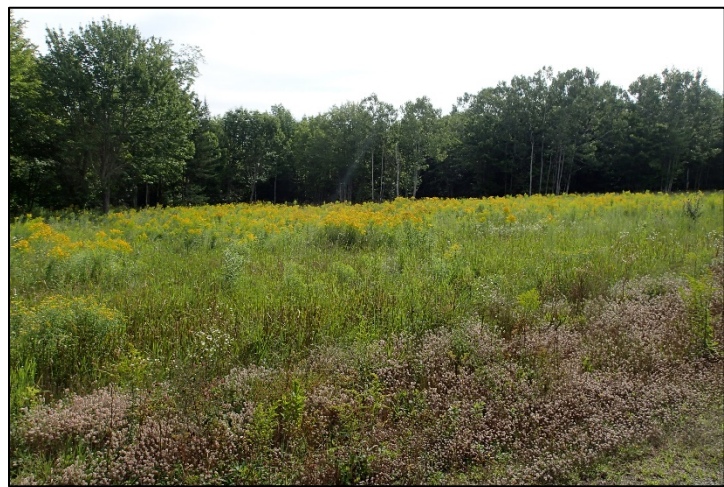
The logging roads, old log landings, and other associated clearings remain. The cleared, roadside areas that remain open are now grown into flowering herbs and graminoids (and ubiquitous rabbit-foot clover, *Trifolium arvense*) that at the time of the site visit were abundant with insect, small mammal, and amphibian activity. Based on these limited observations it appears that these early successional fields and meadows currently provide excellent native forage for pollinating insects and cover and habitat for vertebrates.

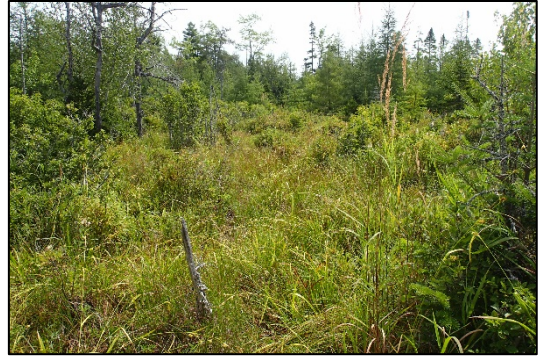
In the southern end of the parcel a core of scrub-shrub wetland is located within a surrounding area of red maple swamp. Here the organic soils support a range of peatland-associated shrubs, primarily rhodora (*Rhododendron canadense*), mountain holly (*Ilex mucronata*), sheep

laurel (*Kalmia angustifolia*), and withe-rod (*Viburnum nudum*). Other associated species include leatherleaf (*Chamaedaphne calyculata*) and lowbush blueberry (*Vaccinium angustifolium*). Field observations (cut stumps) and images from 15-year old aerial photos indicate that timber was removed from this area of wetland. Notably this location was mapped by NWI as “forested” but currently it is scrub-shrub and may remain in that state for some time due to the heavy shrub regeneration and difficult growing conditions.

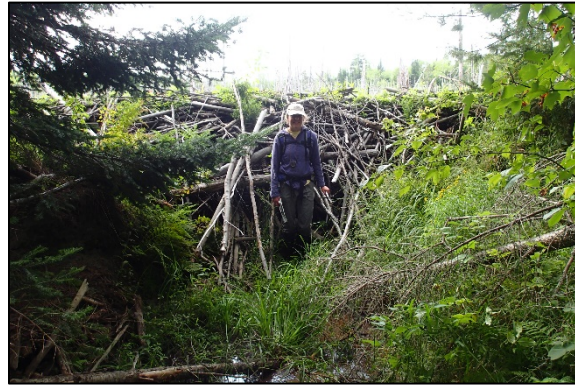
There are extensive networks of emergent wetlands across the property, almost entirely due to beaver activity. Other emergent wetlands are those located along the flat, low gradient floodplains of the two streams on the property. Based on aerial photos it appears that beaver most recently moved onto the property around 2005, after which time a series of wetlands with 3 or 4 terraced dams, side channels, and lodges transformed what would have been forested at that time.

Dam, that's big.

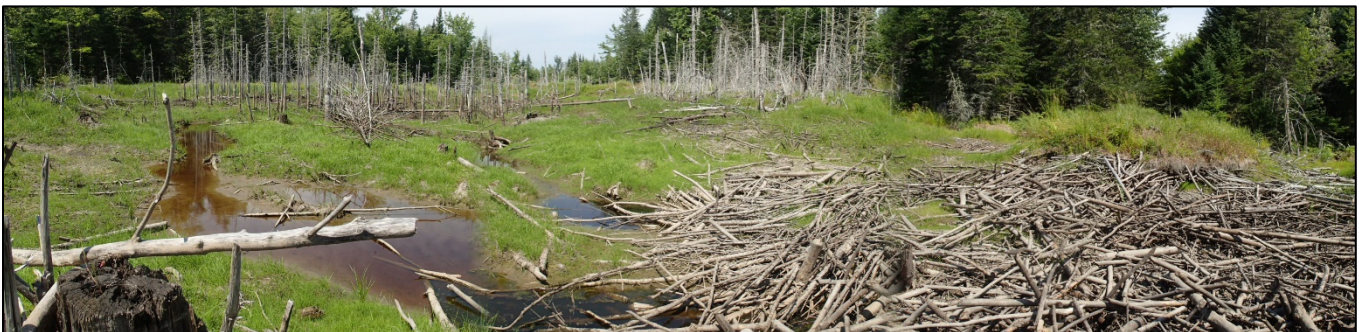
One of a series of beaver wetlands, this one recently dewatered.

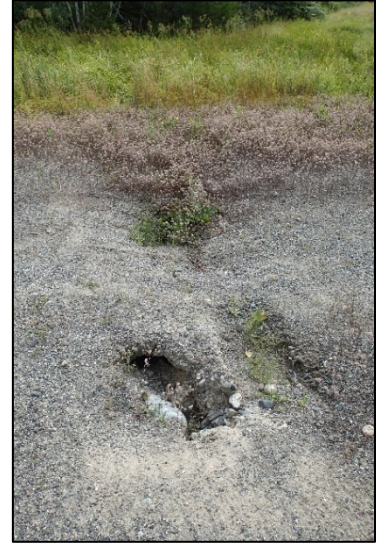
- 1) In the southeast portion of the property the road runs northeast-southwest and crosses an area mapped as forested wetland. There is a culvert beneath the road from a log landing toward the forested wetland, but the road has collapsed on top, and water is backed up onto the road. The culvert appears to be 18" wide with some channelization of a stream and there is a fan of sediment that has washed from the road into the wetland.

If this section of road is no longer needed, this stretch could be considered for restoration. The road bed should be further evaluated to verify hydric soils beneath what is assumed to be road fill. If verified, fill removal and soil stabilization would in that case support the restoration of wetland vegetation and hydrology. At a minimum the two culverts could be removed, and slopes pulled back and stabilized to avoid further sedimentation into the wetland and prevent blockage of water movement.

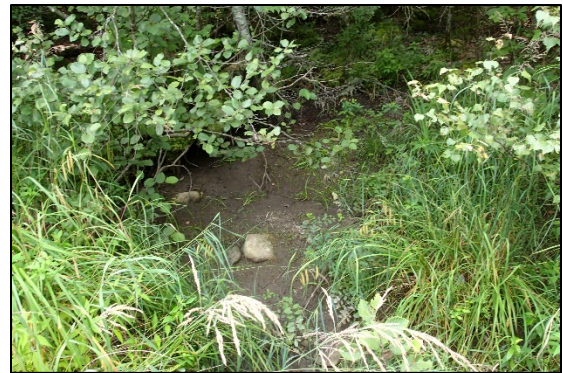
- 2) Approximately 800' to the southwest a second culvert was located. This one also has erosion and road collapse, the culvert is hung, and sediment has washed into the wetland.

Sedimentation into wetland at outlet of culvert.

Both of these culvert locations are associated with forested wetland that borders both sides of the road (or in one case a cleared landing that appears to have hydric soils and vegetation). The road is approximately 20' wide and spans up to 800 feet through this wetland and between the culverts. Although it appears some soil disturbance, or even removal, may have occurred in association with recent logging activities along the roadside, the area adjacent to and under the road is mapped as hydric soils and may have been part of the original wetland area.
