Figure 3
Sheet 29 of 58
Aquatic Resource Survey Results
Western Maine Renewable Energy Project

Appendix D
Western Maine Renewable Energy Project
Representative Site Photographs

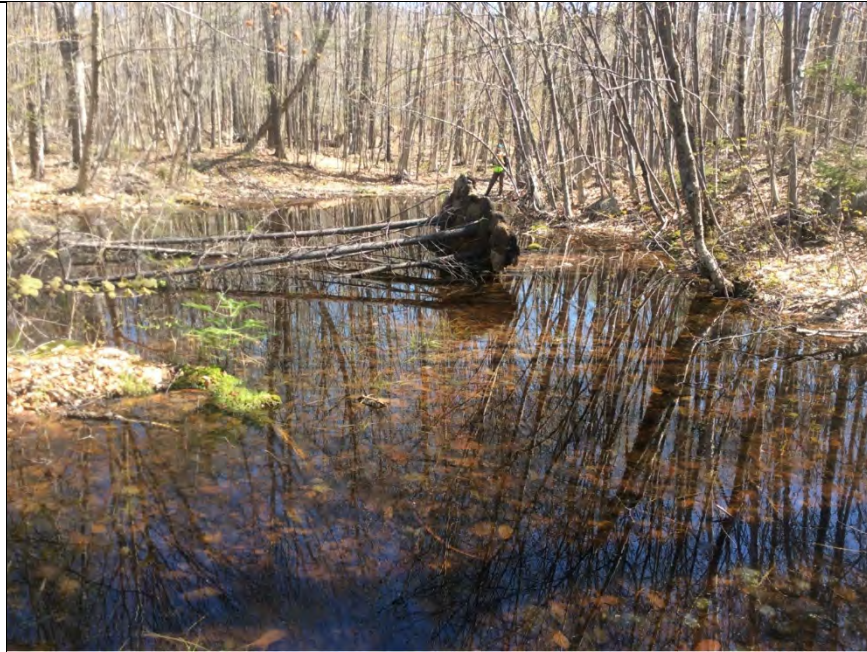
Photo: 02

Description: Vernal pool VP19CP, a significant vernal pool. Photo depicts spotted salamander (*Ambystoma maculatum*) egg masses observed in the pool.

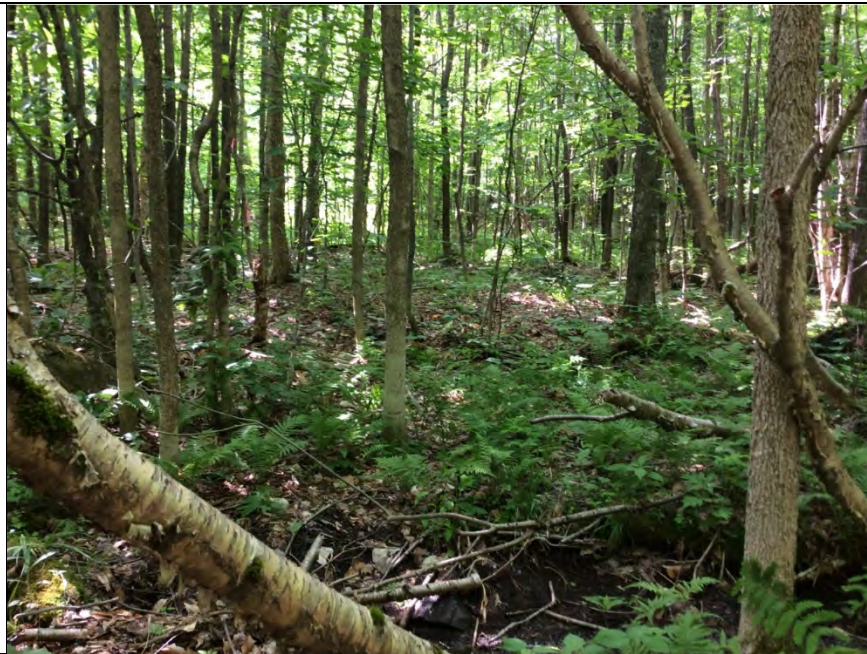
Photo: 06

Description: Wetland W08EI; typical forested wetland with shallow soils to bedrock. Dark organic soils with depleted matrix 2–6 inches above rock ledge.

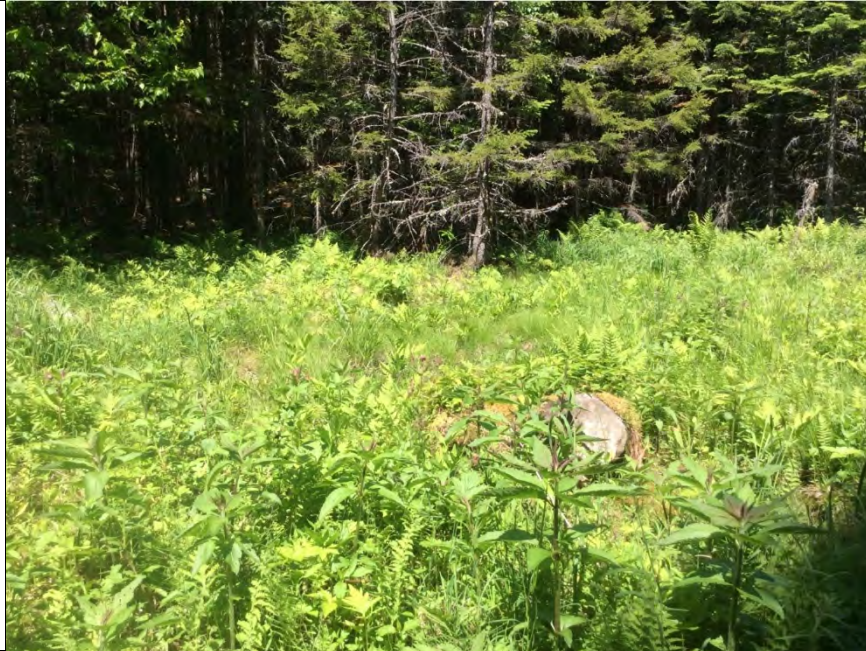
Photo: 10

Description: Wetland W30EI; seepy wetland on hillslope shallow, dark organic muck over ledge/rock material; disturbed from timber harvest activities.

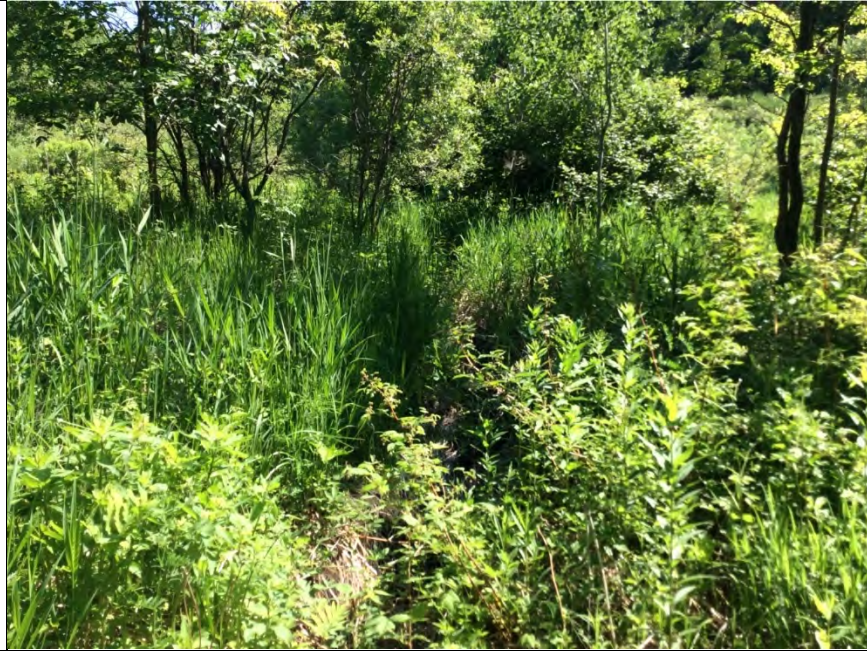
Photo: 12

Description: Wetland
W43EI; forested isolated
depression.

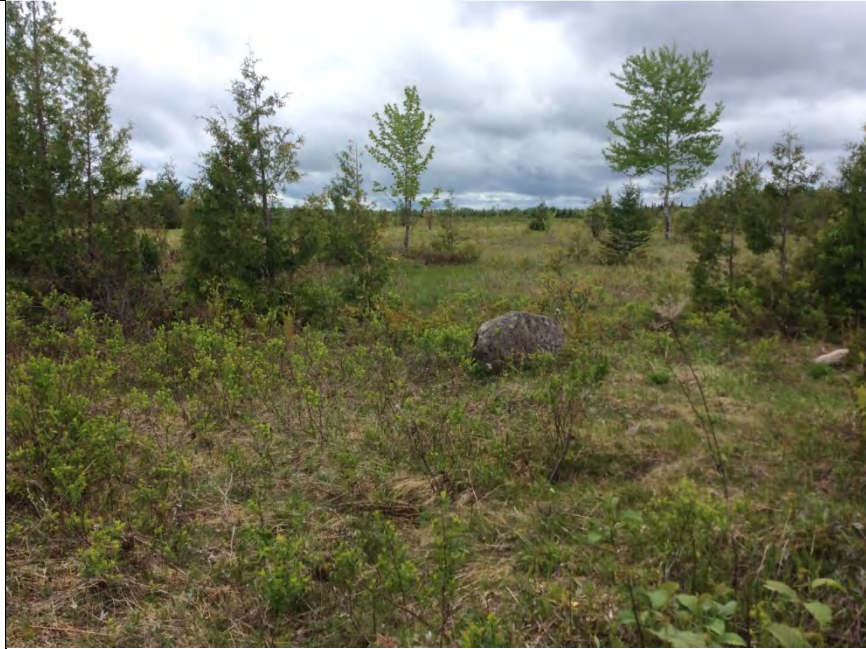
Photo: 14

Description: Wetland W06KN continues off-Site and contains a watercourse that flows into Chase Pond.

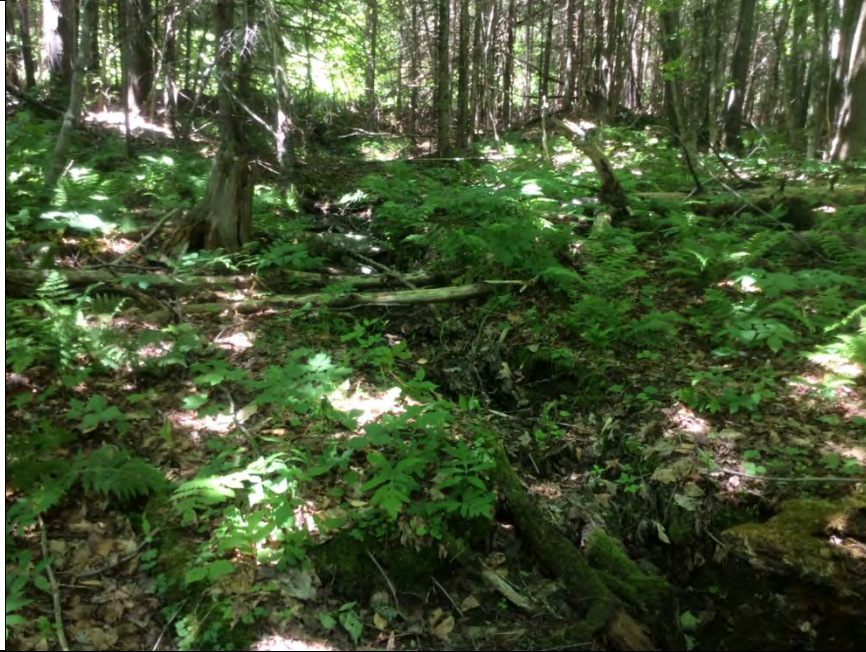
Photo: 16

Description: Intermittent watercourse S32EI; crosses the Study Area. Ephemeral watercourse S33EI is a tributary to this watercourse, and both flow through wetland W59EI.

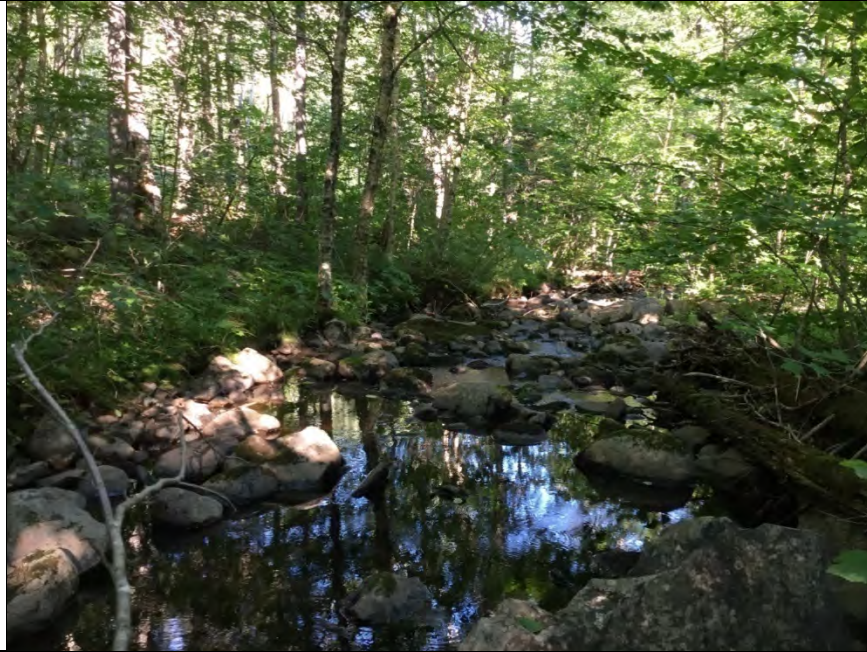
Photo: 18

Description: Watercourse S51E1 (Bassett Brook); Photo of the approximately 7-foot culvert outlet with some damage.

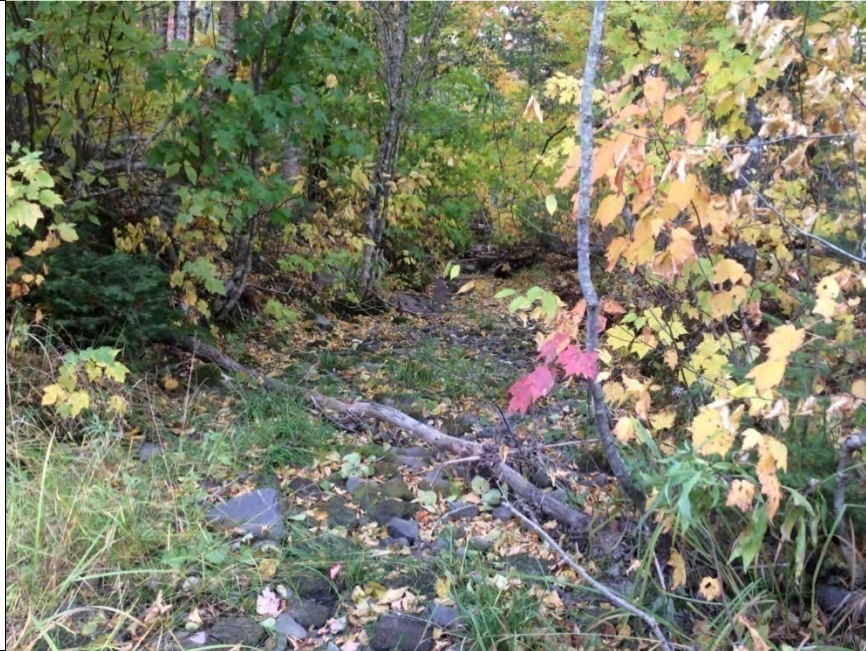
Photo: 20

Description: Watercourse S01KN flows south through a culvert in a road, towards Chase Pond.
