# TMDL Assessment Summary

# Whitney Brook Watershed Description

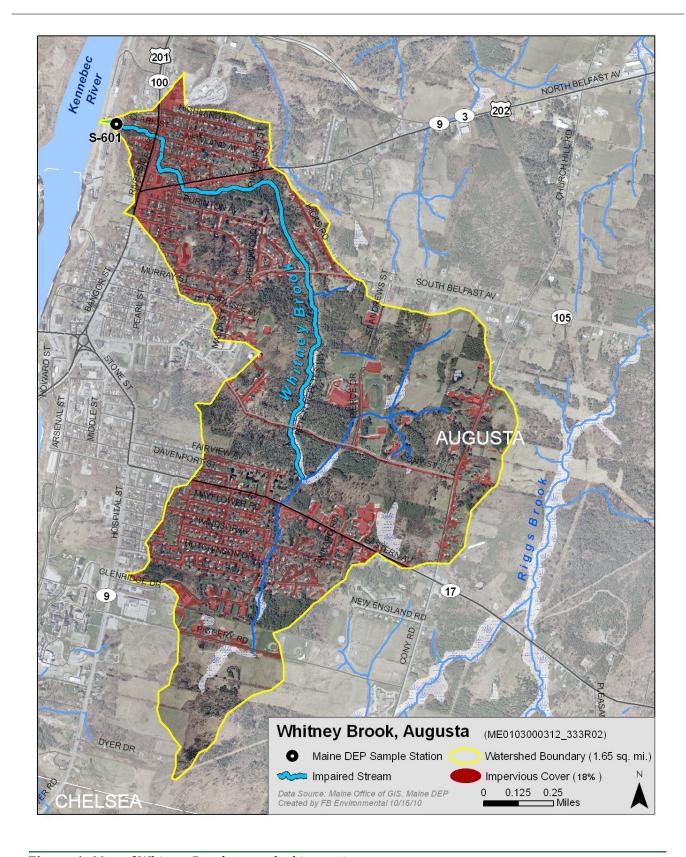
**Figure 1:** Map of Whitney Brook watershed impervious cover.

The Impervious Cover Calculations are based on analysis of GIS coverage's presented in Figure 1. The impervious area is derived from 2007 1 meter satellite imagery and the watershed boundary is an estimation based on contours and digital elevation models.

linked to decreasing stream health (CWP, 2003). Because Whitney Brook's impairment is not caused by a single pollutant, %IC is used for this TMDL to represent the mix of pollutants and other impacts associated with excessive stormwater runoff. The Whitney Brook watershed has an impervious surface area of 18% (Figure 1). DEP has found that in order to support Class B aquatic life use, the Whitney
