Natural Resource Assessment Survey Results

To: Eric Ham, MaineDOT
From: Linda Rivard, Tetra Tech, Inc.
Subject: Natural Resource Assessment Survey Results for the Maine Department of Transportation Frank J. Wood Bridge (#2016) Project (WIN#22603.00)
Date: January 8, 2016

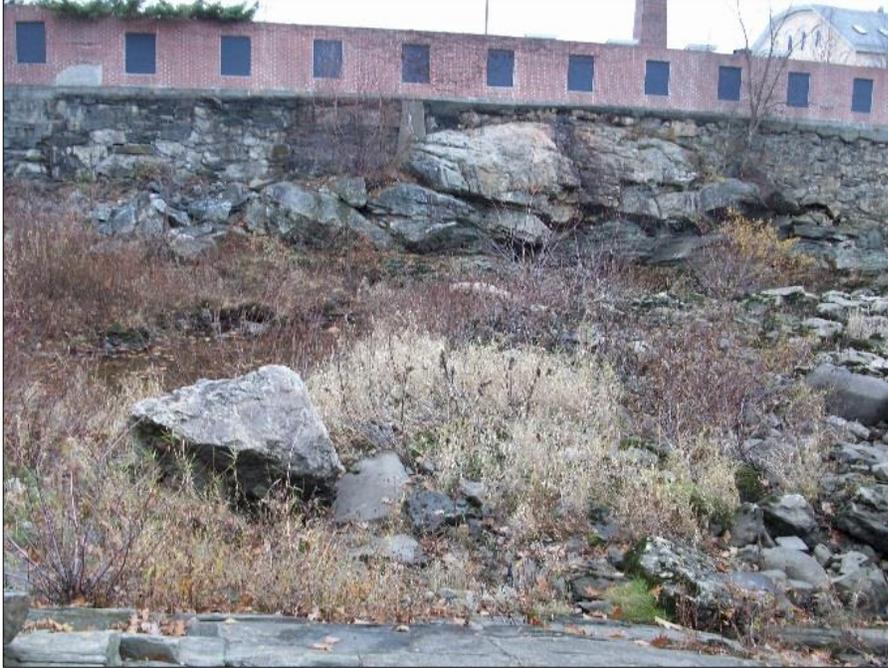
Figure 2. Facing east towards the retaining wall of the Seadog Brewing Company parking lot, standing on top of a small concrete dam with water overflow.

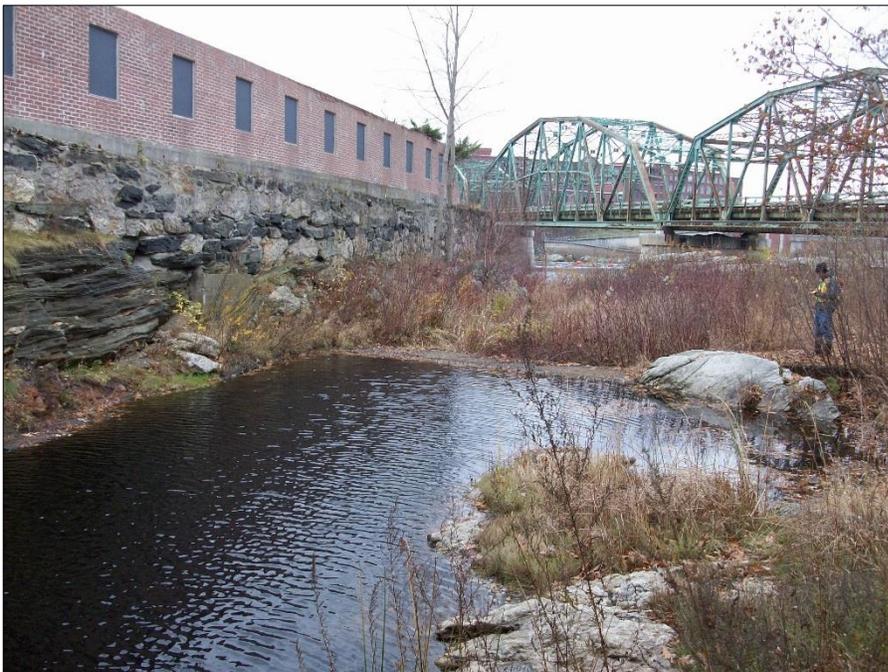
Figure 3. Drainage area (facing south) between Bowdoin Mill Island and Route 201/Main Street. The pool did not exhibit flow in November 2015.

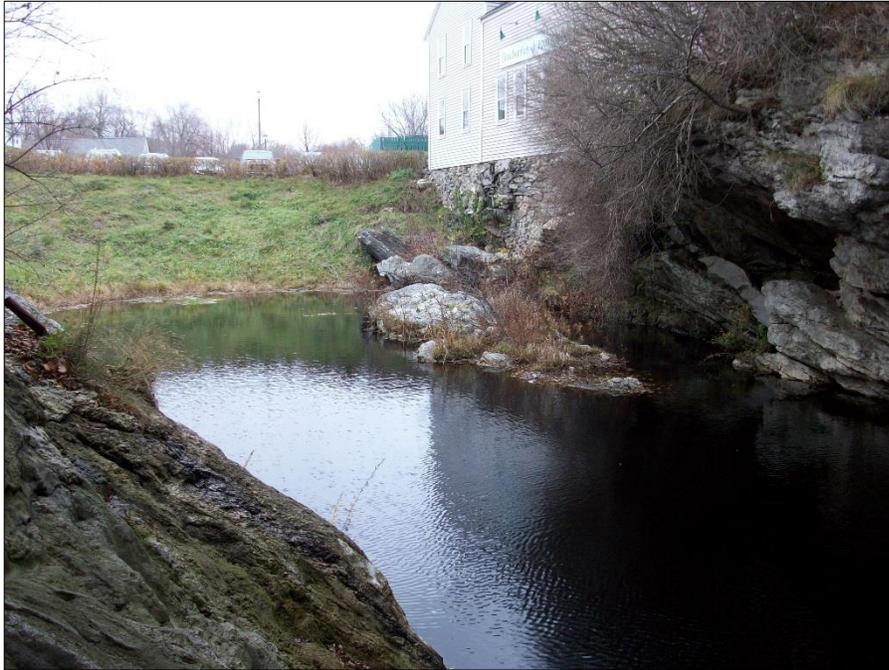
Figure 4. Additional view of drainage area (under bridge, facing north) between Bowdoin Mill Island and Route 201/Main Street.

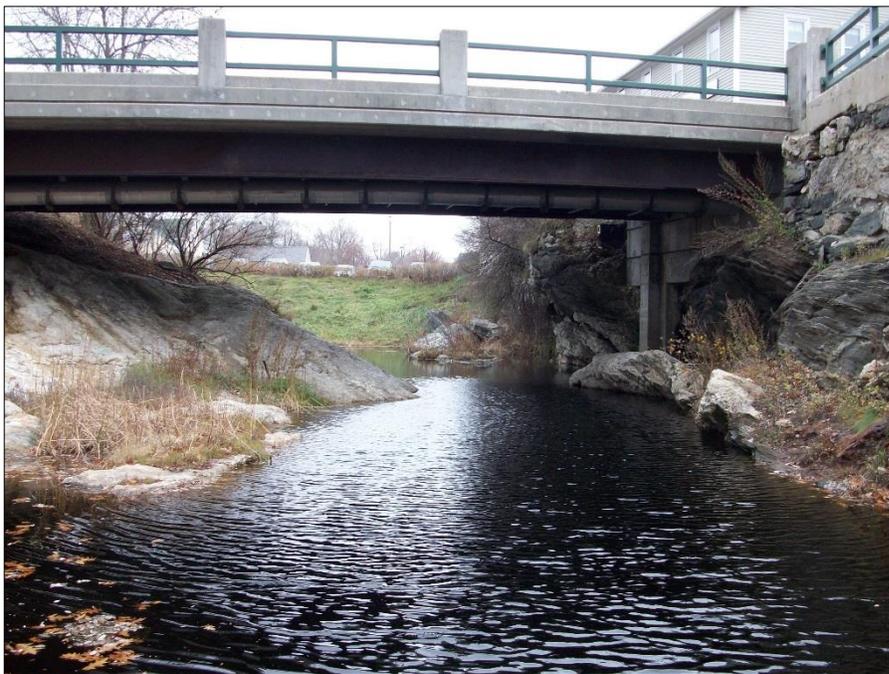
Figure 5. Additional view of drainage area (facing north) between Bowdoin Mill Island and Route 201/Main Street. This bridge provides access from Route 201/Main Street to Bowdoin Mill Island.

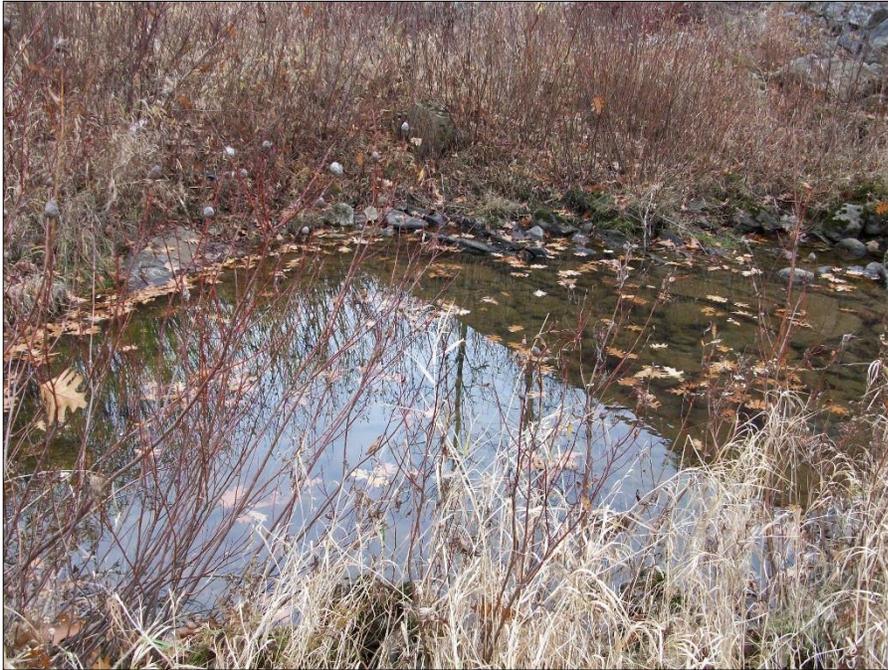
Figure 6. Small emergent wetland that is anecdotally known to be inundated with water from the Androscoggin River in the spring.

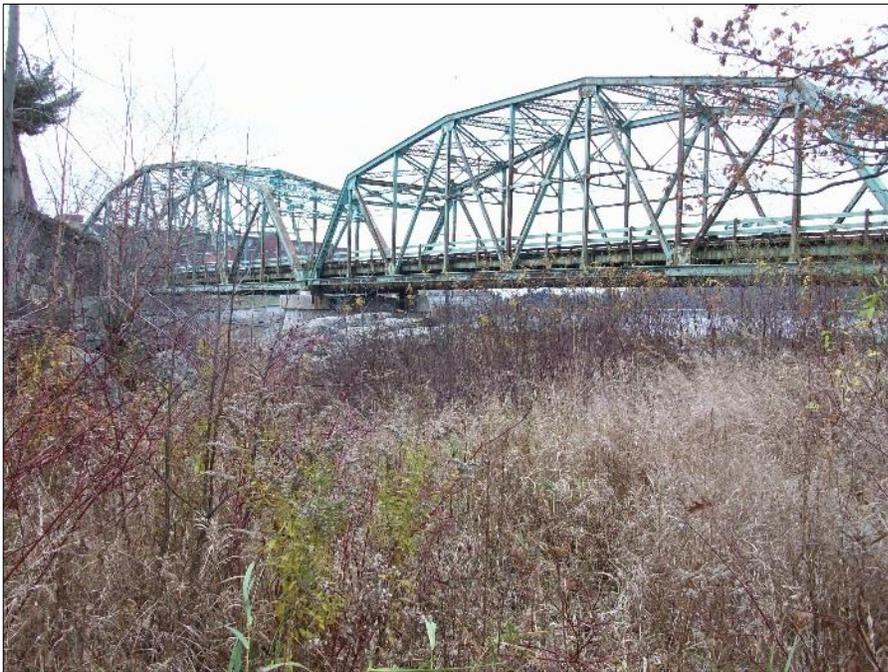
Figure 7. Looking southwesterly towards the Frank J. Wood Bridge (#2016) from a seasonally wet drainage area/palustrine emergent wetland near the small bridge to Bowdoin Mill Island. Vegetation includes reed canary grass (*Phalaris arundinacea*), broadleaf cattail (*Typha latifolia*), speckled alder (*Alnus incanca*), and willow (*Salix* sp.).

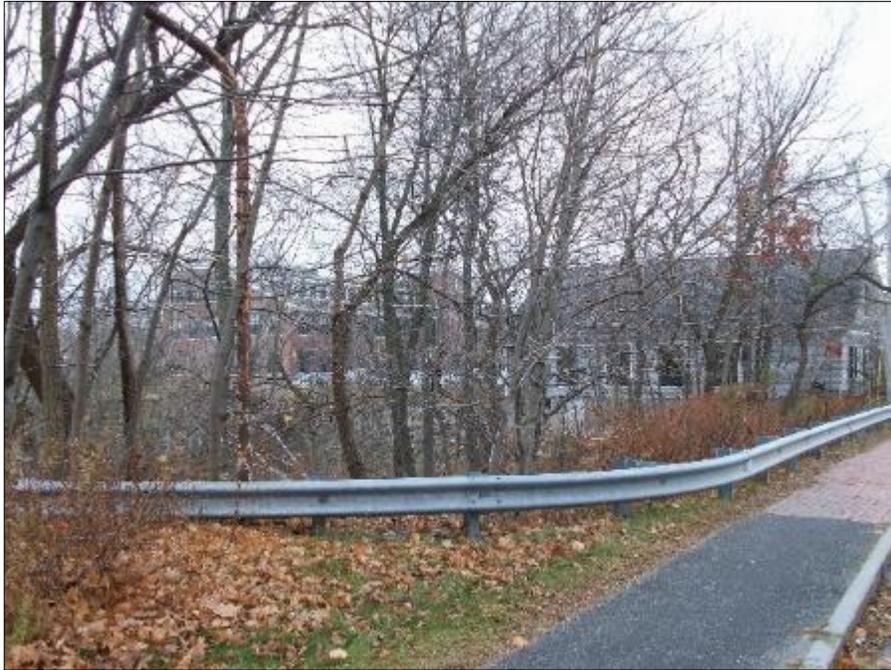
Figure 8. Looking southerly on Route 201/Main Street towards a small drainage area on the east side of the right-of-way.

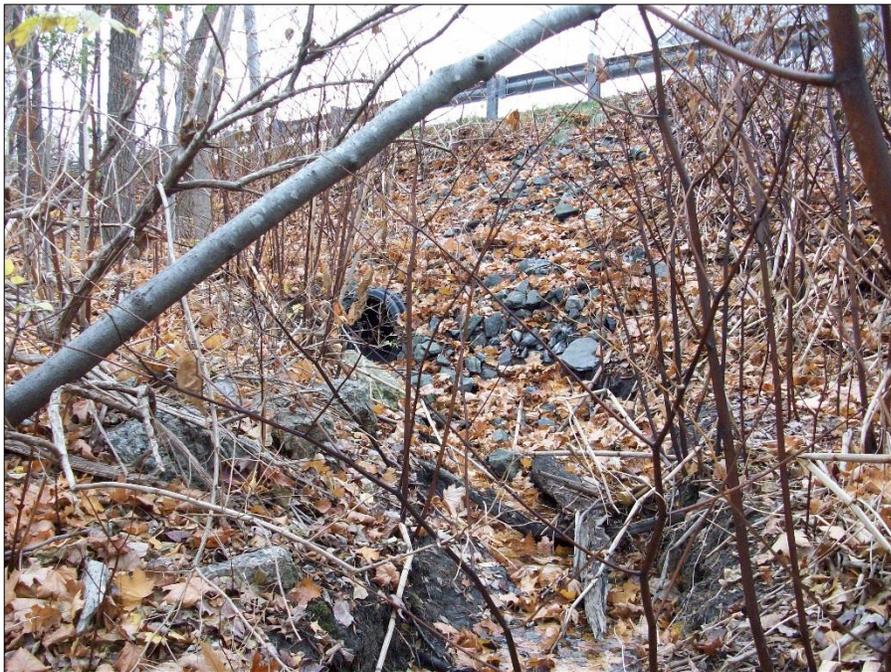
Figure 9. Looking southwesterly up towards Route 201/Main Street from the drainage area.

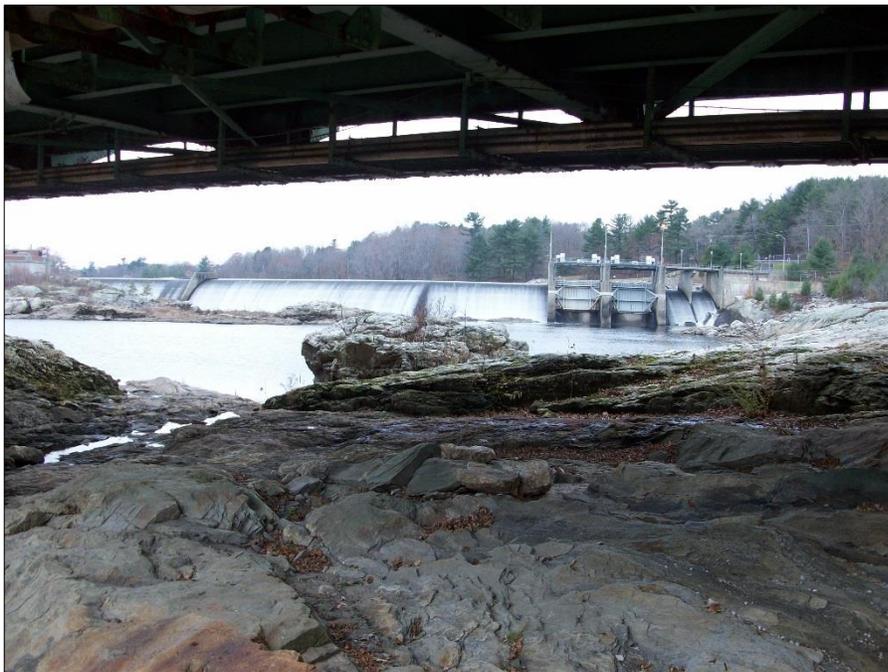
Figure 10. Looking westerly towards the hydro dam from under the Frank J. Wood Bridge (#2016).

Tetra Tech biologists surveyed the area on the north bank of the Androscoggin River (in Topsham) and the area on the south bank east of the bridge. The north bank of the river consisted of ledge habitat, bridge rip rap, and constructed rock retaining walls (Figures 10 and 11). There are two structural concrete pilings located under the deck of the Seadog Brewing Company (Figure 12). The ledge habitat and bridge rip rap extends from the western end of the Project study area under the bridge to the rock retaining wall on the southern end of the Project study area. A rock retaining wall also supports the Seadog Brewing Company building and parking area (Figures 2, 3, and 11).

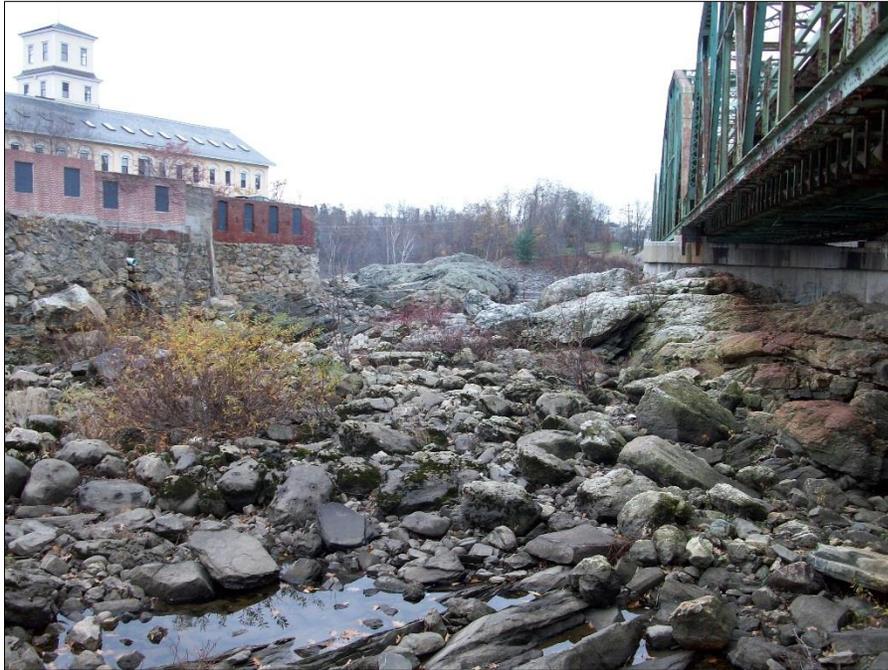
Figure 11. Looking southerly towards the Town of Brunswick showing rock ledge, retaining walls, bridge pilings, and rip-rap within the Project area.

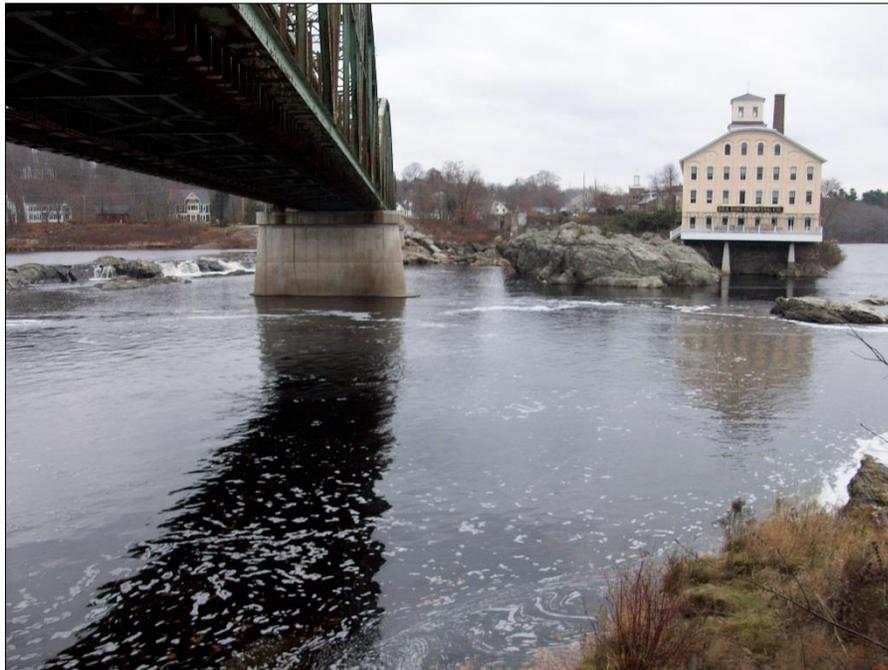
Figure 12. Looking northerly towards Seadog Brewing Company.

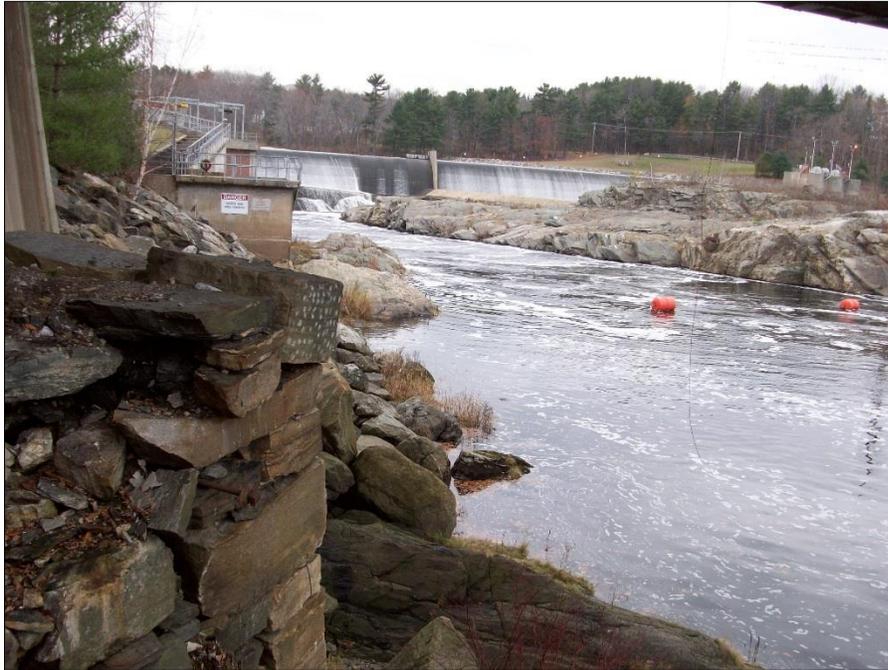
Figure 13. Looking northwesterly from the south bank towards the hydro dam and fish ladder. From a distance it appears that reed canary grass is growing along the left bank of the river.

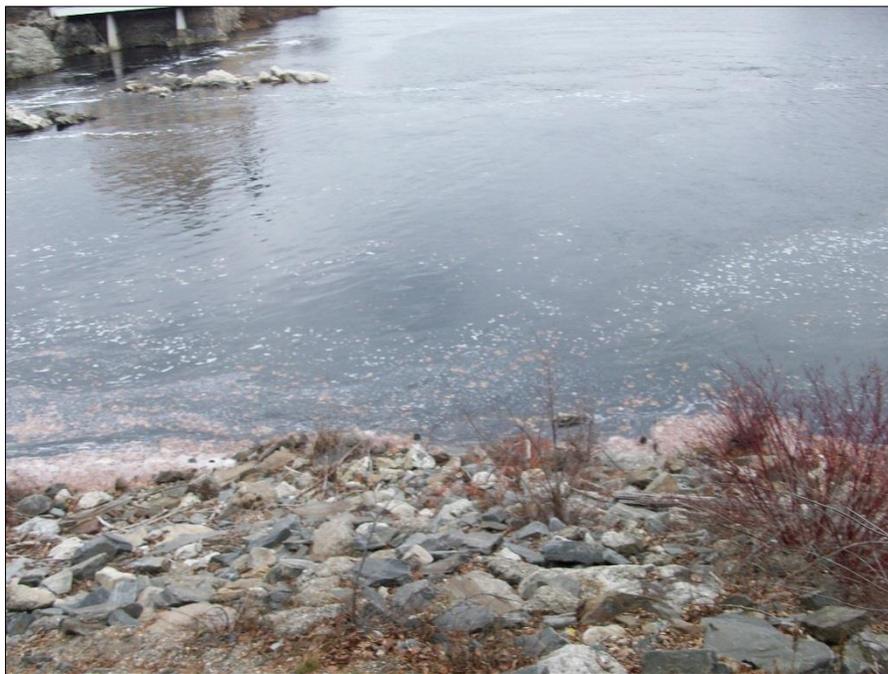
Figure 14. Looking from the south bank down a steep and inaccessible slope.

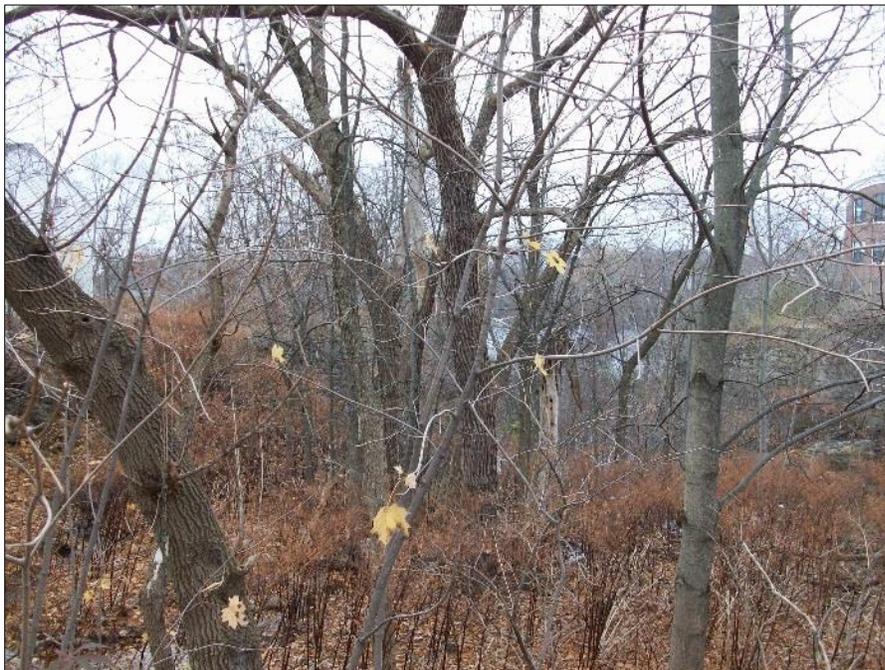
Figure 15. Looking east from Route 201/Main Street towards drainage area. Surveyors observed trash and debris in the drainage area, steady traffic, and traffic-related noise along the right-of-way.

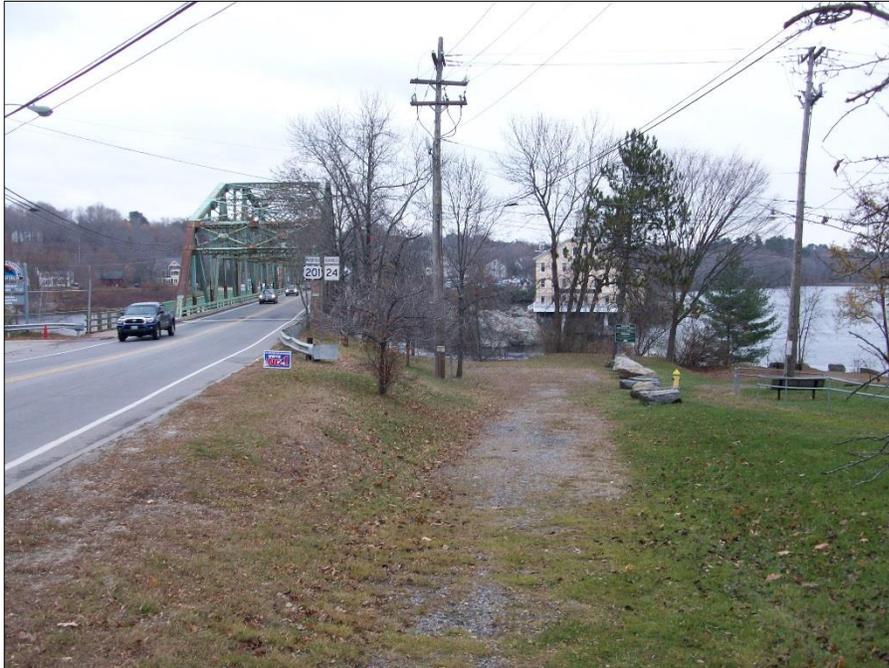
Figure 16. Looking northeasterly towards the Frank J. Wood Bridge (#2106) and the Seadog Brewing Company. This small, landscaped park with sparse ornamental trees has very little habitat value for bats and other wildlife.

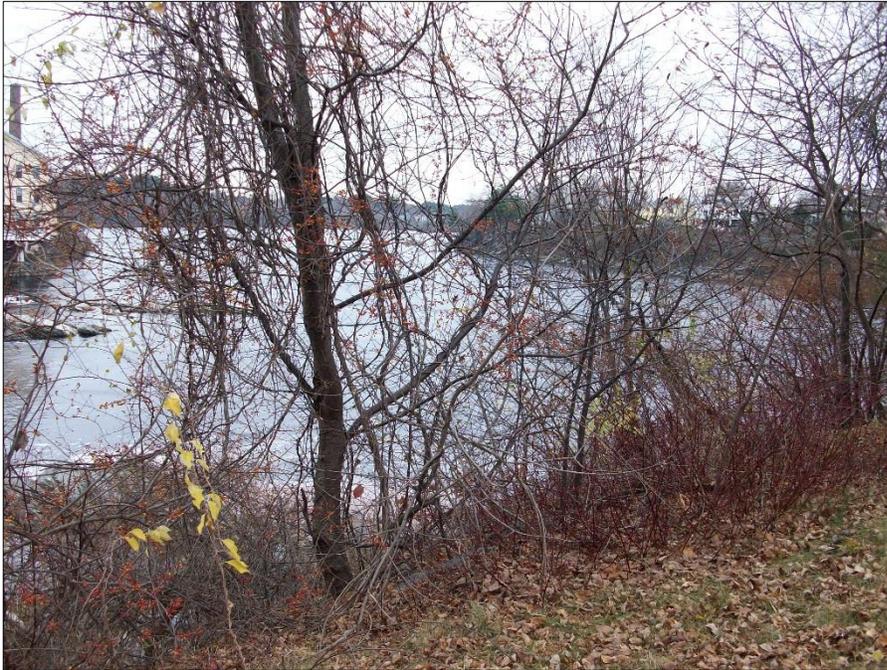
Figure 18. Looking northeasterly towards the Androscoggin River at disturbed habitat along a steep embankment to the east of the Frank J. Wood Bridge (#2016). Very little habitat value for bats and other wildlife is present.

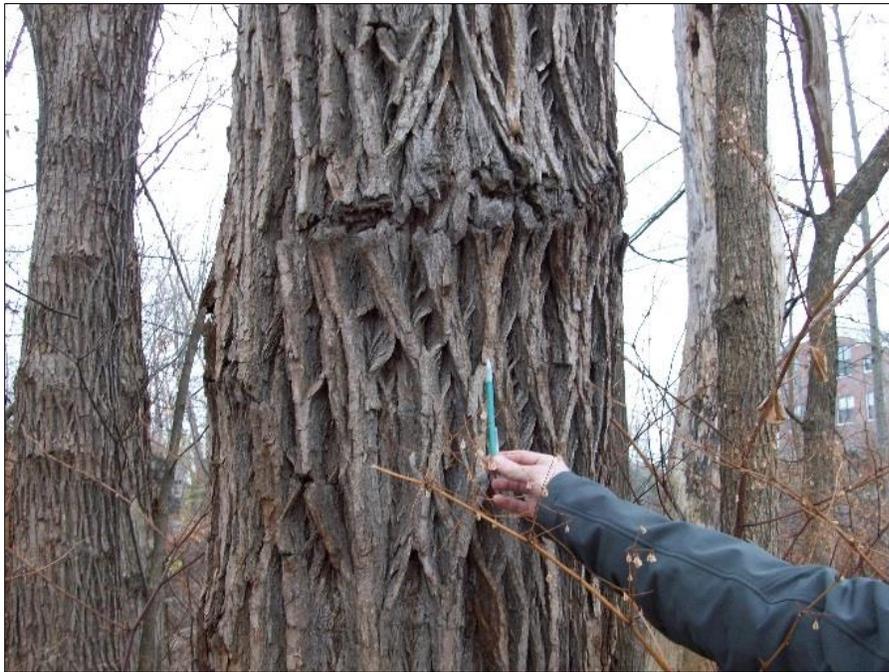
Figure 19. Small drainage area on east side of Route 201/Main Street behind 11 Main Street. This large multiple-stem (each stem approximately 30 inches diameter at breast height [dbh]), deeply furrowed black locust (*Robinia pseudoacacia*) is a potential roost tree for northern long-eared bat. Note: black locust is a Maine Natural Areas Program potential or probable invasive species.

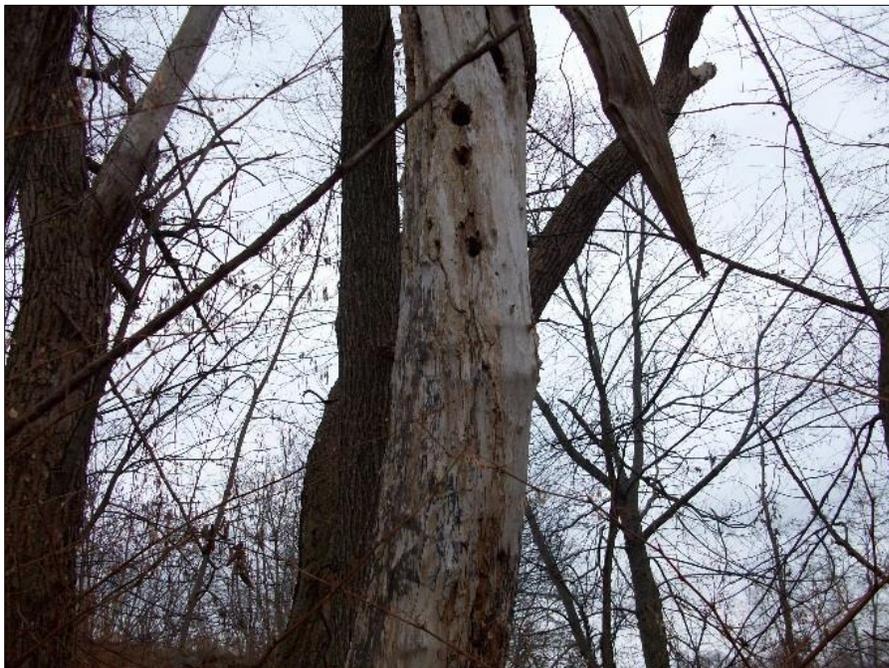
Figure 20. Small drainage area on east side of Route 201/Main Street behind 11 Main Street. This dead stem (snag) of a multiple-stem black locust with cavities (approximately 30 inches dbh) is a potential roost tree for NLEB. The immediate habitat is small and marginal for NLEB, but flight corridors are available that connect to more contiguous forest habitat.

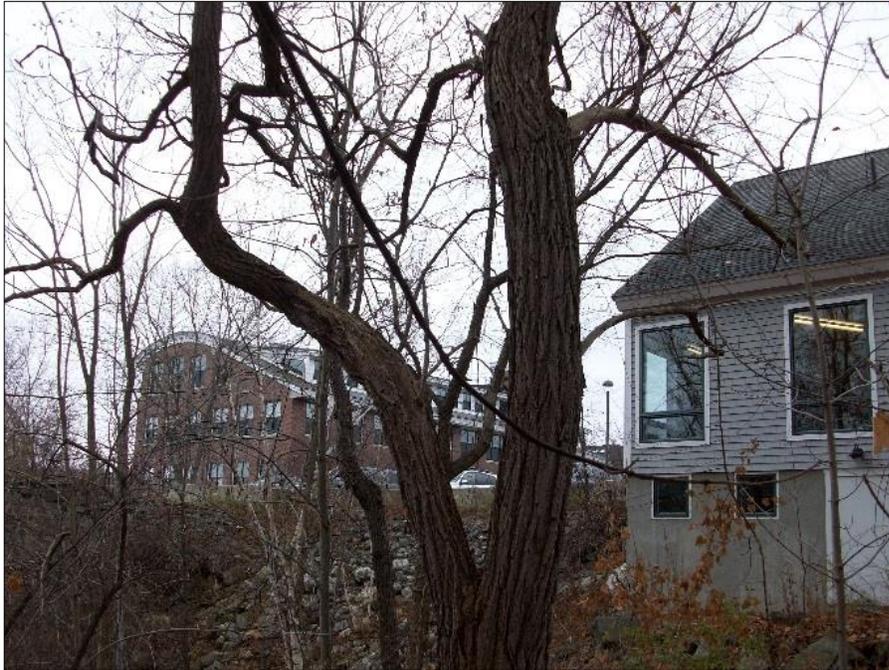
Figure 21. Small drainage area on east side of Route 201/Main Street behind 11 Main Street. This double-stem black locust (each stem approximately 12 inches dbh) is a potential NLEB roost tree.

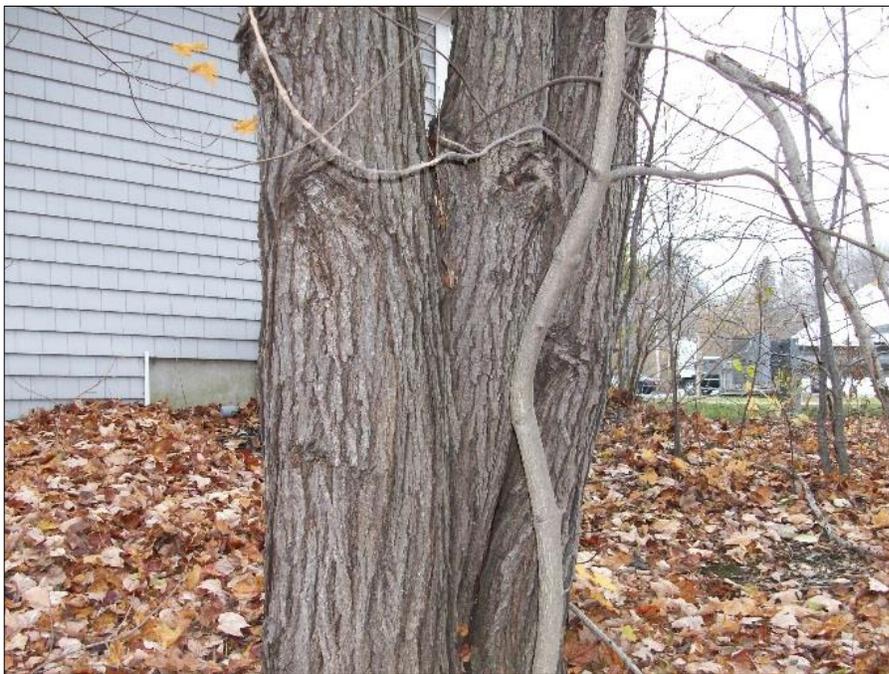
Figure 22. Small drainage area on east side of Route 201/Main Street behind 11 Main Street. This triple-stem sugar maple (each stem approximately 12 inches dbh) is a potential NLEB roost tree.

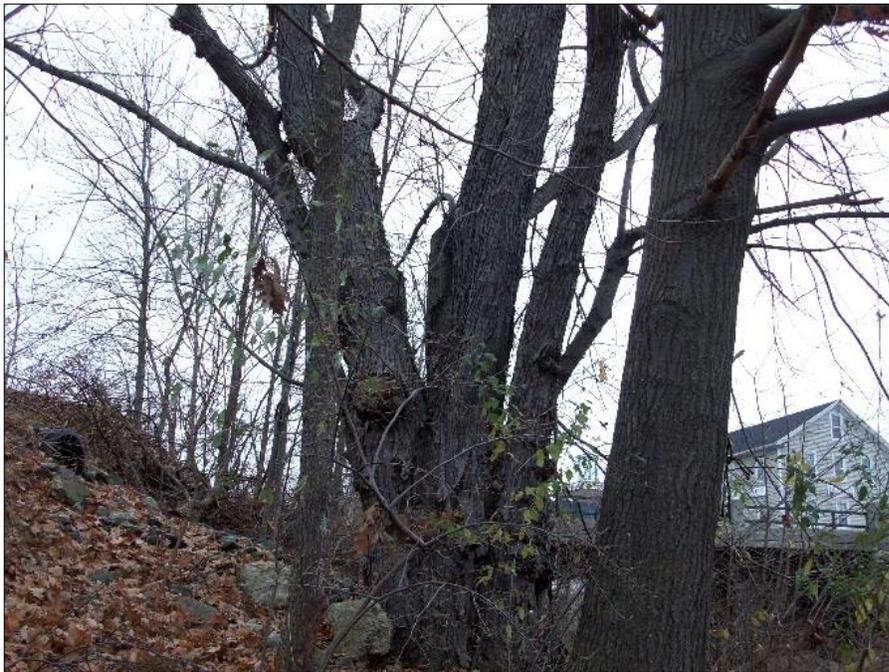
Figure 23. Drainage area between Route 201/Main Street and Bowdoin Mill Island. This large, multiple-stem (each stem approximately 20 inches dbh) red maple is a potential NLEB roost tree.

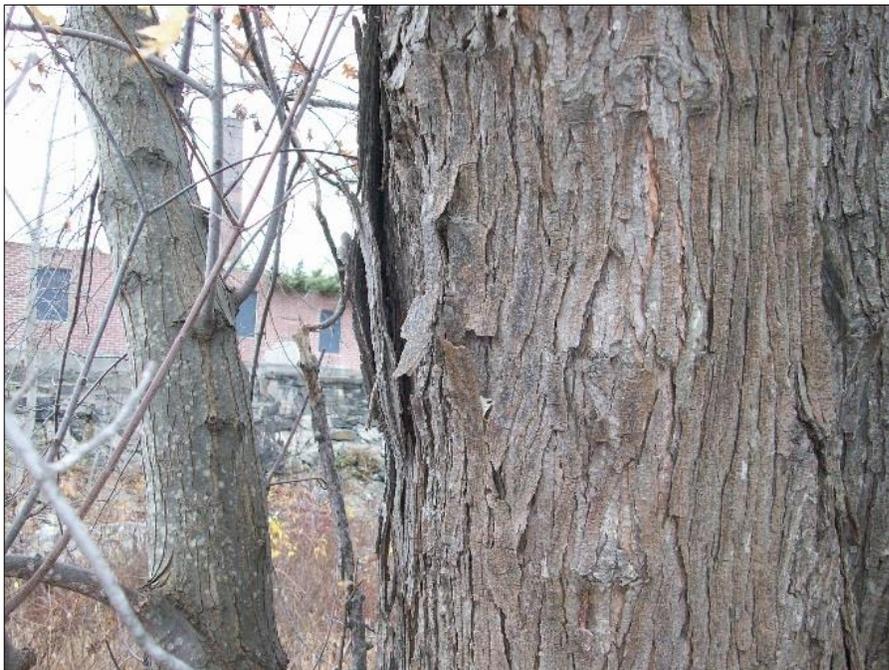
Figure 24. Drainage area between Route 201/Main Street and Bowdoin Mill Island. Close up of red maple bark exhibiting flaking characteristic required by NLEB.

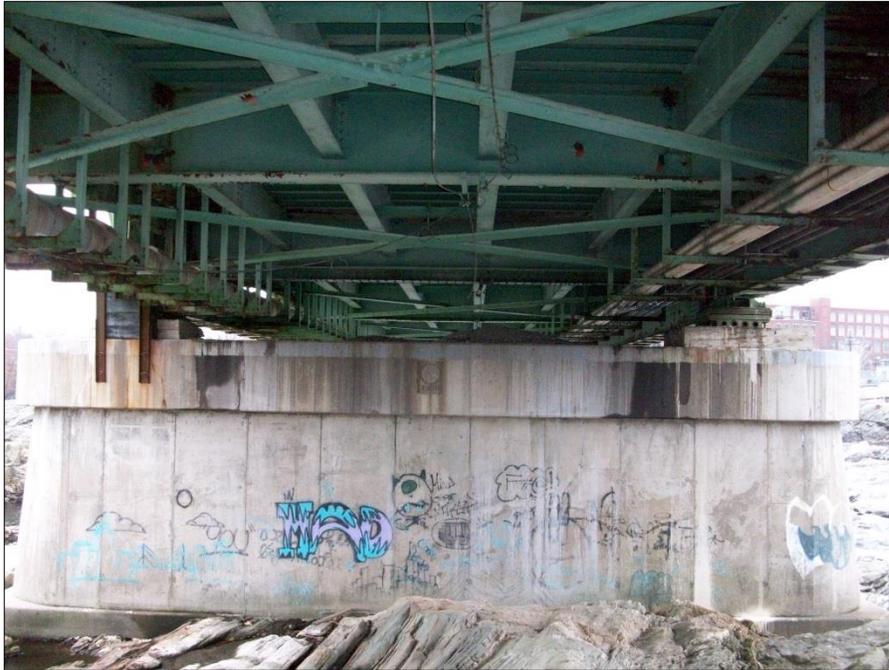
Figure 25. Looking southerly from under the bridge at bridge pier and underneath bridge deck. No guano deposits or staining were visible. Bridge does not mimic “cave-like” atmosphere.

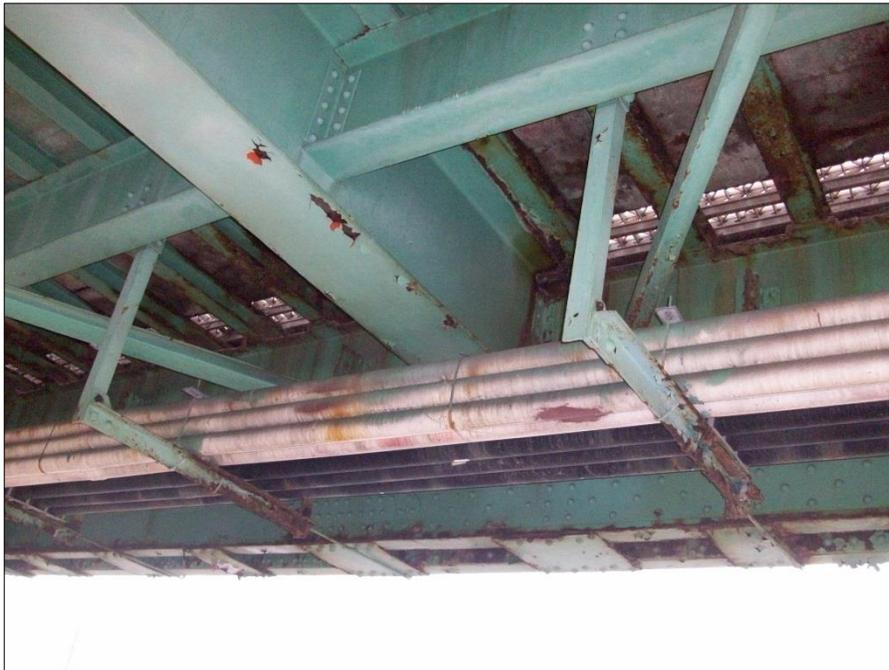
Figure 26. Looking up at bridge deck. No guano deposits or staining were visible.
