The Design and Operation of a Picket Weir to Sample Brook Trout and Landlocked Salmon in Tributaries to Moosehead Lake

Progress Report No. 1

July 2018
Maine Department of
Inland Fisheries & Wildlife
Fisheries and Hatcheries Division

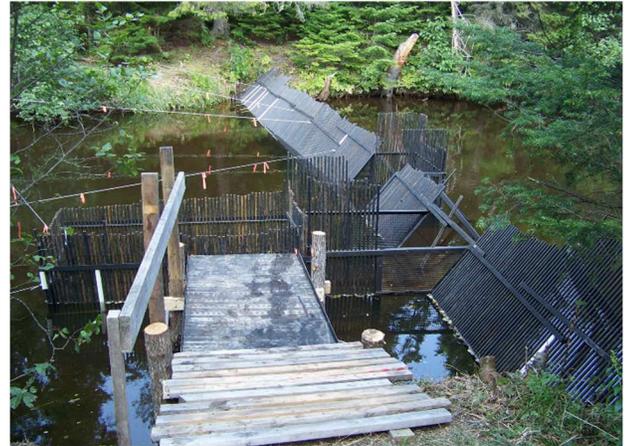
Figure 2. The finished Socatean Stream weir in 2009.

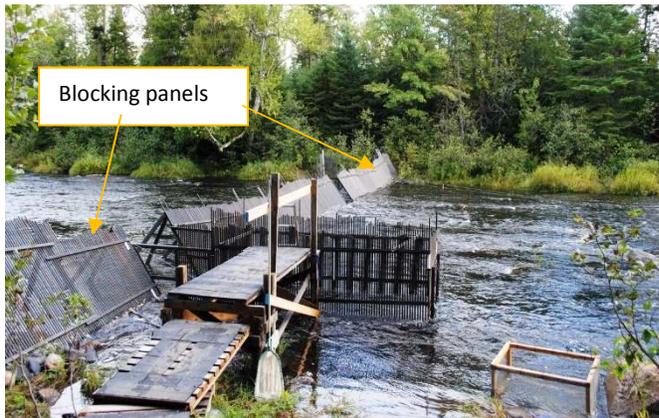
Figure 5. View of blocking panels spanning the stream.

by a tripod or anchored into the streambank. These panels prohibit fish movement upstream or downstream of the weir site. The blocking panels consist of 6 ft x 3 in x $\frac{1}{4}$ in channeled steel, with 1 in holes that start $\frac{1}{4}$ in from the end and spaced $\frac{1}{2}$ in apart and run lengthwise down the center of the piece of steel. There are 8 holes per linear foot of channeled steel. Each section of the blocking panel contains two pieces of the drilled channeled steel. Sections of $\frac{1}{2}$ in pipe with an outside diameter of 0.84 in are slid through the holes in the channeled steel to form the "picket" appearance. Three different lengths of pipe (5, 6, and 7 ft) are used to accommodate varying water depths across the stream (Figure 5).

The blocking panels are the large panels which span the stream and extend from each side of the entrance of the collection box to the shore on either side. Blocking panels are supported at each end

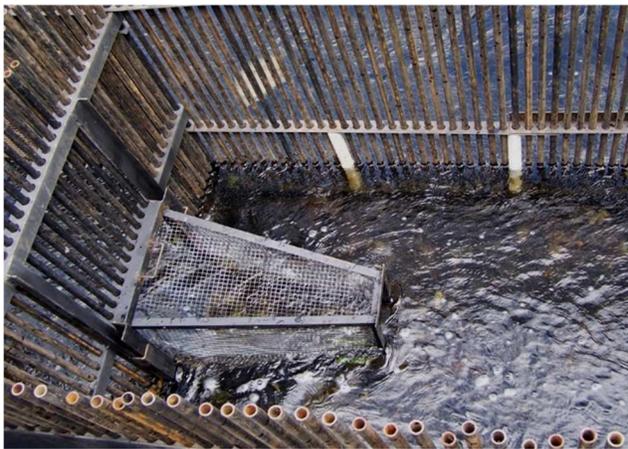
The fyke is used to funnel fish from the entrance into the collection box (Figure 7). The small end is located inside the collection box and is approximately 12 in off the bottom of the stream bed, making it difficult for fish to find the opening to escape. The initial fyke consisted of a wooden frame covered

Figure 7. Top view of the fyke inside the collection box.

with a ½ in wire material. However, it was replaced due to beavers chewing on the frame. A second fyke, with a similar design was constructed using 1 in angled steel and covered with ½ in metal diamond screen. The back has a welded flange on either side which allows it to be lowered into a slot on the front panel of the collection box. The new fyke was designed to accommodate both deep and shallow water depths. The fyke is placed in the entrance

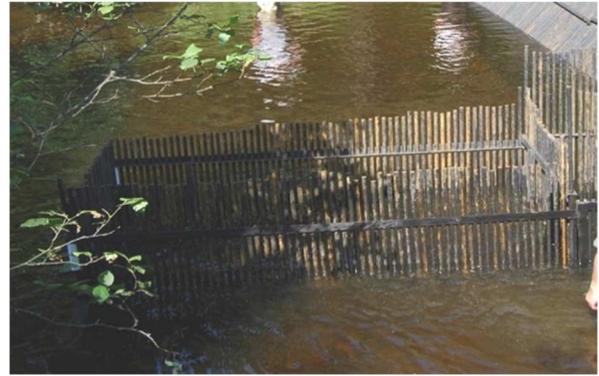
The collection box is the part of the weir that holds the fish (Figures 7 and 8). Studies designed to collect fish moving into and dropping out of a stream require two collection setups. Each collection box is comprised of a front panel, a back panel, and two side panels made of six (3 per side) 8 ft x 2 in x 2 in angled steel. The front and back panels are welded rigid frames (Figures 9 and 10).

Figure 8. Outside view of the collection box.

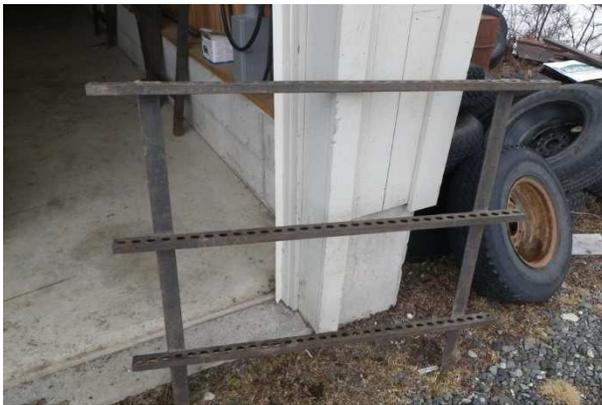
The back panel has two - 4 ft x 2 in x 2 in upright pieces of angled steel (undrilled) that have three - 4 ft x 2 in x 2 in angled steel (drilled). Similar to the 6 ft channel pieces of the blocking panels, all pieces receiving pipes are drilled with 1 in holes spaced $\frac{1}{2}$ in apart and run lengthwise down the center of the angled steel.

Figure 10. View of the back panel of the collection box.

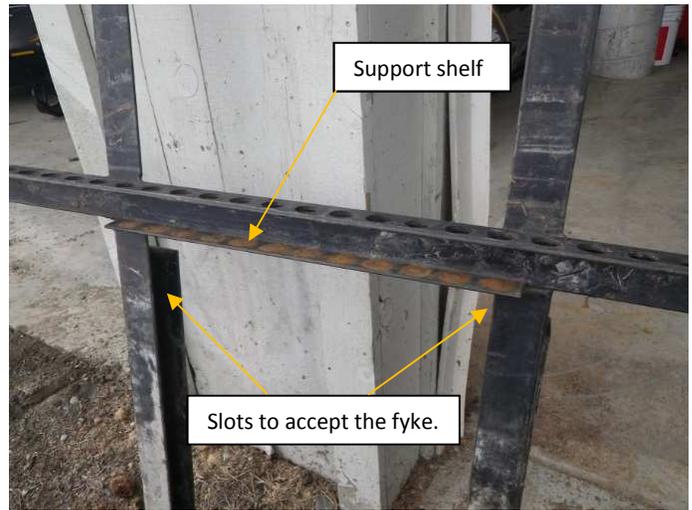
of the fyke to form a suspended panel above the fyke (Figure 11). A piece of plywood is typically placed over the top of the collection box to keep birds and other predators from entering the box.

Figure 11. View of shelf for the short pipes and slots for the fyke to slide into on the front panel of the collection box.

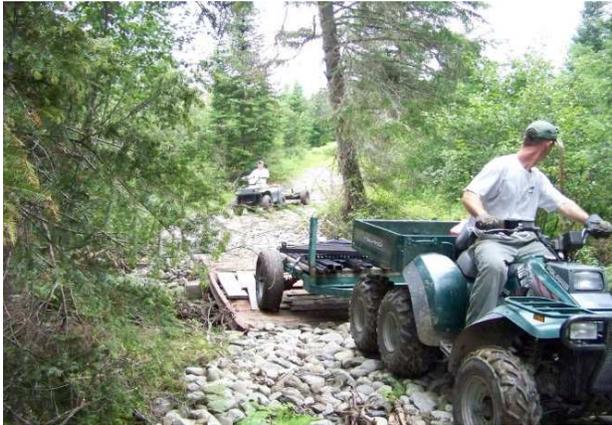
Figure 13. Transporting material to the weir site using ATV's and trailers.

The road conditions used to reach the access trails often determined how heavy we loaded the trucks. If roads were rough or muddy the loads were lighter, however if road conditions were favorable, more material was hauled on a single truck. We transported all the material for a weir spanning a 55 ft wide stream on three pickup trucks and one utility trailer in one situation where access was good. It was loaded into the back of an ATV equipped with a rear dump box or onto small utility trailers and towed by ATV's (Figure 13). Several trips were needed to move the material from the trucks to the weir site where it was placed near the stream bank and organized. It should be noted that when off-loading the material at the stream bank, it should be stock piled in an organized fashion (Figure 14).

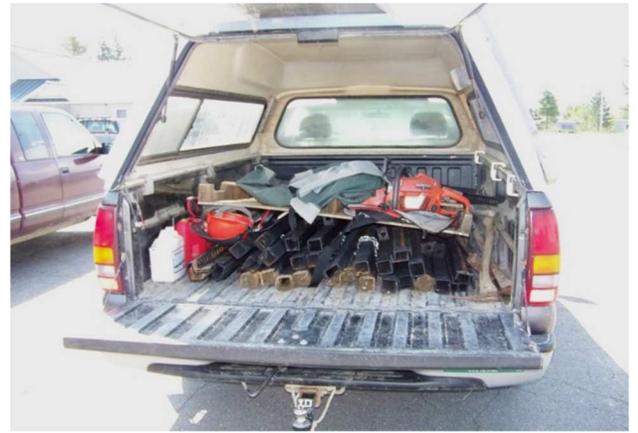
Figure 12. Weir parts and gear loaded for transport to the stream.

We had to consider how we would transport the materials to and from the site with minimal machinery when designing the weir. The weir material and associated gear were loaded onto pickup trucks and utility trailers for transport to the weir site (Figure 12).

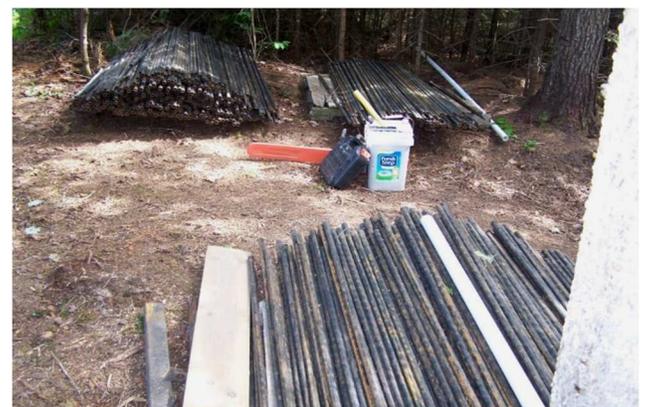
Figure 14. Material organized and ready to be assembled.

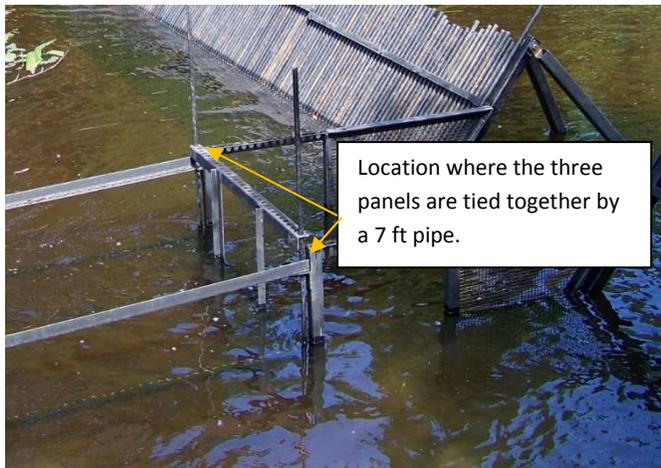
Figure 16. View of the entrance panels, front panel of the collection box and drilled angled steel, tied together by 7 ft pipes.

The three tabs on the backs of the left and right entrance panels, the ends of the front panel to the collection box, and the six drilled pieces of angled steel that form the sides of the collection box were tied together by inserting a 7 ft pipe through the intersection of all three components (Figure 15). The back panel of the collection box was then tied to the other ends of the six pieces of drilled angled steel by inserting a 7 ft pipe on either side of the back panel. One tripod was placed on the outside edge of each entrance panel for stability

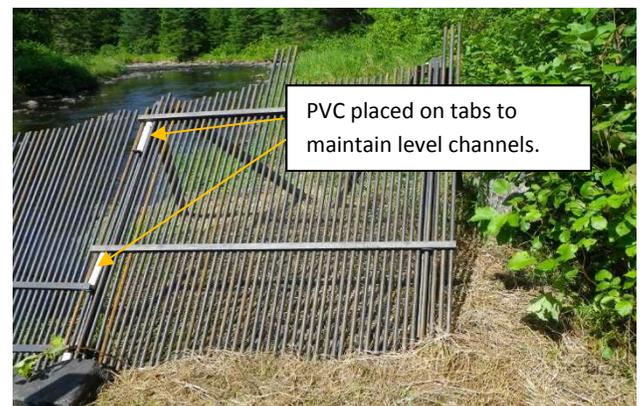
across the stream. Two sections of 6 ft drilled channel iron were tied into the three tabs located on the side of the front portion of the entrance panel and the tabs on the leading edge of the tripod by running a 7 ft piece of pipe through these at the same time. Tripods were placed approximately 5 ft apart and run perpendicular across the stream. It was important to keep the angles of the front and back legs for each tripod the same. The channeled steel pieces were laid on

Figure 15. Use of PVC sections, resting on tab of front tripod leg to maintain level channels in the blocking panel when moving up the streambank.

the tabs of the front legs on the tripods and tied together using 7 ft pieces of pipe. Some overlap of the 6 ft channeled steel occurred. Close attention was needed to assure that we maintained the same number of open holes on the top and bottom pieces of channeled steel between the pipes tying the front legs of the tripods. We noted that if the number of open holes on top and bottom differed, then the pipes will not line up correctly and openings larger than $\frac{1}{2}$ in will result potentially allowing fish to pass through the weir. When uneven pipes were encountered, the pipes were pulled out and the channeled steel was realigned so there were the same number of open holes on the top and bottom

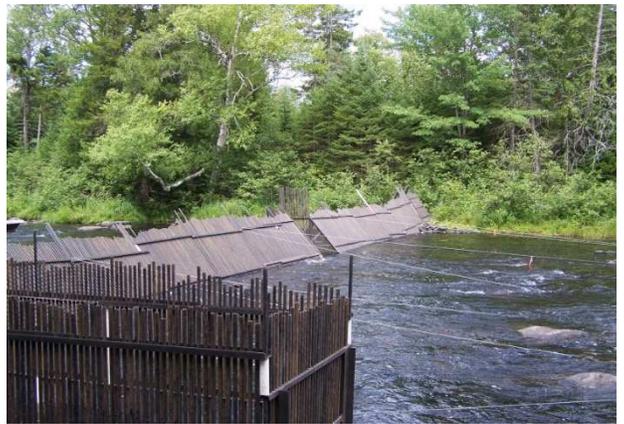
Once the weir was completed we used $\frac{1}{4}$ in to $\frac{3}{8}$ in cables to help support the structure during high flow events. The number of cables we used varied from site to site, and was based on the width of the stream and the potential flows that could occur during high water events. Typically, one was placed on each end of the weir, one on each corner of the upstream portion of the collection box, and others were evenly spaced across the weir to help support the weight of debris and the force of the water against the weir (Figure 17). The cable was attached to the upstream leg of a tripod by wrapping it around and securing it with a cable clamp. The other end of the cable was then fastened to something stationary, such as a tree or boulder, upstream of the weir. Small loops were placed in the cable using cable clamps, and then a come-a-long was used to tighten and secure the cable back onto itself with additional cable clamps.

Figure 17. View of support cables connected to the weir panels and upstream portion of the collection box.

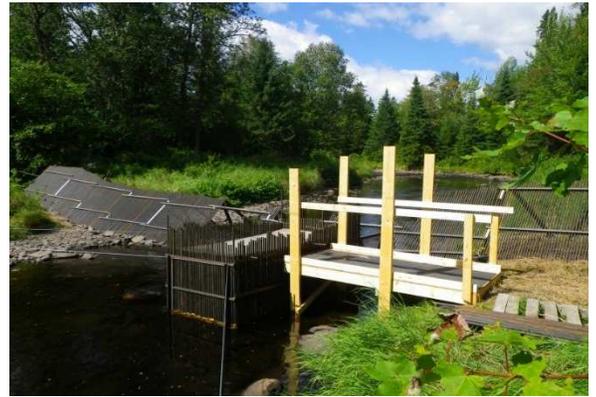
The platform was then leveled from the bank to the collection box then attached to six posts positioned upright on the bottom of the stream and cross-braced for support. The six posts should be long enough to extend above the platform and wooden 2 x 4 rails attached between them on either side, approximately 36 in above the platform to create a rail for safety (Figure 18). A ladder was lowered from the work platform into the collection box to gain access. On one occasion a ladder was positioned against the outside of the collection box to enter the collection box when a walkway could not be constructed.

Figure 18. Walkway/work platform extending from the streambank to the collection box.

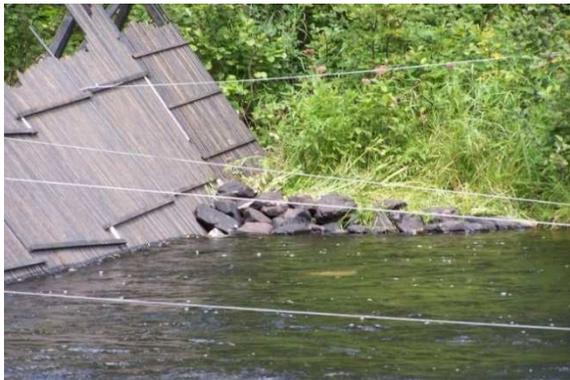
Rocks were placed along the upstream ends of the blocking panels where they tied into the stream banks to help the overall performance of the structure and assure that fish didn't circumvent the weir.

Figure 19. Rip-rap material piled along the streambank to reduce potential erosion during high flow events.

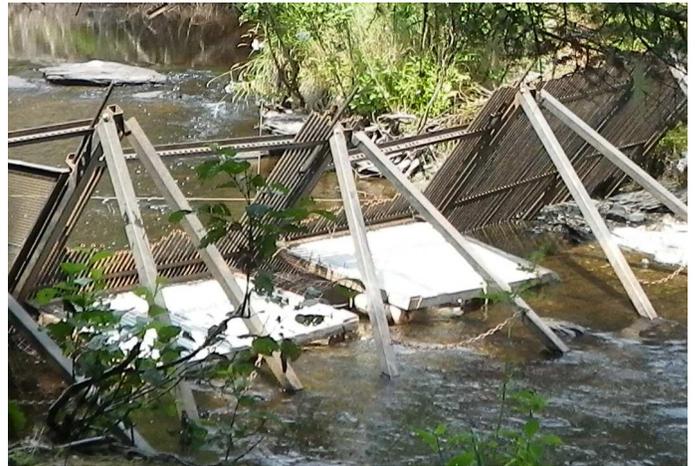
We developed drop-down panels to help reduce the damming effect created by the leaves/debris on the blocking panels. These drop-down panels were designed to act as automatic relief valves during high flows. The openings created by these panels allowed water and debris to pass through the weir, thus reducing the amount of pressure behind it (Figure 20). The panels are 3 ft x 4 ft and the frame is built from 2 in x 3 in lumber. A 3 ft x 1 in x 1 in piece is fastened in the center of the frame for stability. On the 3 ft sides, 1 in holes were recessed 1 in by drilling into the wood and spaced $\frac{1}{2}$ in apart. PVC conduit was cut to the appropriate length to insure a snug fit into the frame to create a panel with similar bar spacing as the blocking panels. For flotation, three

Figure 20. Drop-down panels installed in the weir. Note the shorter pipes at the bottom of the large opening.
