Frank J. Wood Bridge Public Meeting

April 5, 2017 WIN 22603.00

Frank J. Wood Bridge

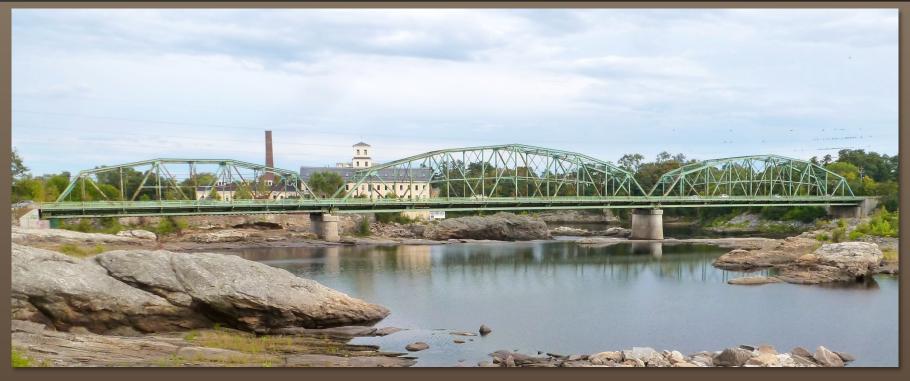
- 805 ft, three-span steel truss
- Built in 1931

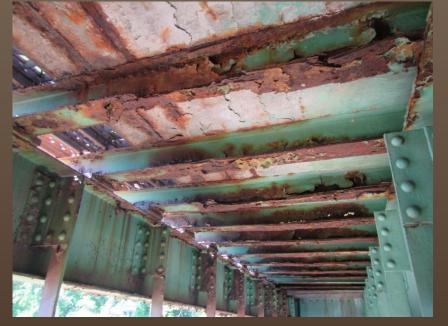
Project Background Information

Deck, floor system & truss bottom chord are in poor condition Bridge posted for 25 tons

- 2012 & 2014 Routine and Fracture Critical Inspection
 - Deck & superstructure condition "Fair"
- June 2016 Routine and Fracture Critical Inspection
 - Deck & superstructure condition "Poor"
- August 2016 Special Inspection
 - Load posting to 25 tons

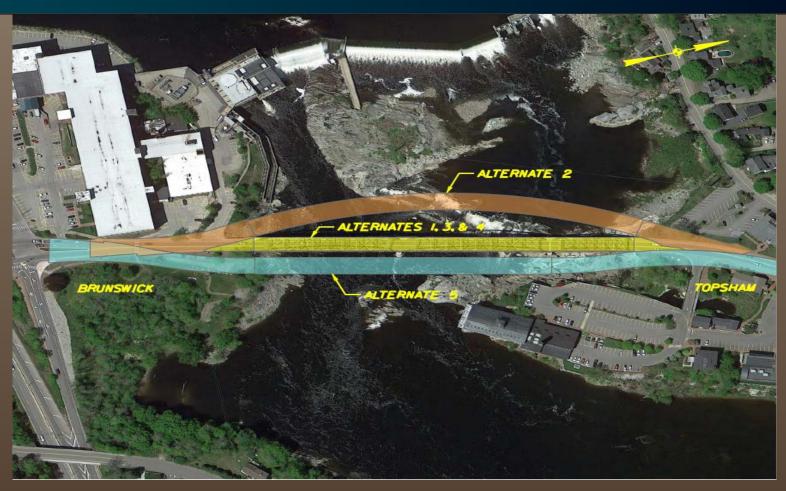
Alignments

- 1. New bridge on the existing alignment
- 2. New bridge on a curved upstream alignment
- 3. Rehabilitation of the existing bridge
- 4. Rehabilitation of the existing bridge, with added second sidewalk
- 5. New bridge on a parallel downstream alignment

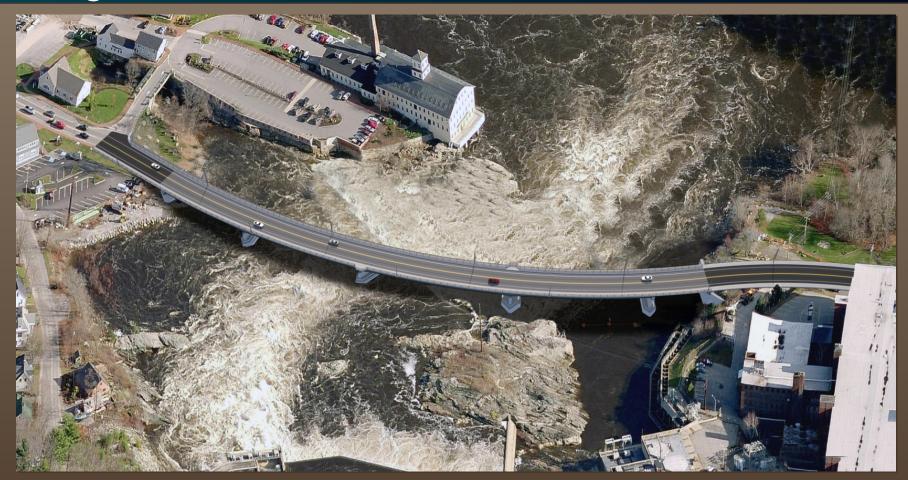
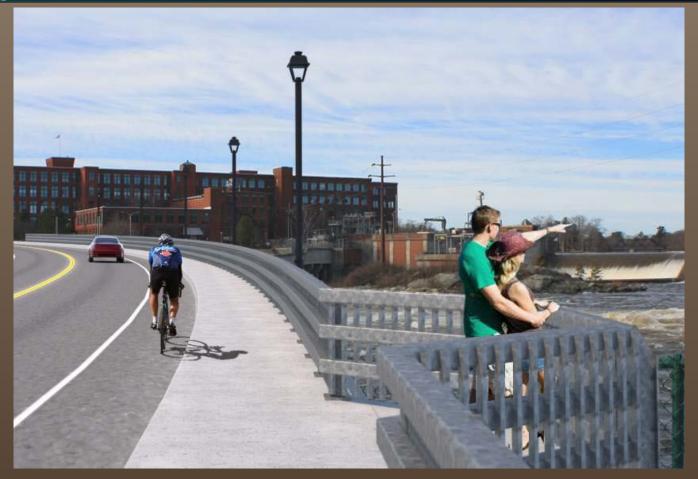
Rendering of Curved Upstream Bridge

- Construction duration: 2½ years
- Traffic impacts: on existing bridge
- Utility impacts: relocate existing utilities to new bridge
- Right of way impacts: 3 properties
- Construction cost: \$13 Million
- Life cycle cost: \$13.7 Million
- Cumulative service lifetime cost: \$17.3 Million

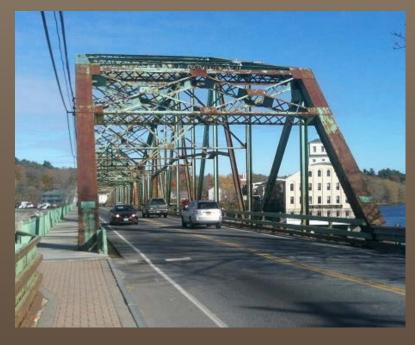
Alt. 3 - Rehabilitation of Existing Bridge

- New deck
- New floor framing
- Paint

- Sidewalk support framing repair
- Bottom chord repair
