Appendix F
Project Summaries

2021 INFRA GRANT Bridge Summaries

Bridge #6165- Casey Road/ I-95. Carries Casey Road over Interstate 95 in Benedicta Twp. Interchange 259.

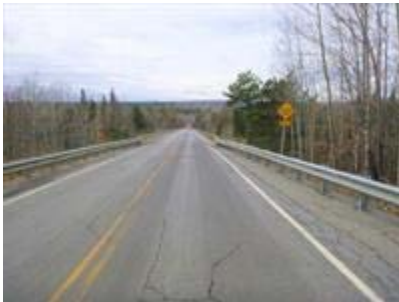
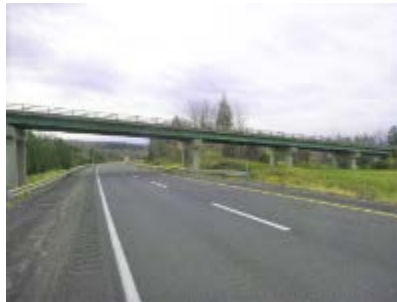
Condition Ratings: Deck = 4 Poor, Superstructure = 6 Satisfactory, Substructure = 6 Satisfactory; Structurally Deficient.

- **Date of last inspection report:** 10/29/20
- **Repair history:**
- **Bridge Posting:** N/A
- **Traffic Safety Features:** Currently does **not meet** acceptable standards
- **Presence of fracture critical members:** No
- **Functional Classification:** Rural Minor Collector over the NHS
- **Scour Critical:** No
- **Condition of the main structural components:** Structure is in overall poor condition. Deck bottom has scattered areas of moderate cracking and staining. Extensive cracking with efflorescence in west span. Superstructure has 50% paint system distress with moderate rusting at high corrosion areas. Abutment and wings have scattered minor map cracking. East backwall has large spall with exposed re-steel. Piers have scattered areas of minor map cracking.

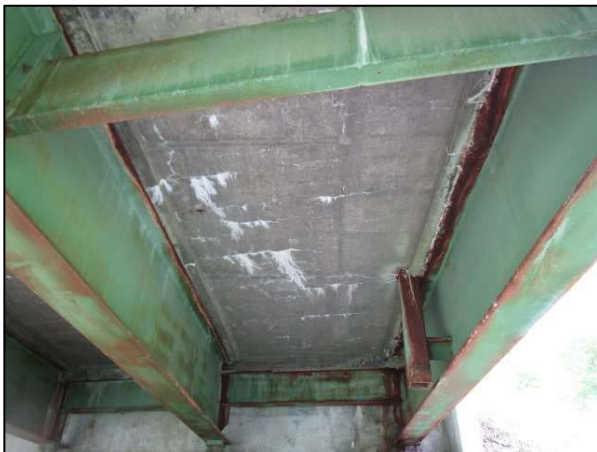
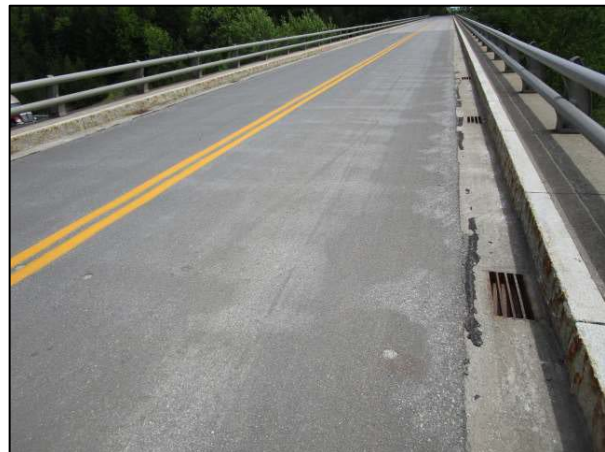
**Photos 2 & 3: Casey Road/I-95 Bridge –
Heavy Cracking and Efflorescent Staining of Underside of Deck (left) and
Rutted Wearing Surface, Heavily Rusted Drains, and Substandard Bridge Rail (right)**

The project focuses on redeveloping the existing infrastructure to remove this bridge from the list of structurally deficient bridges and return it to a state of good repair. The scoped deck replacement project provides an additional environmental benefit by innovative reuse of the existing substructure units and structural steel elements with selective rehabilitation of these elements. This economically intelligent and environmentally conscious decision will extend the useful life of the structure by reusing elements that are in satisfactory condition, resulting in fewer materials that will need to be harvested, refined, delivered, and placed.

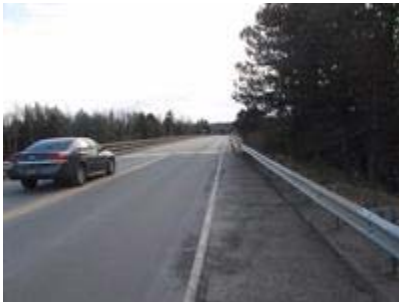
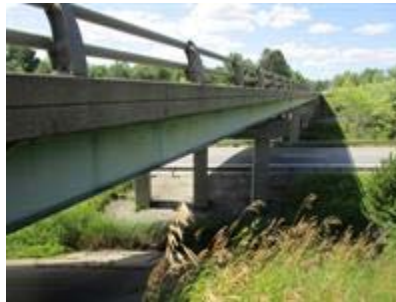
Condition Ratings: Deck = 4 Fair, Superstructure = 6 Satisfactory, Substructure = 6 Satisfactory; Structurally Deficient.

- **Date of last inspection report:** 08/06/19
- **Repair history:**
- **Bridge Posting:** N/A
- **Traffic Safety Features:** Currently does **not meet** acceptable standards
- **Presence of fracture critical members:** No
- **Functional Classification:** Rural Minor Arterial over the NHS
- **Scour Critical:** No
- **Condition of the main structural components:** Structure is in overall poor condition. Deck bottom has scattered areas of cracking and staining. Extensive areas of spalled concrete with exposed re-steel on each of the exterior bays. Superstructure has 20% paint system distress with moderate rusting at high corrosion areas. Minor to isolated moderate cracking on concrete piers. Minor cracking on pier cap ends. Heavy map cracking of east abutment backwalls.

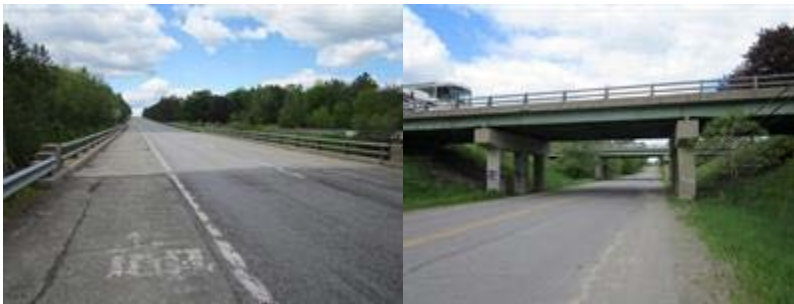
Condition Ratings: Deck = 4 Poor, Superstructure = 6 Satisfactory, Substructure = 6 Satisfactory; Structurally Deficient.

- **Date of last inspection report:** 06/01/20
- **Repair history:** Joint rehab and beam end paint 2018
- **Bridge Posting:** N/A
- **Traffic Safety Features:** Currently does **not meet** acceptable standards
- **Presence of fracture critical members:** No
- **Functional Classification:** Rural - Principal Arterial - Interstate
- **Scour Critical:** No
- **Condition of the main structural components:** Structure is in overall poor condition. Deck bottom has cracking, staining and pop-outs. Superstructure has 15% paint system distress with minor rusting. Abutments have moderate cracking & staining concrete at high exposure areas.

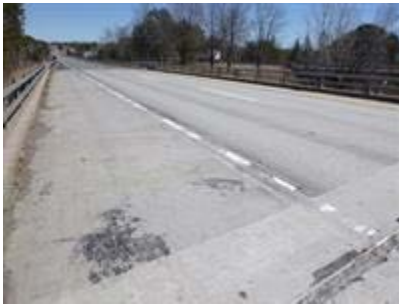
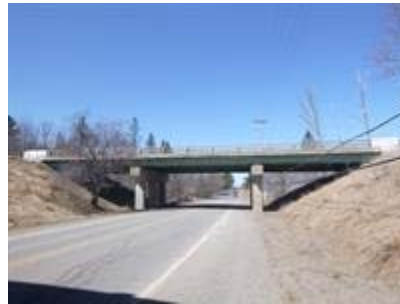
Condition Ratings: Deck = 4 Poor, Superstructure = 6 Satisfactory, Substructure = 6 Satisfactory; Structurally Deficient.

- **Date of last inspection report:** 06/01/20
- **Repair history:** Joint rehab and beam end paint 2018
- **Bridge Posting:** N/A
- **Traffic Safety Features:** Currently does **not meet** acceptable standards
- **Presence of fracture critical members:** No
- **Functional Classification:** Rural - Principal Arterial - Interstate
- **Scour Critical:** No
- **Condition of the main structural components:** Structure is in overall poor condition. Deck bottom has cracking, staining and pop-outs. Superstructure has speckled rust on bottom flanges, complete paint loss in areas of high exposure areas. Abutments and piers have minor cracking & staining of concrete.

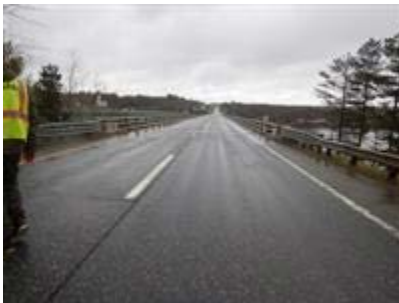
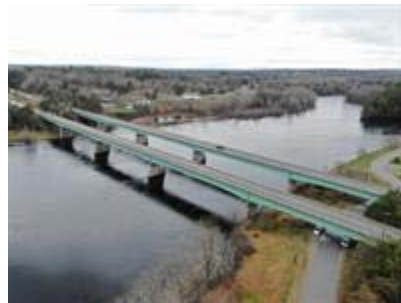
Condition Ratings: Deck = 4 Poor, Superstructure = 7 Good, Substructure = 6 Satisfactory; Structurally Deficient.

- **Date of last inspection report:** 05/12/20
- **Repair history:** Full paint 2015. Wearing surface 2018.
- **Bridge Posting:** N/A
- **Traffic Safety Features:** Currently does **not meet** acceptable standards
- **Presence of fracture critical members:** No
- **Functional Classification:** Rural - Principal Arterial - Interstate
- **Scour Critical:** No
- **Condition of the main structural components:** Structure is in overall poor condition. Deck bottom has widespread minor cracking. Both the up and down stream soffits have areas of spalled and delaminated concrete. Abutment backwalls have heavy map cracking and minor delaminations. Pattern cracking at most piers noses and concrete erosion/abrasion noted at and above waterline.

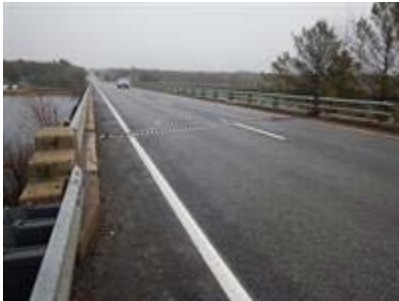
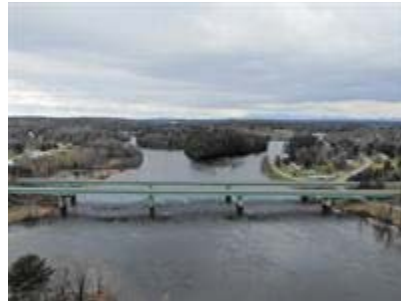
Condition Ratings: Deck = 4 Poor, Superstructure = 6 Satisfactory, Substructure = 6 Satisfactory; Structurally Deficient.

- **Date of last inspection report:** 05/12/20
- **Repair history:** Full paint 2016. Wearing surface 2018.
- **Bridge Posting:** N/A
- **Traffic Safety Features:** Currently does **not meet** acceptable standards
- **Presence of fracture critical members:** No
- **Functional Classification:** Rural - Principal Arterial - Interstate
- **Scour Critical:** No
- **Condition of the main structural components:** Structure is in overall poor condition. Deck bottom has widespread minor cracking. Both the up and down stream soffits have areas of spalled and delaminated concrete. Abutment backwalls have heavy map cracking and minor delaminations. Pattern cracking at most piers noses and concrete erosion/abrasion noted at and above waterline.

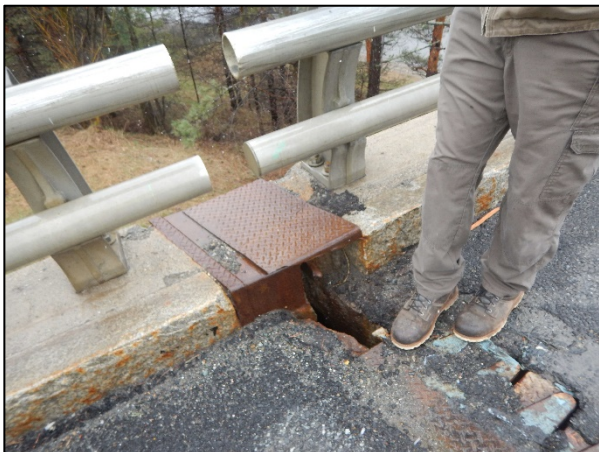
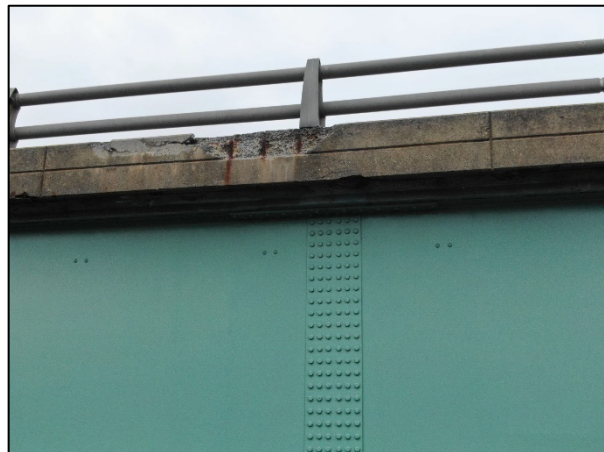
**Photos 2 & 3: Vaughan Daggett Memorial Bridges –
Condition of Deck Joint at North Abutment and Substandard Bridge Rail (left) and
Deteriorated Deck Overhang (right)**

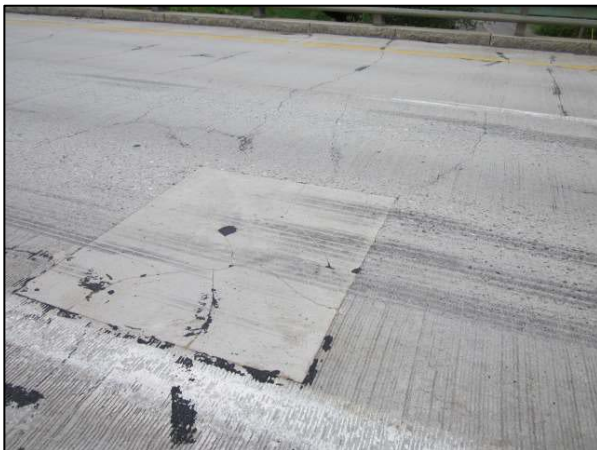
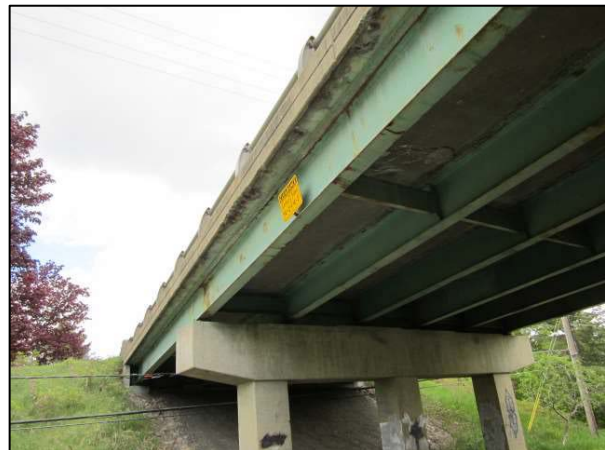
**Photos 5 & 6: I-95 NB/SB over Route 116 Bridges –
Deck Condition with Topside Cracking and Previous Patch Repair (left) and
Deteriorated Deck Overhang (right)**

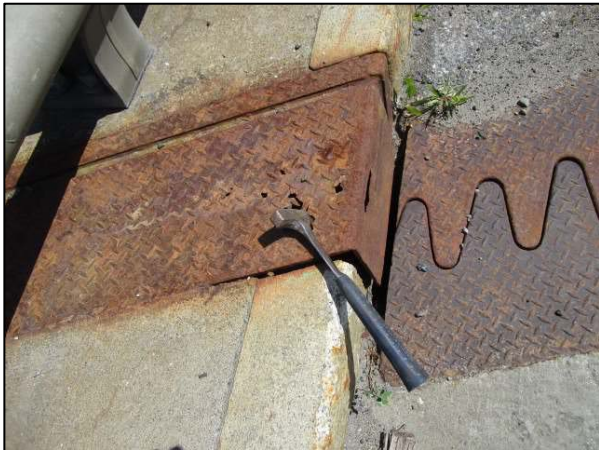
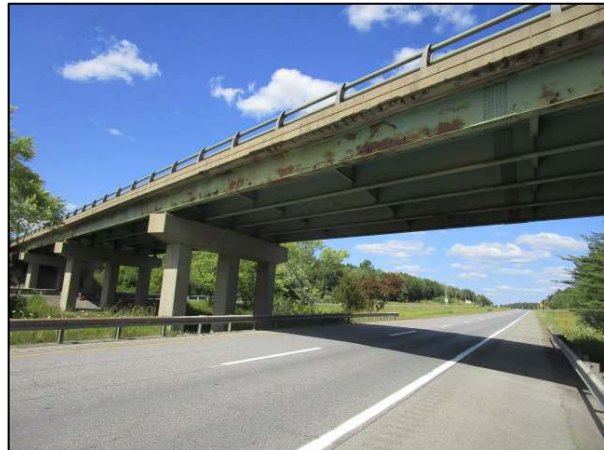
**Photos 8 & 9: Route 157/I-95 Interchange Bridge –
Deteriorated Condition of Deck Joint (left) and
Deteriorated Deck Overhang (right)**

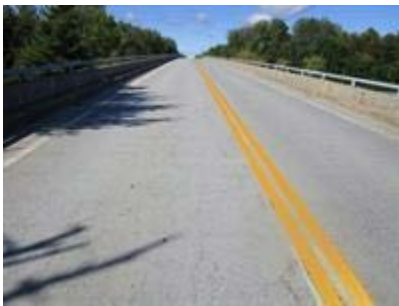
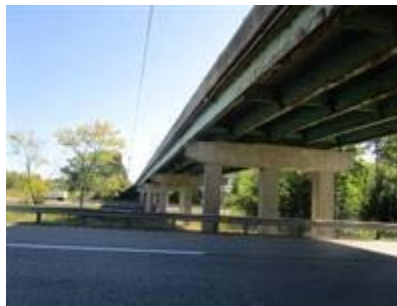
Condition Ratings: Deck = 4 Poor, Superstructure = 6 Satisfactory, Substructure = 4 Poor; Structurally Deficient.

- **Presence of fracture critical members:** No
- **Functional Classification:** Rural Minor Arterial over the NHS
- **Scour Critical:** No
- **Condition of the main structural components:** Structure is in overall poor condition. Deck bottom has scattered areas of heavy cracking & staining, and scattered delaminations (previously patched areas throughout). Moderate cracking & staining of exterior bays & fascia areas. Superstructure has 60% paint system distress with moderate rusting at high corrosion areas. Abutment bridge seat areas have moderate to isolated heavy areas of section loss and deterioration. East backwall has large spall with exposed re-steel. Piers have small areas of moderate cracking & staining.

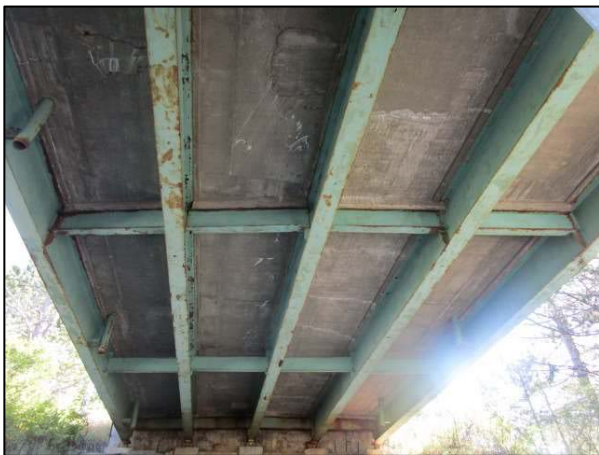
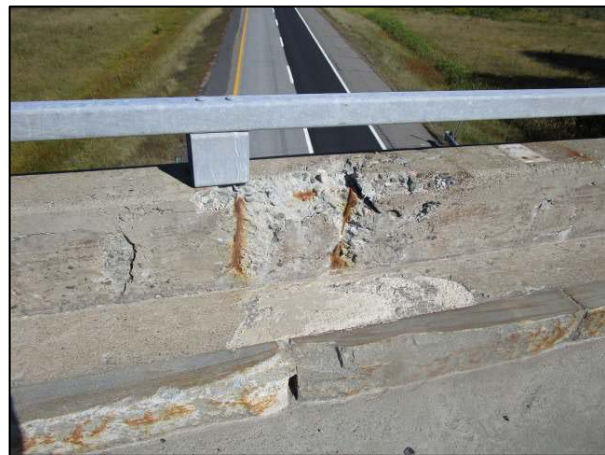
**Photos 2 & 3: Route 155/I-95 Bridge –
Scattered Cracking, Efflorescent Staining, and Delamination of Underside of Deck (left) and
Deteriorated Substandard Bridge Rail (right)**

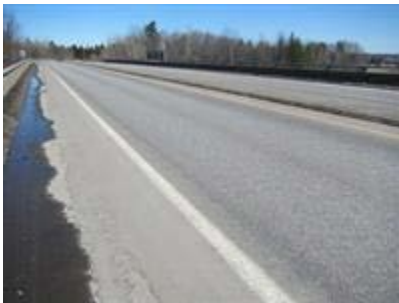
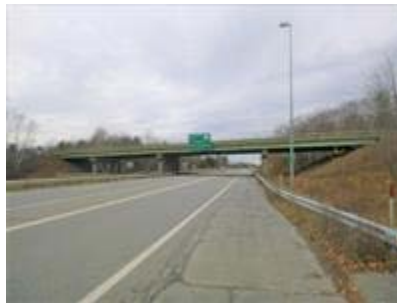
Condition Ratings: Deck = 4 Poor, Superstructure = 7 Good, Substructure = 7 Good; Structurally Deficient.

- **Date of last inspection report:** 03/19/19
- **Repair history:** Deck Rehab and Wearing surface 2004
- **Bridge Posting:** N/A
- **Traffic Safety Features:** Currently does **not meet** acceptable standards
- **Presence of fracture critical members:** No
- **Functional Classification:** Principal Arterial on NHS
- **Condition of the main structural components:** Structure is in overall poor condition. Deck bottom has 20% scattered spalls with exp. rebar, delaminations, impending spalls and repairs throughout. Superstructure has sporadic paint loss. All beam ends and bearings at abutments have almost total paint loss with minor to moderate section loss and scaling rust. Abutments have scattered minor to moderate cracking and staining. Piers are in good condition.
- **Scour:** Not scour critical

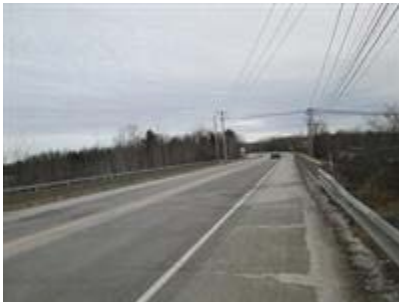
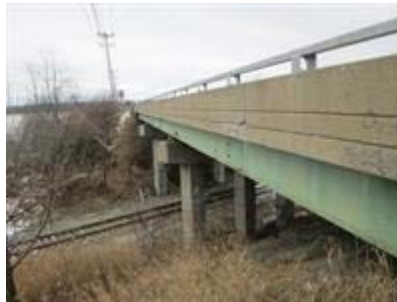
Condition Ratings: Deck = 4 Poor, Superstructure = 6 Satisfactory, Substructure = 6 Satisfactory; Structurally Deficient.

- **Date of last inspection report:** 12/02/19
- **Repair history:** Wearing surface 1988
- **Bridge Posting:** N/A
- **Traffic Safety Features:** Currently does **not meet** acceptable standards
- **Presence of fracture critical members:** No
- **Functional Classification:** Principal Arterial on NHS
- **Condition of the main structural components:** Structure is in overall poor condition. Deck bottom has moderate cracking, efflorescence and scattered delaminations. Joints are damaged. Superstructure has 20% paint system distress. Exterior girders have isolated heavy rusting to the web stiffener. Abutment backwalls and bridge seat areas are cracking and stained. Piers and columns in satisfactory condition.
- **Scour:** Not scour critical

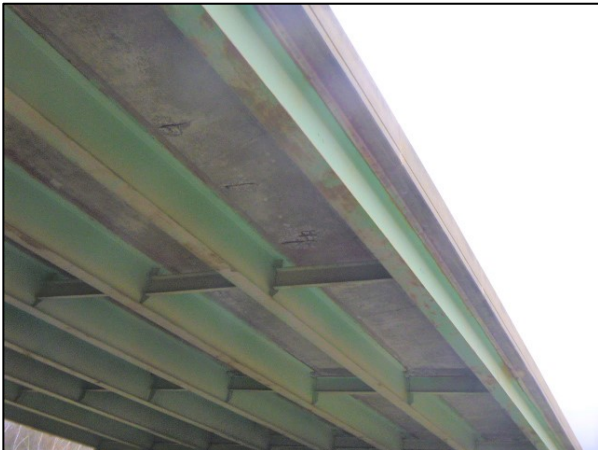
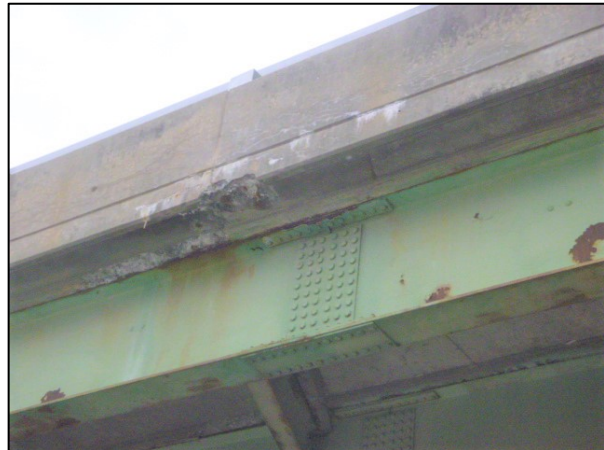
Photos 2 & 3: Route 202 over I-395 Bridge
Numerous Deck Spalls over Travel Lanes of I-395 (left) and
Spalled Deck Overhang (right)

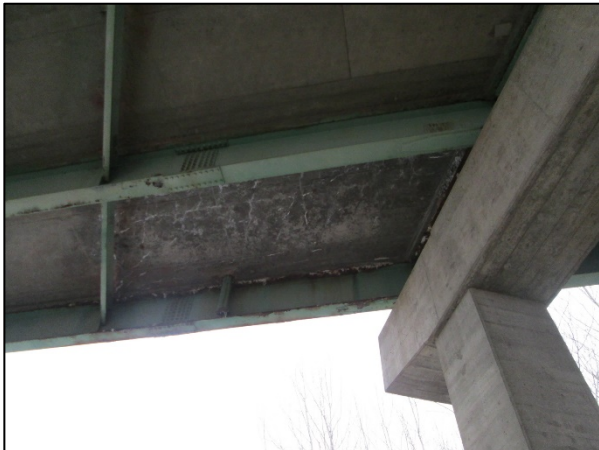
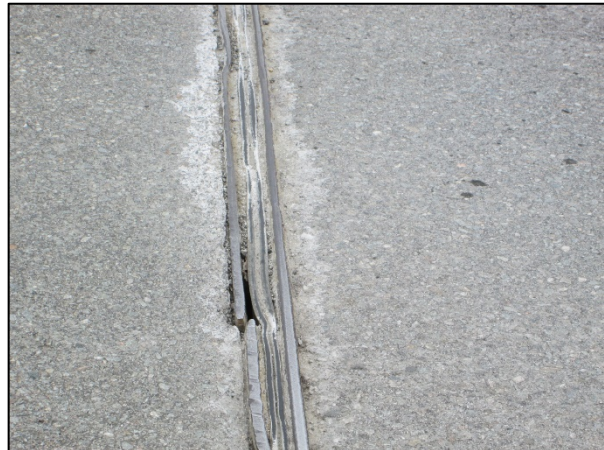
**Photos 5 & 6: Route 202 over MCR Bridge –
Deck Condition with Cracking and Efflorescence Staining (left) and
Damaged and Leaking Deck Joint (right)**

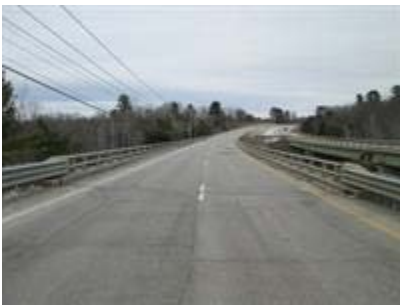
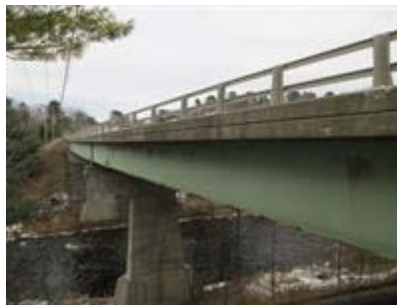
- **Date of last inspection report:** 12/02/19
- **Repair history:** Paint 1988
- **Bridge Posting:** N/A
- **Traffic Safety Features:** Currently **does not** meet acceptable standards
- **Presence of fracture critical members:** No
- **Functional Classification:** Principal Arterial on NHS
- **Condition of the main structural components:** Structure is in overall poor condition with delaminations and heavy rust stained areas on the underside of the deck. Deck fascias and exterior bays have moderate cracking and stained areas. The superstructure has 30% distressed paint and one girder has heavy section loss. The substructure has isolated heavy staining of the back walls and the bridge seat pedestals have moderate cracking. Piers are in satisfactory condition.
- **Scour:** Not Scour critical

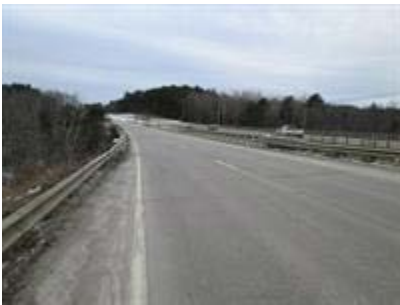
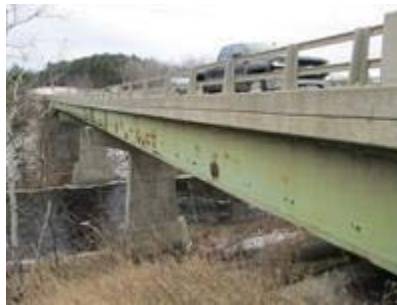
- **Date of last inspection report:** 12/02/19
- **Repair history:** N/A.
- **Bridge Posting:** N/A
- **Traffic Safety Features:** Currently does **not meet** acceptable standards
- **Presence of fracture critical members:** No
- **Functional Classification:** Principal Arterial on NHS
- **Condition of the main structural components:** Structure is in overall poor condition. The deck underside has areas of heavy staining and leakage. Joints have minor leakage. The superstructure has 30% paint system distress with moderate rusting at high corrosion areas. Beam end web areas at west end have heavy section loss and holes. Substructure has moderate to heavy staining on abutment back walls. Seats have scattered delaminations and spalling pedestals with exposed rebar. Piers are in good condition.
- **Scour:** Not scour critical.

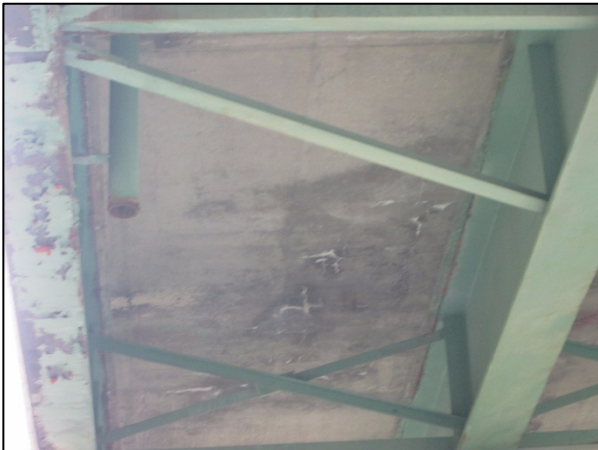
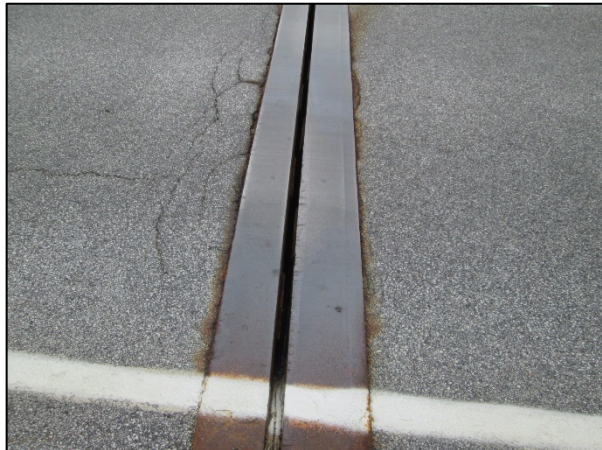
**Photos 2 & 3: Route 202/Soudabscook Stream Bridges –
Condition of Deck Underside with Cracking and Efflorescence Staining (left) and
Failed Bridge Joint (right)**

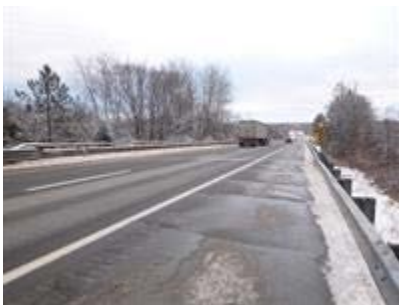
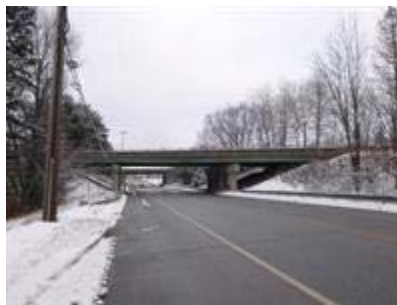
- **Date of last inspection report:** 12/18/19
- **Repair history:** Wearing Surface and Joint Repairs in 1989 and 2015. Paint in 1989. Concrete protective coating in 2018.
- **Bridge Posting:** N/A
- **Traffic Safety Features:** Currently **does not** meet acceptable standards
- **Presence of fracture critical members:** No
- **Functional Classification:** Principal Arterial on NHS
- **Scour Critical:** N/A
- **Condition of main structural components:** Structure is in overall poor condition. Deck bottom has several areas of delaminations 1-2 SF in size. Extensive fine cracking and efflorescence in last 6' of deck at both ends. 30% paint distress in superstructure. Sheet failures in web areas. In the substructure, backwalls have moderate cracking and piers have minor cracking.

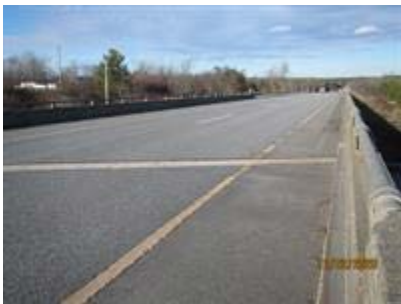
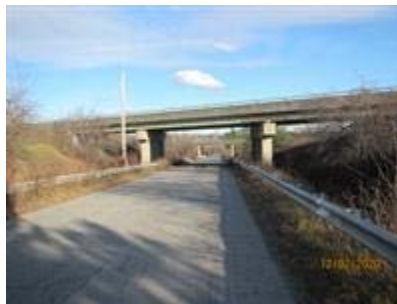
- **Date of last inspection report:** 12/02/20
- **Repair history:** deck rehabilitation and new wearing surface -1989. Paint 1991. Wearing surface and joint repairs in 2015. Concrete protective coating in 2018.
- **Bridge Posting:** N/A
- **Traffic Safety Features:** Currently **does not** meet acceptable standards
- **Presence of fracture critical members:** No
- **Functional Classification:** Principal Arterial on NHS
- **Scour Critical:** N/A
- **Condition of main structural components:** Structure is in overall poor condition. The deck bottom has areas of spalling. The superstructure has 30% paint system distress of the girders and heavy rusting of the fixed bearings. Substructure piers are in satisfactory condition and the abutments have isolated moderate to severe spalls and cracking.

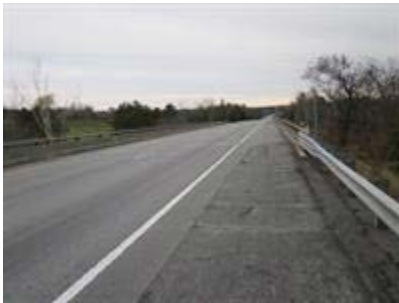
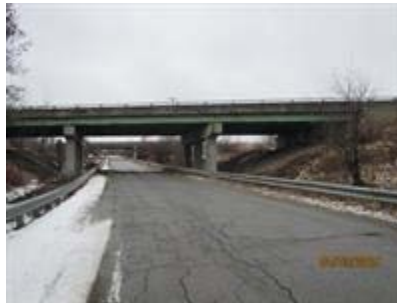
- **Functional Classification:** Rural -Principal Arterial-On NHS
- **Scour Critical:** N/A
- **Condition of the main structural components:** Structure is in overall poor condition. Deck has approximately 20% discoloration with fine map cracking areas. Small spalls and exposed reinforcing steel. Superstructure has approximately 15% paint system distress with sheet failures at exterior girders. Minor beam end paint failure and heavy rust pack on outside bearings. Substructure: abutments have moderate cracking to bearing pedestals. Minor spalling at north abutment and backwalls stained and wet.

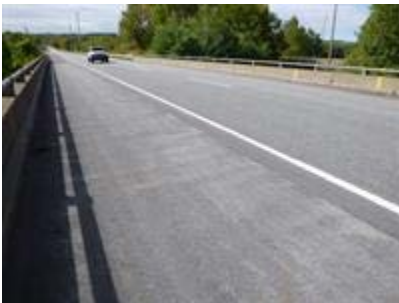
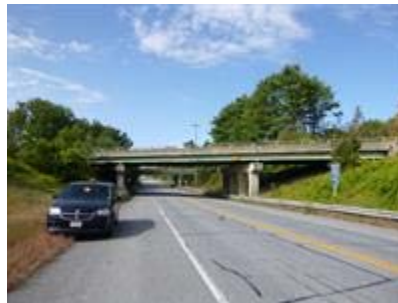
- **Date of last inspection report:** 09/18/20
- **Repair history:** Wearing Surface, 1989. Joint Replacement and wearing surface, 2017. Concrete protective coating 2018.
- **Bridge Posting:** N/A
- **Traffic Safety Features:** Currently **does not** meet acceptable standards
- **Presence of fracture critical members:** No
- **Functional Classification:** Principal Arterial on NHS
- **Scour Critical:** N/A
- **Condition of main structural components:** Structure is in overall poor condition. Deck has widely scattered delaminations and spalls with exposed reinforcing steel. Haunches have sporadic spalling. Approximately 50% paint scattered paint failures in superstructure. Beam ends and bearing have paint failures. In the substructure, abutments have scattered minor cracking and efflorescence.

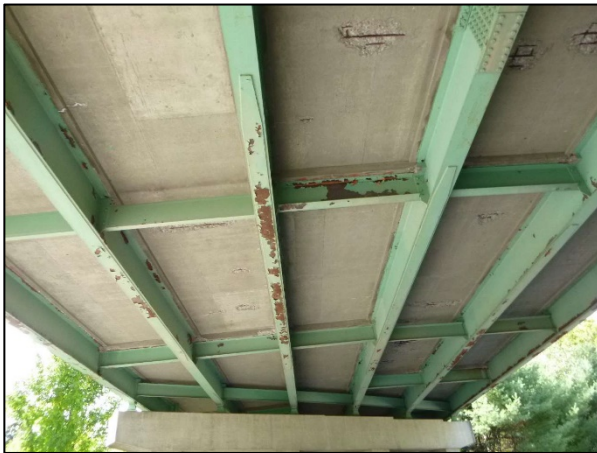
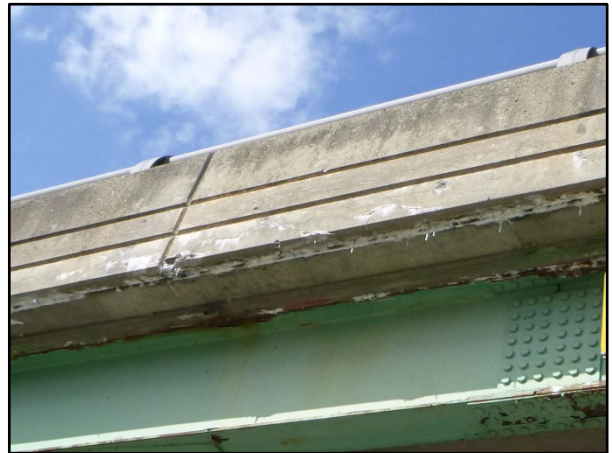
**Photos 2 & 3: I-95 NB/SB over Somerset Avenue Bridges –
Deteriorated Underside of Deck with Exposed Reinforcing Steel (left) and
Deteriorated Deck Overhang with Delaminations and Excessive Efflorescent Staining (right)**

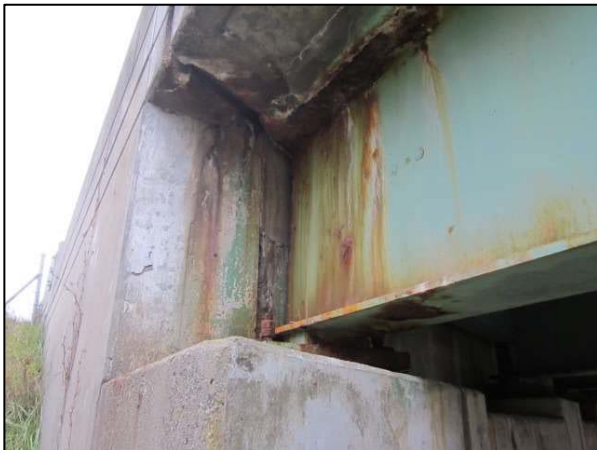
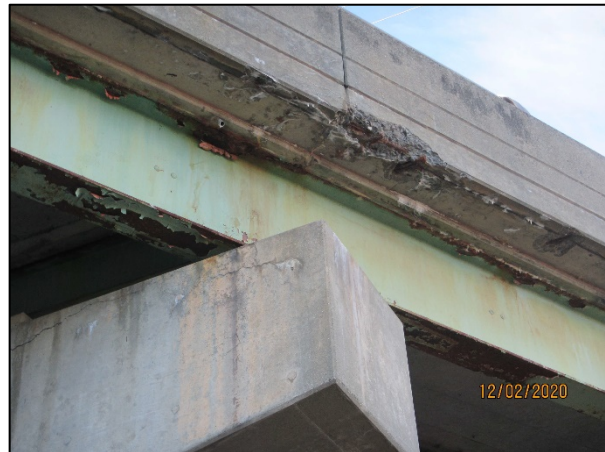
**Photos 5 & 6: I-95 NB/SB over Webb Road Bridges –
Poor Deck End and Backwall Condition due to Failed Deck Joint (left) and
Deteriorated Deck Overhang (right)**
