Lower Road Rail Corridor
RAIL USE ADVISORY COUNCIL MEETING
January 25, 2023

MaineDOT

Lower Road Rail Corridor Context

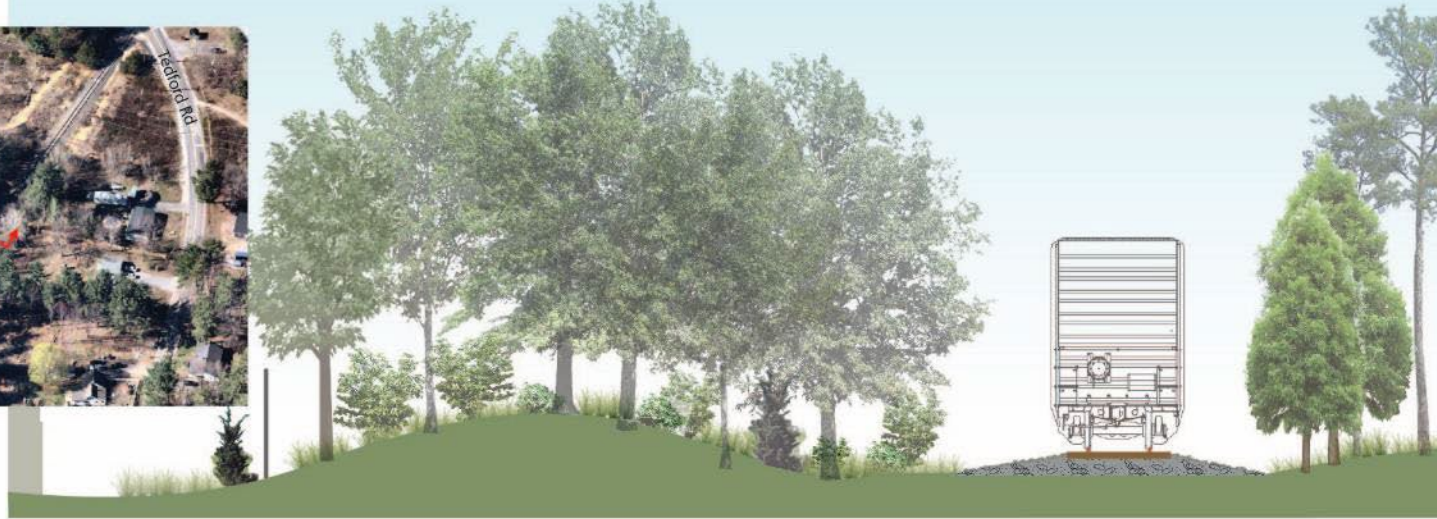
Option 1: Restoration of Rail Service

Lower Road Corridor*, Topsham
SECTION A1: View looking north adjacent to Tedford Rd. (between Tedford Rd. and Rt. 196.)

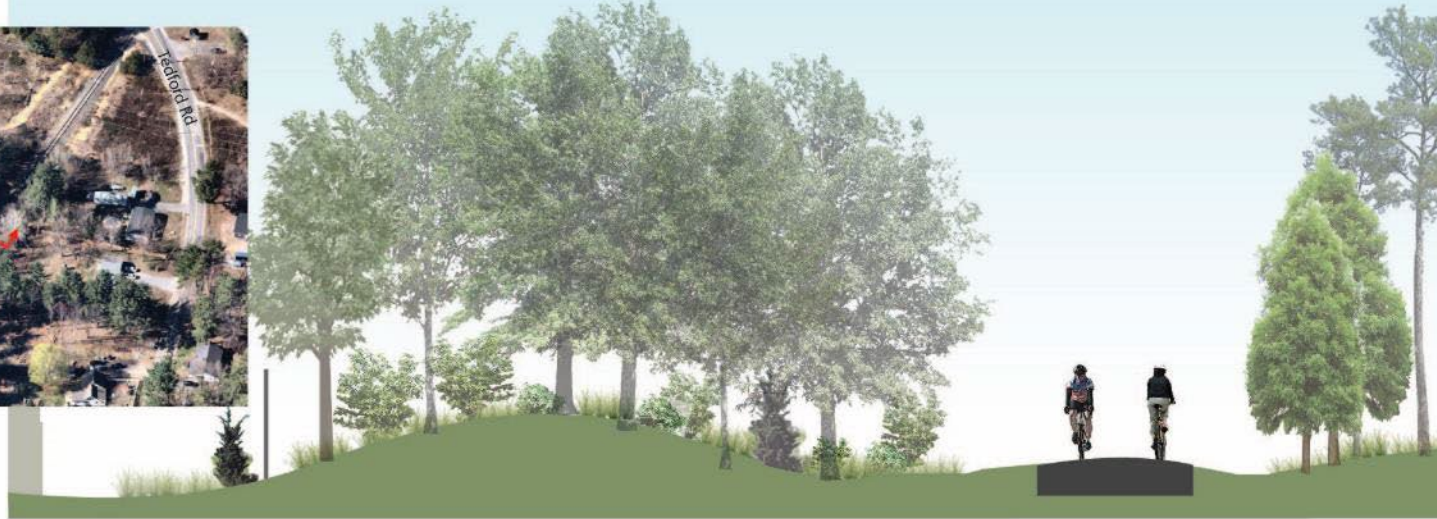
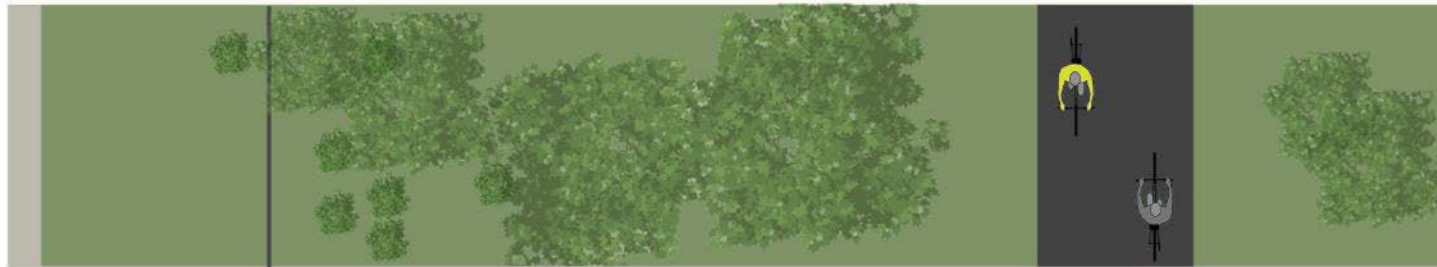
Lower Road Corridor*, Topsham
SECTION A2: View looking north adjacent to Tedford Rd. (between Tedford Rd. and Rt. 196.)

Option 2: Trail Until Rail

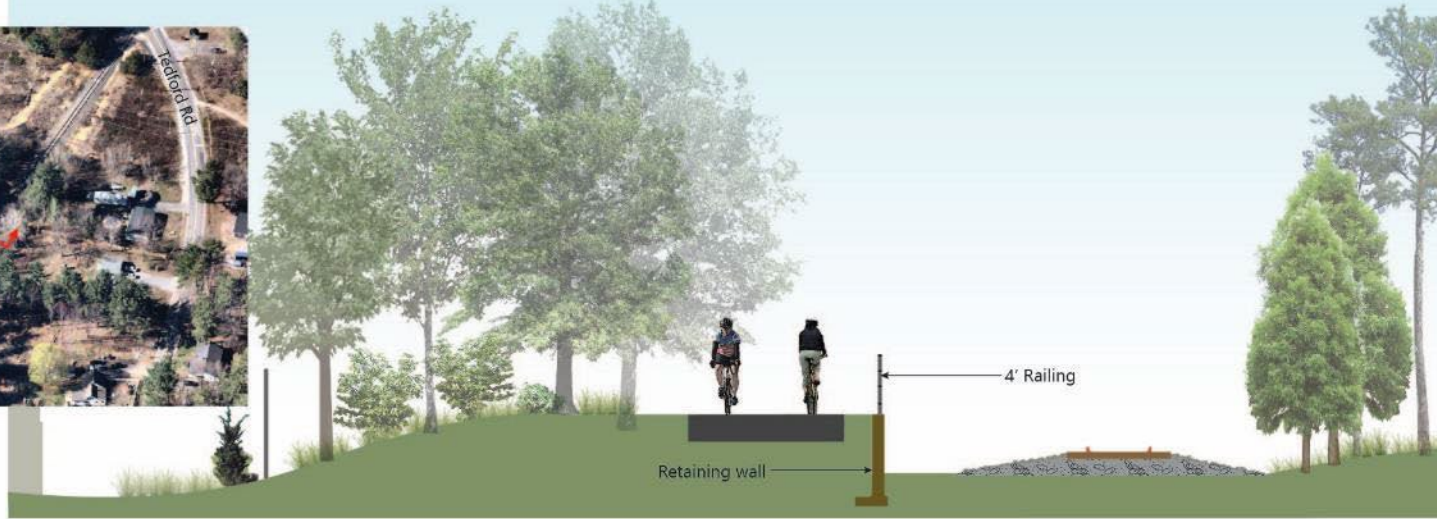
SECTION A3: View looking north adjacent to Tedford Rd. (between Tedford Rd. and Rt. 196.)

Option 3: Rail with Trail

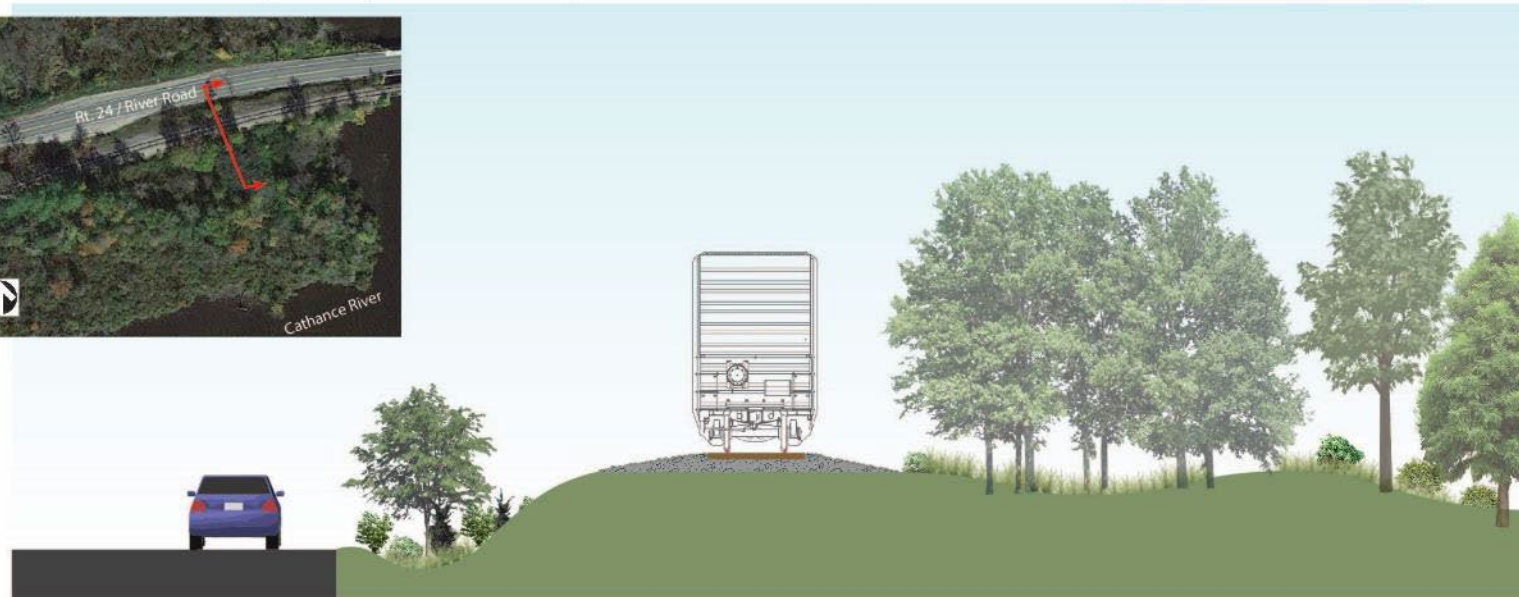
Option 1: Restoration of Rail Service

SECTION B1: View looking north adjacent to River Rd. (just north of Cathance River)

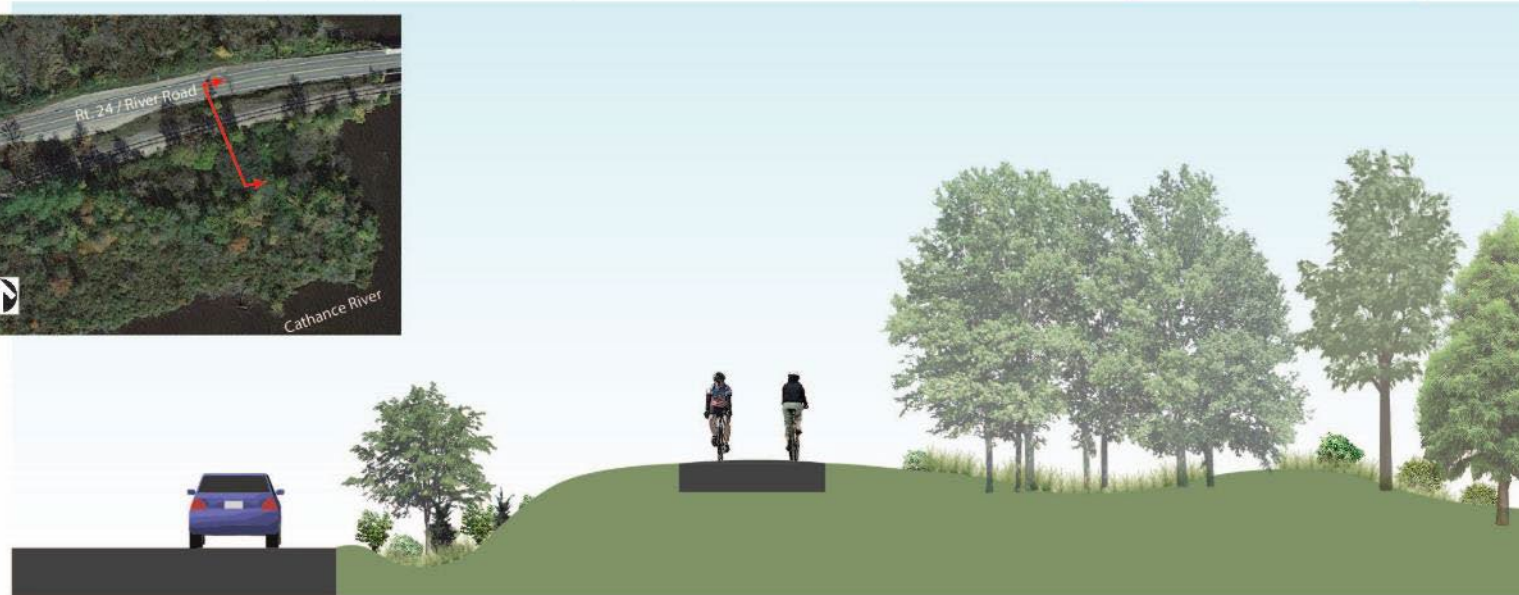
Option 2: Trail Until Rail

Lower Road Corridor*, Bowdoinham
SECTION B2: View looking north adjacent to River Rd. (just north of Cathance River)

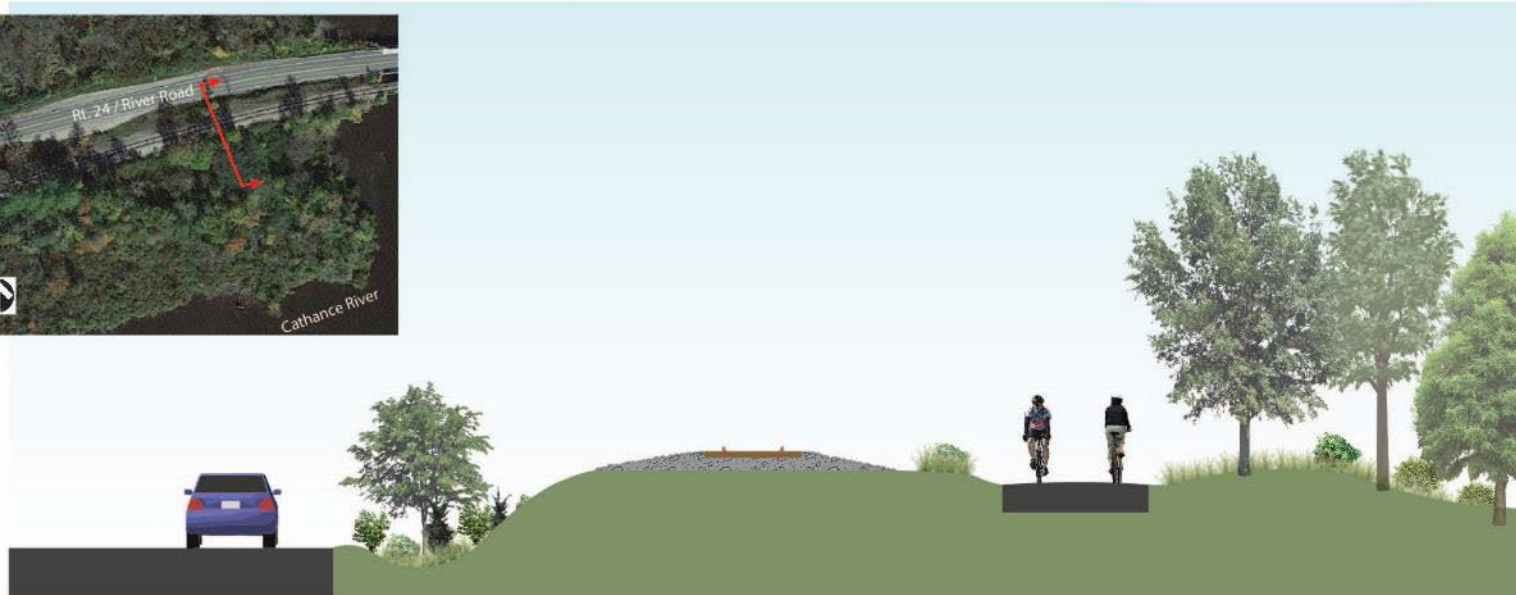
Lower Road Corridor*, Bowdoinham
 SECTION B3: View looking north adjacent to River Rd. (just north of Cathance River)

Option 3: Rail with Trail

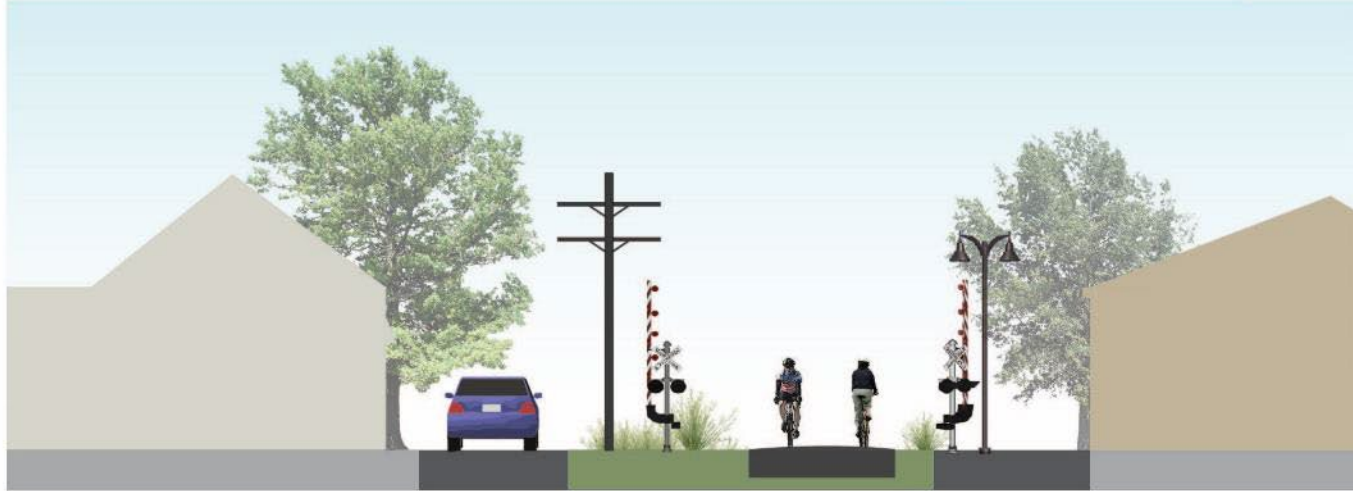
SECTION C2: View looking north adjacent to Summer Ln. (between Main St. and Kimball St.)

Option 2: Trail Until Rail

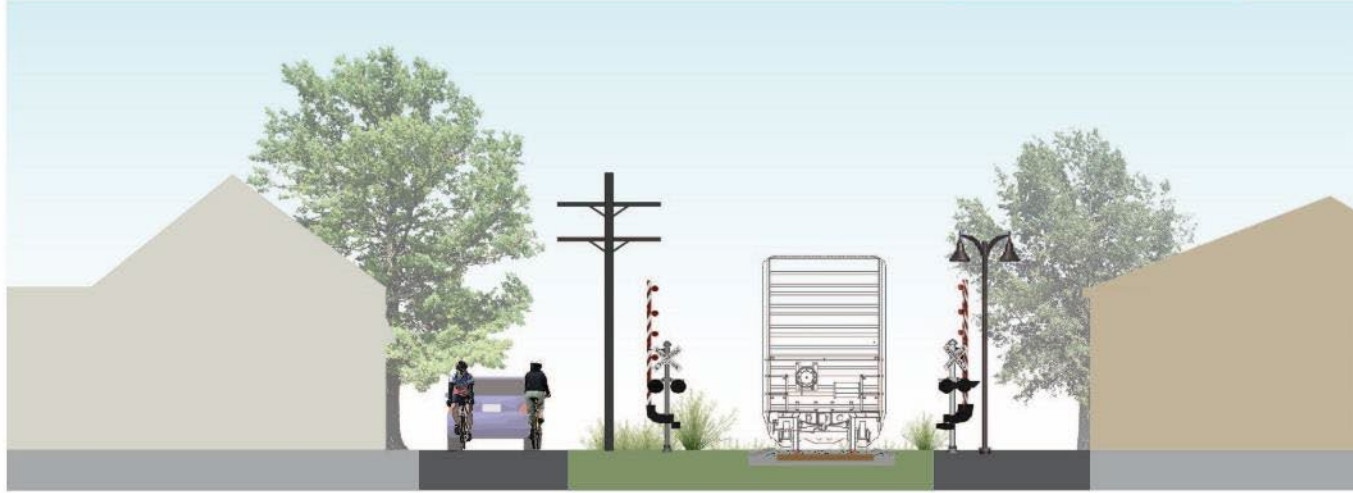
SECTION C3: View looking north adjacent to Summer Ln. (between Main St. and Kimball St.)

Option 3: Rail with Trail

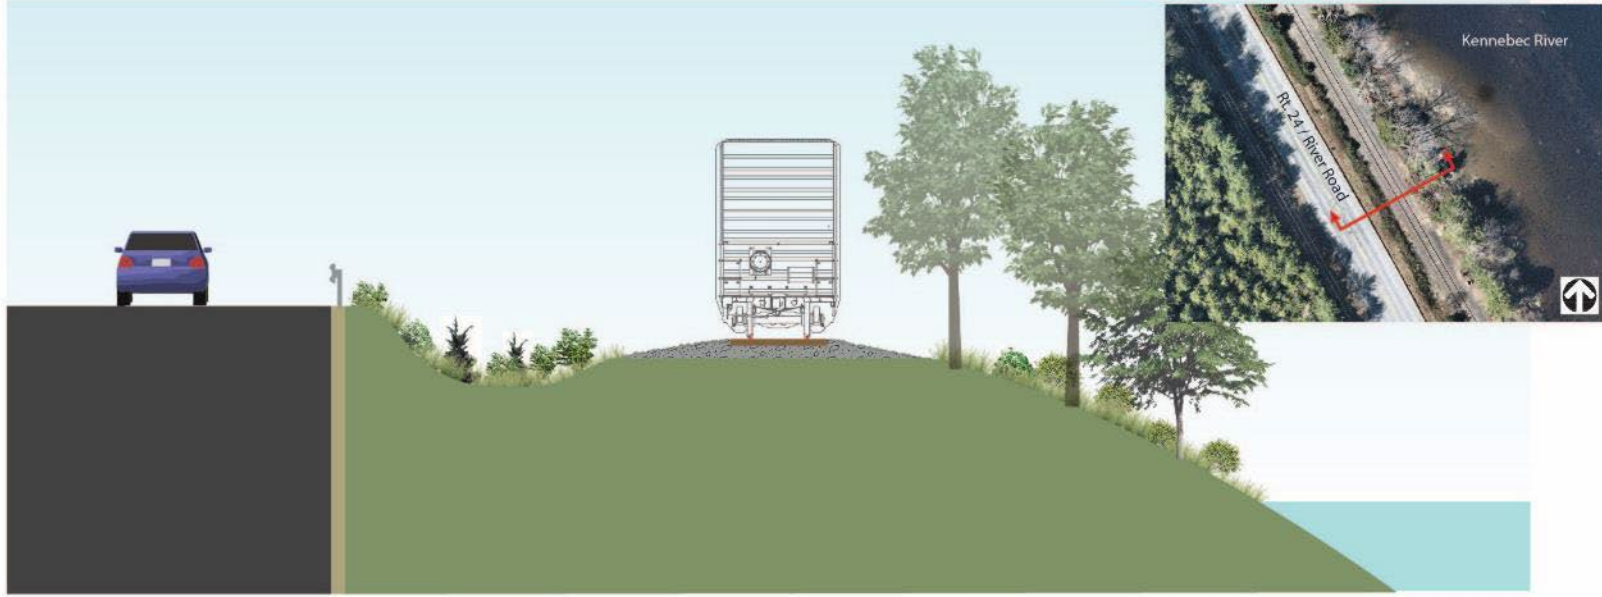
Option 1: Restoration of Rail Service

Lower Road Corridor*, Gardiner
SECTION D1: View looking north adjacent to Rt. 24/River Rd. and Kennebec River

~30' to edge of road

~35' to edge of river

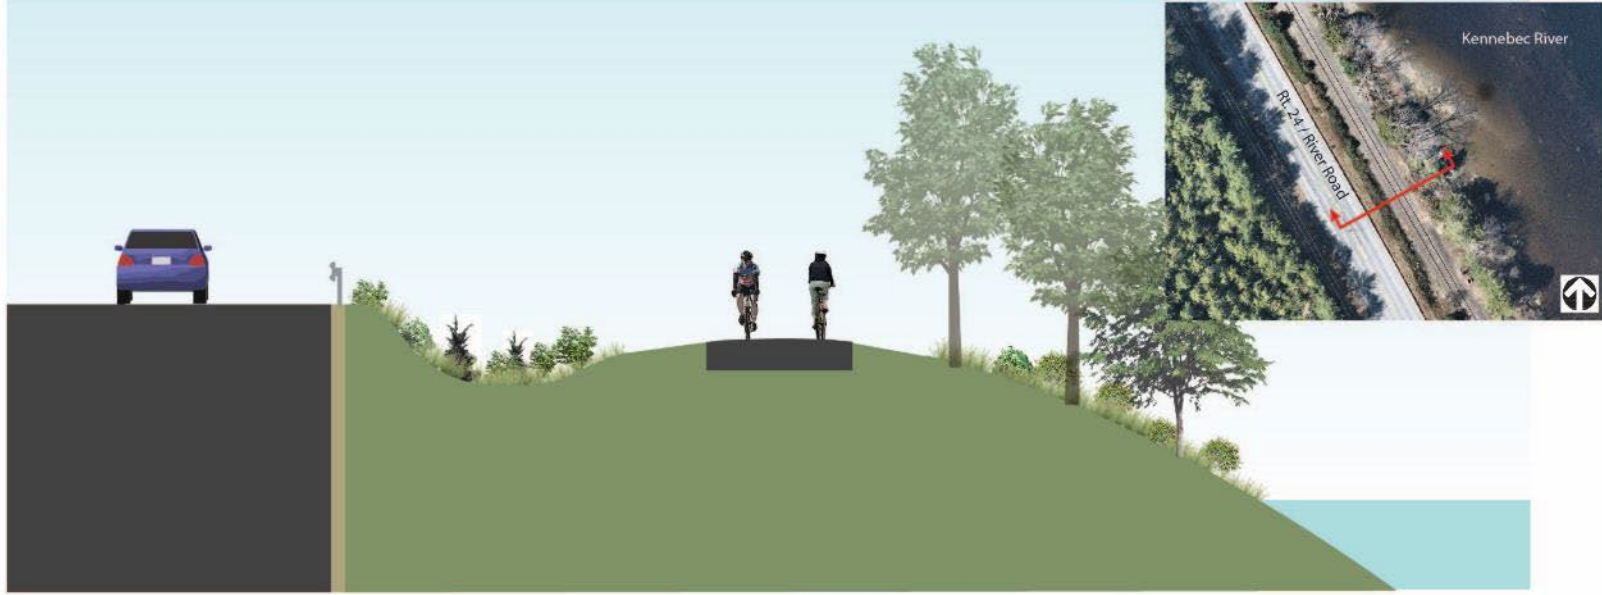
Option 2: Trail Until Rail

Lower Road Corridor*, Gardiner
SECTION D2: View looking north adjacent to Rt. 24/River Rd. and Kennebec River

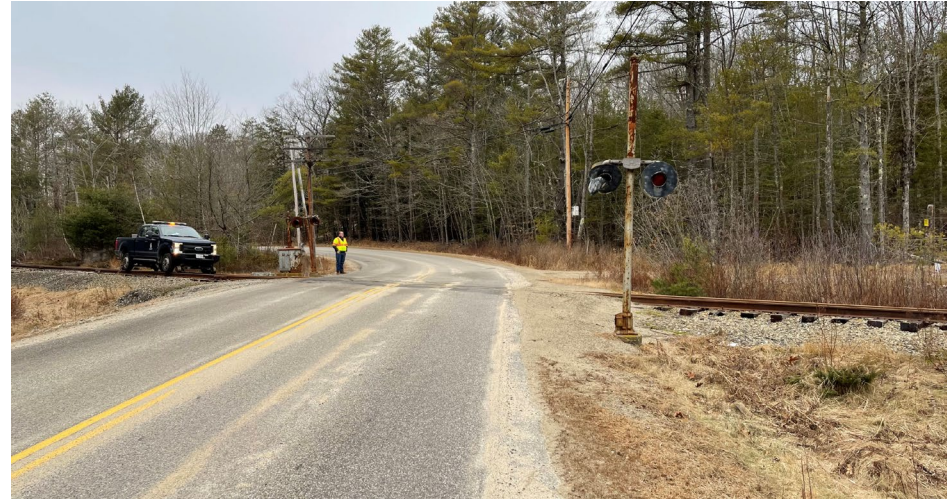
Browns Point Road – Bowdoinham (Old AHCW Devices)

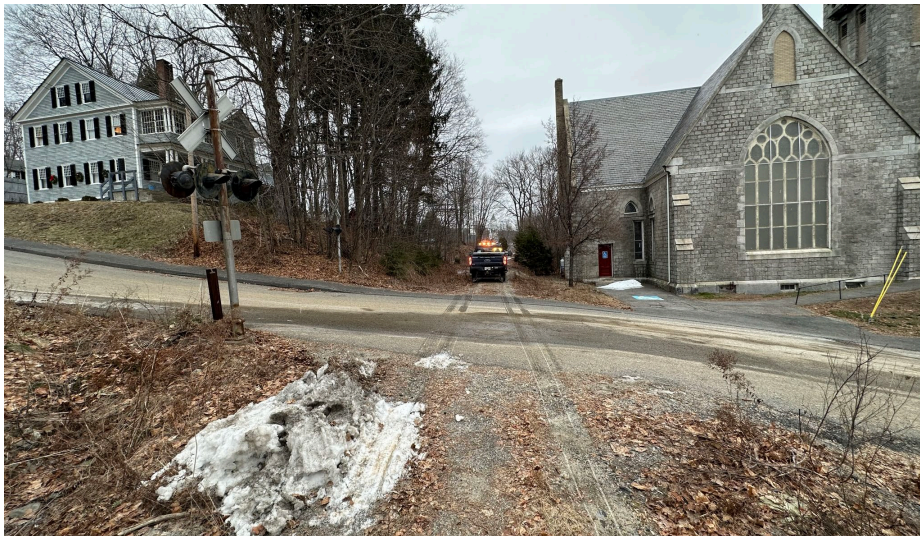
Chestnut St. crossing, Hallowell (Roadway Grade)

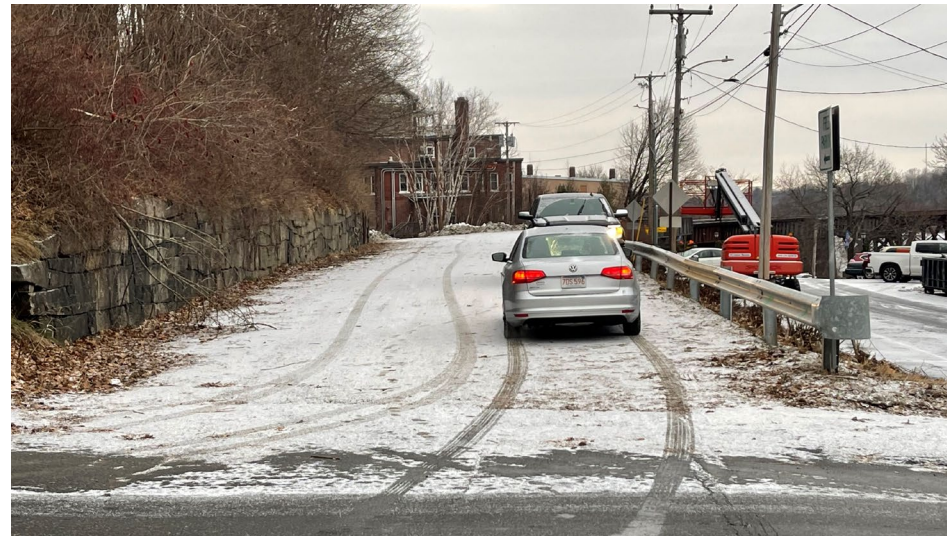
Bridge Street / Parking Area – Augusta (Tracks Removed)

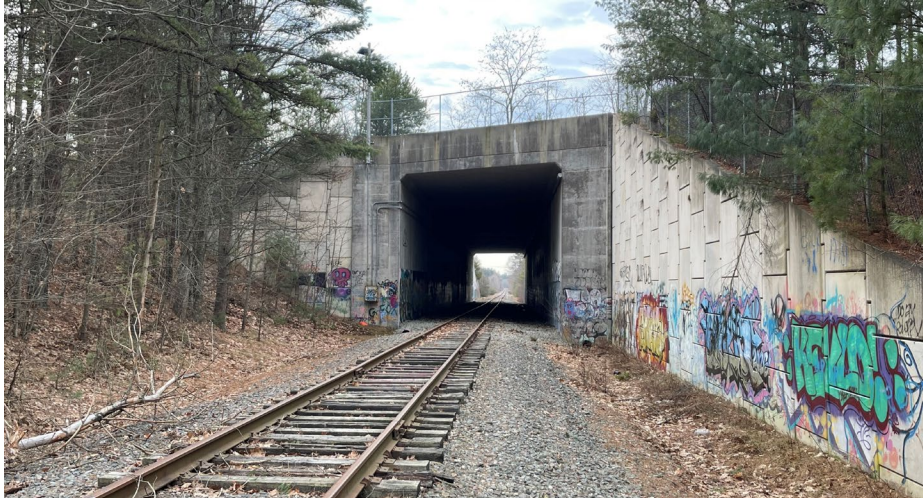
Route 196 – Topsham (Single Track Bridge)

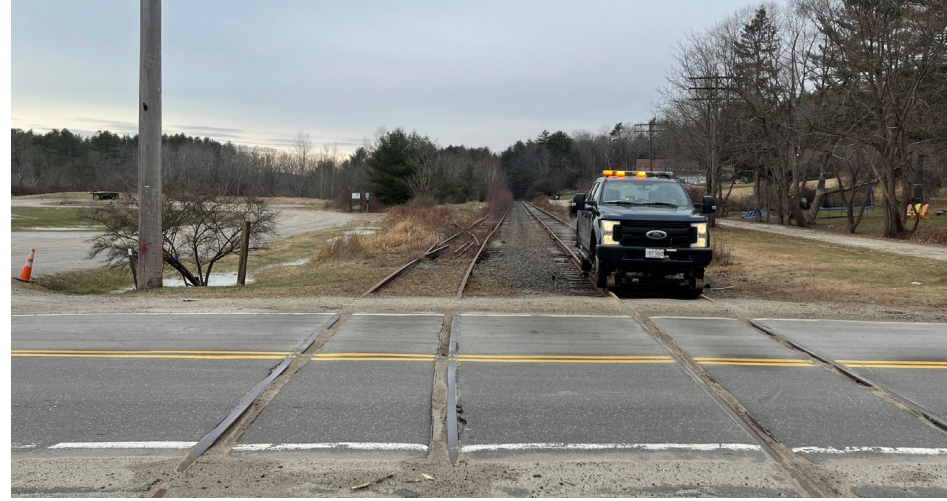
Center Street– Bowdoinham (Former 2 Track ROW)

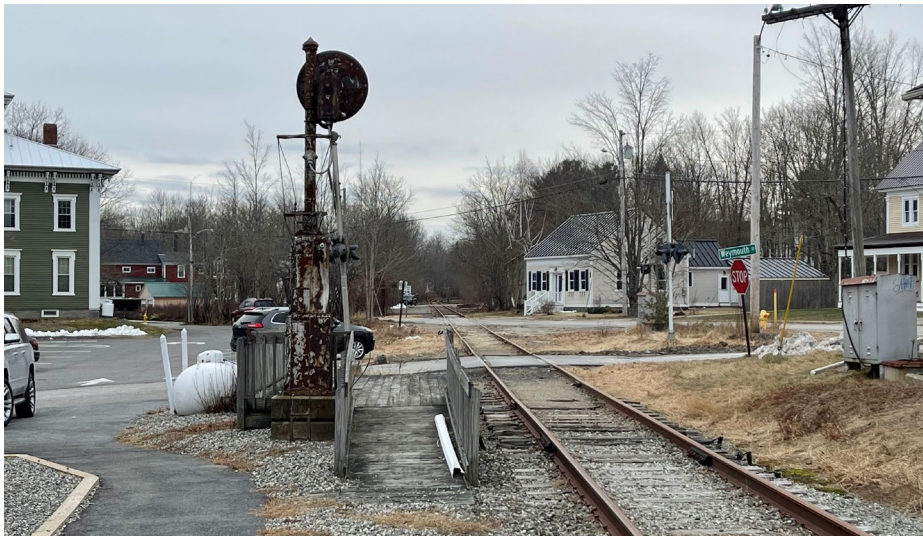
Weymouth Road – Richmond (Former Platform & Signal)

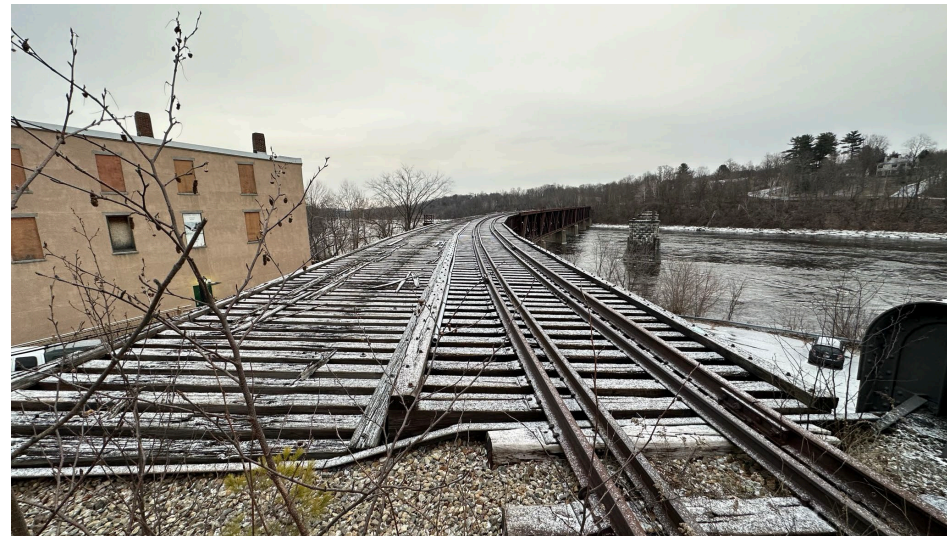
Kennebec River Bridge – Augusta (OOS - 1 Track Removed)

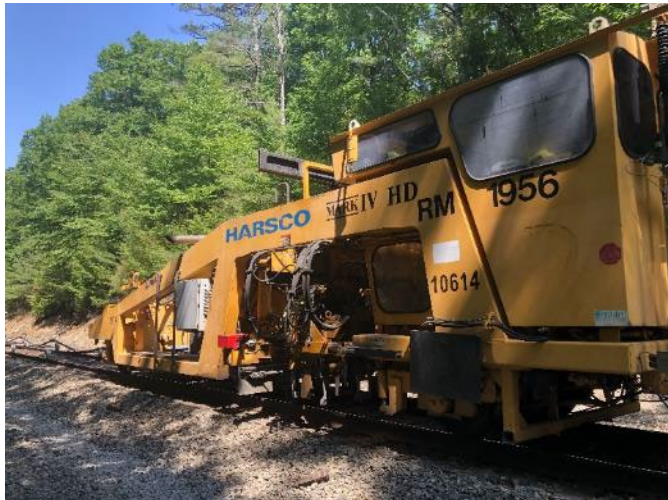
Tamper for Track Surfacing

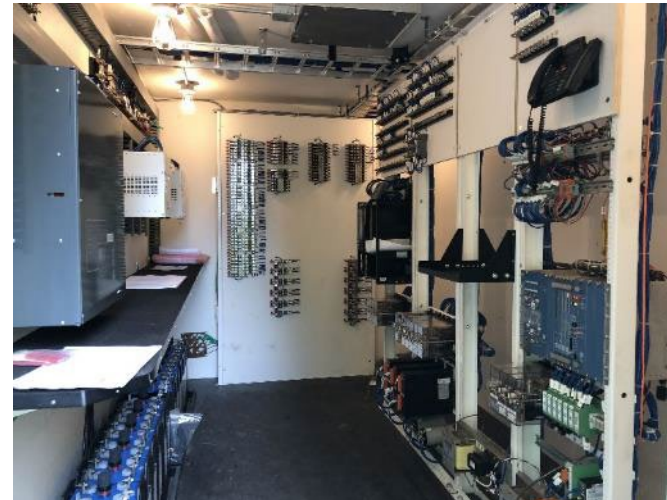
Signal Bungalow Interior
