Maine Department of Transportation

Pavement Condition Report

DEWITT FIELD OLD TOWN MUNICIPAL AIRPORT (KOLD)

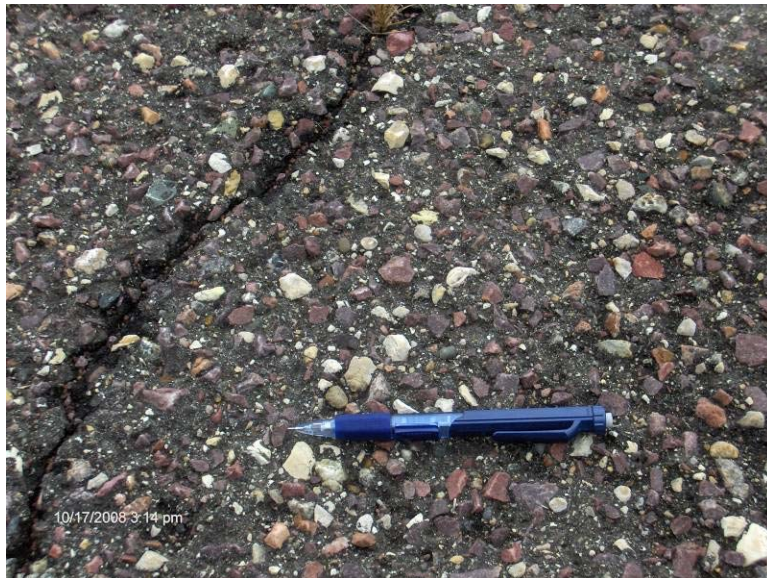
Example of Raveling/Weathering

Raveling and weathering are the wearing away of the pavement surface. Raveling is the condition where the mid- to large size aggregates are becoming dislodged; weathering is when the fine aggregate wears away exposing the edges of the larger aggregate. These distresses are usually evident over large areas and may occur together (pictured above) or separately. Raveling and weathering may indicate that the asphalt binder has hardened significantly.

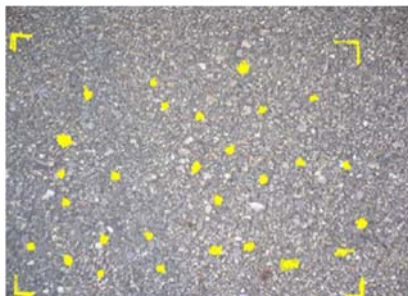
Raveling – At low severity, the number of missing coarse aggregates (> 3/8 inch) is between 5-20 missing/yd², medium severity (pictured below where the missing coarse aggregates have been dotted with yellow paint) is 21-40 missing/yd², and high severity is > 40 missing/yd².
