Geologic Site of the Month
November, 2007

Brunswick, Maine Patriots' Day 2007 Landslide

Text by
Michael E. Foley

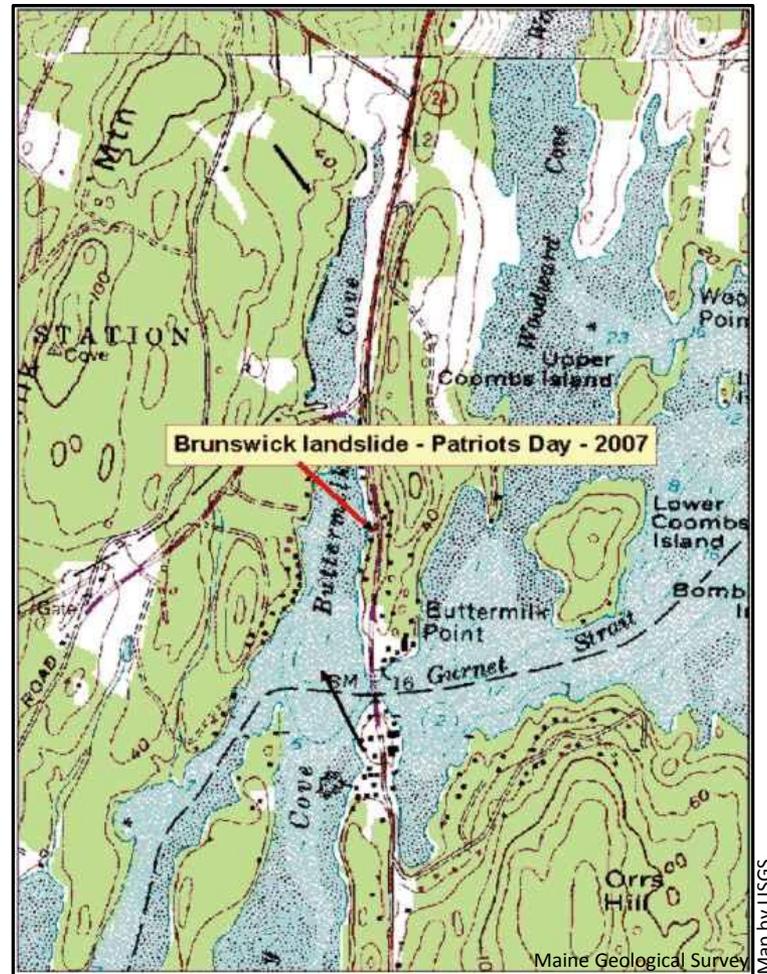
The slide occurred along a steep bluff (Bryant and others, 2002) adjacent to Route 24 (Gurnet Road) (Figure 3). The bluff top was about 30 feet above sea level (Figure 1, Right).

Figure 3. Topographic map showing location of the April 16, 2007 landslide in Brunswick.

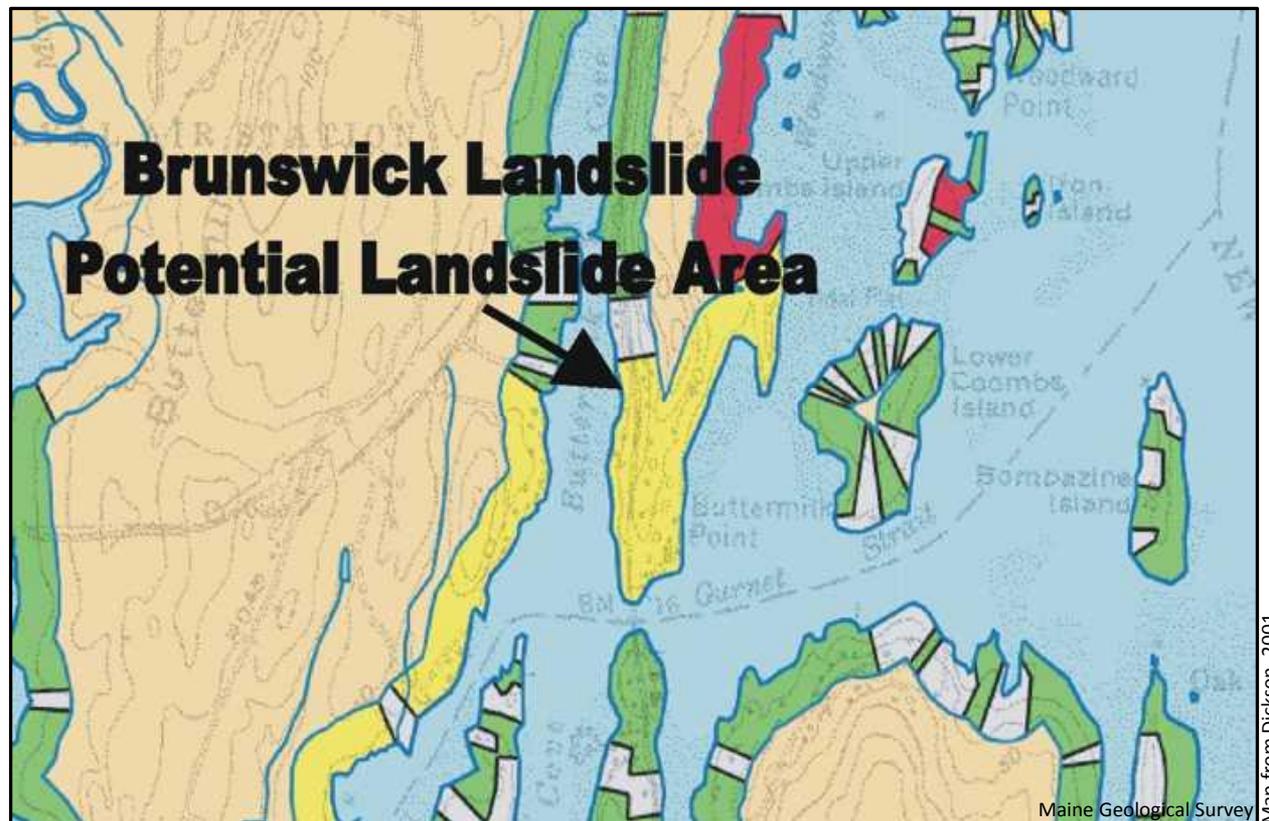
This shoreline has been mapped by the Maine Geological Survey as a "Potential Landslide Area" (Dickson, 2001; Figure 4).

Figure 4. Brunswick landslide located in the yellow map unit, a Maine Geological Survey "Potential Landslide Hazard Area."
