October 19, 2021

Project 171.06108.011

RE: Asbestos Conditions Assessment
Mason Station
Wiscasset, Maine

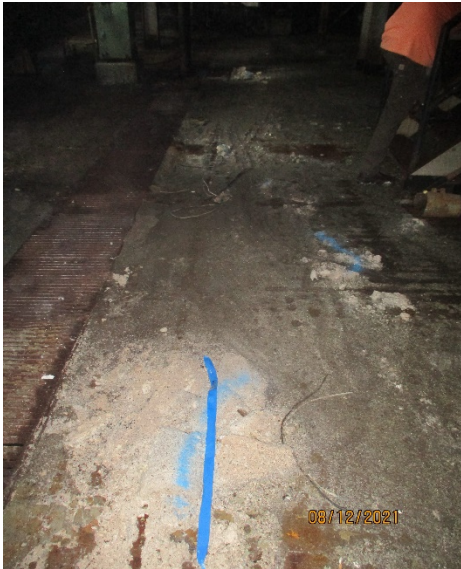
Photo 1&2-26: Non-ACM by Analysis
