Final Report
Docket No. 2005-705
CMP Distribution Plant Evaluation

M*aine Public Utilities Commission*
P
U
C

February 26, 2007

Williams Consulting, Inc.

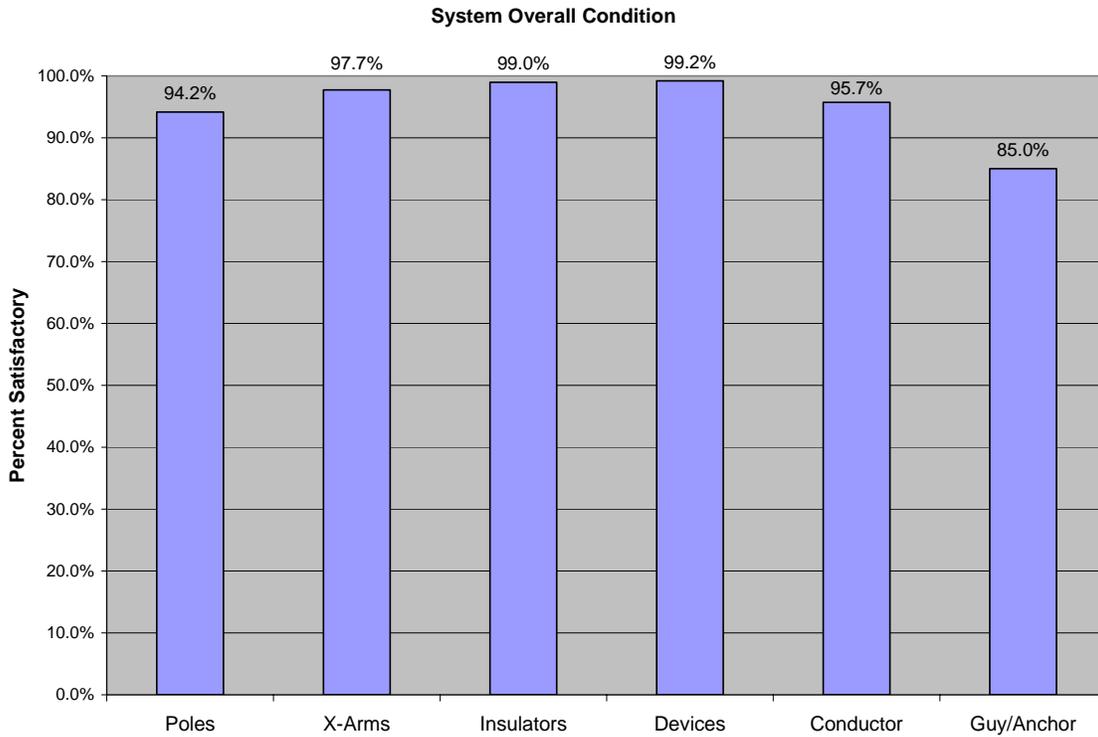
CMP's distribution system appears to be in good condition electrically and mechanically based on the inspection results shown below:

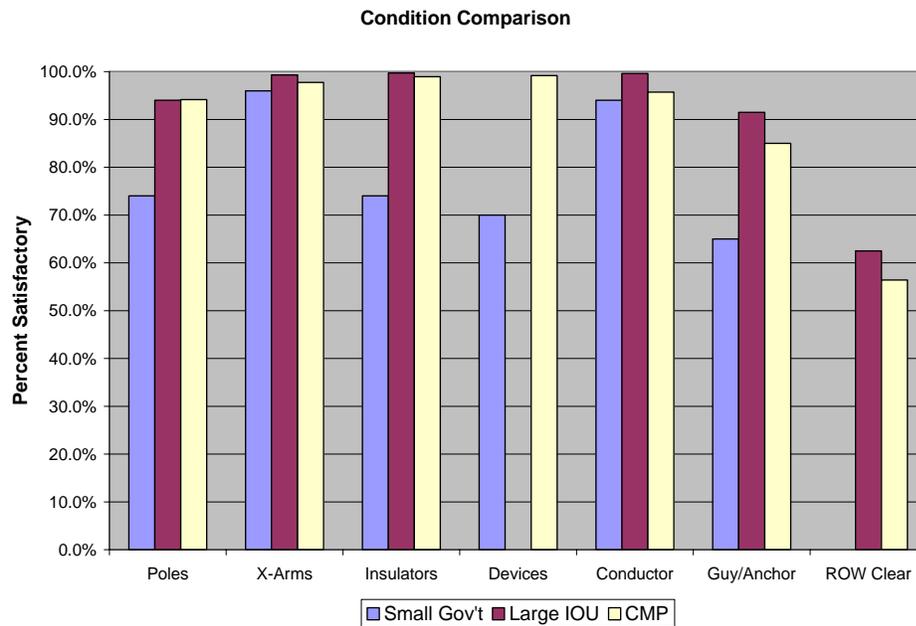
Excluding the status of its vegetation management, CMP's overhead electric distribution system condition compares favorably with several other utilities¹² for which we have conducted condition assessments:

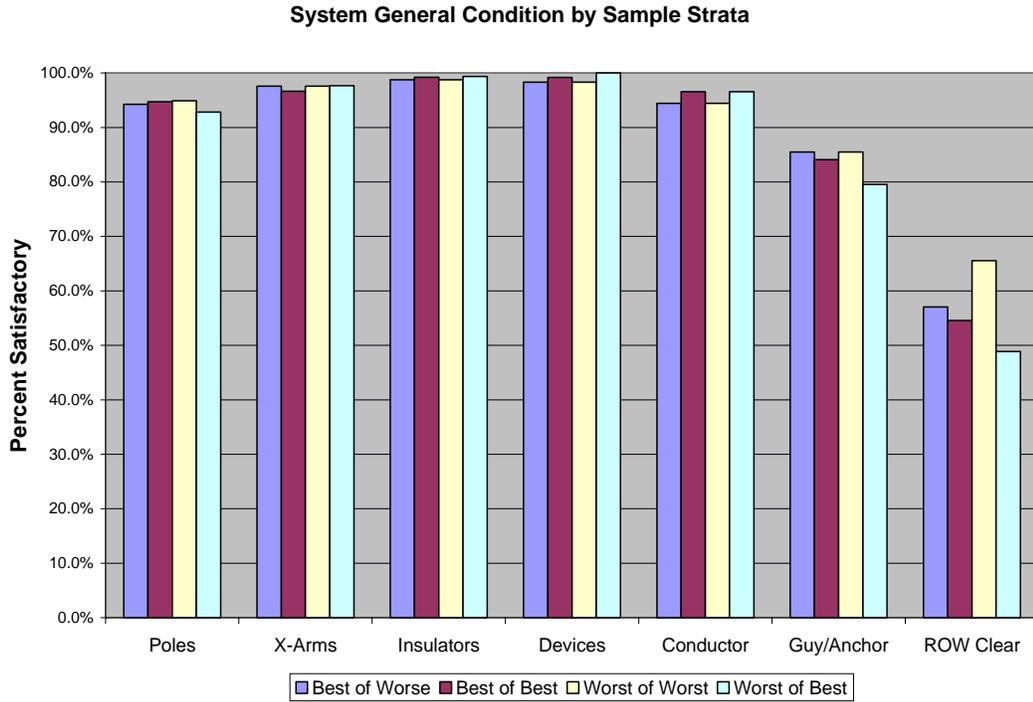
The following charts depict distribution system condition broken out by sample strata and by single-phase and three-phase circuits, which we believe are representative of CMP's service area. Therefore, we conclude that the system mechanical and electrical condition is generally uniform across the service area. The percent of ROW that is clear of vegetation, or where vegetation is more than 8 feet away from the conductor, varies within the sample strata from 49% to 65%.

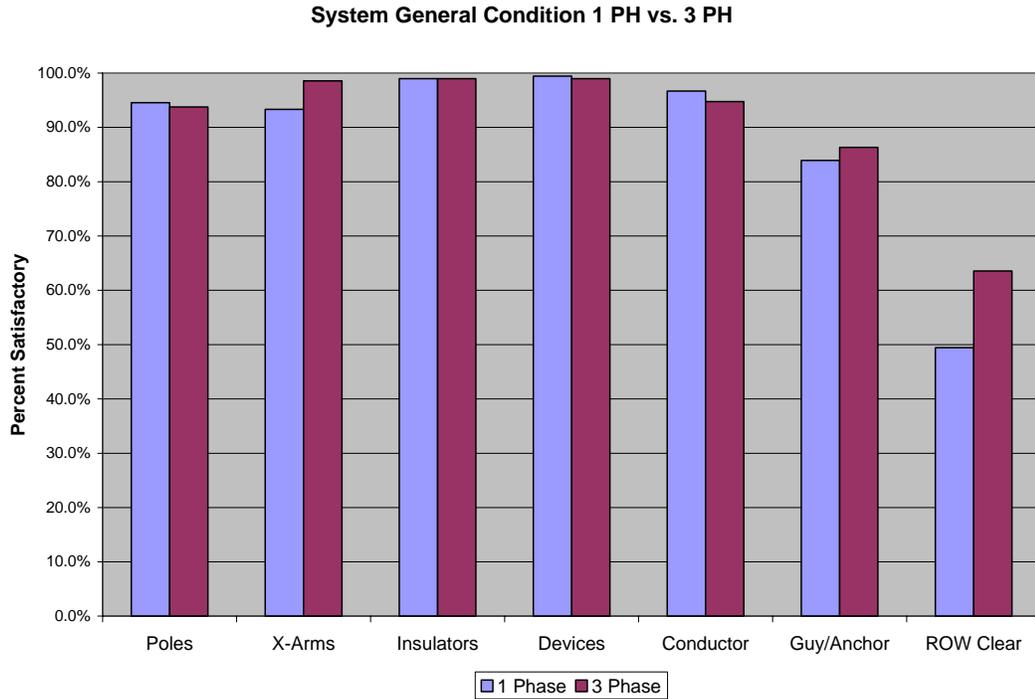
For single-phase vs. three-phase, as shown in the chart below, the three-phase sample circuits at 63.3% clear of vegetation encroachment were significantly better than the single-phase sample circuits at only 49.4% clear. This is in line with our expectations and indicates that more tree-related outages could be expected to occur on single-phase circuits.

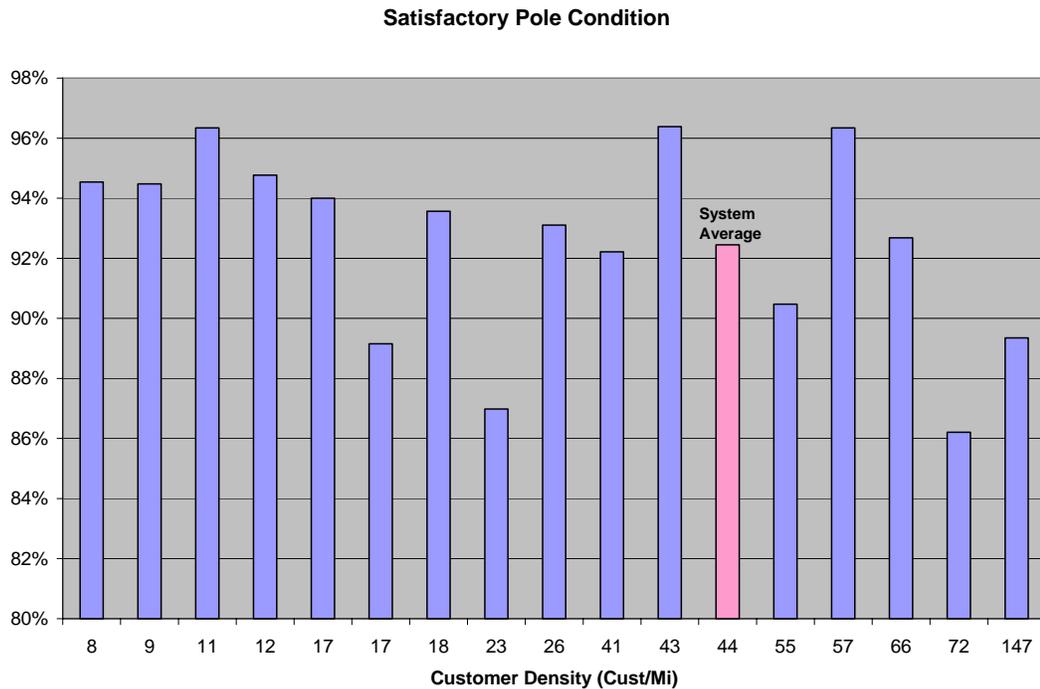
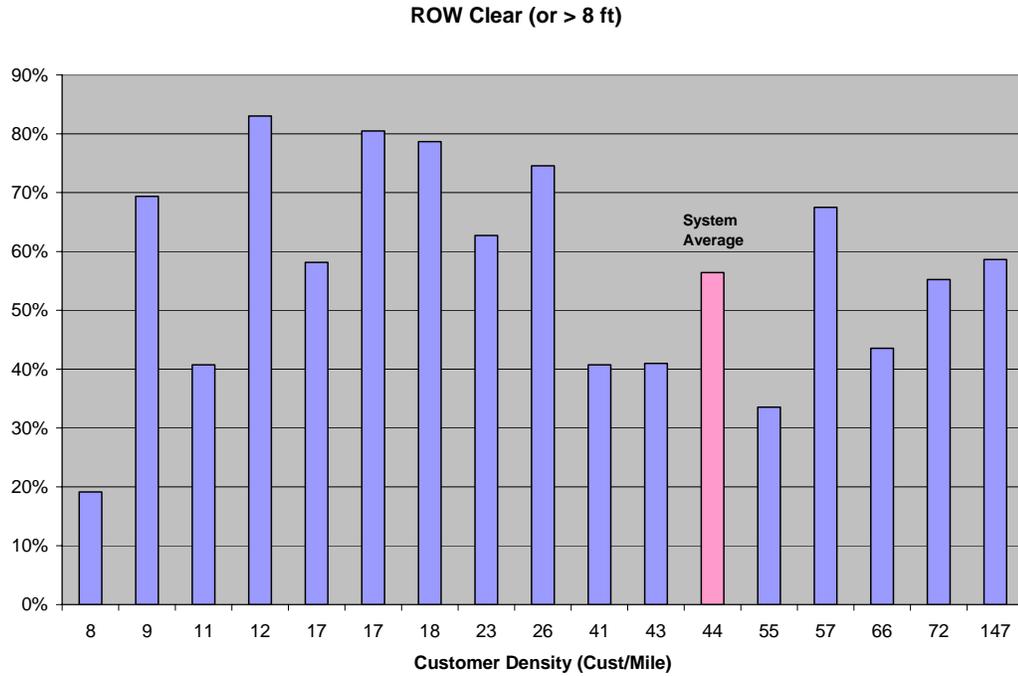
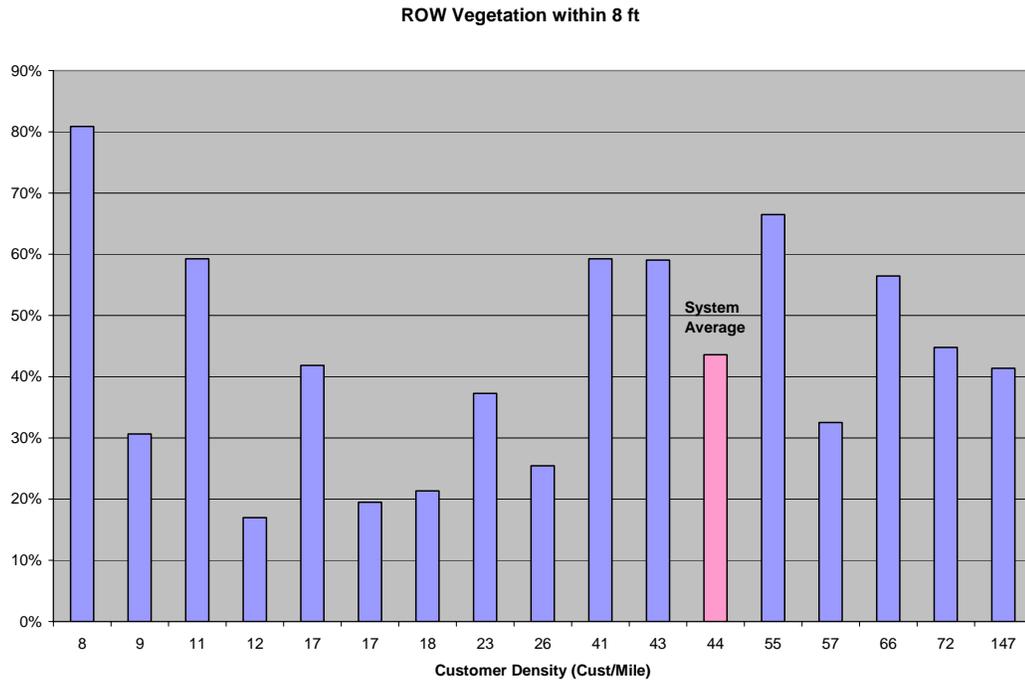
As depicted on the following charts, the results indicate that system condition is fairly uniform across various customer densities. While there are differences in satisfactory pole condition and vegetation clearance (for example), we do not detect any bias toward less dense circuits.
