Appendix G
Project Summaries

Project Description – Interstate 95 over Webb Road Bridges in Waterville

Originally constructed in 1959, the bridges carrying Interstate 95 northbound and southbound over Webb Road in Waterville Maine are functionally obsolete with advanced deterioration and require complete replacement. Interstate 95 is the primary highway corridor in Maine, and any disruption to traffic on this vital transportation link has a severely negative impact to the movement of freight, mobility of residents, and viability of businesses throughout Maine. Compounding the importance of these structures is their rural location, with limited viable detour options. Any disruption to traffic along this corridor creates negative impacts throughout the local community, including two nearby colleges (Thomas College and Colby College) which utilize these bridges.

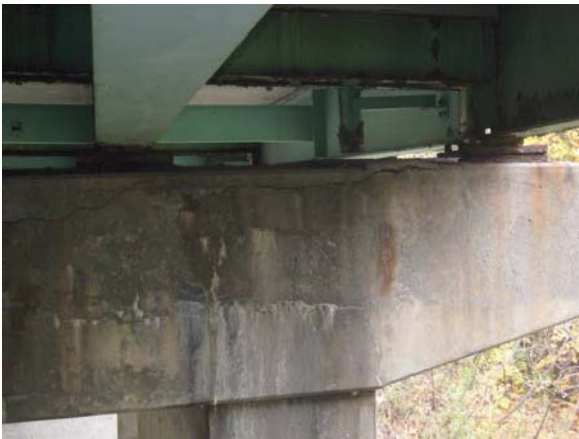
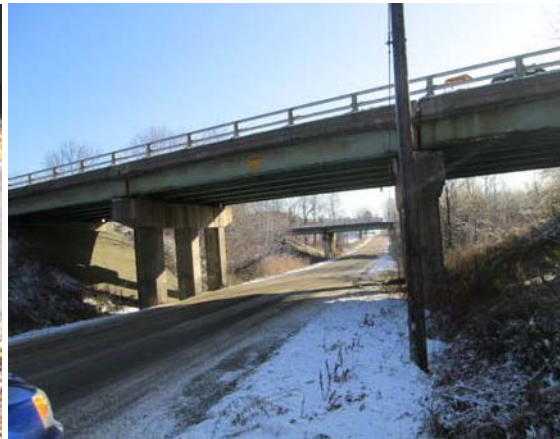
Bridge #1461- Carries I-95 SB over Webb Road in Waterville.

Bridge Structure: Multi steel beam, 2 lane roadway with concrete deck and bituminous concrete wearing surface. 138' long by 40.4' wide, curb to curb.

Condition Ratings: Deck = 6 Satisfactory, Superstructure = 5 Fair, Substructure = 5 Fair

- **Date of last inspection report:** 11/13/19
- **Repair history:** Reconstructed 1989
- **Bridge Posting:** N/A
- **Traffic Safety Features:** does **not** meet currently acceptable standards
- **Presence of fracture critical members:** No
- **Functional Classification:** Urban - Principal Arterial – Interstate, on NHS
- **Bypass detour length:** 1 mile; moderate to severe impact
- **ADT:** 15,250 vehicles, volume of heavy truck traffic: 5%
- **Condition of the main structural components:** Structure is in overall fair condition with moderate deterioration of steel superstructure and its protective coating. Substructure, slope protection and bearing deterioration.
- **Scour:** N/A
- **Economic impacts:** major impact
- **Is located on:** NHS and STRANET
- **Replacement Cost Estimate:** \$5,411,000

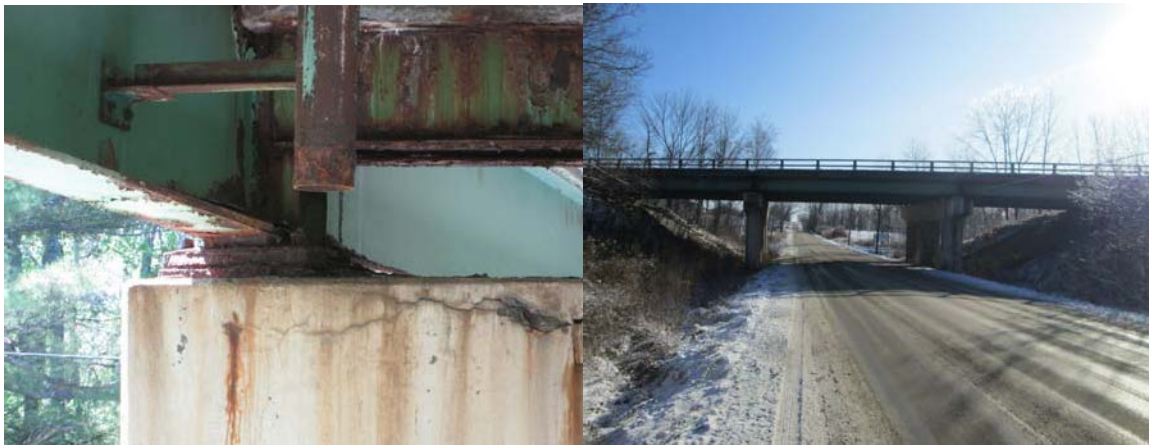
- **Date of last inspection report:** 11/13/19
- **Repair history:** Reconstructed 1989
- **Bridge Posting:** N/A
- **Traffic Safety Features:** does **not** meet currently acceptable standards
- **Presence of fracture critical members:** No
- **Functional Classification:** Urban - Principal Arterial – Interstate, on NHS
- **Bypass detour length:** 1 mile; moderate to severe impact
- **ADT:** 15,150 vehicles, volume of heavy truck traffic: 5%
- **Condition of the main structural components:** Structure is in overall fair condition with moderate deterioration of steel superstructure and its protective coating. Substructure and bearing deterioration. Exposed rebar on deck.
- **Scour:** N/A
- **Economic impacts:** major impact
- **Is located on:** NHS and STRANET
- **Replacement Cost Estimate:** \$5,411,000

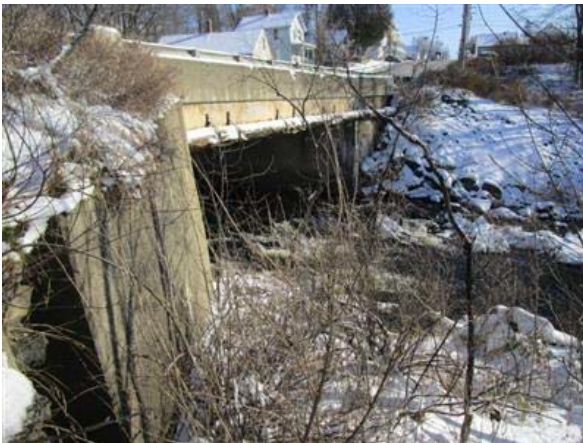
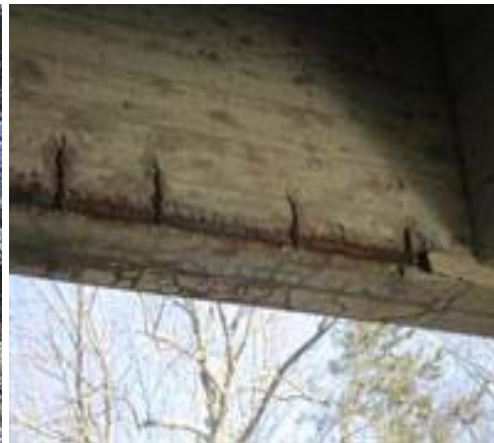
- **Date of last inspection report:** 11/13/19
- **Repair history:** wearing surface replaced in 1976.
- **Bridge Posting:** N/A
- **Traffic Safety Features:** does **not** meet currently acceptable standards
- **Presence of fracture critical members:** No
- **Scour Critical:** No
- **Functional Classification:** Rural - Principal Arterial – Interstate, on NHS
- **Bypass detour length:** greater than 100 miles; moderate impact
- **ADT:** 4081 vehicles, volume of heavy truck traffic: 5%
- **Condition of the main structural components:** Structure is in overall poor condition. Advanced deterioration on the deck and substructure, including severe shear cracking. Superstructure has spalled concrete with exposed rebar.
- **Scour:** none
- **Economic impacts:** major impact
- **Is Located on:** NHS
- **Replacement Cost Estimate:** \$4,363,500

The Solon, Main Street Bridge #2504 is an 89-year old, single span, cast-in-place concrete T-beam bridge built in 1931 with a concrete deck, reinforced concrete wearing surface, concrete bridge rail, and a raised concrete sidewalk. The bridge is sitting on pre-existing stacked stone abutments with reinforced concrete cast-in-place facing that was added in 1931 when the previous crossing was replaced by this bridge. The substructure is founded on bedrock.

The T-beam superstructure is in fair condition with spalled concrete and exposed rebar with rust staining. The concrete deck is in poor condition and the underside of the deck has several large areas of full depth patching with areas of cracking and efflorescence. The concrete sidewalk is in satisfactory condition; however, it is only 3' wide and does not meet ADA compliance. Fifteen percent of the concrete wearing surface shows signs of cracking.

The substructure is in poor condition. There is a 4" gap between the south wingwall and the abutment. Abutments have moderate cracking throughout, with isolated to severe shear cracking. There are areas of spalled concrete on the north abutment with exposed rebar and heavy cracking and scaling in the wingwalls.

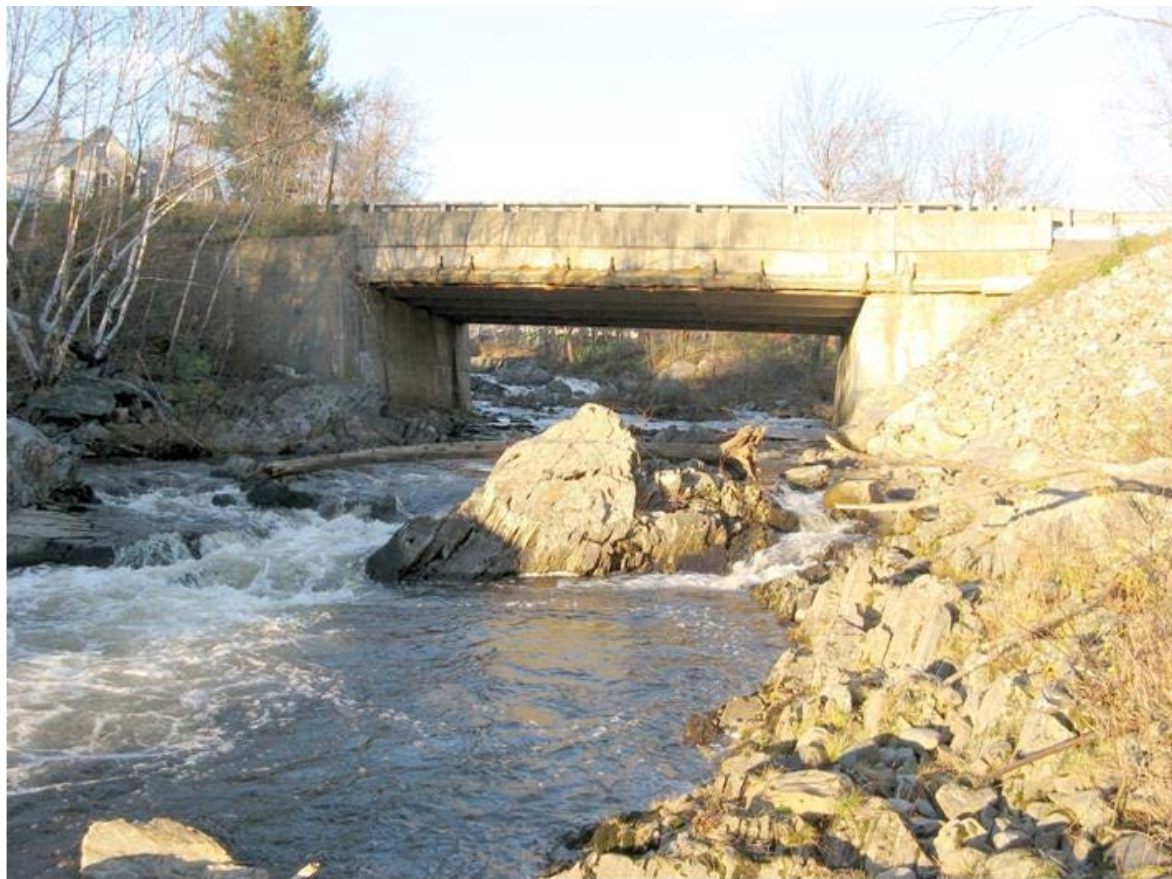
Looking upstream.

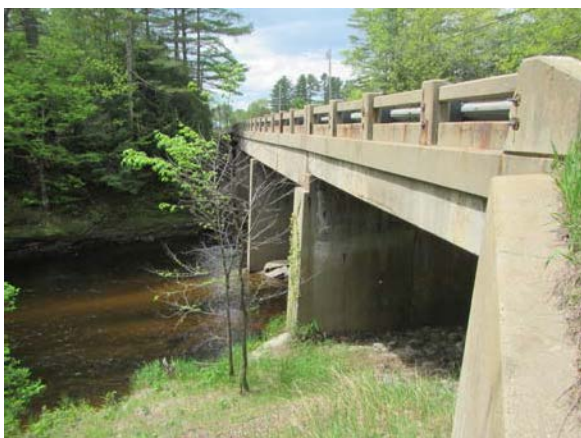
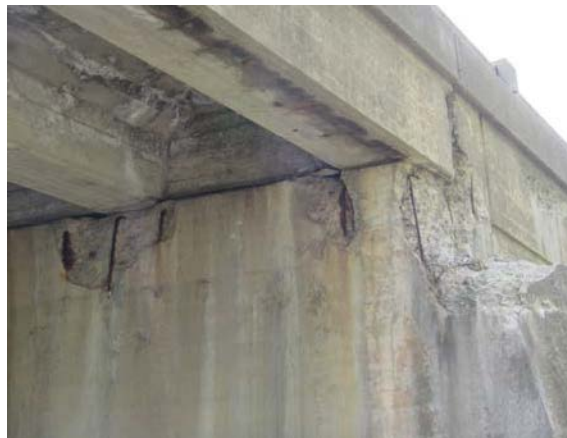
Bridge Structure: Multi Span, Concrete Tee-Beam, 2 lane roadway with concrete deck and bituminous concrete wearing surface. 165' long by 30.4 wide, curb to curb.

Condition Ratings: Deck = 4 Poor, Superstructure = 5 Fair, Substructure = 4 Poor with channel condition rating 6- Bank Slump

- **Bypass detour length:** 52 miles; moderate impact
- **ADT:** 4239 vehicles, volume of heavy truck traffic: 5%
- **Condition of main structural components:** Structure is in overall poor condition. Severe cracking and delamination on the deck. Superstructure has delamination, deep spalling and exposed rebar. Tee-Beams under current wheel path have large sections of spalling/exposed rebar. Substructure has severe including cracking, spalling and exposed rebar.

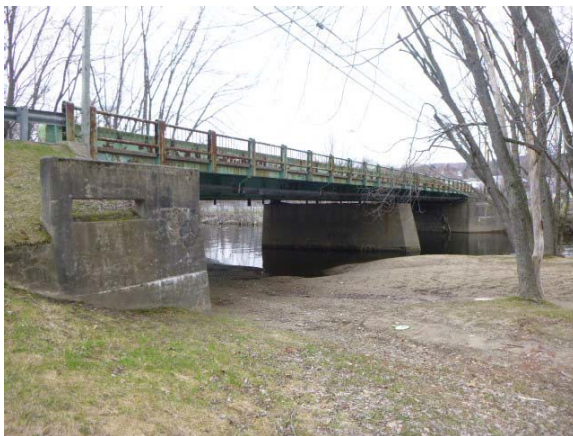
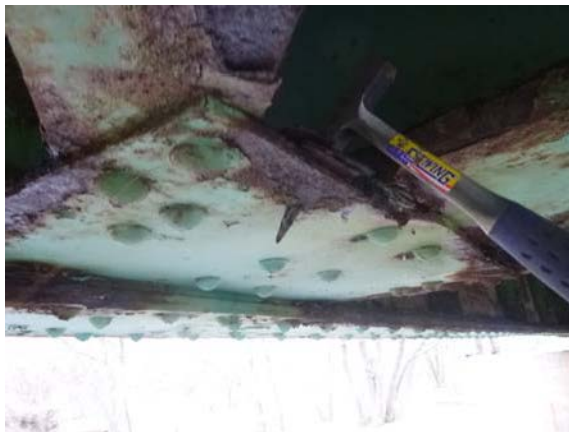
Bridge Structure: Steel two span riveted thru girder and floor beam system, 2 lane roadway with concrete deck and integrated concrete wearing surface. 176' long by 28.1' wide, curb to curb.

Condition Ratings: Deck = 4 Poor, Superstructure = 4 Poor, Substructure = 6 Satisfactory. Channel condition rating 6- Bank Slump

- **Bypass detour length:** 0 miles; minor to moderate impact
- **ADT:** 10,165 vehicles, volume of heavy truck traffic: 5%
- **Condition of main structural components:** Structure is in overall poor condition. Advanced spalling and delamination on the deck. Superstructure has heavy rust pack with warping between rivets on the bottom flanges. Holes at web stiffeners at roadway and bottom flange areas. Protective coating failure. Deterioration of concrete abutments. West abutment of footing is moving. Minor rip rap damage in the channel.

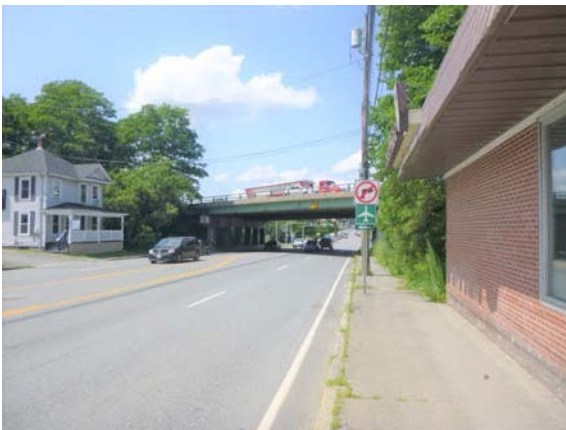
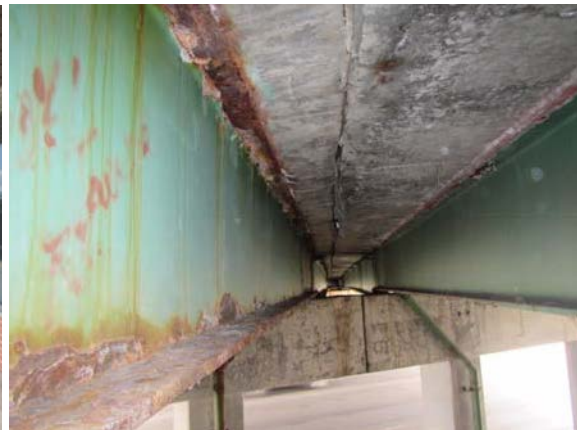
Bridge Structure: Multi Span Steel multi girder, 4 lane roadway with concrete deck and bituminous concrete wearing surface. 157' long by 90.1' wide, curb to curb.

Condition Ratings: Deck = 4 Poor, Superstructure = 6 satisfactory, Substructure = 5 fair.

- **Date of last inspection report:** 8/1/19
- **Repair history:**
- **Bridge Posting:** N/A
- **Traffic Safety Features:** does **not** meet currently acceptable standards
- **Presence of fracture critical members:** No
- **Functional Classification:** Urban - Principal Arterial – Interstate, on NHS
- **Bypass detour length:** 1 mile; severe impact
- **ADT:** 25,340 vehicles, volume of heavy truck traffic: 5%
- **Condition of the main structural components:** Structure is in overall fair/poor condition. Deck has several areas of spalling and exposed rebar. Superstructure has scattered paint failure. Two fascia girders have collision damage. Abutments have moderate cracking with efflo. Pier caps are cracked. Previous pier repairs are delaminating.
- **Scour:** N/A
- **Economic impacts:** major impact
- **Is on:** NHS and on STRAHNET
- **Replacement Cost Estimate:** \$20,177,500

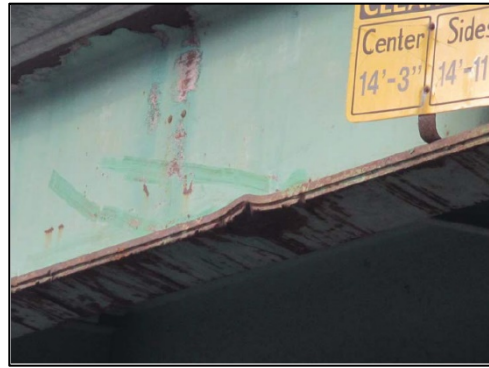
Geometric Constraints – a November 2017 bridge inspection evaluation reported impact damage to the two southerly facias girders of the center span. With Broadway being a main traffic artery for the city of Bangor, ME and the I-95 overpass providing substandard vertical clearance the likelihood of impact damage like this occurring is compounded. The 14 feet, 5 inches of vertical clearance provided is insufficient to support modern freight vehicles safely or efficiently, and currently requires large vehicles to detour away from the bridge, which places increased traffic demands on smaller roadways.

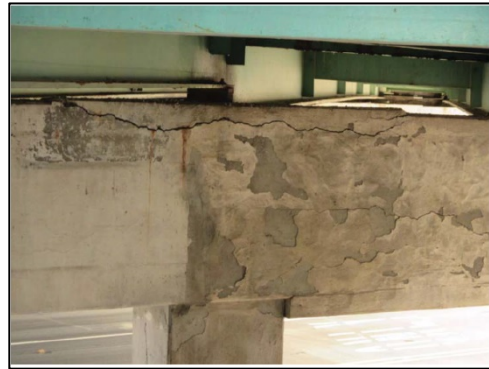
Poor condition of structural members – in general the steel girders have scattered surface paint failure and minor section loss at their ends; with the girders at pier joints experiencing extensive paint loss and rust. The concrete deck is in fair condition with scattered spalls, delaminations, cracking, exposed rebar, and efflorescence. Deck concrete at the pier joints has extensive cracking and spalling. The piers are in fair to poor condition with map cracking throughout the pier caps. Previous repairs are deteriorating/delaminating, and several cracks have formed directly under the bearings. Pier columns have scattered large areas of delaminations and vertical cracking. Overall the structure is functionally obsolete with advanced stages of deterioration that will require extensive rehabilitation or complete replacement soon.

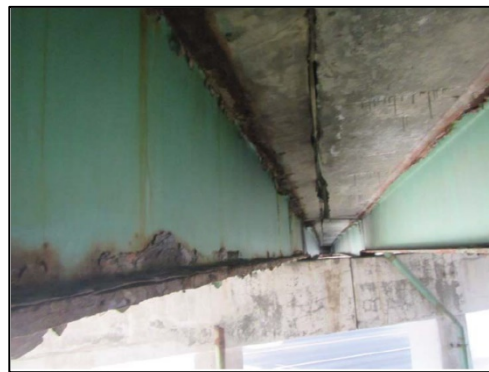
Extensive Deteriorating Repairs and Retrofits – the bridge has undergone numerous repairs over its 60-year service life. The original finger joint was replaced after 7 years, in 1967. In 1982 the bridge received a new concrete parapet and aluminum rail, as well as, new compression seals over both piers. There has been repair work done to both piers and abutments, assumed to be completed in the mid-1990s, which has since begun to deteriorate and delaminated.

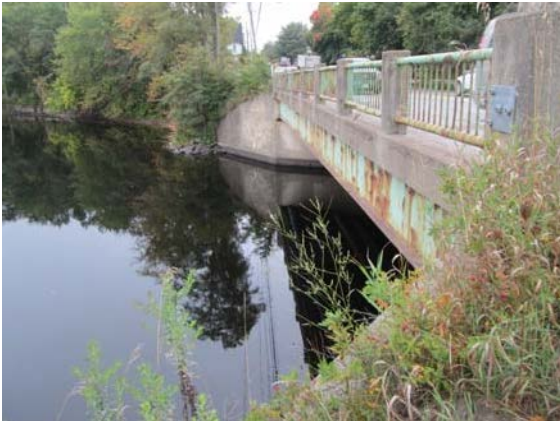
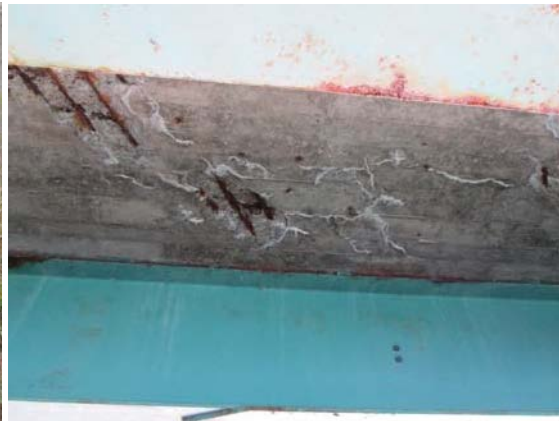
Bridge #1472- Stillwater # 1. Carries Stillwater Ave. over South Channel of the Stillwater River in Old Town.

Bridge Structure: Steel multi girder, two lane roadway with concrete deck and monolithic concrete wearing surface. 89' long by 36' wide, curb to curb.

Condition Ratings: Deck = 4 Poor, Superstructure = 6 satisfactory, Substructure = 5 Fair. Channel condition rating 5

- **ADT:** 16,728 vehicles, volume of heavy truck traffic: 5%
- **Condition of the main structural components:** Structure is in overall fair condition. Deck has advanced spalling with joint headers having cracking and seal plow damage. Superstructure has 30% paint system distress, bearing at west abutment not aligned. Vertical cracks on both abutments. Washout behind wing walls.

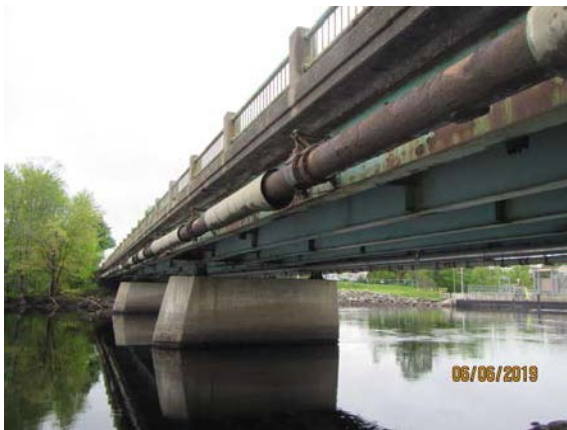
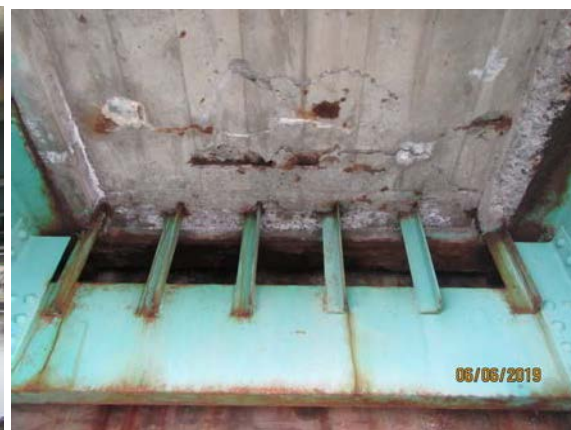
Bridge #2806- Stillwater # 2. Carries Stillwater Ave. over the North Channel of the Stillwater River in Old Town.

Bridge Structure: Multi Span Steel multi girder, 2 lane roadway with concrete deck and monolithic concrete wearing surface. 254' long by 26' wide, curb to curb.

Condition Ratings: Deck = 4 Poor, Superstructure = 6 satisfactory, Substructure = 6 Satisfactory. Channel condition rating 4- Protection severely undermined

- **Bypass detour length:** 2 miles; moderate impact
- **ADT:** 16,728 vehicles, volume of heavy truck traffic: 5%
- **Condition of the main structural components:** Structure is in overall poor condition. Deck has scattered areas of pop outs and exposed rebar and delamination. Superstructure has 25% paint system distress and moderate rusting at high exposure areas. Bearings have moderate to severe section loss. Abutments have minor cracks at seats and breast walls have heavy cracks at bearing areas. S. abutment exposed pile has been covered with rip rap. Moderate rip rap damage.
