# Class B Soil Map Report for 285 Northport Road, Belfast, Maine

**March 2019**

Appendix D-Class B Soil Map

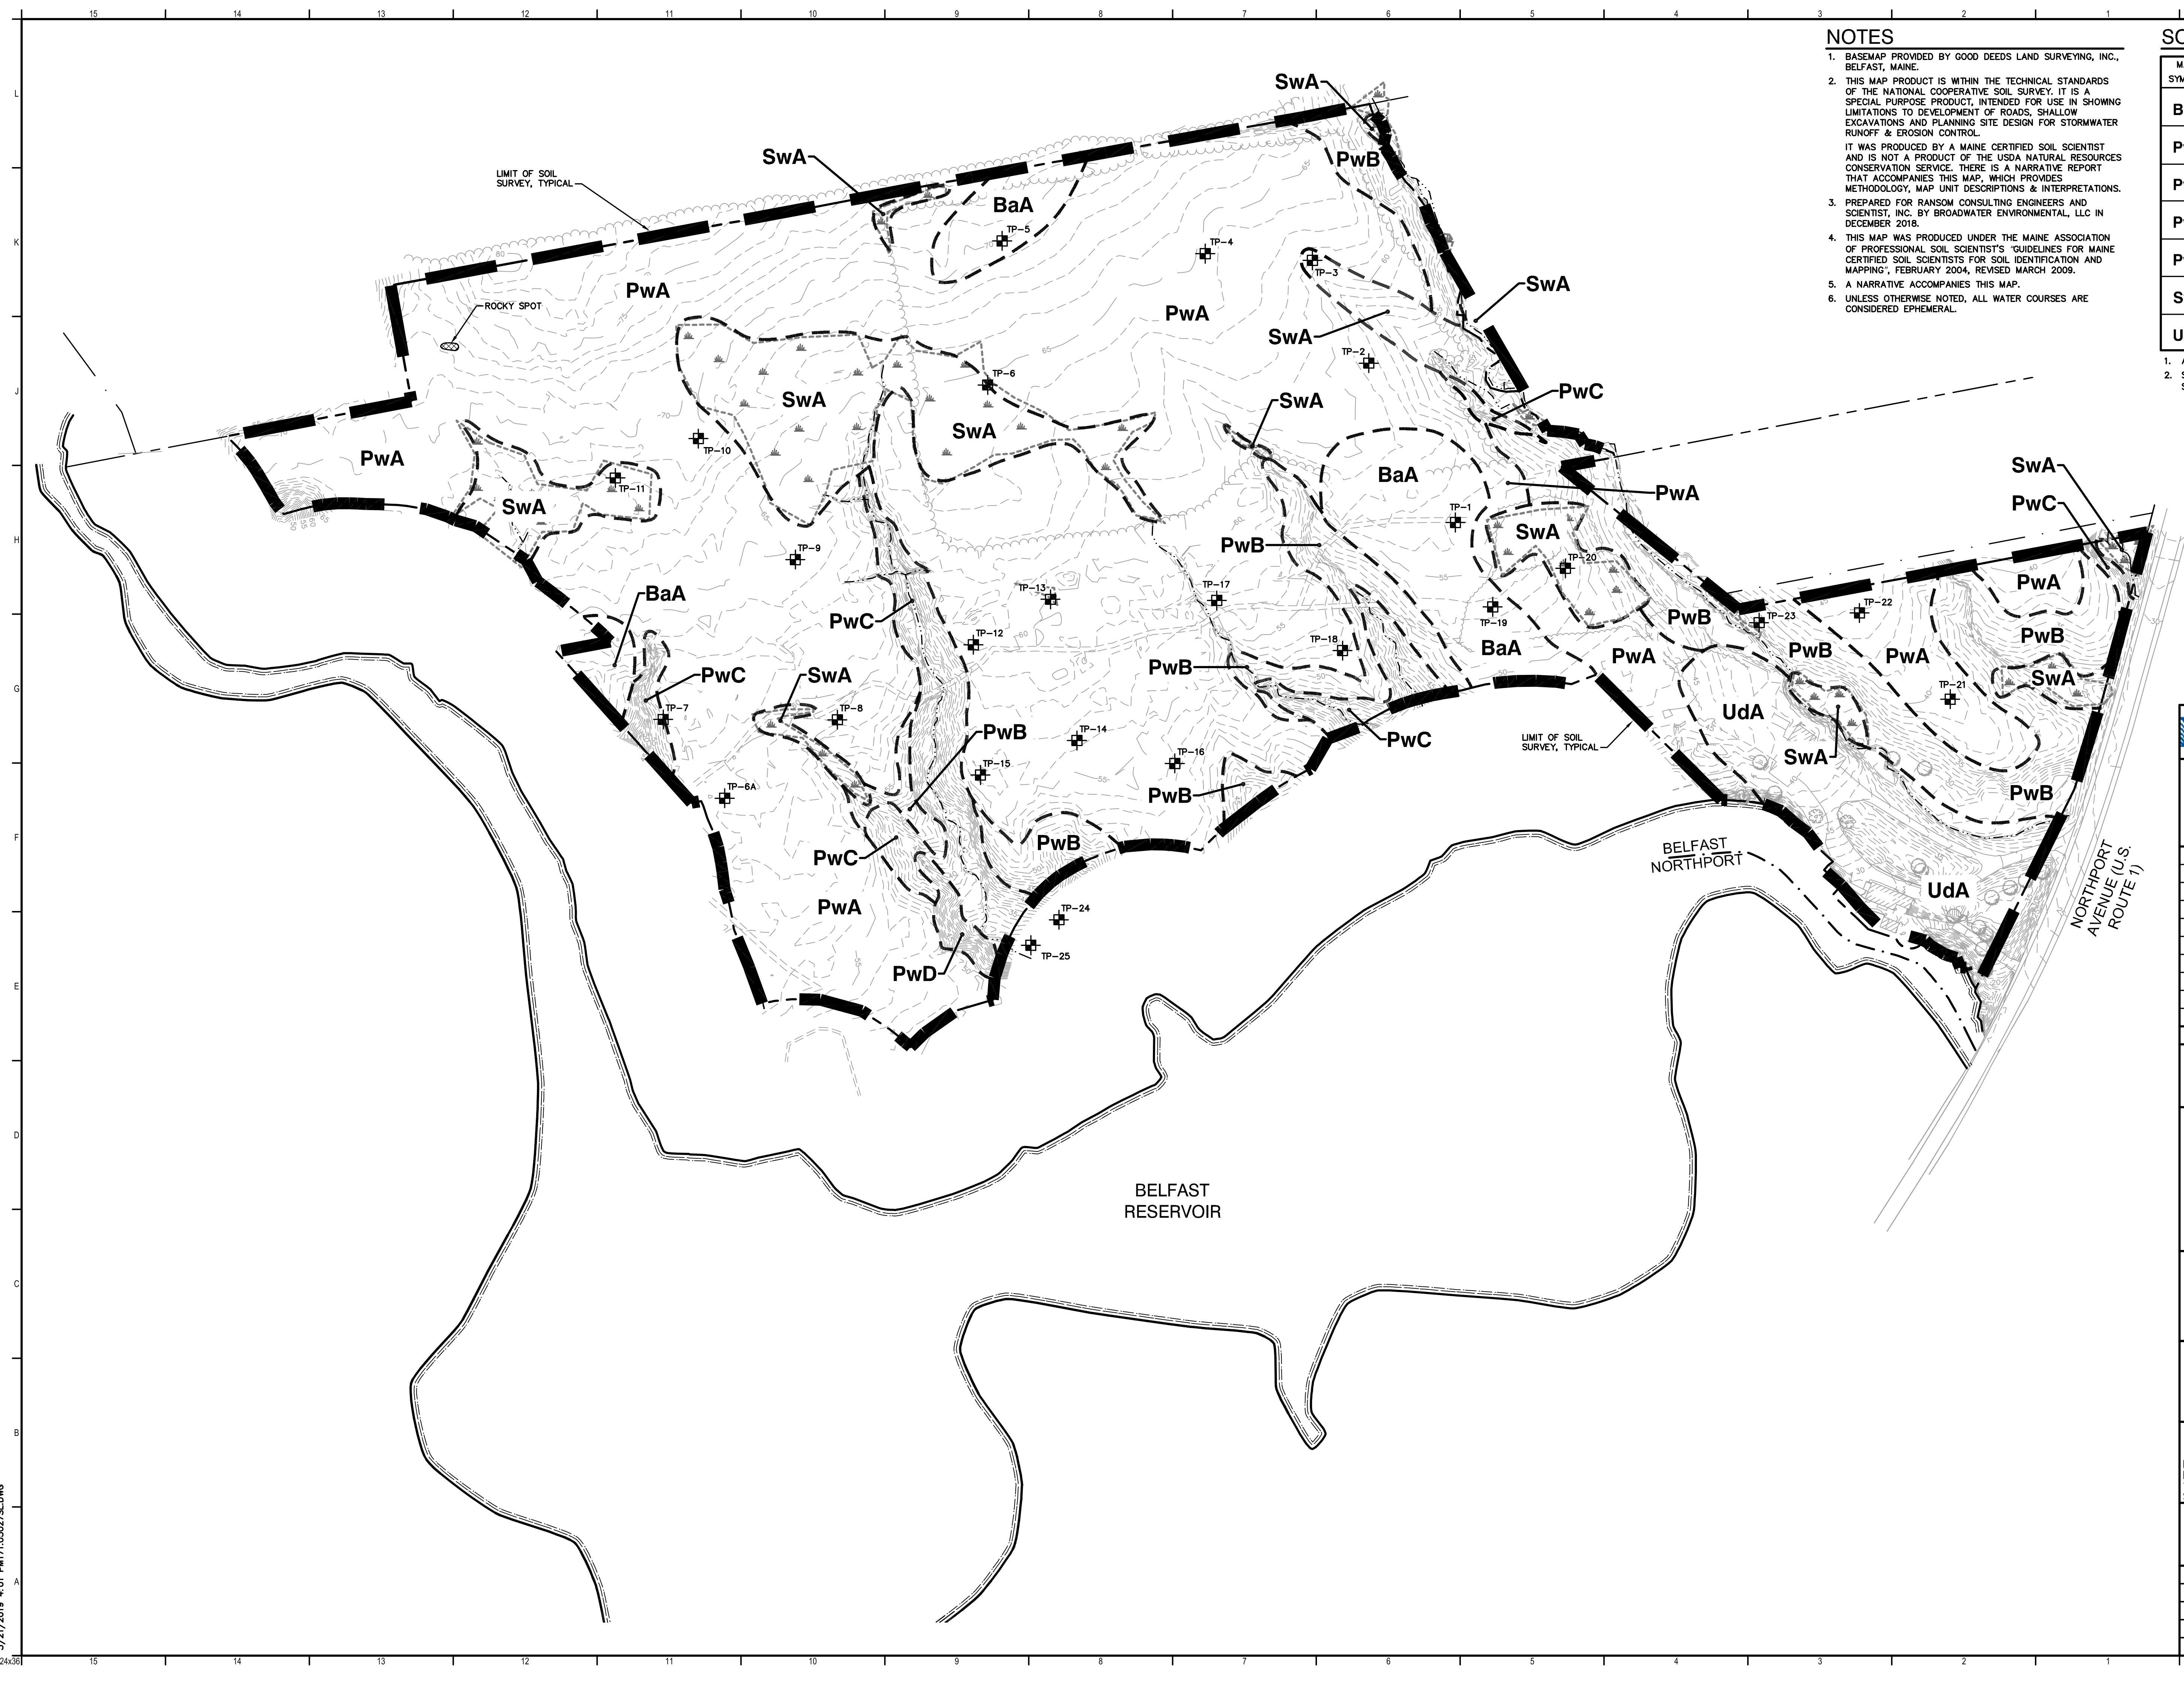
# SOILS KEY

MAP	MAP UNIT	SLOPE	HYDROLOGIC
SYMBOL		(%)	GROUP
BaA	BOOTHBAY SILT LOAM	0-8	C2
PwA	PUSHAW SILT LOAM	0-8	C/D
PwB	PUSHAW SILT LOAM	8–15	C/D
PwC	PUSHAW SILT LOAM	15–25	C/D
PwD	PUSHAW SILT LOAM	25–35	C/D
SwA	SWANVILLE SILT LOAM	0-8	D
UdA	UDORTHENT	0–15	D

A majority of the undeveloped portion of the site was found to be Pushaw silt loam, a somewhat poorly drained soil related to Boothbay silt loam by having the same parent material; marine sediment with a like mineral composition. Areas of Boothbay silt loam, a moderately well drained soil, were also found on the site as well but comprised much less of the site than Pushaw silt loam. It should be noted that when the NRCS mapped this area of Maine, Pushaw silt loam was not a recognized soil series which likely explains its absence on the NRCS mapping. Appendix A contains a description of the soil series and the characteristics of their occurrence on this site.

Wetlands identified by Normandeau (Normandeau, 2018) in 2018 on the site were found to contain Swanville silt loam, a poorly drained, hydric soil that is also derived from the same parent material. Swanville was also found in small amounts in select locations of ravines that are present on the site as discussed below.

**Pushaw silt loam-** This soil series, a somewhat poorly drained soil derived from marine sediments, was mapped on a majority of the undeveloped portion of the site. Several different slope phases were observed for this soil series up to a D class slope in the southwest portion of the site, along a ravine. A majority of the area mapped as Pushsaw was fairly level with a slope of less than 8%. However, along the ravine landscape features, slopes ranging from 10% to 35% were observed. Included in this map unit are small areas of Boothbay silt loam and Swanville silt loam as well as recent alluvium in the intermittent stream segment.

**Swanville silt loam-** This soil series was found in the wetlands mapped by Normandeau. This soil is a poorly drained hydric soil that forms in marine sediment. It is related to Boothbay and Pushaw by mineral composition of the parent material. A large map unit of this series was found in the center of the site in a forested wetland. Included in this series are small inclusions of Pushaw silt loam and Swanville silt loam.

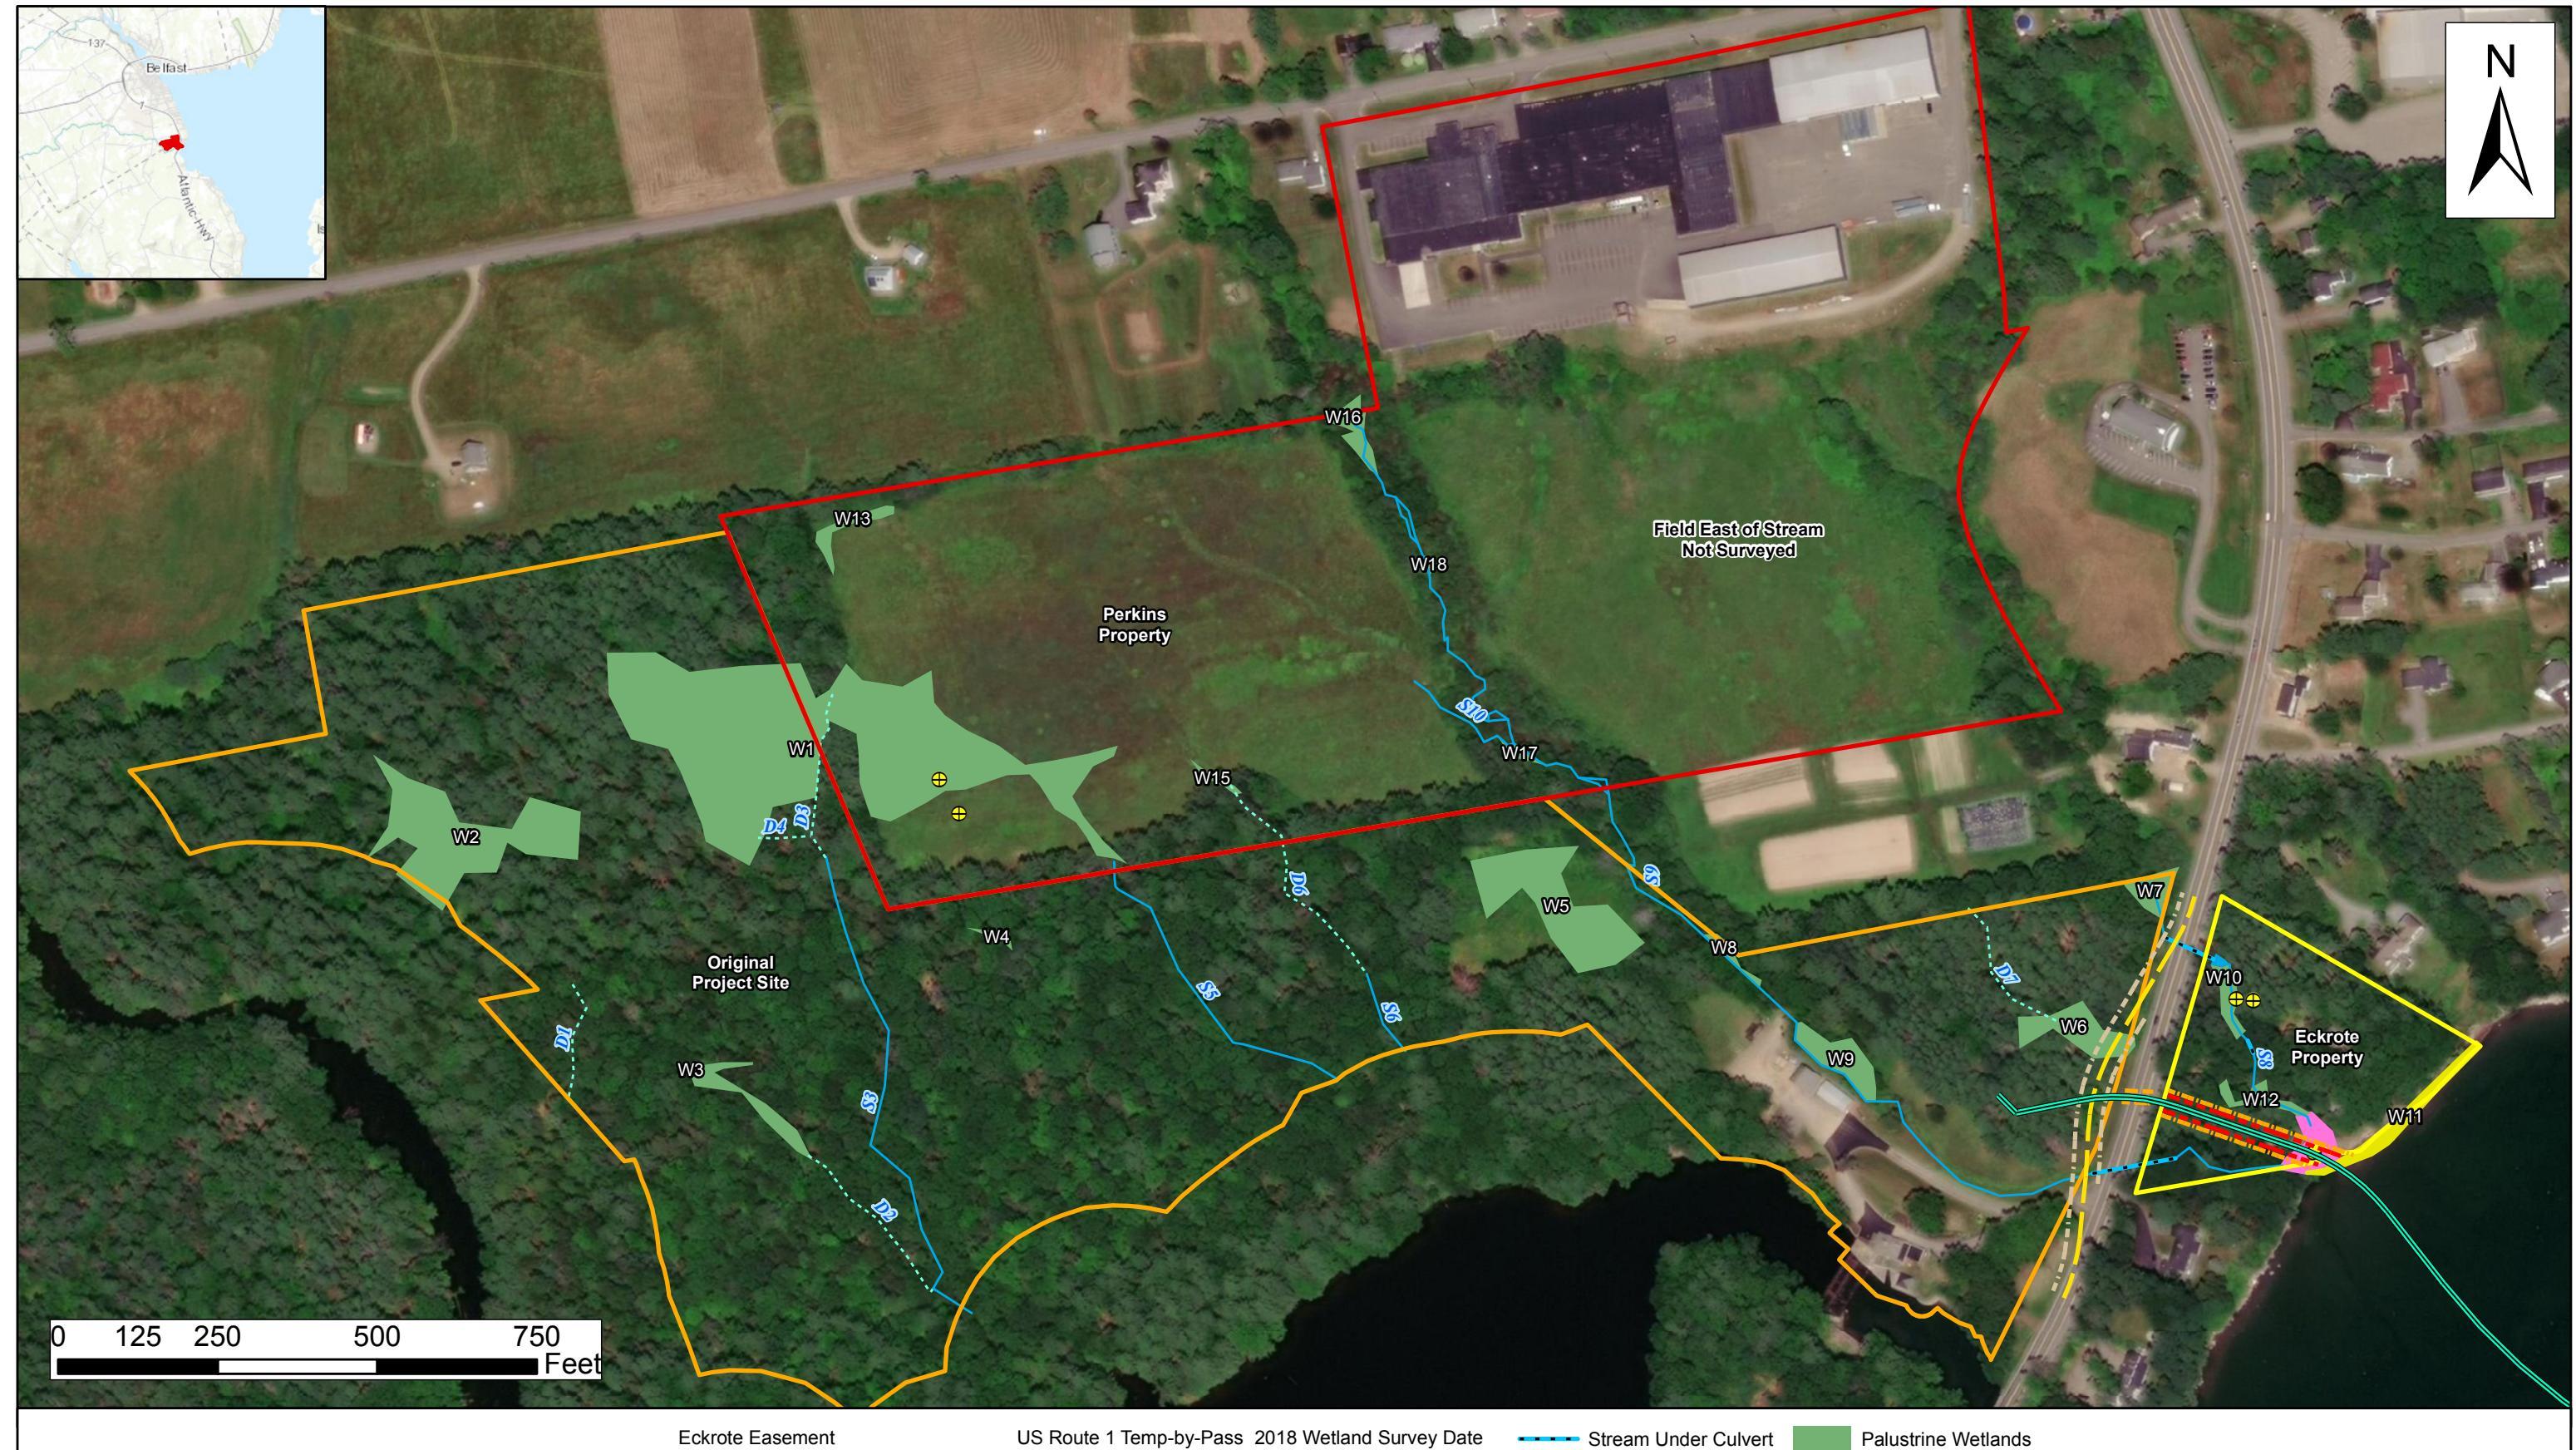
Appendix E-Water Courses Figure By Normandeau

**Belfast Aquaculture Project** Wetland and Stream Survey

S3, S5, S6, S8, and S9 all contained flowing water. With the exception of S8, streams were covered with approximately 2 inches of ice, but flows could either be heard underneath the ice (S6 and S9) or a small hole broken through the ice layer allowed for sampling of the streambed beneath the frozen channel (S3 and S5). During the aquatic fauna survey, snails were located on the undersurface of rocks within the channel of S8, meeting the criteria for aquatic animals. These streams also had flowing water in December, January, and May and at this time it is reasonable to conclude that they meet the 6 months of continuous flow criteria, and are therefore jurisdictional.

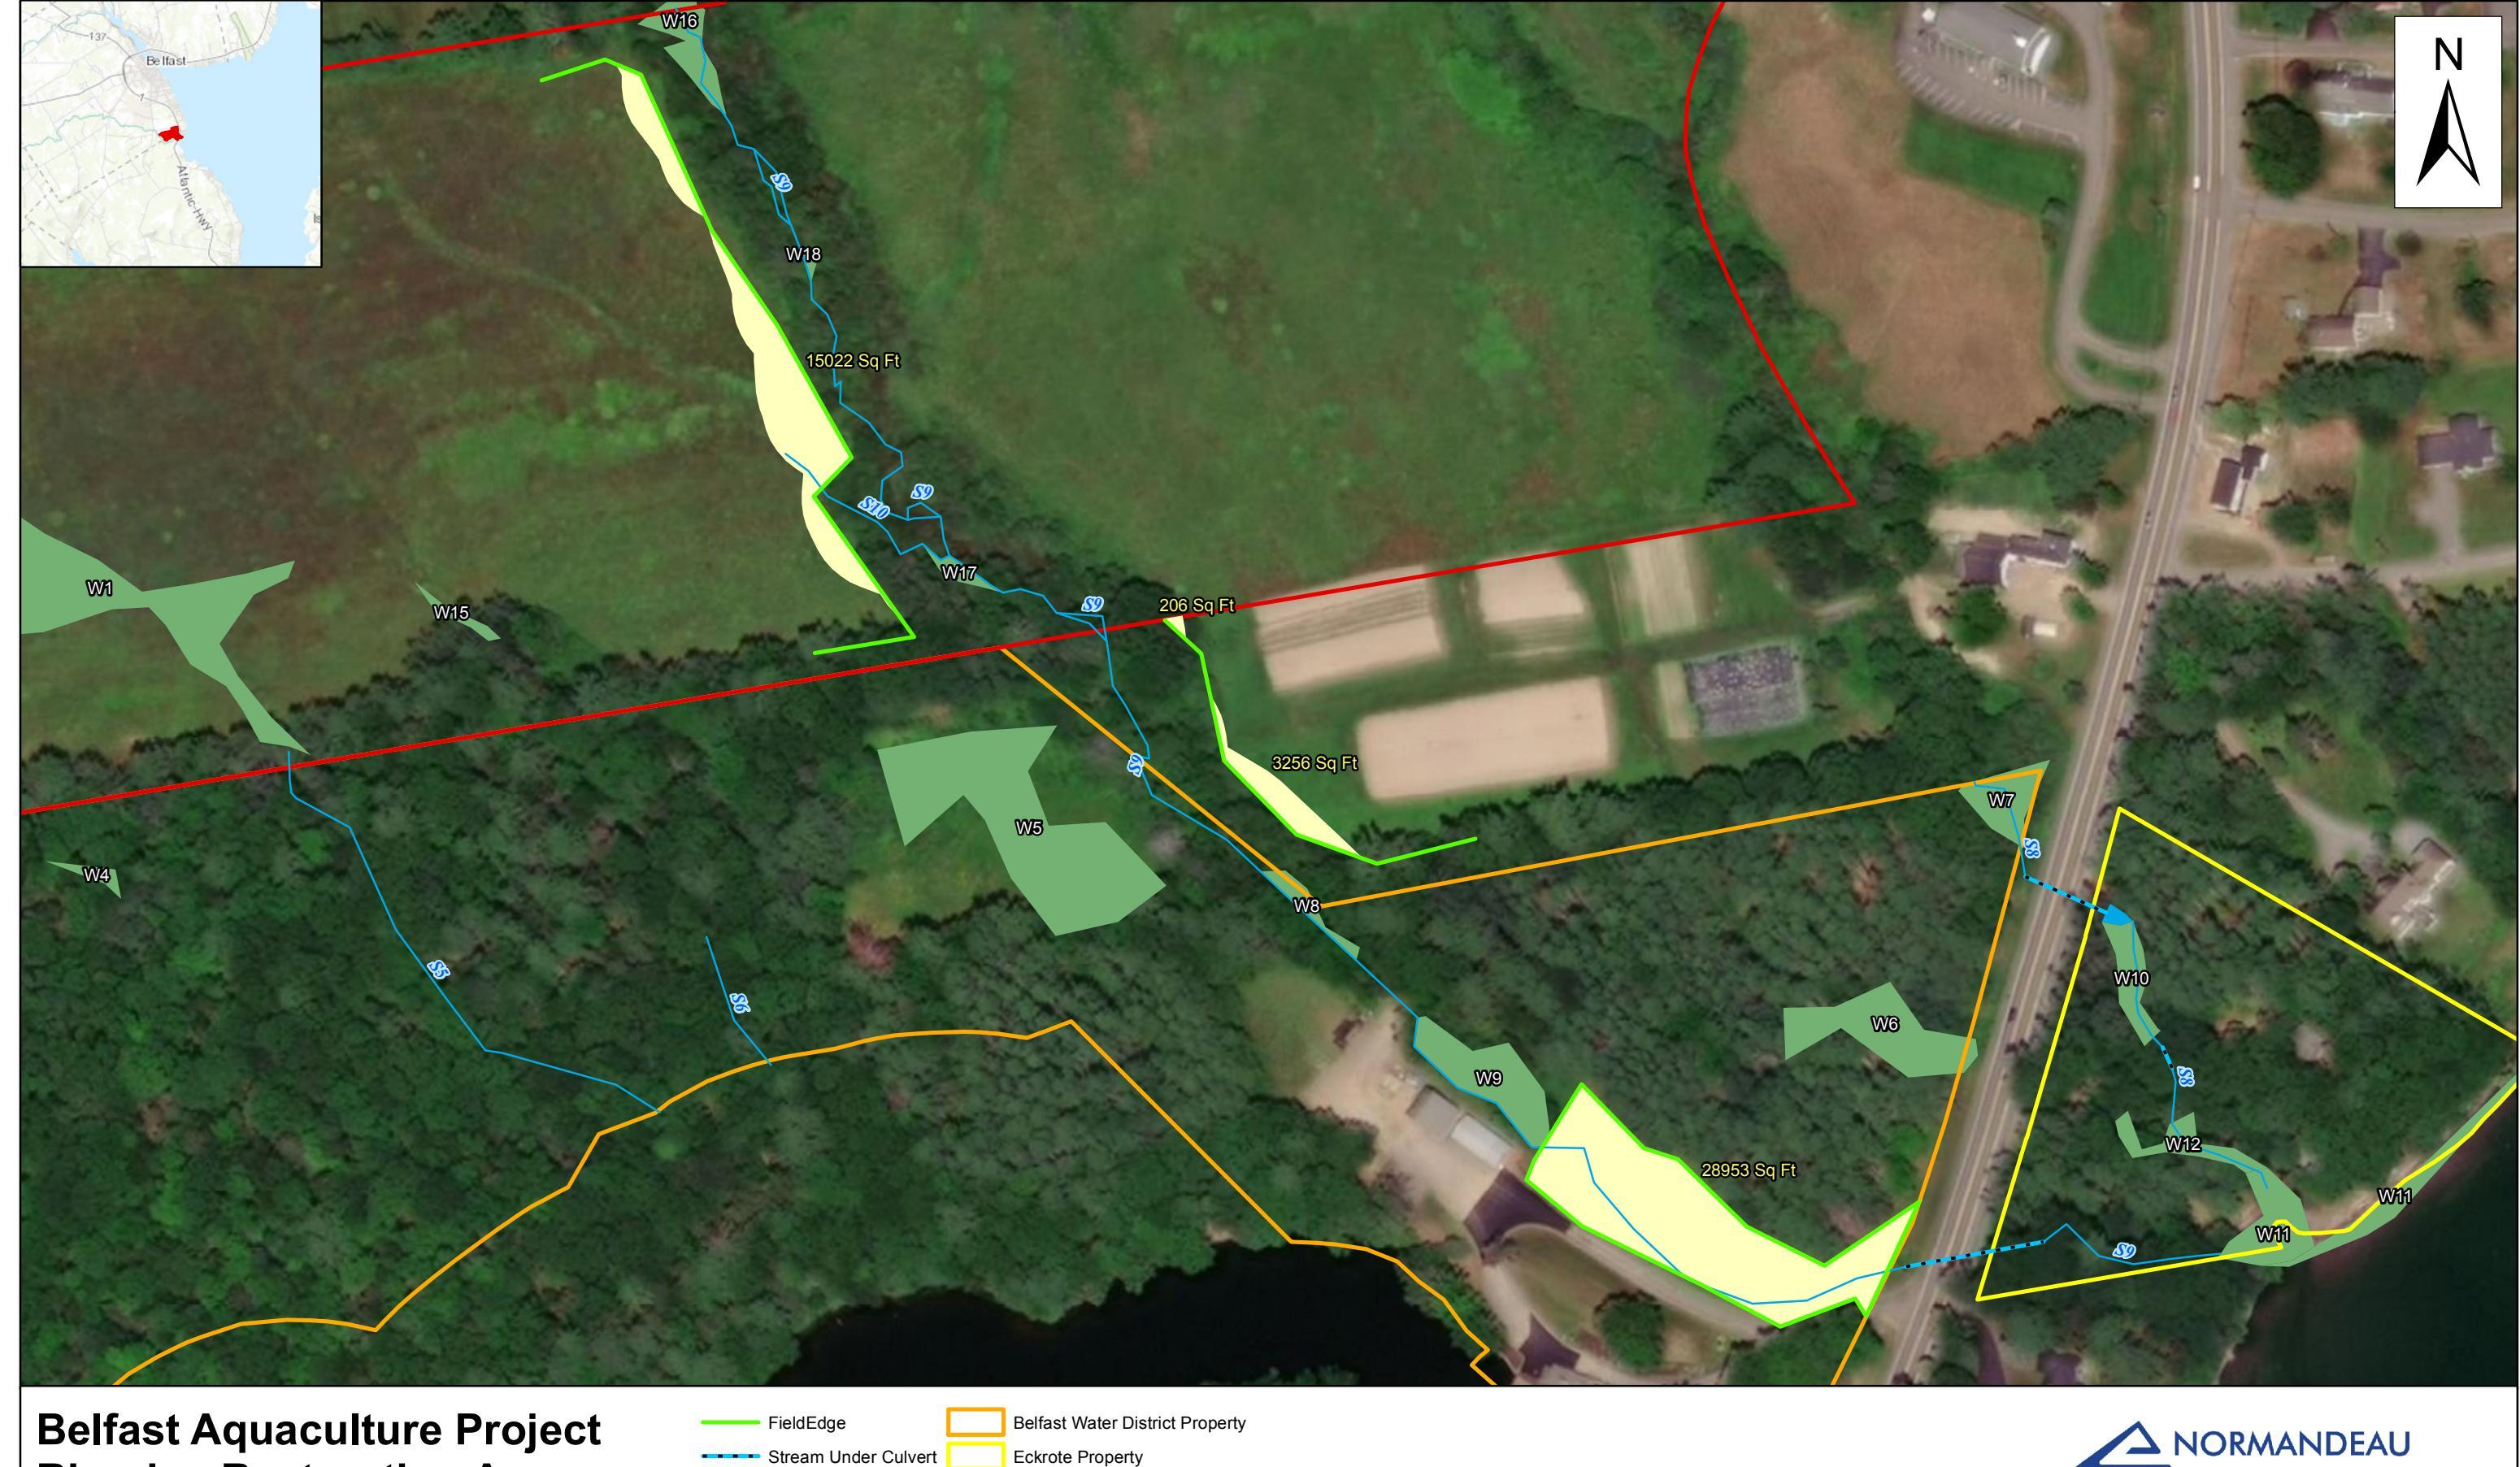
Belfast Aquaculture Project Riparian Restoration Areas

FieldEdge
 Stream Under Culve
 Intermittent
Restoration Area

Due to the season, riparian vegetation was limited primarily to woody species. Dominant species within the riparian area include red maple and quaking aspen in the tree stratum and multiflora rose and speckled alder in the shrub stratum. Other species noted in the riparian zone included black ash, red oak, paper birch, meadowsweet, white pine, rough-stemmed goldenrod, and sensitive fern. During the August field review, spotted touch-me-not was also noted as being dominant in the riparian area. A map showing the riparian planting locations is attached, which total approximately 1 acre.
