# Coastal Bluffs

# Wiscasset Quadrangle, Maine

## Open-File No. 02-222

## Types of Bluffs Along Maine's Coast

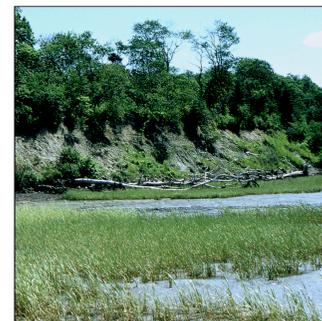
Highly unstable bluff with an unvegetated bluff face and a salt marsh shoreline. Sediments on the bluff face are exposed and fallen tree trunks lie at the base of the bluff. A salt marsh has recently formed on the tidal flat, partly on the top of an old landslide deposit.

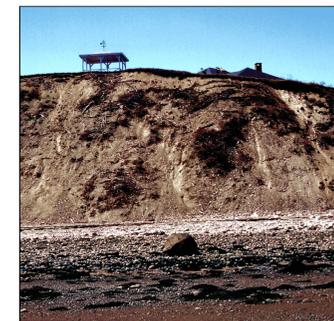
Highly unstable bluff with an unvegetated bluff face and a beach/gravel flat shoreline. The bluff face is too unstable to support vegetation. This bluff, a glacial esker, is eroded by waves to create a mixed sand and gravel beach in front of the bluff.

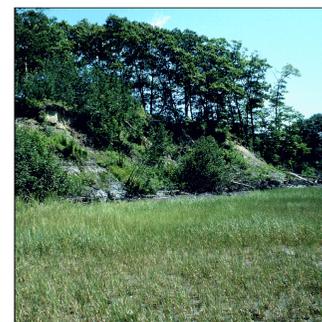
Unstable bluff with a partially vegetated bluff face and a salt marsh shoreline. This bluff, protected by a salt marsh, remains unstable. There are small bushes on the bluff as well as small non-vegetated areas that indicate continuing bluff retreat.

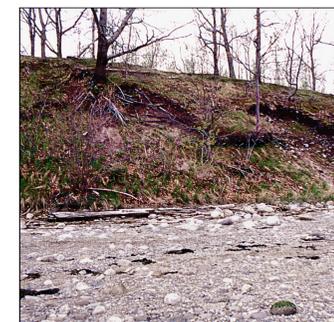
Unstable bluff with a partially vegetated bluff face and a beach/gravel flat shoreline. Slump scars on the bluff face expose sand, gravel, and roots. Fine sediments are removed by waves and currents, leaving gravel to form a beach at the base of the bluff.

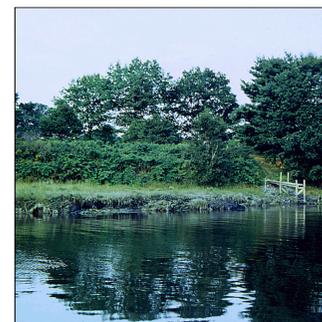
Stable bluff with a vegetated bluff face and a salt marsh shoreline. A low bluff face is covered by shrubs landward of a salt marsh terrace. In this location the mature marsh protects the base of the bluff from rapid erosion and slows bluff recession or retreat.
