SECOND CURRIER POND
T9 R11 Piscataquis Co.
U.S.G.S. Chase Lake, Me. (7 1/2')

Surveyed - August, 1974

Maine Department of Inland Fisheries and Wildlife

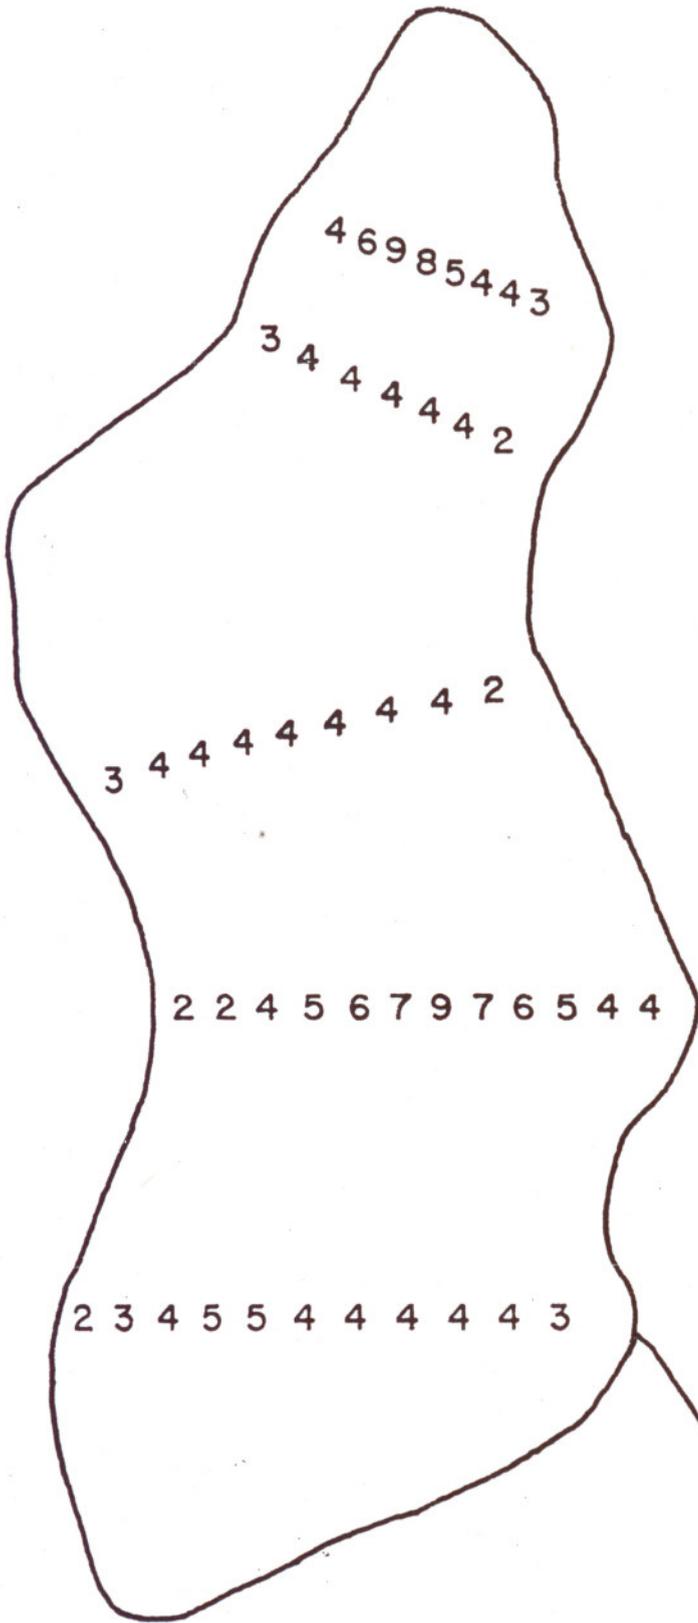
SECOND CURRIER POND
T9RII, PISCATAQUIS CO., ME.

AREA 28 ACRES

ONE TENTH MILE
