# PALMER POND

SOMERSET CO., MAINE

Mayfield Twp., Somerset County  
U.S.G.S. Foster Ridge, Maine (7½')

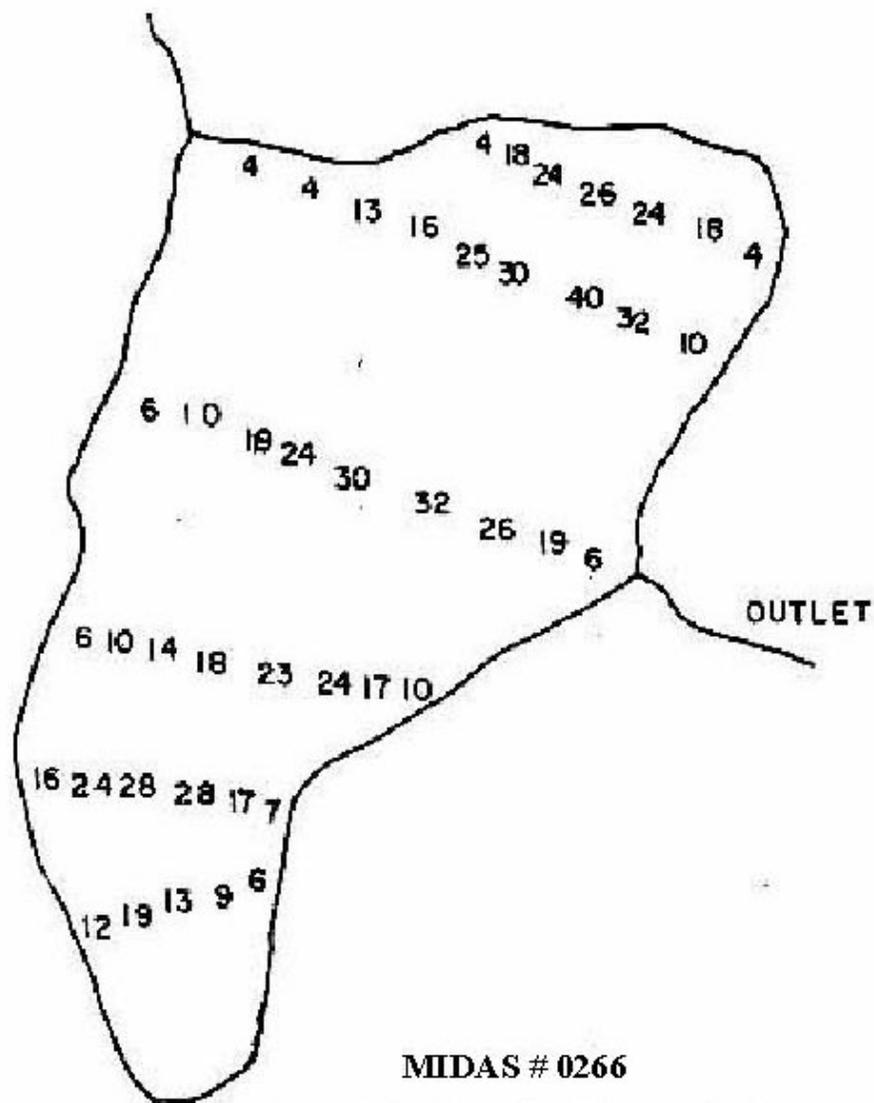
MIDAS # 0266

Area - 40 acres

Maximum depth - 40 feet

Temperatures:

Surface - 76°F

40 feet - 45°F

Palmer Pond is located south of Austin Pond. Its main inlet enters the northwest corner of the pond from nearby Little Palmer Pond. The pond's outlet, Palmer Stream, exits the southeast side and flows into the South Branch of Austin Stream. Its shoreline is undeveloped.

Water quality in Palmer Pond is good for coldwater gamefish. A limited amount of spawning gravel is located in the outlet and is utilized by the small native brook trout population. Trout growth is good despite heavy competition for food and space from other fish species. The pond is stocked annually to supplement the wild population and maintain an adequate fishery.
