PRETTY POND
T24 MD, Washington Co.
U.S.G.S. Tug Mountain, Me.

Surveyed - August, 1961

Maine Department of Inland Fisheries and Wildlife

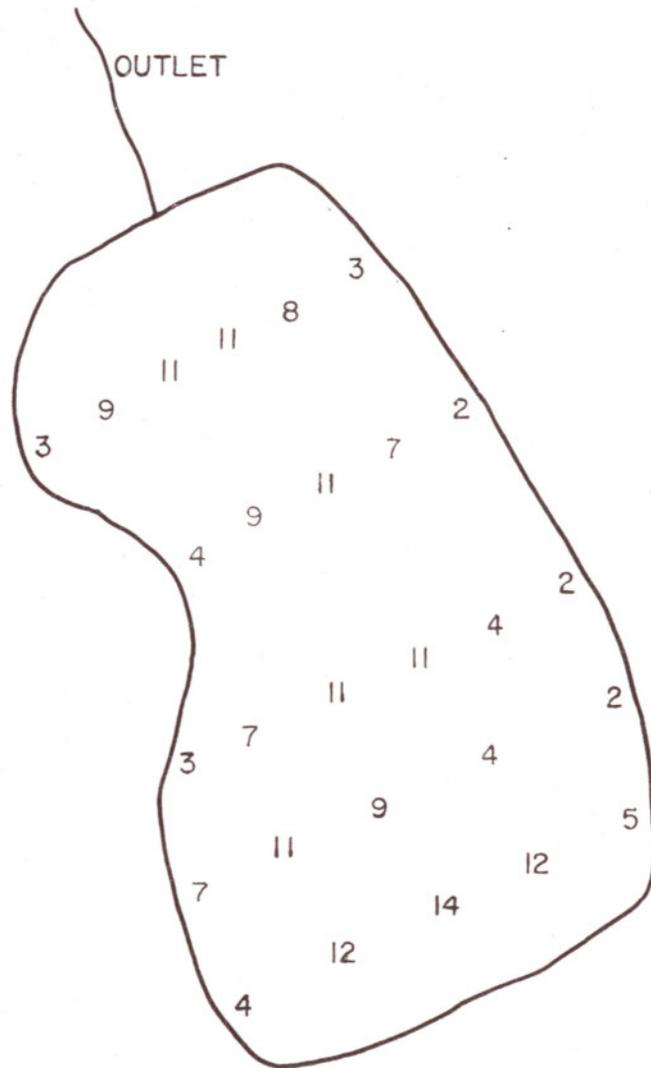
PRETTY POND

T24 MD, WASHINGTON CO., MAINE

27 ACRES

TENTHS OF MILES
